Inspection #66930086

COGCC Inspection Photographs: 30<sup>th</sup> September, 2015

EE3 LLC Photographs: 26<sup>th</sup> October, 2015

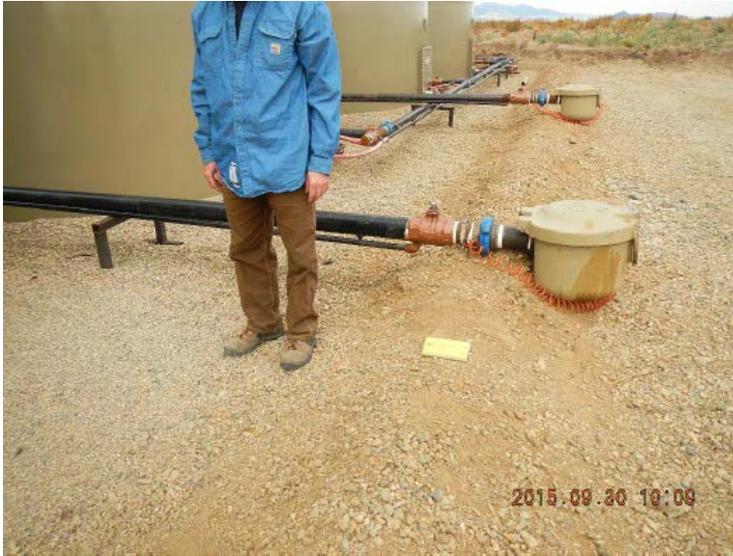
It is observed that low point is approximately 8-10" above pad surface.

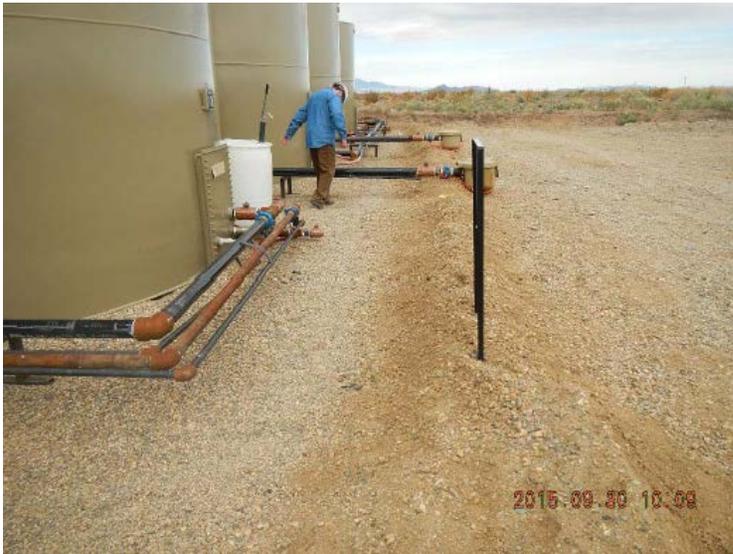
It is observed that low point is approximately 8-10" above pad surface.  
Note: No labels on tanks.

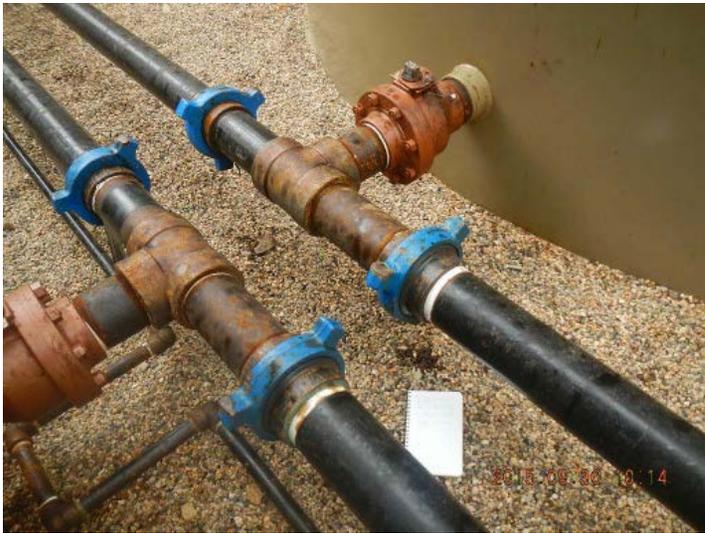
Spill below hammer union

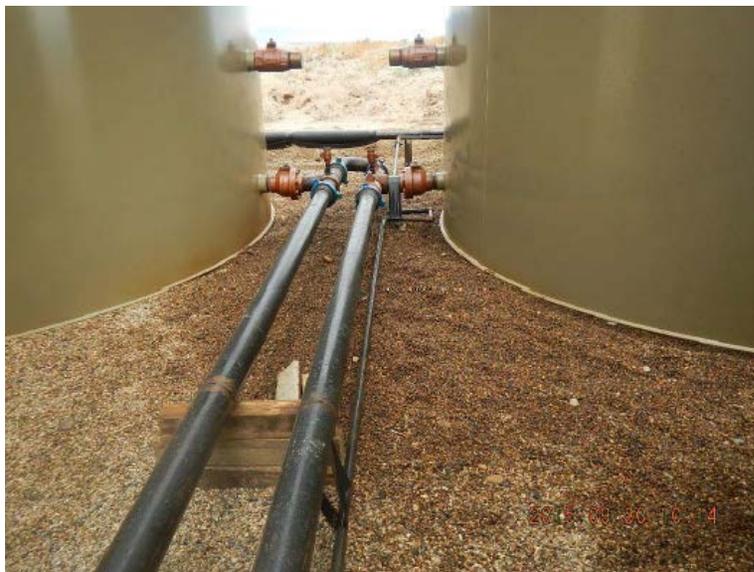
Discoloration of gravel on north side of tank battery

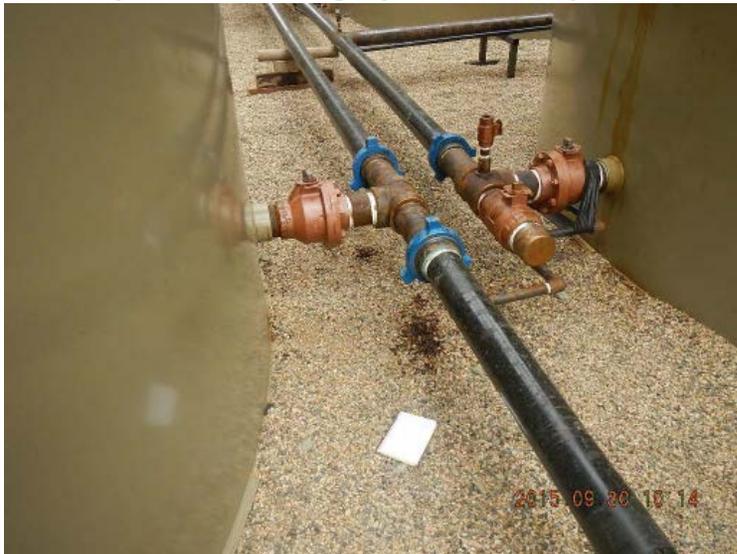
Spill below hammer union

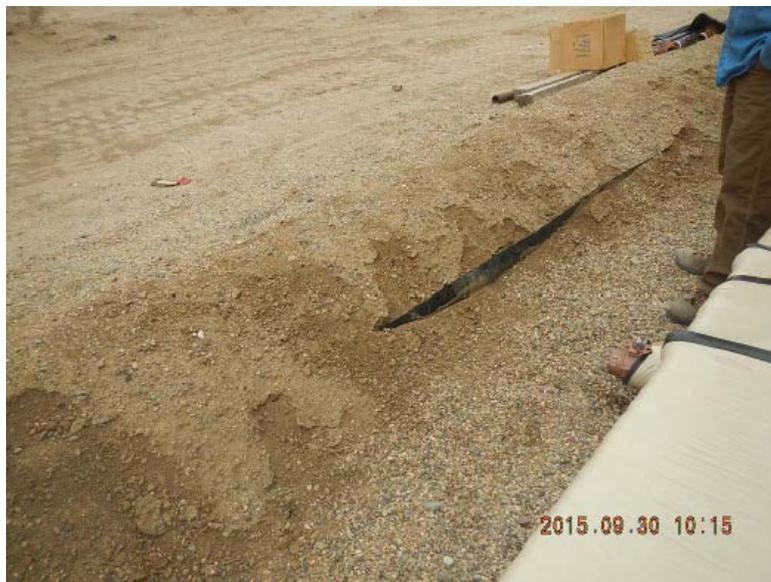
Liner day lighting on Westside of location

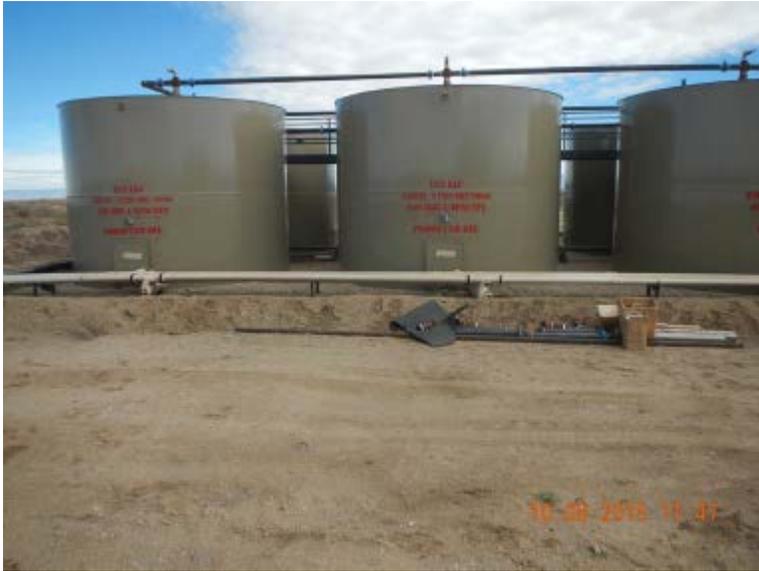
Two tanks without NFPA diamond, (Rest of tanks contain diamond). Trash in foreground outside berm.

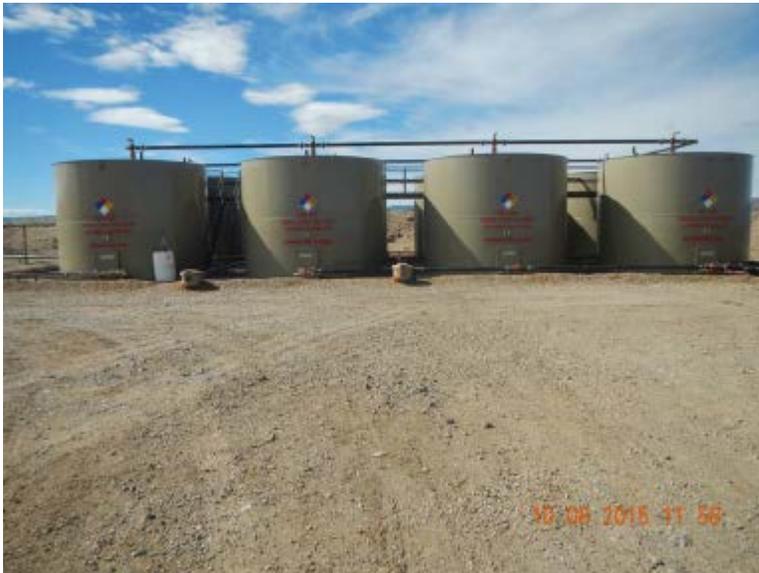
Tank battery with low spots at loadouts visible.

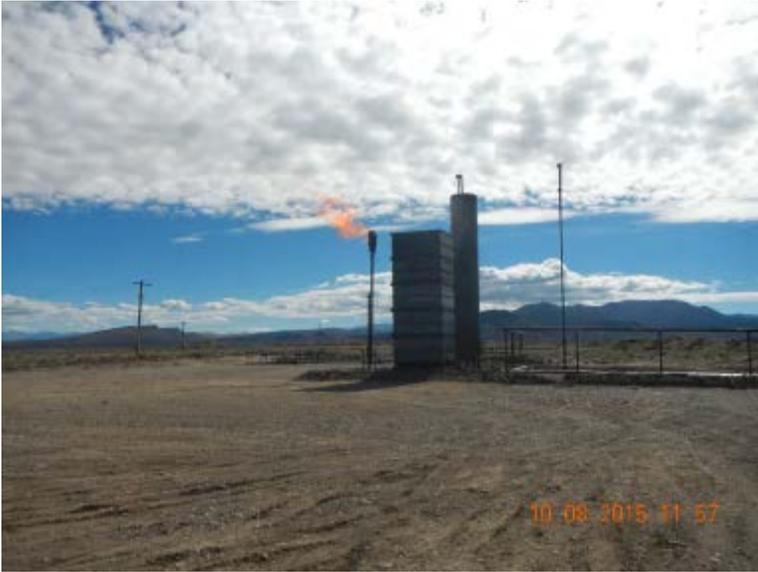
One enclosed flare, 1 unenclosed flare; both lit.

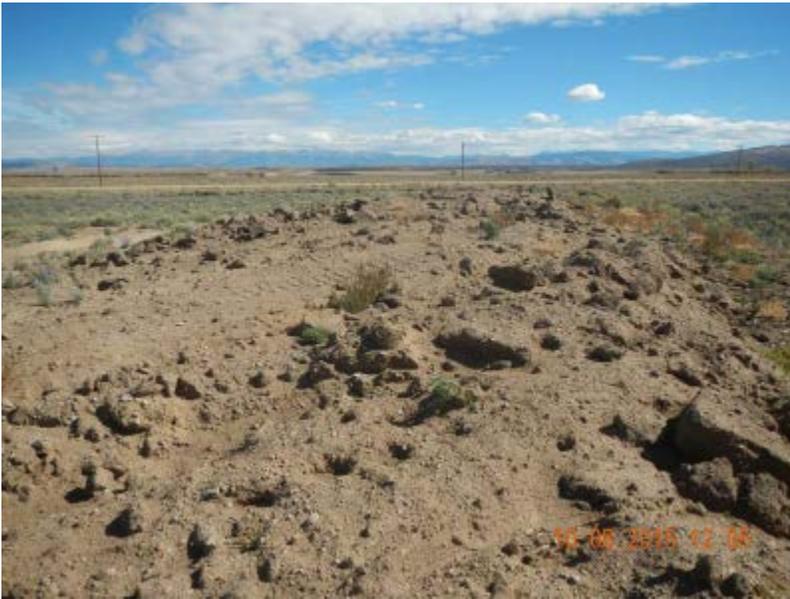
Topsoil pile on south side of location with no visible protection or preservation.

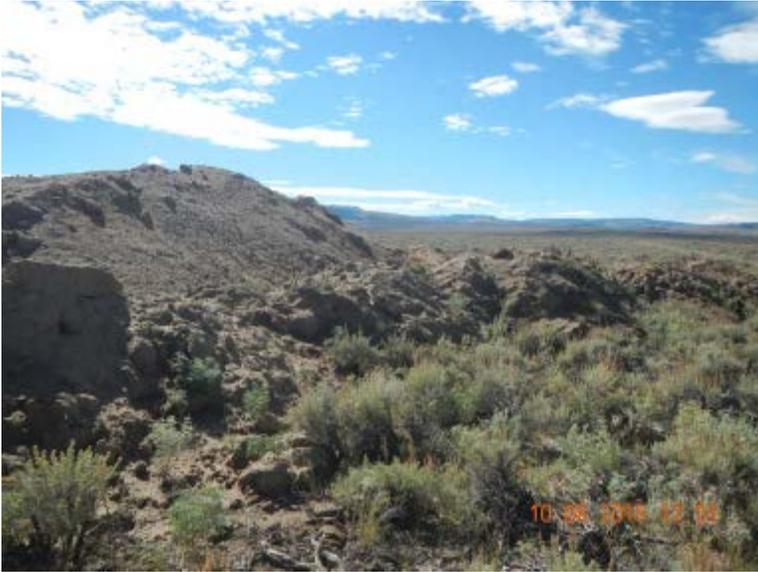
Topsoil pile on west side of location with o visible protection or preservation.

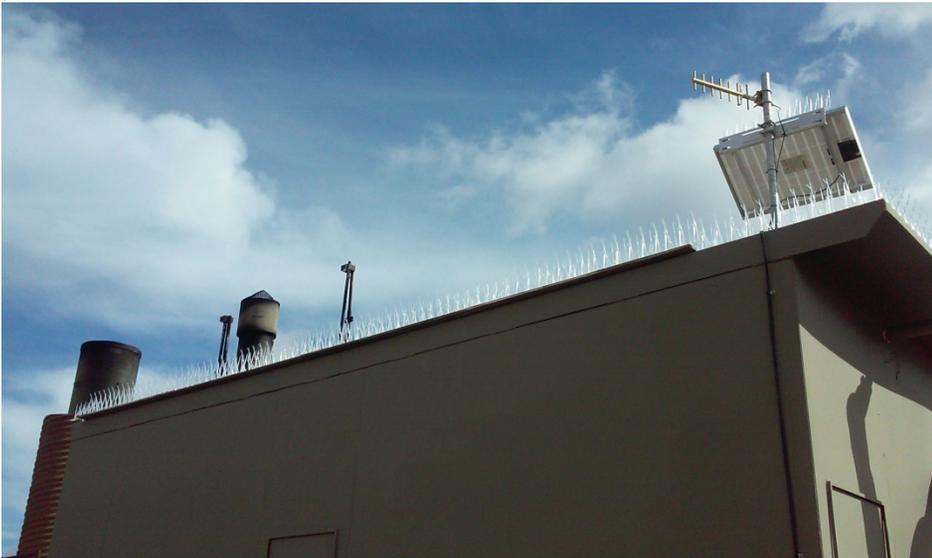
COA #5 – Install raptor perch deterrents on equipment, fences, cross arms and pole tops in greater sage grouse habitat.

Raptor perch deterrents have been installed.
