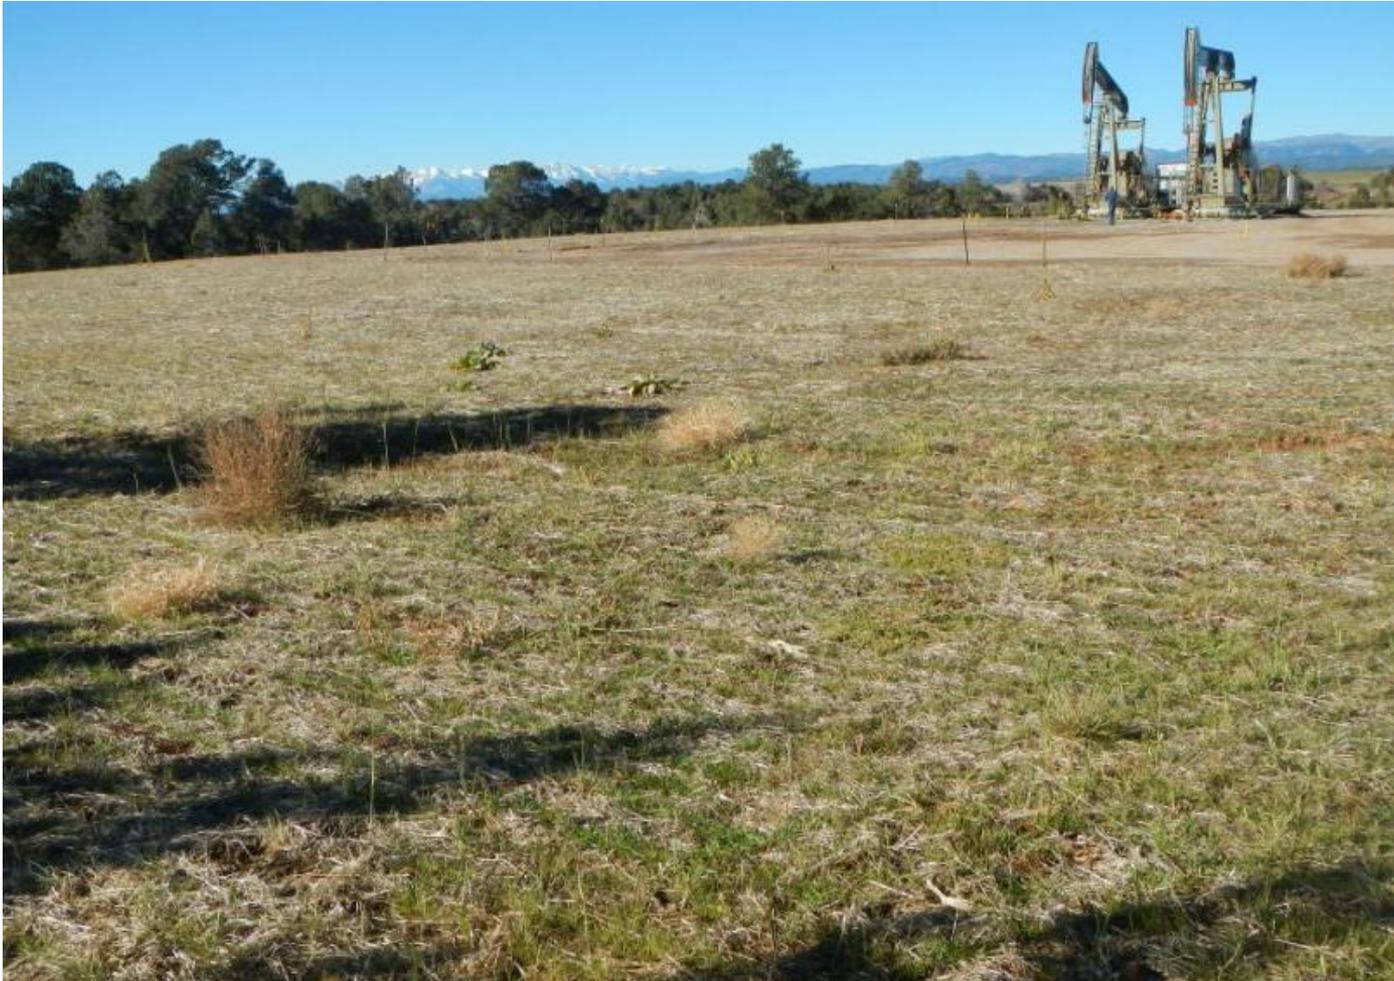
Photo 1. View of project area from the southwestern corner facing center.

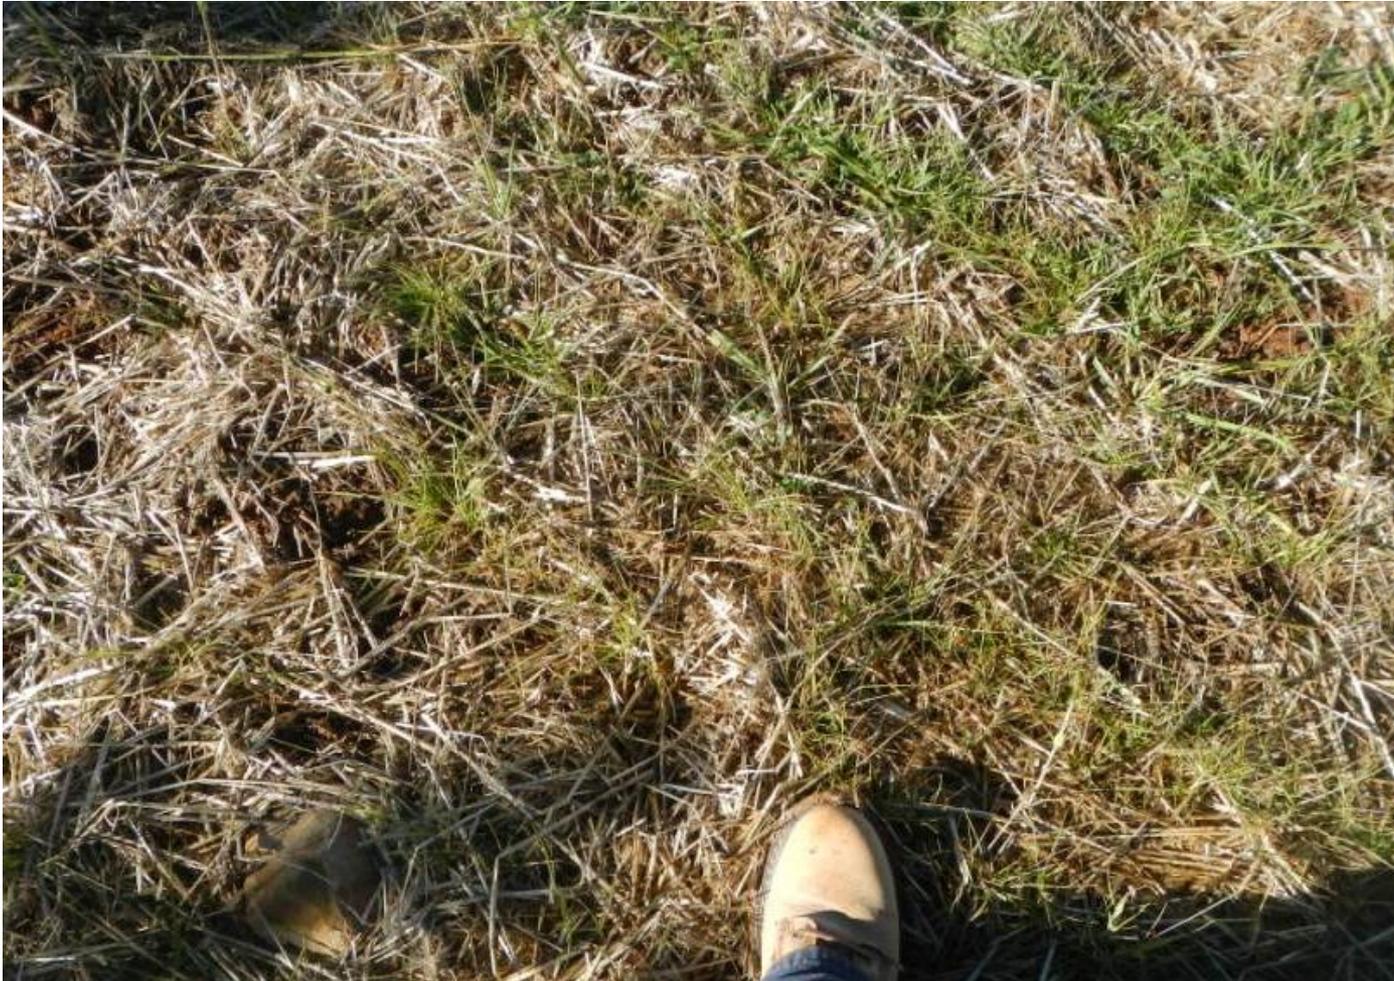
Photo 2. View of straw mulch and revegetation within the interim reclamation area. Revegetation appears to be comprised of a cover crop of annual wheatgrass (*Triticum* sp.) and perennial grasses (not yet identifiable).

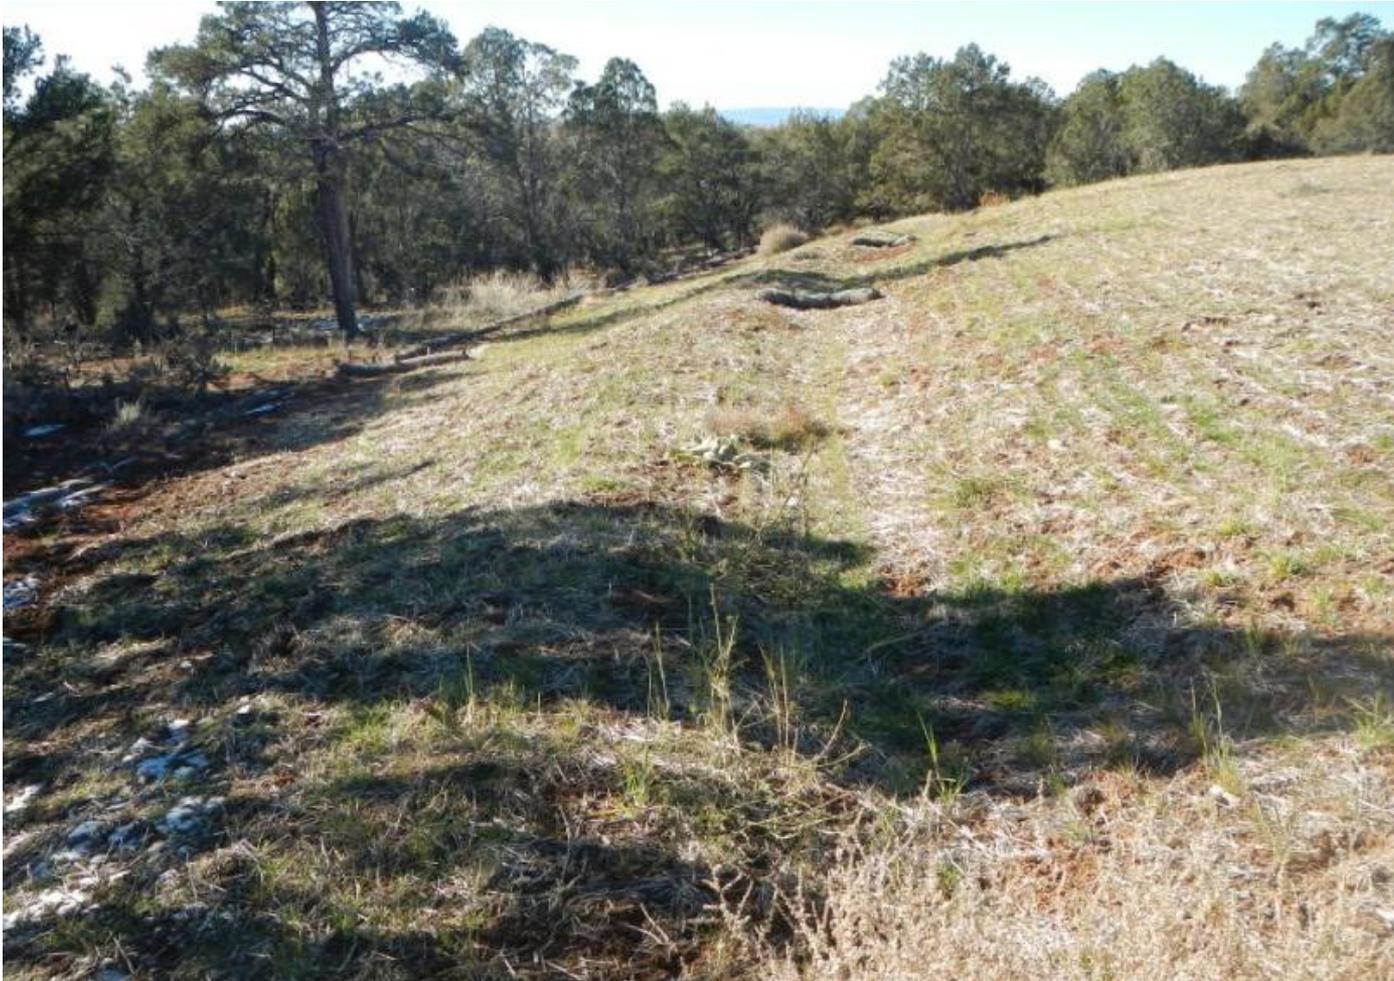
Photo 3. View of the western portion of the project area facing northward. Straw wattles are in place along the stormwater diversion channel and revegetation is progressing.

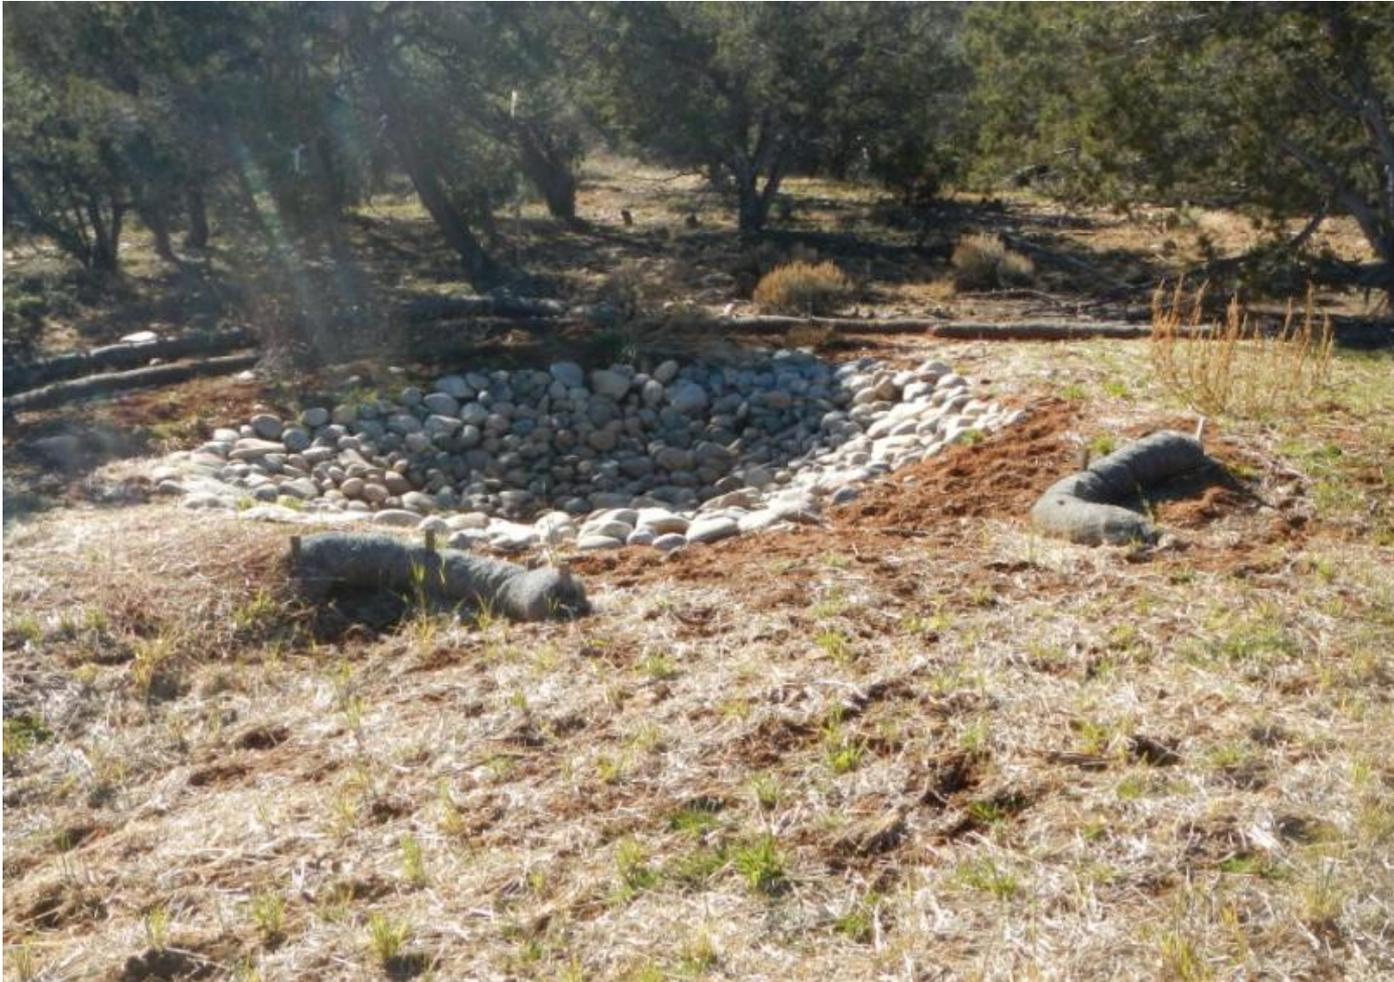
Photo 4. View of cobble lined silt trap and wattles appear to be in good condition within the southwestern corner of the project area.

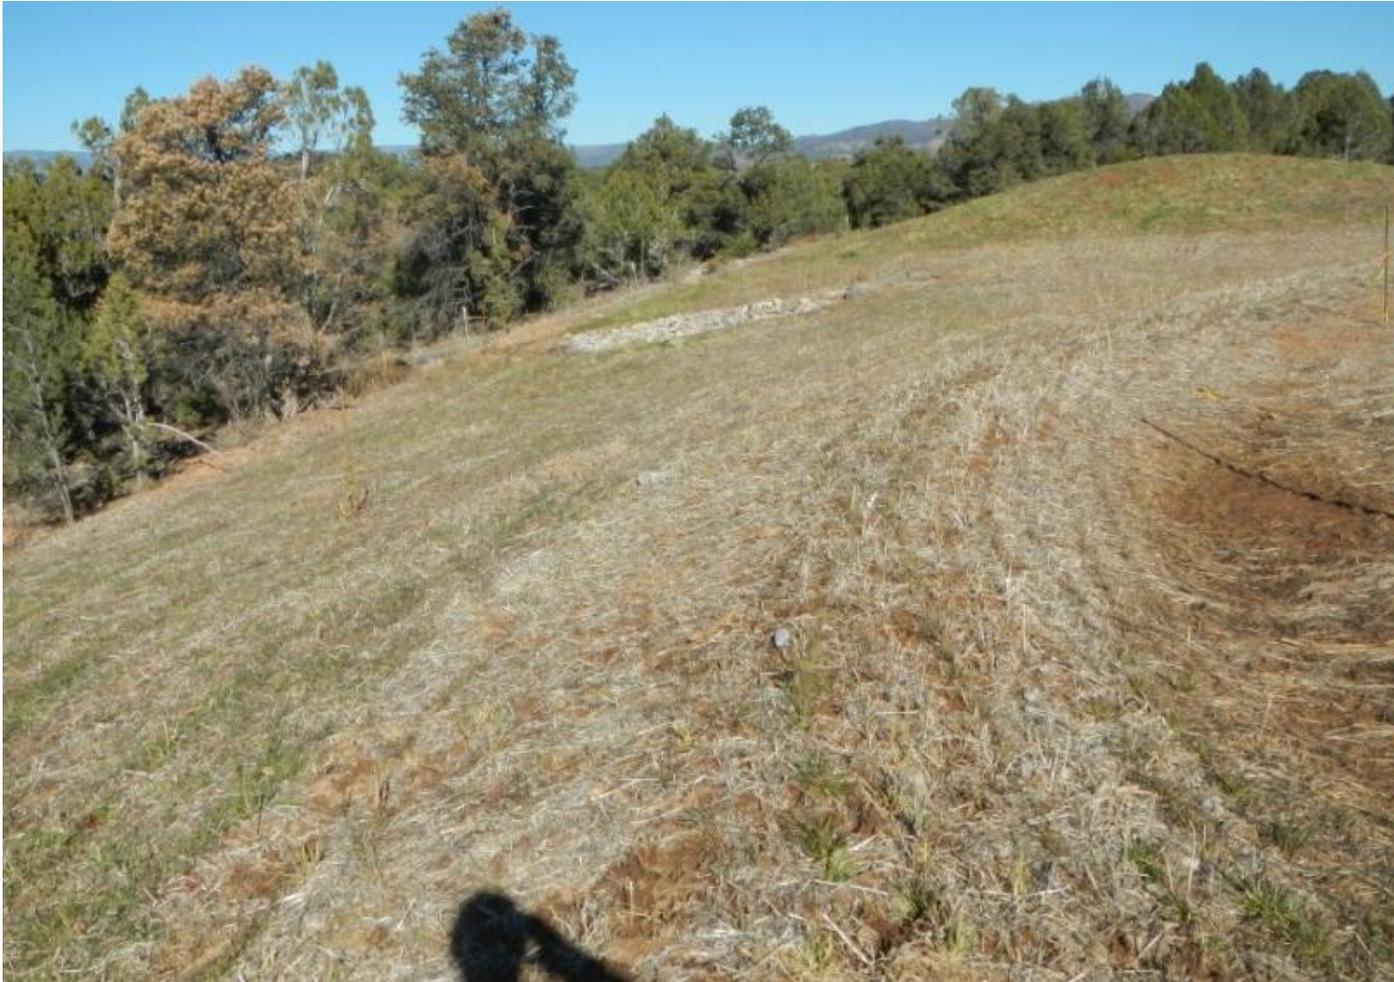
Photo 5. View of northern portion of the project area from the northwest edge of the working area facing eastward.
