Stormwater and Construction Inspection

12/10/2015

Operator: Edge Energy LLC

Location ID: 443962

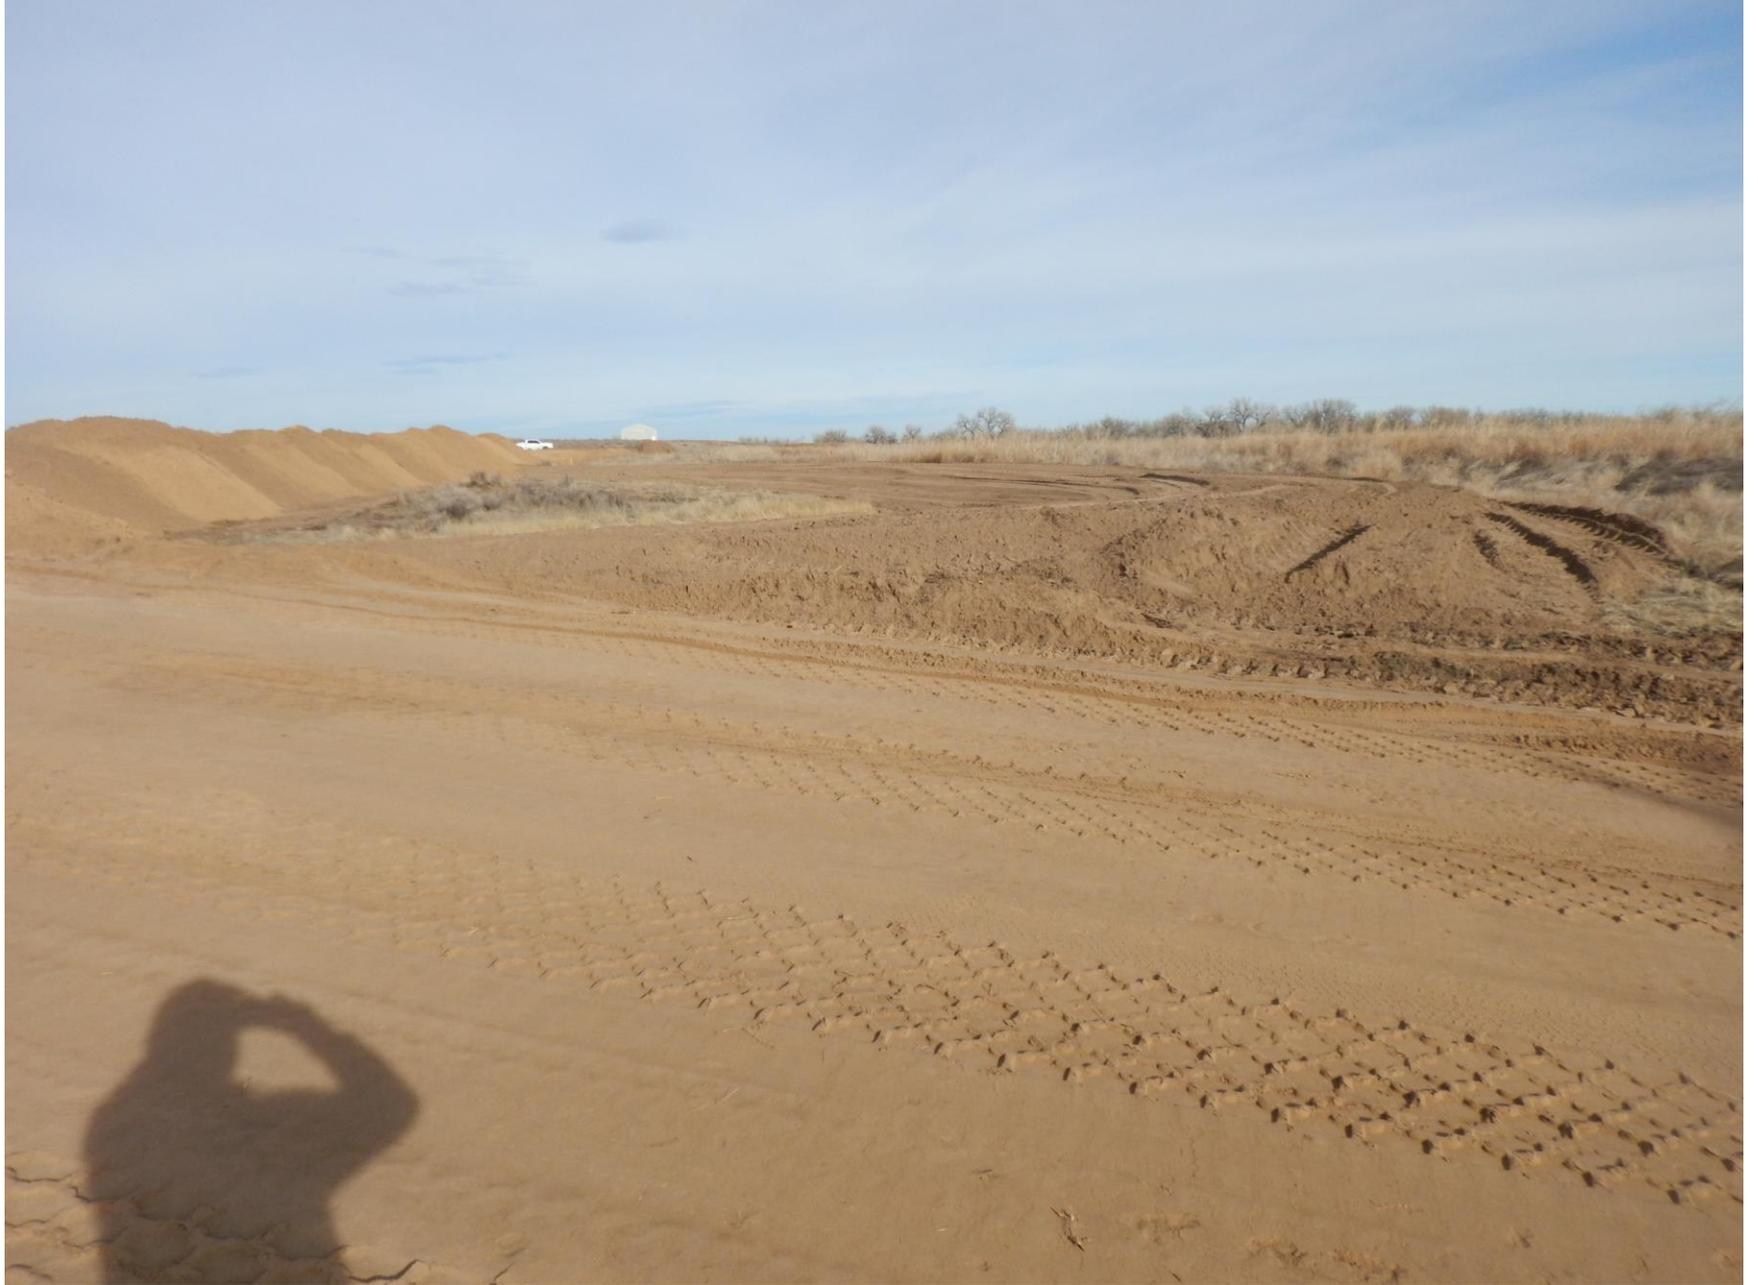
Figure 3: Photo taken from southeast end of location, facing north. Photo of topsoil berm.

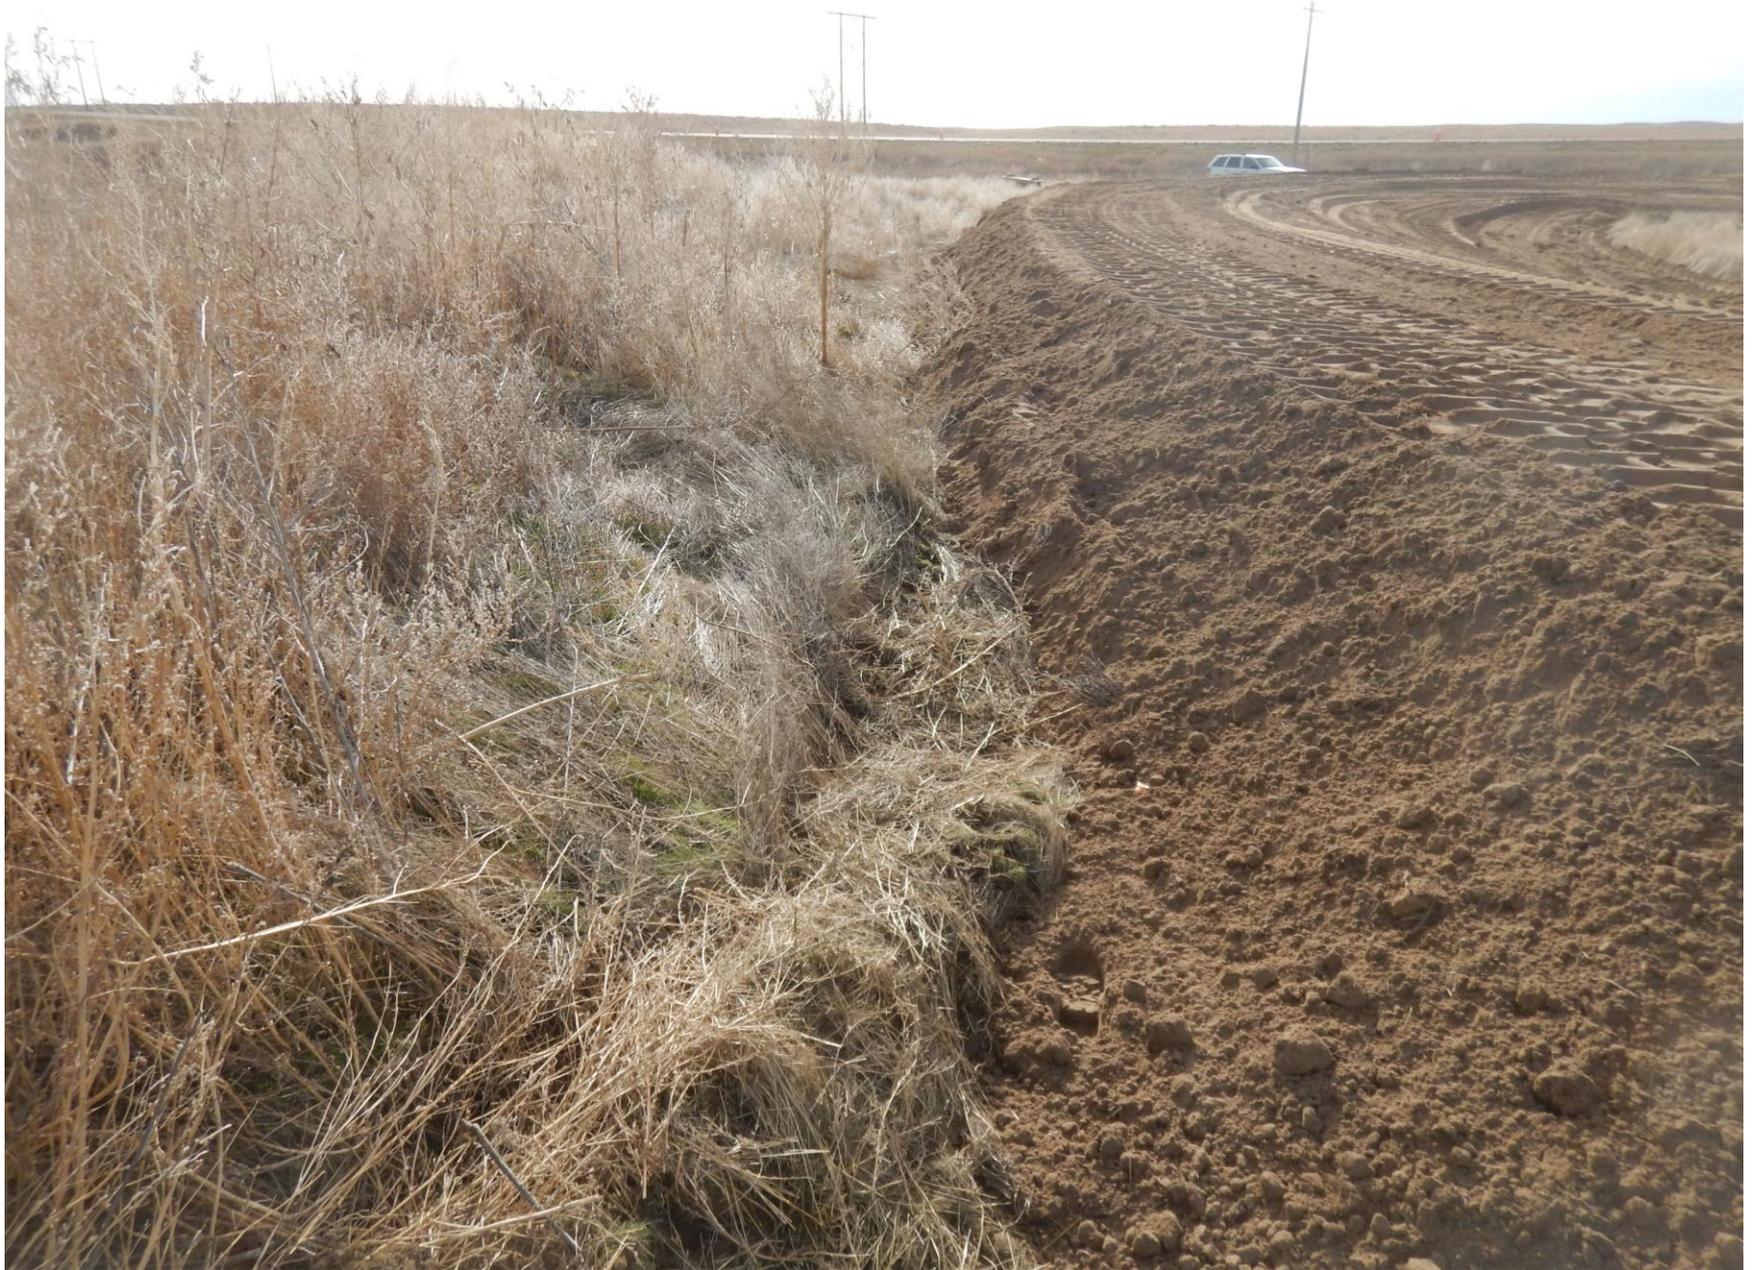
Figure 4: Photo taken from topsoil berm on east end of location, facing south. Photo shows insufficient stormwater BMPs in place.

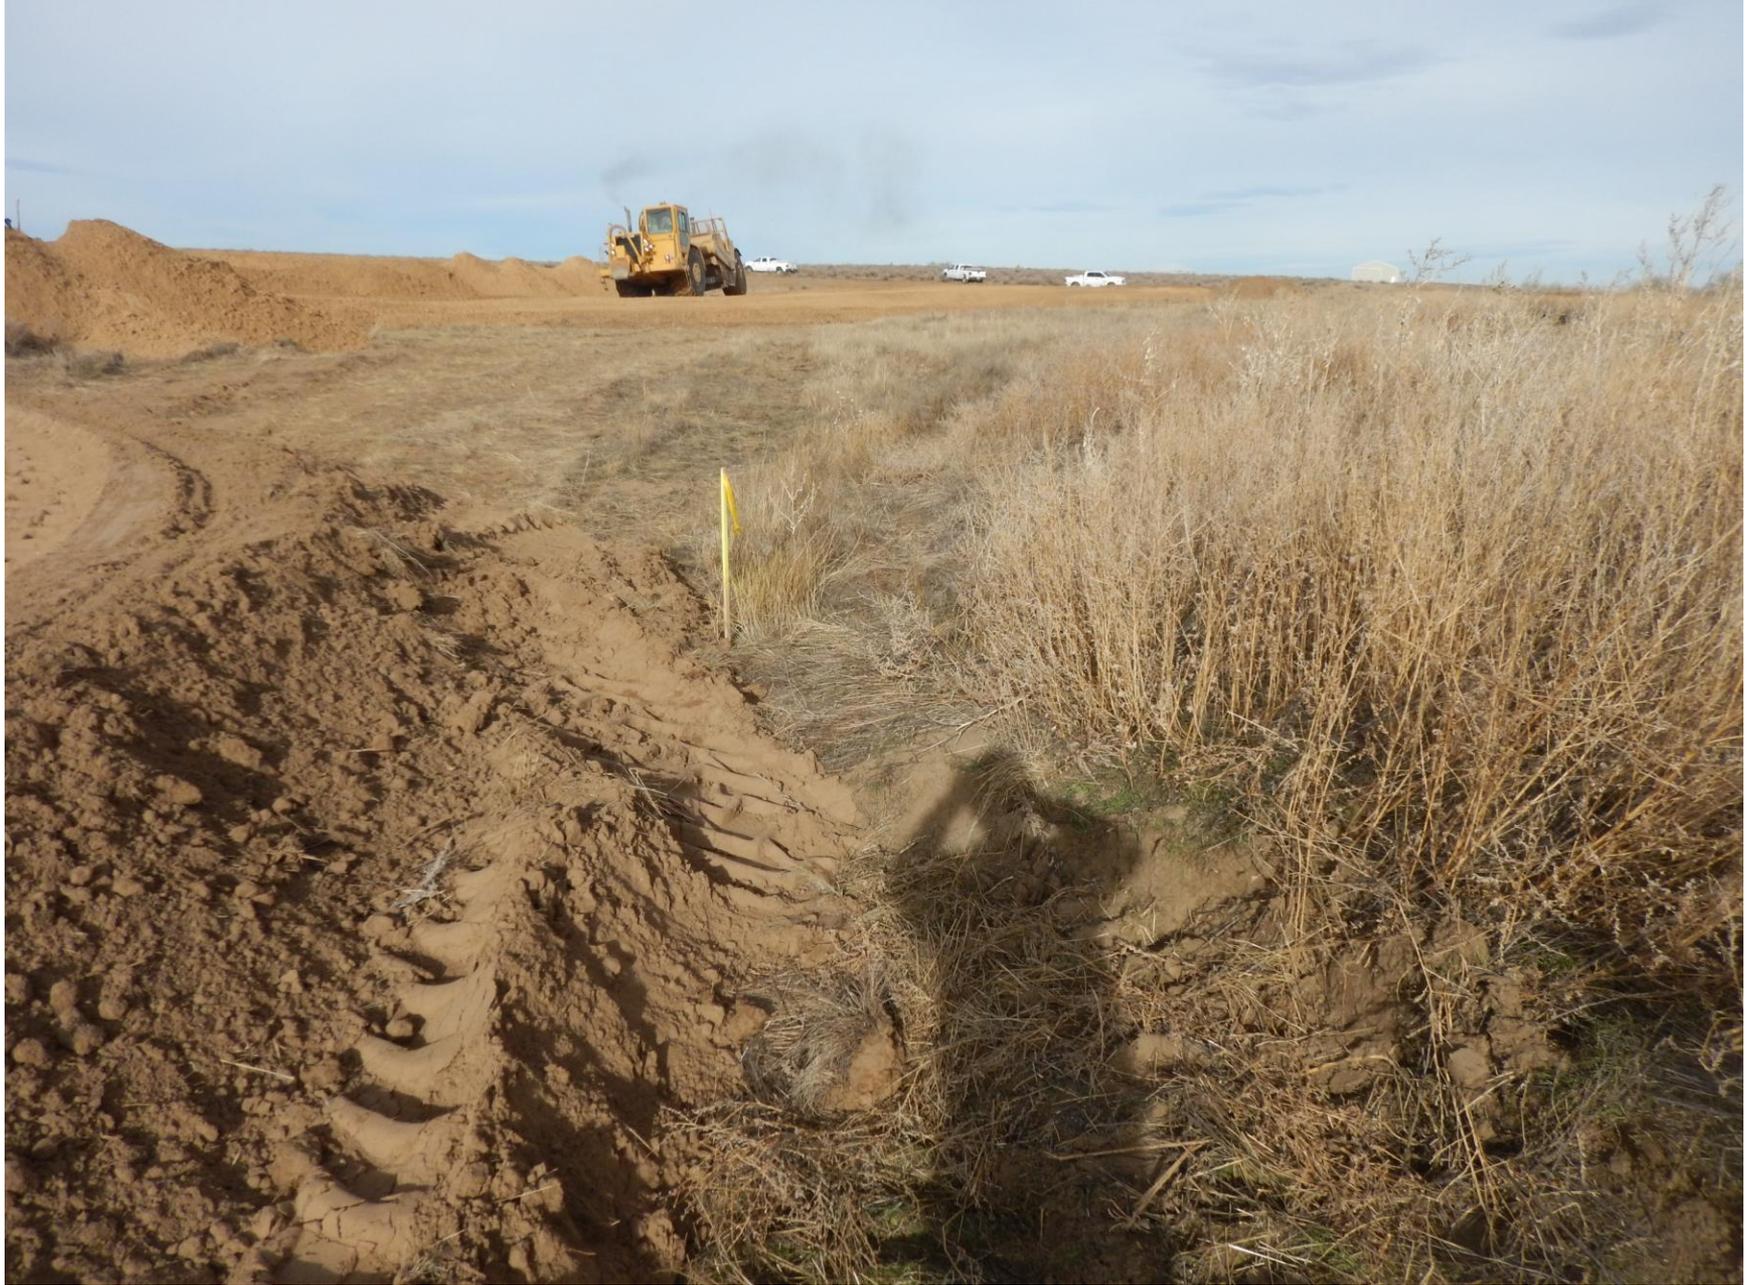
Figure 5: Photo taken from topsoil berm on east end of location, facing northwest. Photo shows insufficient stormwater BMPs in place.

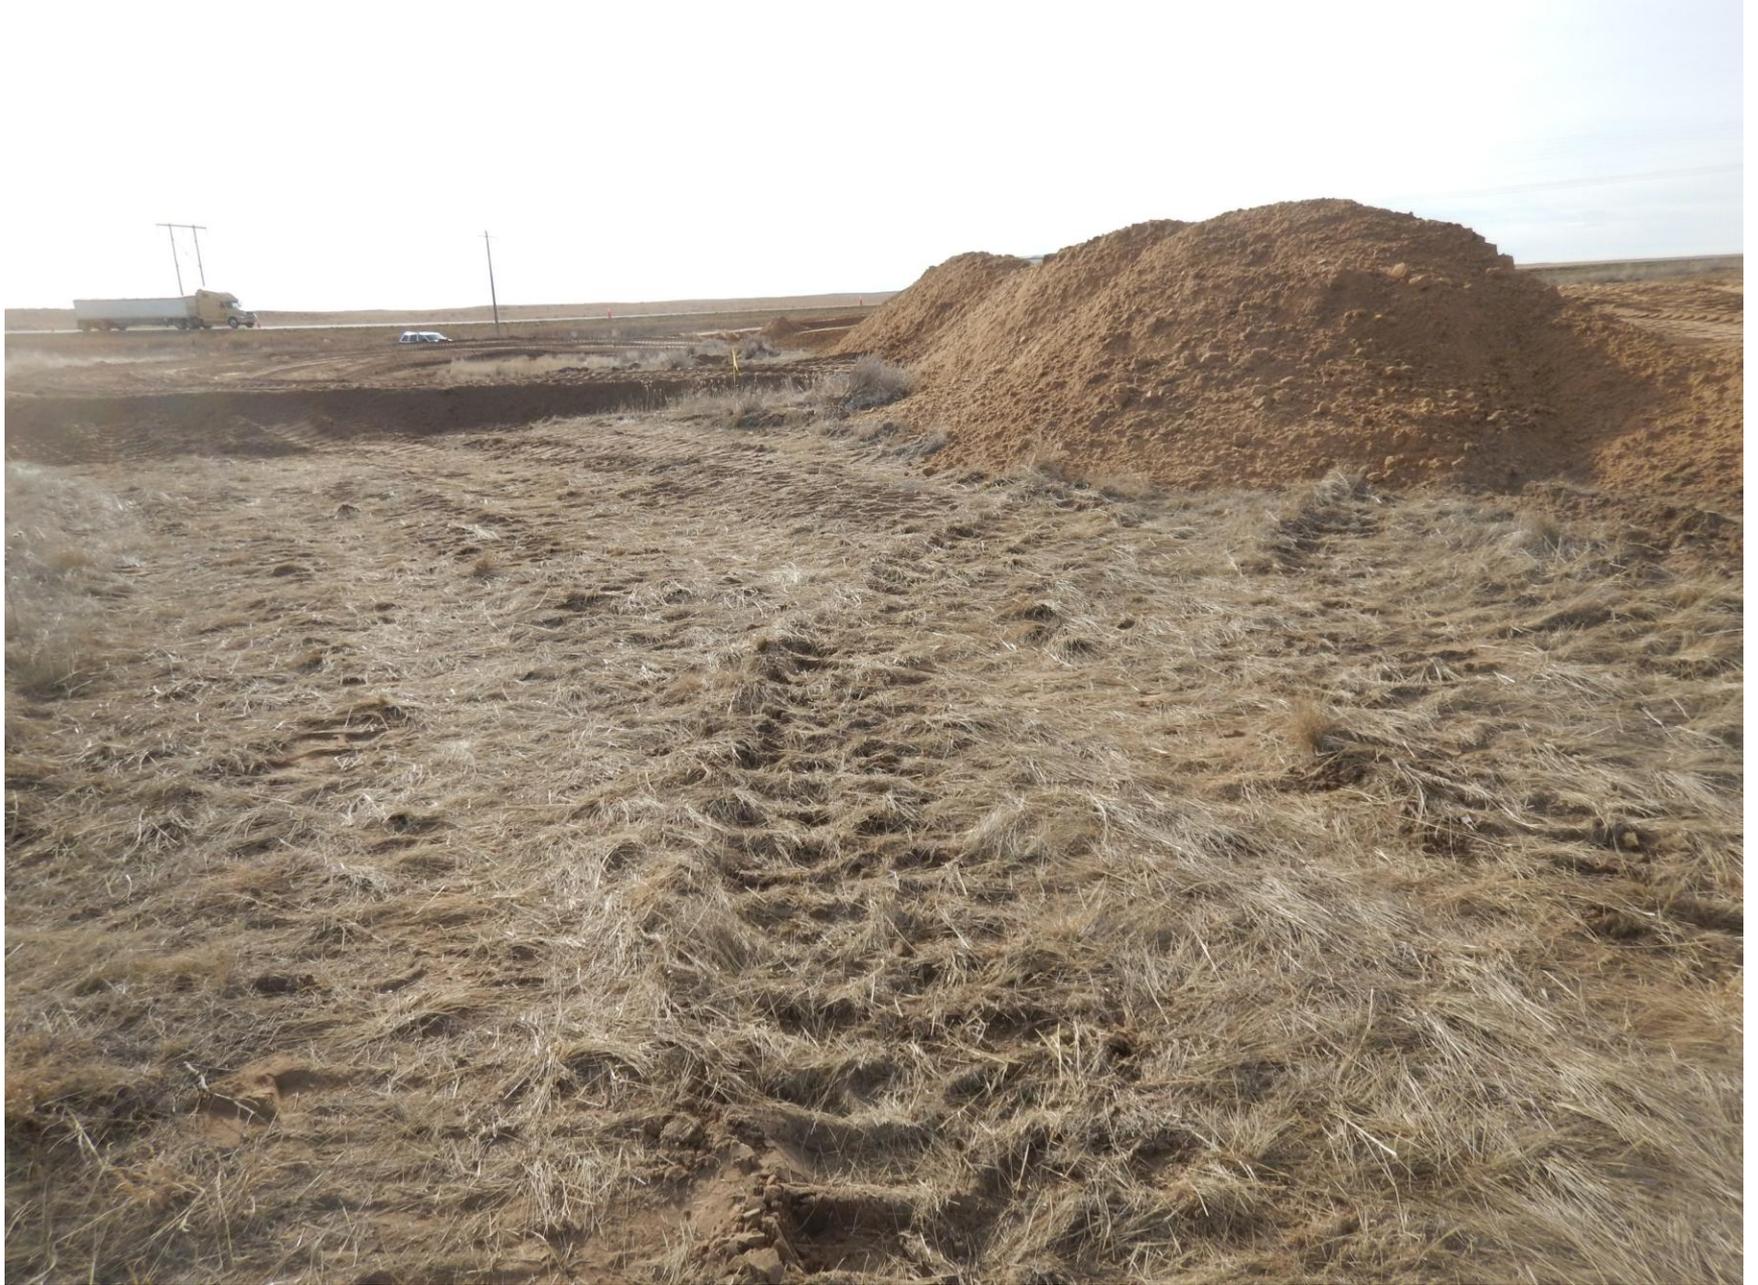
Figure 6: Photo taken from east end of location, facing south. Photo shows insufficient stormwater BMPs in place.

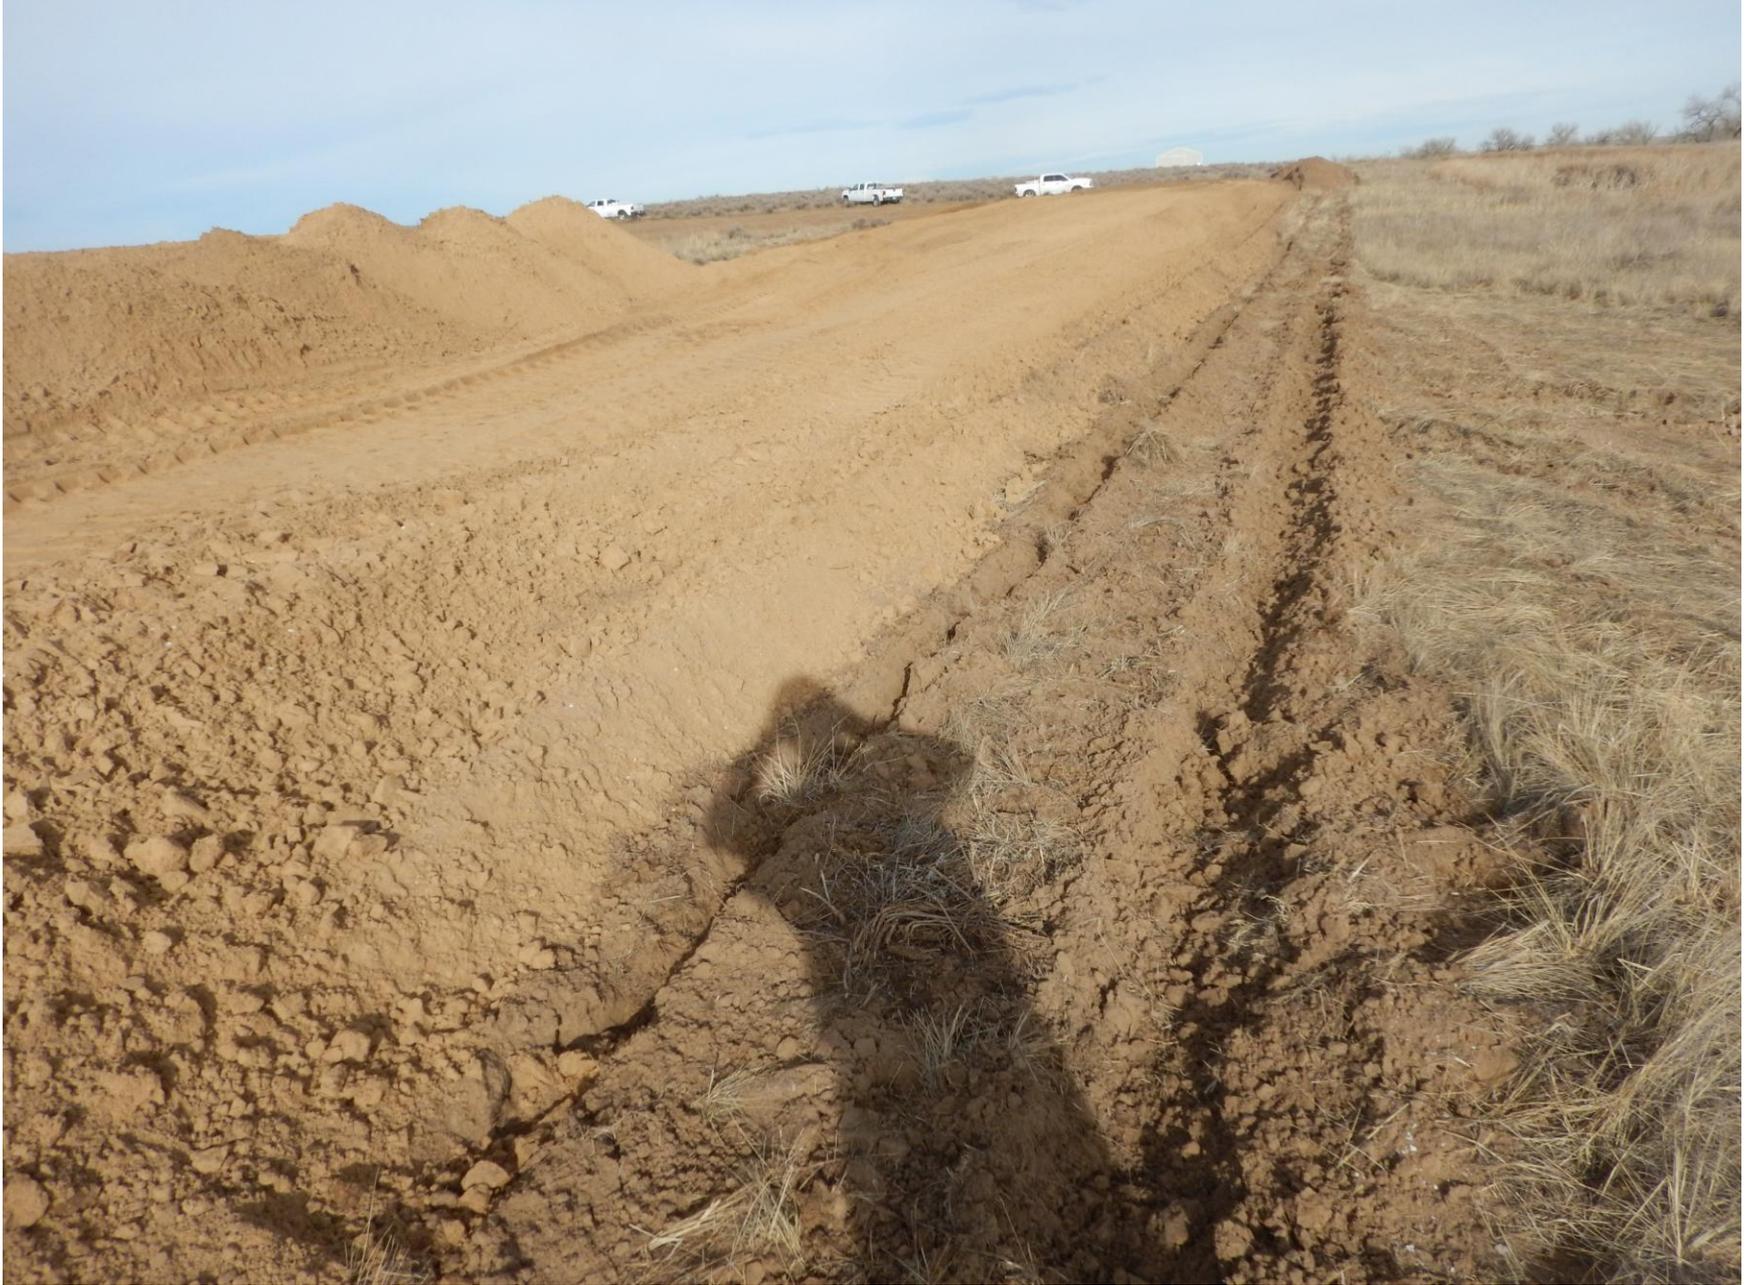
Figure 7: Photo taken at east end of location, facing north. Photo of stormwater BMP.

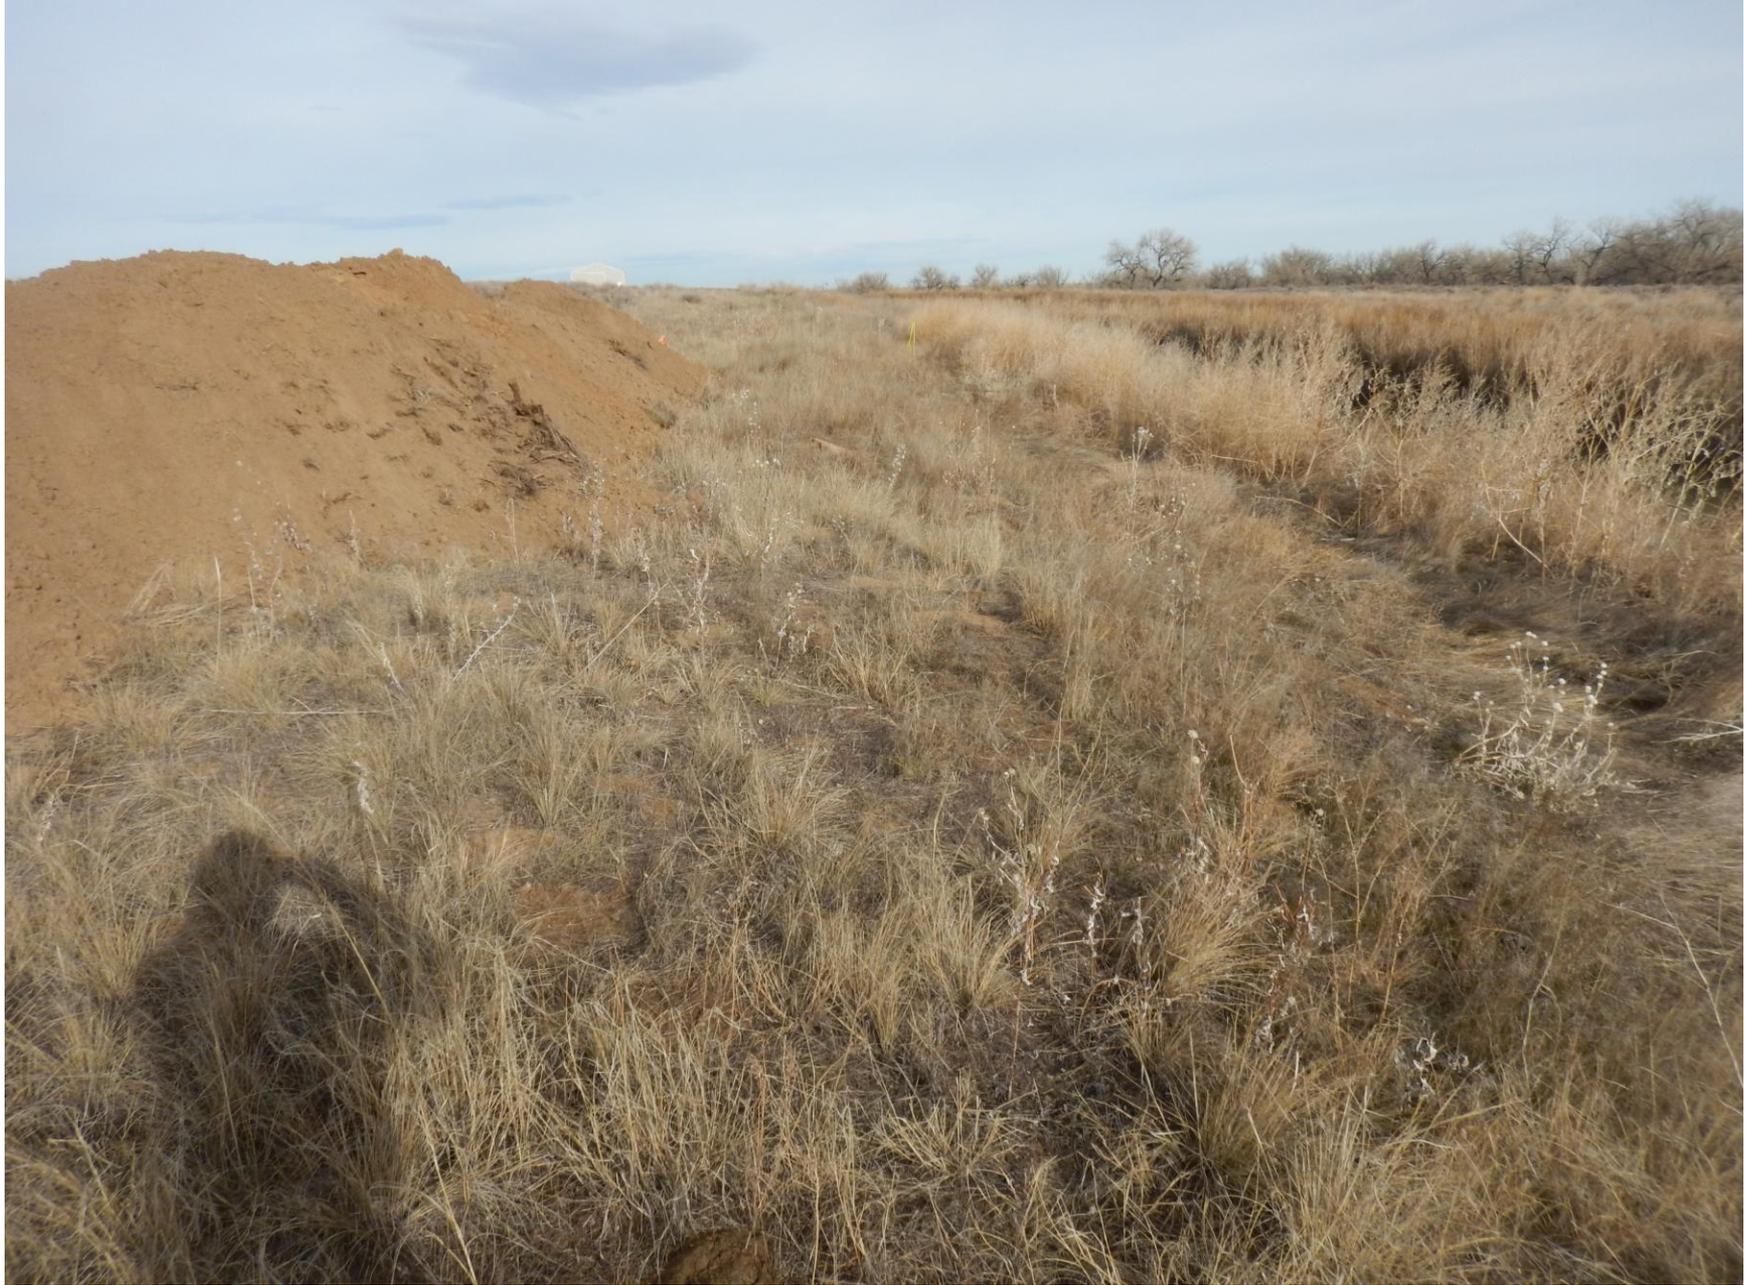
Figure 8: Photo taken at northeast end of location, facing north. Photo shows insufficient stormwater BMPs. Please note irrigation ditch on right of photo.

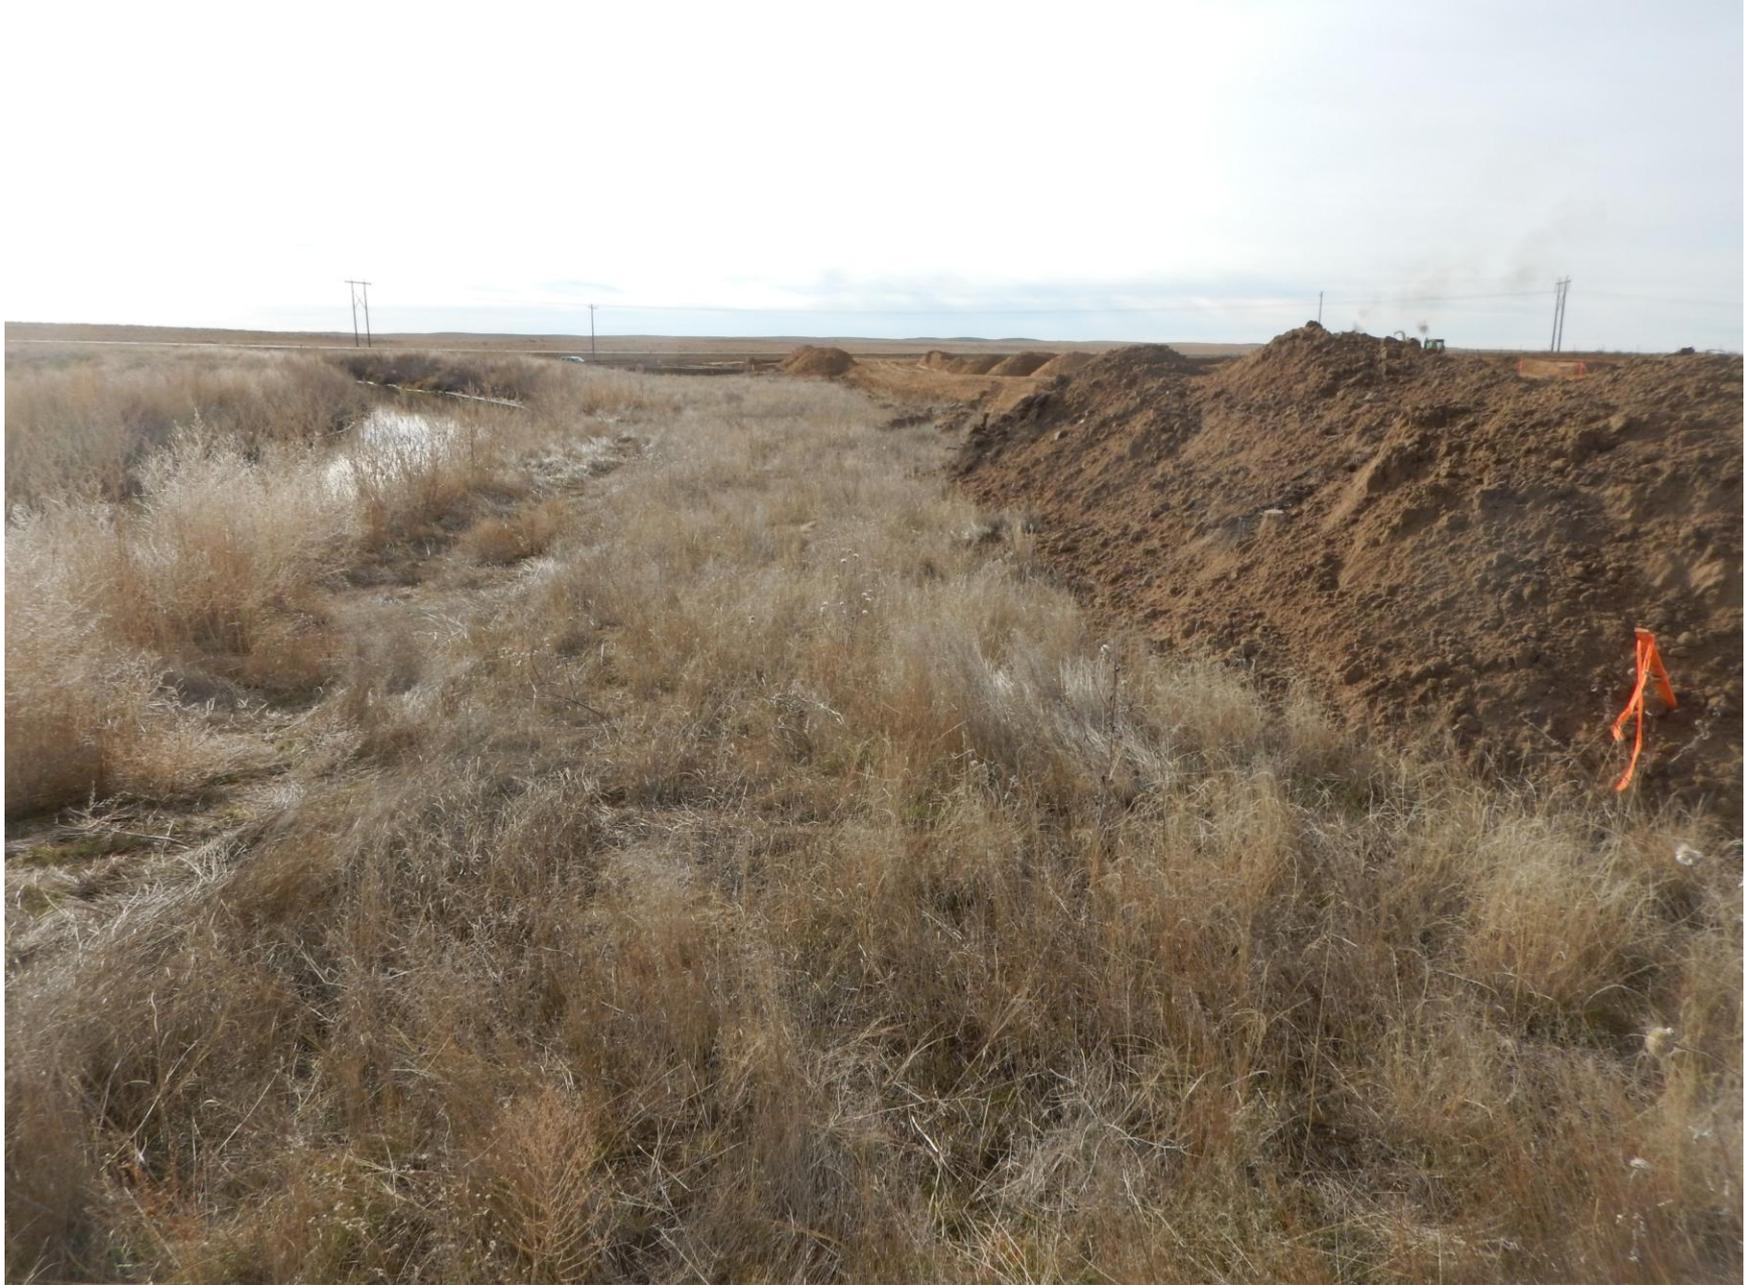
Figure 9: Photo taken from northeast end of location, facing south. Photo shows insufficient stormwater BMPs. Please note irrigation ditch on left of photo.

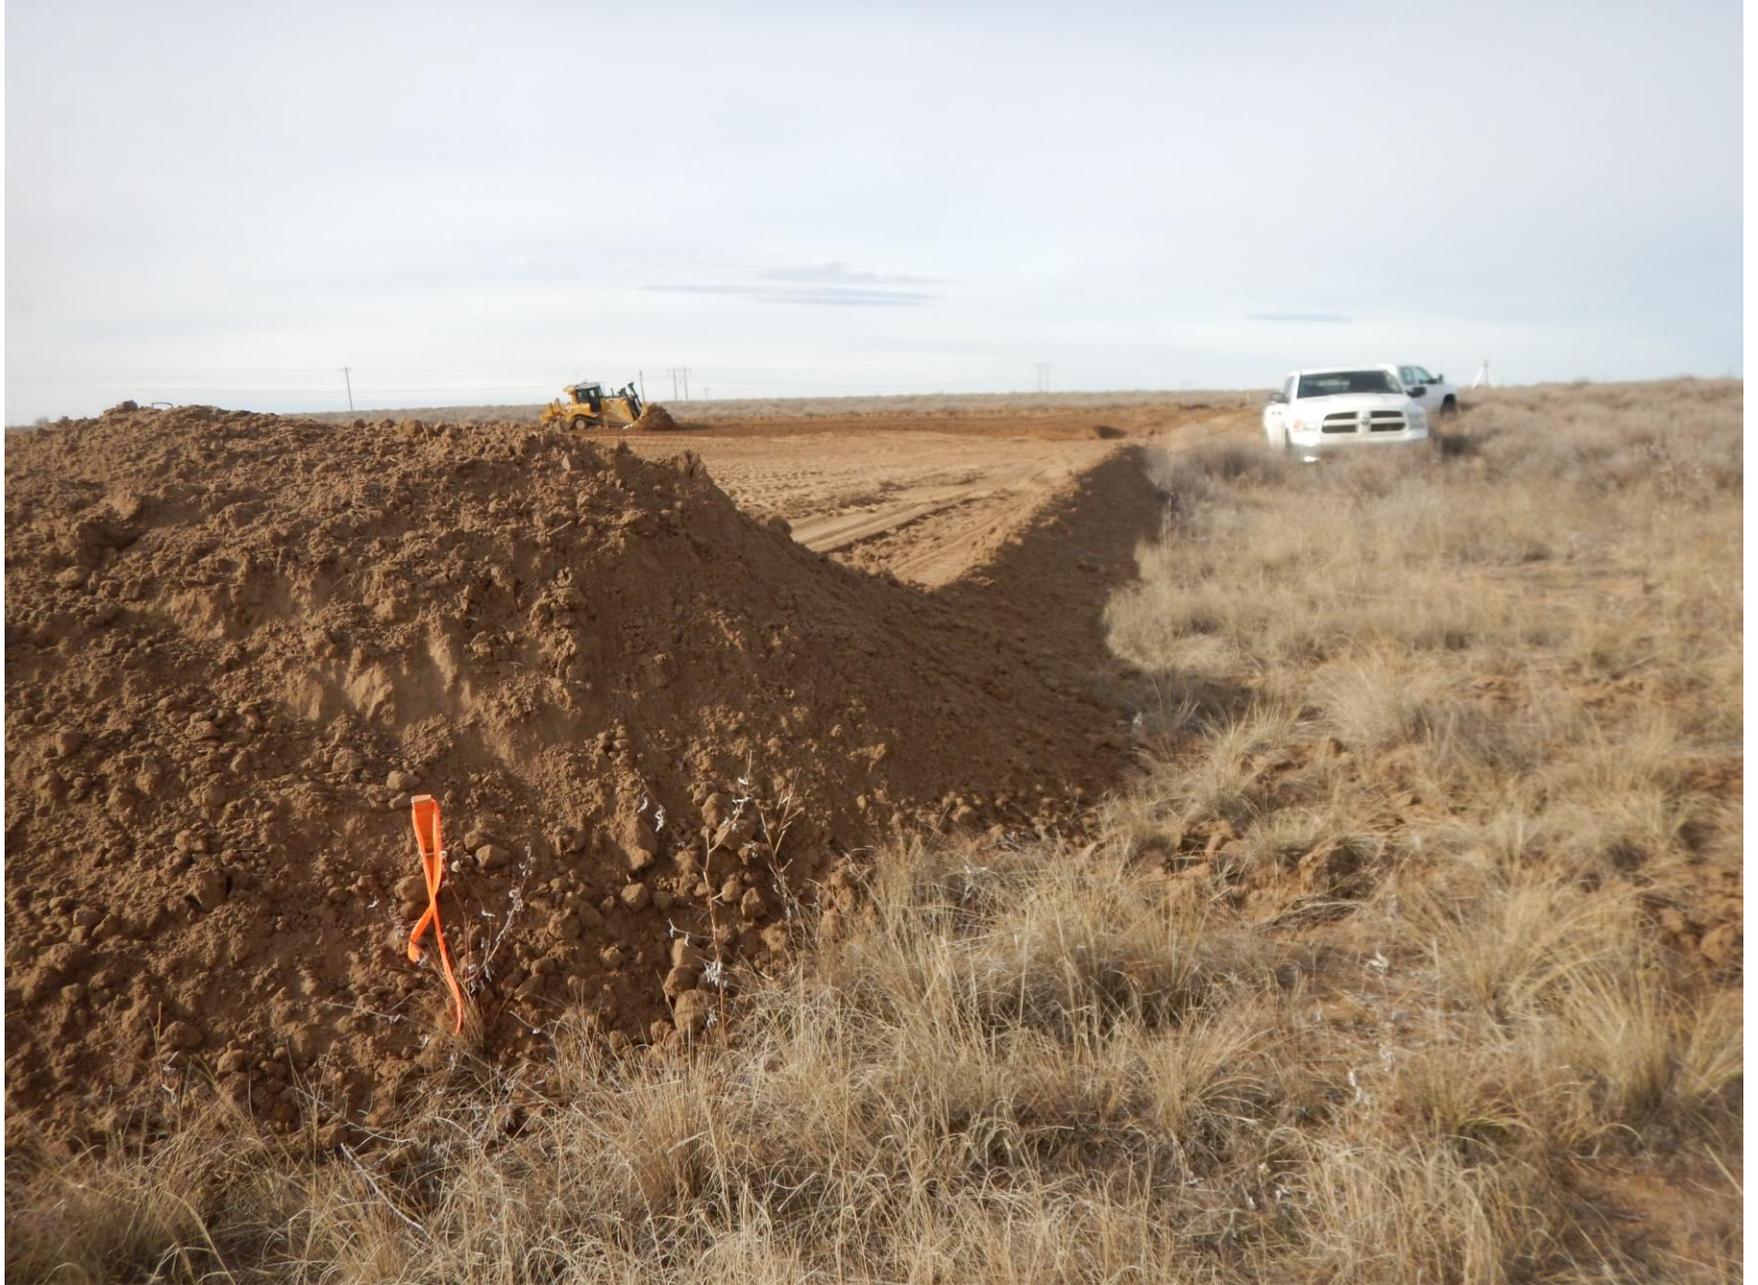
Figure 10: Photo taken from northeast end of location, facing west. Photo shows insufficient stormwater BMPs.

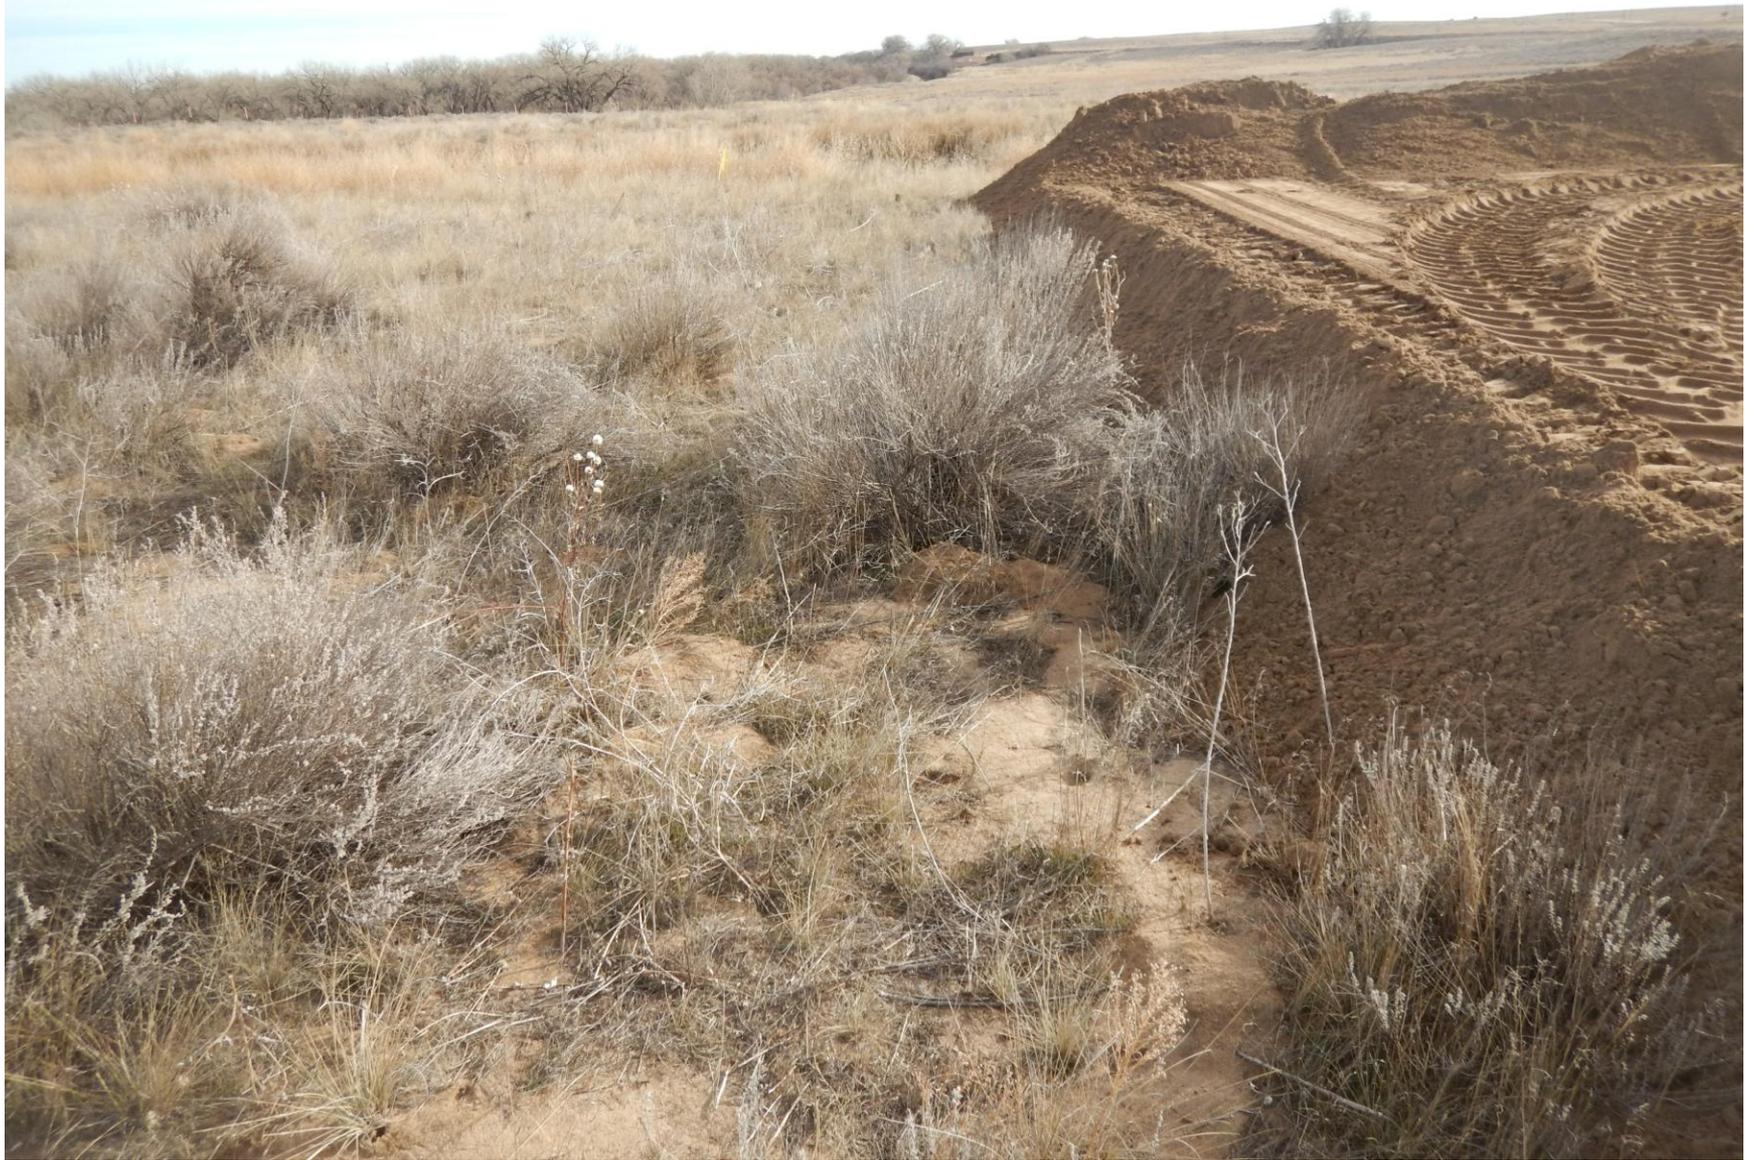
Figure 11: Photo taken from north end of location, facing east. Photo shows insufficient stormwater BMPs.
