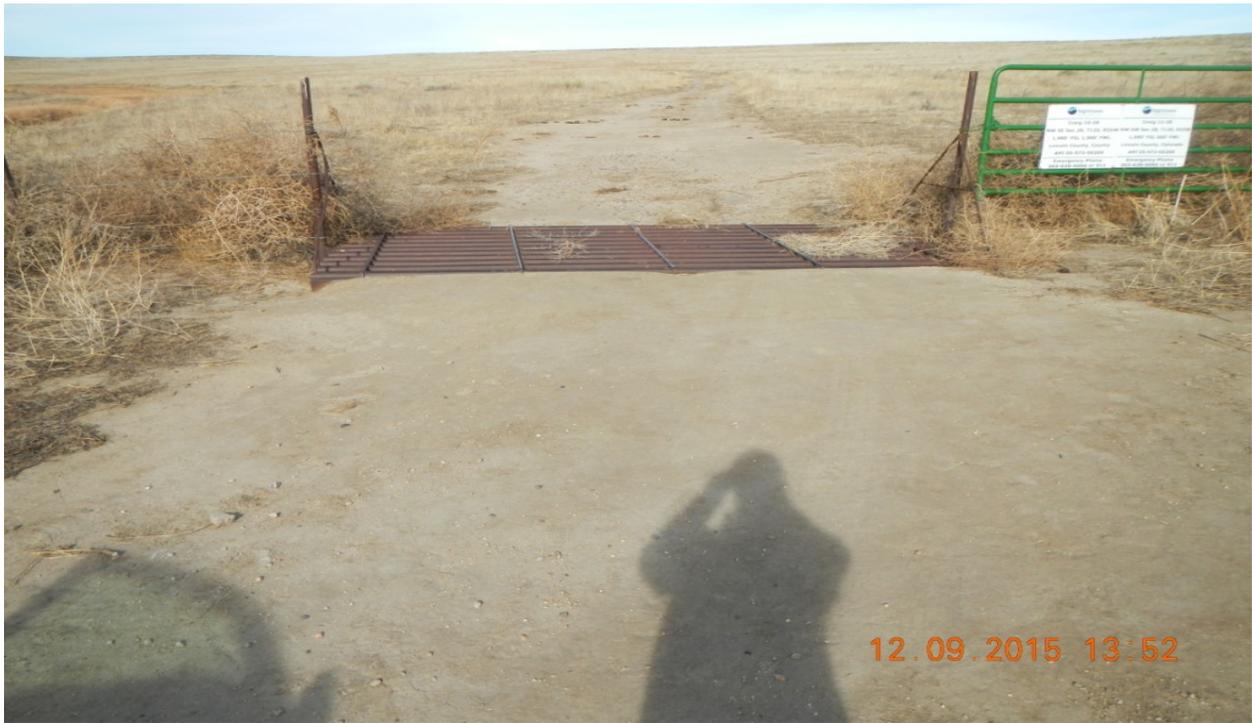
photo 1: Facing north along former access road towards the location.

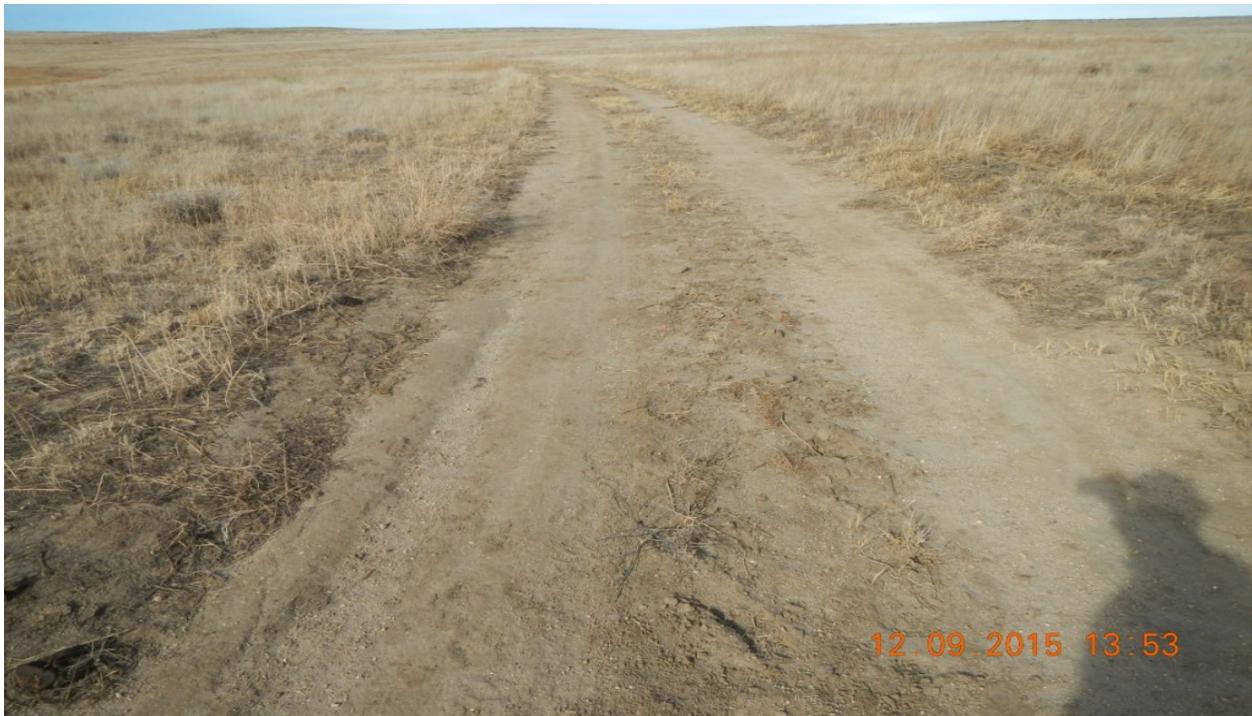
photo 2: Facing northwest along former access road towards the location.

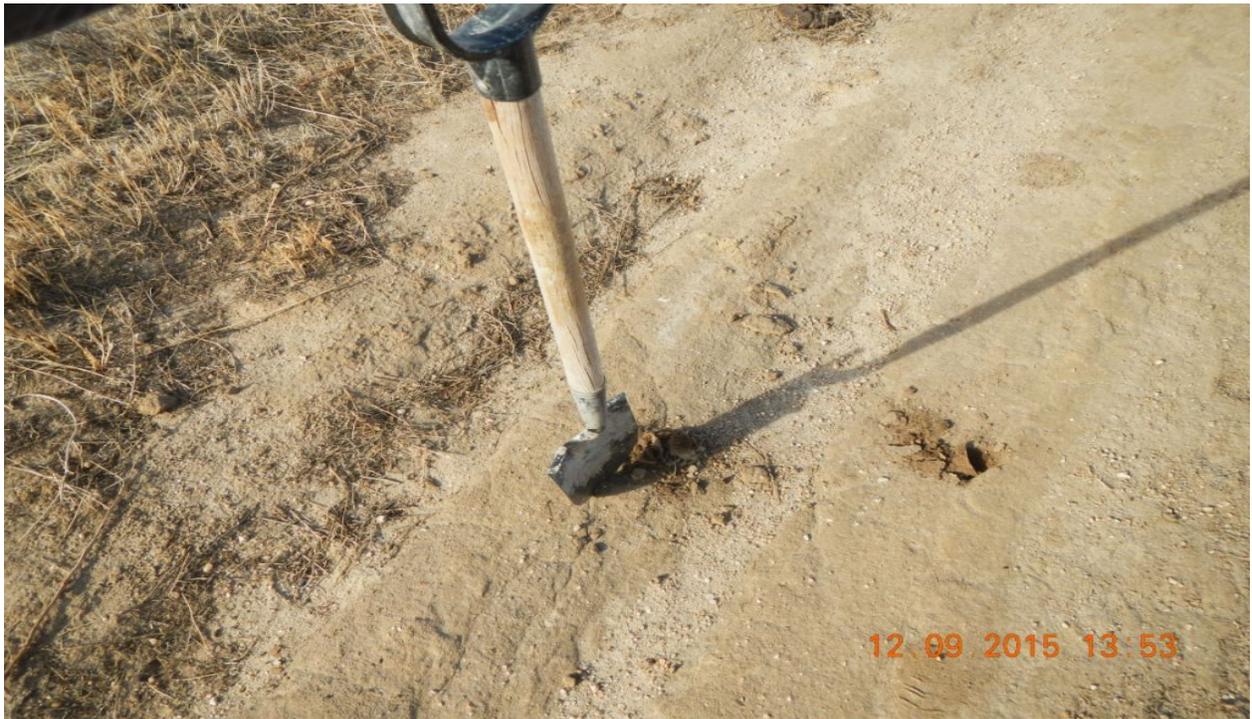
photo 3: Soils along the former access road were compacted.

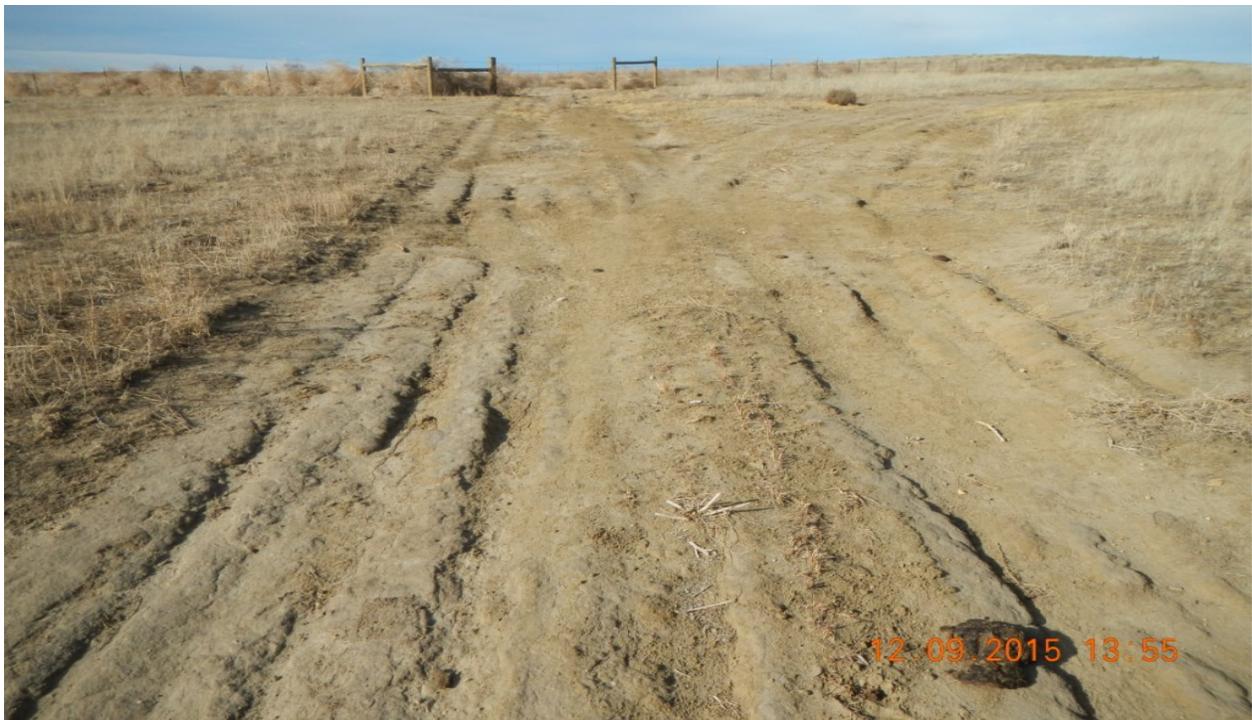
photo 4: Facing northwest towards the location. Erosion occurring where soils were ripped.

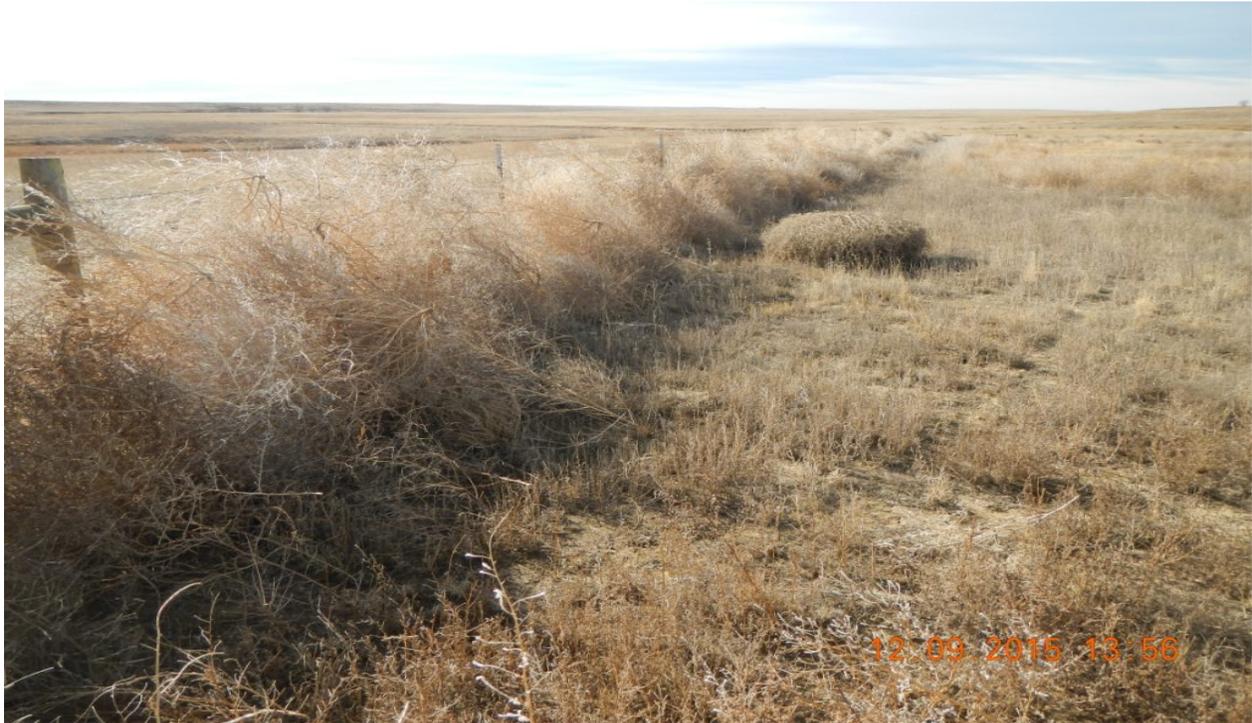
Photo 5: Southeast corner of location facing west. Weed debris is piling up along the fence line.

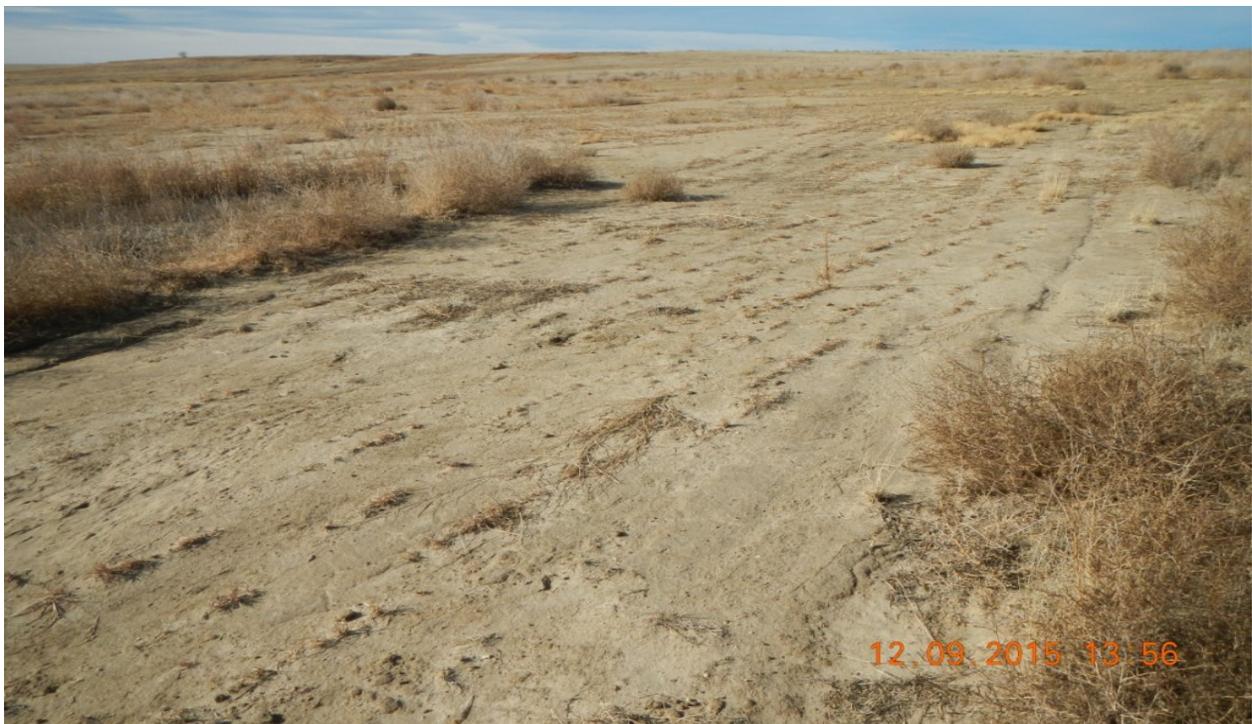
Photo 6: Southeast corner of location facing northwest.

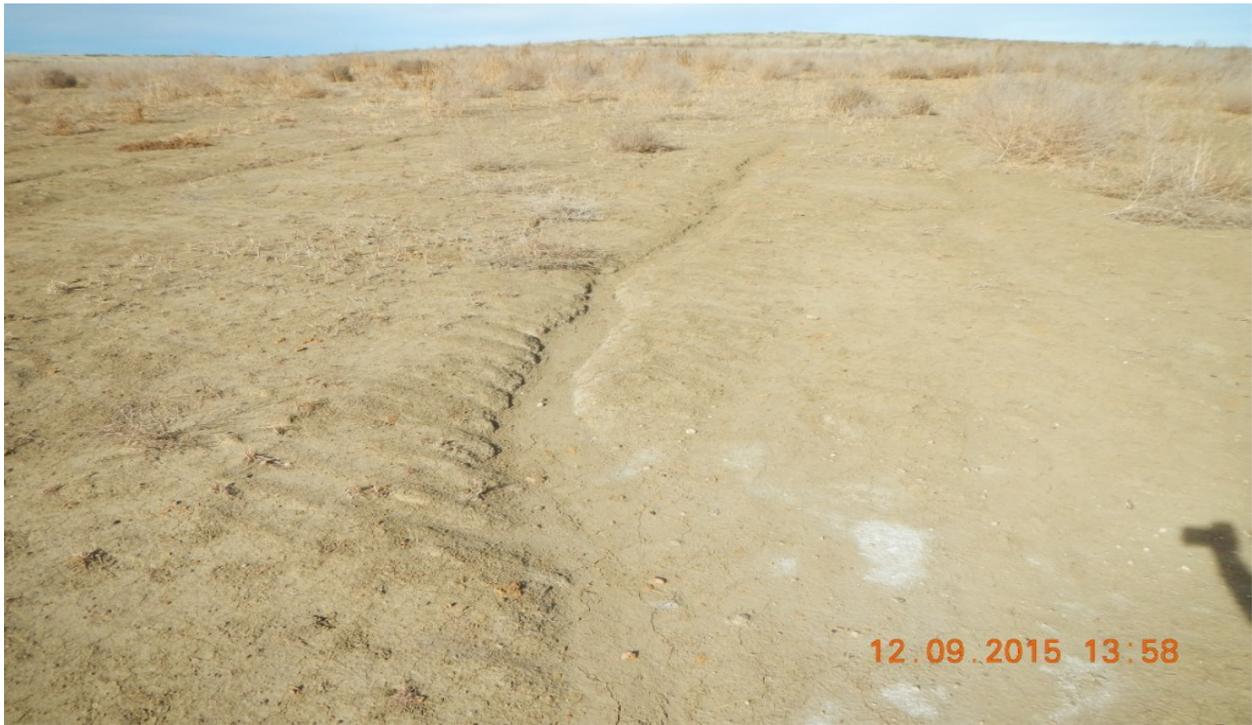
Photo 7: Erosion channel beginning to develop near the center of the location.

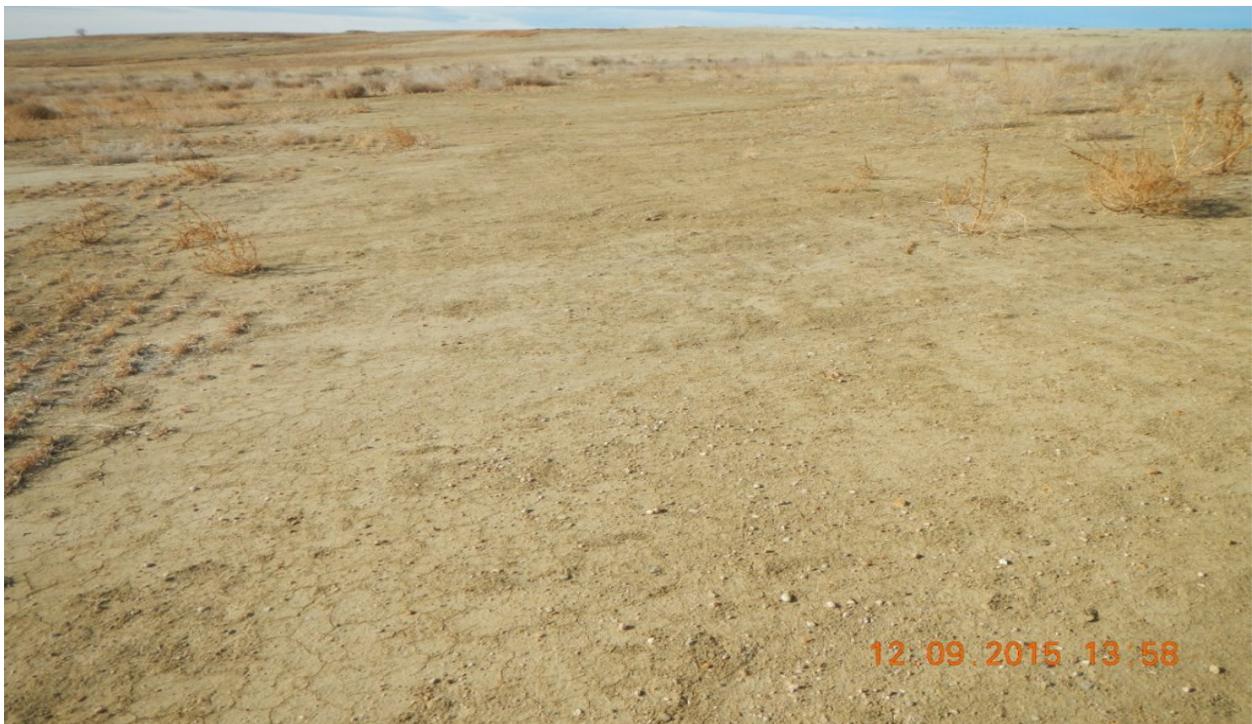
Photo 8: Facing northwest near the center of the location. There was no vegetation establishment at this area.

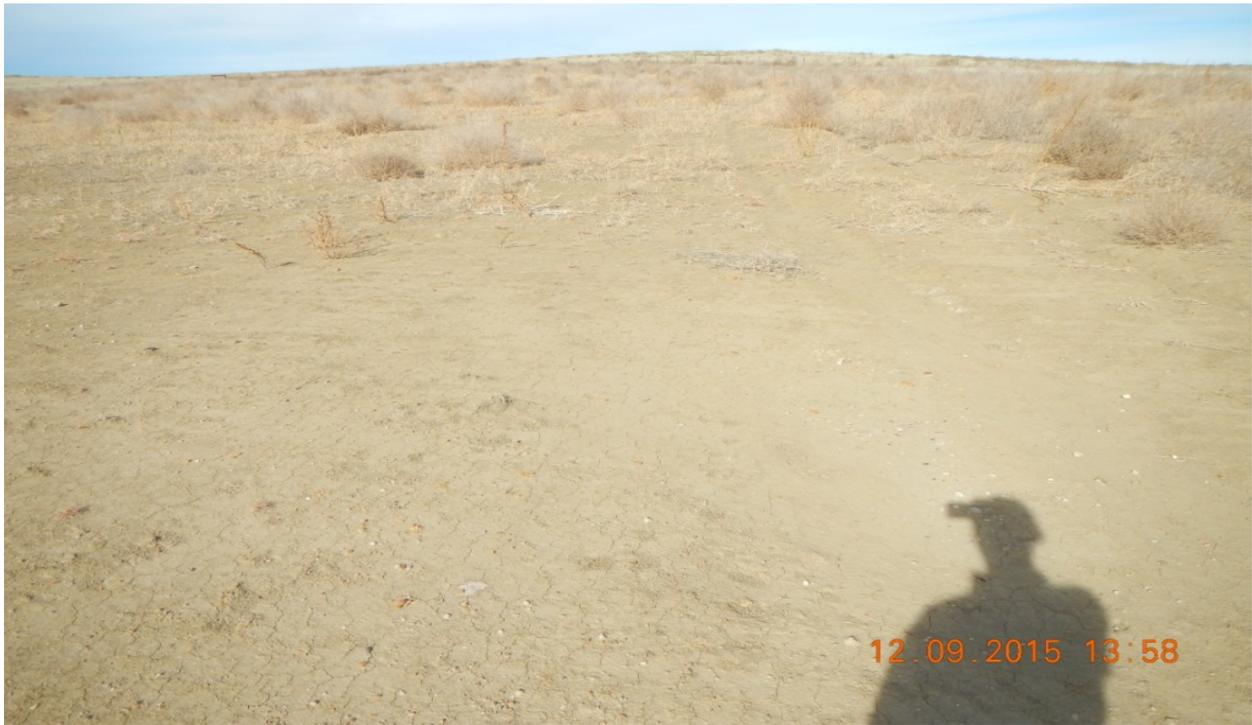
Photo 9: Center of the location facing north.

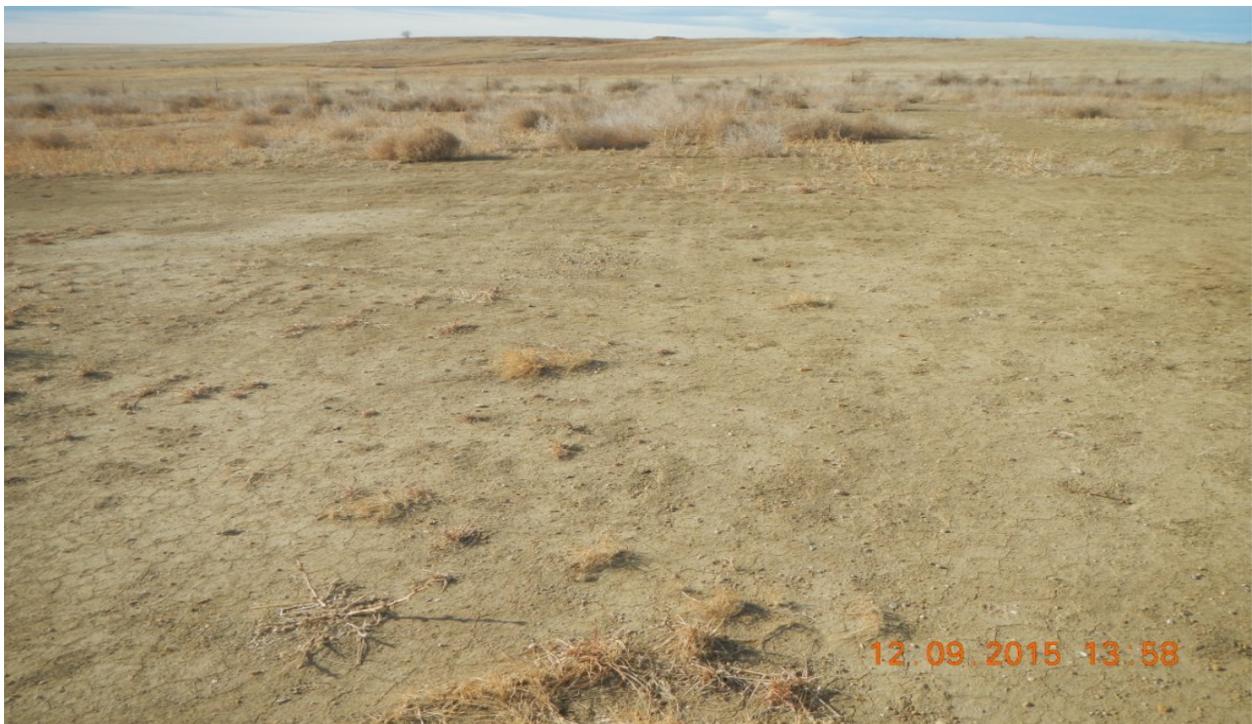
photo 10: Center of the location facing west.

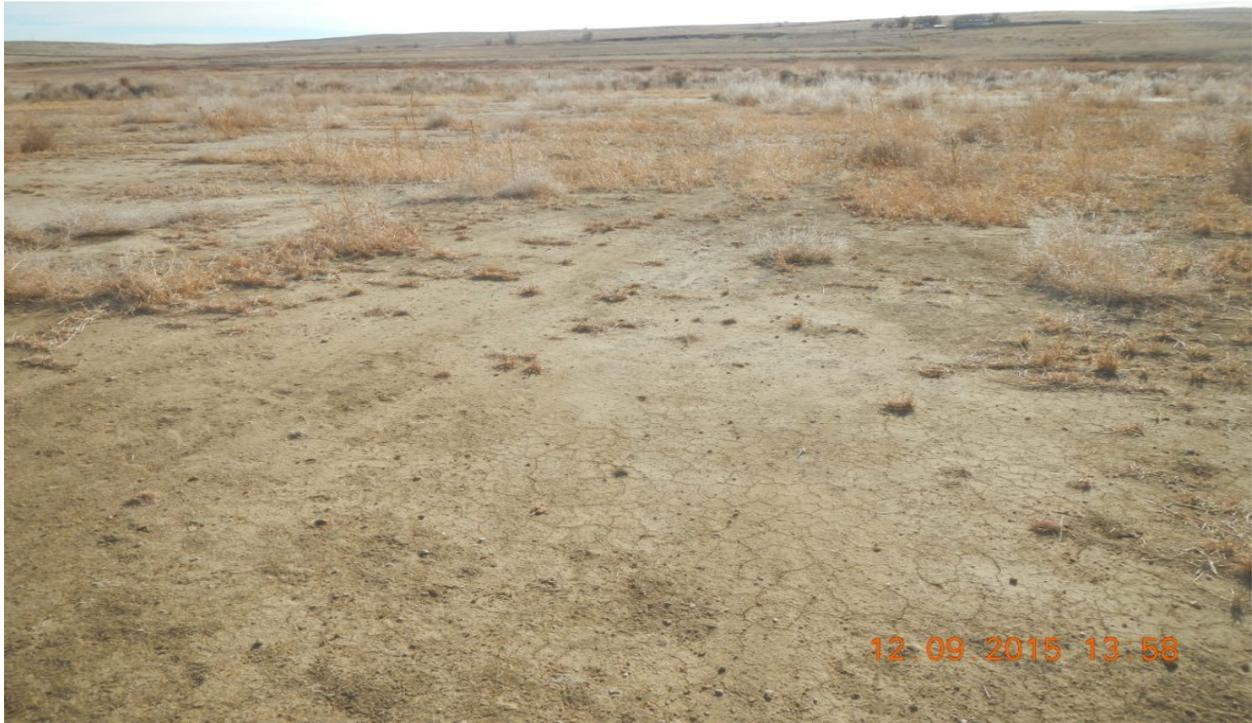
photo 11: Center of the location facing south.

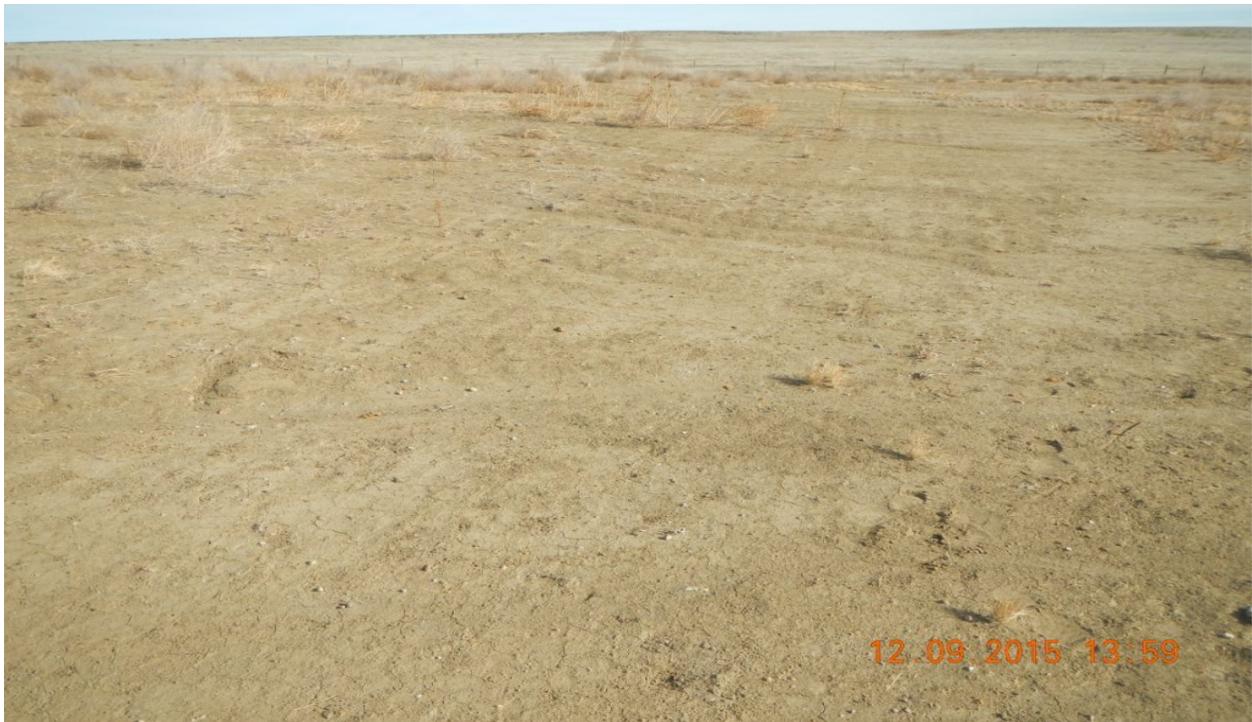
photo 12: Center of the location facing east

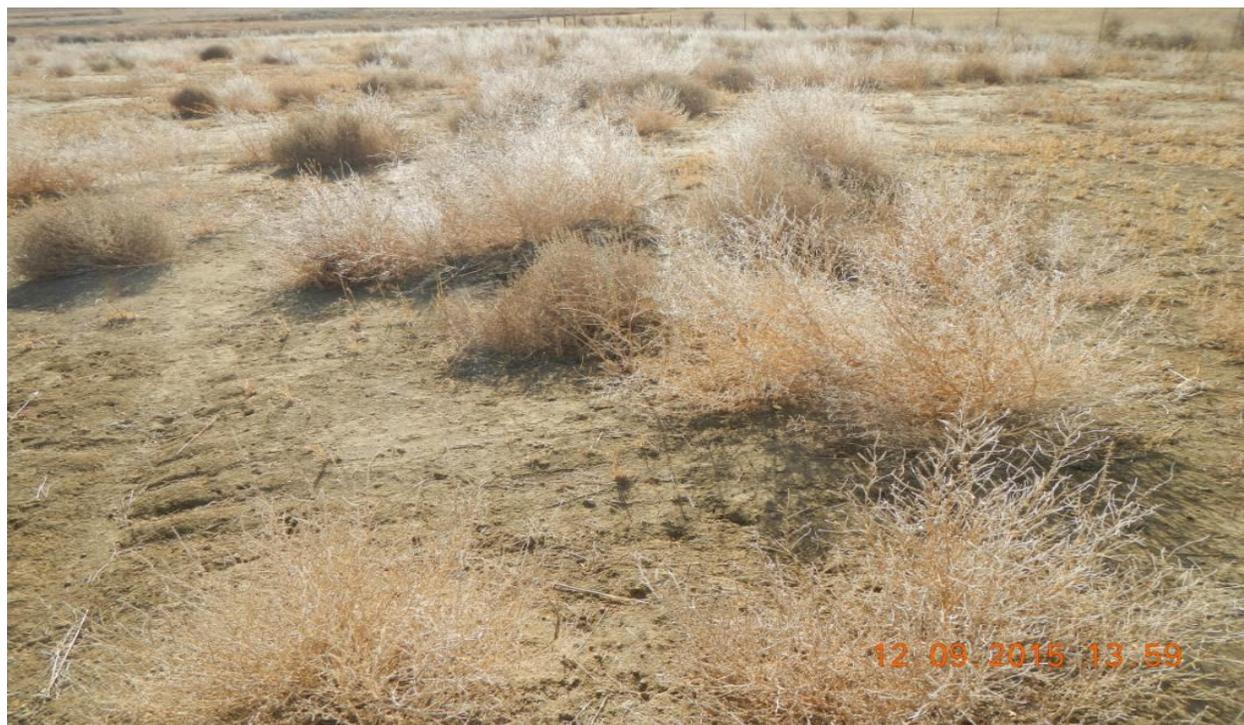
photo 13: Facing south east towards the west side of the location.

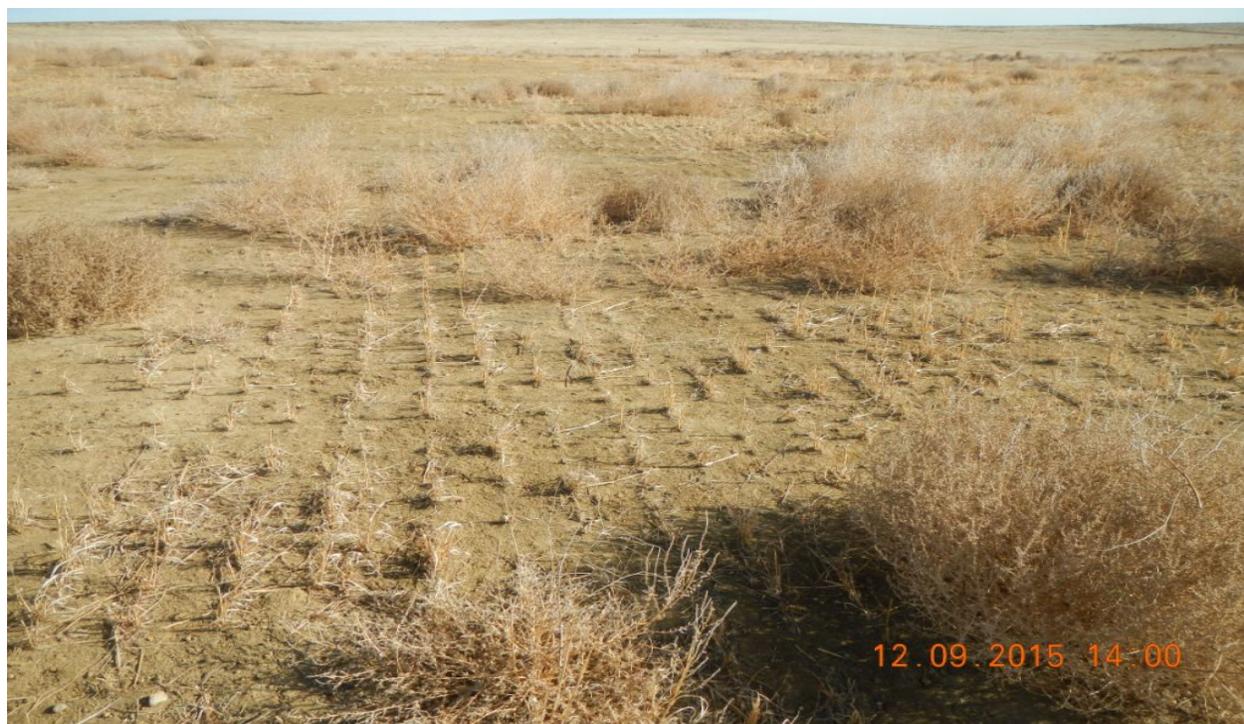
photo 14: West side of the location facing southeast.
