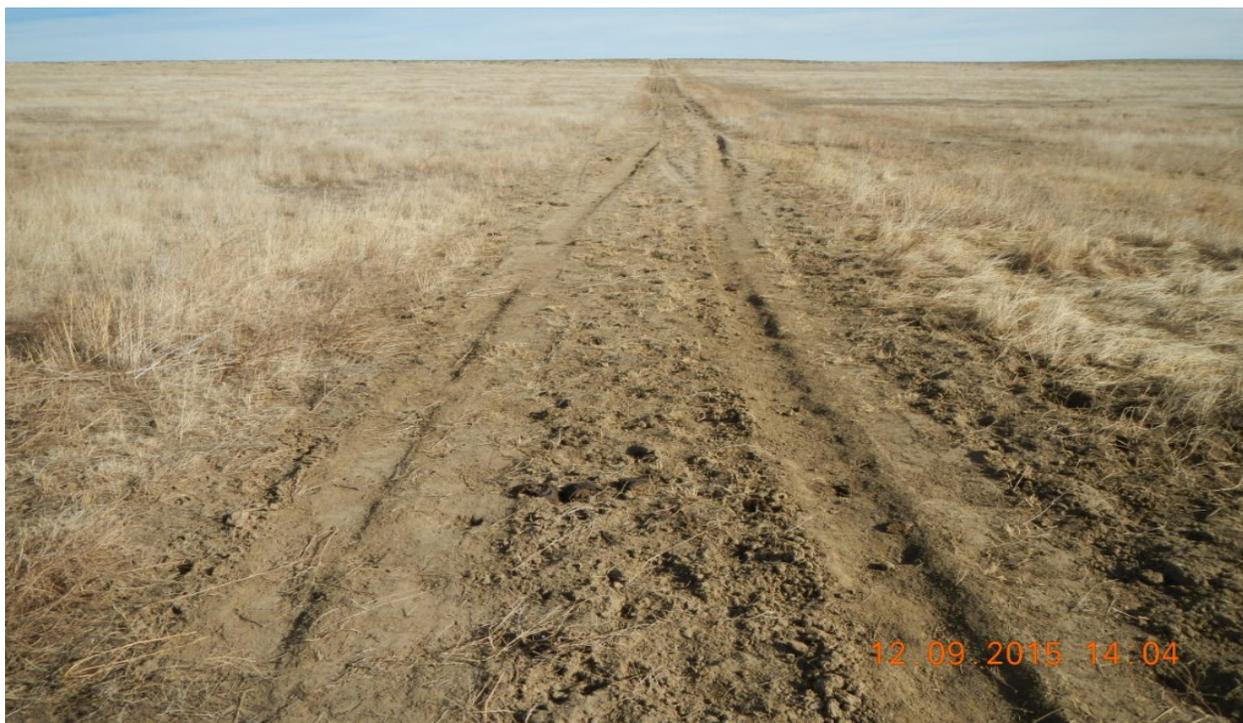
photo 1: Facing east along former access road towards the location.

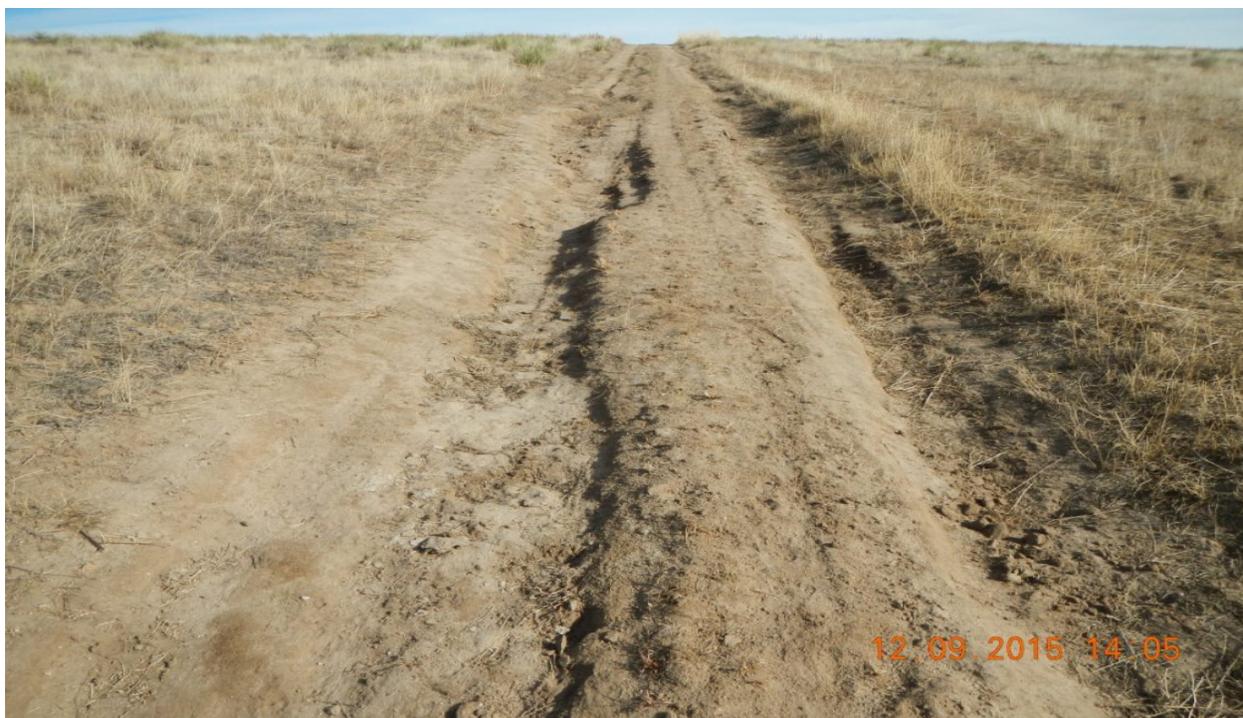
photo 2: Erosion occurring along the access road.

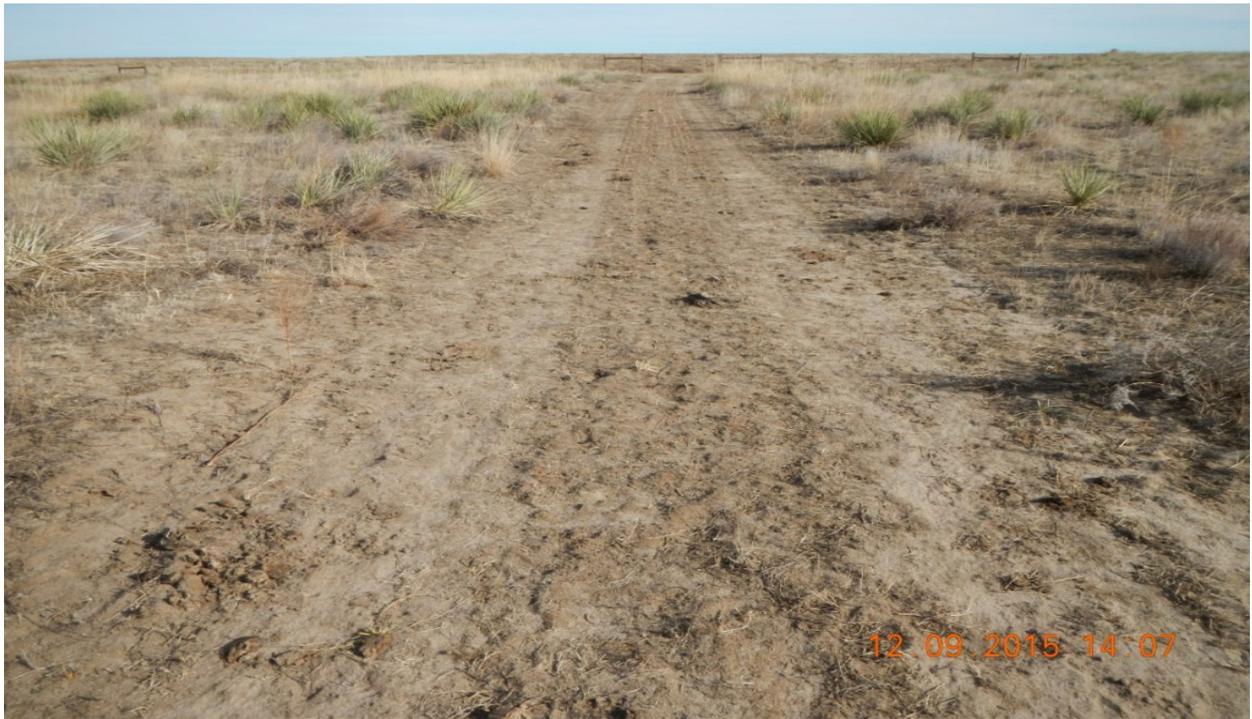
photo 3: Facing east towards the location.

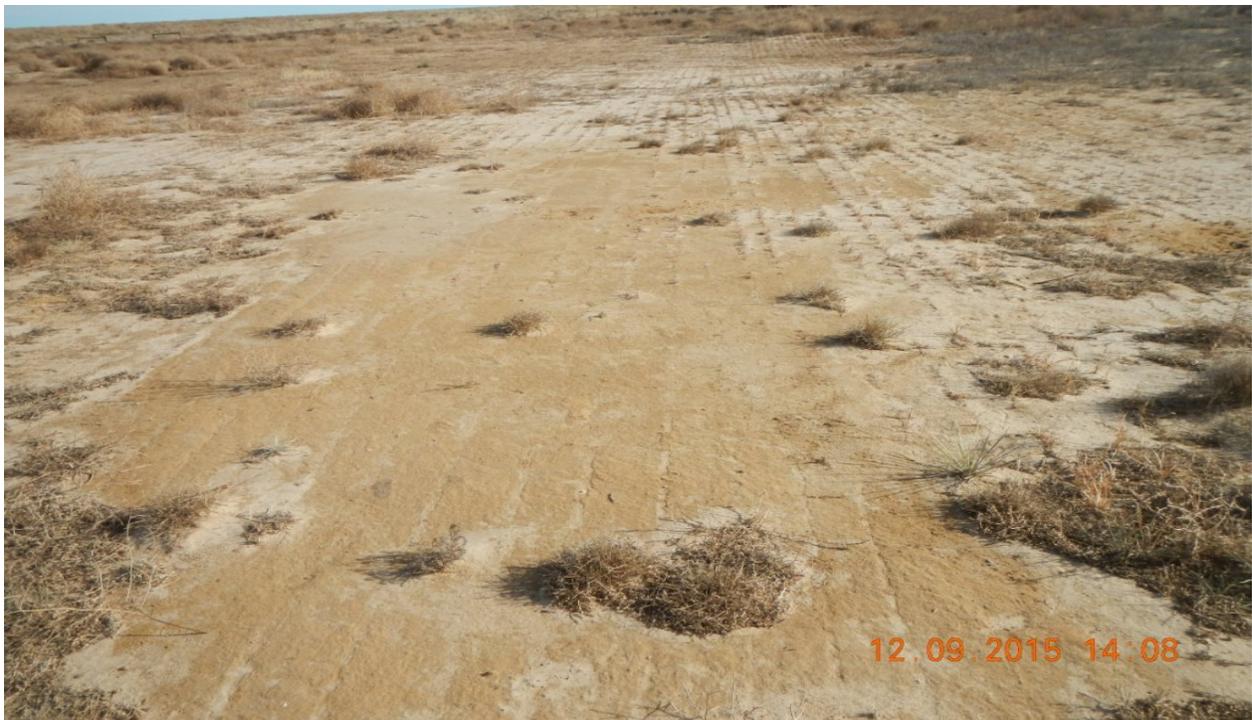
photo 4: West side of the location facing east.

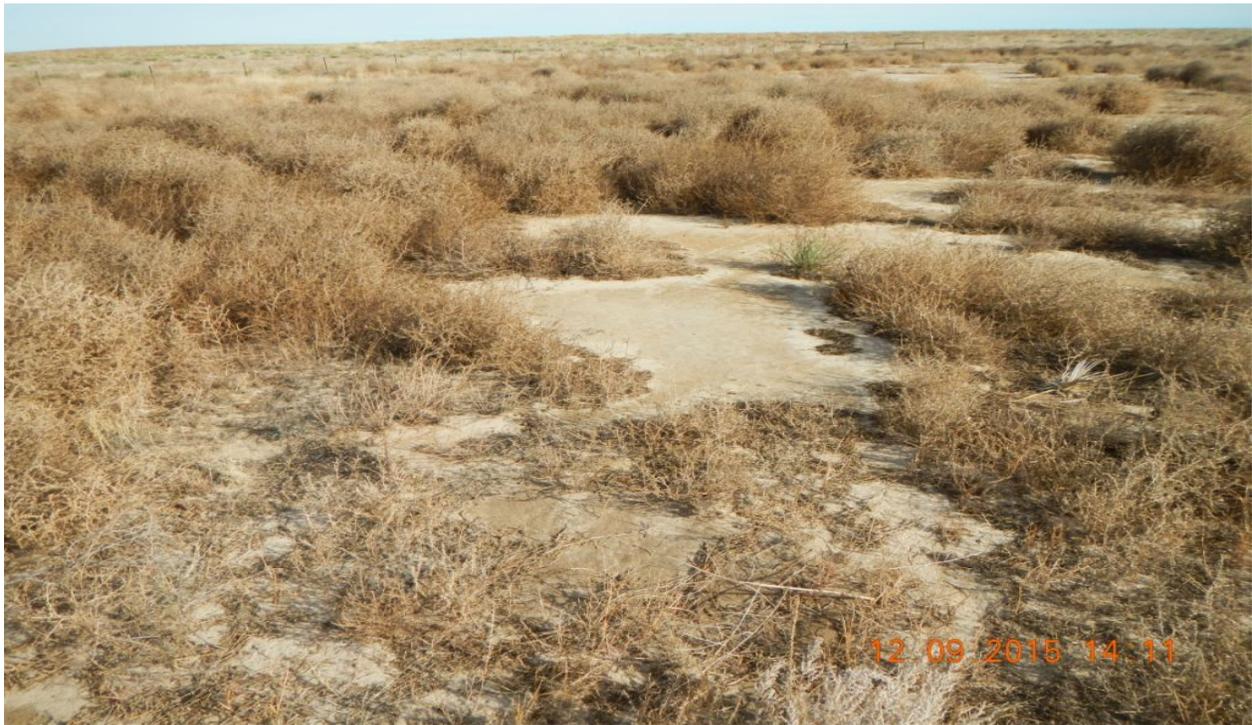
Photo 5: West side of the location facing northeast.

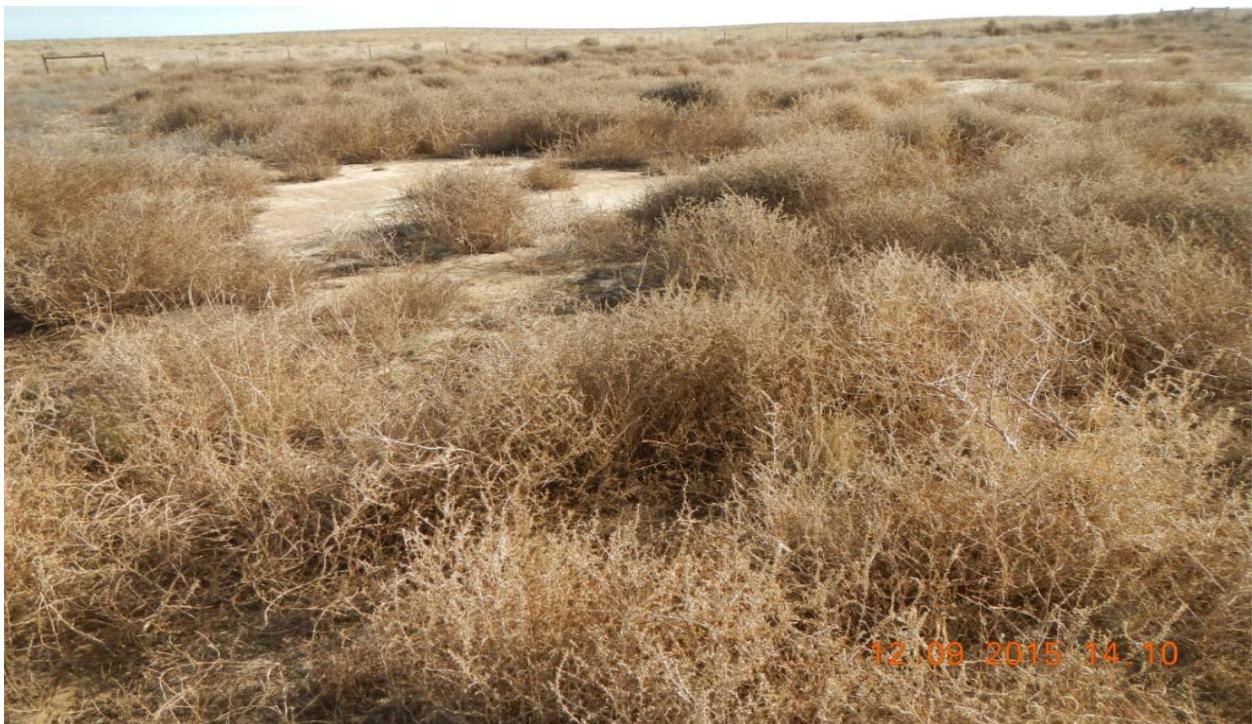
Photo 6: North side of the location facing southeast.

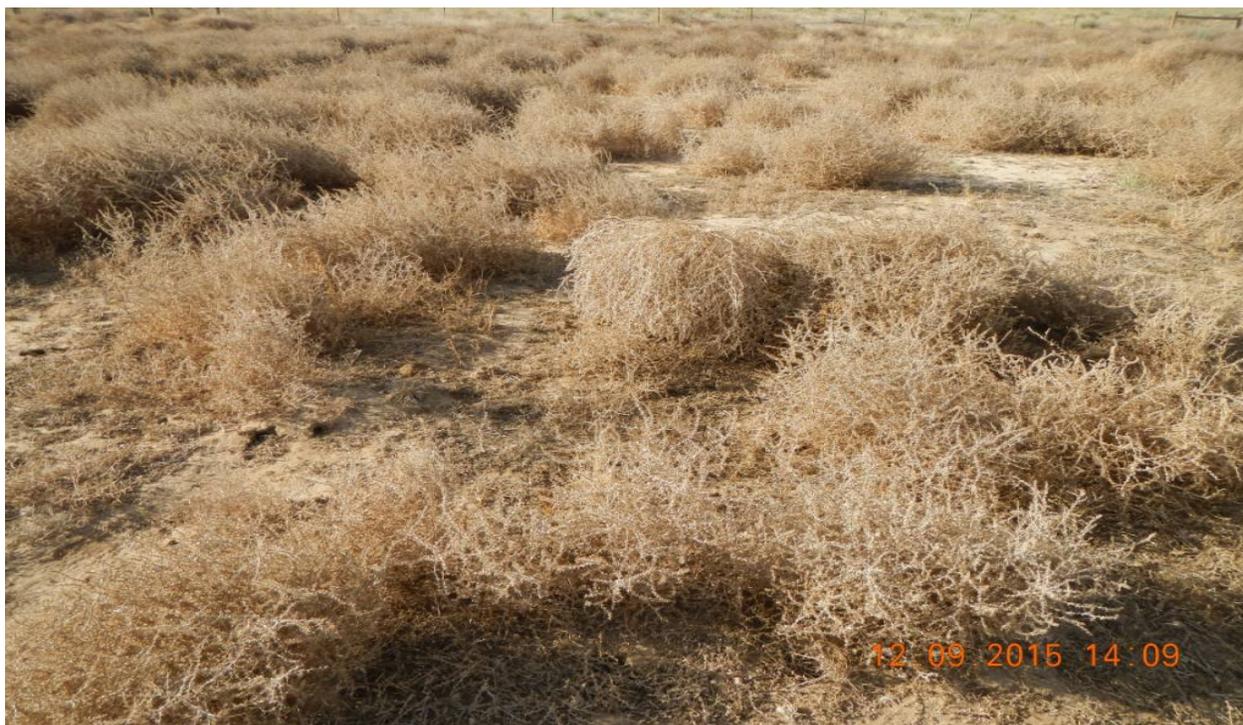
Photo 7: Weed debris (russian thistle) along the north side of the location.

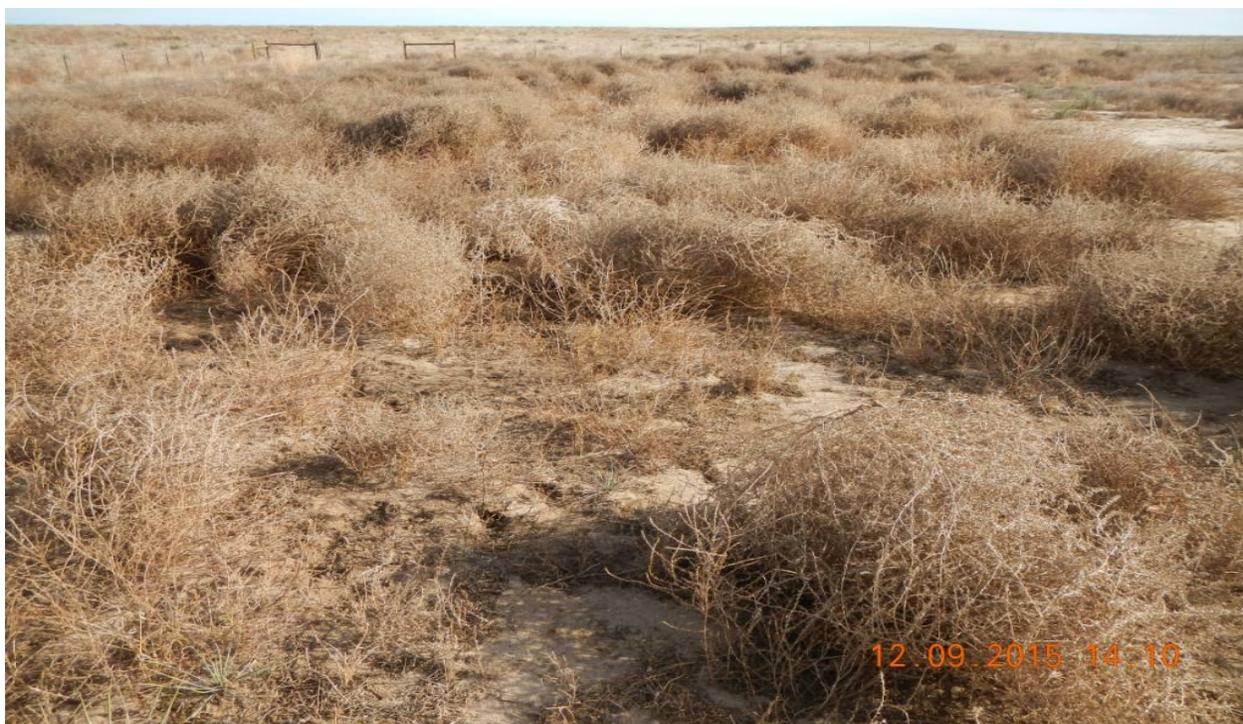
Photo 8: North side of the location facing east.

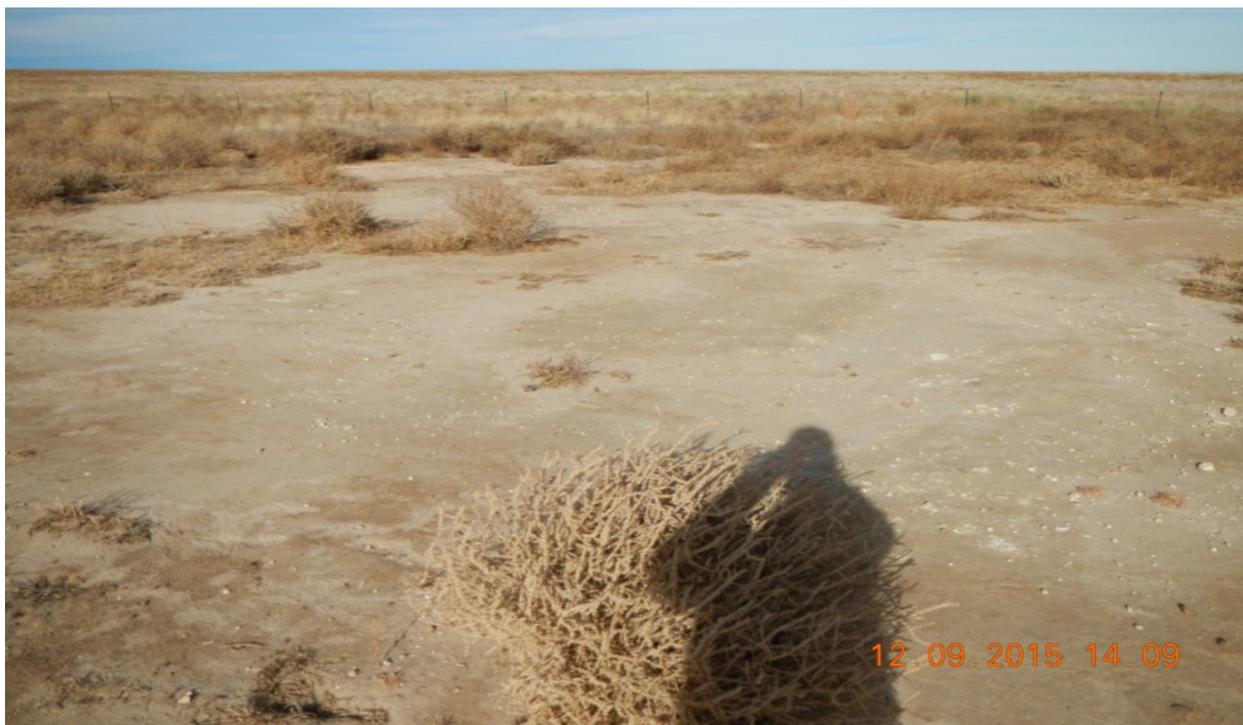
Photo 9: Center of the location facing north.

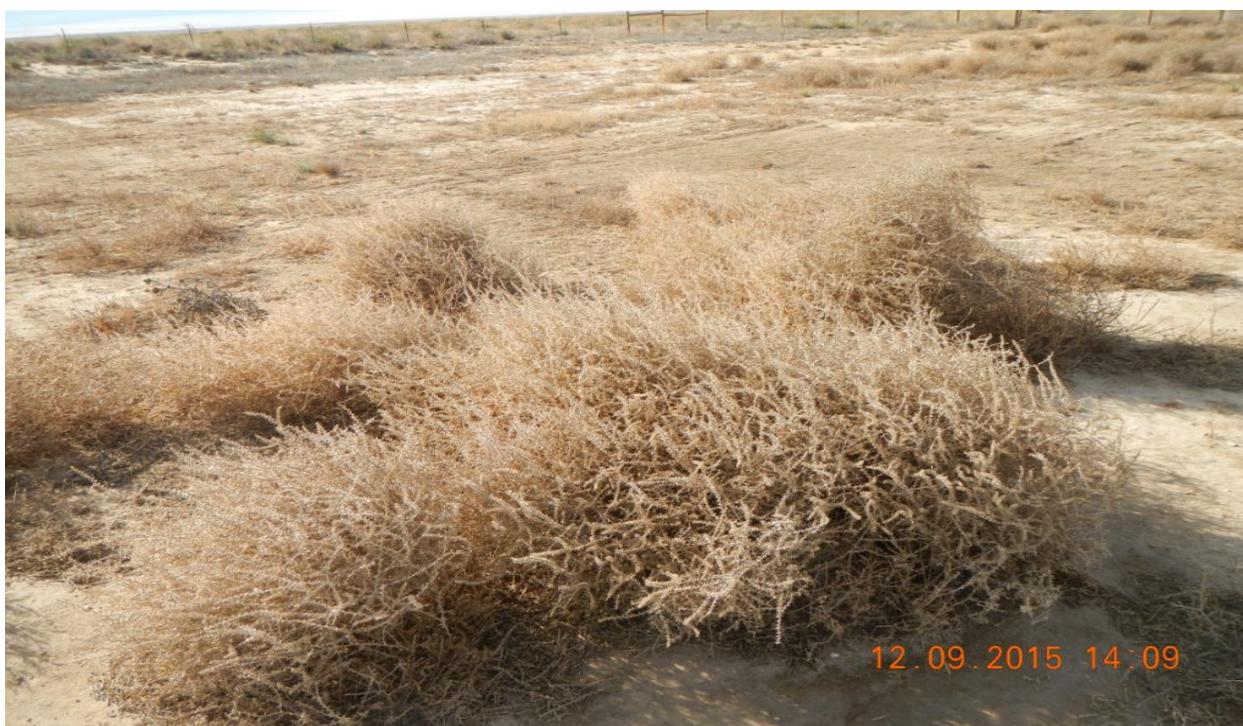
photo 10: Center of the location facing west.

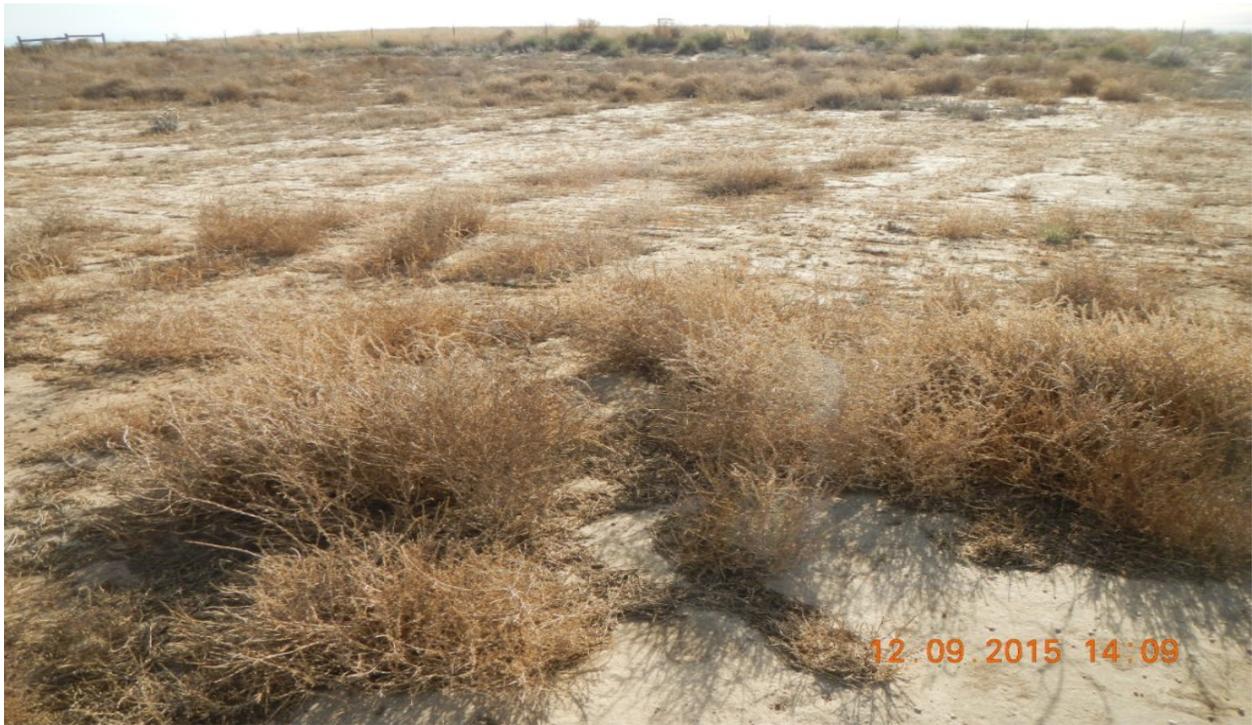
photo 11: Center of the location facing south.

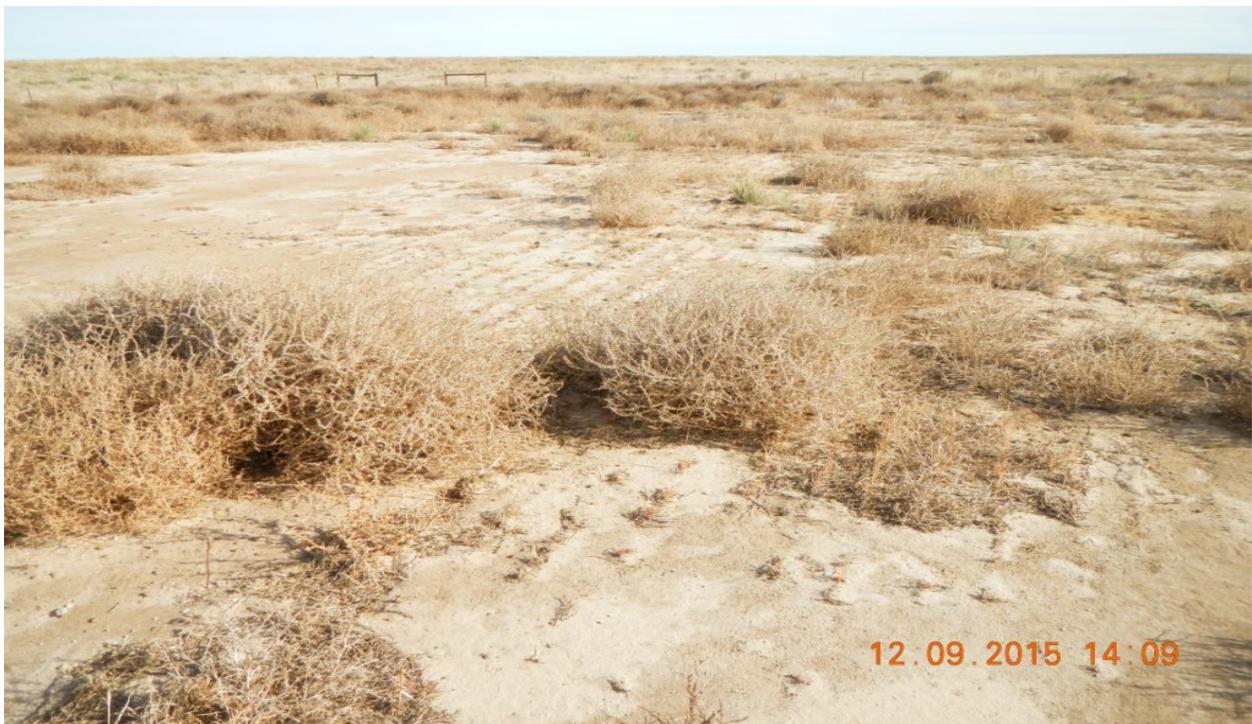
photo 12: Center of the location facing east

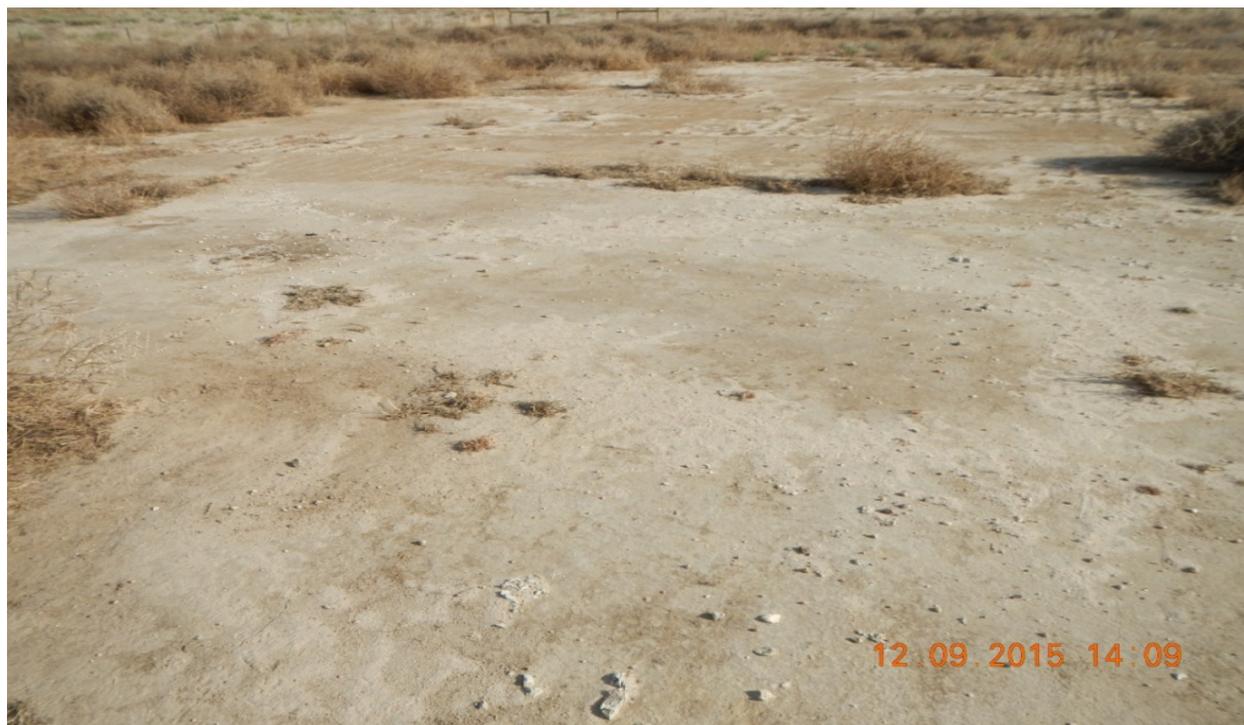
photo 13: Near the center of the location facing east. This area has no vegetation establishment..

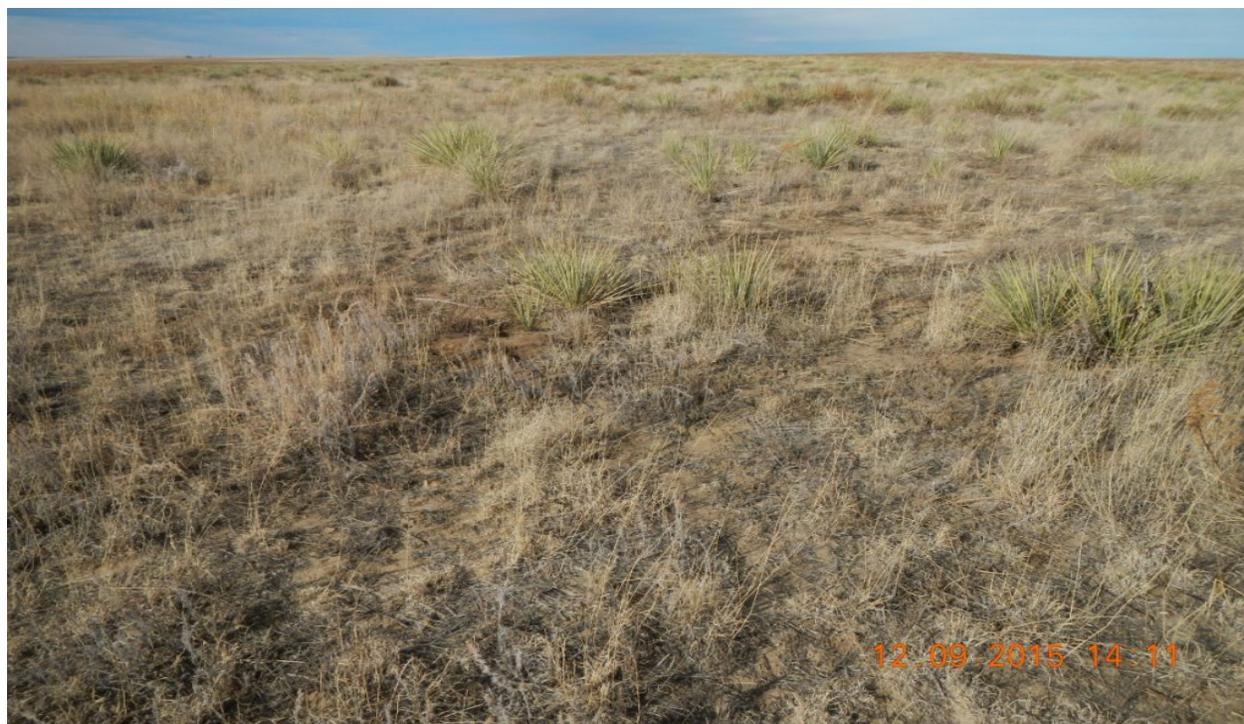
photo 14: Surrounding vegetation.
