## Reinspection Report- Greasewood 4-8H

## Reinspection Report- Pipeline

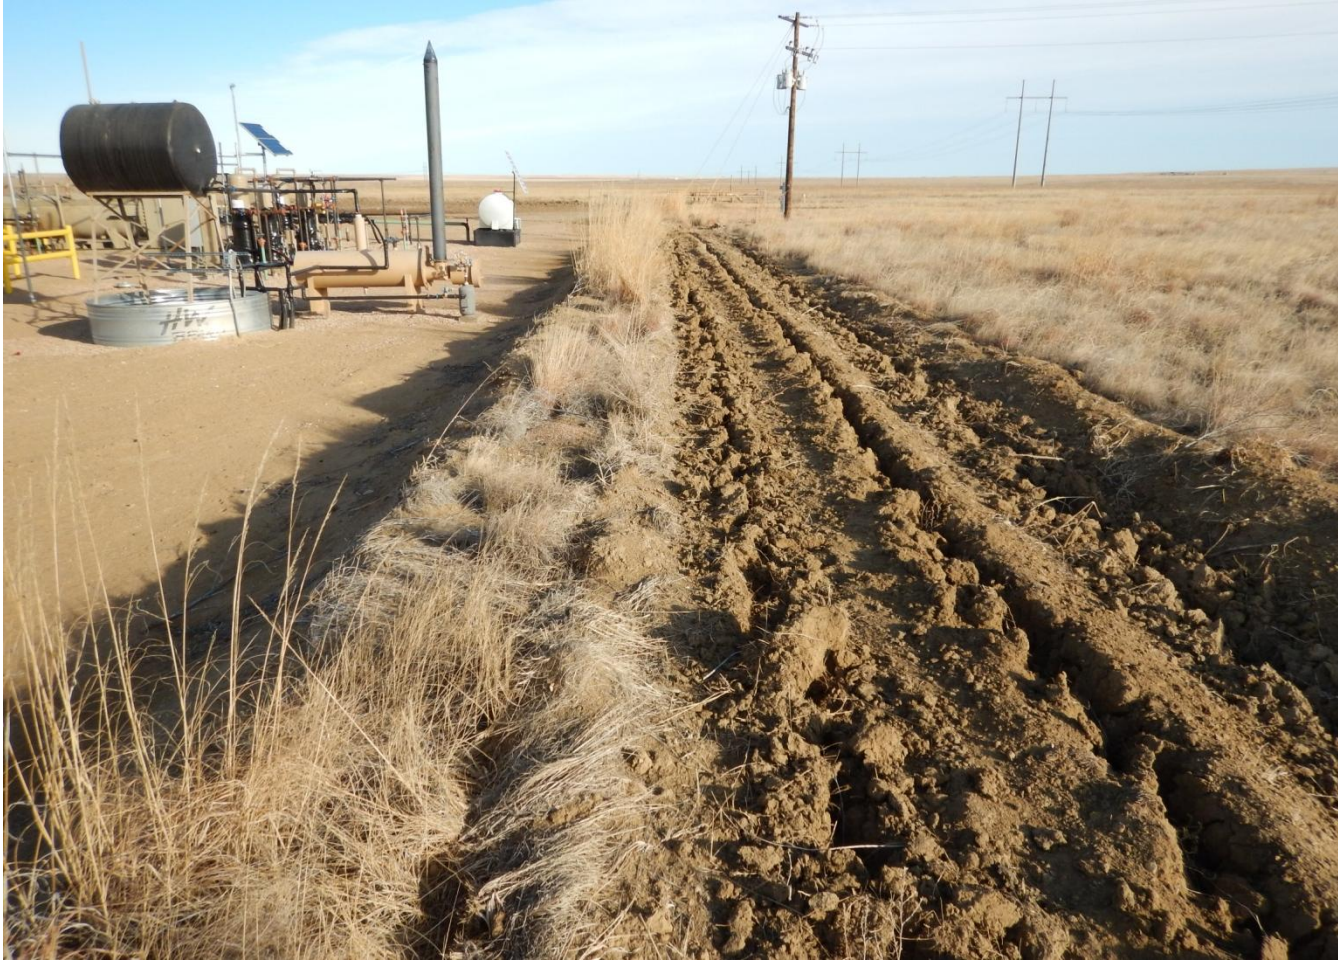
**Photo 2.** Photo taken from southern location, facing East. Recent interim reclamation work has been completed. Reclaimed area lacks stabilization post seeding. Surface roughening is a temporary BMP and should be used in conjunction with other BMPs.

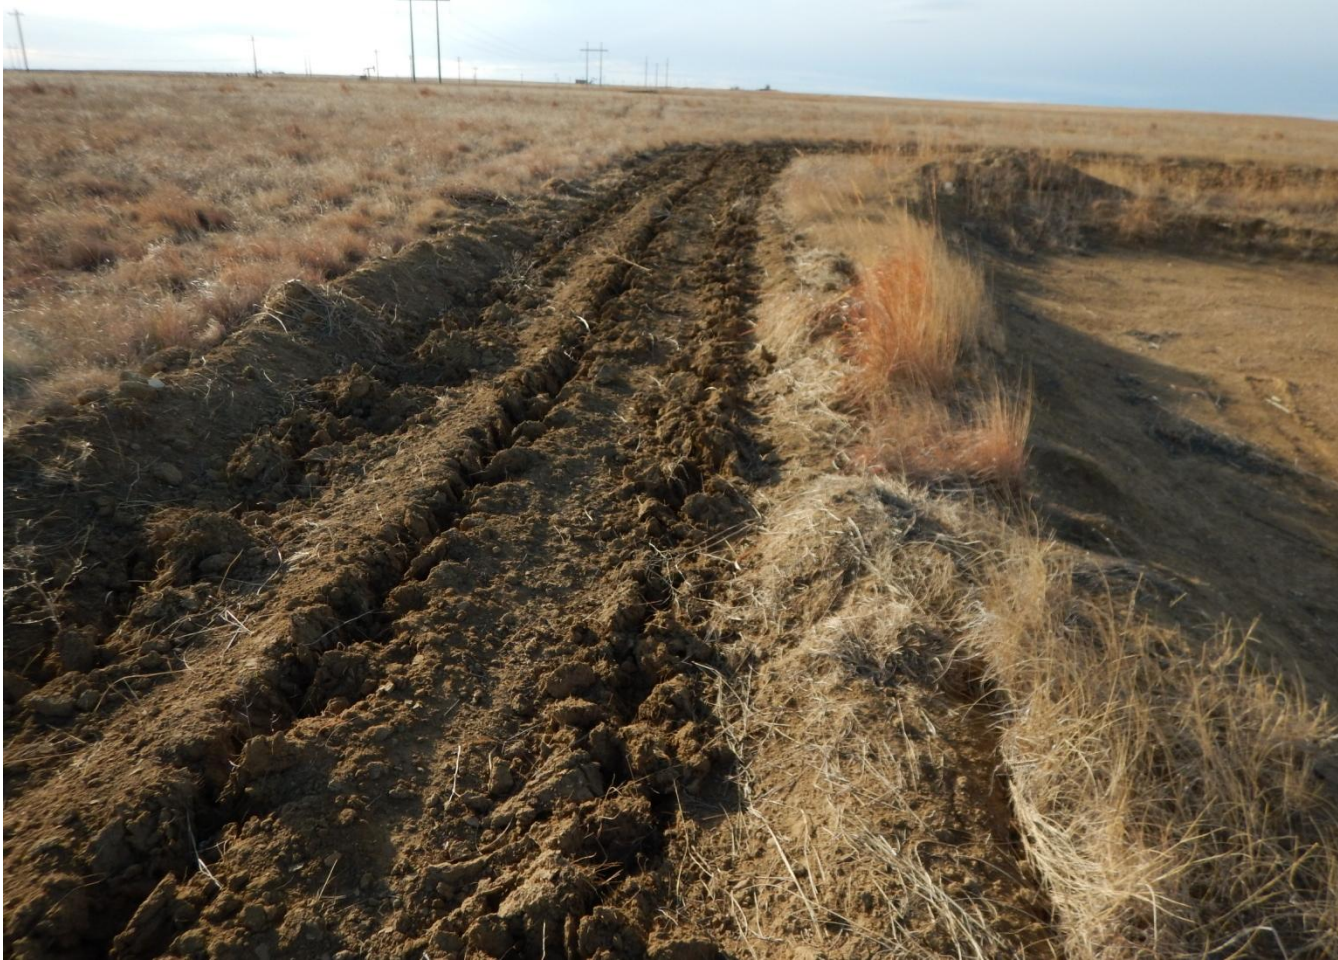
**Photo 3.** Photo taken from southern location, facing West. Recent interim reclamation work has been completed. Reclaimed area lacks stabilization post seeding. Surface roughening is a temporary BMP and should be used in conjunction with other BMPs.

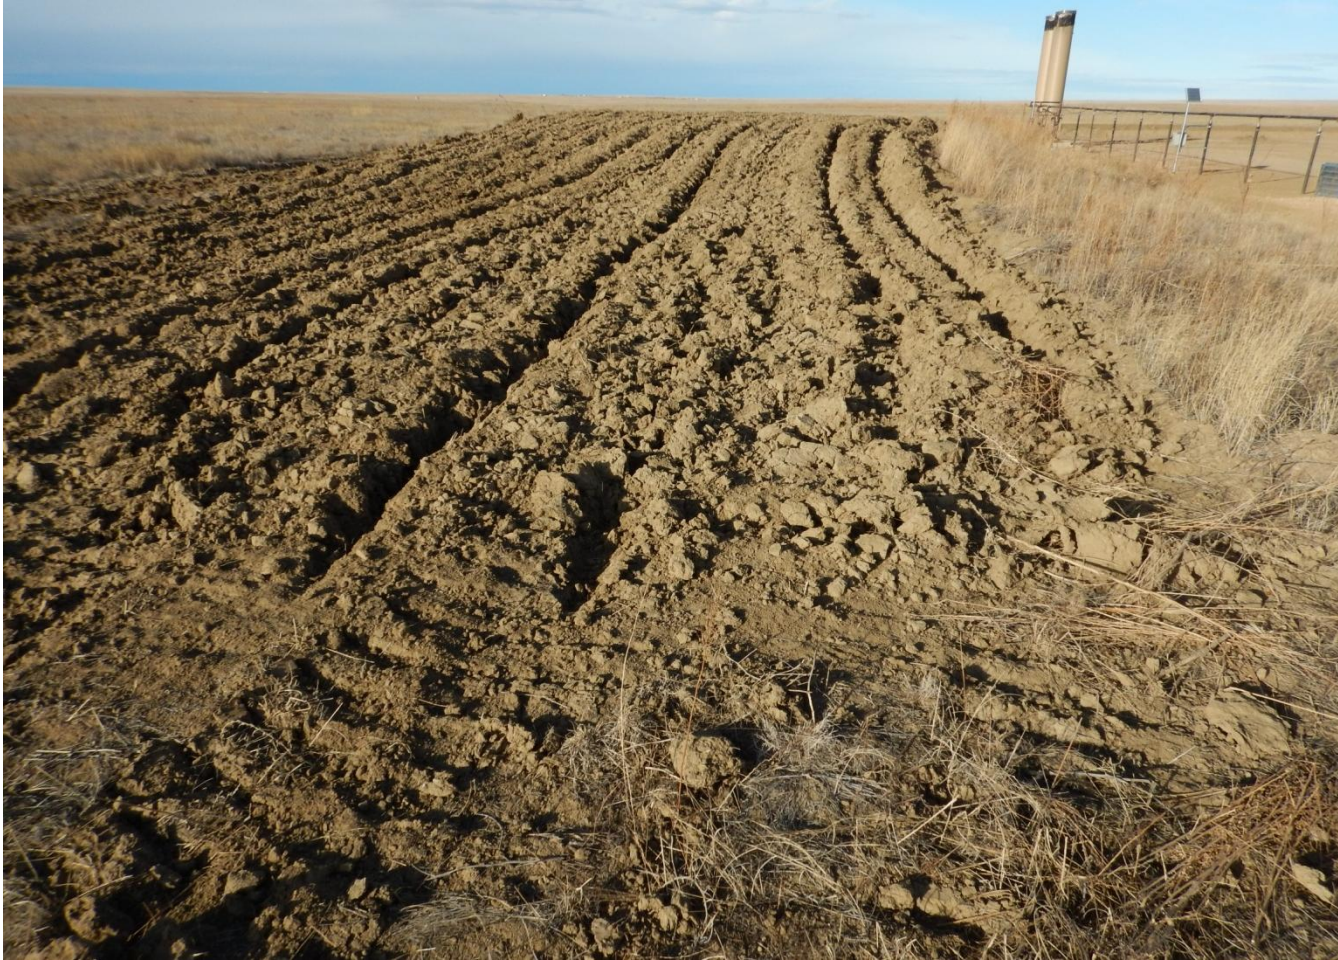
**Photo 4.** Photo taken from southern location, facing North towards topsoil stockpile. Recent interim reclamation work has been completed. Reclaimed area lacks stabilization post seeding. Surface roughening is a temporary BMP and should be used in conjunction with other BMPs.

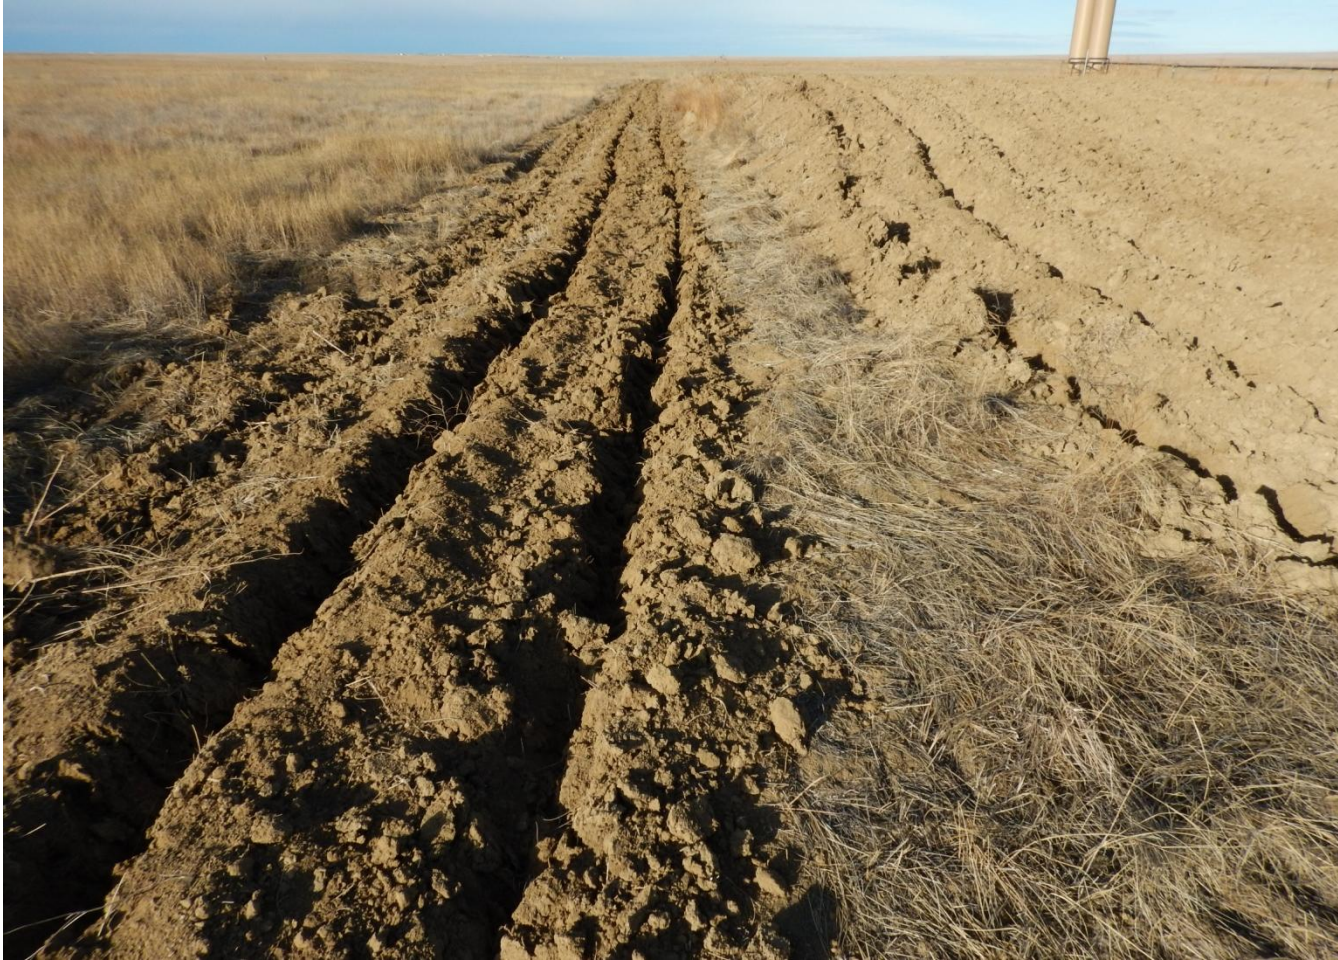
**Photo 5.** Photo taken from southwest location, facing North towards topsoil stockpile. Recent interim reclamation work has been completed. Reclaimed area lacks stabilization post seeding. Surface roughening is a temporary BMP and should be used in conjunction with other BMPs.

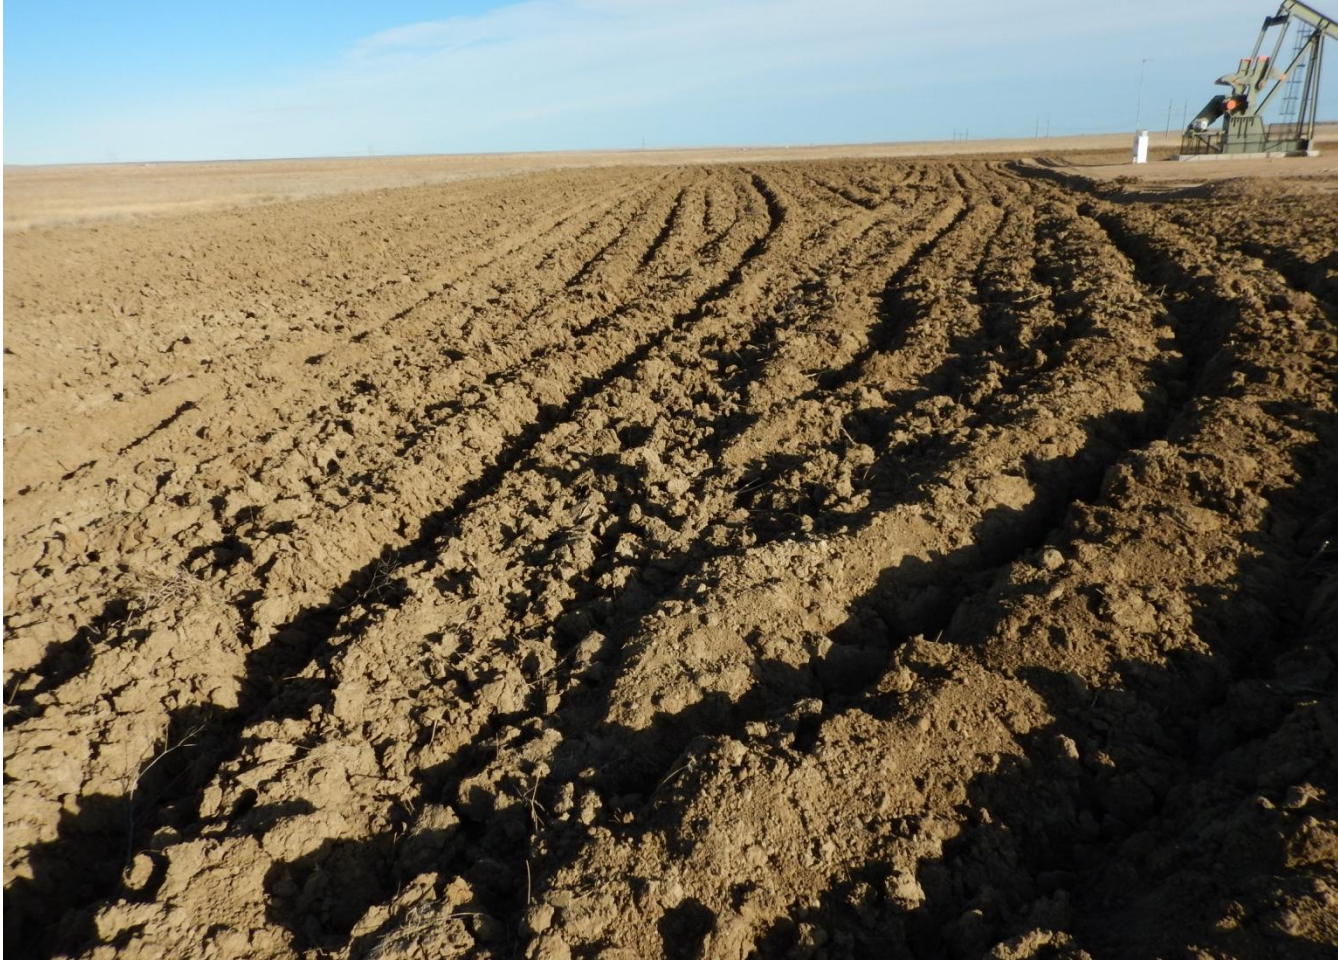
**Photo 6.** Photo taken from northern location, facing East. Recent interim reclamation work has been completed. Reclaimed area lacks stabilization post seeding. Surface roughening is a temporary BMP and should be used in conjunction with other BMPs.

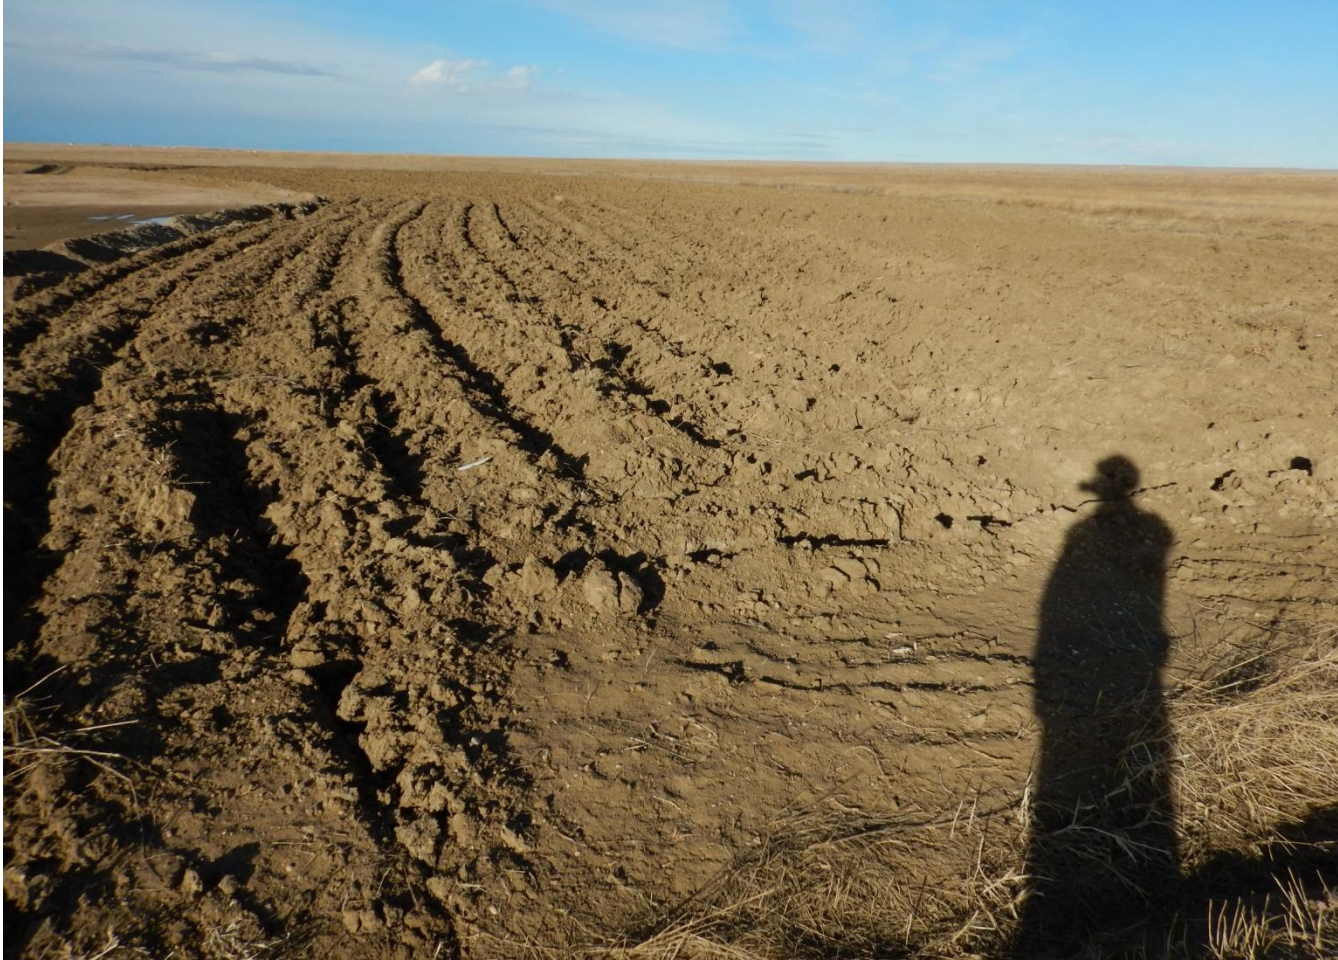
**Photo 7.** Photo taken from southeast location, facing North. Recent interim reclamation work has been completed. Reclaimed area lacks stabilization post seeding. Surface roughening is a temporary BMP and should be used in conjunction with other BMPs.

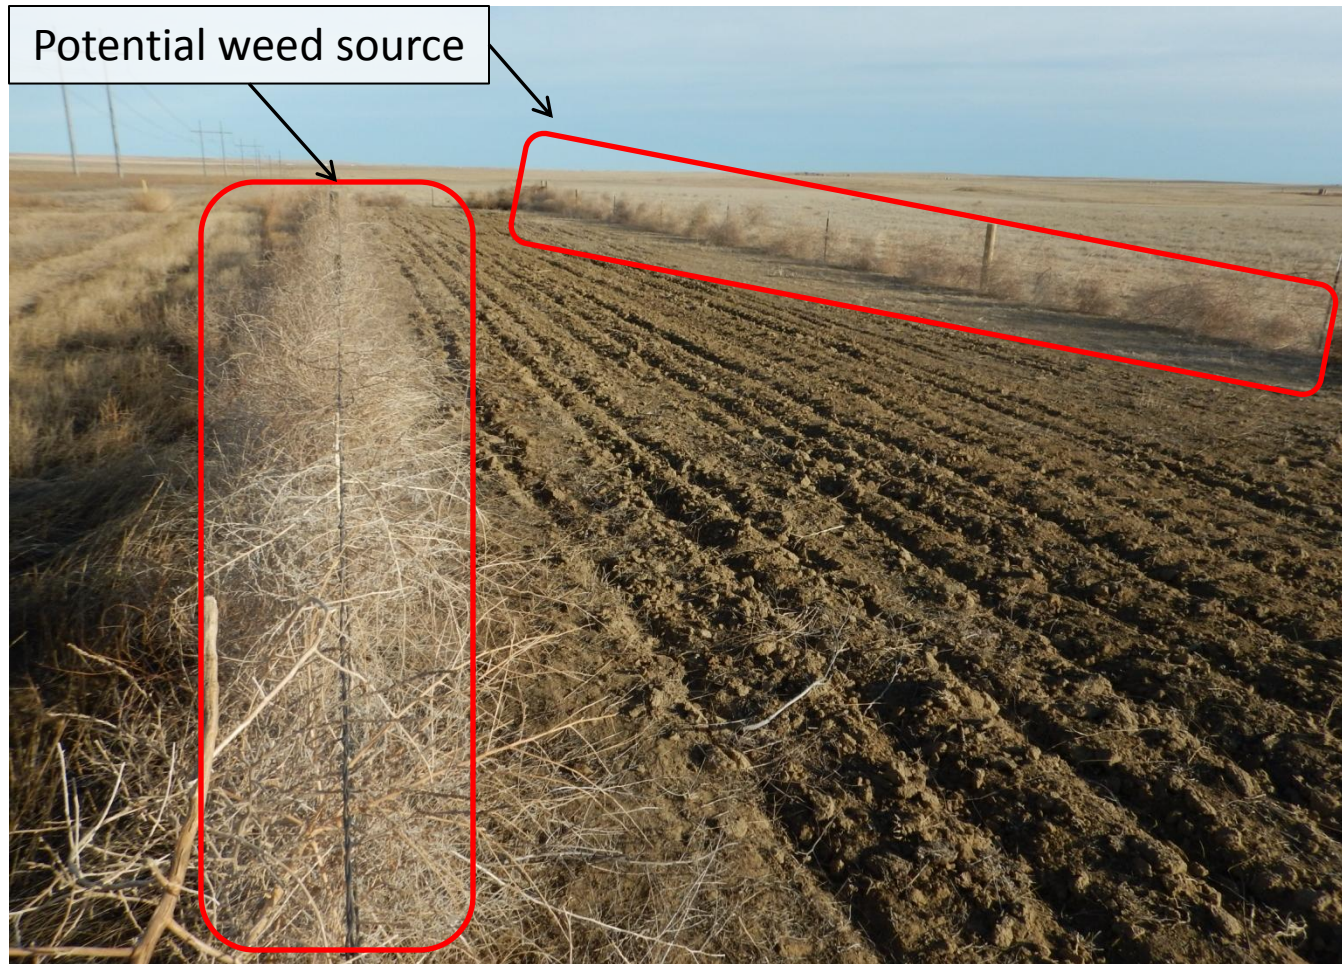
**Photo 8.** Photo taken from eastern pipeline ROW, facing East. Recent interim reclamation work has been completed. Tumbleweeds caught inside the fence could be a potential weed source affecting perennial vegetative growth. Pipeline ROW lacks stabilization post seeding. Surface roughening is a temporary BMP and should be used in conjunction with other BMPs.

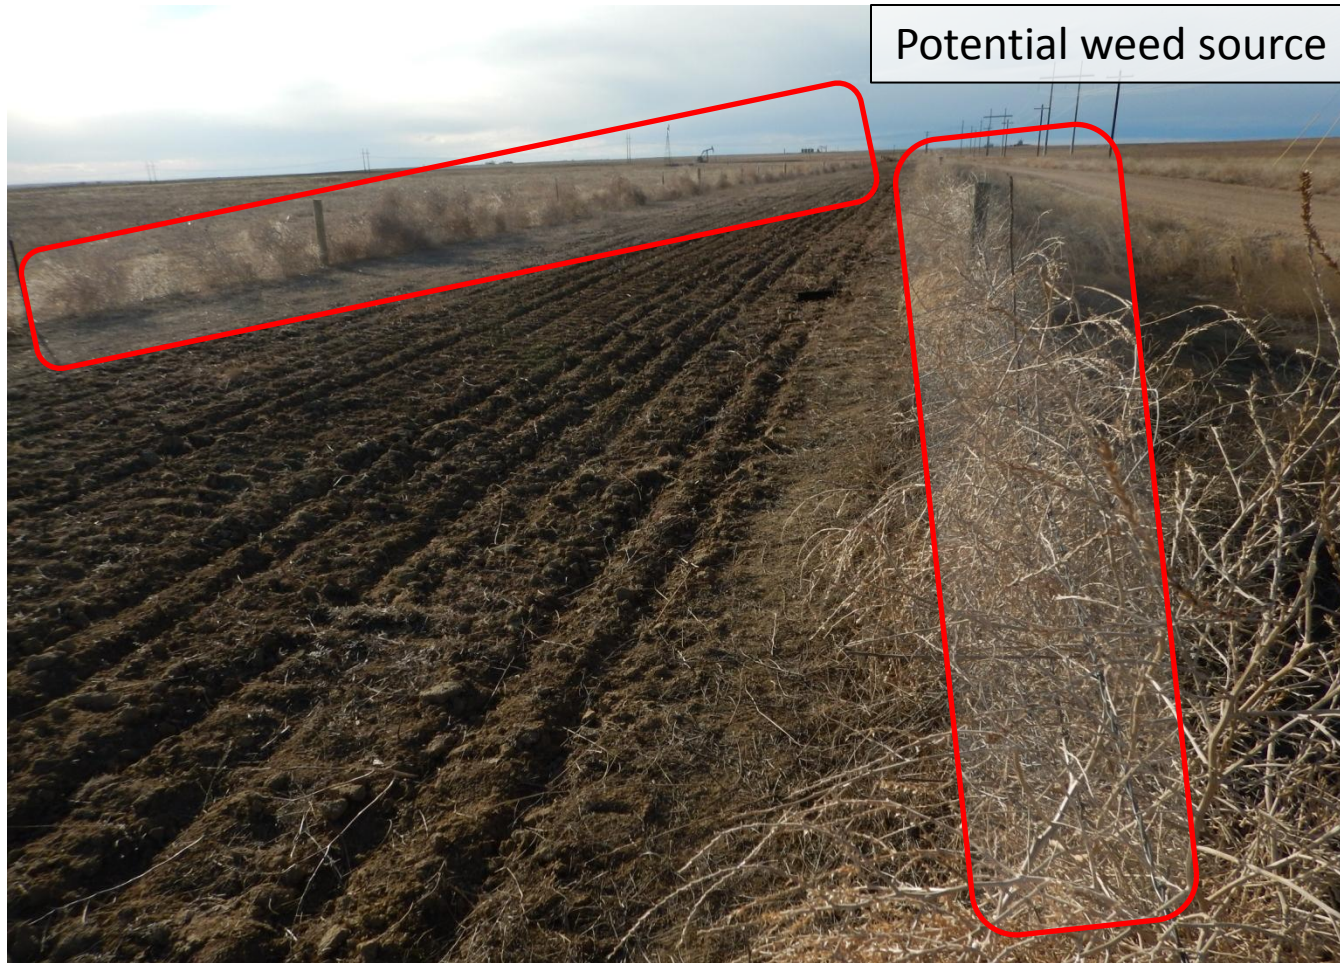
**Photo 9.** Photo taken from eastern pipeline ROW, facing West. Recent interim reclamation work has been completed. Tumbleweeds caught inside the fence could be a potential weed source affecting perennial vegetative growth. Pipeline ROW lacks stabilization post seeding. Surface roughening is a temporary BMP and should be used in conjunction with other BMPs.

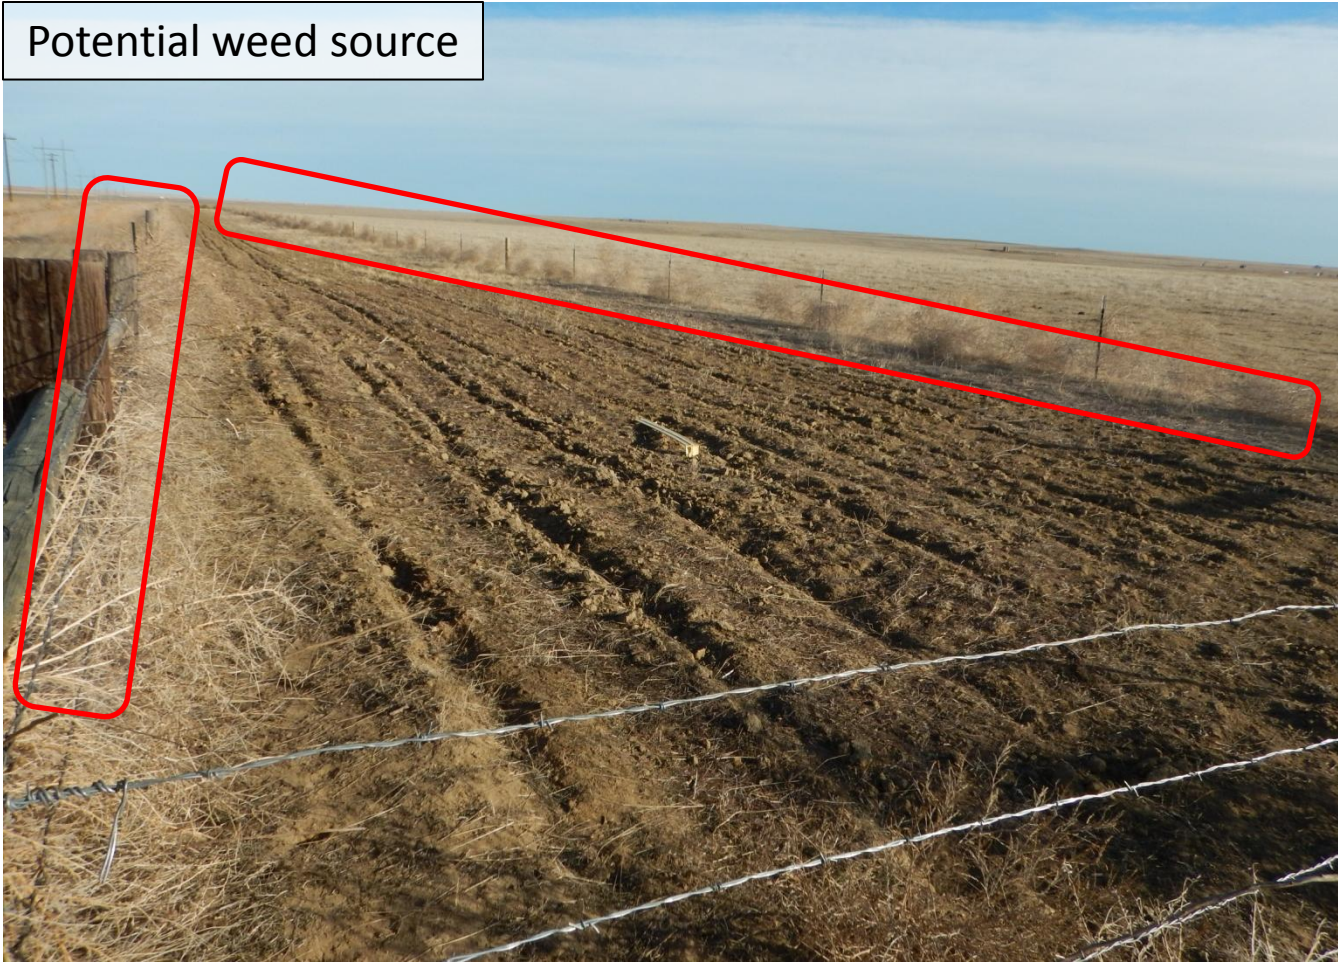
Potential weed source

**Photo 10.** Photo taken from western pipeline ROW, facing East. Recent interim reclamation work has been completed. Tumbleweeds caught inside the fence could be a potential weed source affecting perennial vegetative growth. Pipeline ROW lacks stabilization post seeding. Surface roughening is a temporary BMP and should be used in conjunction with other BMPs.

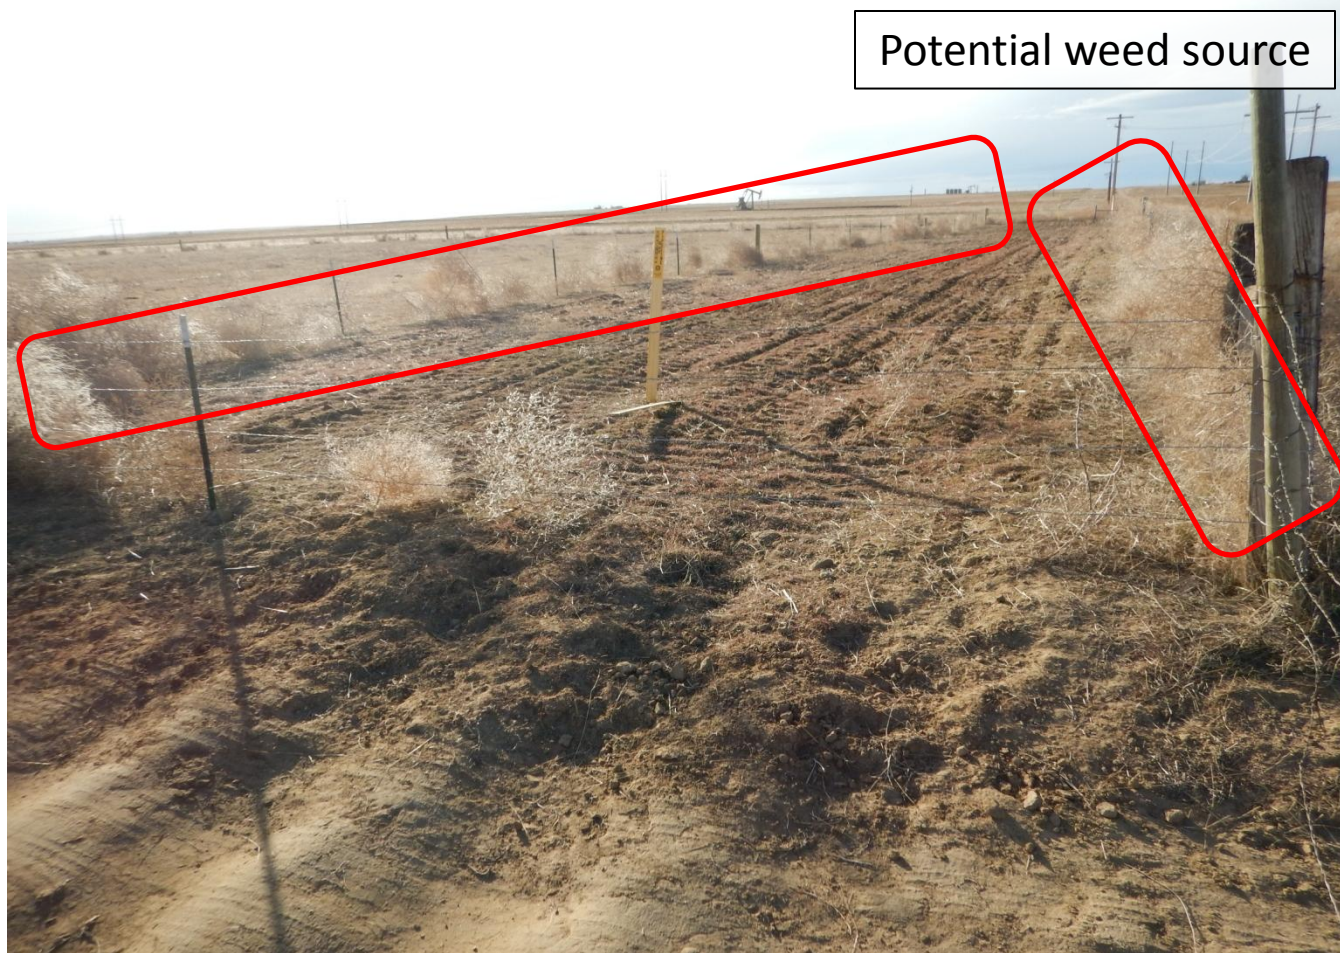
**Photo 11.** Photo taken from western pipeline ROW, facing West. Recent interim reclamation work has been completed. Tumbleweeds caught inside the fence could be a potential weed source affecting perennial vegetative growth. Pipeline ROW lacks stabilization post seeding. Surface roughening is a temporary BMP and should be used in conjunction with other BMPs.
