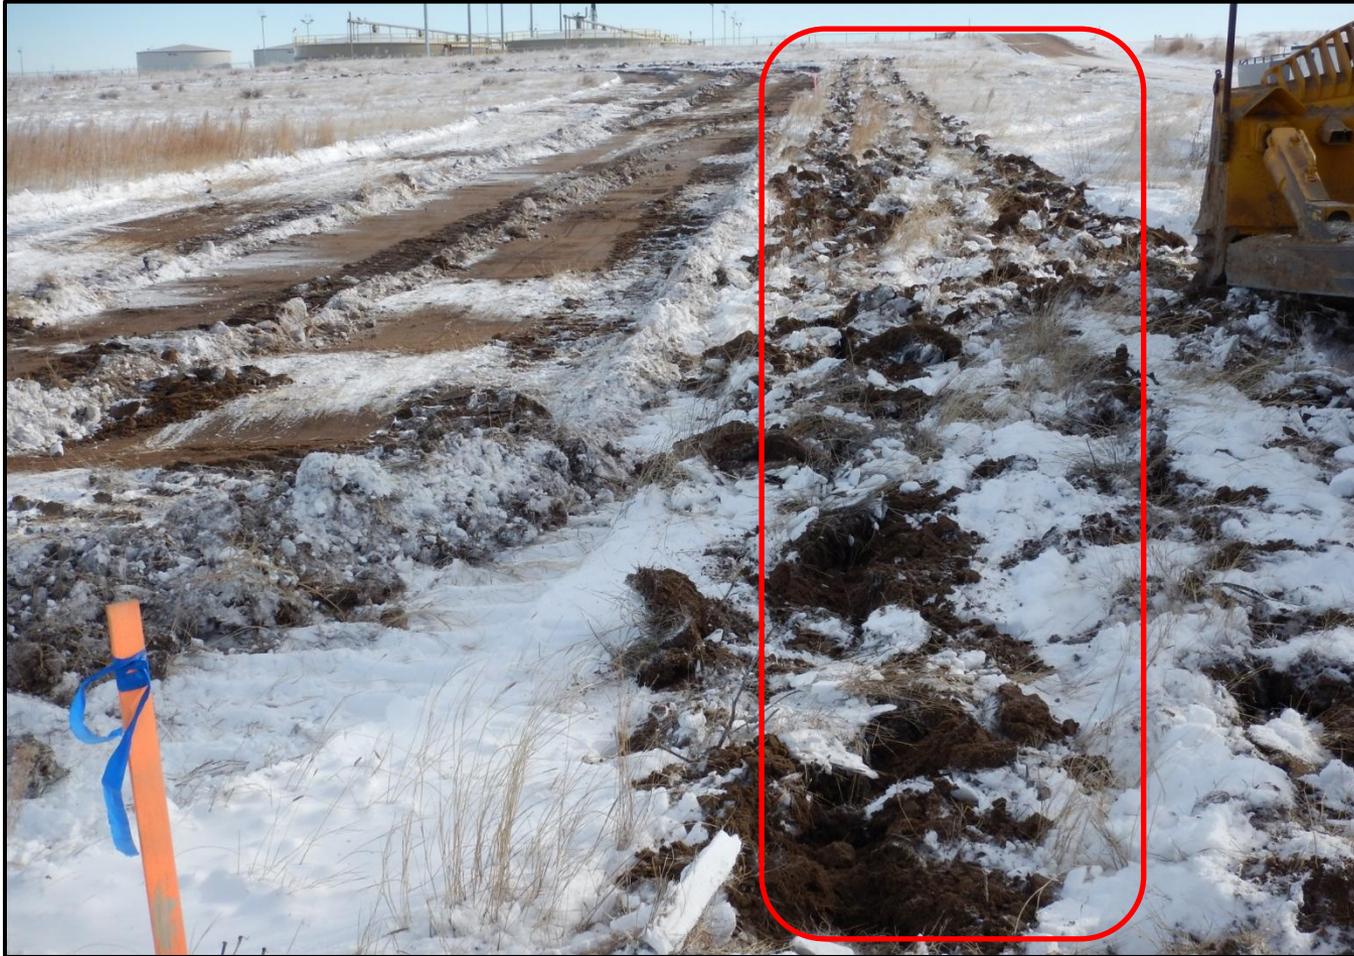
Photo 1. Photo taken from southwestern corner, facing East. Stormwater BMP installed prior to construction of well pad (highlighted in red). Surface roughening is a temporary BMP and should be used in conjunction with other BMPs.

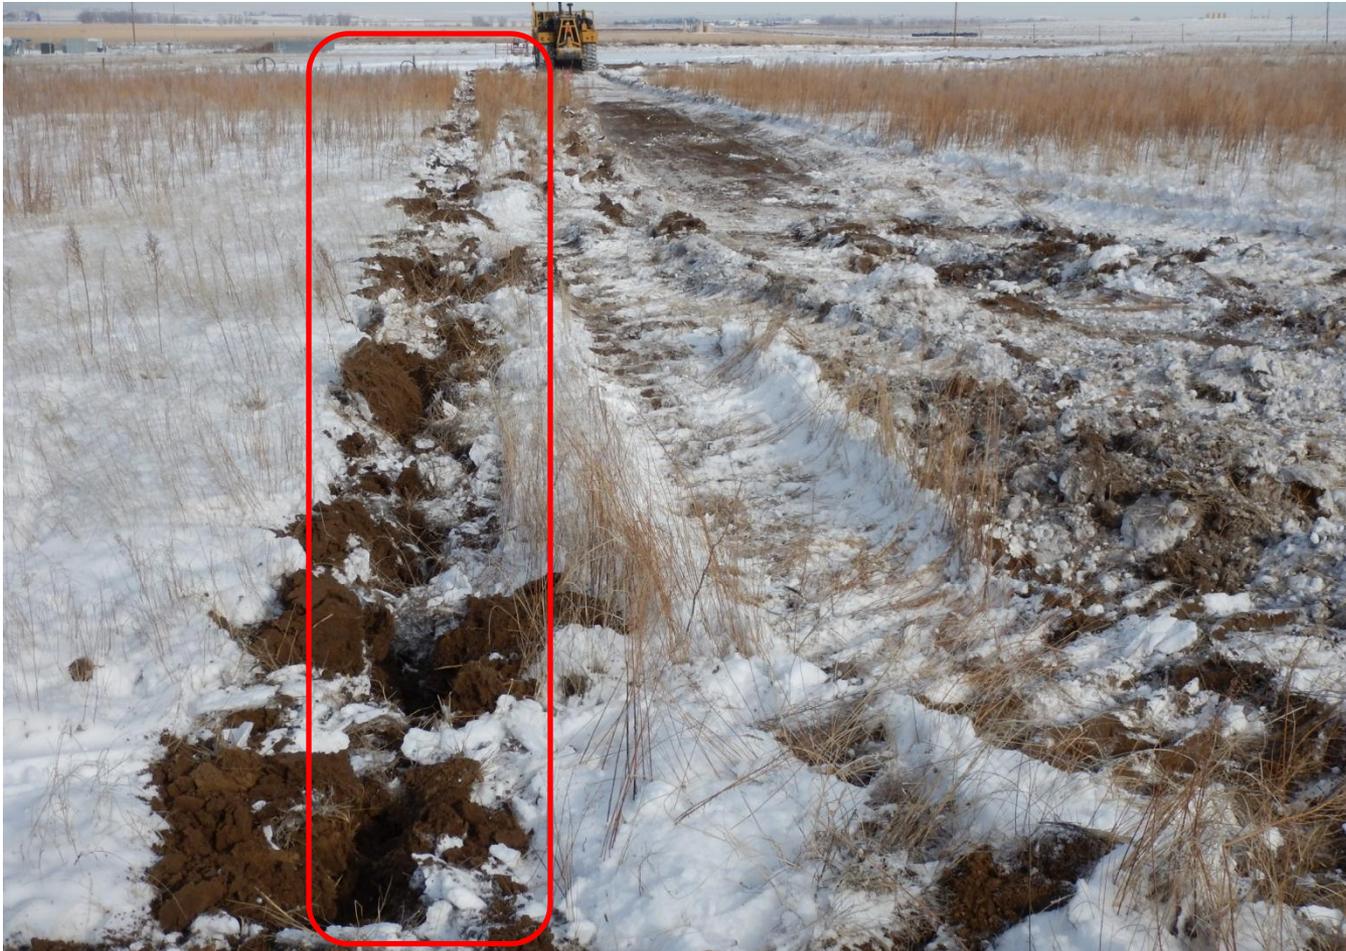
Photo 2. Photo taken from southwestern corner, facing North. Stormwater BMP installed prior to construction of well pad (highlighted in red). Surface roughening is a temporary BMP and should be used in conjunction with other BMPs.

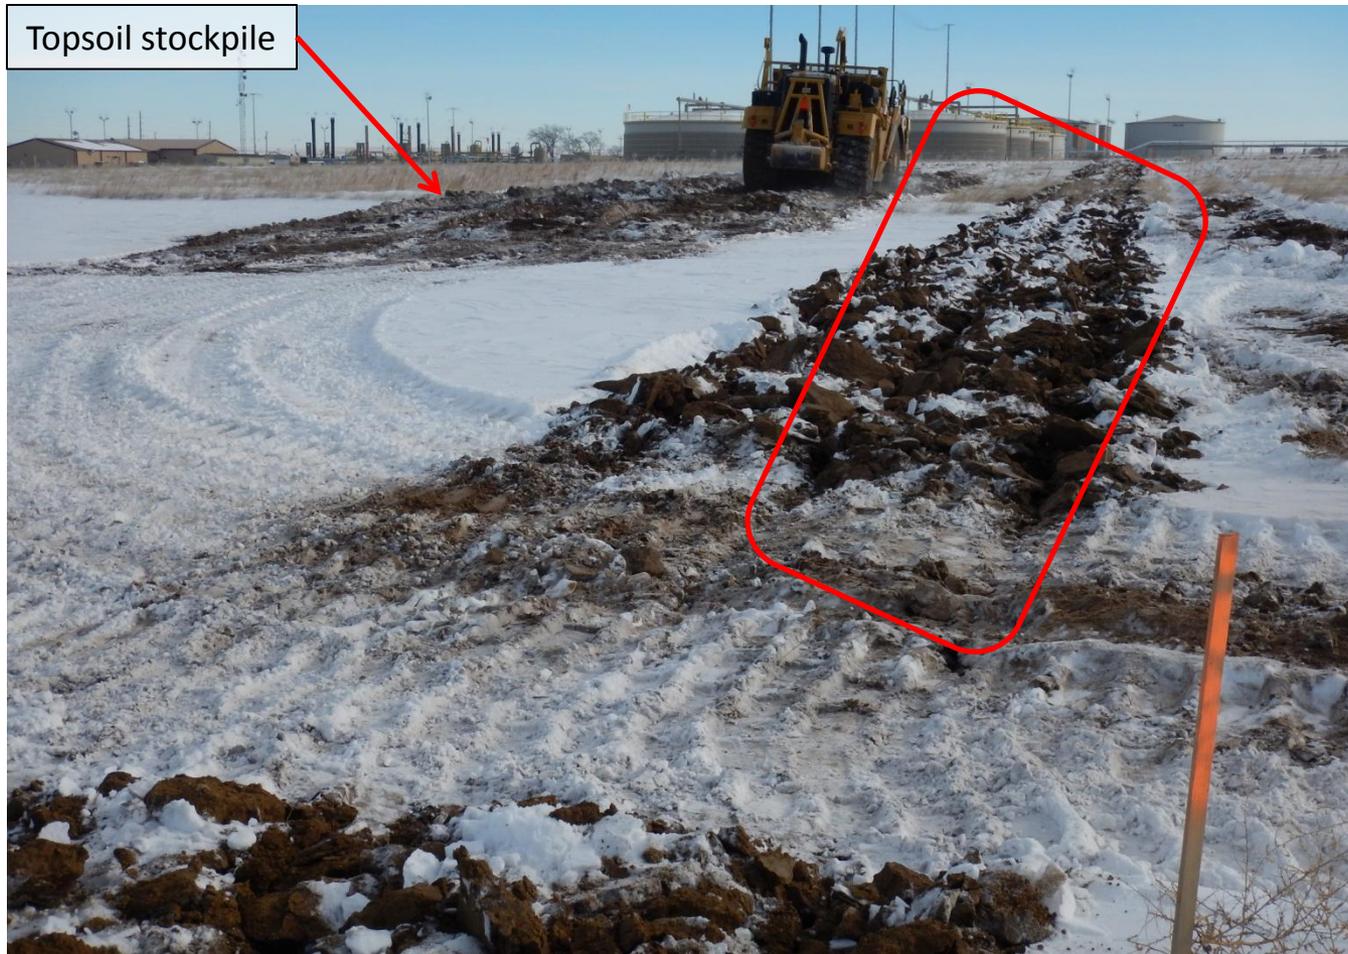
Photo 3. Photo taken from northwestern corner, facing East. Stormwater BMP installed prior to construction of well pad (highlighted in red). Surface roughening is a temporary BMP and should be used in conjunction with other BMPs.

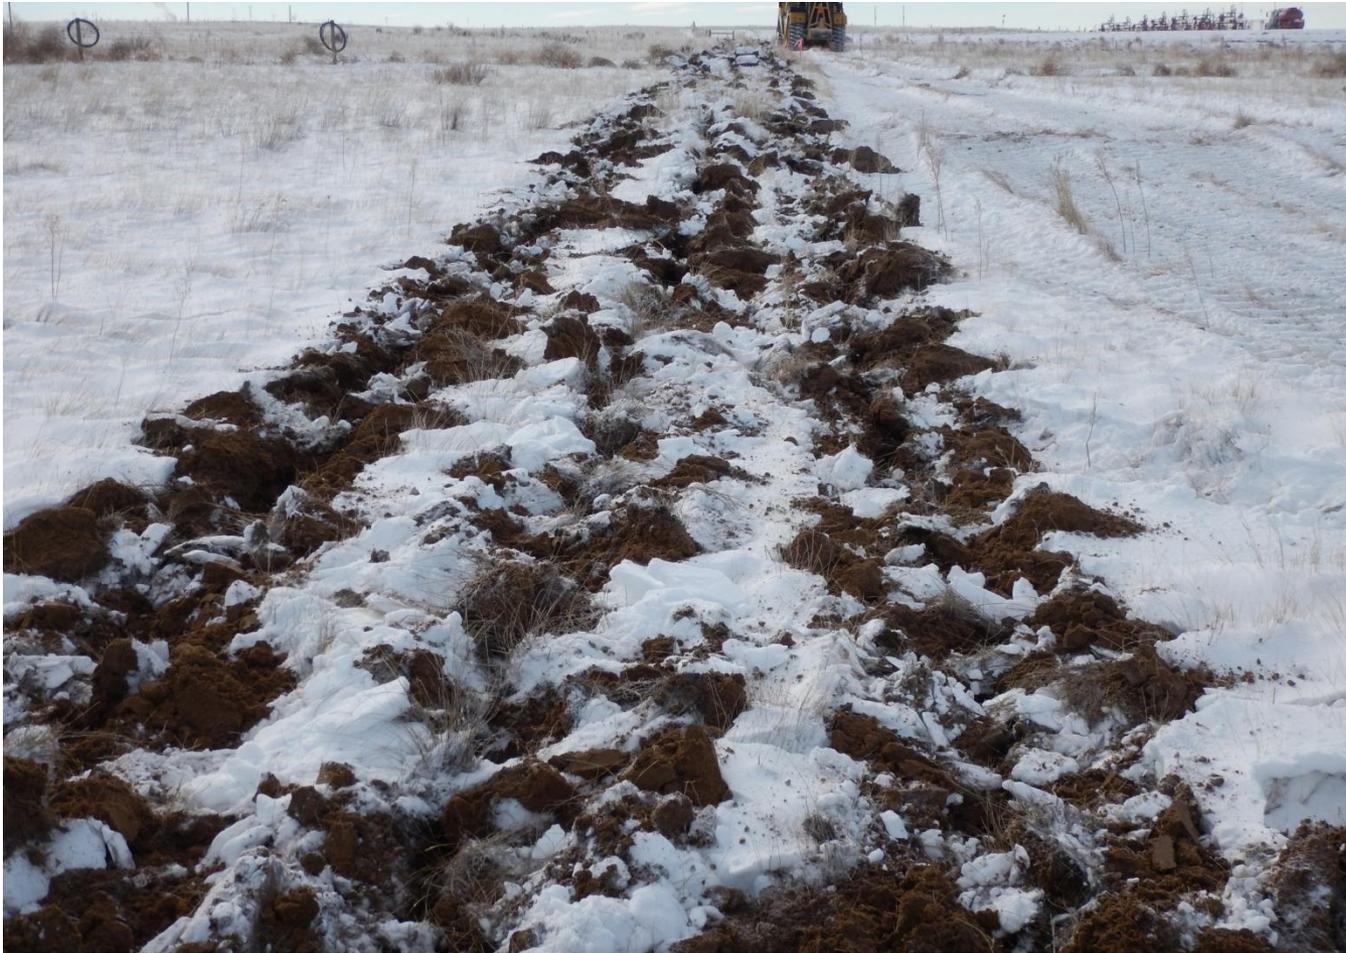
Photo 4. Photo taken from northeast corner, facing South. Stormwater BMP installed prior to construction of well pad (highlighted in red). Surface roughening is a temporary BMP and should be used in conjunction with other BMPs.

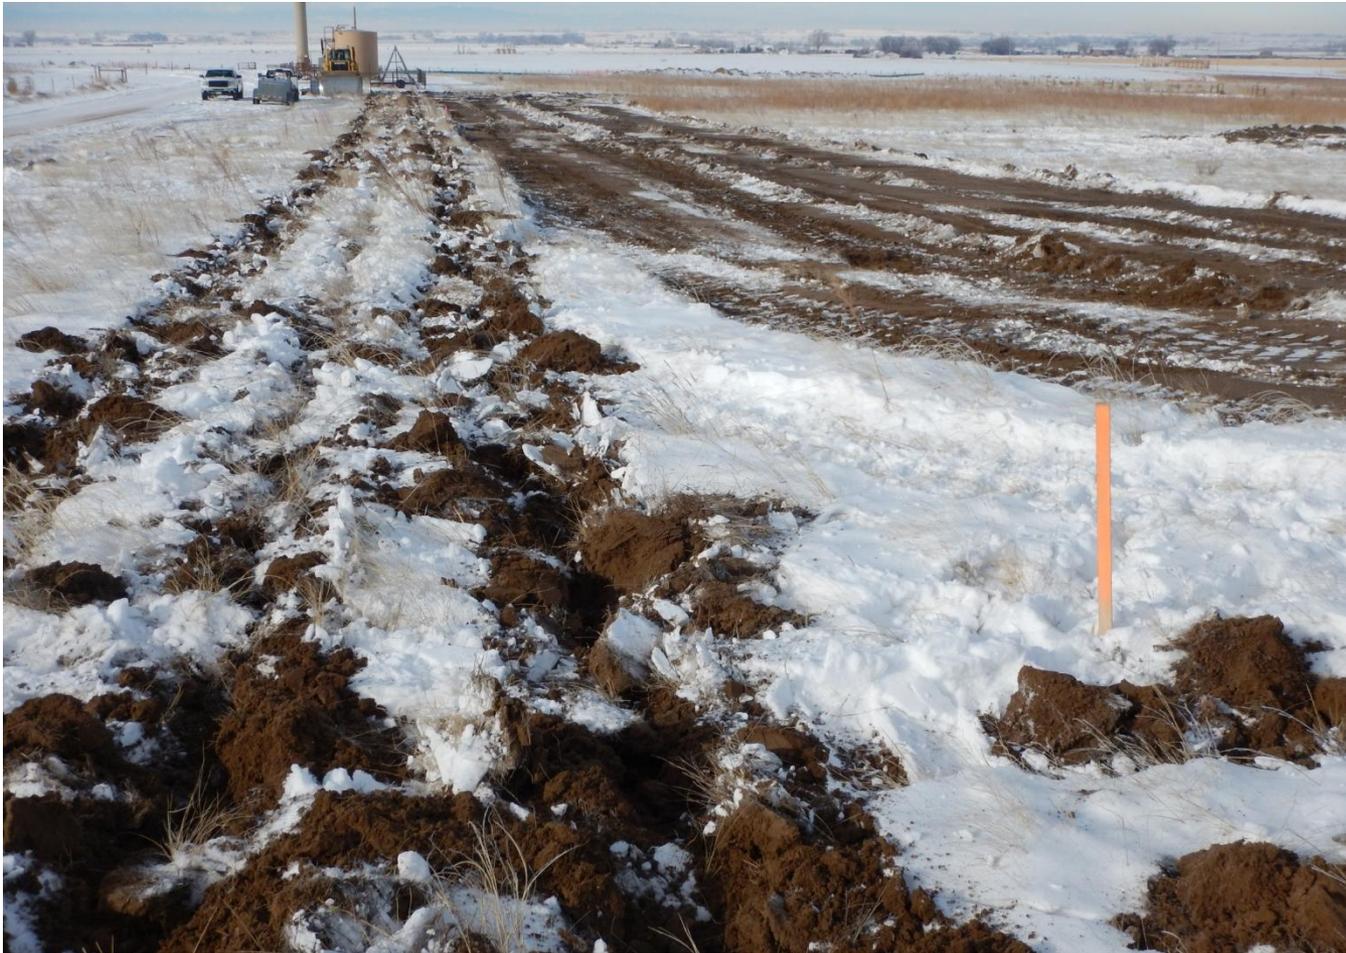
Photo 5. Photo taken from southeast corner, facing West. Stormwater BMP installed prior to construction of well pad (highlighted in red). Surface roughening is a temporary BMP and should be used in conjunction with other BMPs.

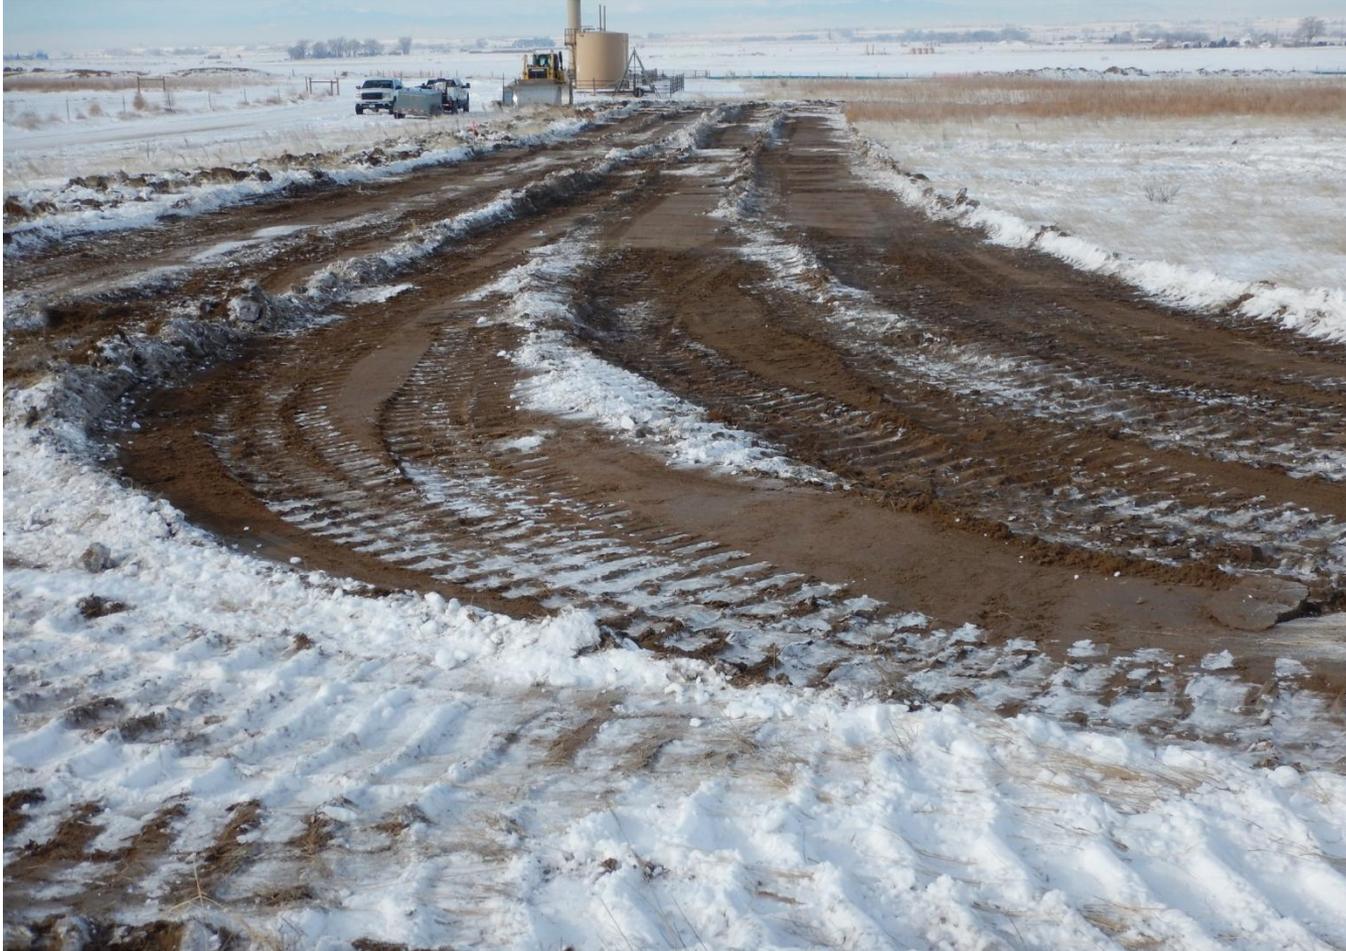
Photo 6. Photo taken from southeast corner, facing West. Topsoil salvage in process.
