Construction Inspection

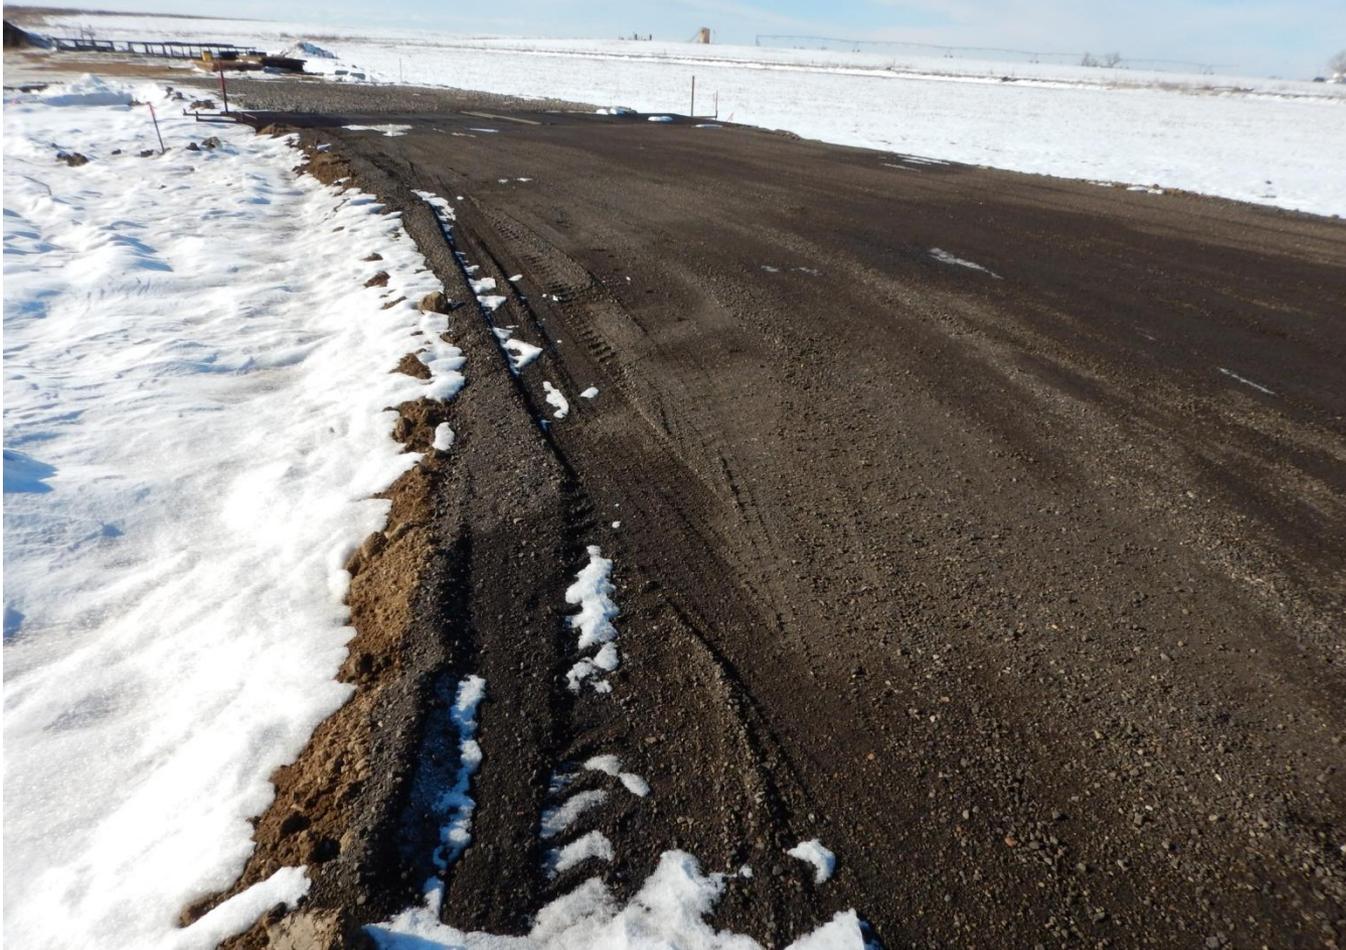
Photo 1. Photo taken from entrance of location, facing West. Lease road BMPs installed and tracking devices.

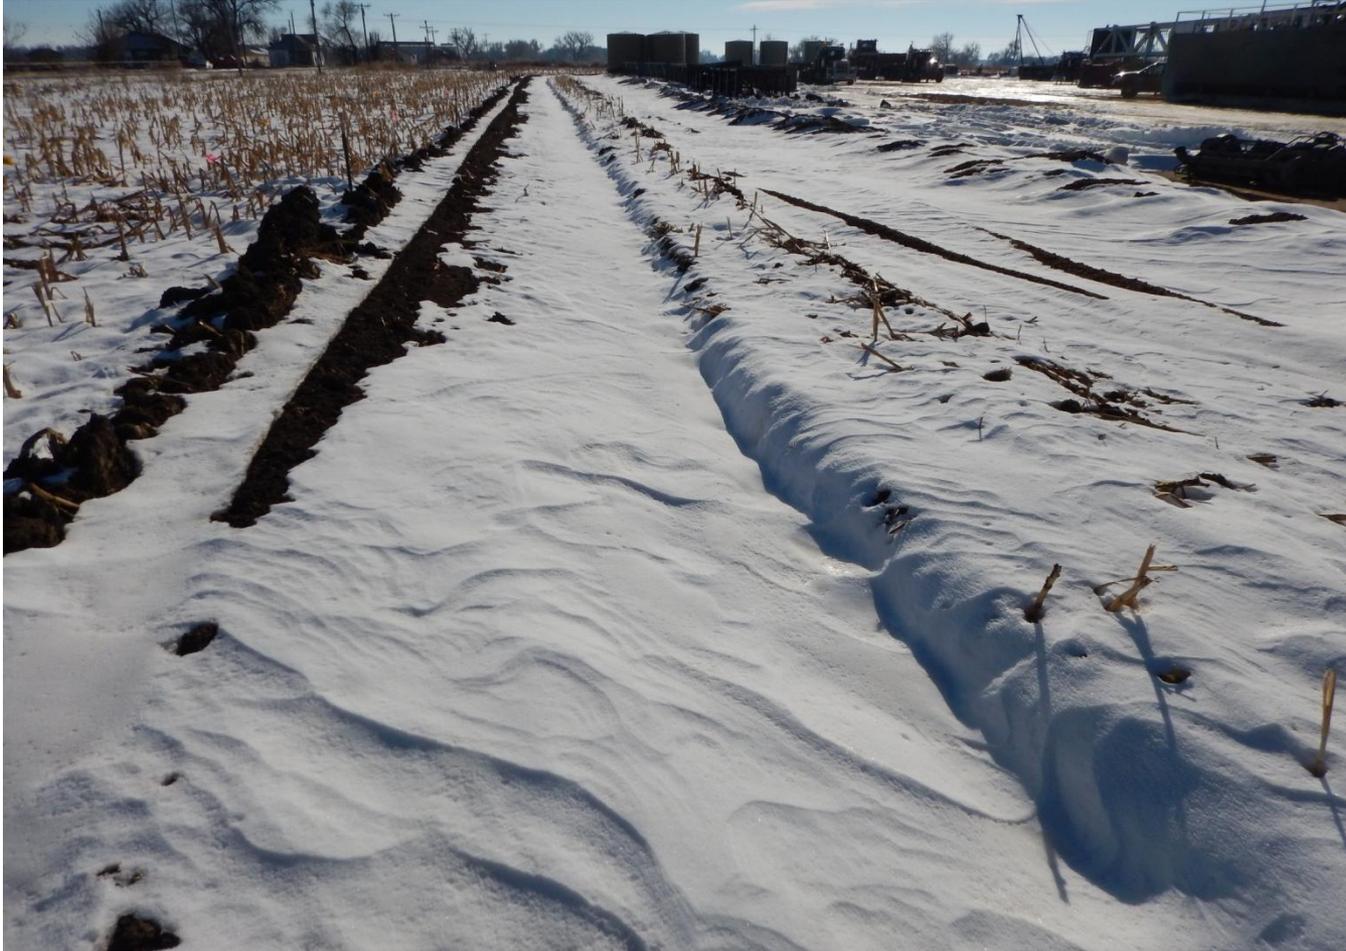
Photo 2. Photo taken from eastern location, facing South. Stormwater BMP installed in center of photo.

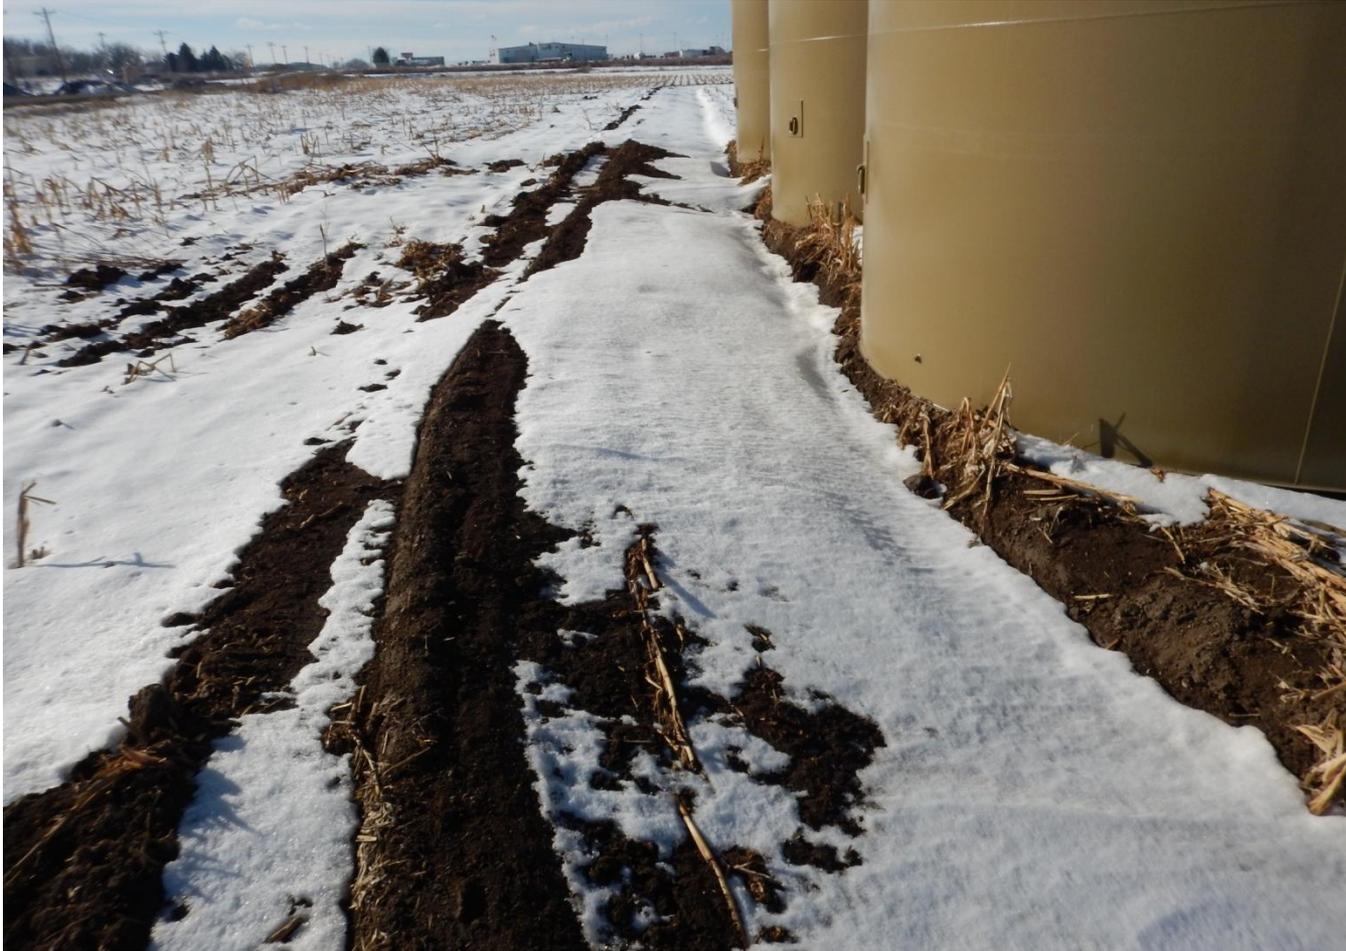
Photo 3. Photo taken from southeast location, facing West. Stormwater BMP installed in center of photo.

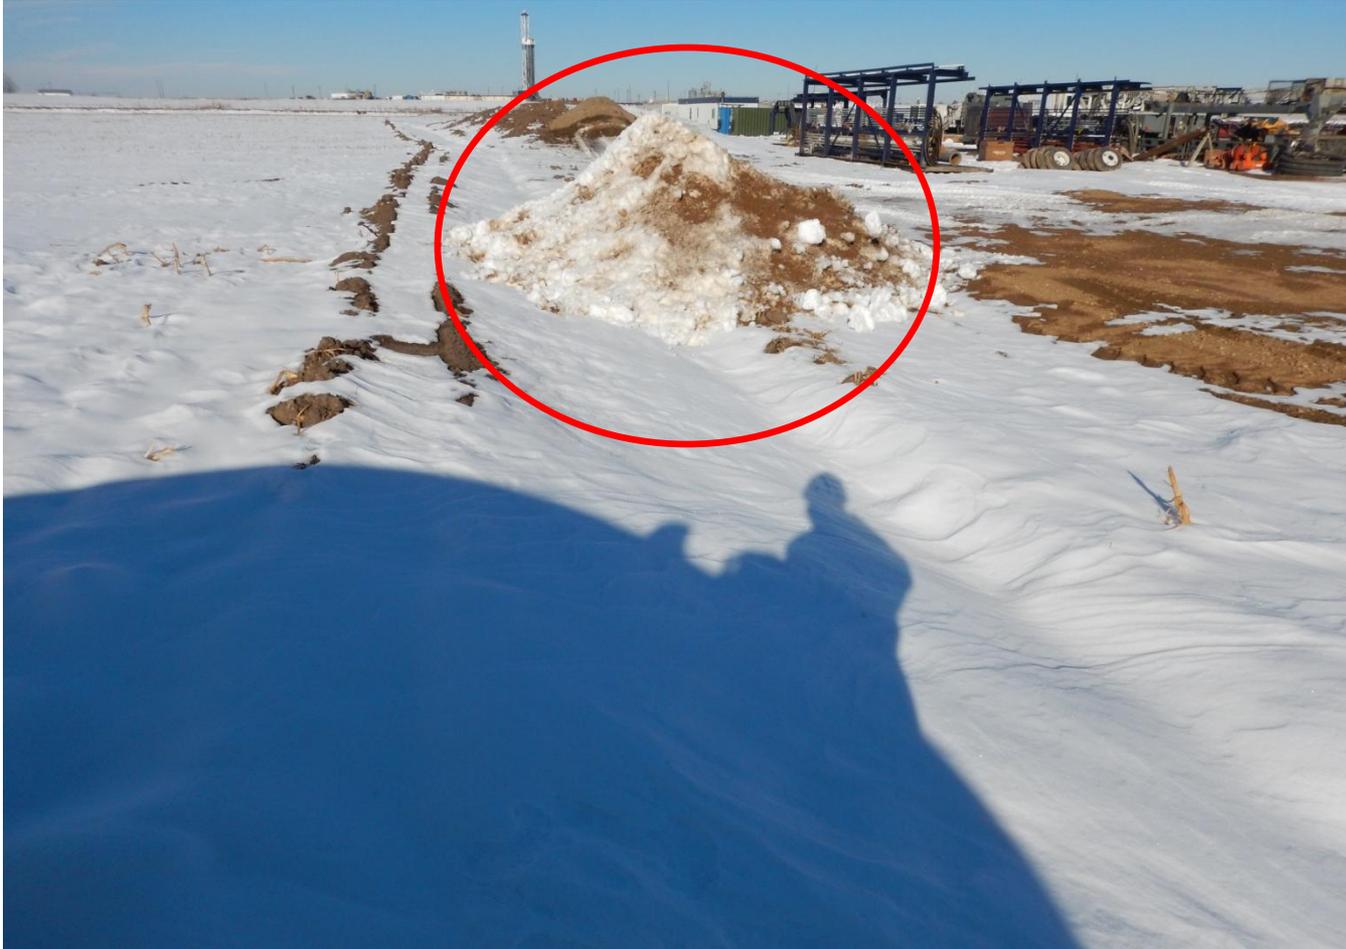
Photo 4. Photo taken from southwest location, facing North. Stormwater BMP installed in center of photo. DO NOT scrape sediment into stormwater ditches. Stormwater ditches need to be maintained.

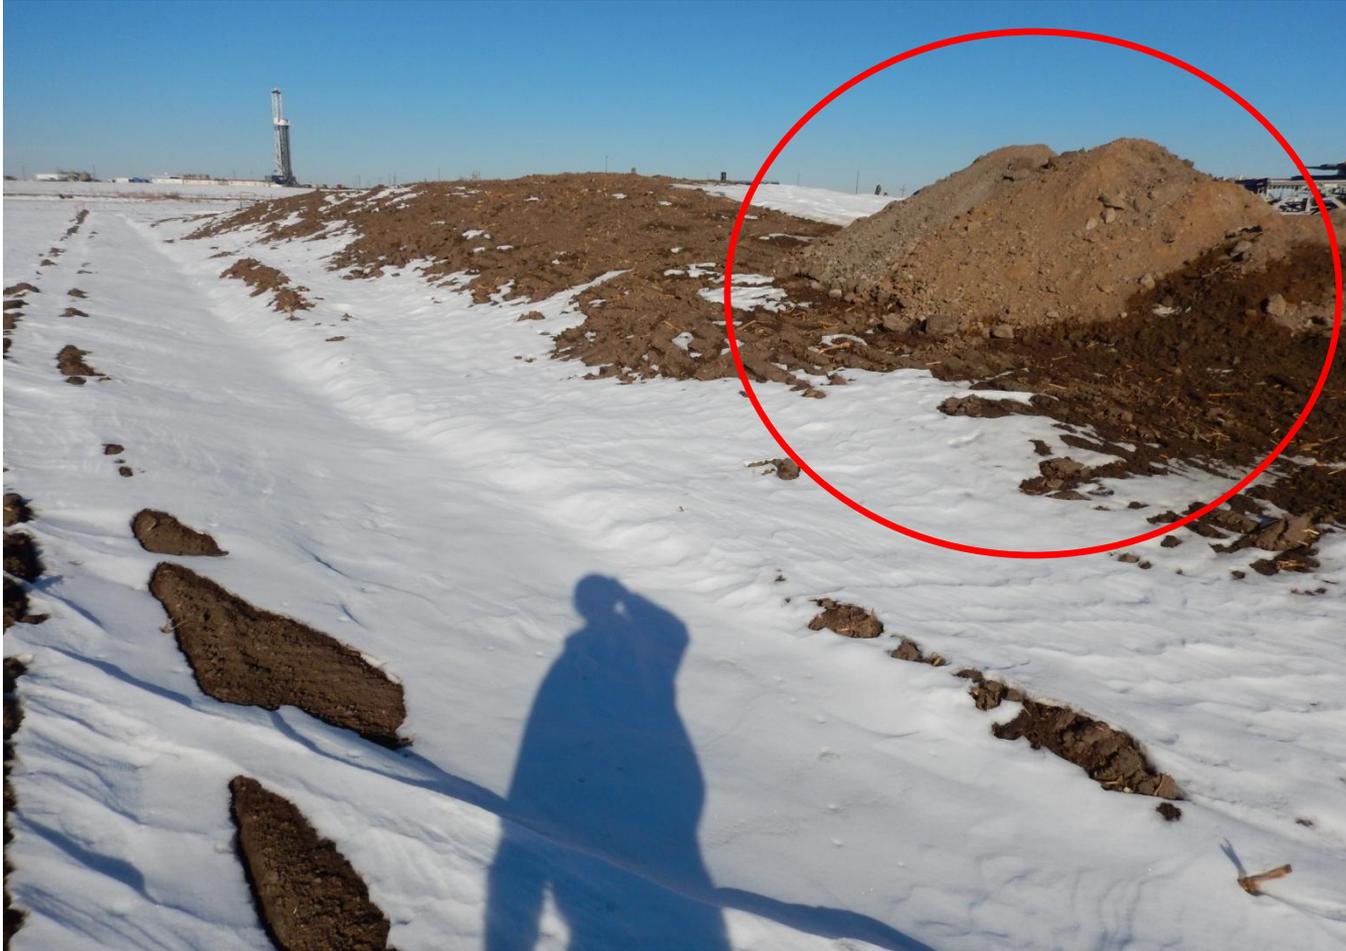
Photo 5. Photo taken from western location, facing North. Stormwater BMP installed in center of photo. DO NOT pile other soil material onto topsoil stockpile. Need to remove soil pile from topsoil stockpile.

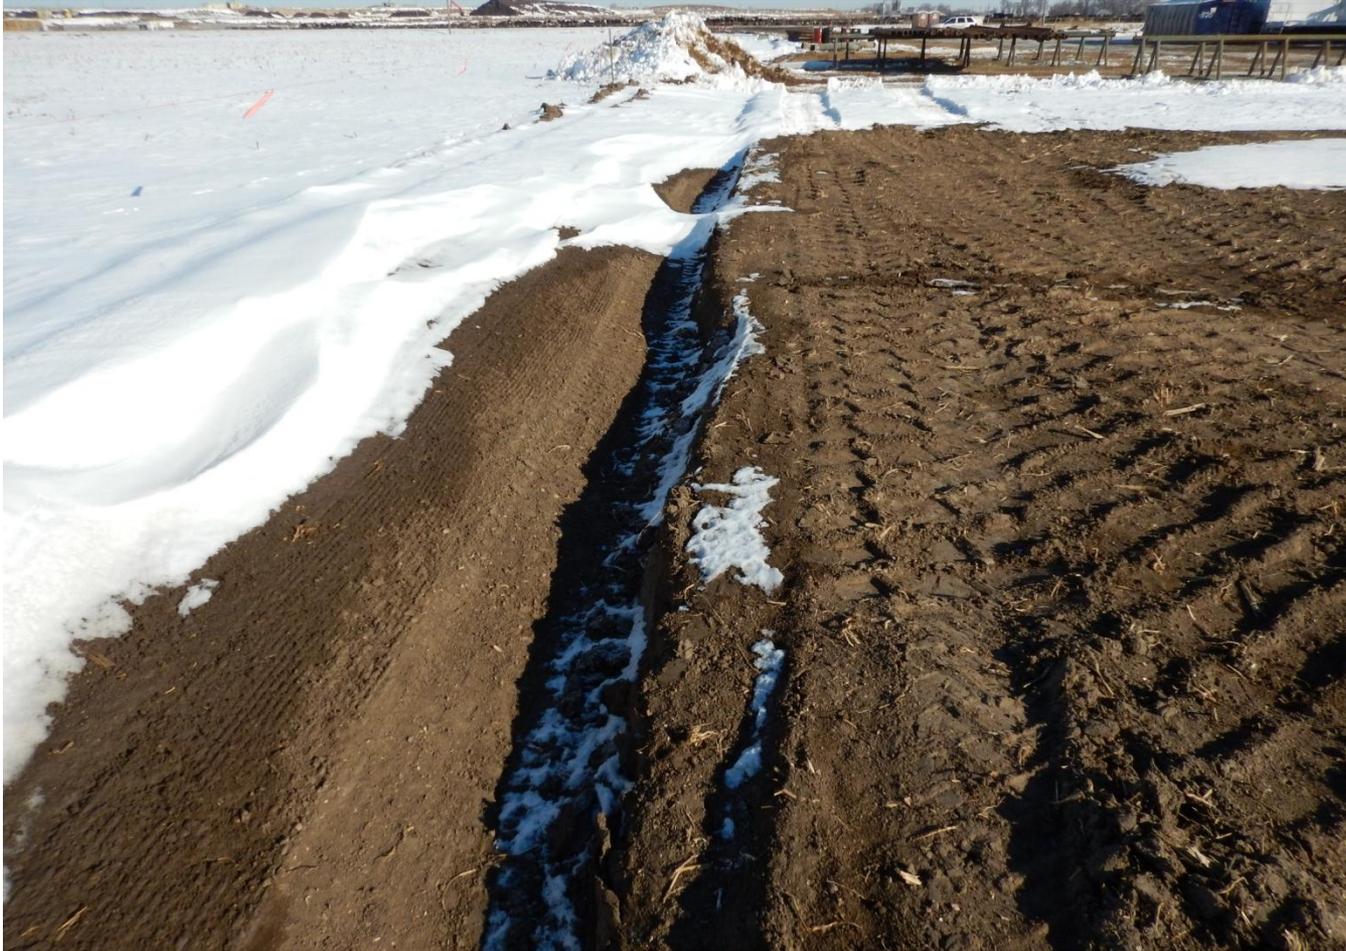
Photo 6. Photo taken from northwest location, facing East. Stormwater BMP installed in center of photo.

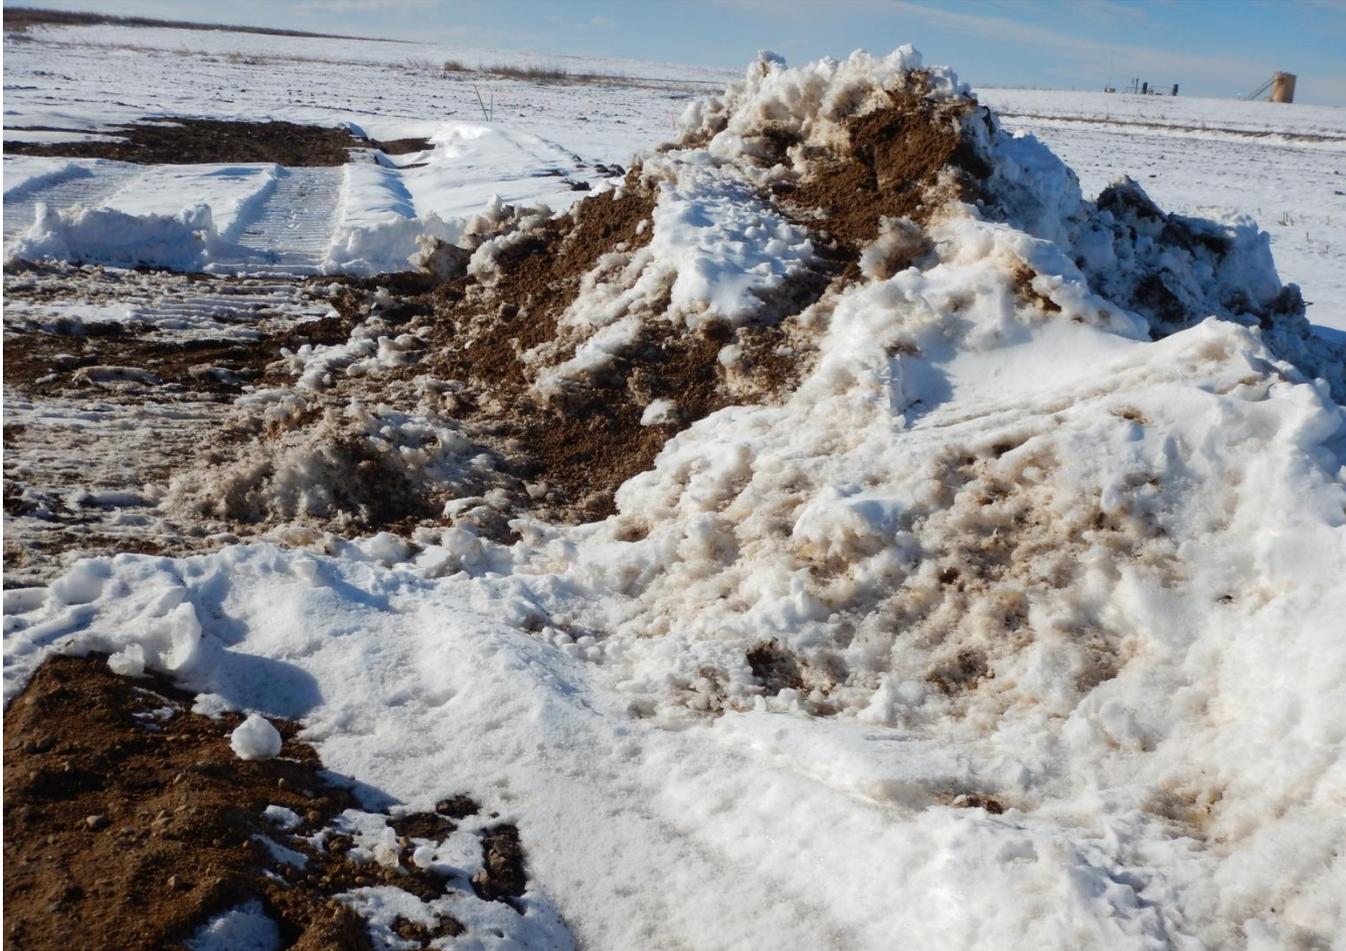
Photo 7. Photo taken from northern location, facing West. Stormwater BMP installed in center of photo. DO NOT scrape sediment into stormwater ditches. Stormwater ditches need to be maintained.
