Construction Inspection

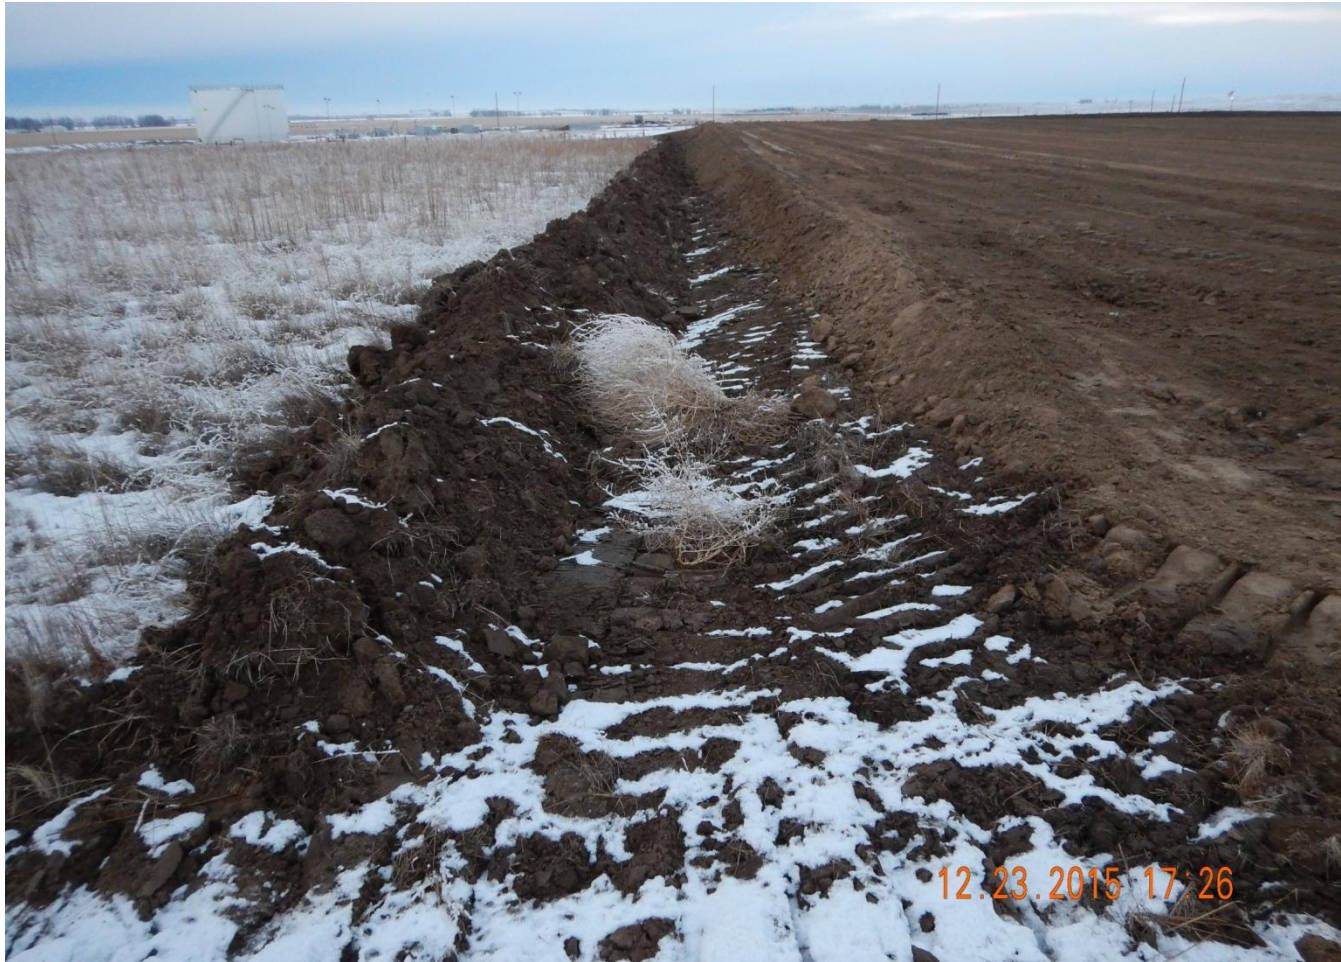
Photo 1. Photo taken from southwest location, facing North. Stormwater BMP installed in center of photo.

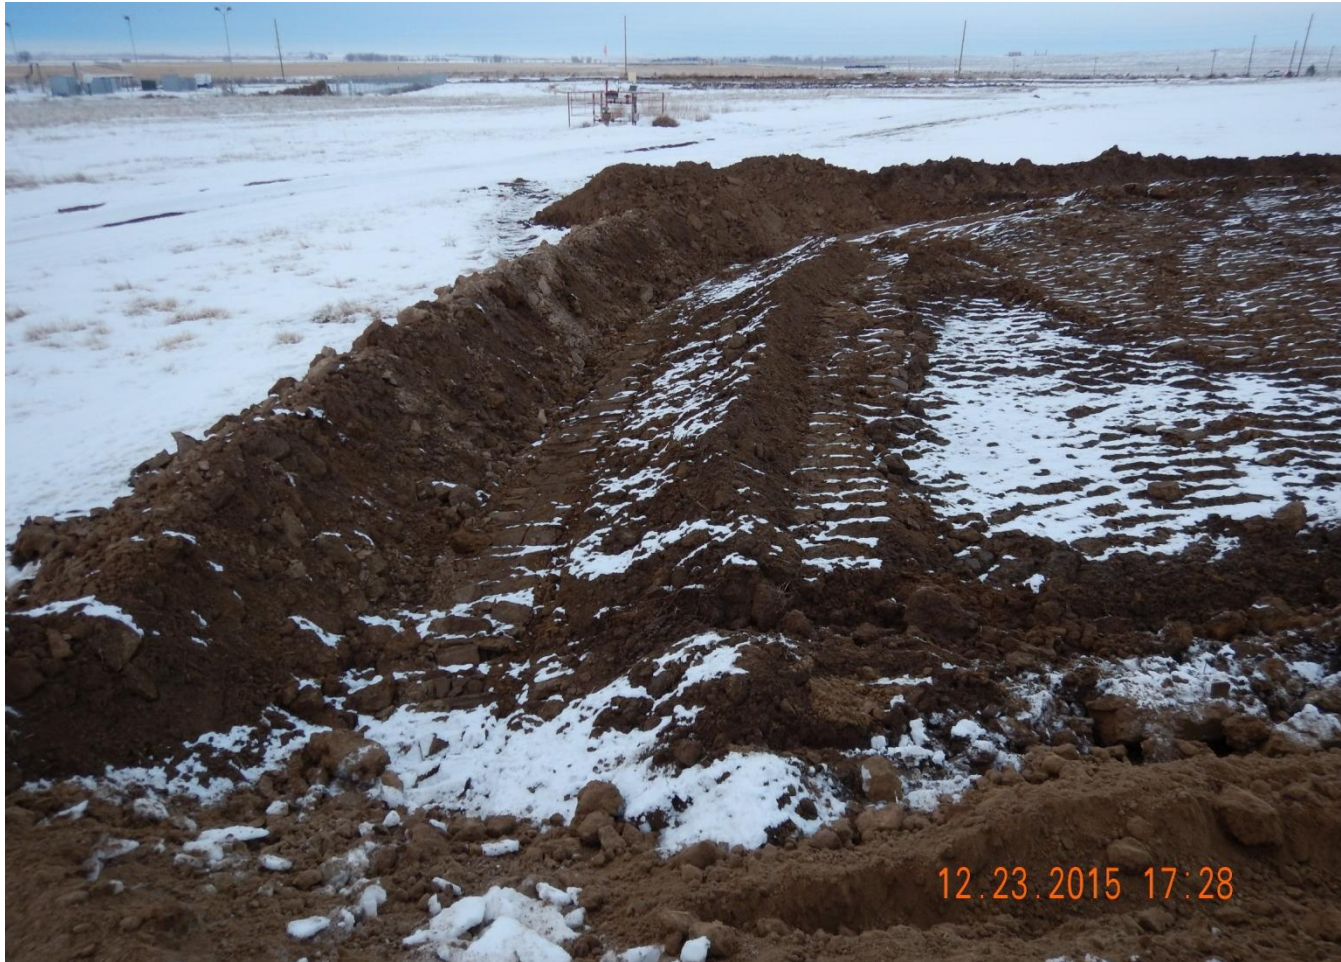
Photo 2. Photo taken from northwest location, facing North. Stormwater BMP installed in center of photo.

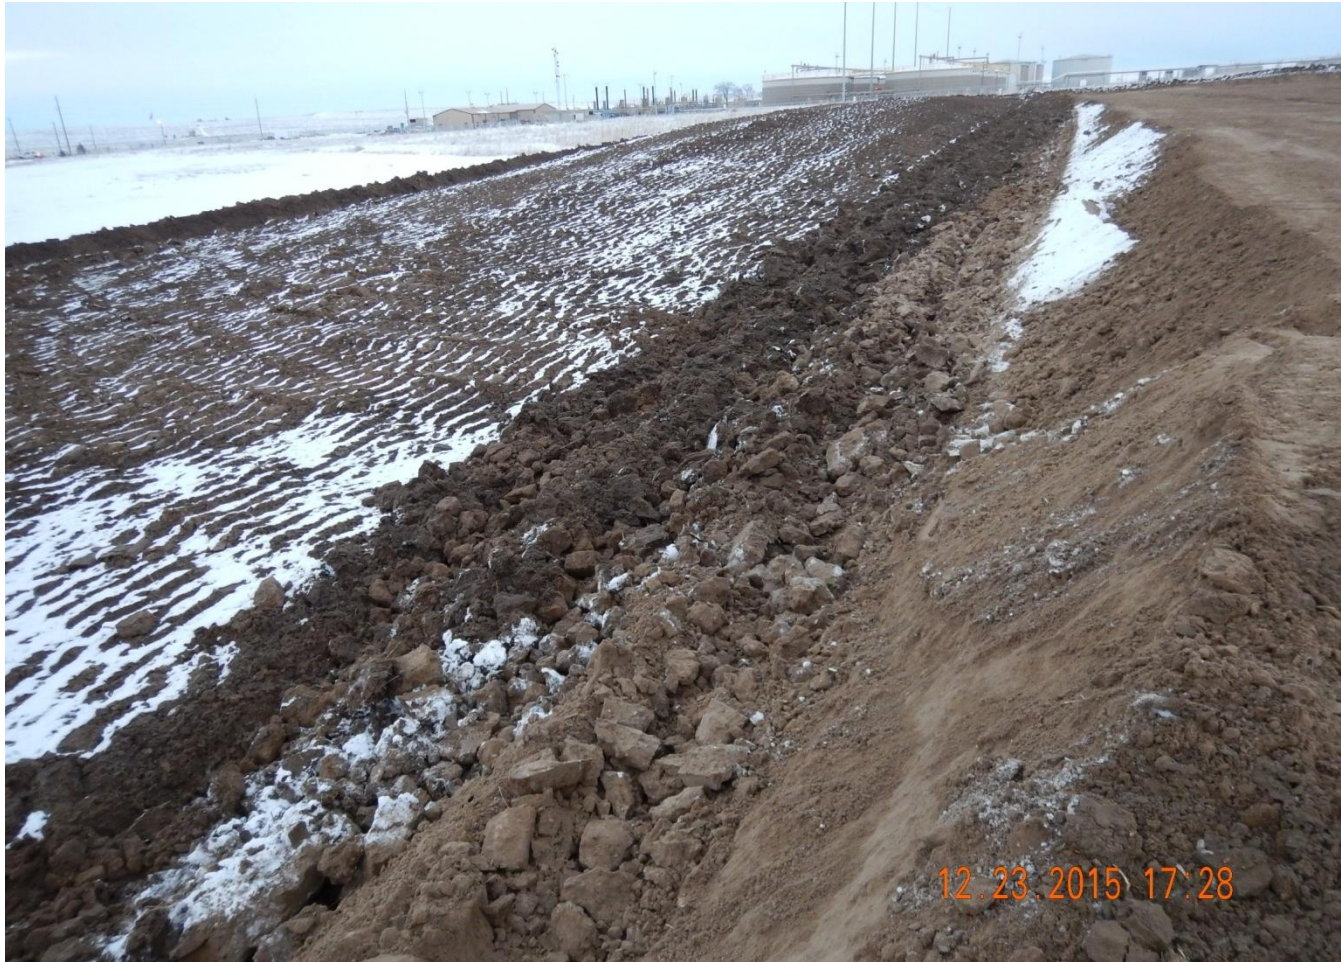
Photo 3. Photo taken from northwest location, facing East. Stormwater BMP installed in center of photo and topsoil salvage stockpile.

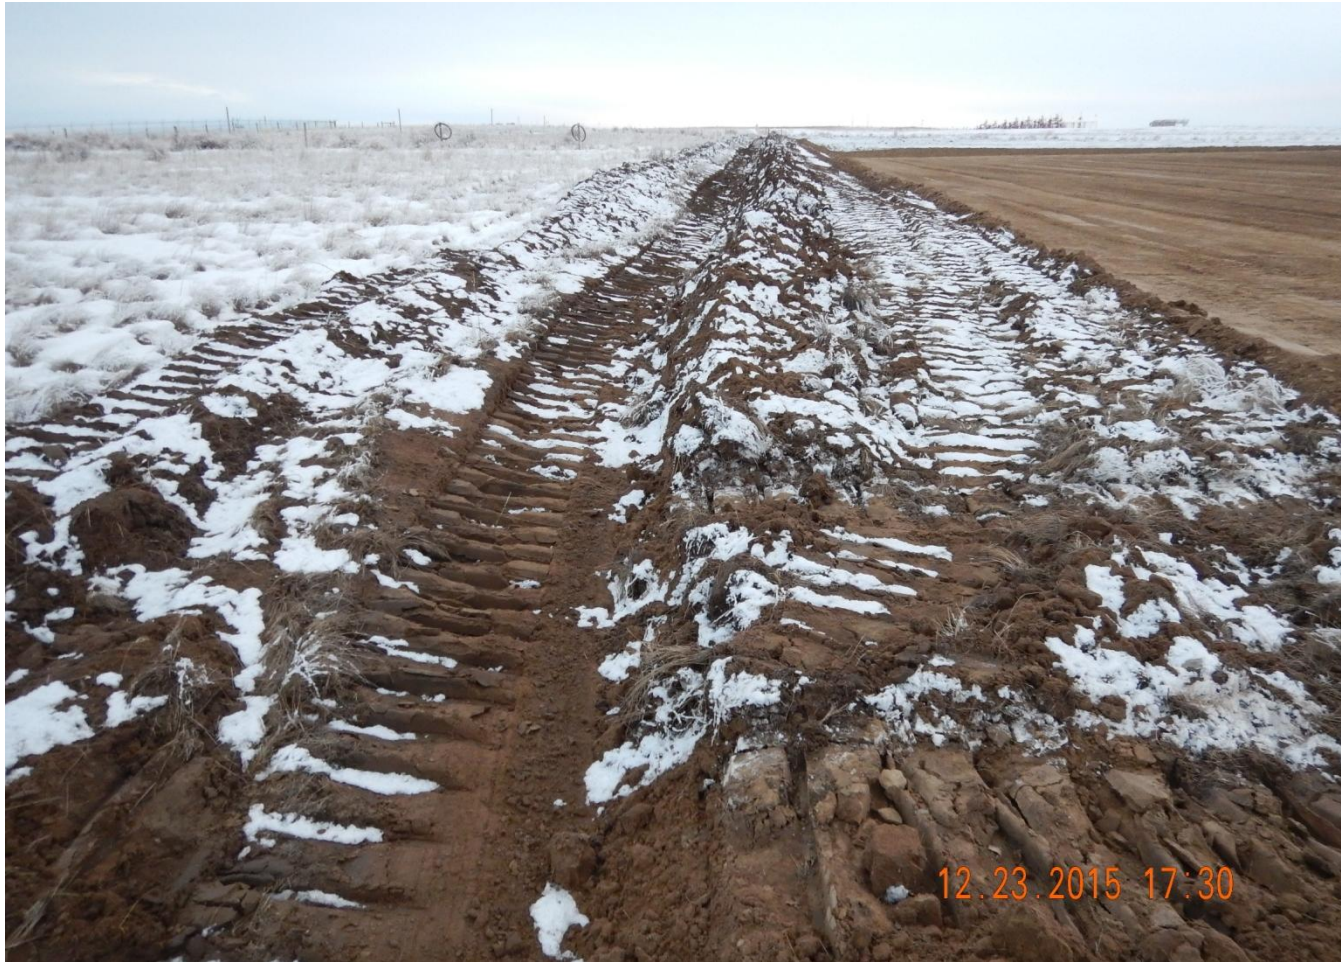
Photo 4. Photo taken from northeast location, facing South. Stormwater BMP installed in center of photo.

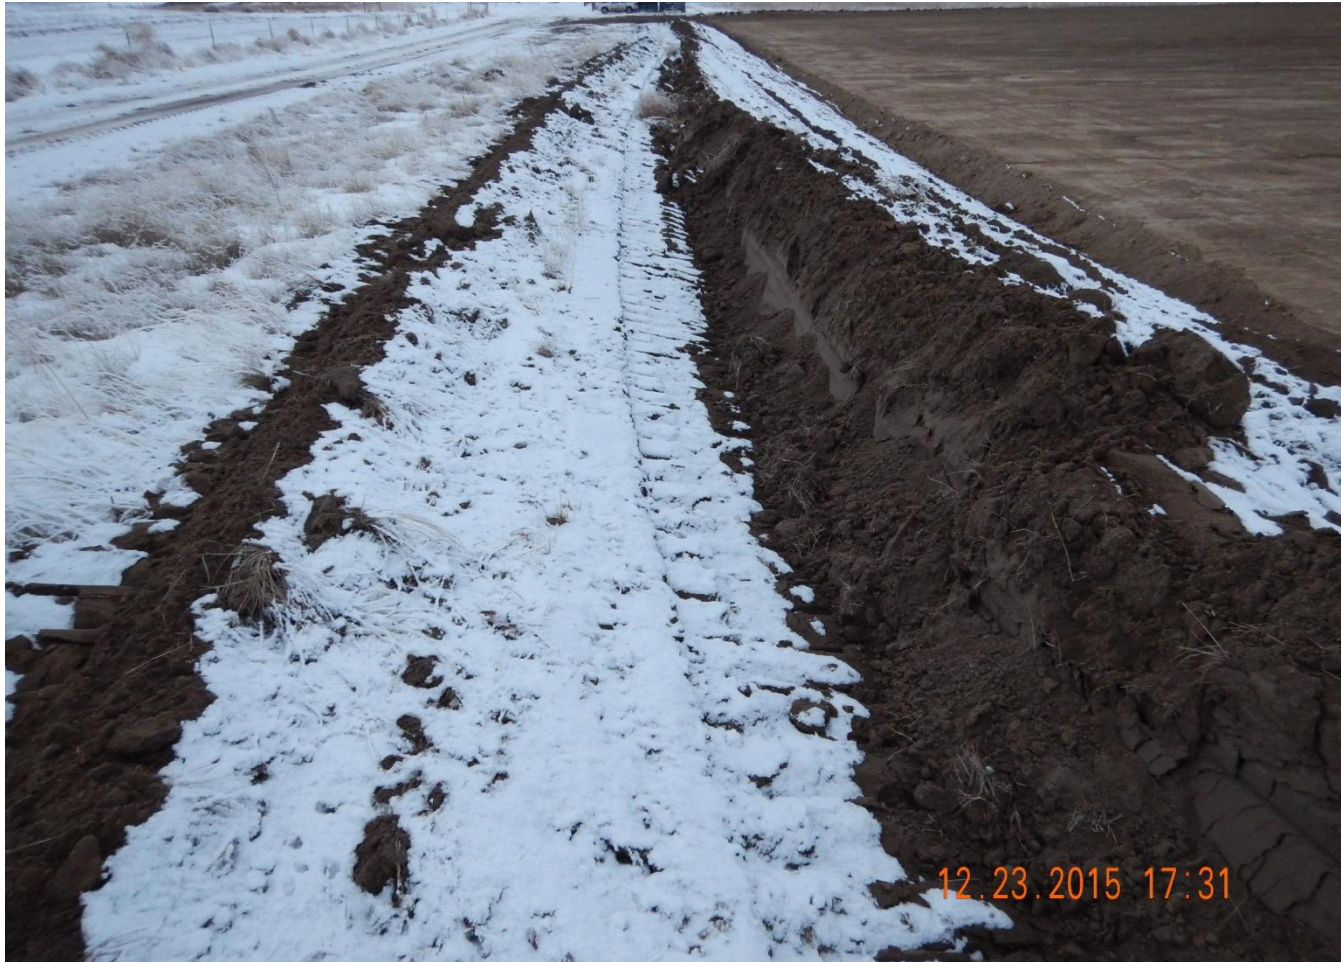
Photo 5. Photo taken from southeast location, facing West. Stormwater BMP installed in center of photo.
