Interim Reclamation Inspection

Photo 1. Photo taken of well signs for PR wells- API: 123-31909 and 123-31974.

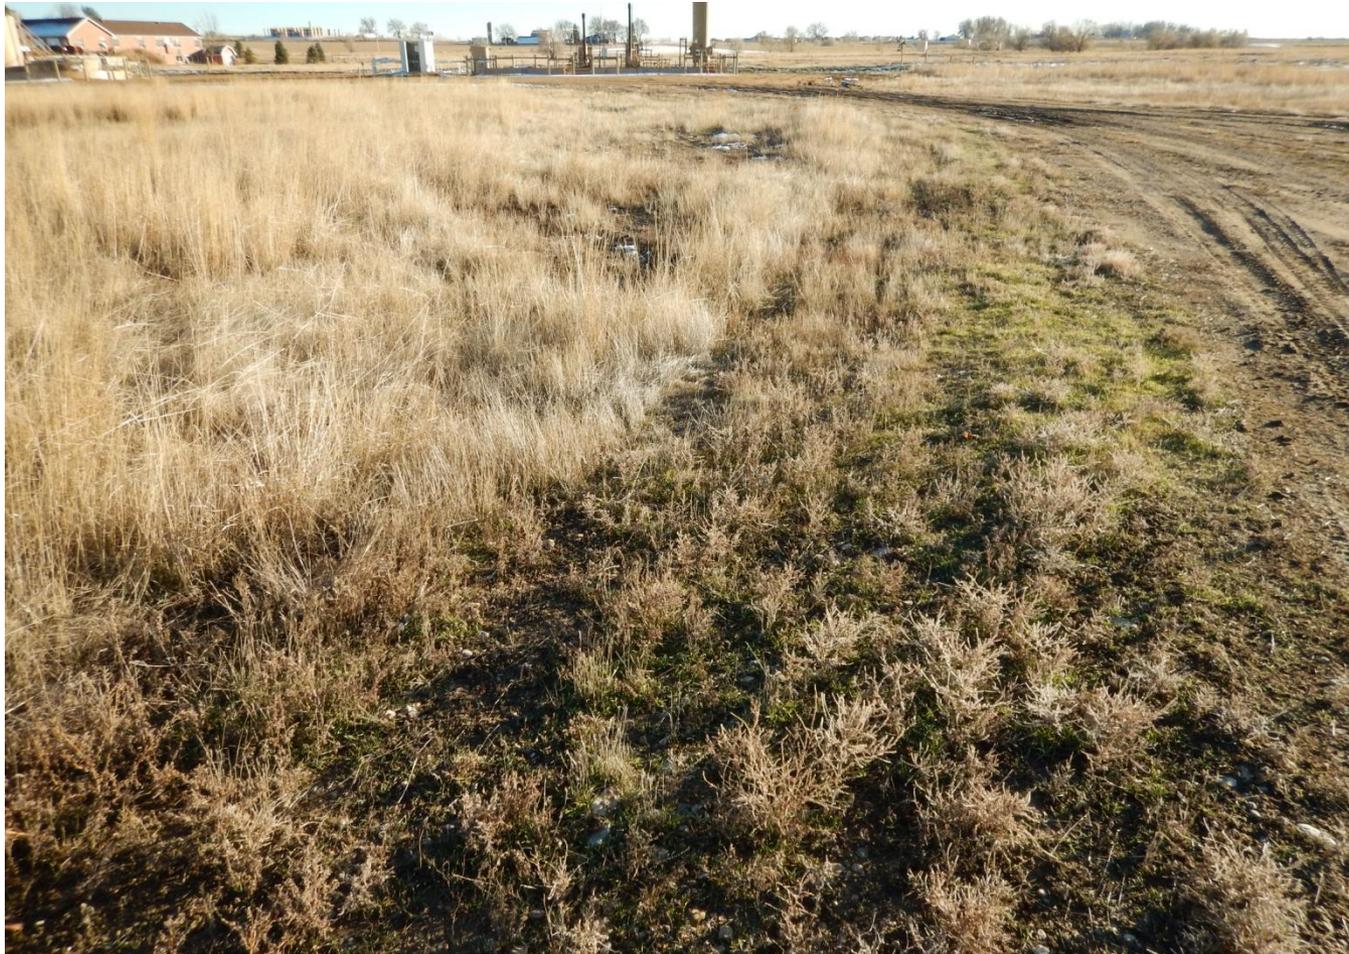
Photo 2. Photo taken from eastern location, facing South. Perimeter of well location being mowed to control undesirable plant species (*Kochia* sp. and Russian thistle).

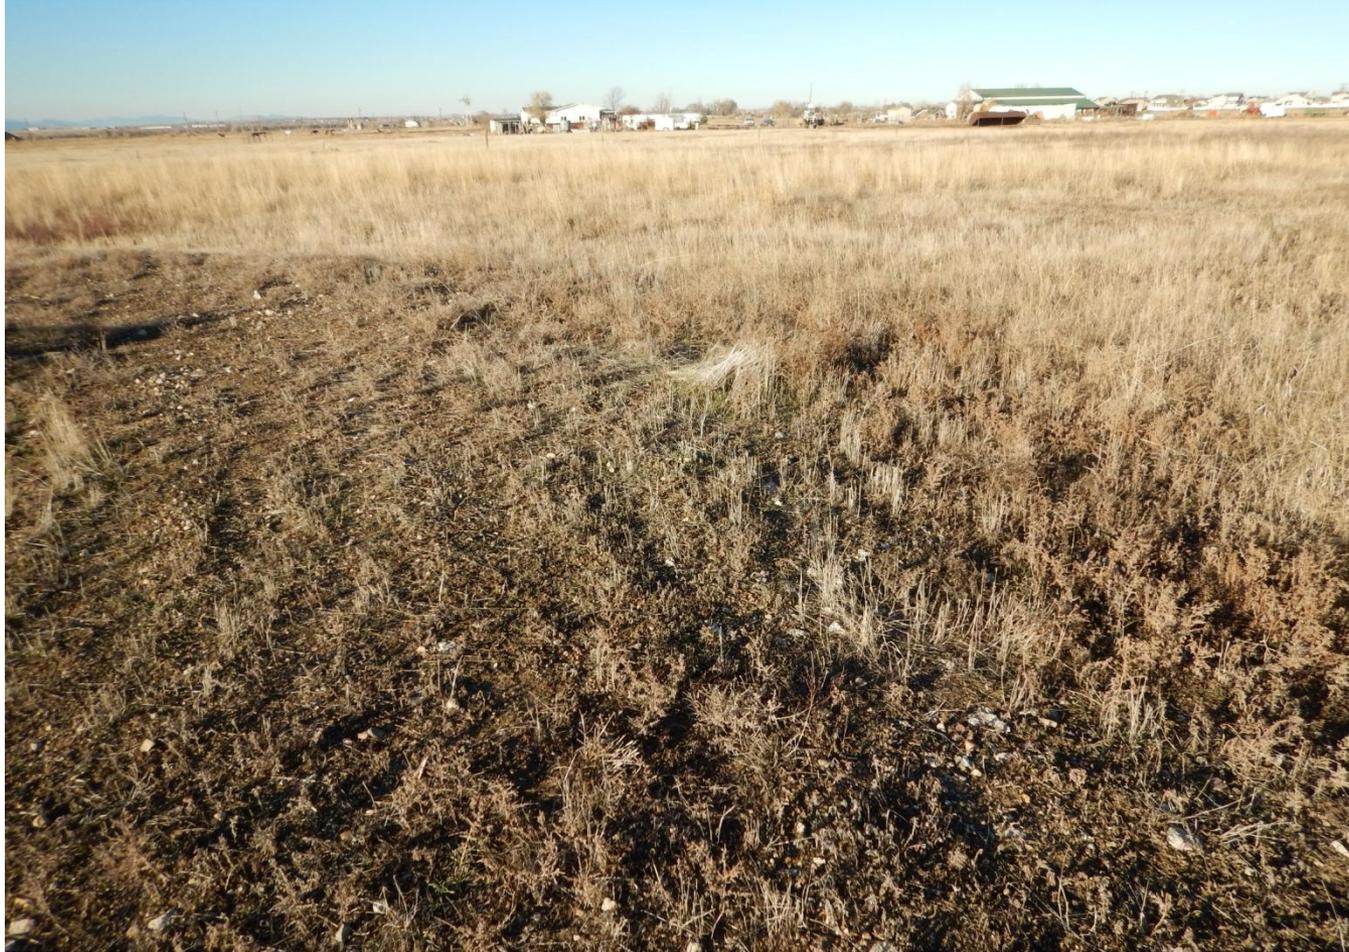
Photo 3. Photo taken from eastern location, facing North. Perimeter of well location being mowed to control undesirable plant species (*Kochia* sp. and Russian thistle).

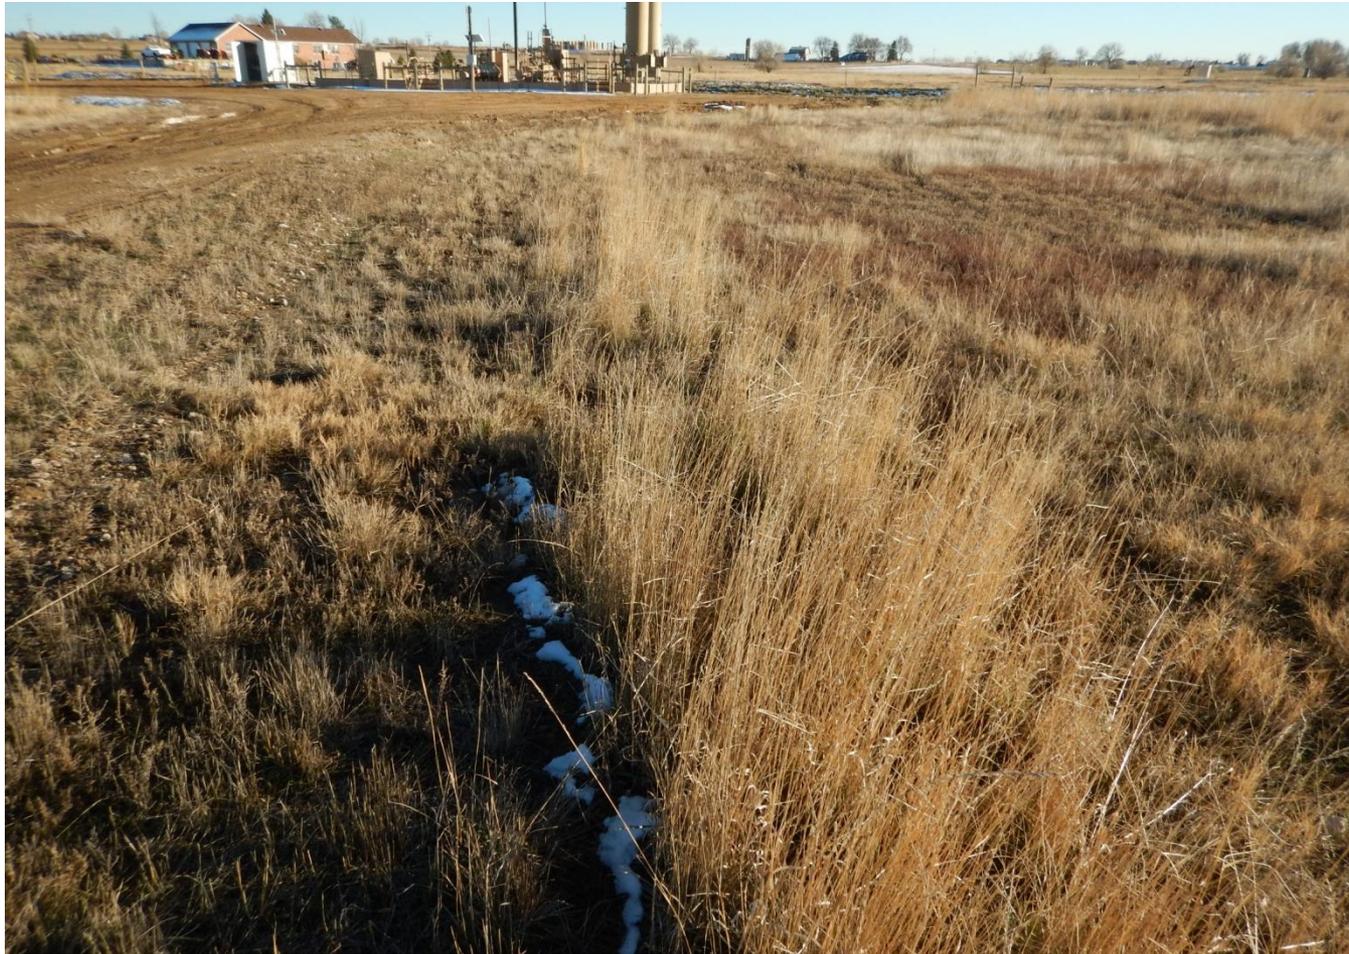
Photo 4. Photo taken from western location, facing South. Perimeter of well location being mowed to control undesirable plant species (*Kochia* sp. and Russian thistle).

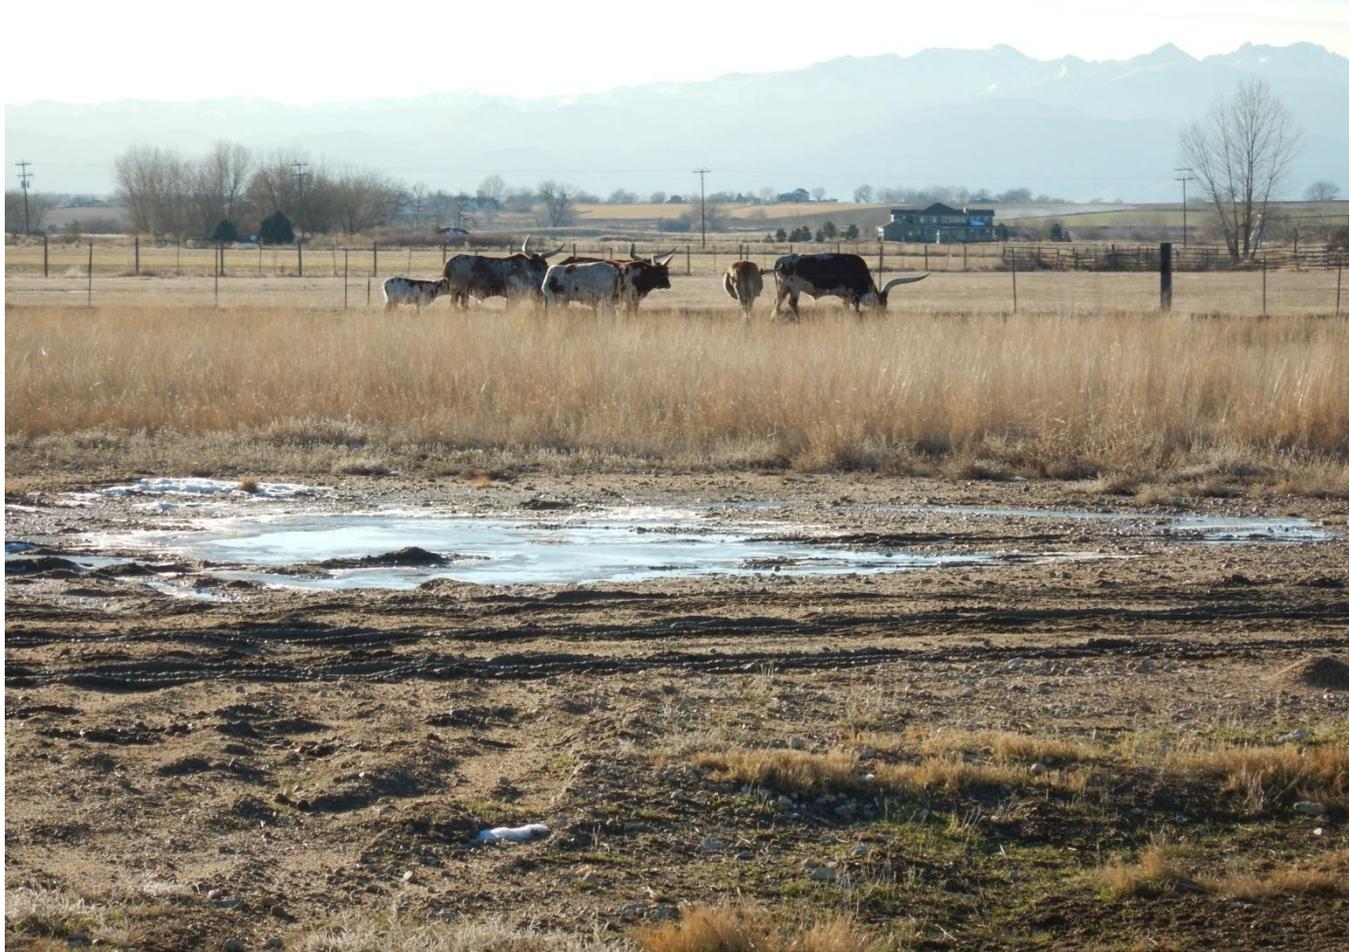
Photo 5. Photo taken from northern location, facing West. Portions of this location lack perennial vegetative growth as shown in the center of the photo.

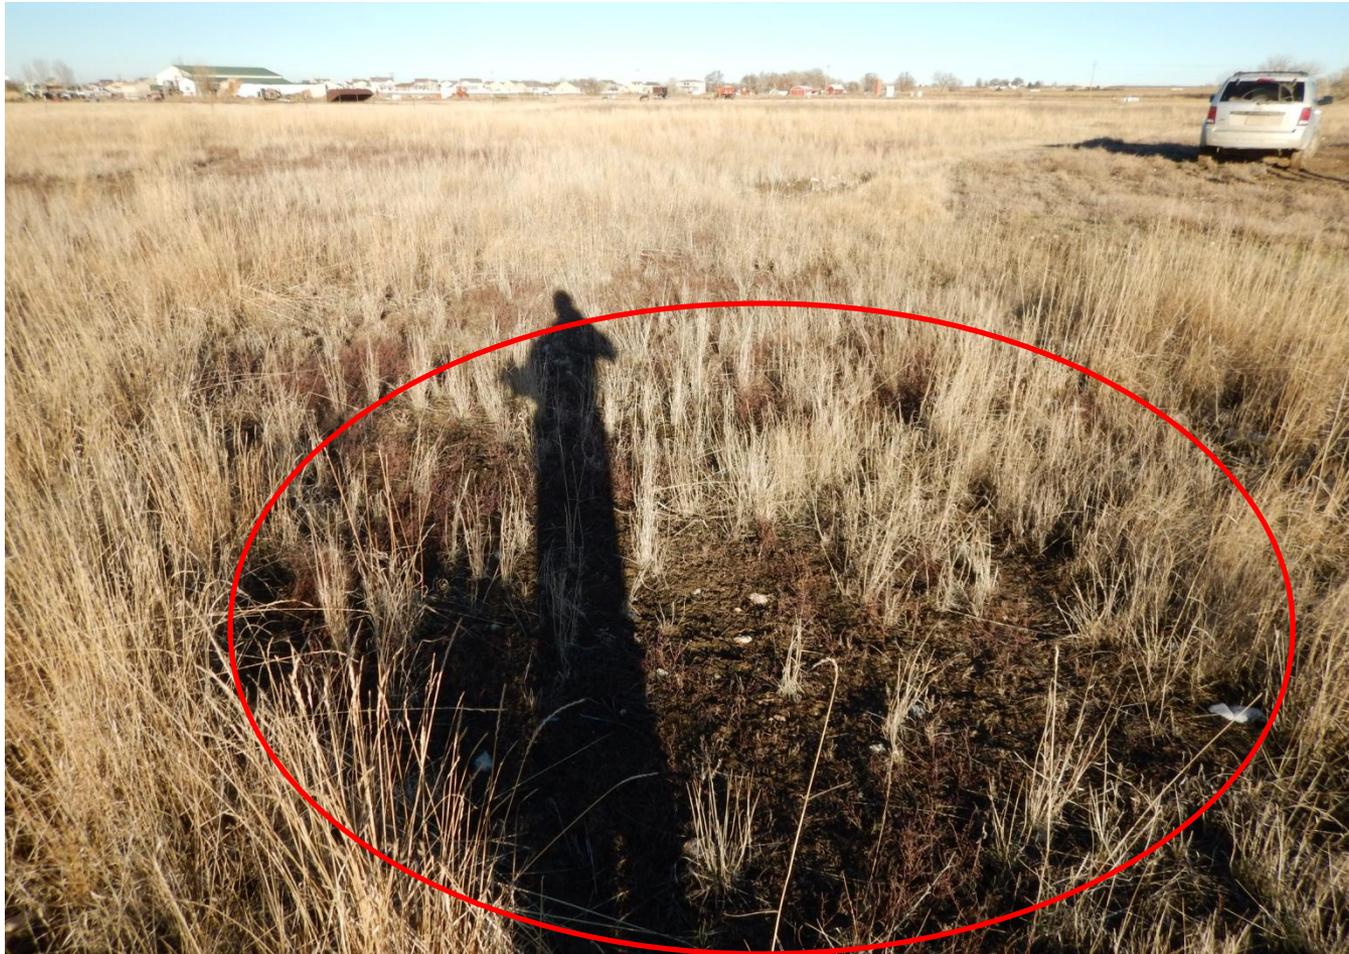
Photo 6. Photo taken from western location, facing Northeast. Portions of this location lack perennial vegetative growth as shown in the center of the photo.

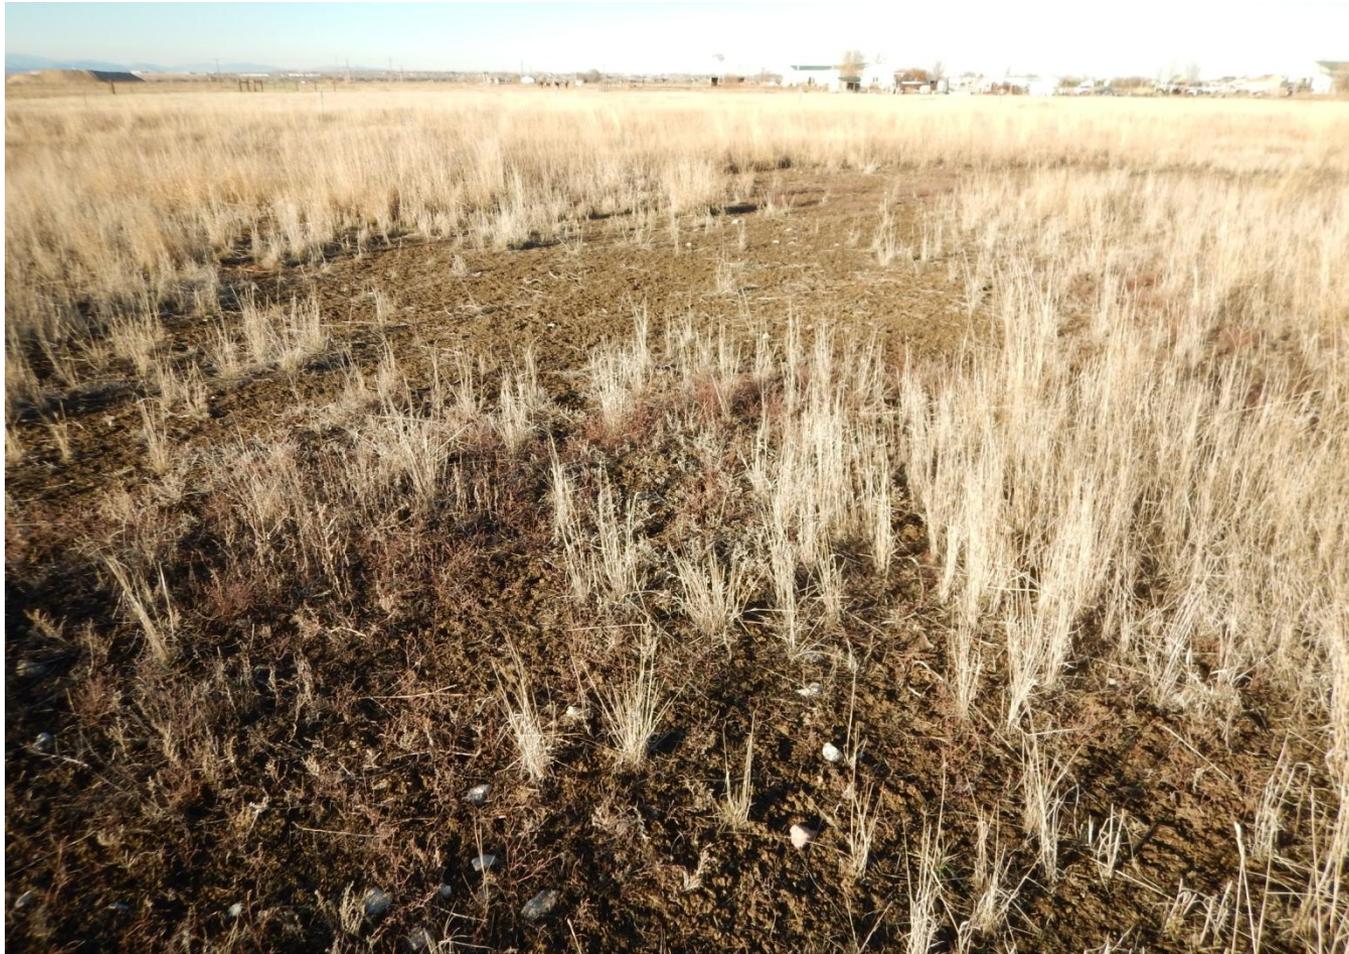
Photo 7. Photo taken from northern location, facing North. Portions of this location lack perennial vegetative growth as shown in the center of the photo.

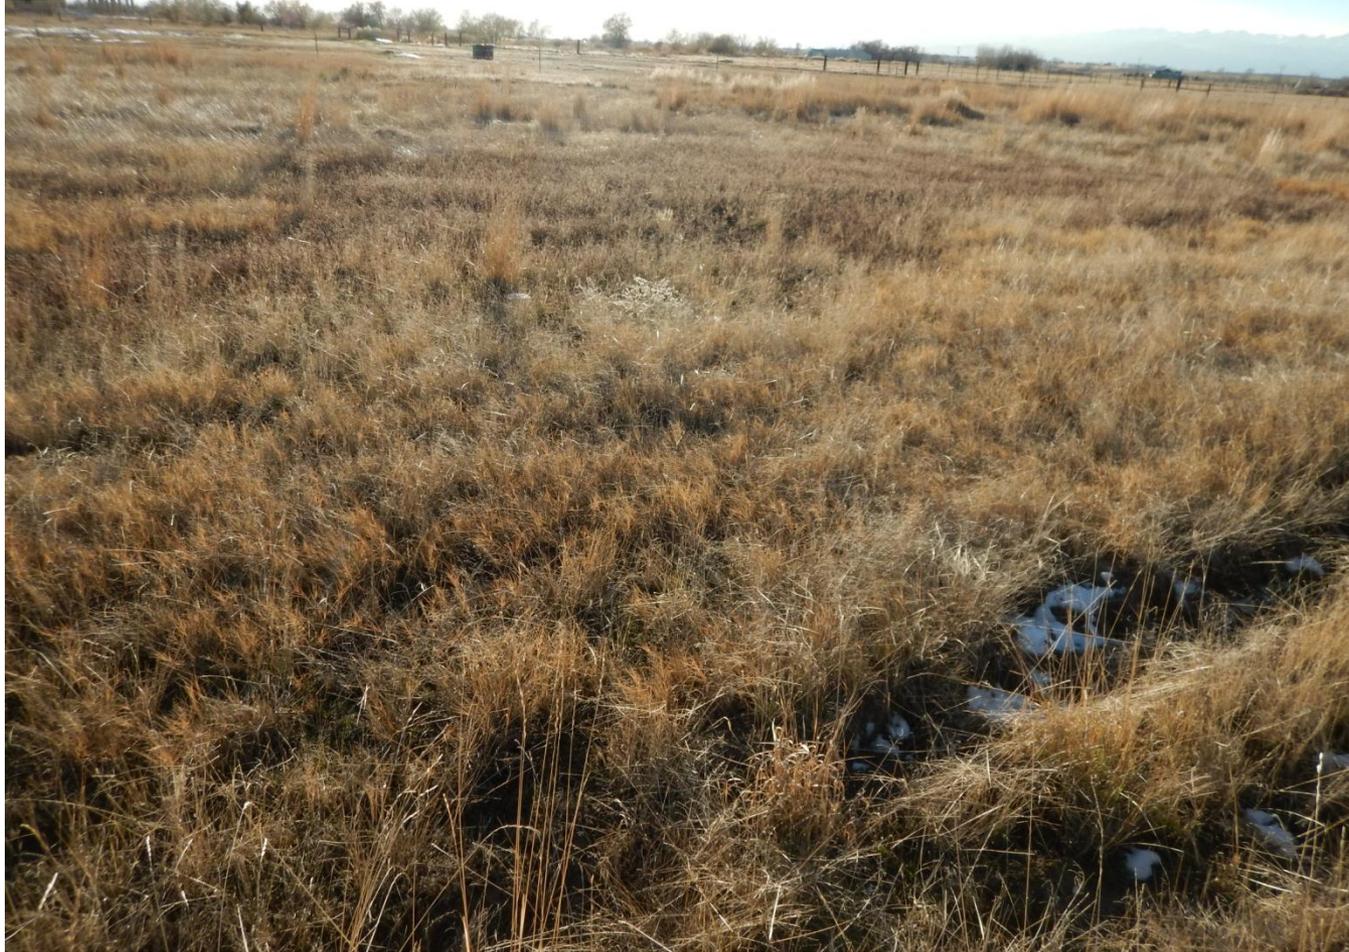
Photo 8. Reference photo taken west of location. Notice the uniform perennial vegetative growth.
