Inspection Photos Loc# 336013,
Conductor?

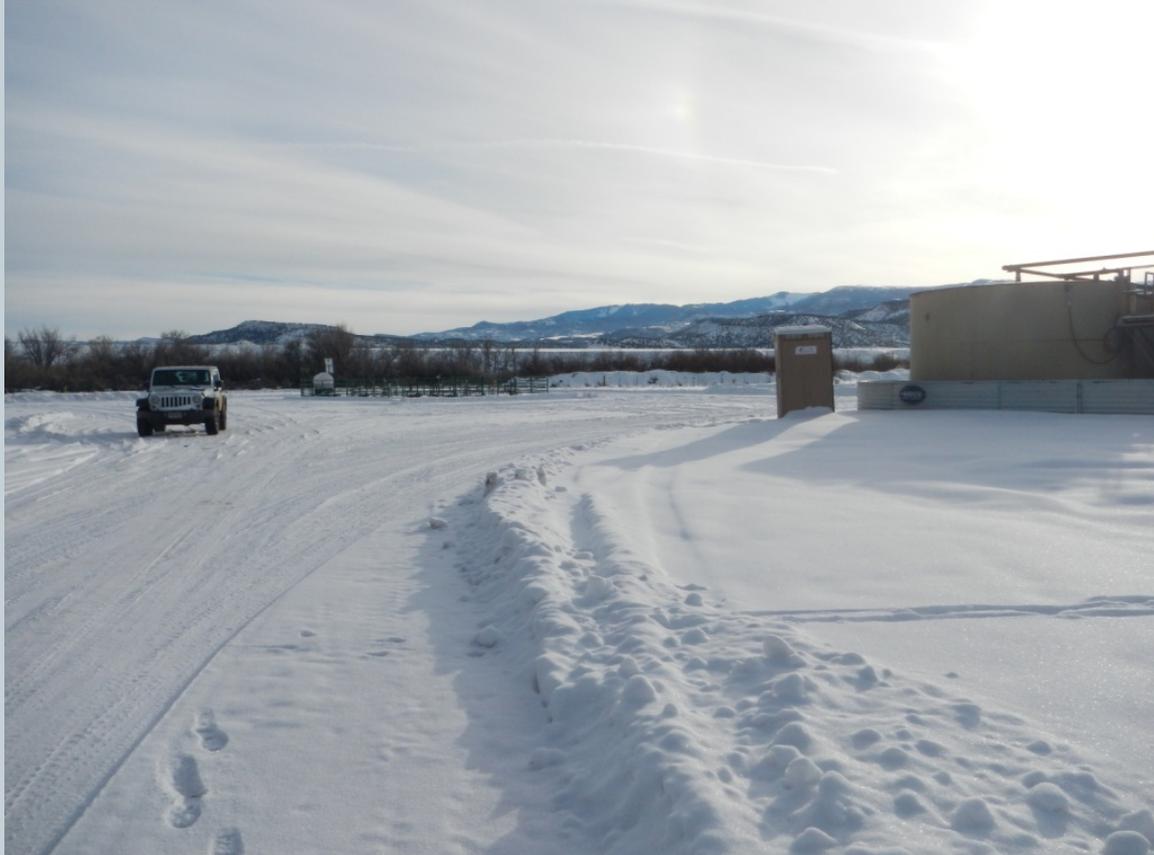
Photo#1: Overview of Location, to South .

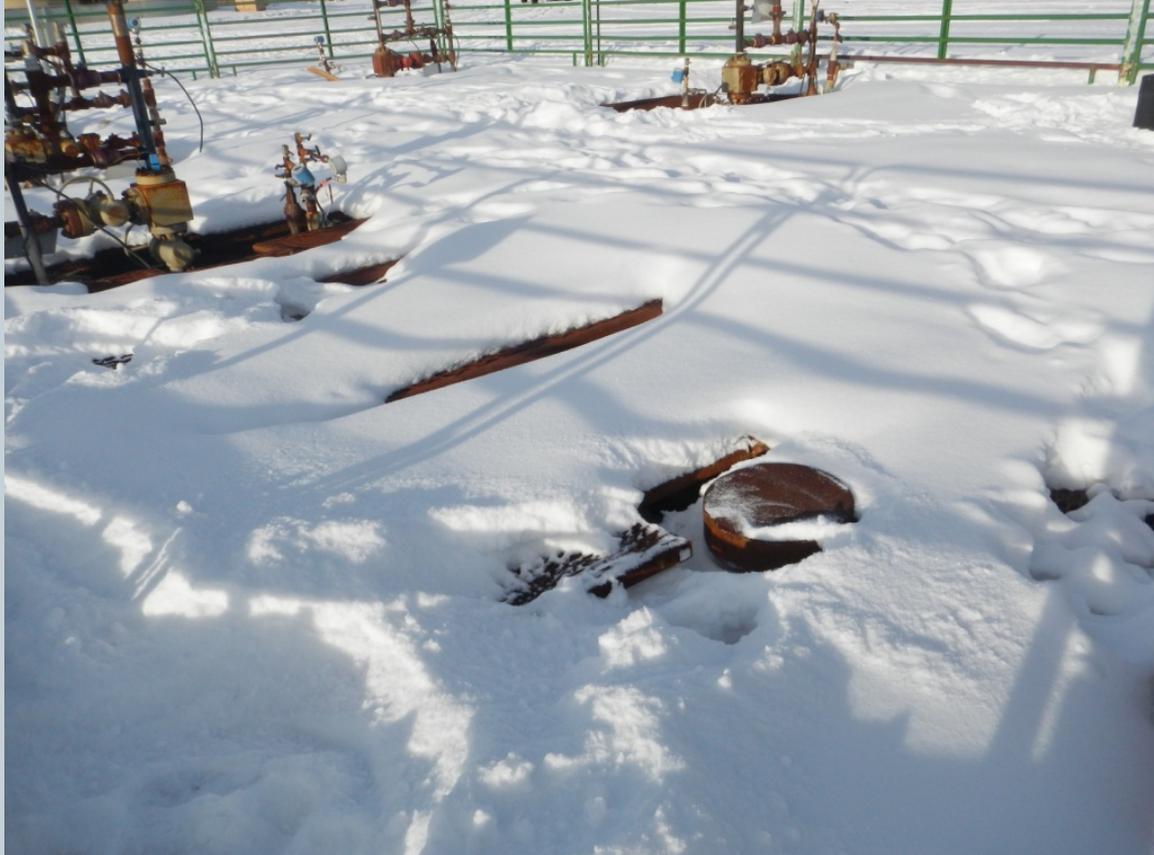
Photo#2: Conductor Set no identification

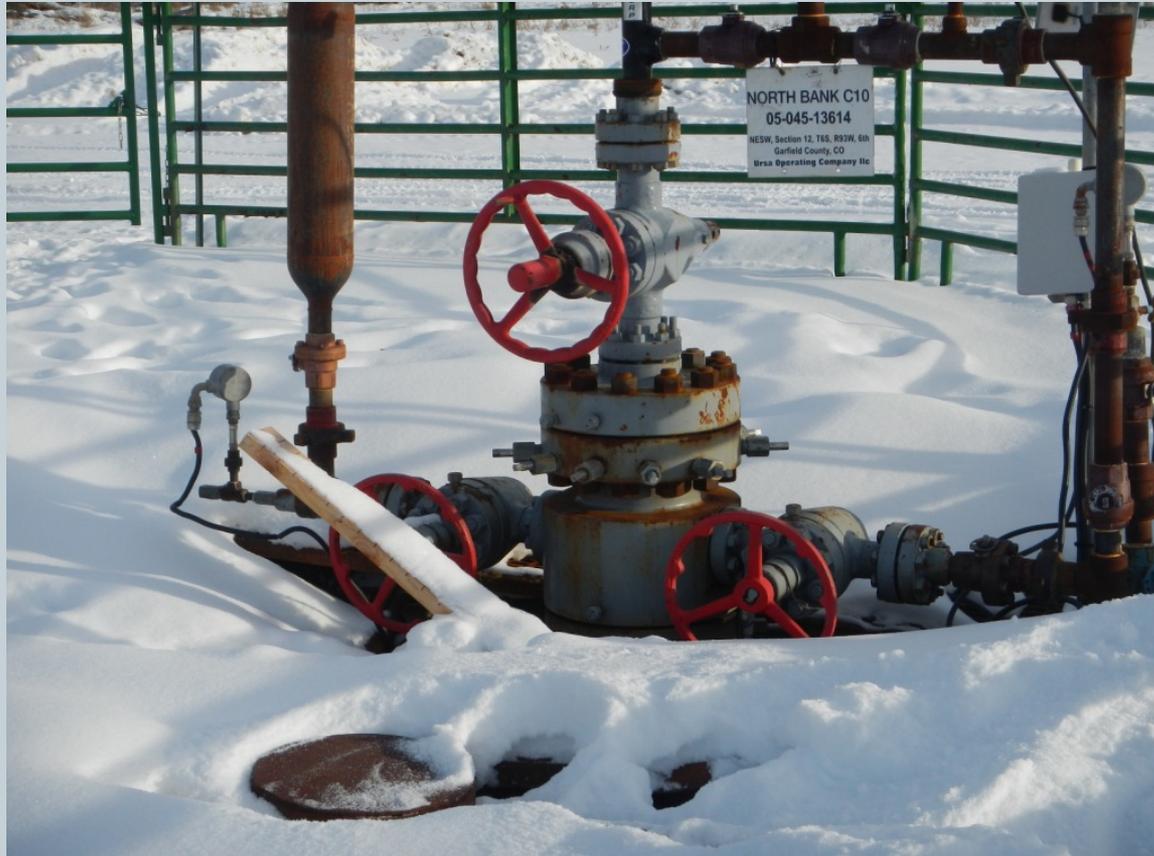
Photo#3: Conductor Set close to C10 Well.
