Construction Inspection

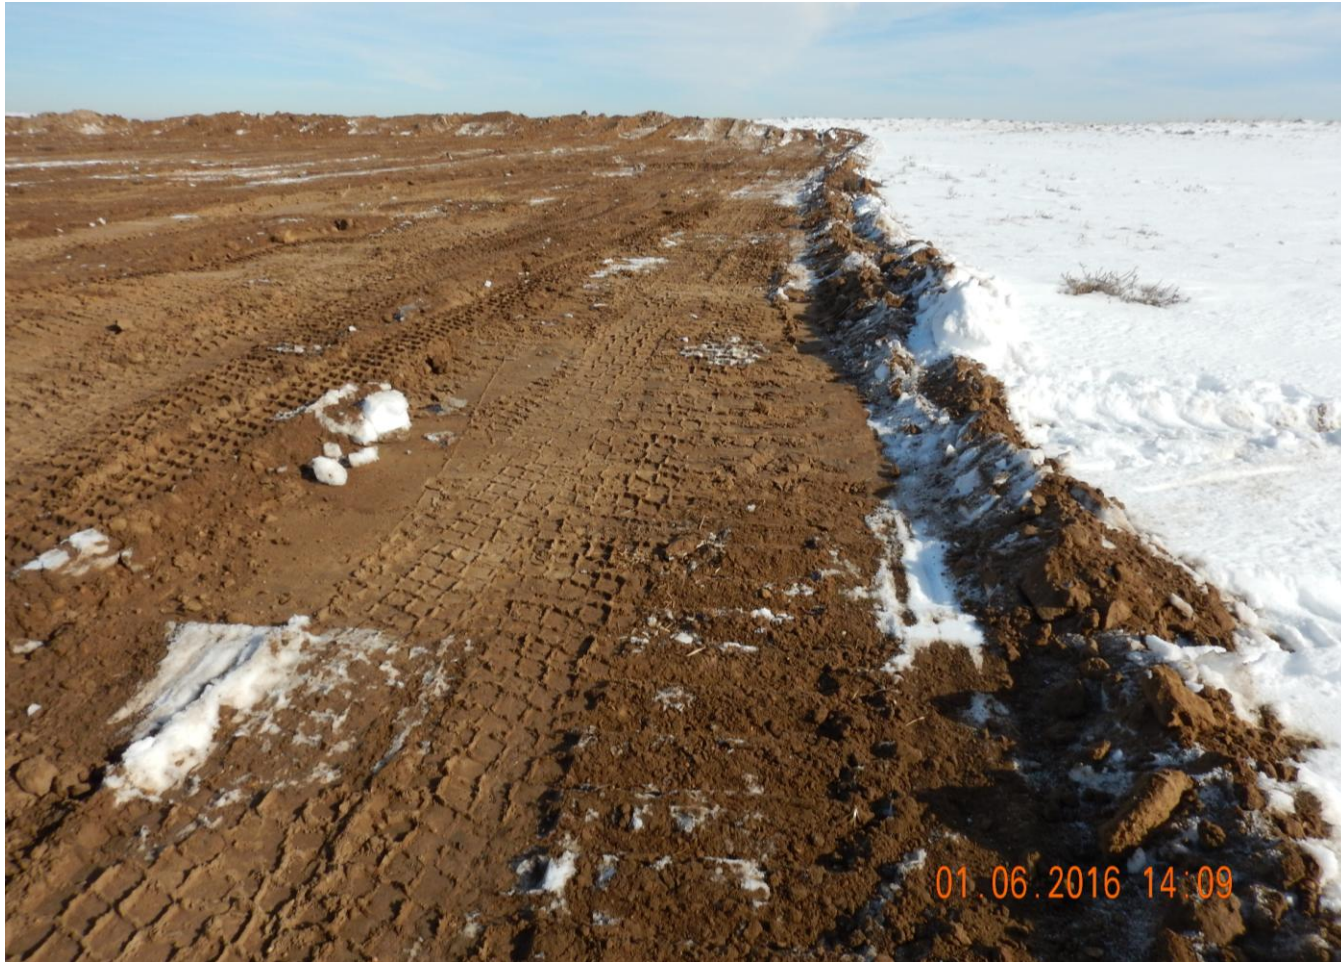
Photo 1. Photo taken from the southwest location, facing East. Stormwater BMPs need to be in place before construction starts.

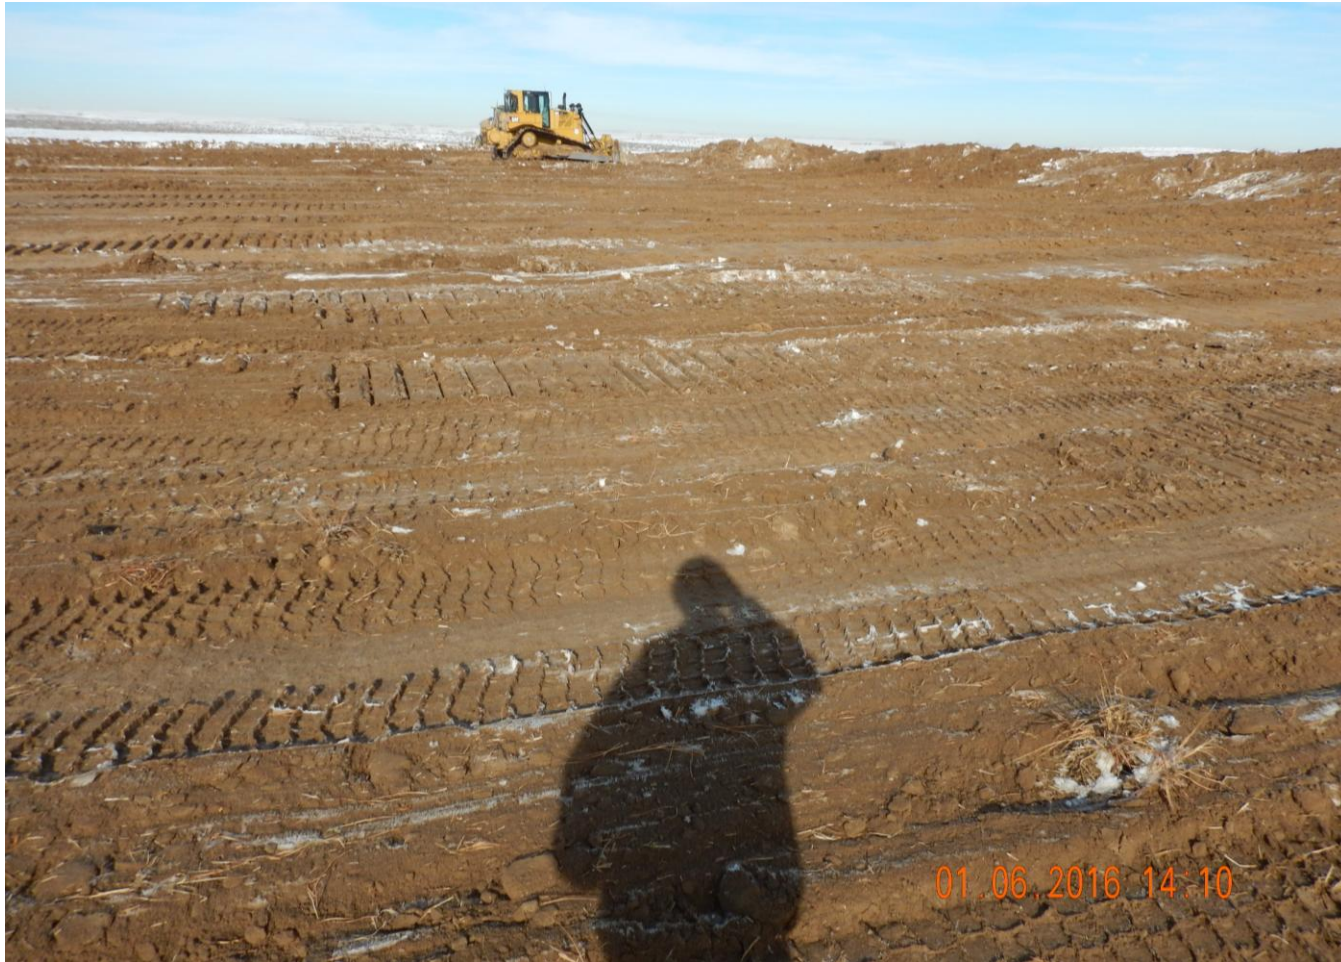
Photo 2. Photo taken from the southern location, facing North. Topsoil salvage in process.

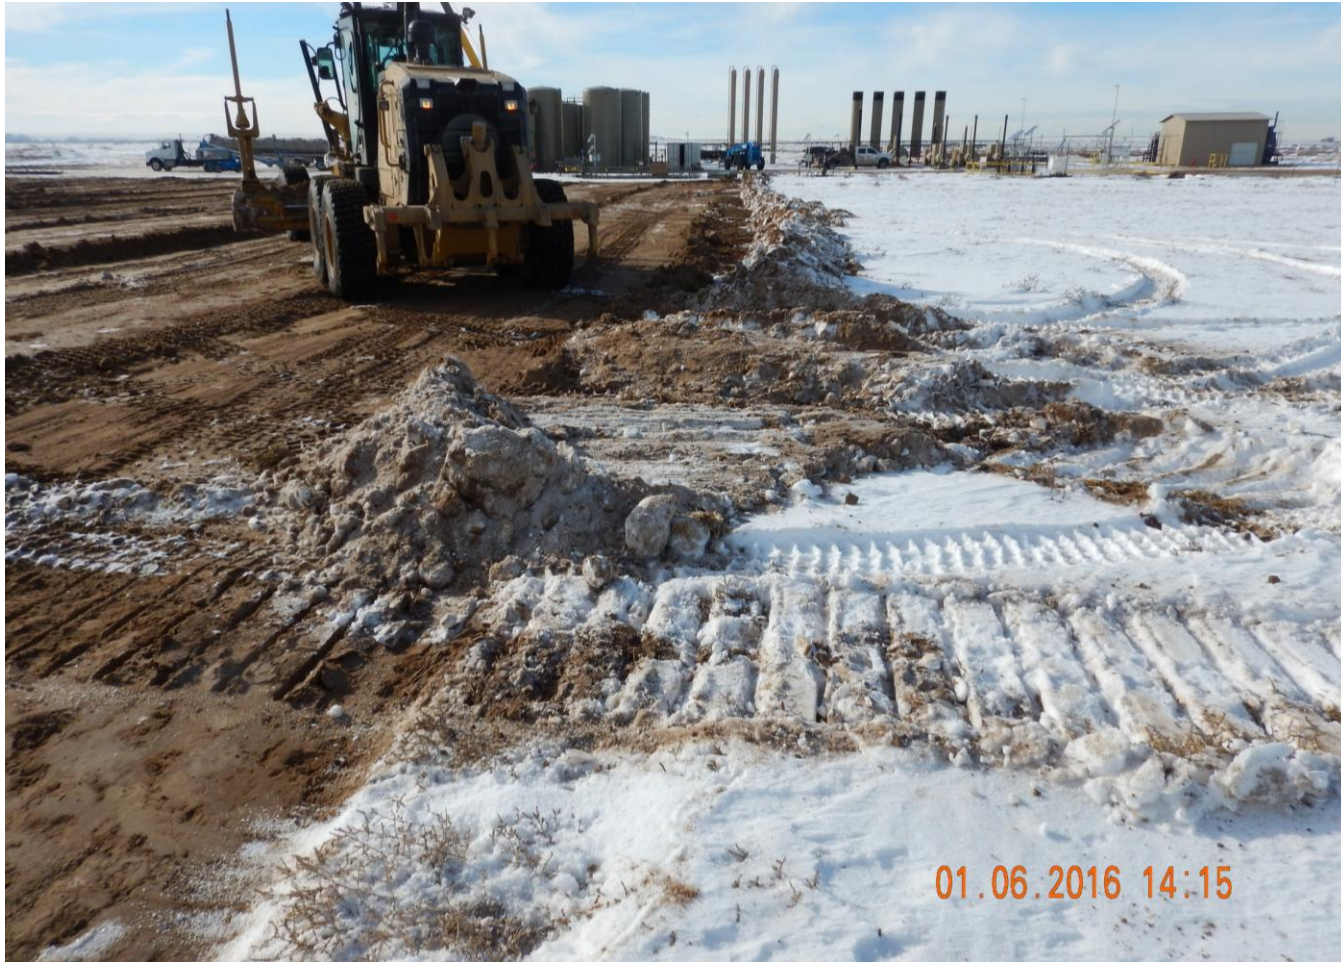
Photo 3. Photo taken from the northeast location, facing West. Stormwater BMPs need to be installed before construction starts.
