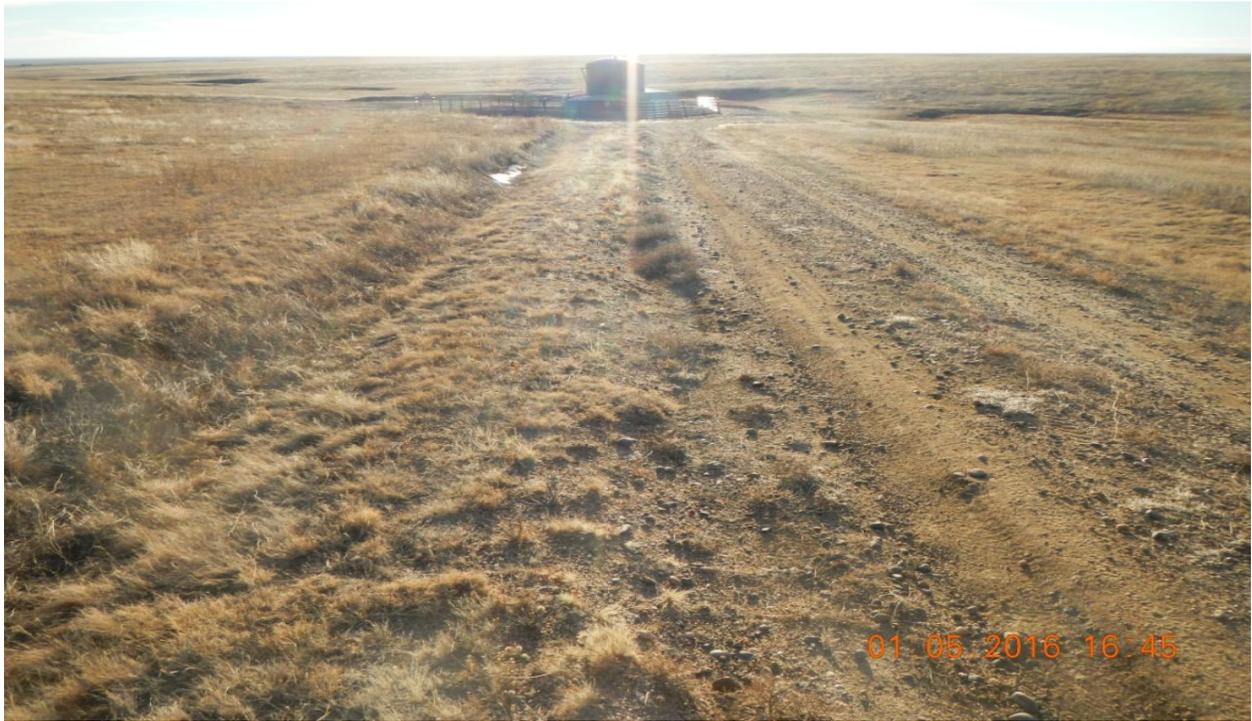
photo 1: Facing southwest towards the location along the access road.

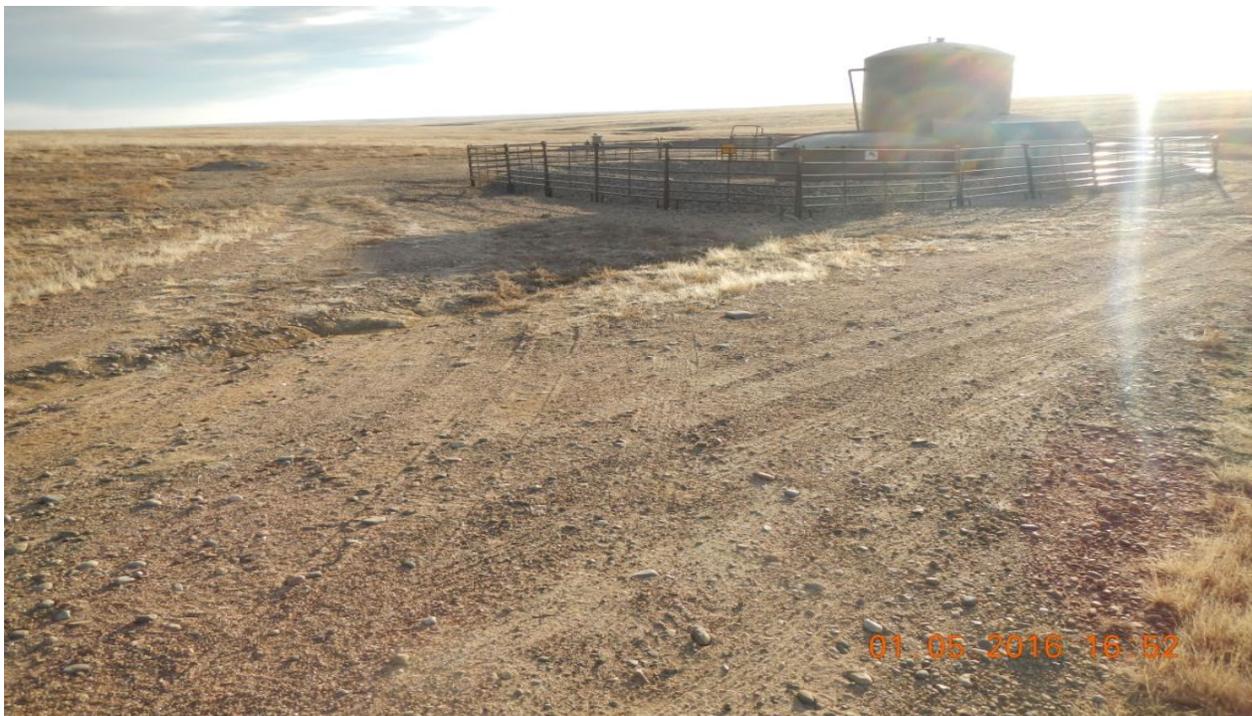
photo 2: Facing southwest towards the location.

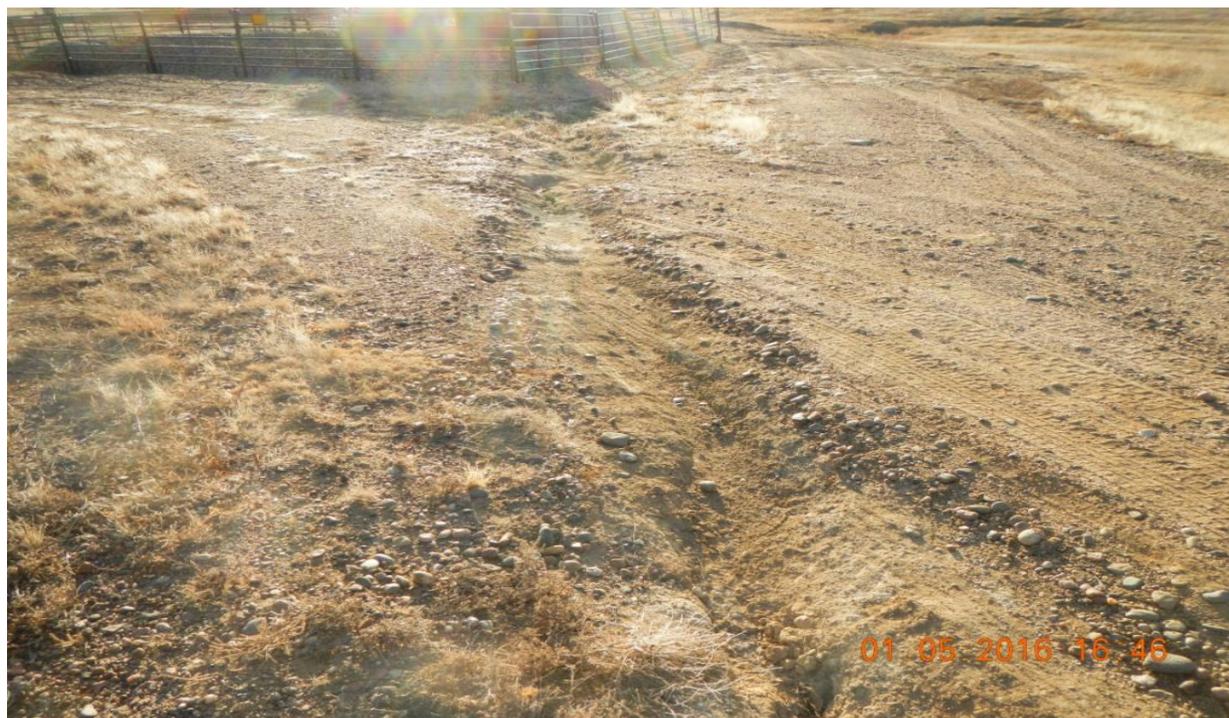
photo 3: Erosion channel cutting across the access road at the location.

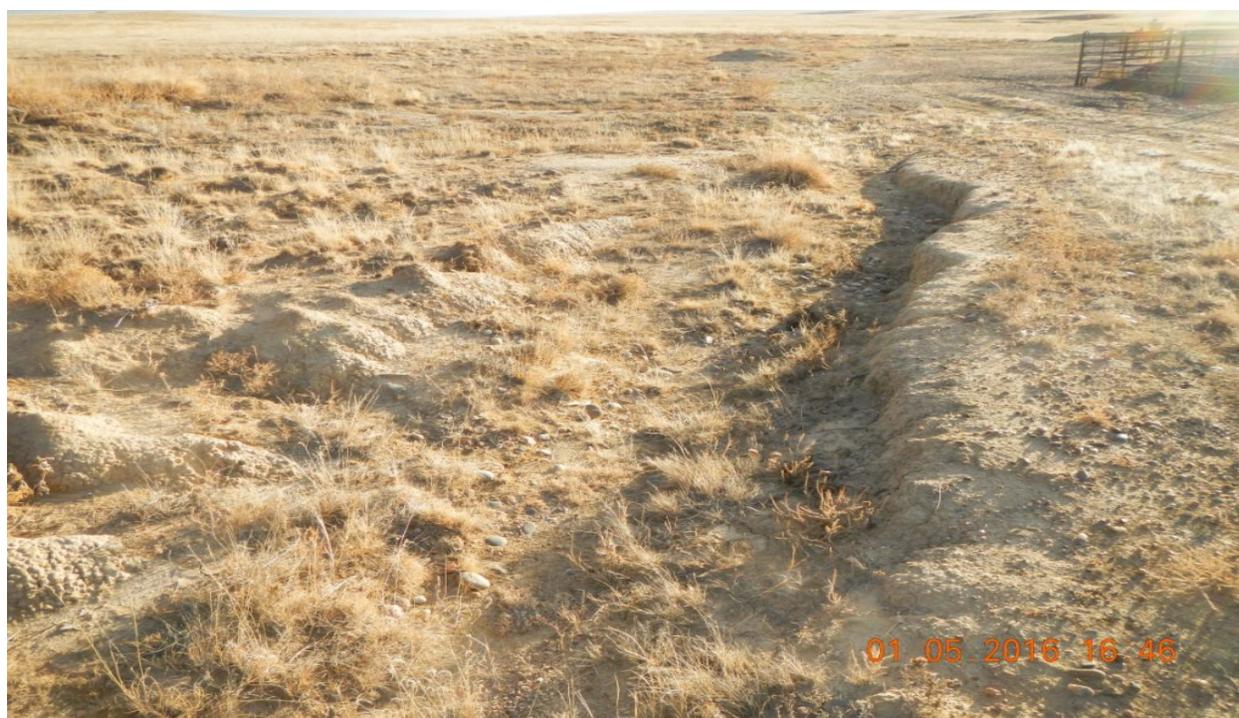
photo 4: Evidence of erosion off the east side of the location.

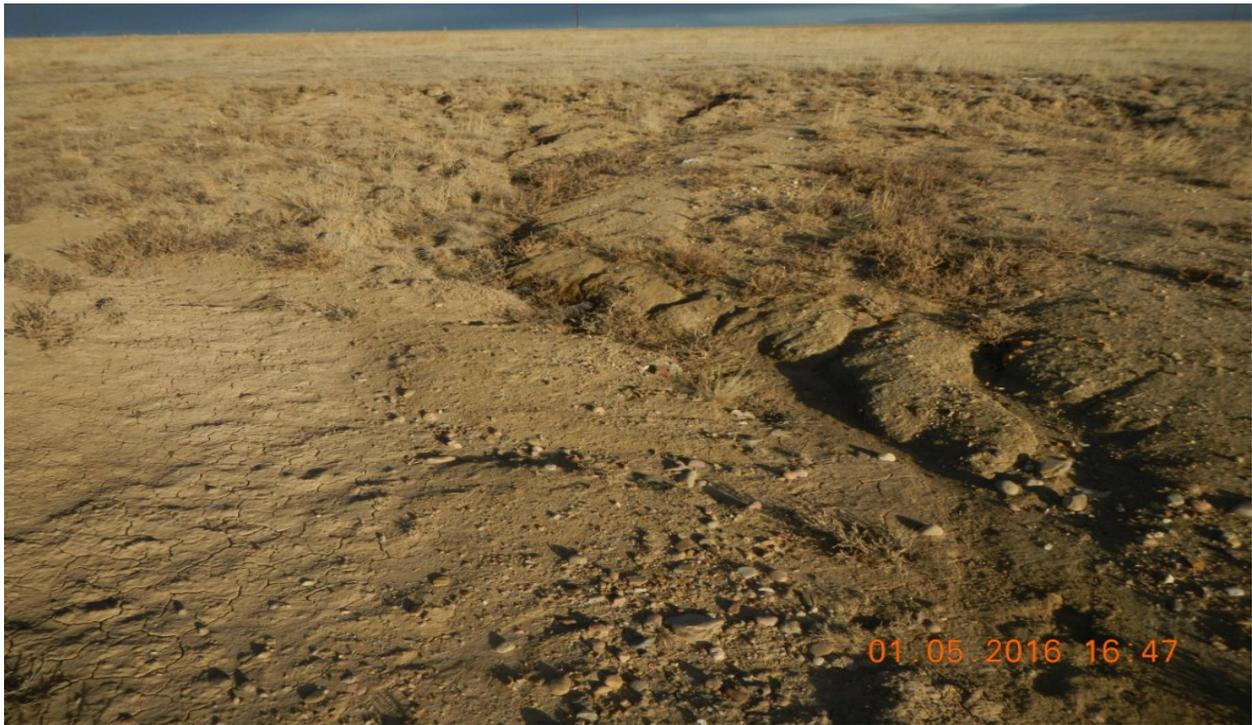
Photo 5: Facing east at the east side of the location. Evidence of erosion occurring onto the location.

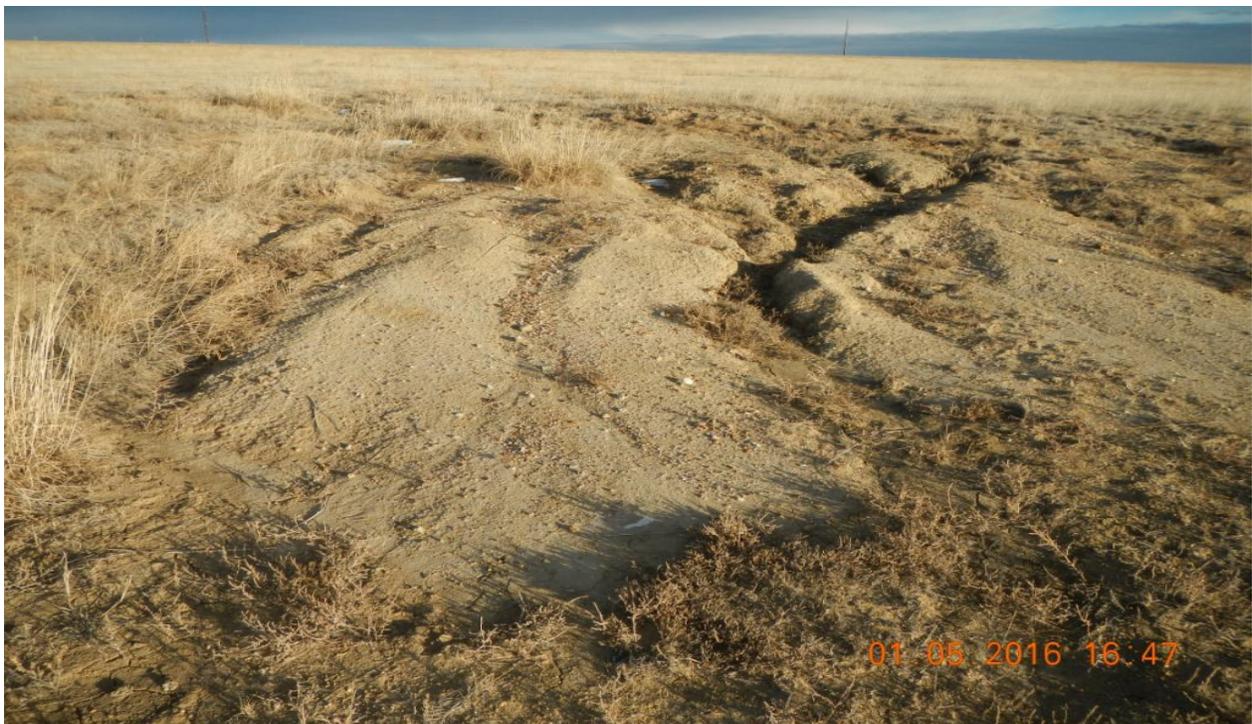
Photo 6: Facing east at the east side of the location. Evidence of erosion occurring onto the location.

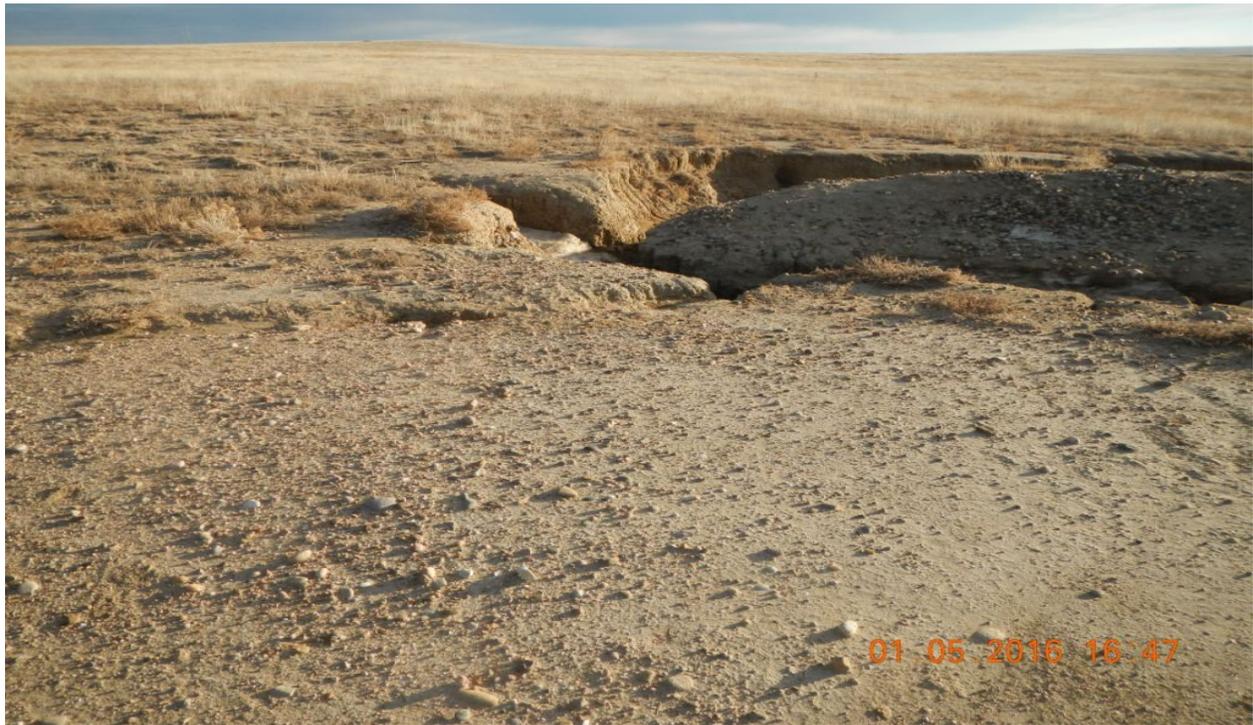
Photo 7: Facing towards the south side of the location where erosion gully has formed.

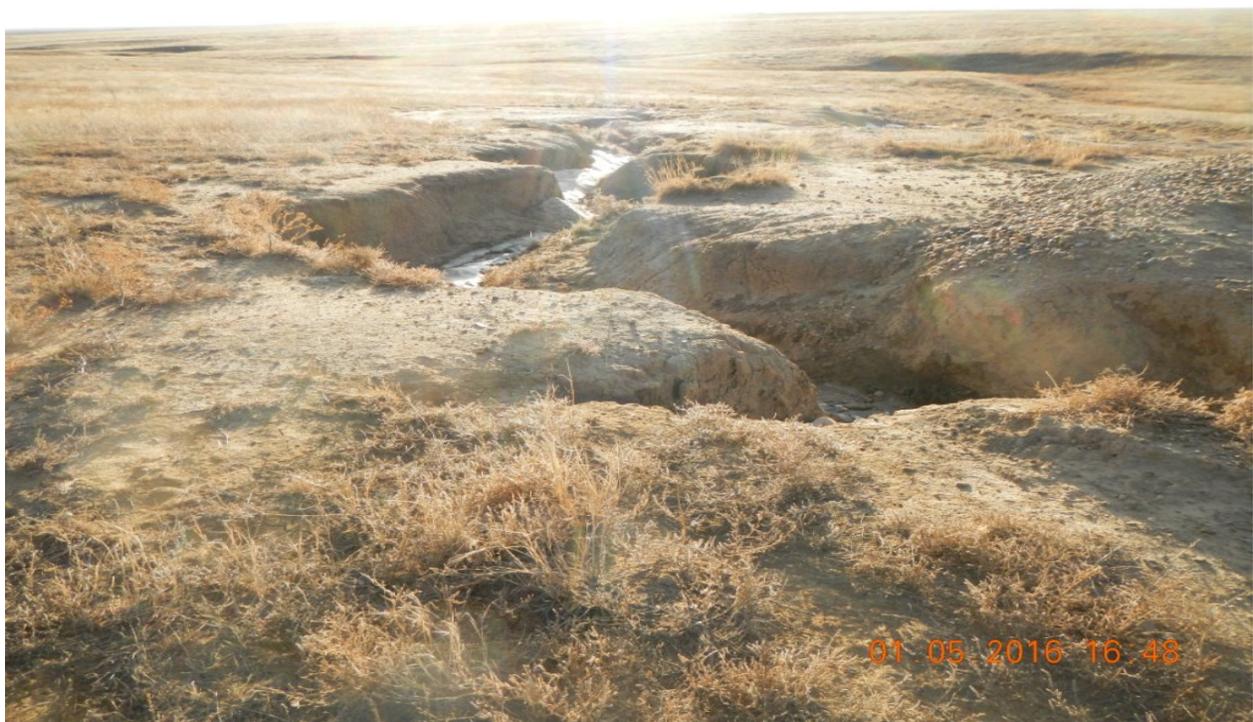
Photo 8: An erosion gully has formed off the southwest side of the location.

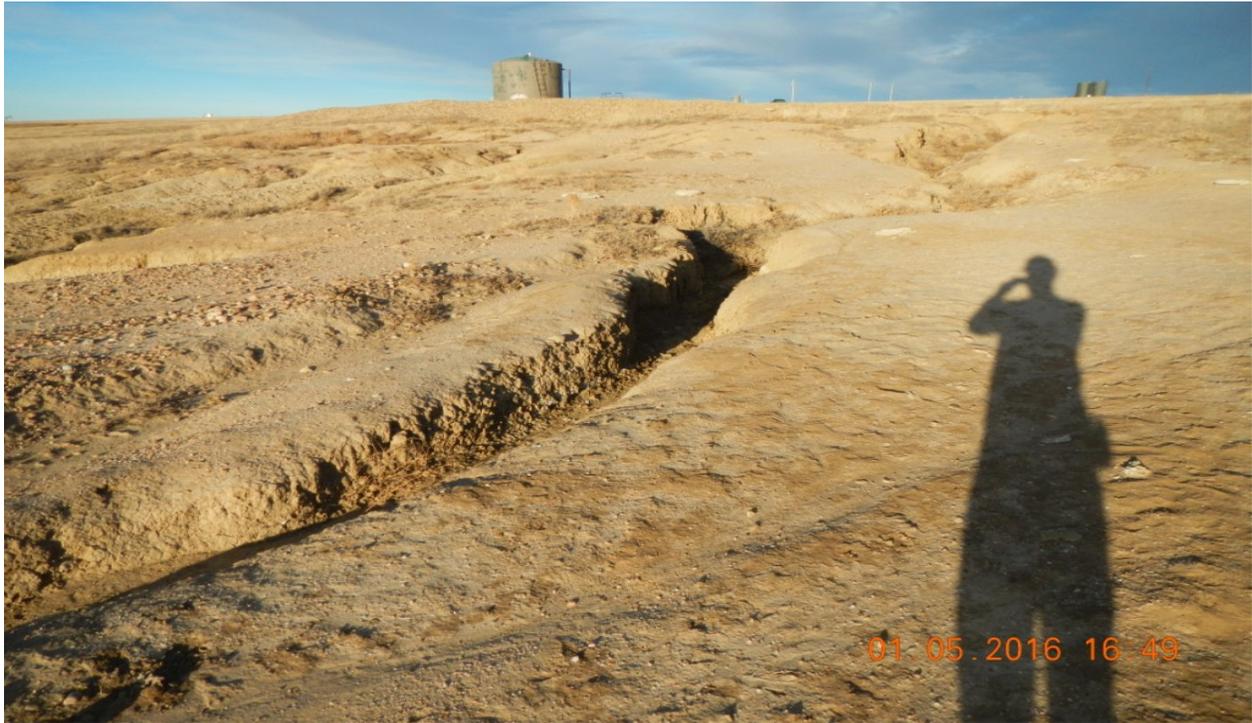
Photo 9: Facing north towards the location where erosion disturbances are evident.

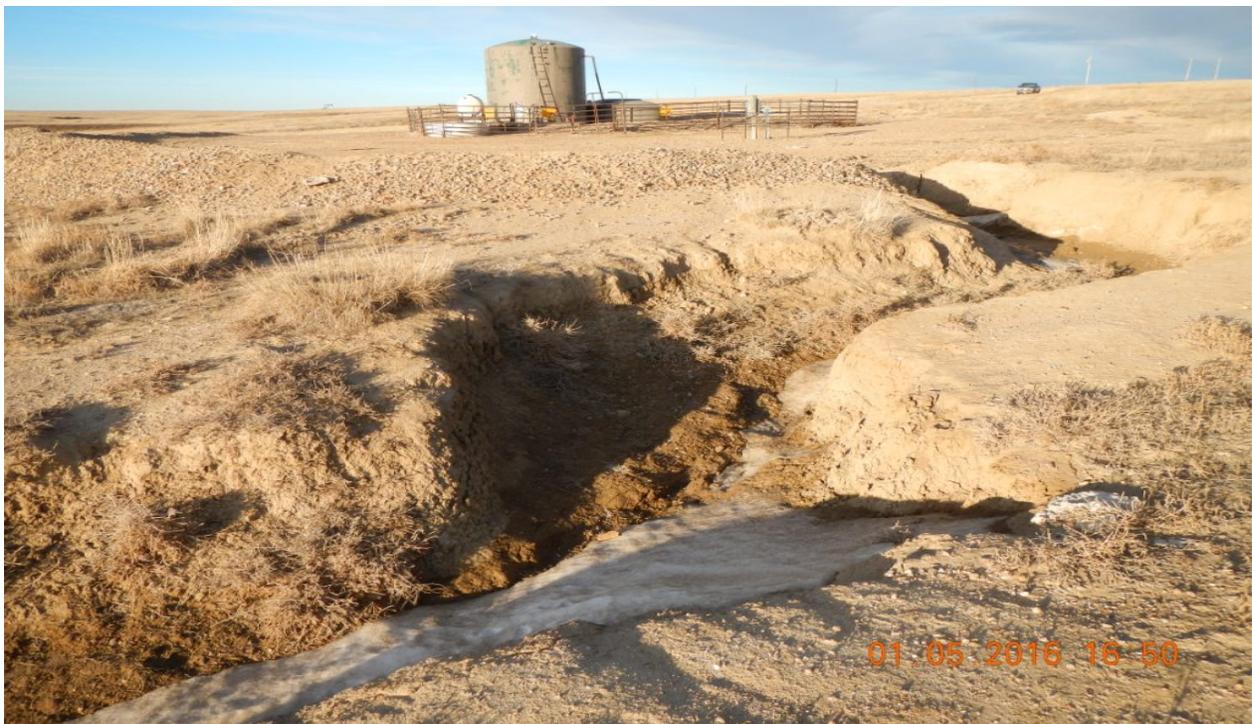
Photo 10: Facing north toward the location. Erosion gully is evident at the southwest side of the location.

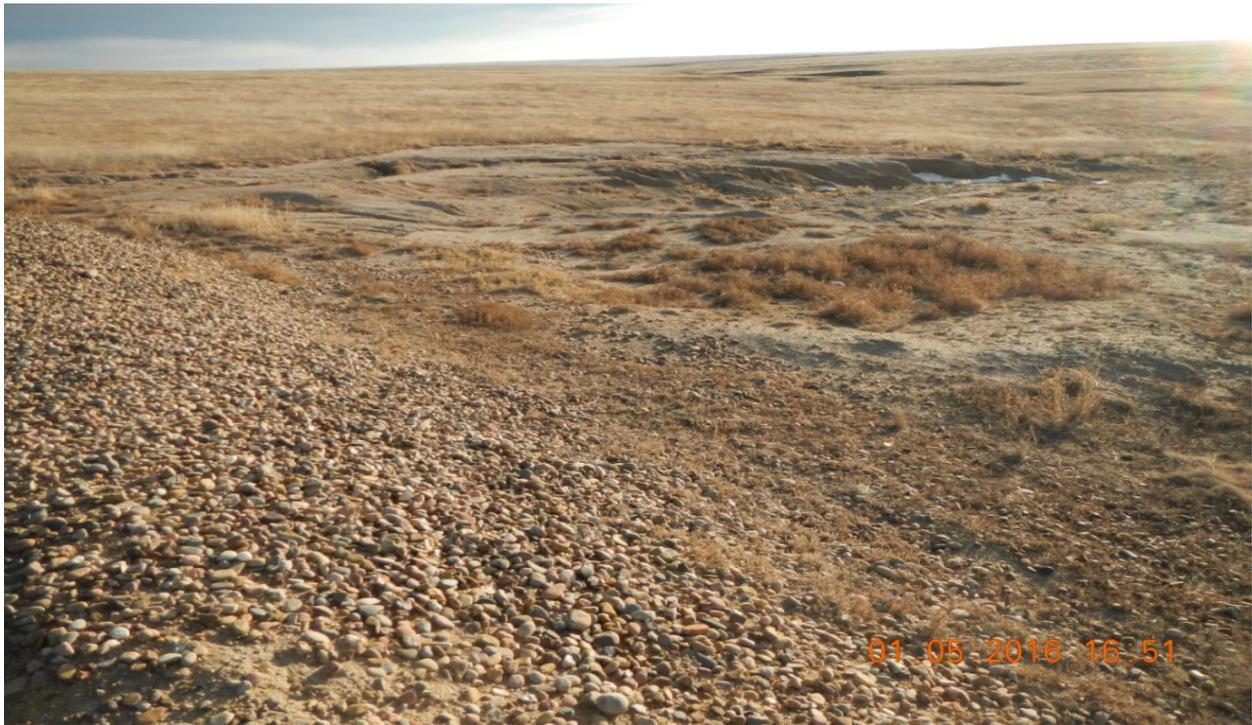
Photo 11: Facing toward the southwest side of the location.

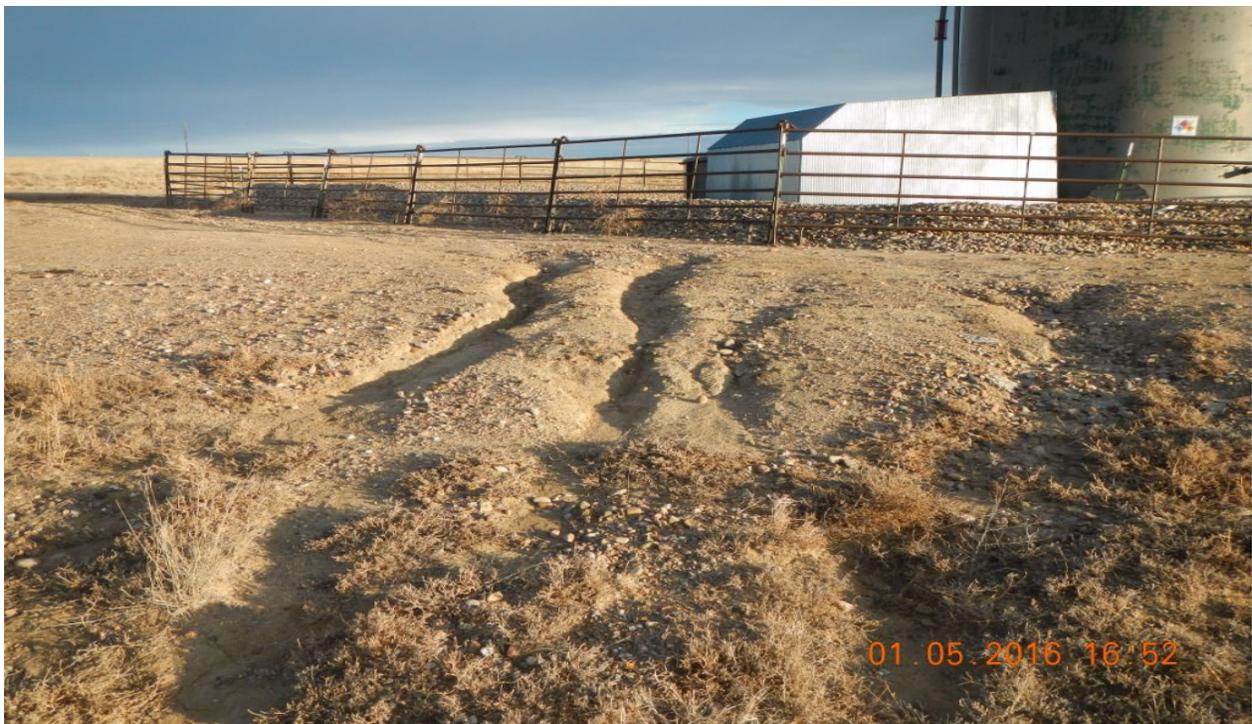
Photo 12: Erosion channels off the northwest side of the location.

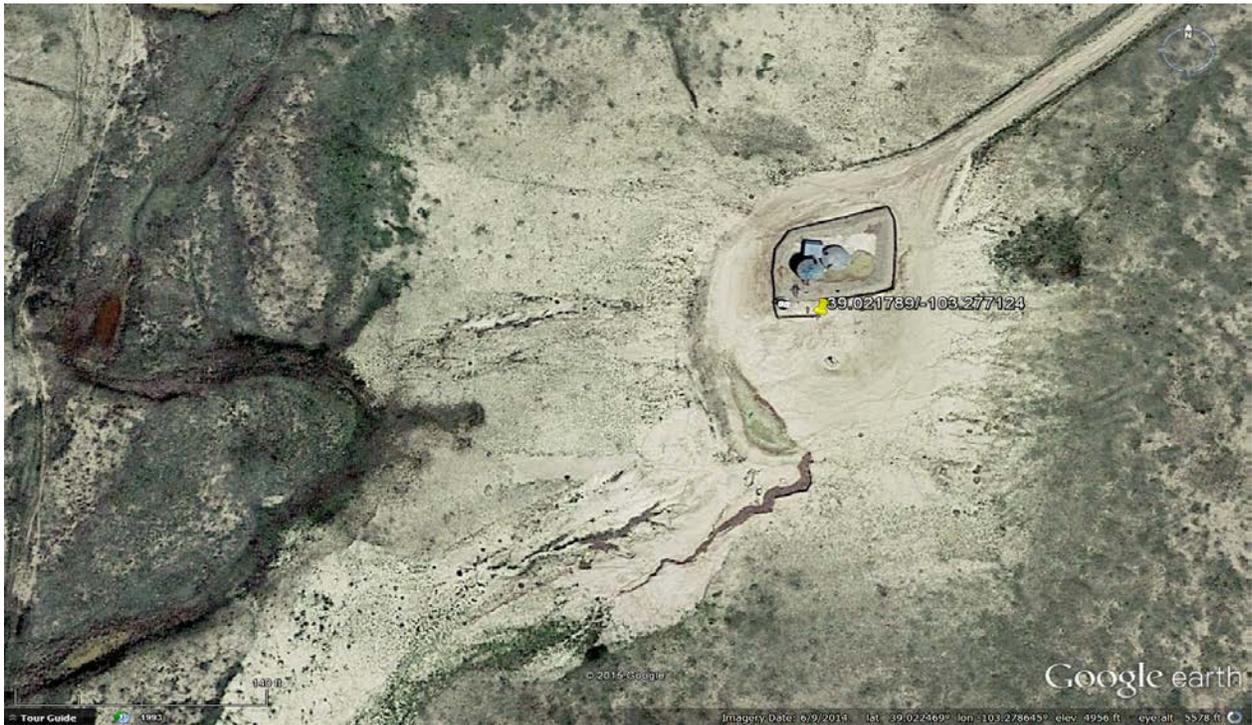
Photo 13: Aerial image of the location from 6/2014. The photo indicates the proximity to a water feature.

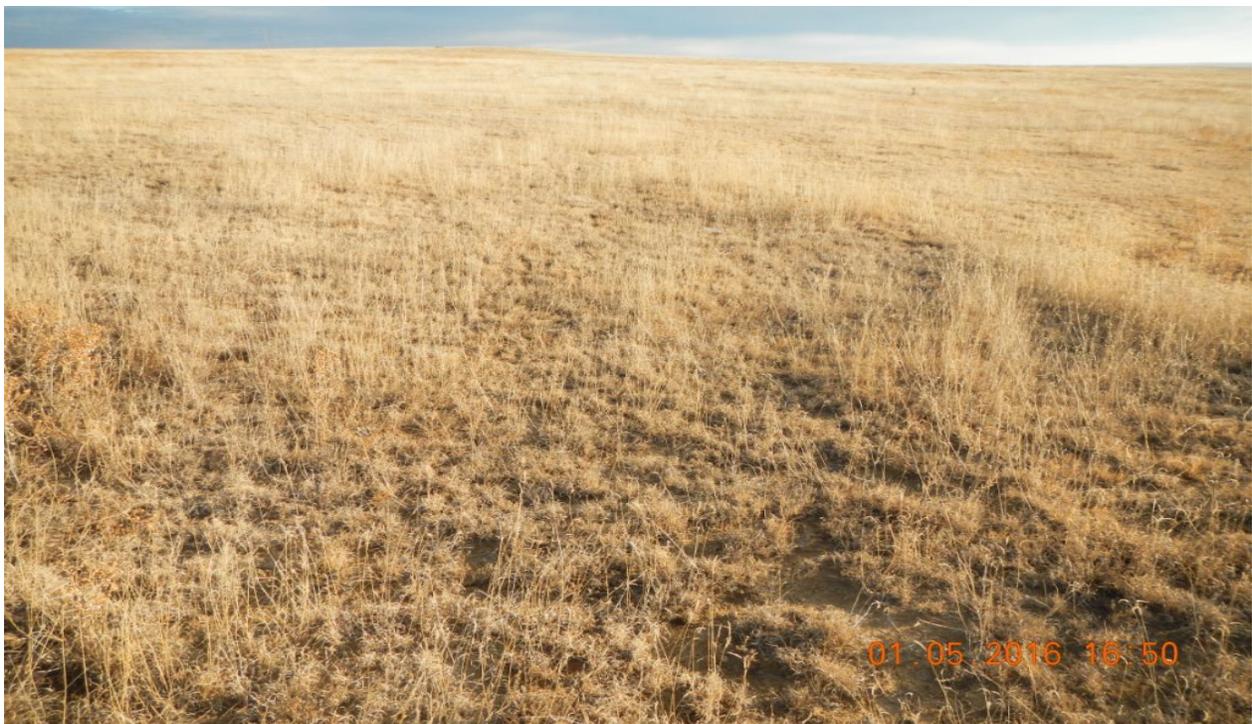
Photo 14: Surrounding pasture adjacent to the location.
