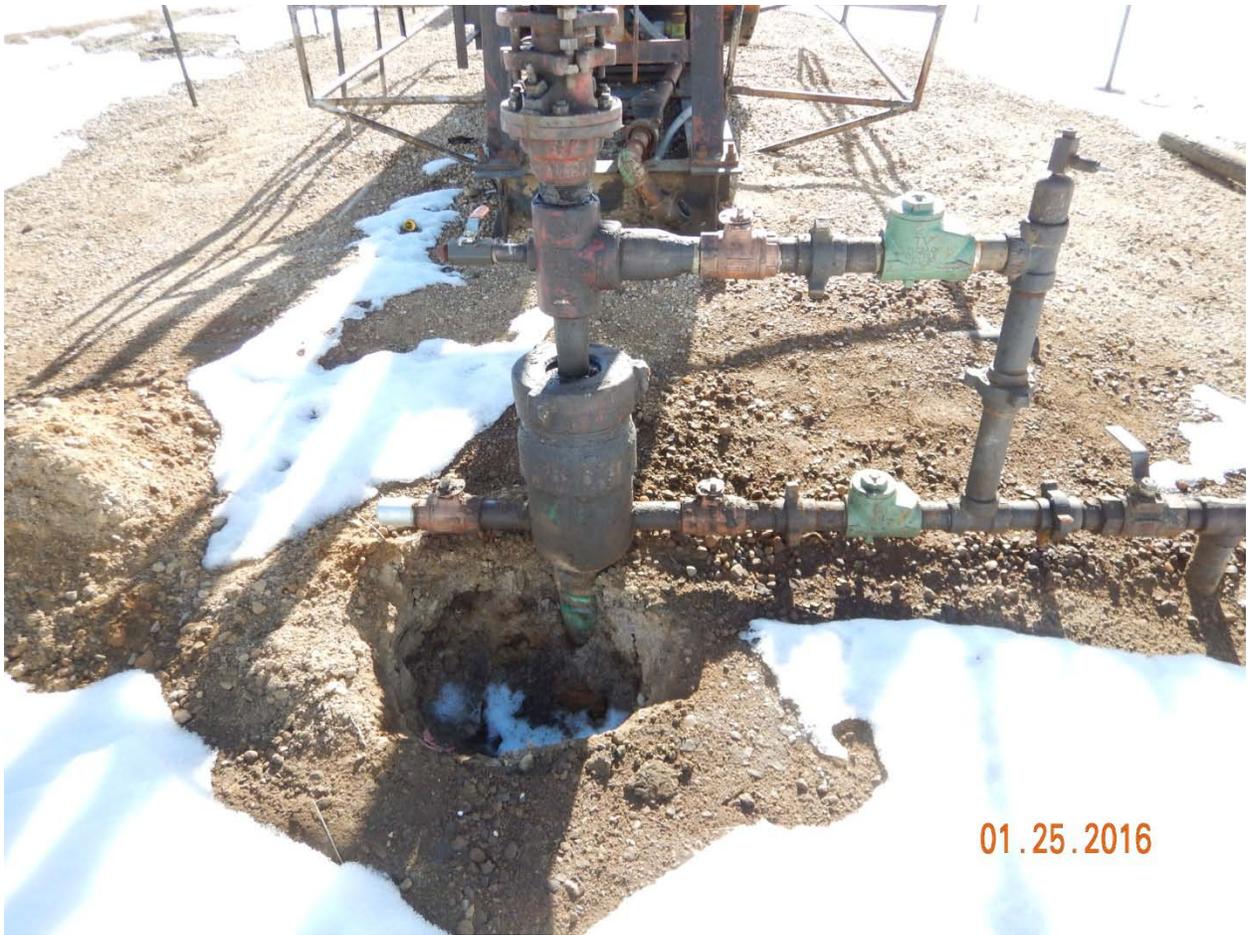
Figure 2 - Becky #1 wellhead with small excavation.

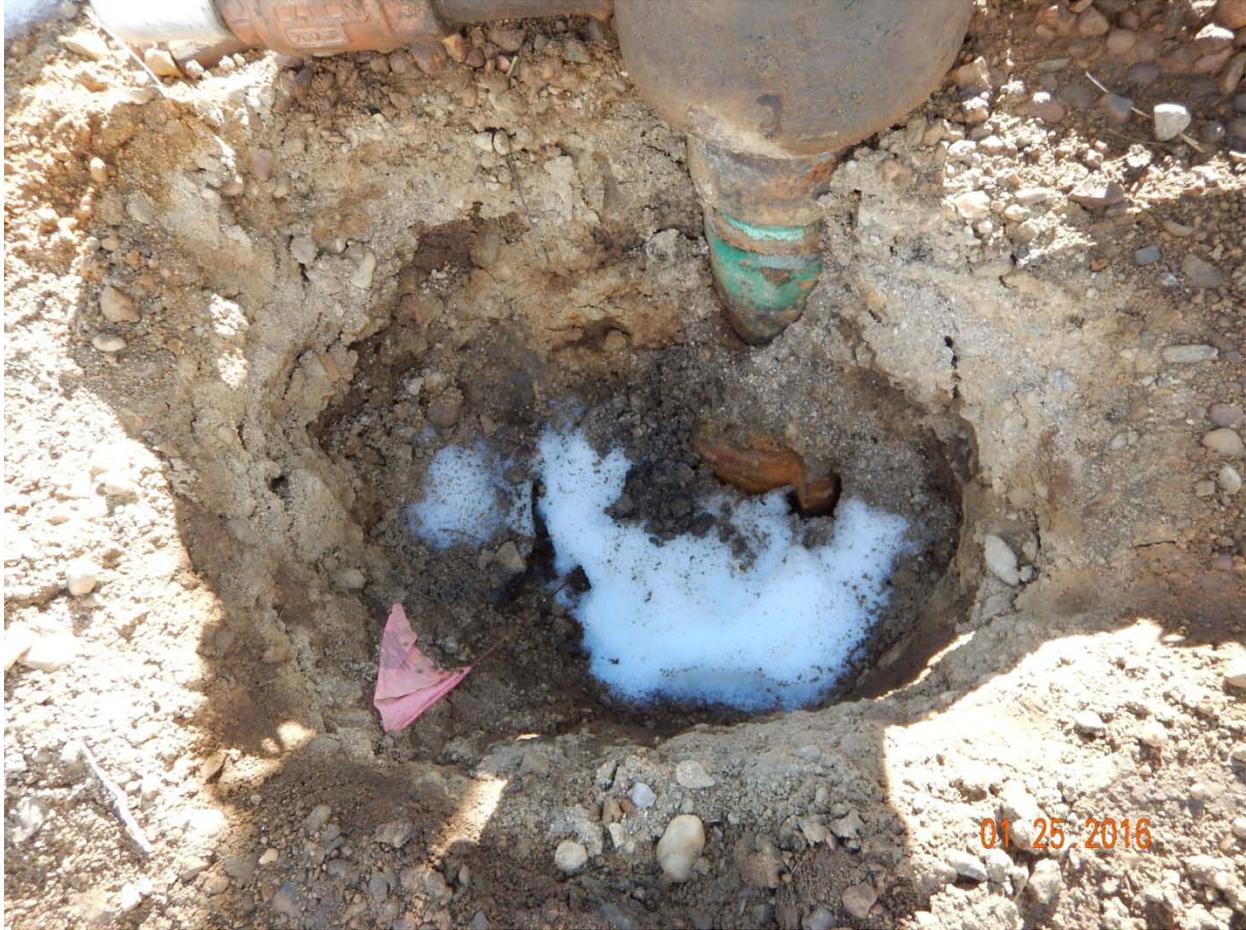
Figure 3 - Localized soil staining inside of wellhead excavation.

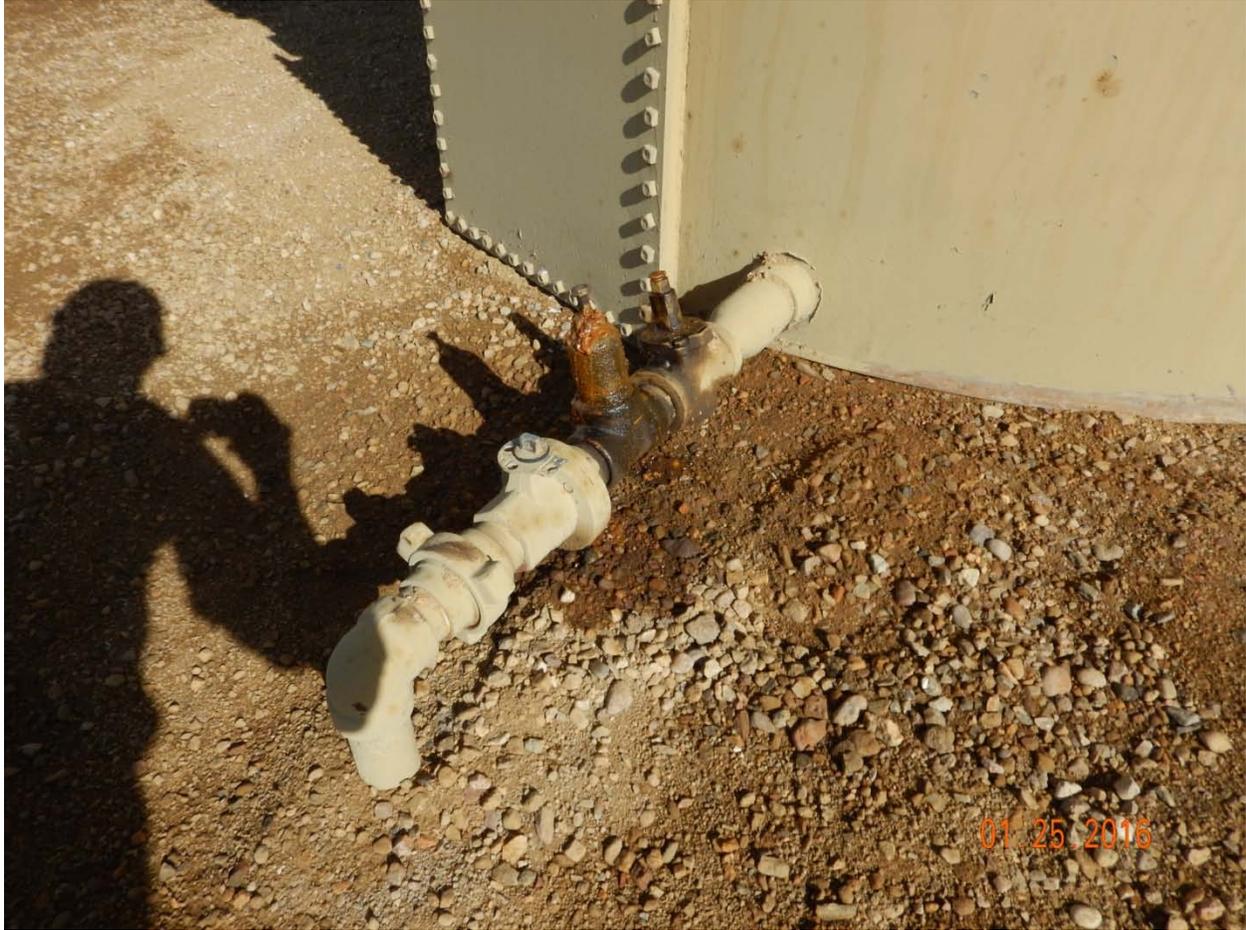
Figure 6 - Paraffin buildup and stained soil beneath valve of north tank.

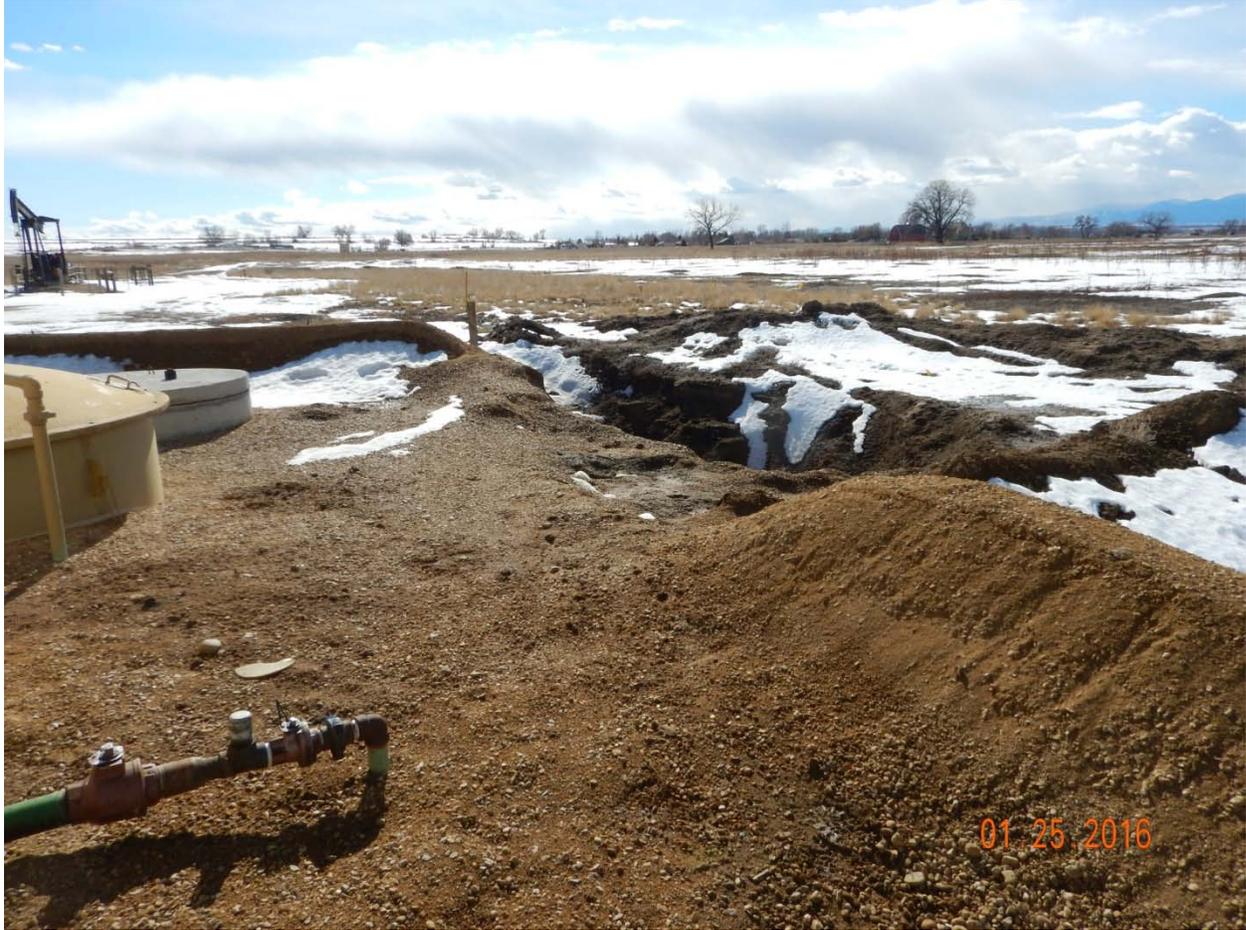
Figure 7 - Open excavation and compromised containment berms at SW corner of tank battery.

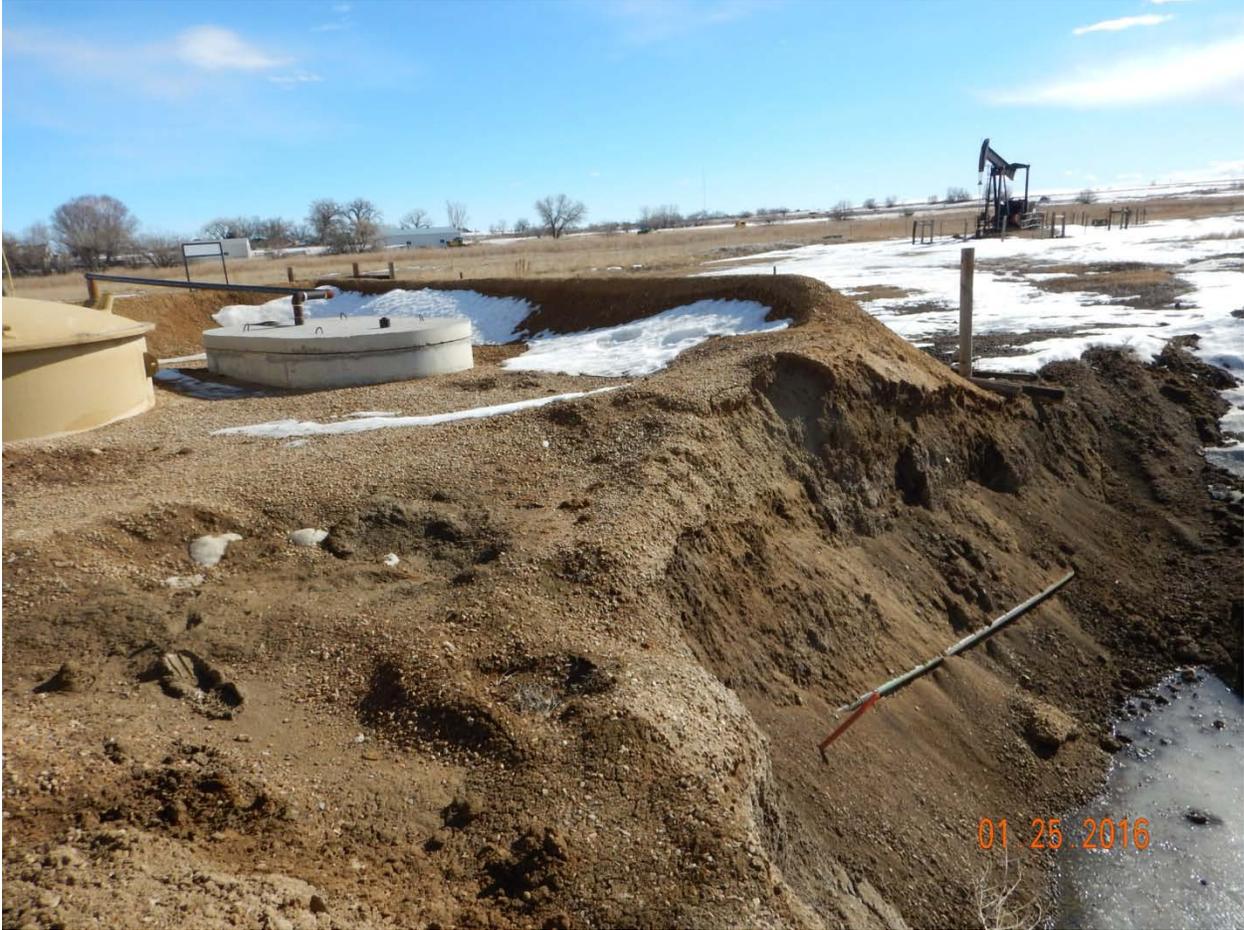
Figure 8 - Visible flowline inside of open excavation.

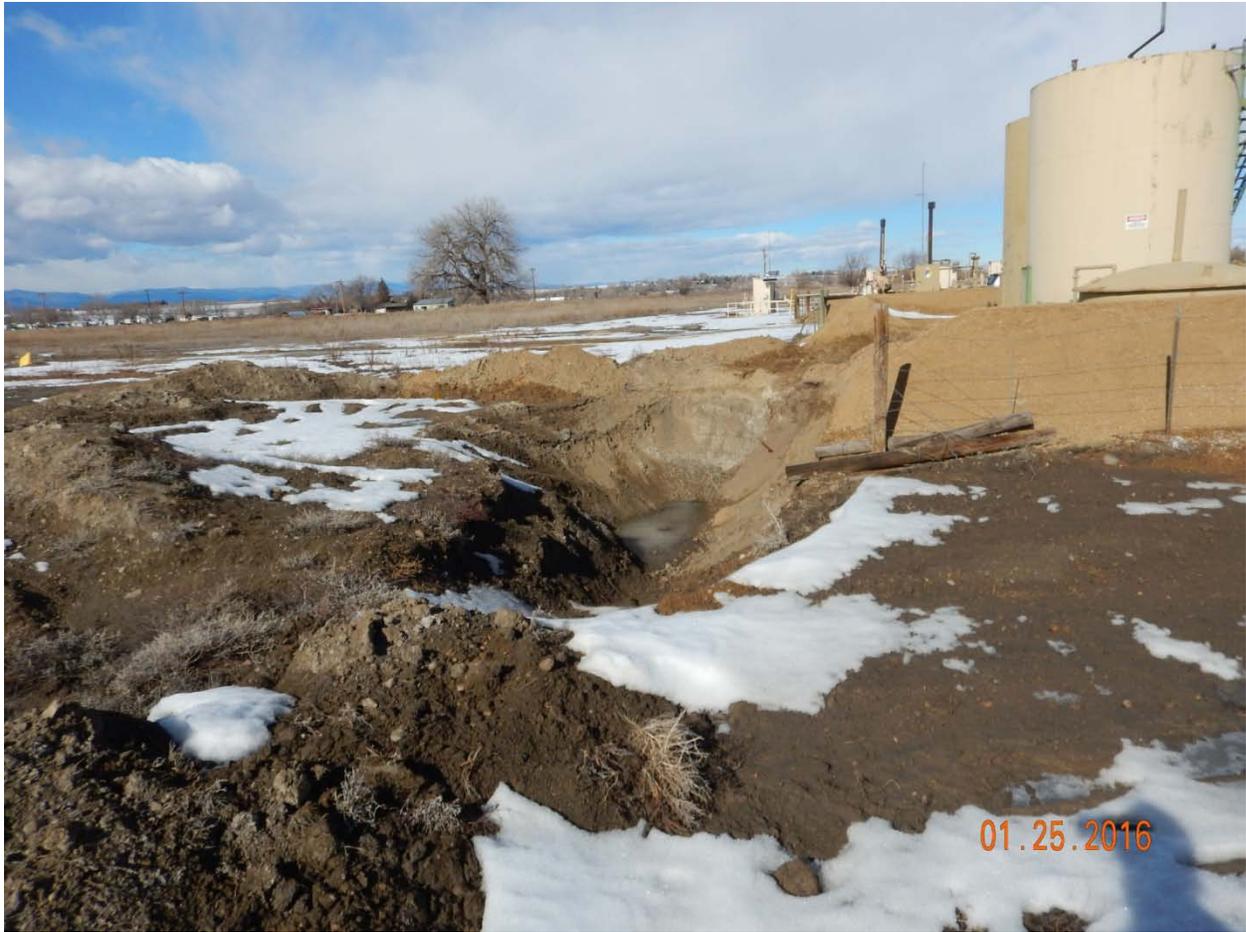
Figure 9 - View of excavation and compromised containment from south of tank battery.

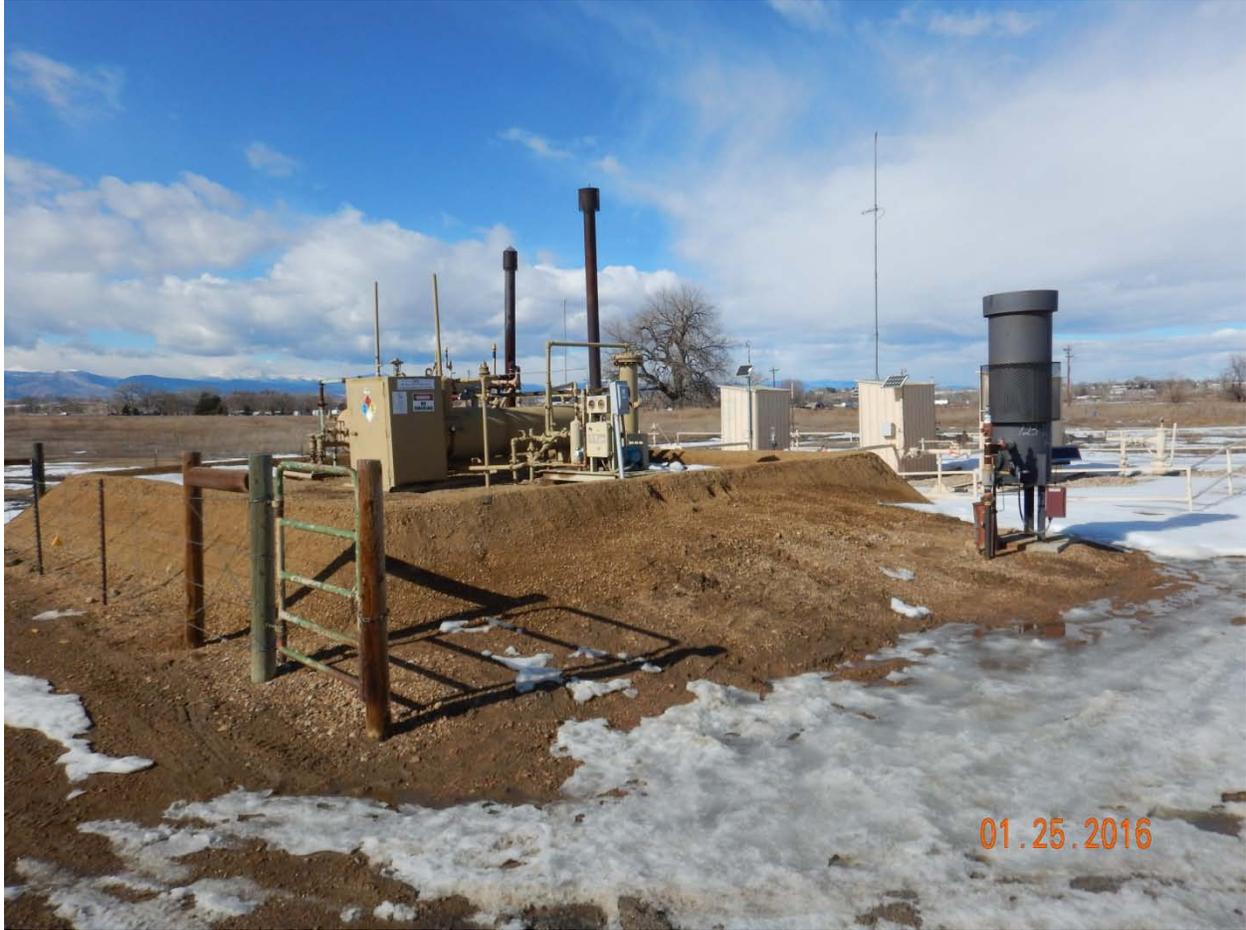
Figure 10 - Horizontal separators, ECD, and partial fencing north of tank battery.
