Construction Inspection

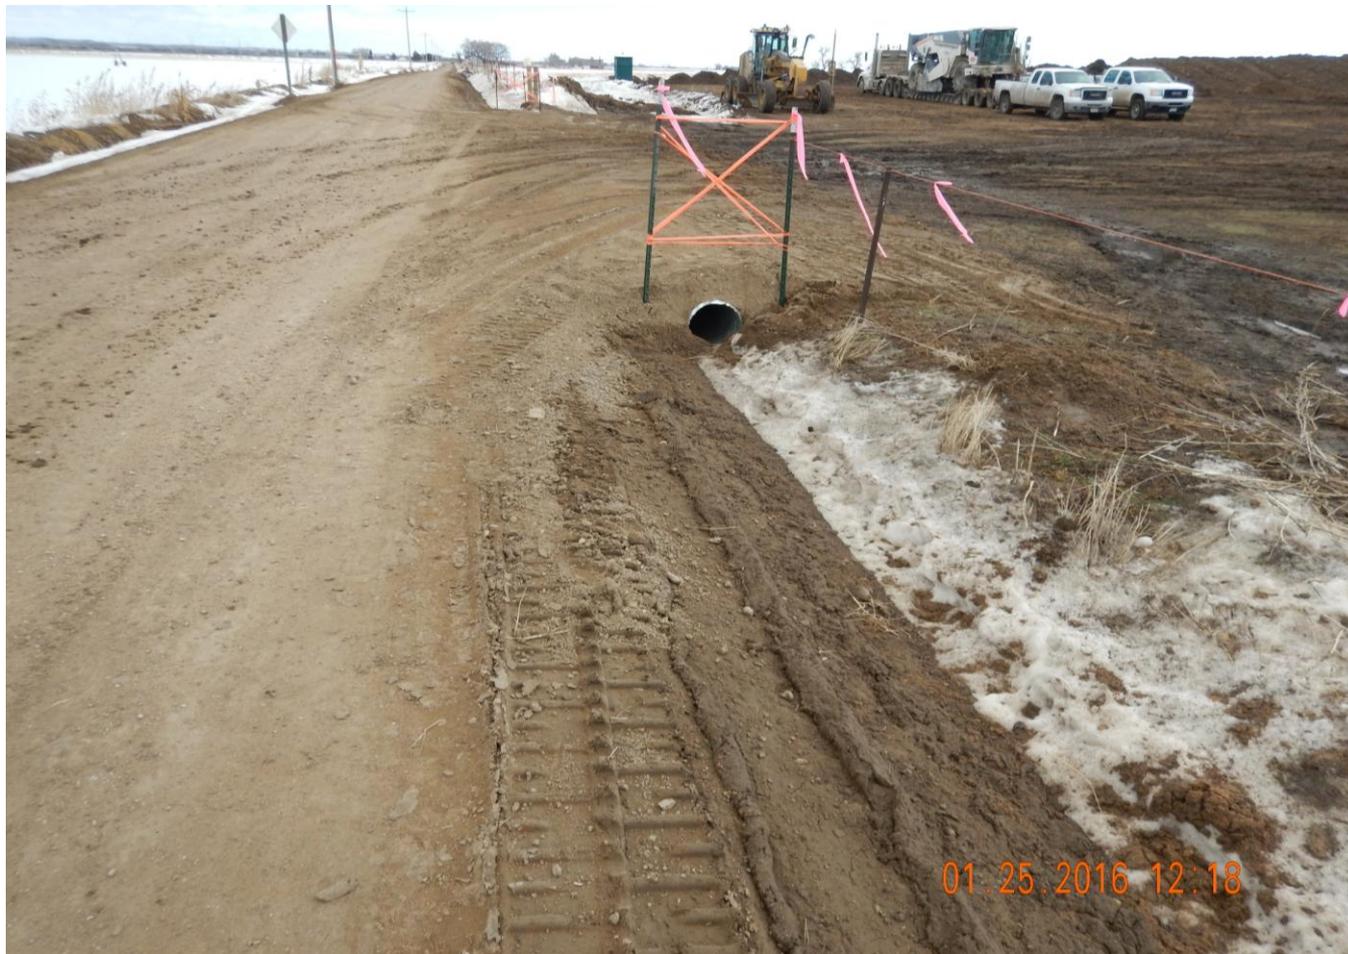
Photo 1. Photo taken from entrance, facing East. Stormwater and sediment control BMPs installed before construction.

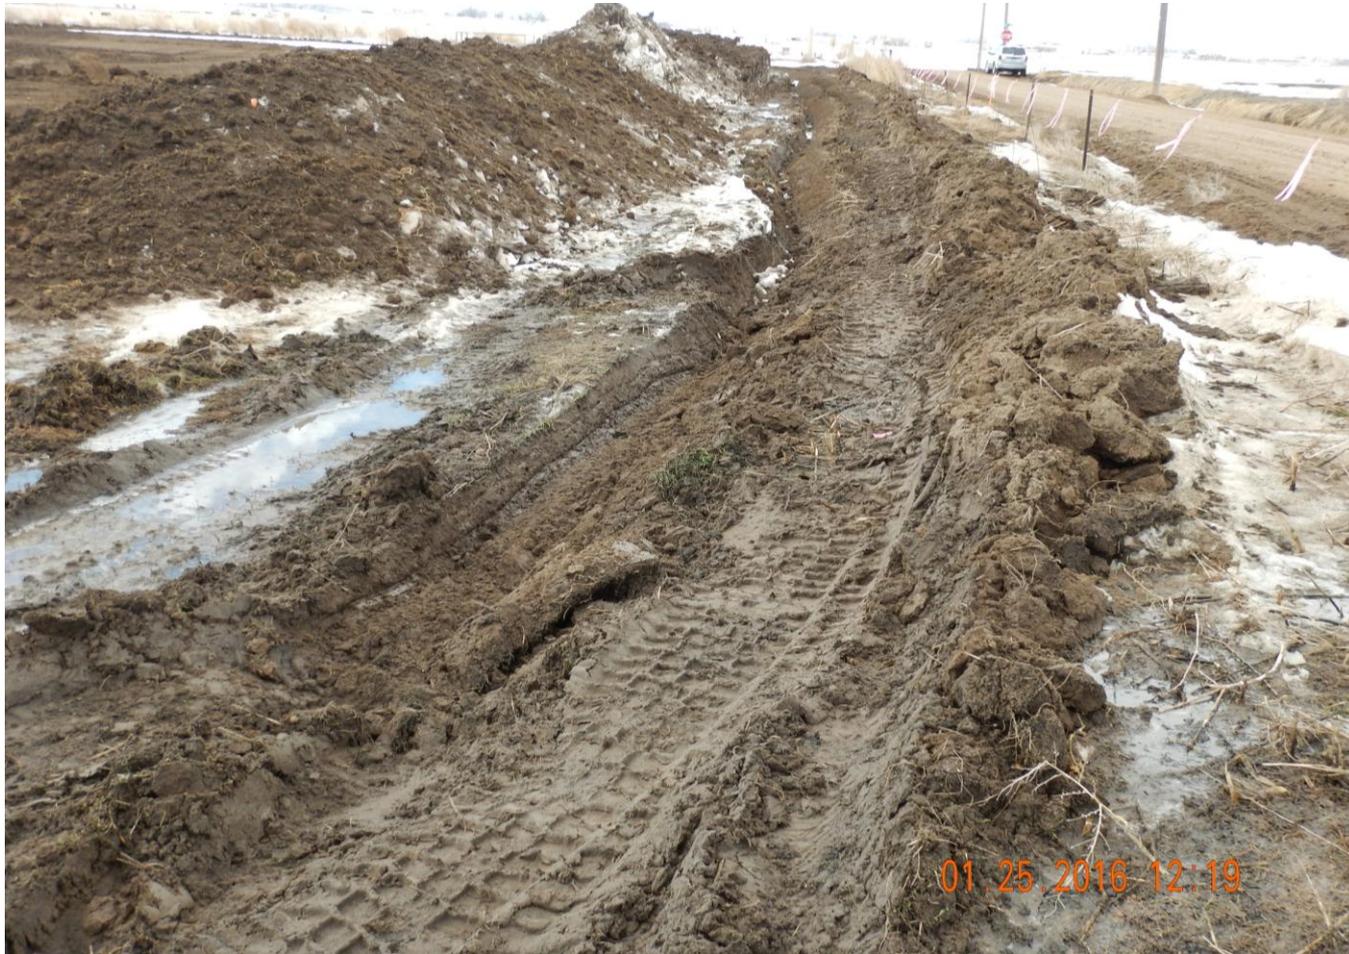
Photo 2. Photo taken from northern location, facing West. Stormwater and sediment control BMPs installed before construction.

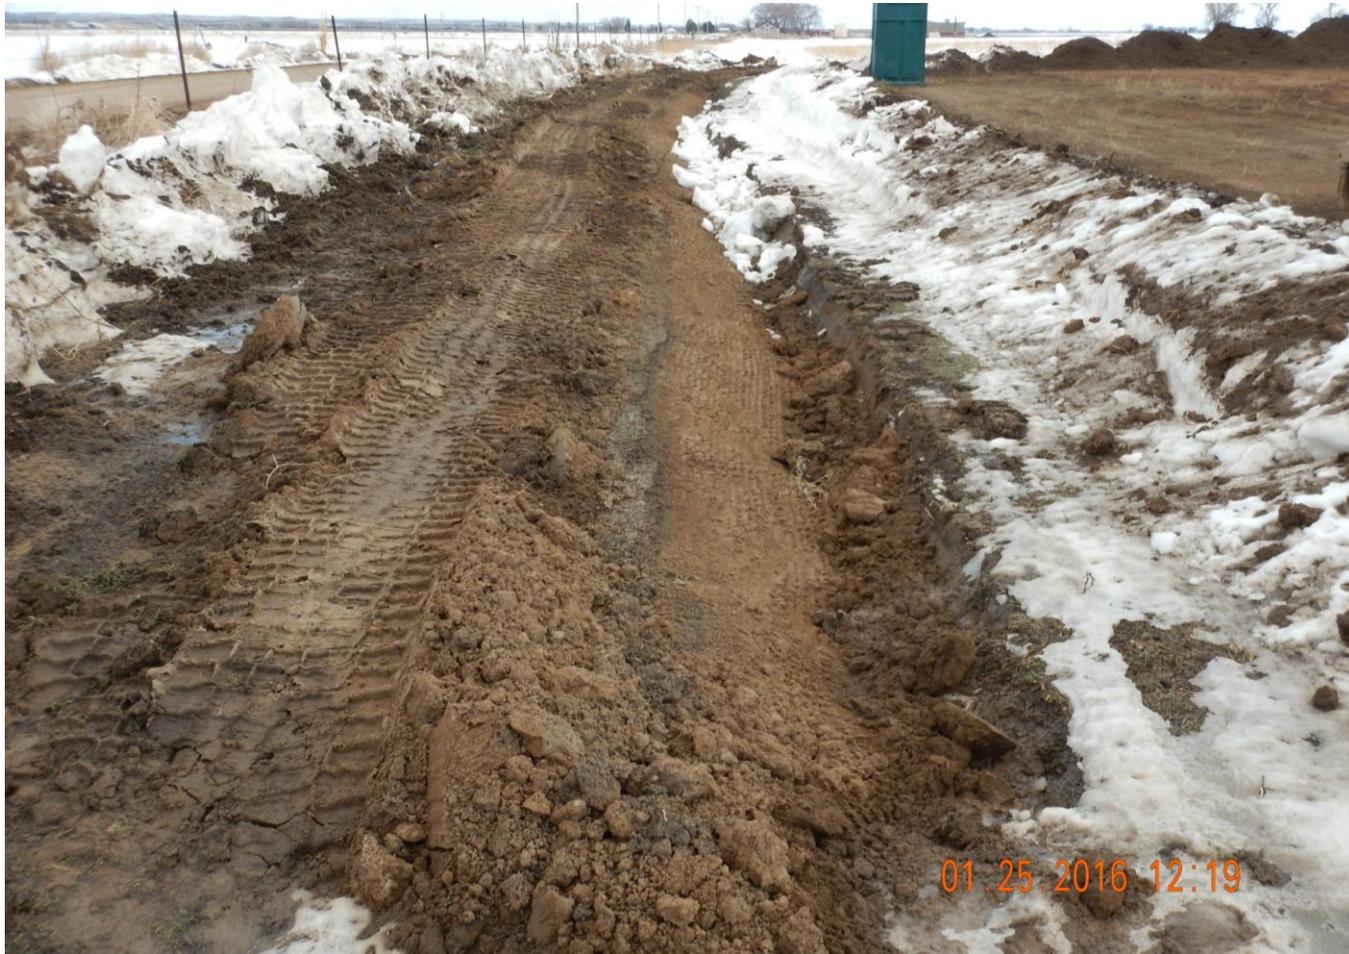
Photo 3. Photo taken from northern location, facing East. Stormwater and sediment control BMPs installed before construction.

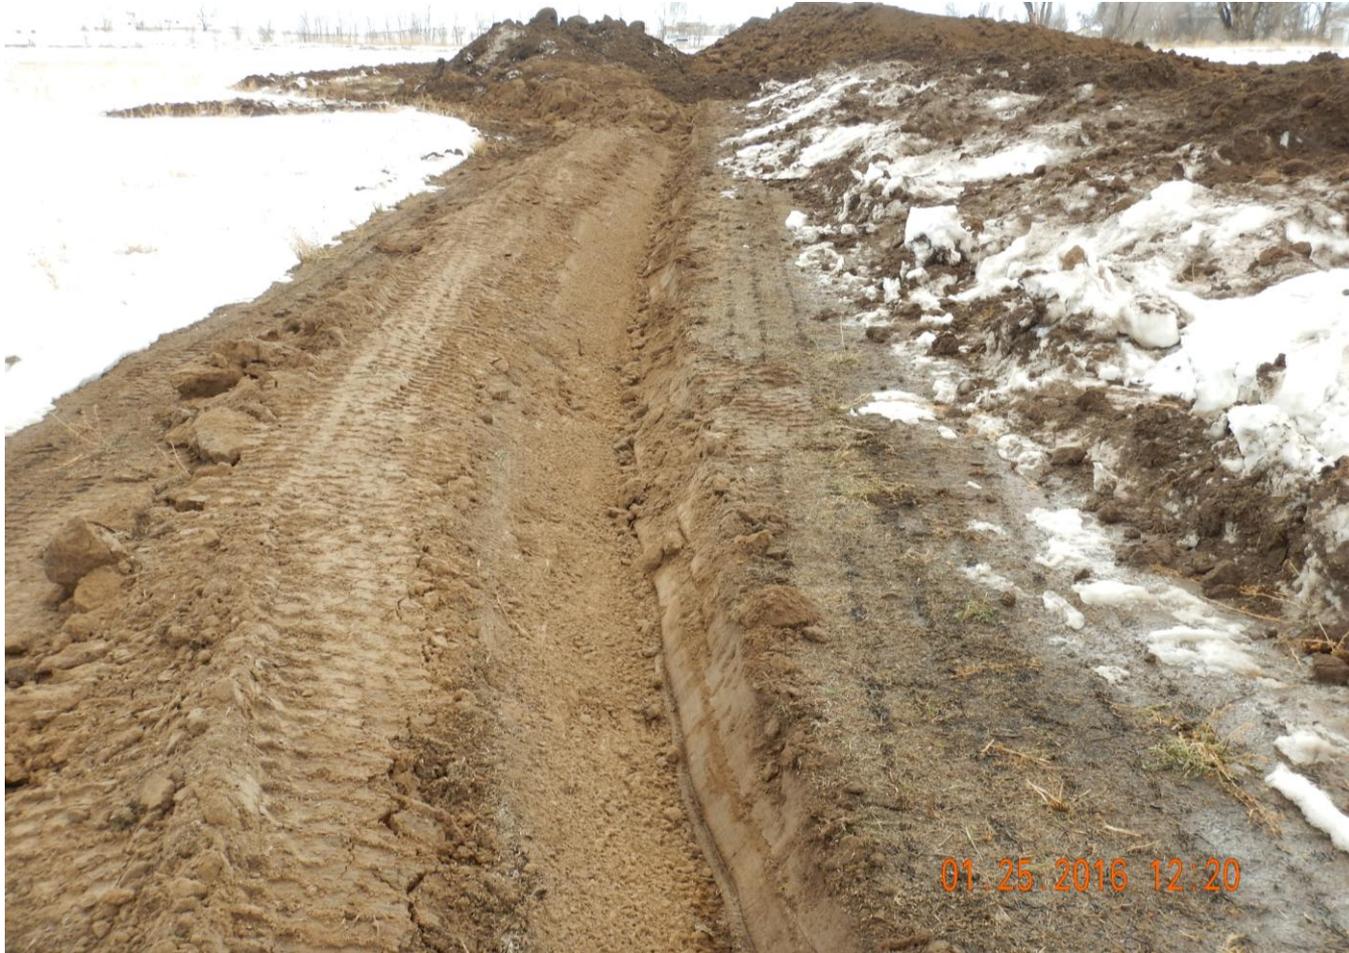
Photo 4. Photo taken from northeast location, facing South. Stormwater and sediment control BMPs installed before construction.

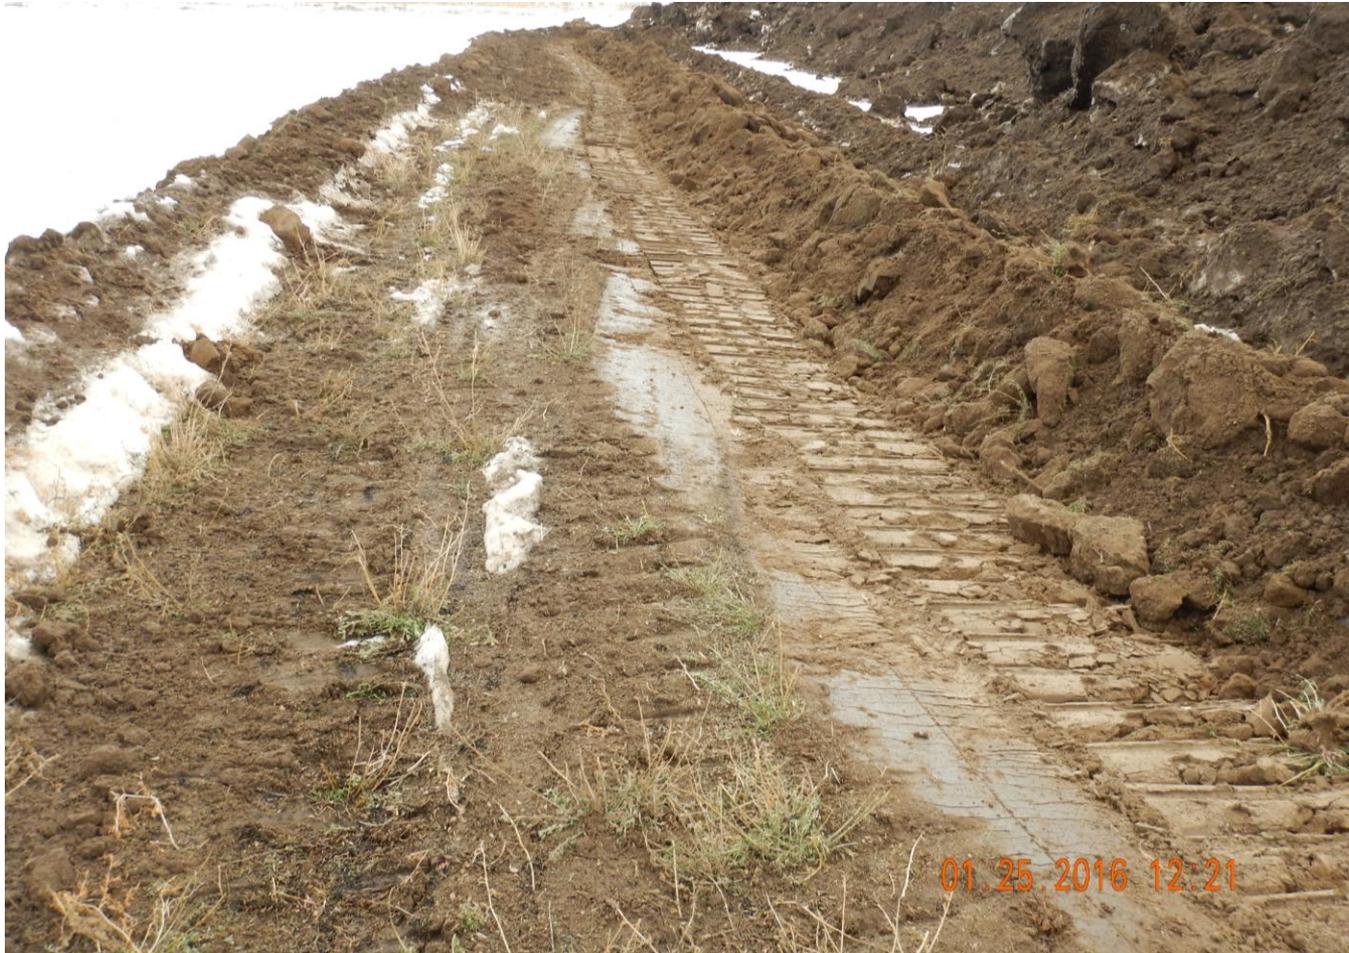
Photo 5. Photo taken from eastern location, facing South. Stormwater and sediment control BMPs installed before construction.

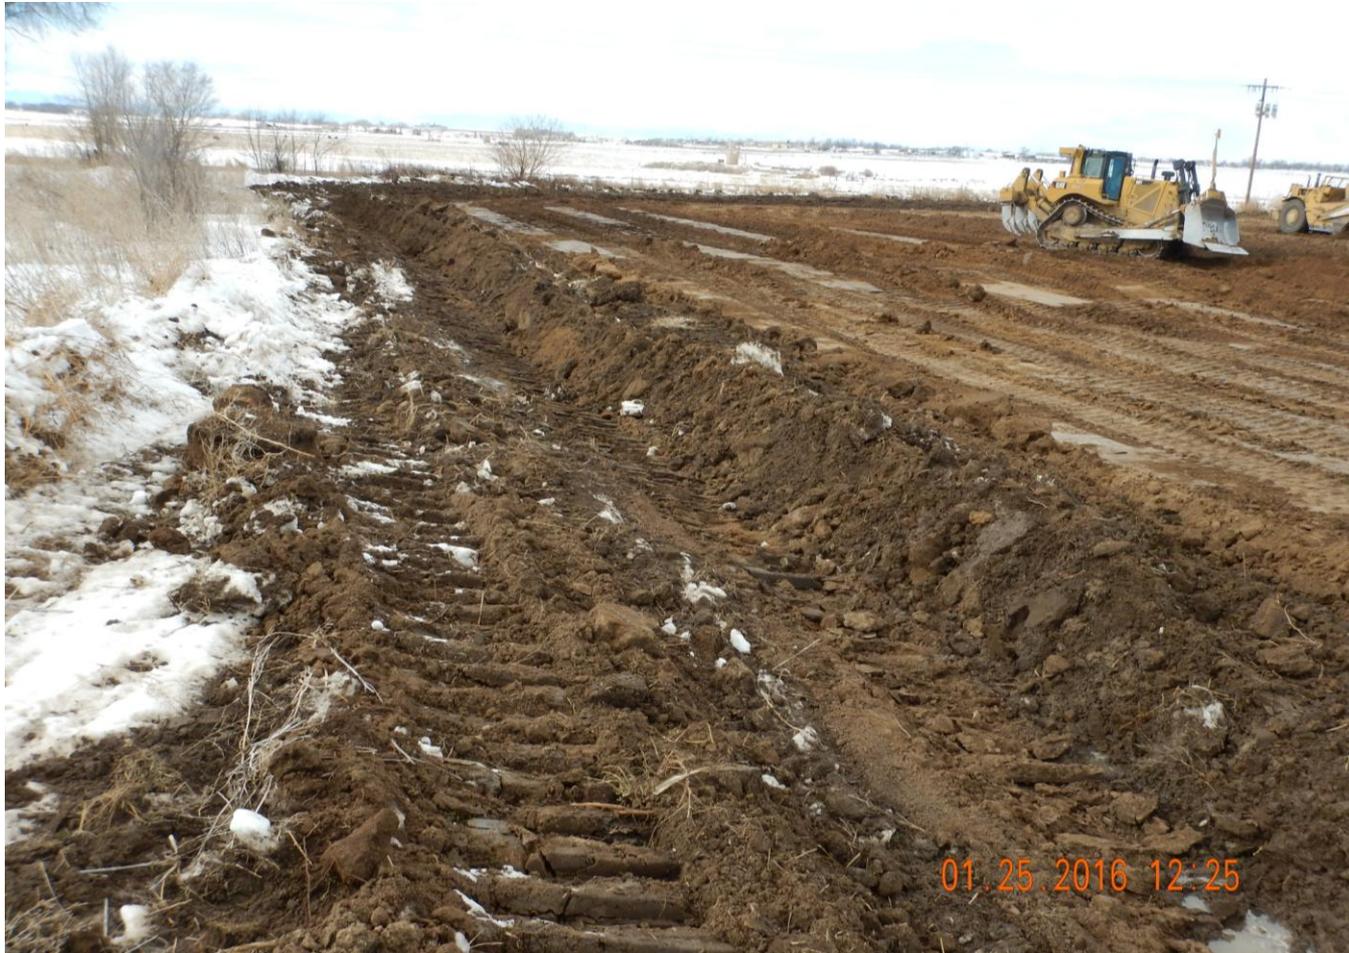
Photo 6. Photo taken from southern location, facing West. Stormwater and sediment control BMPs installed before construction.

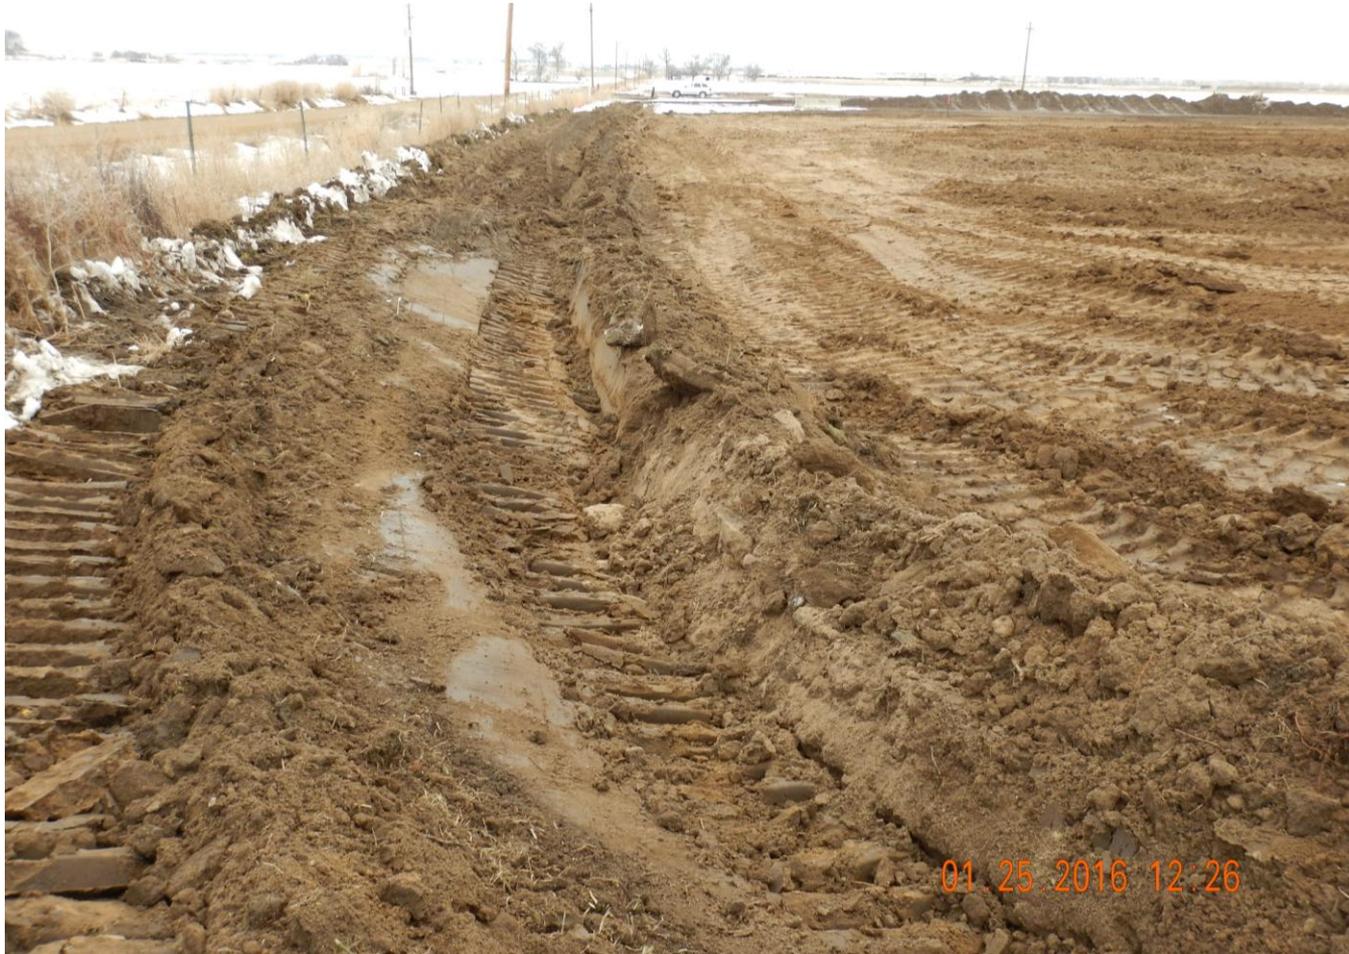
Photo 7. Photo taken from southwest location, facing North. Stormwater and sediment control BMPs installed before construction.

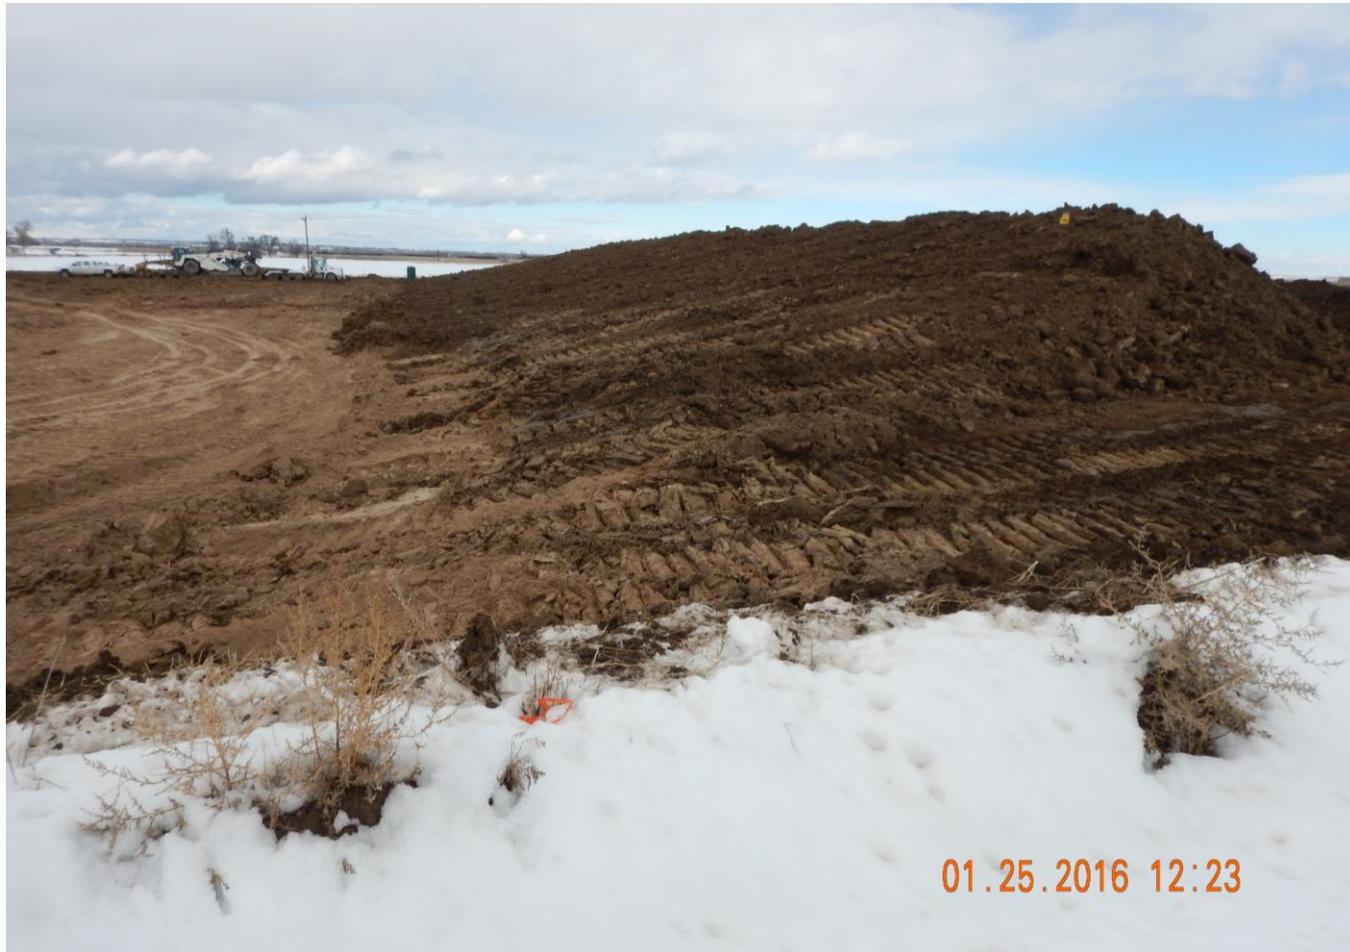
Photo 8. Photo taken from southern location, facing North. Topsoil salvage in process. Need to stabilize topsoil stockpile upon completion of topsoil separation.
