Abandoned Location Inspection

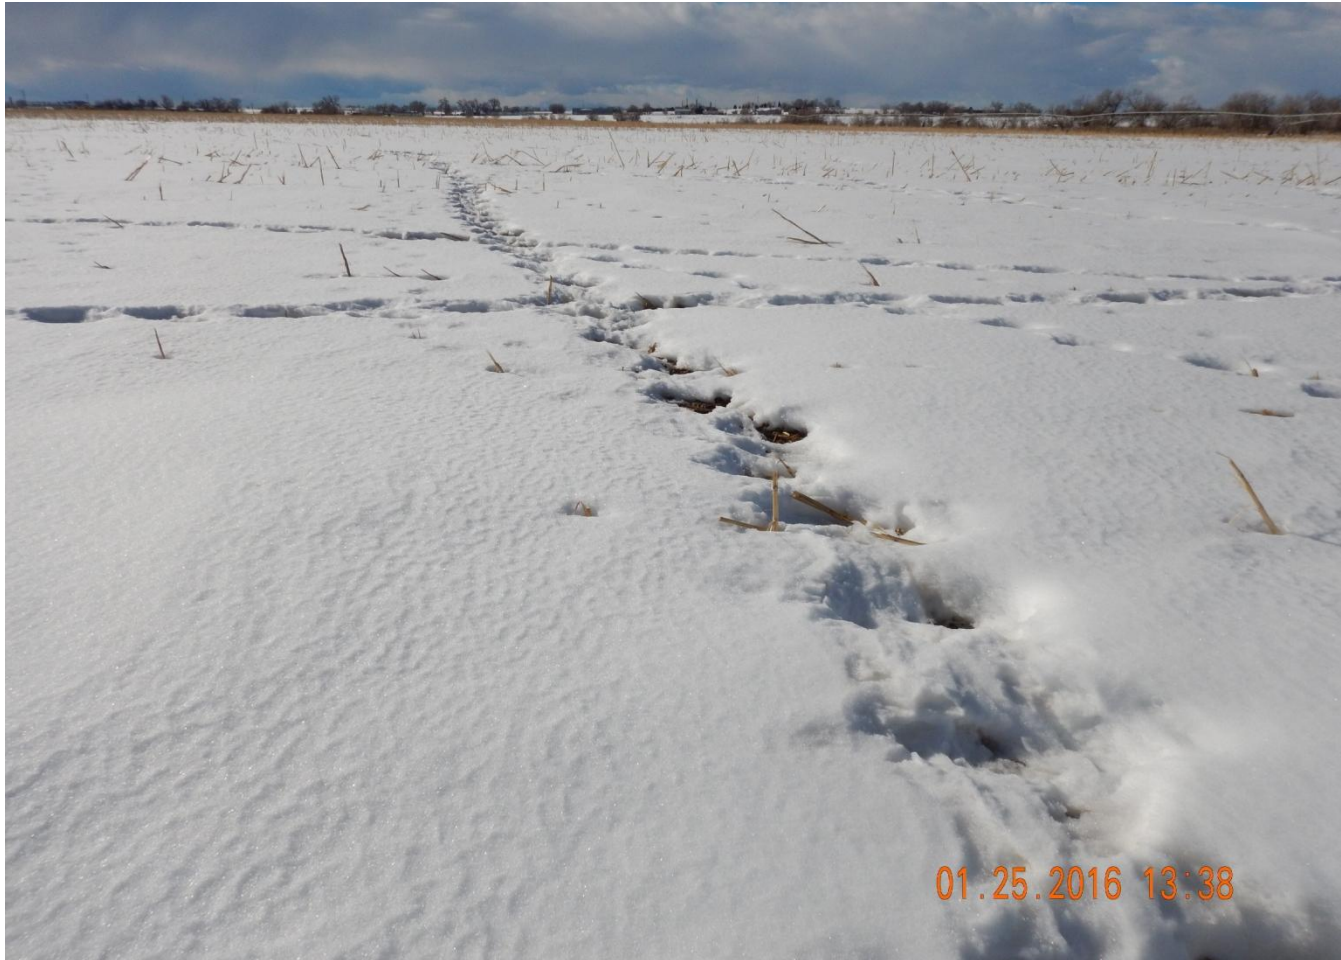
Photo 1. Photo taken from center of location, facing West. It appears the location was never built.

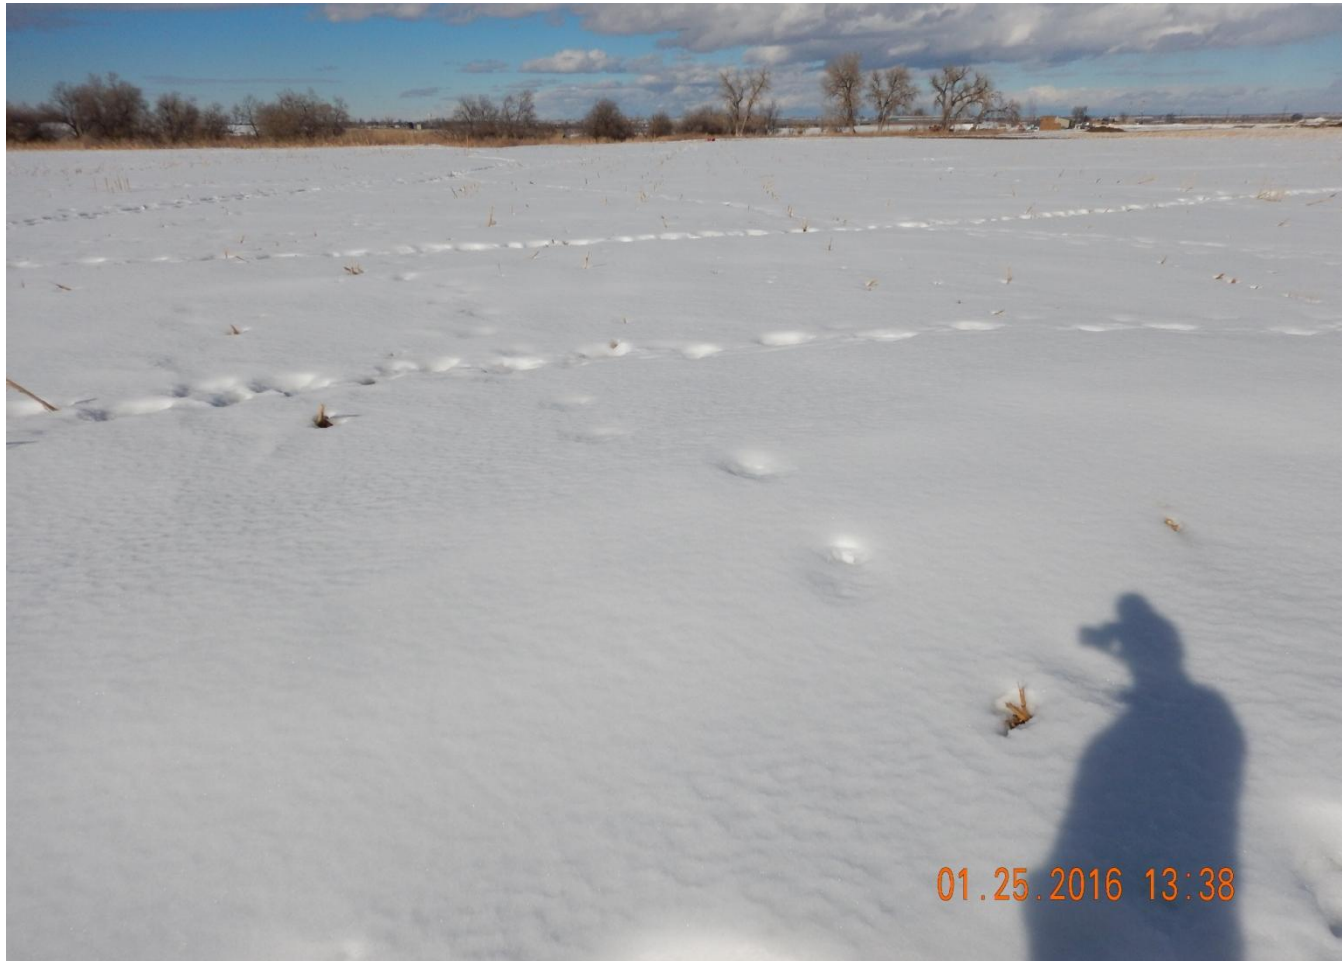
Photo 2. Photo taken from center of location, facing North. It appears the location was never built.

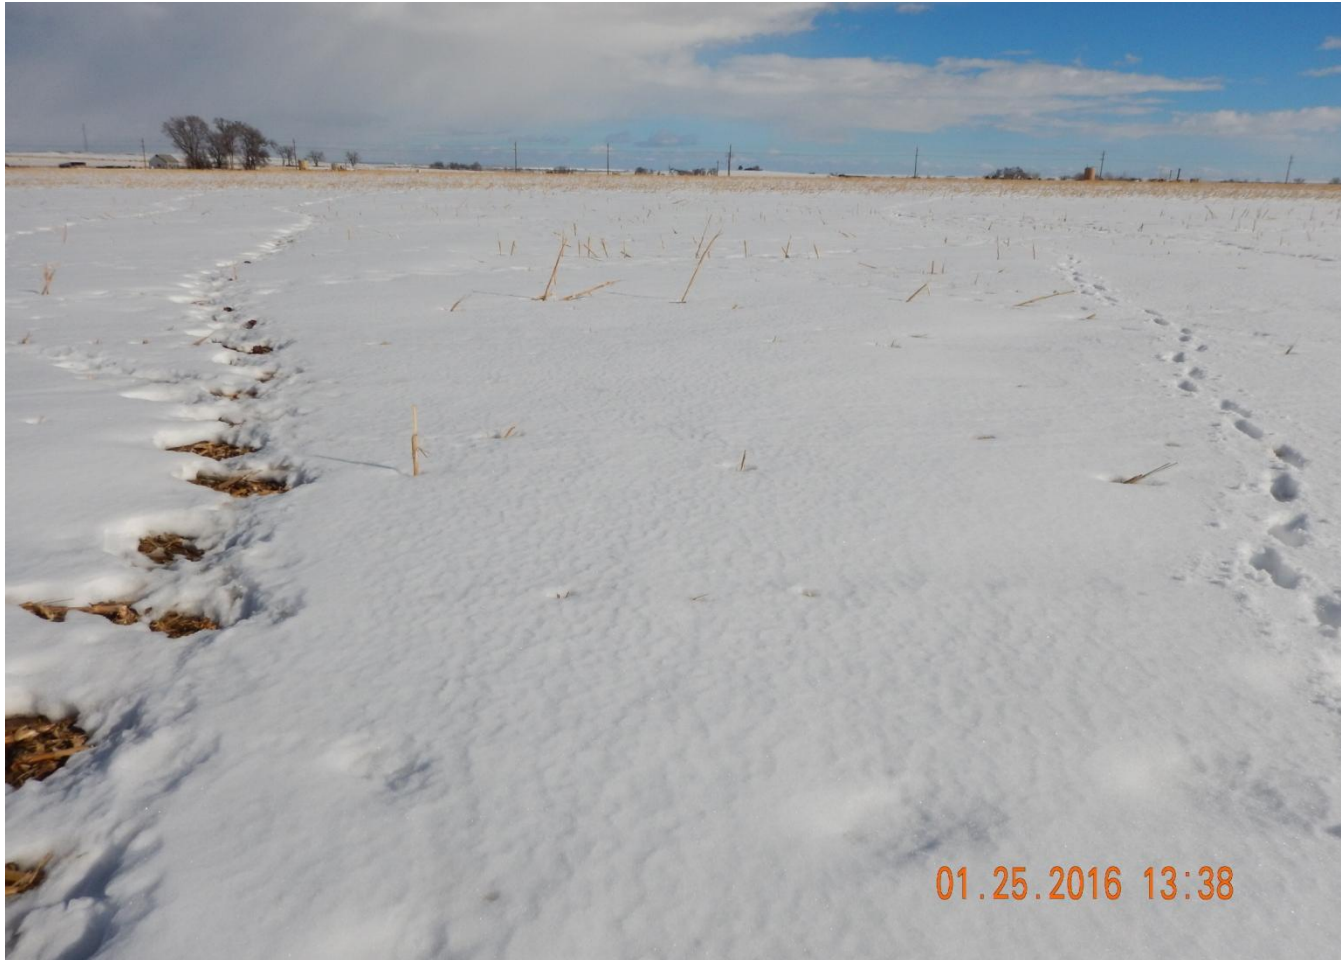
Photo 3. Photo taken from center of location, facing East. It appears the location was never built.

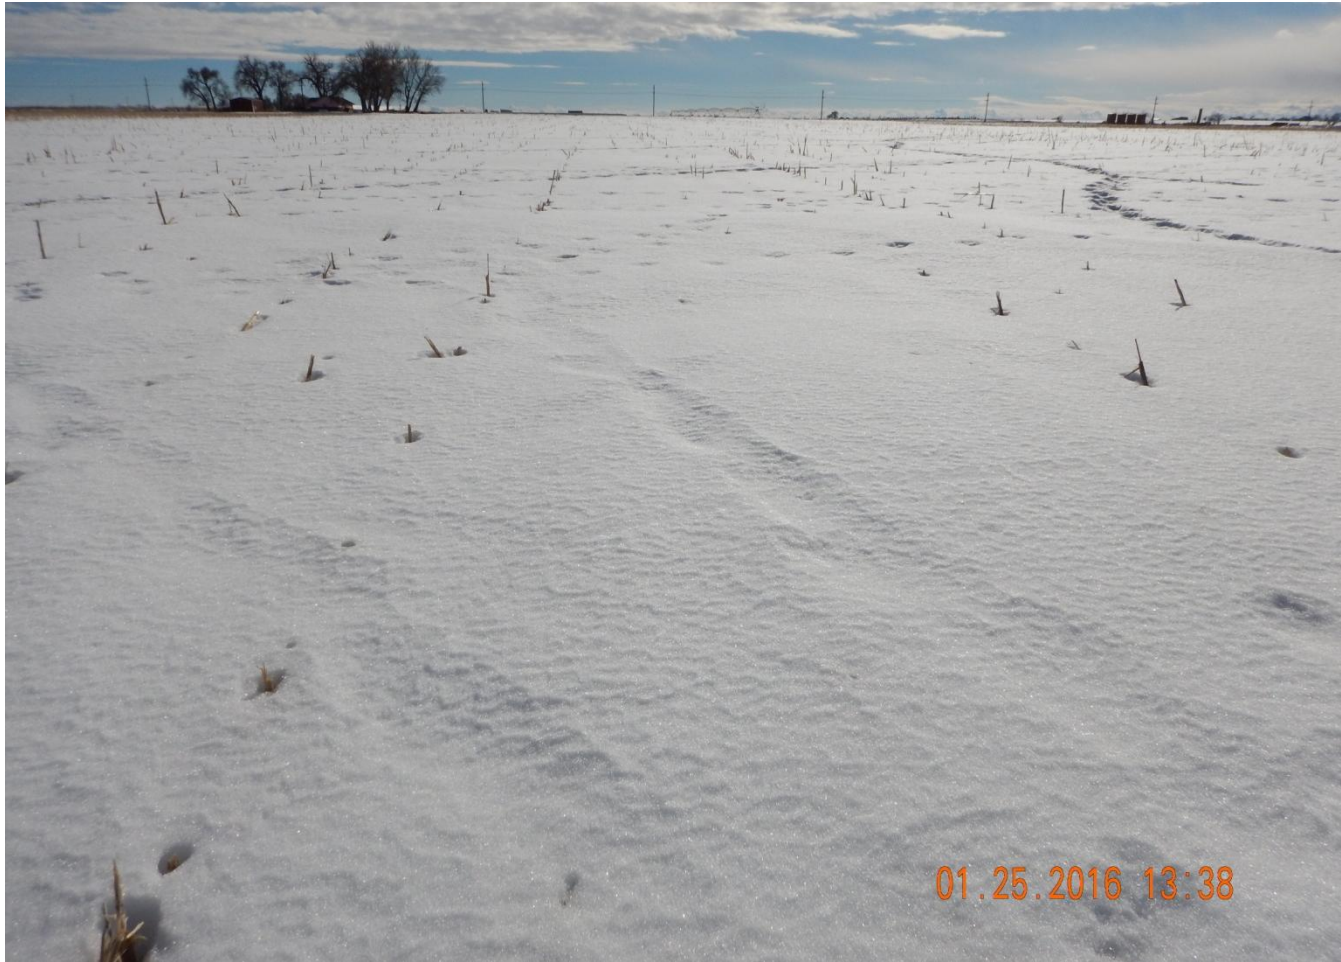
Photo 4. Photo taken from center of location, facing South. It appears the location was never built.

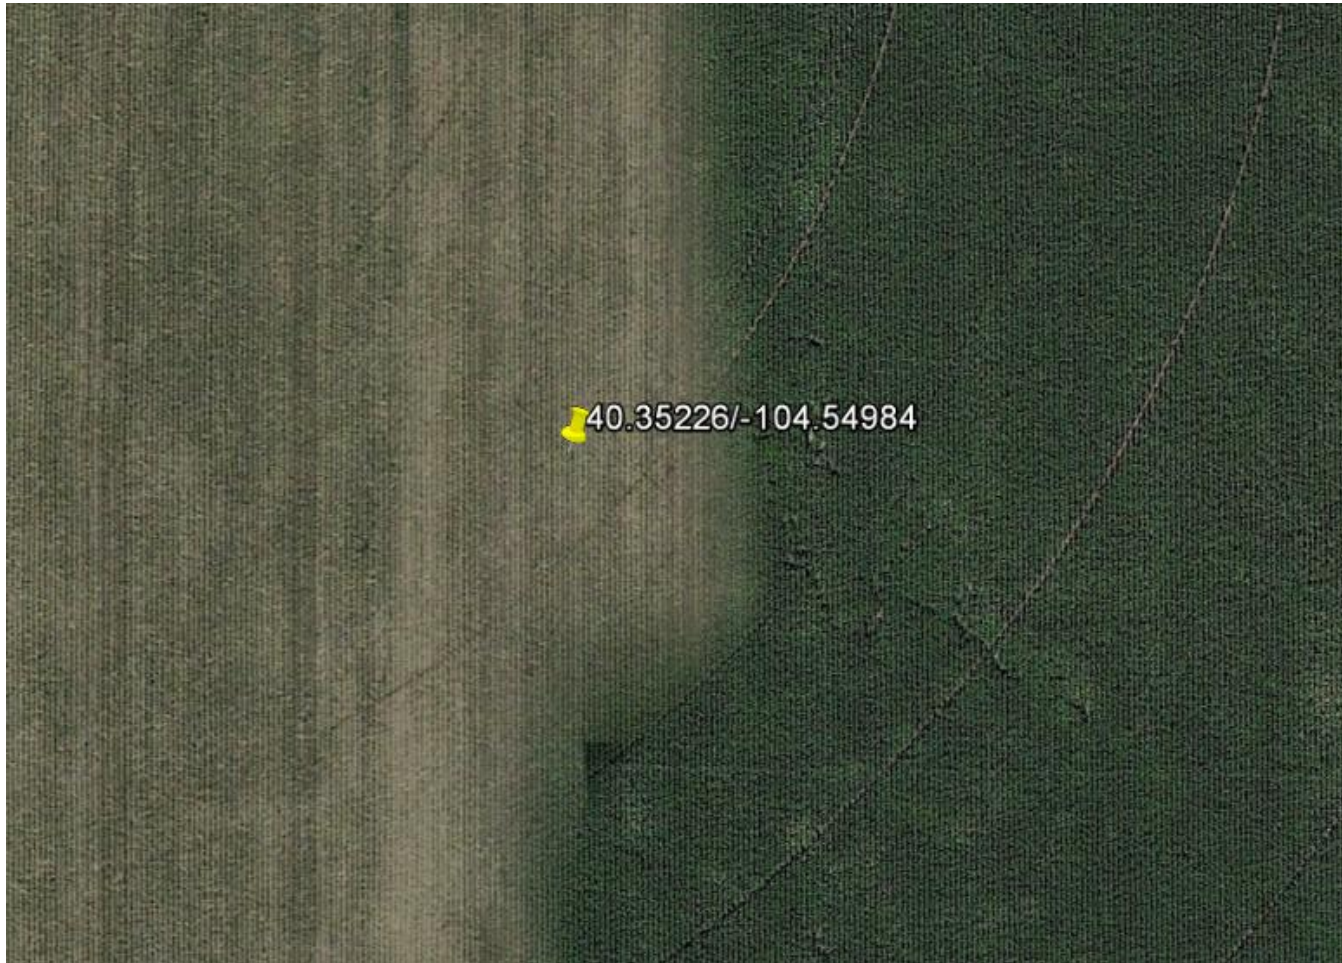
Photo 5. Google Earth aerial photo taken 6/19/2014. It appears the location was never built based off aerial imagery and field observations.
