Construction Inspection

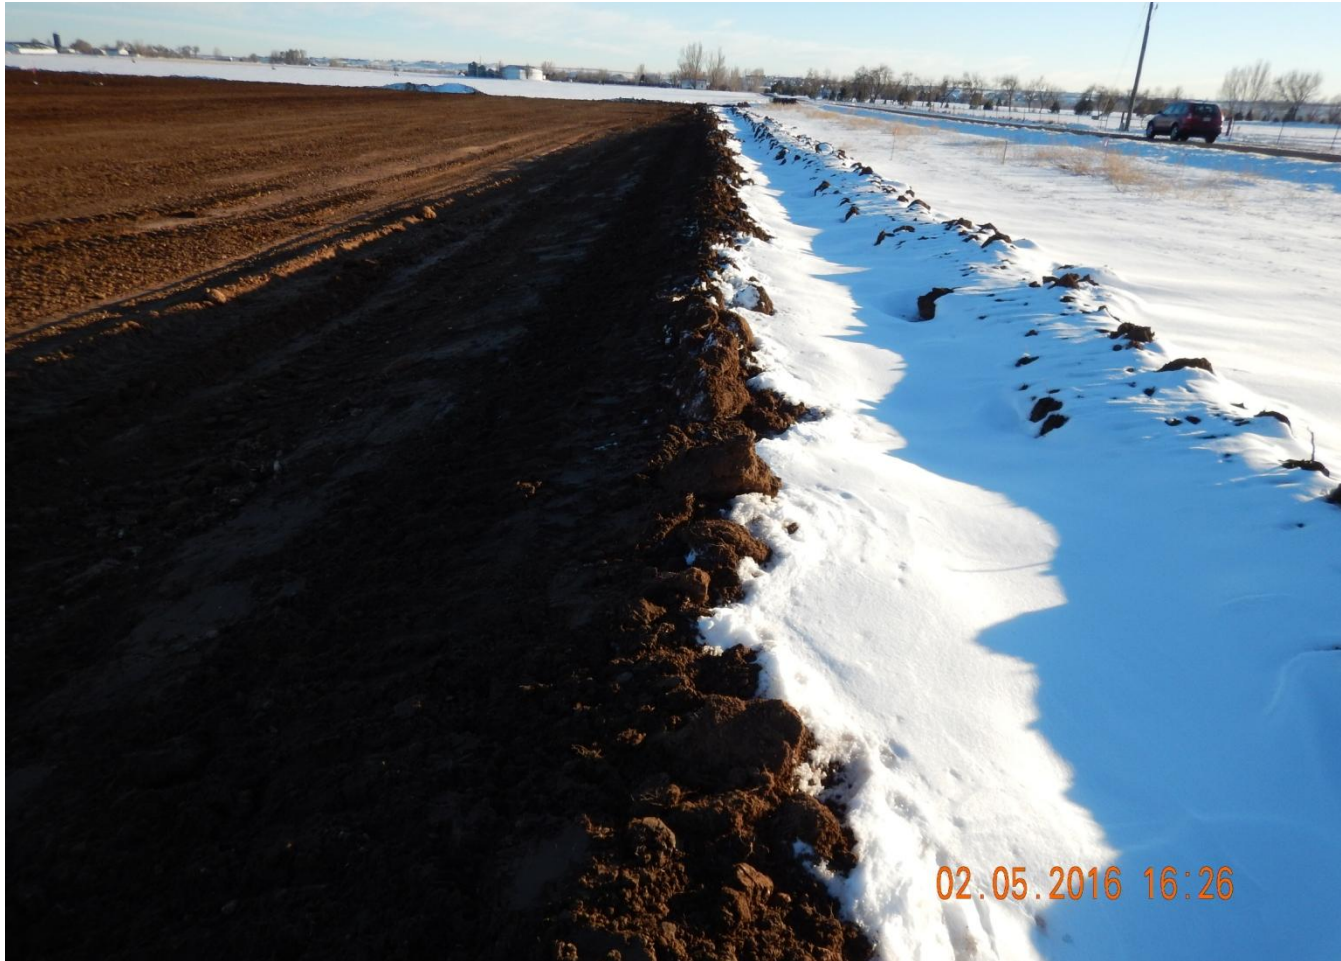
Photo 1. Photo taken from northwest location, facing South. Stormwater and sediment control BMPs installed along perimeter of location.

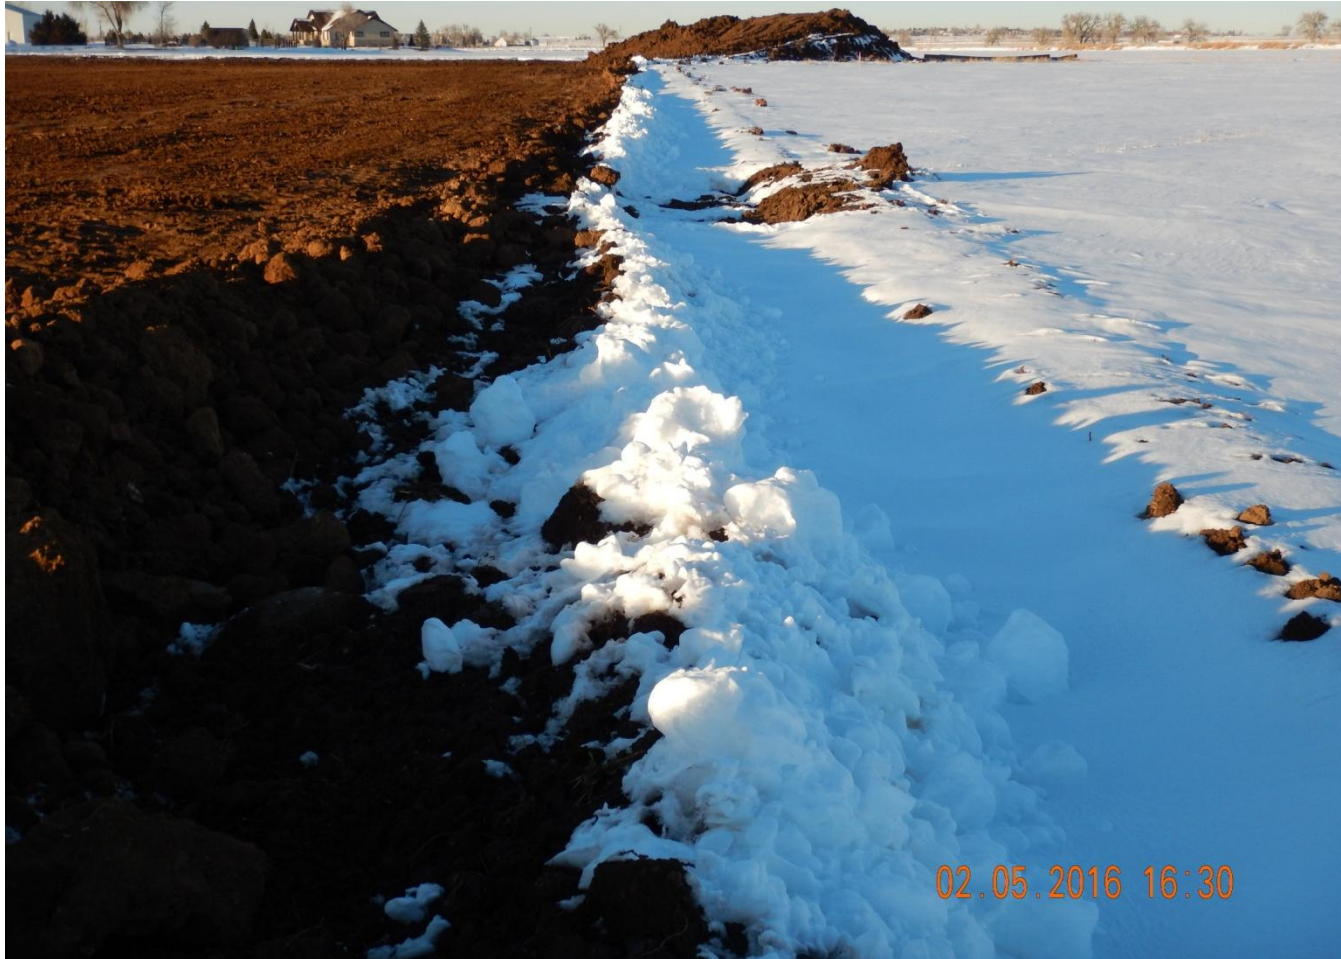
Photo 2. Photo taken from southeast location, facing North. Stormwater and sediment control BMPs installed along perimeter of location.

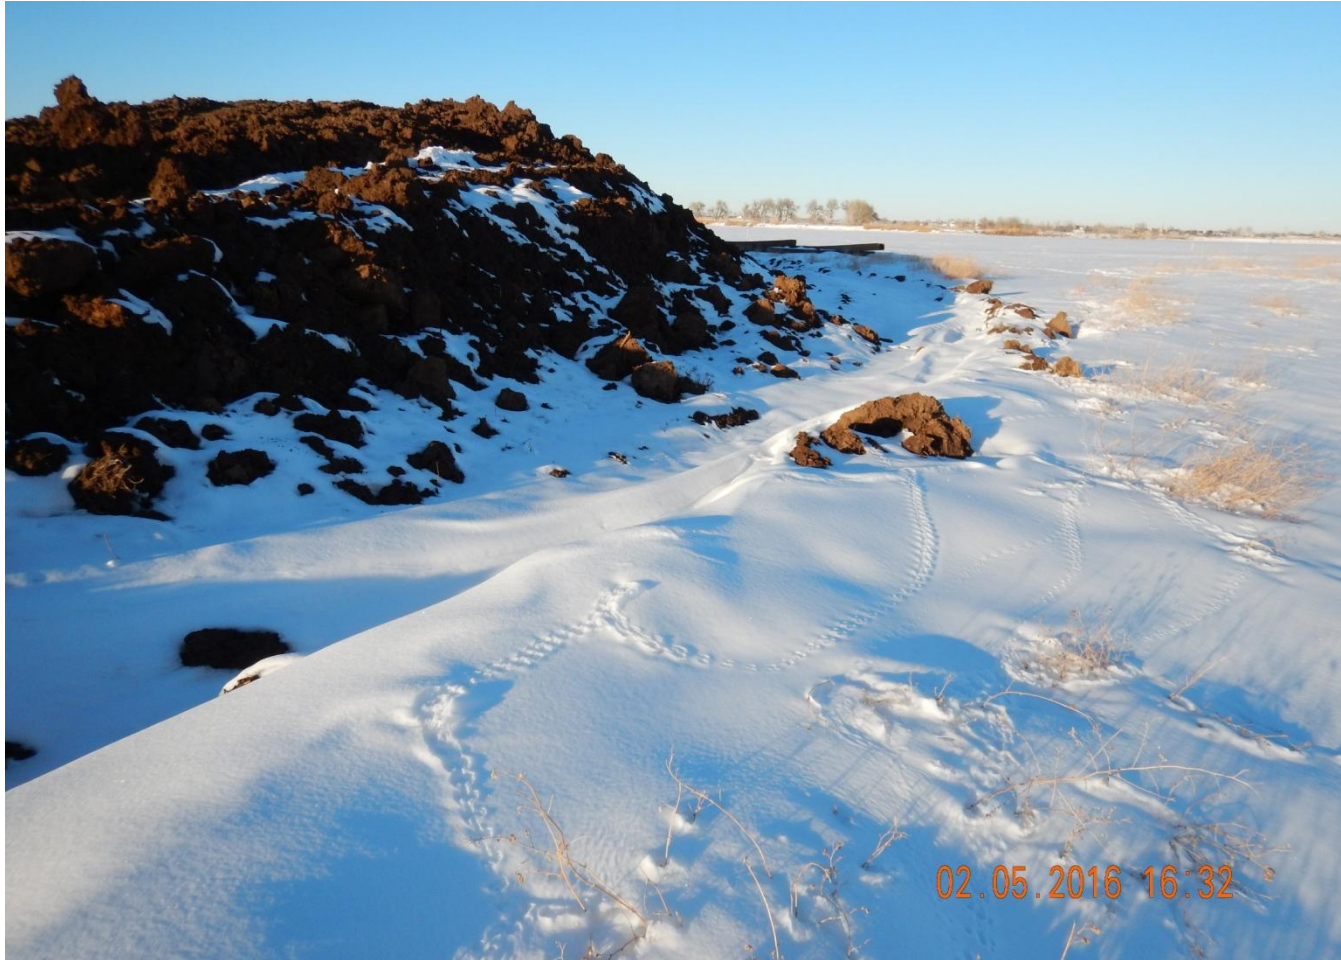
Photo 3. Photo taken from eastern location, facing Northeast. Stormwater and sediment control BMPs installed along perimeter of location.

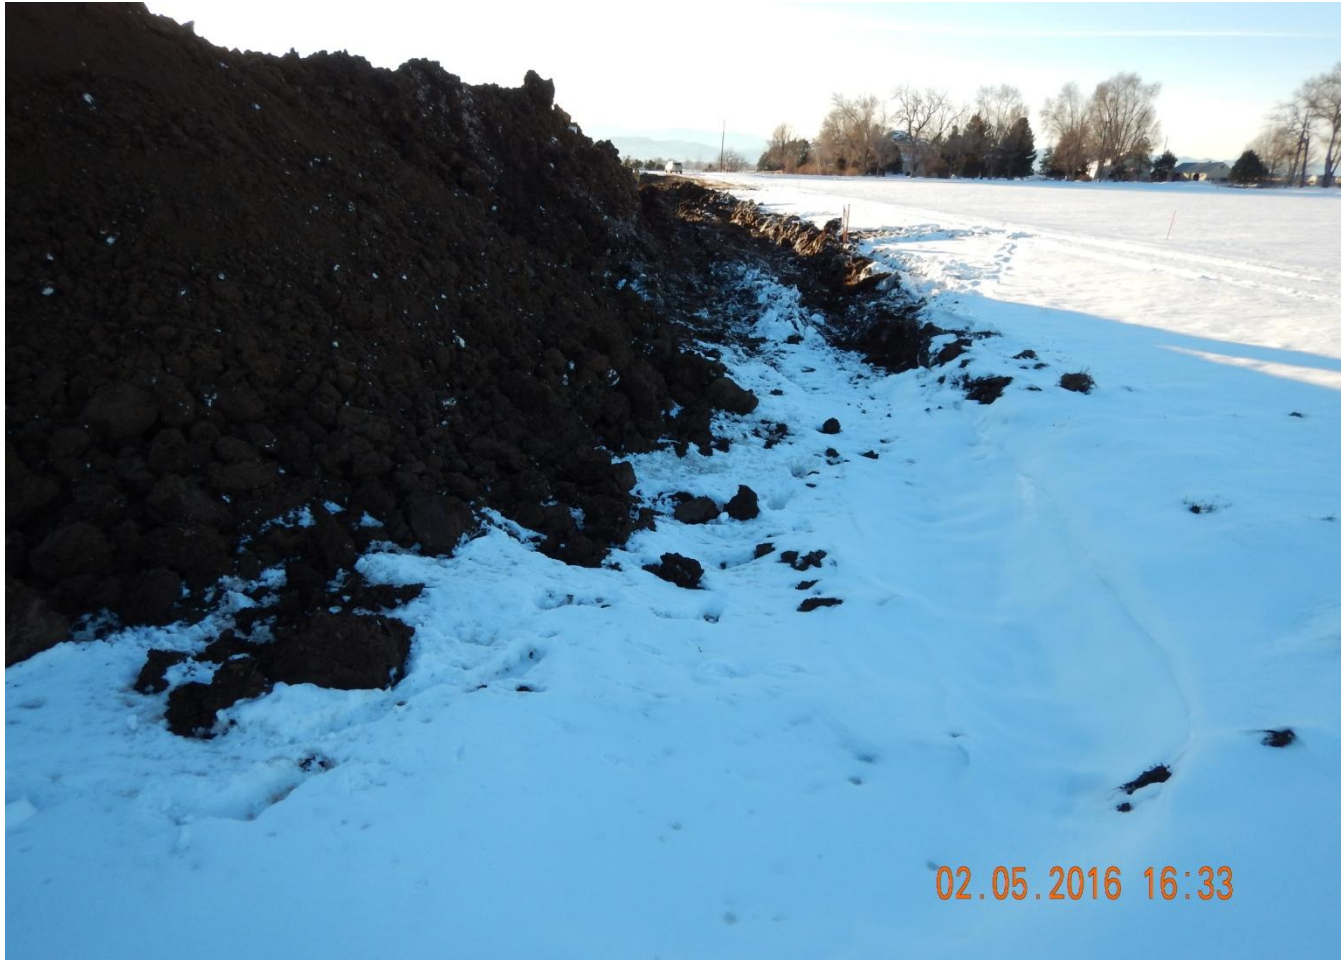
Photo 4. Photo taken from northeast location, facing West. Stormwater and sediment control BMPs installed along perimeter of location. Topsoil stockpile needs to be stabilized upon completion of salvage operations.

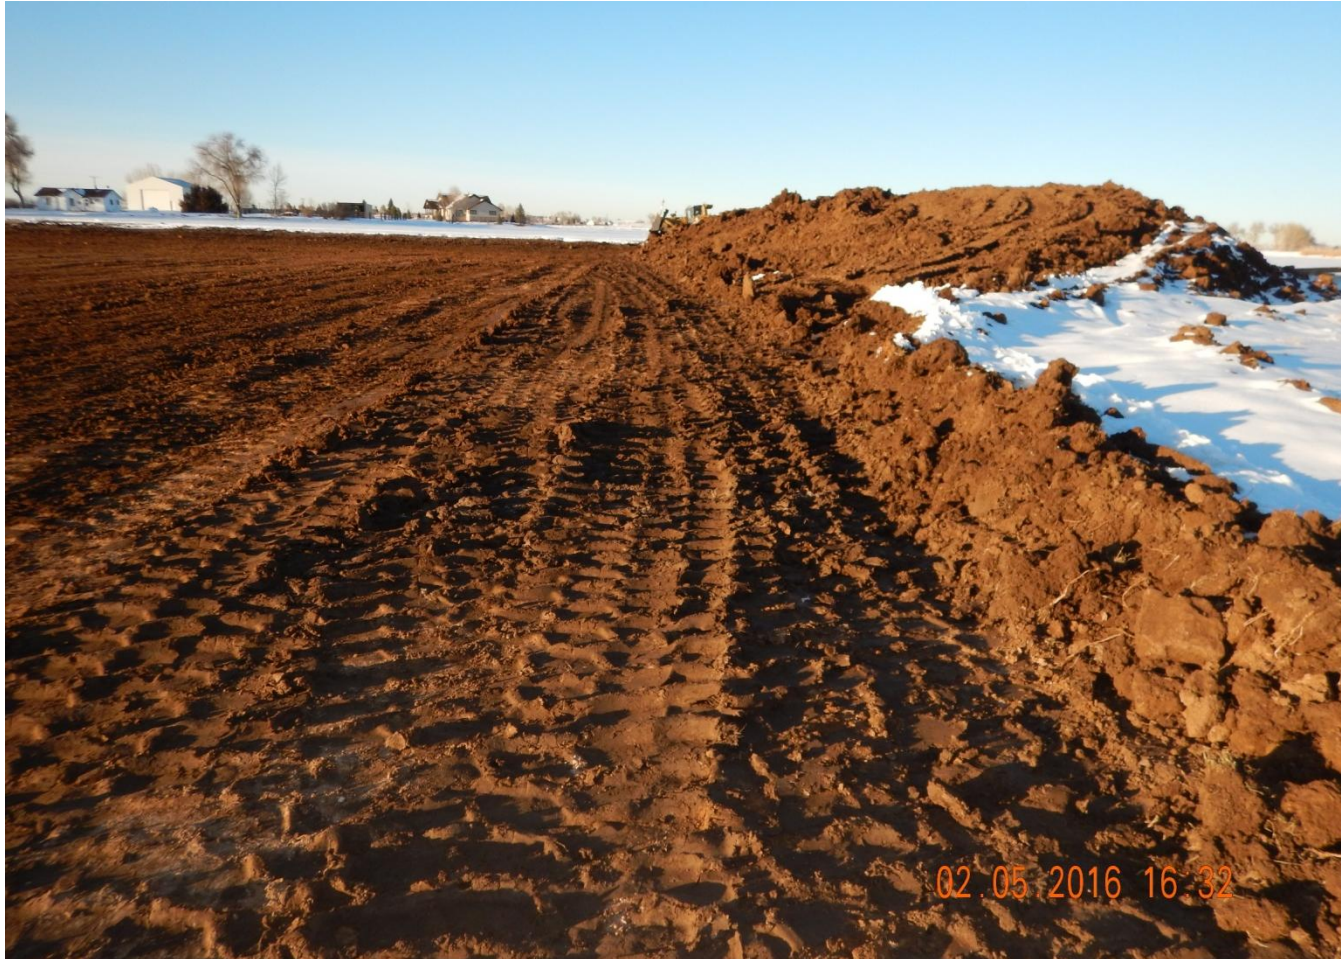
Photo 5. Photo taken from eastern location, facing North. Topsoil stockpile located in center of photo. Topsoil stockpile needs to be stabilized upon completion of salvage operations.
