Interim Reclamation Inspection

2/9/2016

Operator: Whiting Oil and Gas

Location ID: 431632

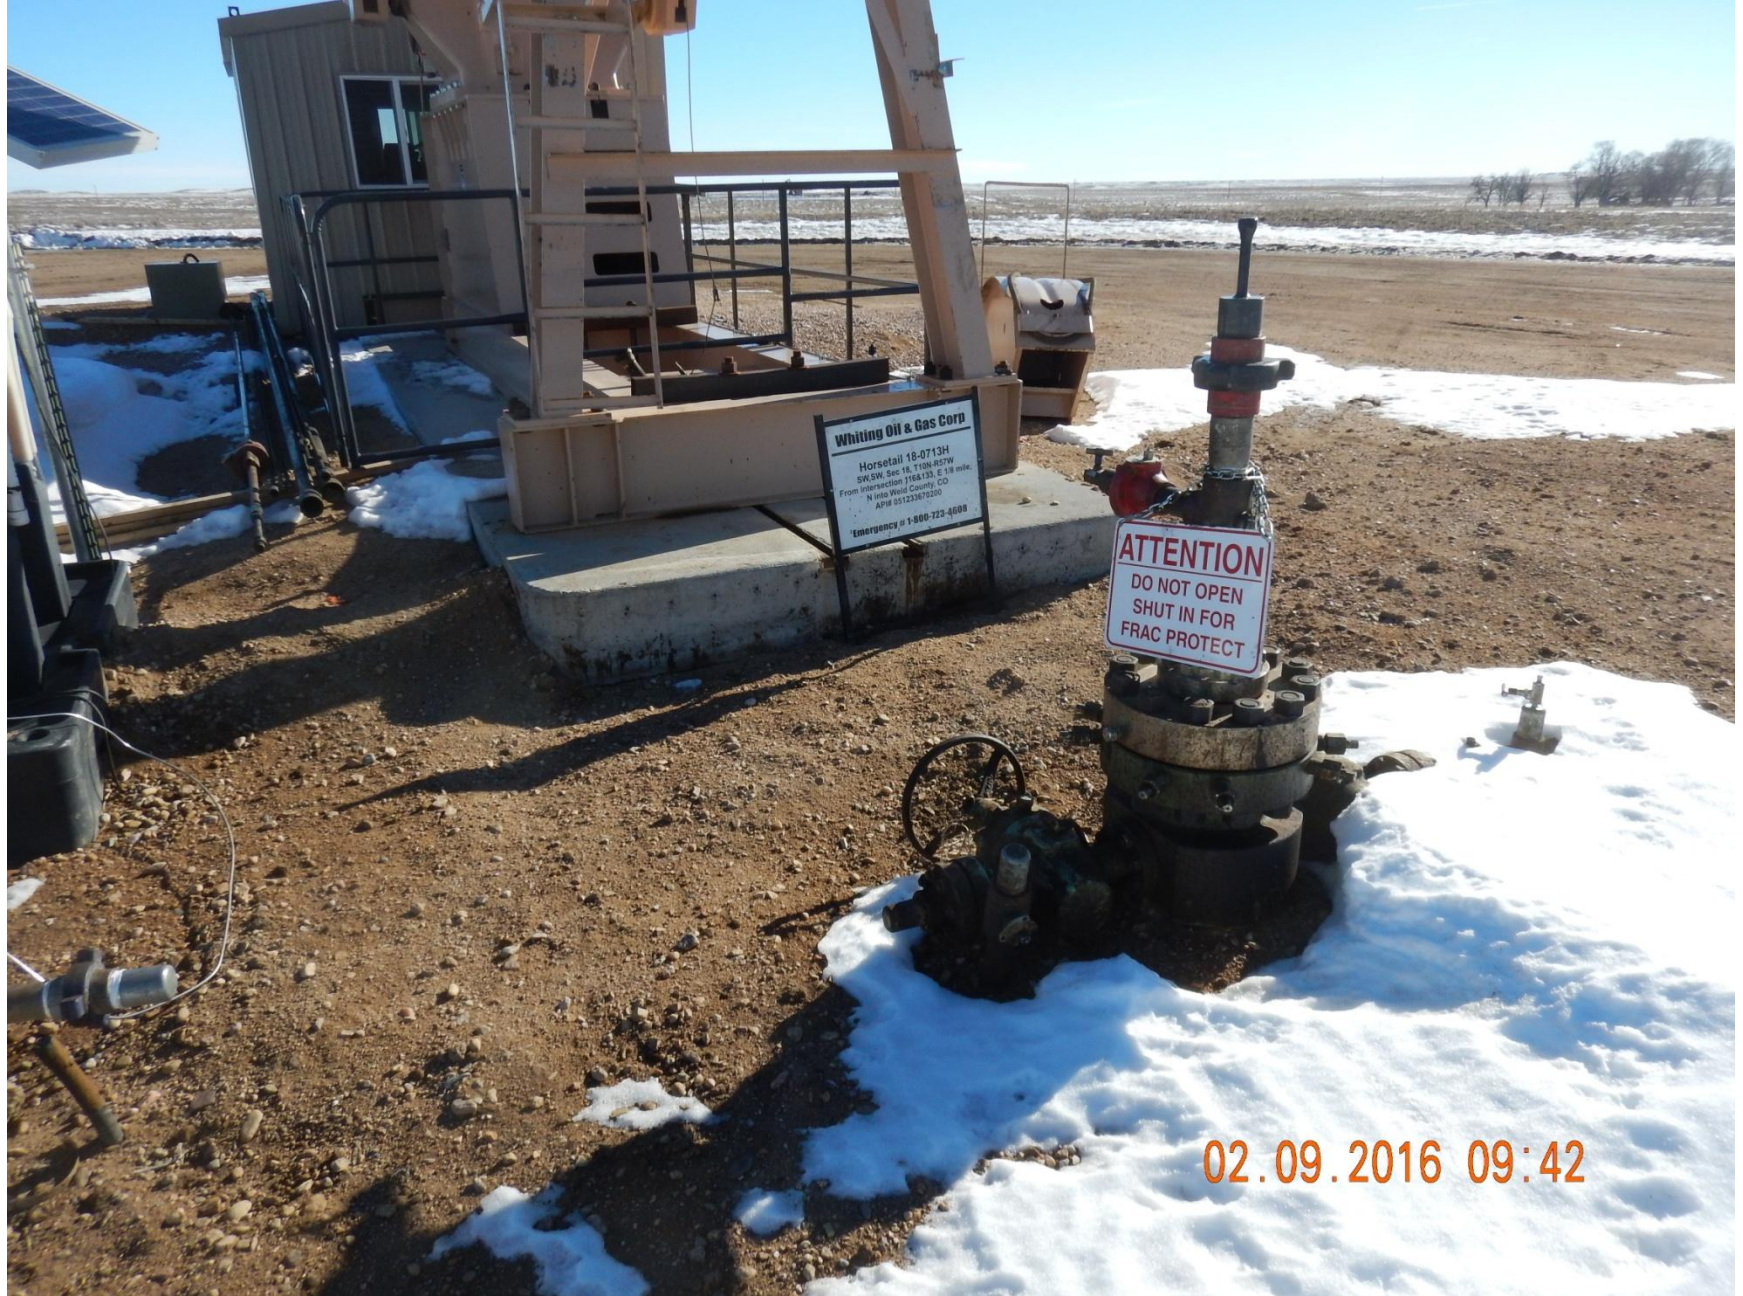
Figure 1: Photo taken from well head, facing east. Photo of well and sign.

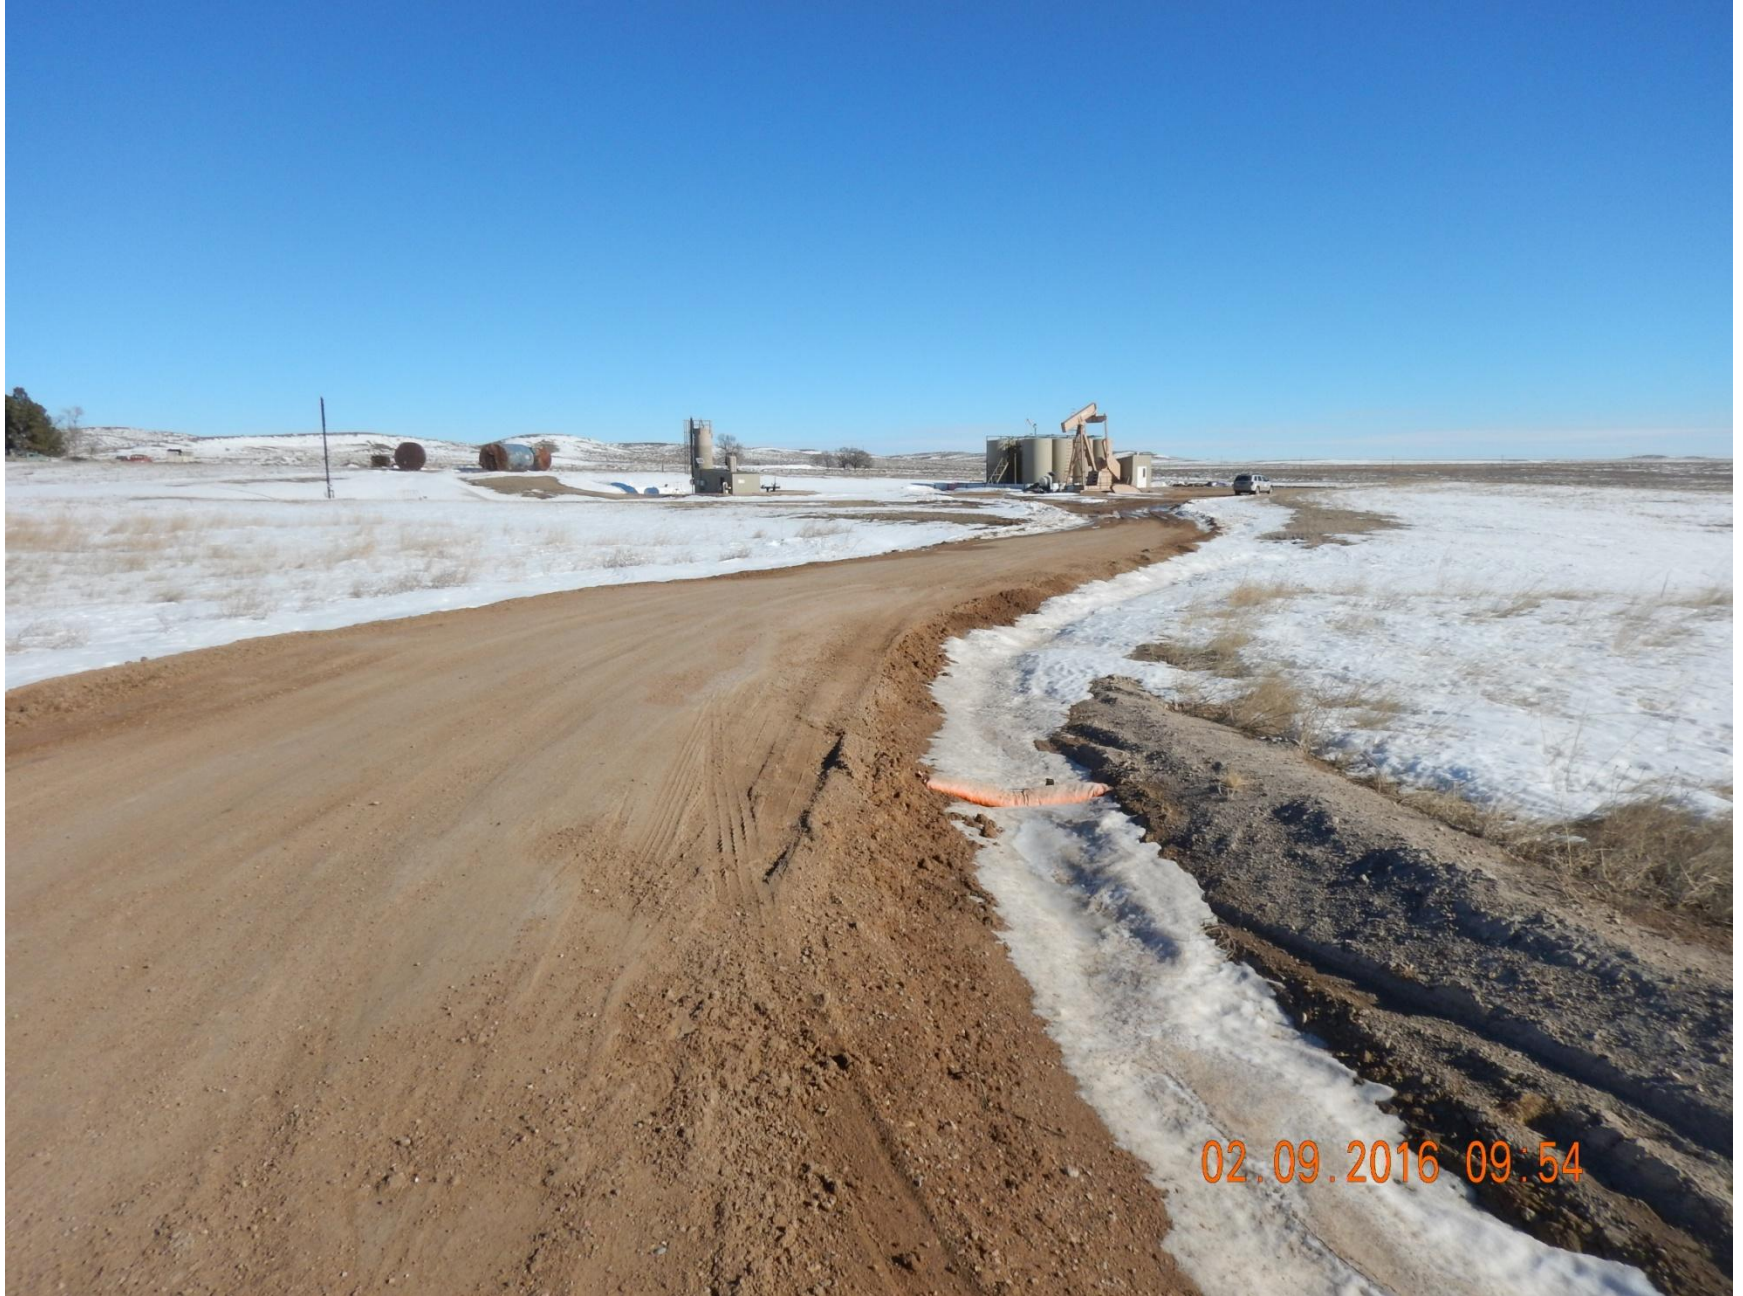
Figure 2: Photo taken from access road south of location, facing north. Photo of location, interim area and stormwater controls.

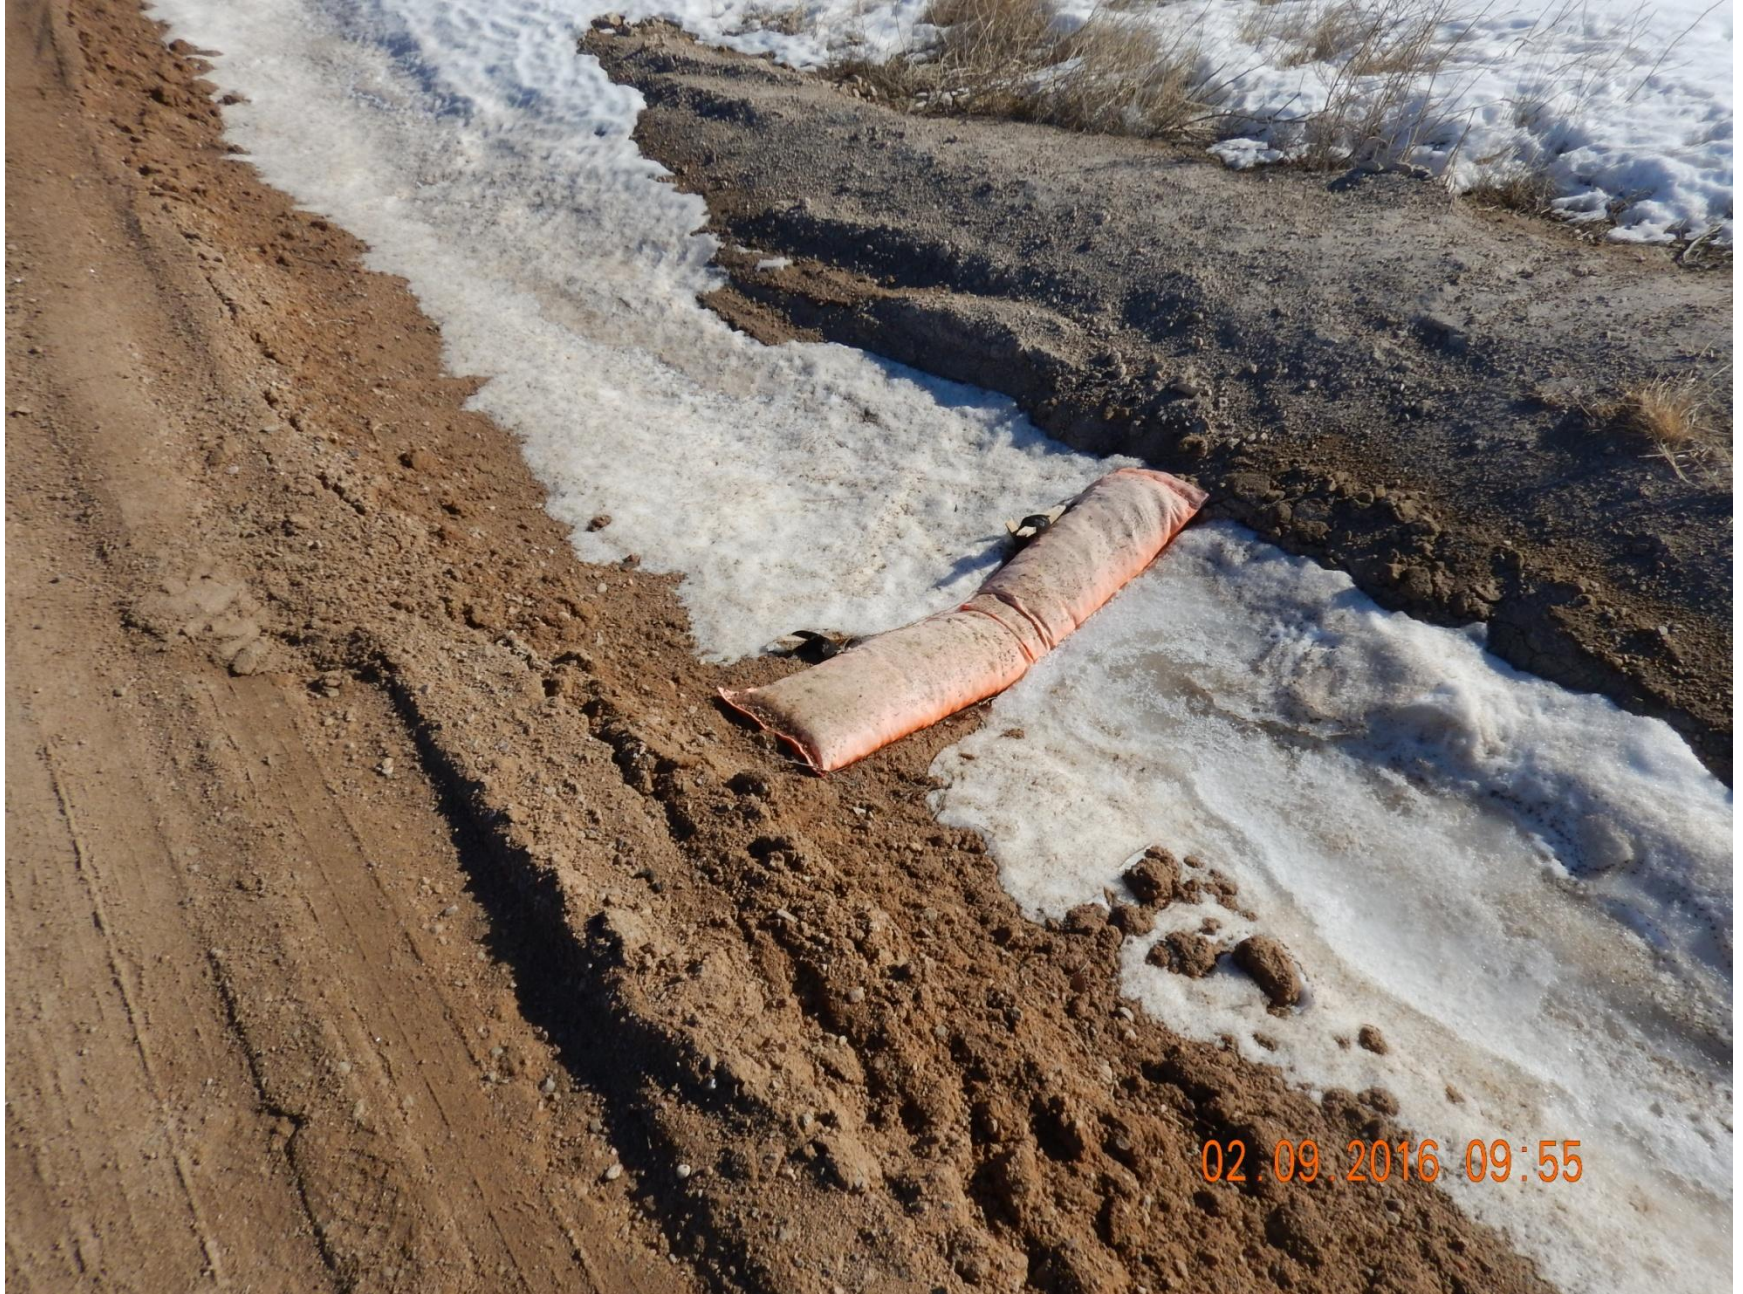
Figure 3: Photo taken from access road south of location. Photo of stormwater control.

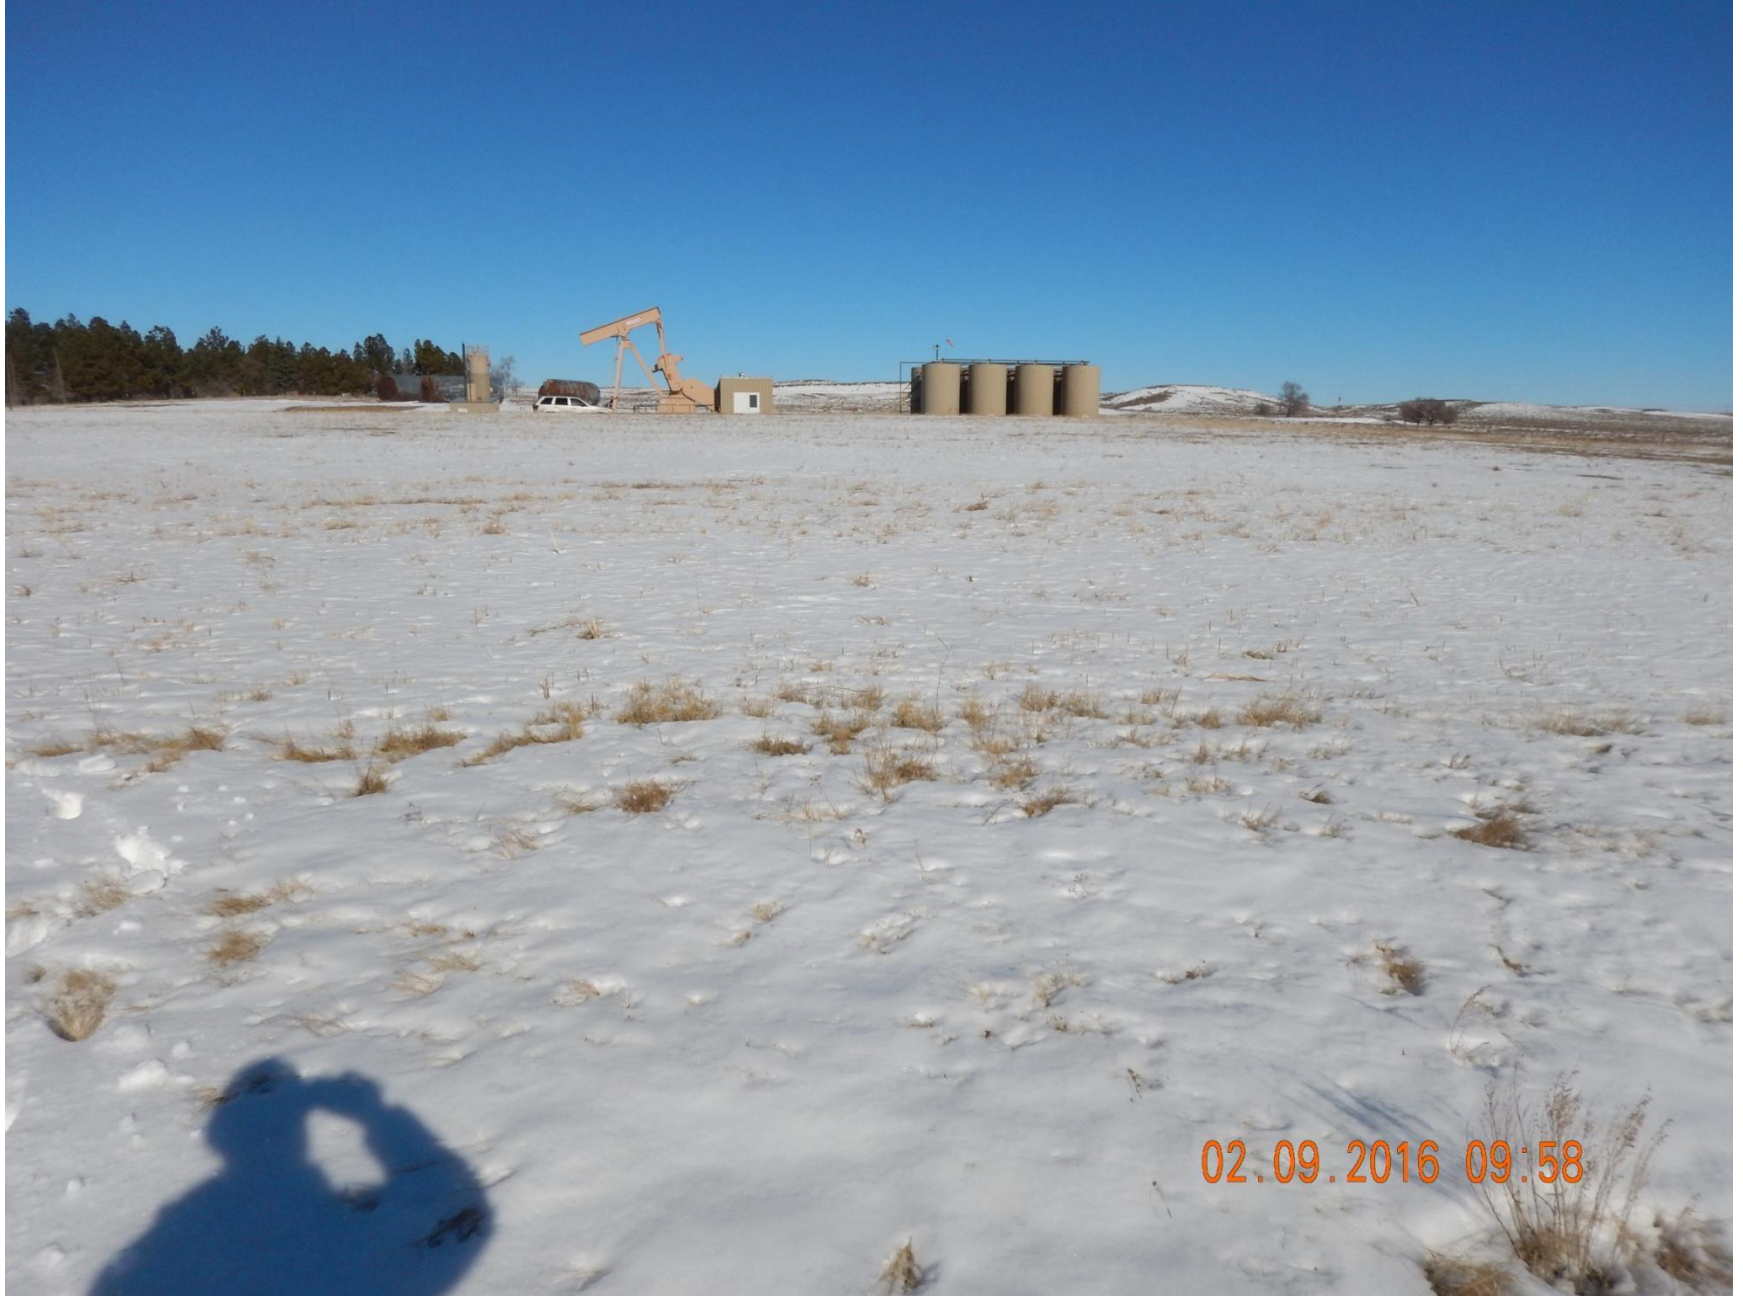
Figure 4: Photo taken from south end of location, facing north. Photo shows interim and project area.

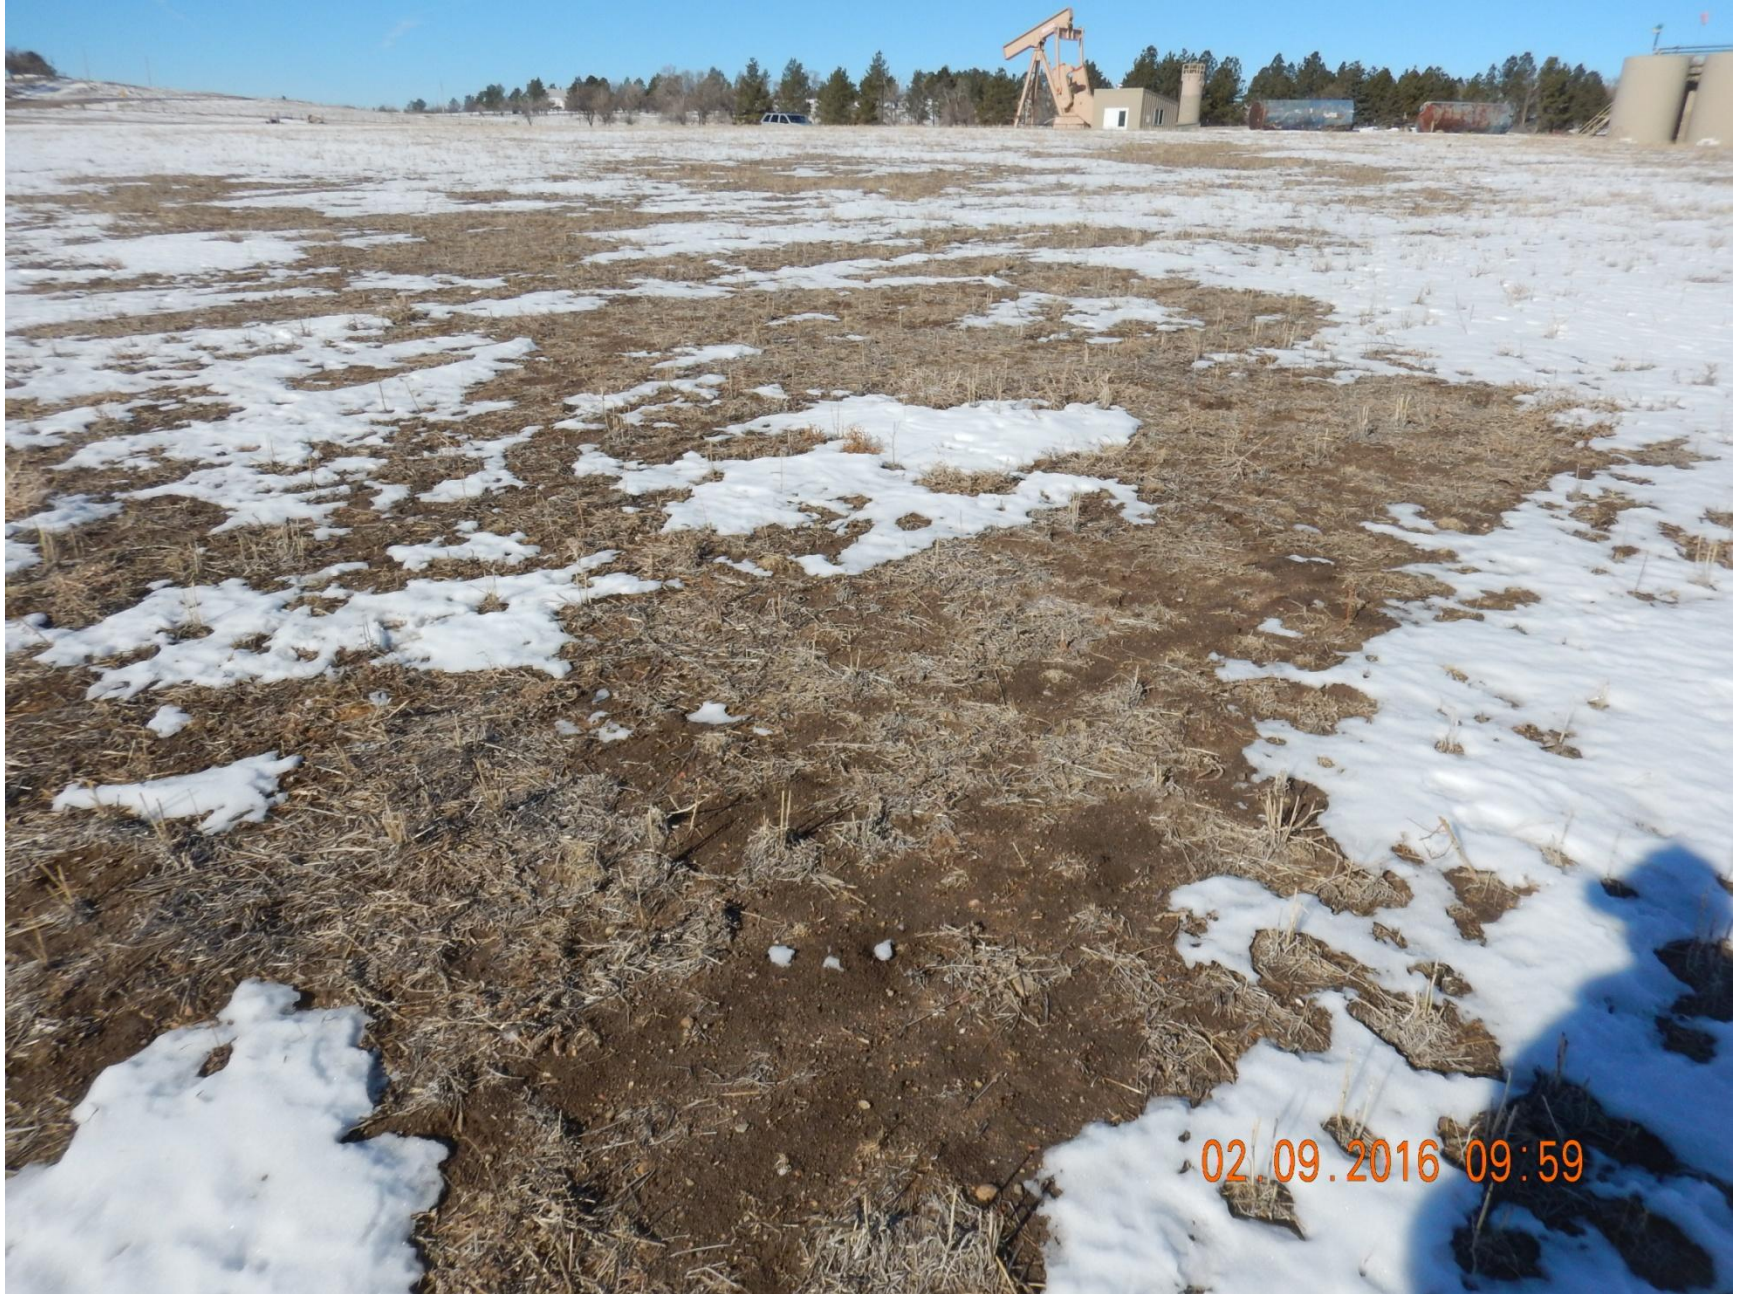
Figure 5: Photo taken from southeast end of location, facing west. Photo shows vegetation on interim area. Eastern portions of interim area dominated by undesirable weedy vegetation.

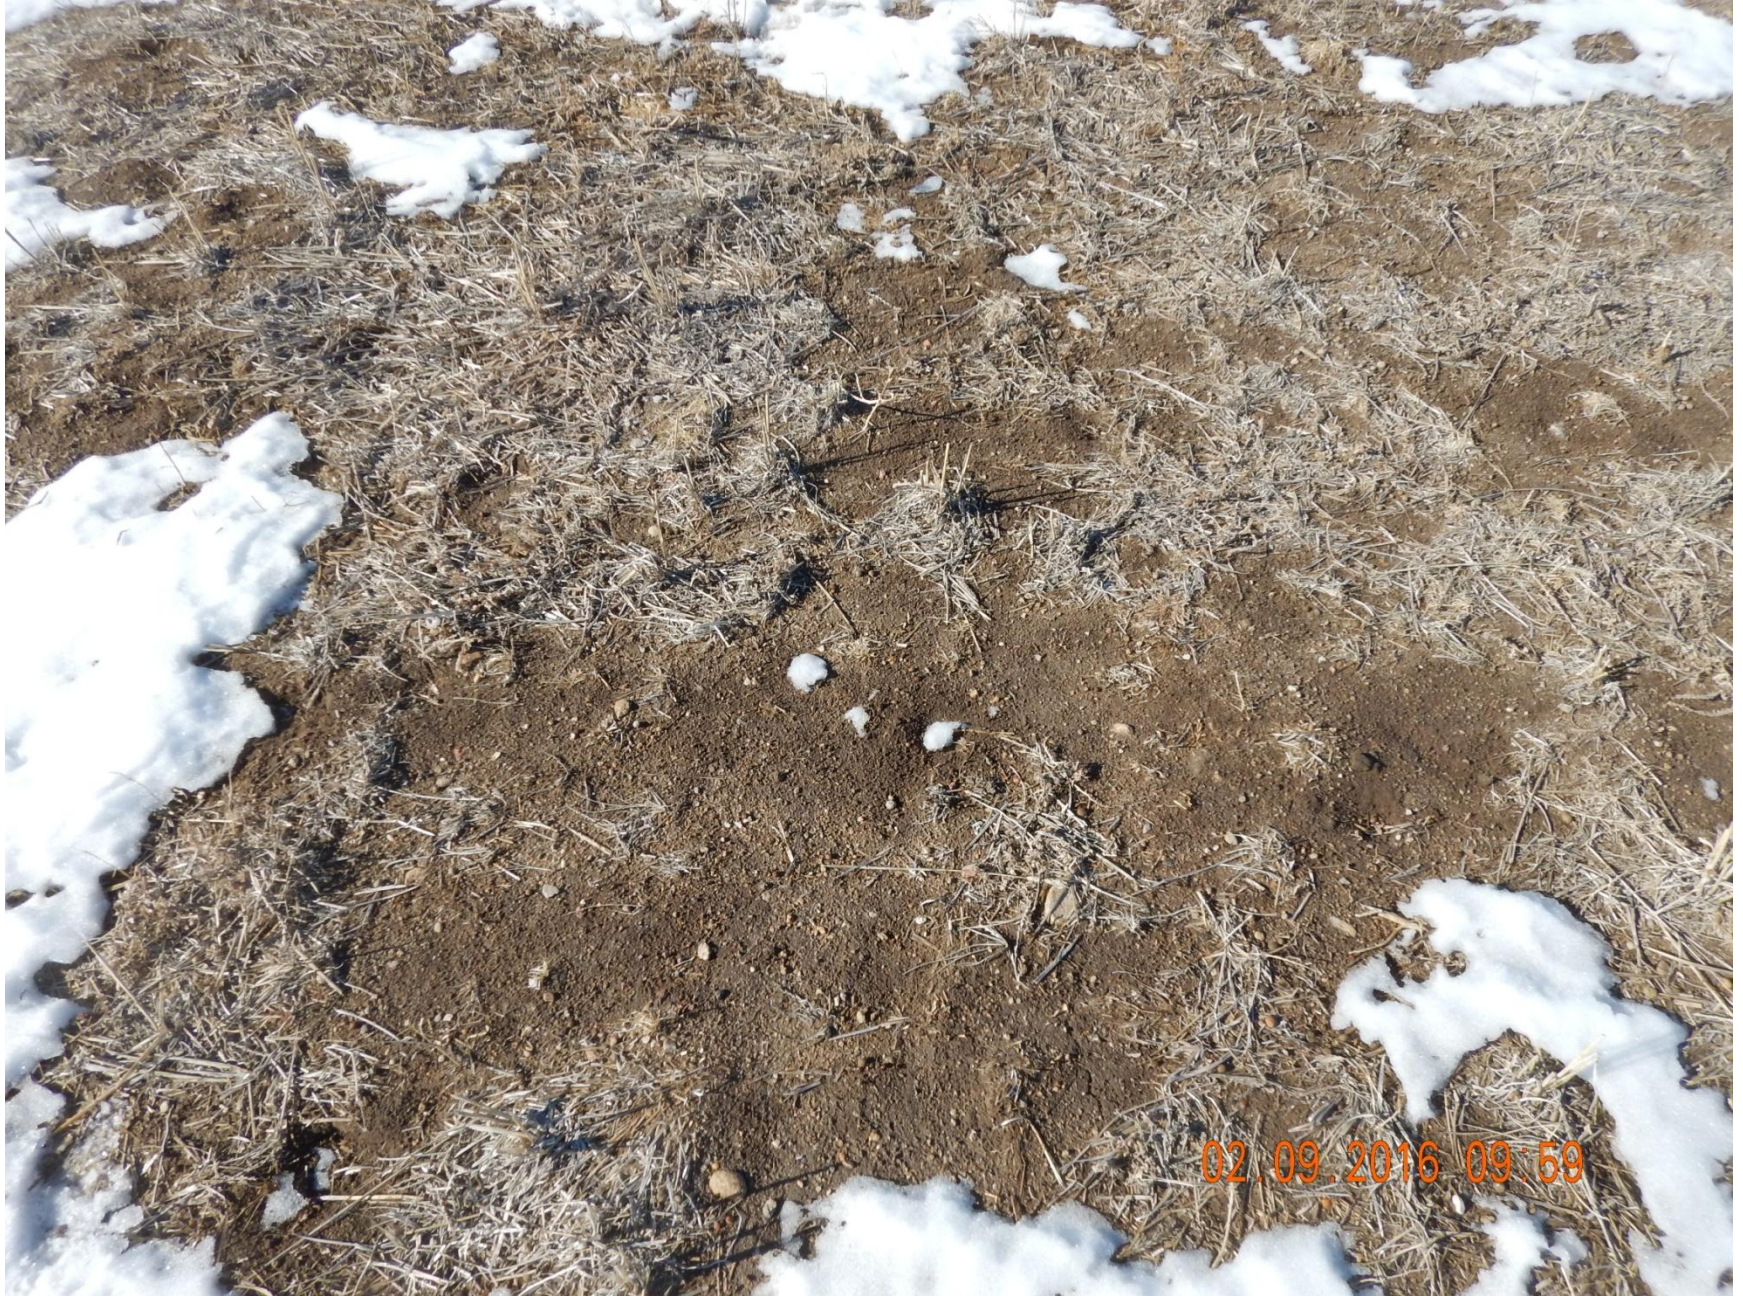
Figure 6: Photo taken from east end of location. Photo shows vegetation on interim area. Eastern portions of interim area dominated by undesirable weedy vegetation.

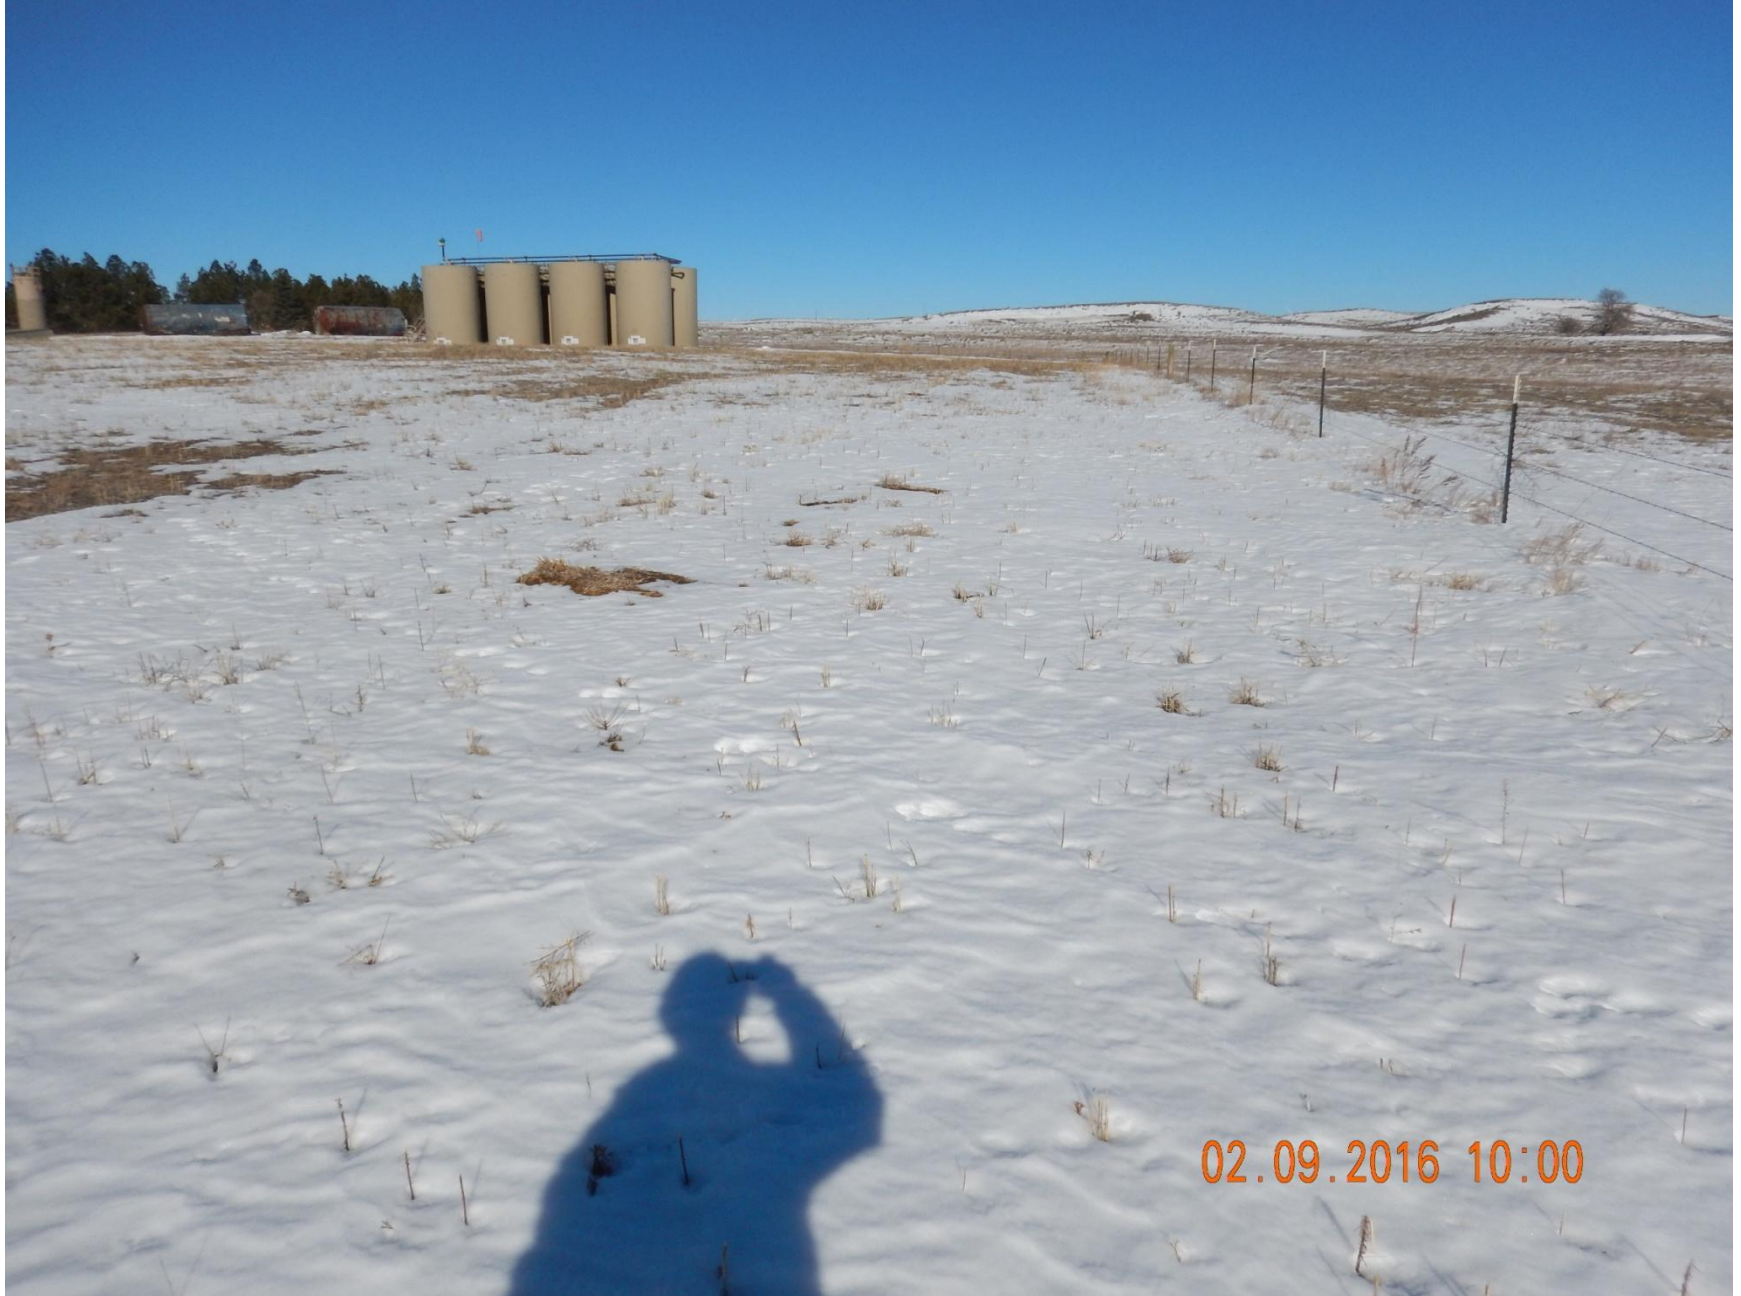
Figure 7: Photo taken from southeast end of location facing north. Photo shows project and interim areas.

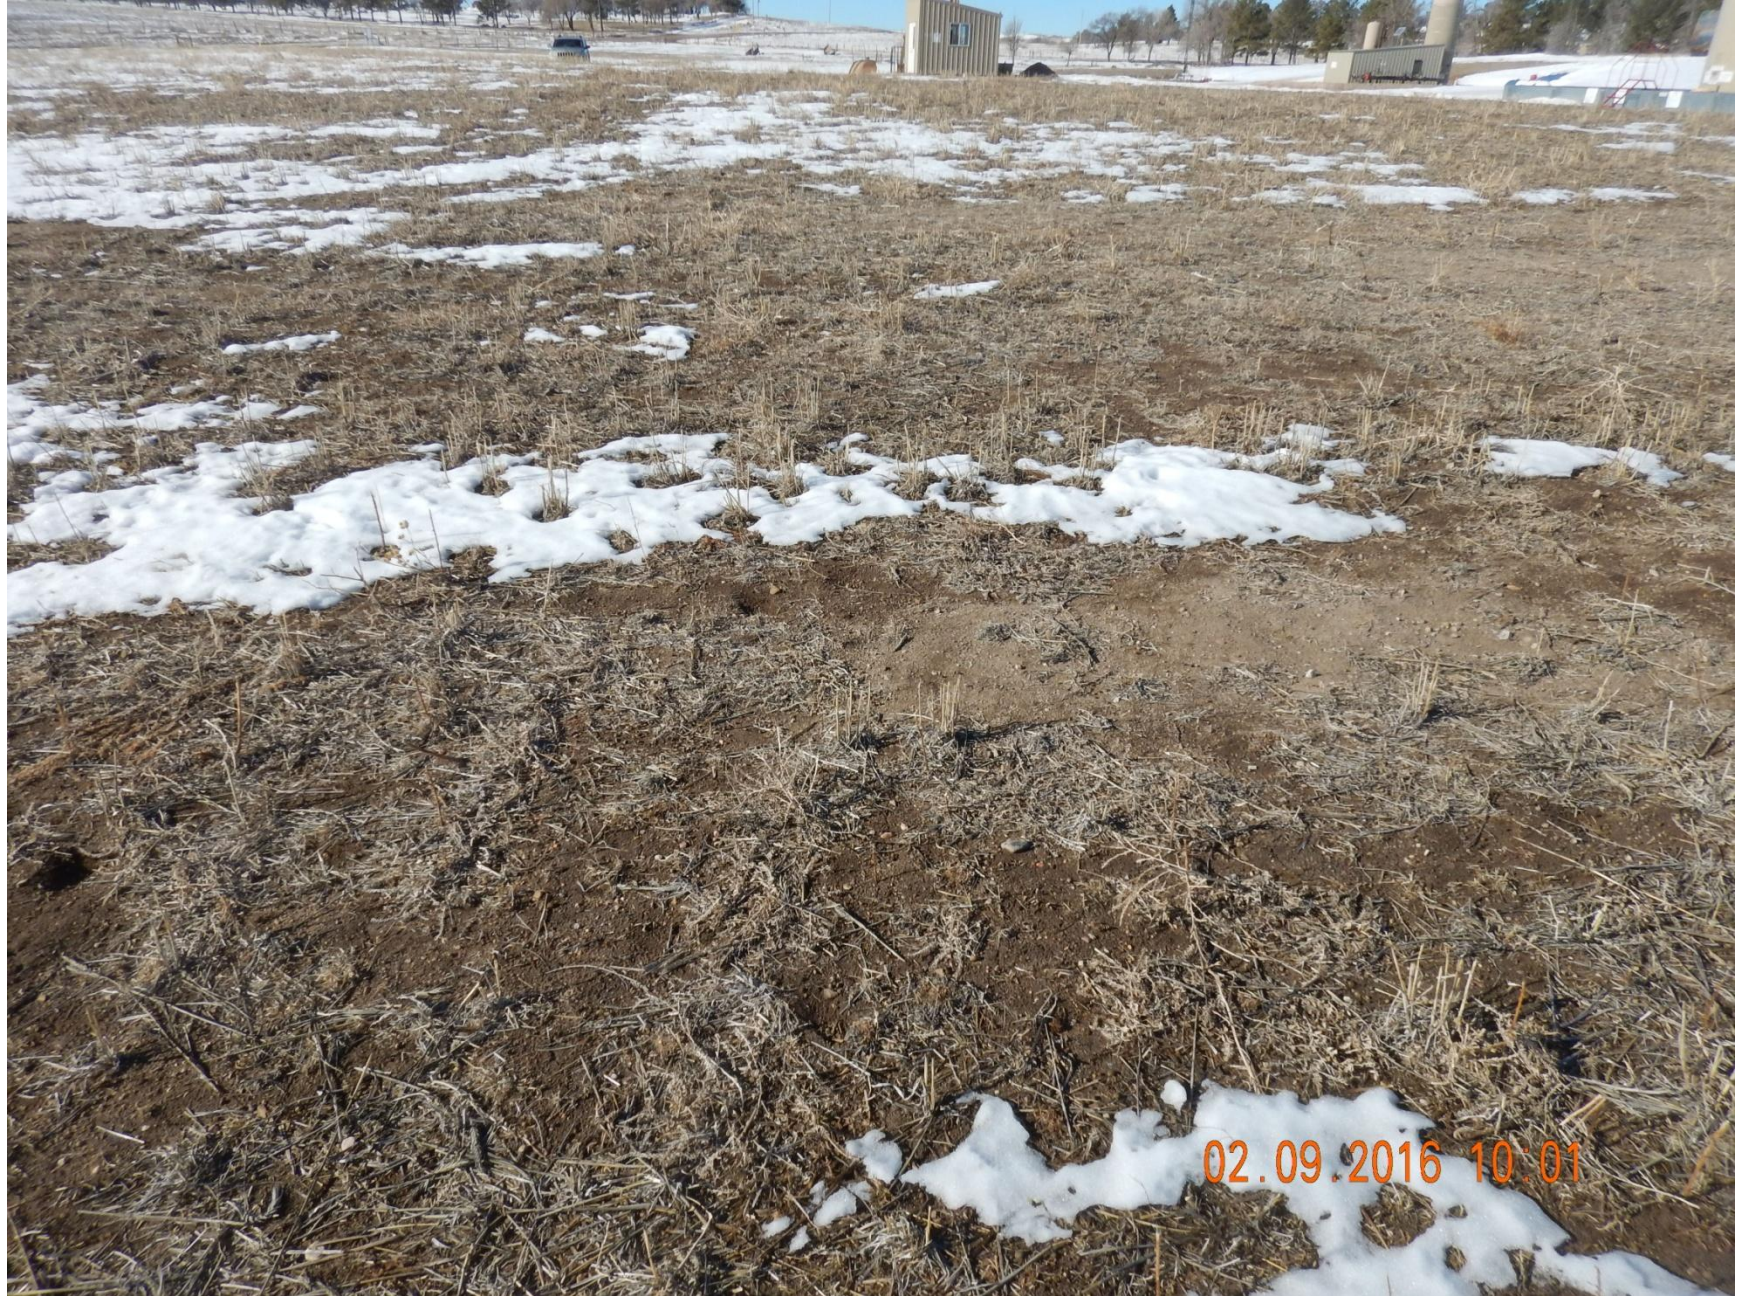
Figure 8: Photo taken from east end of location, facing west. Photo shows vegetation on interim area. Eastern portions of interim area dominated by undesirable weedy vegetation.

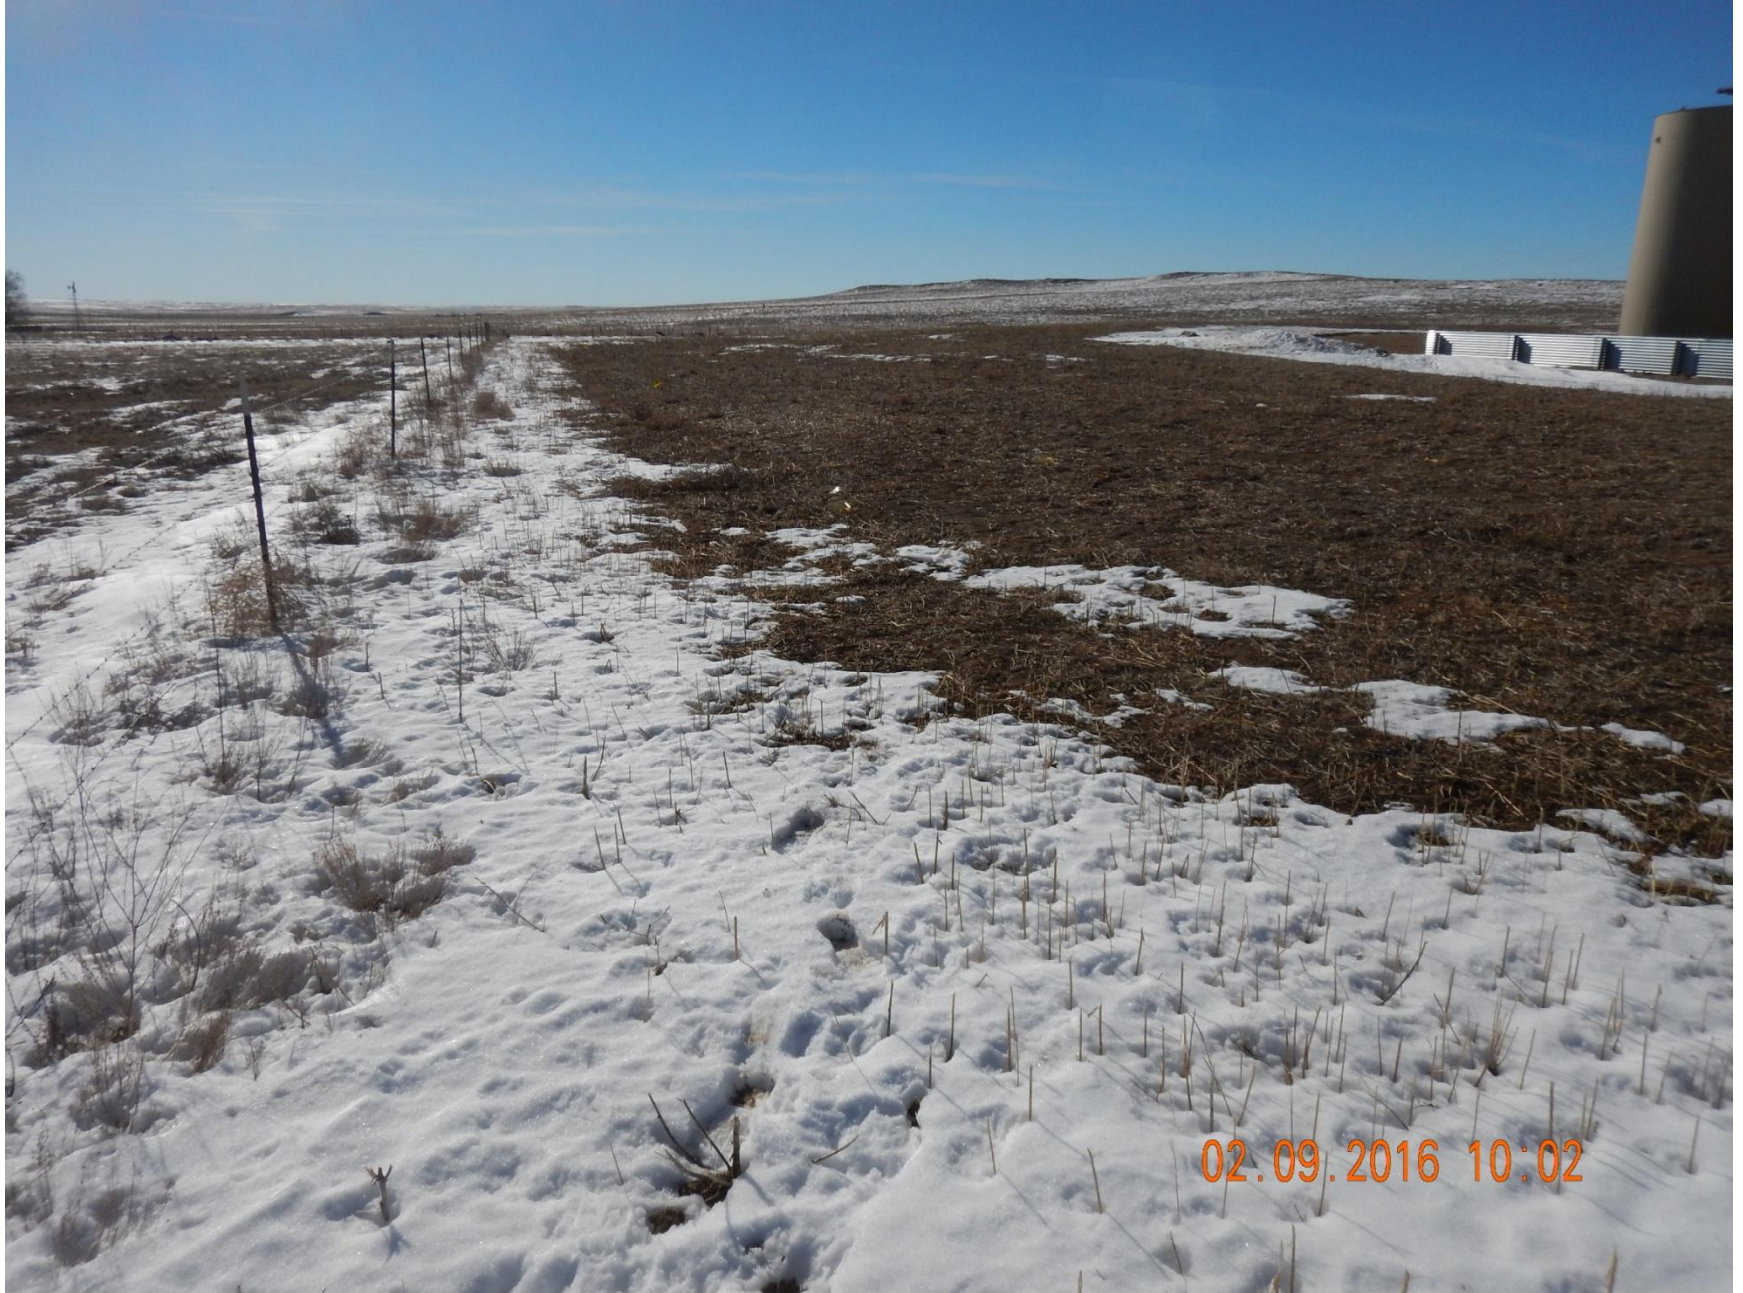
Figure 9: Photo taken from northeast end of location, facing south. Photo shows interim and project area.

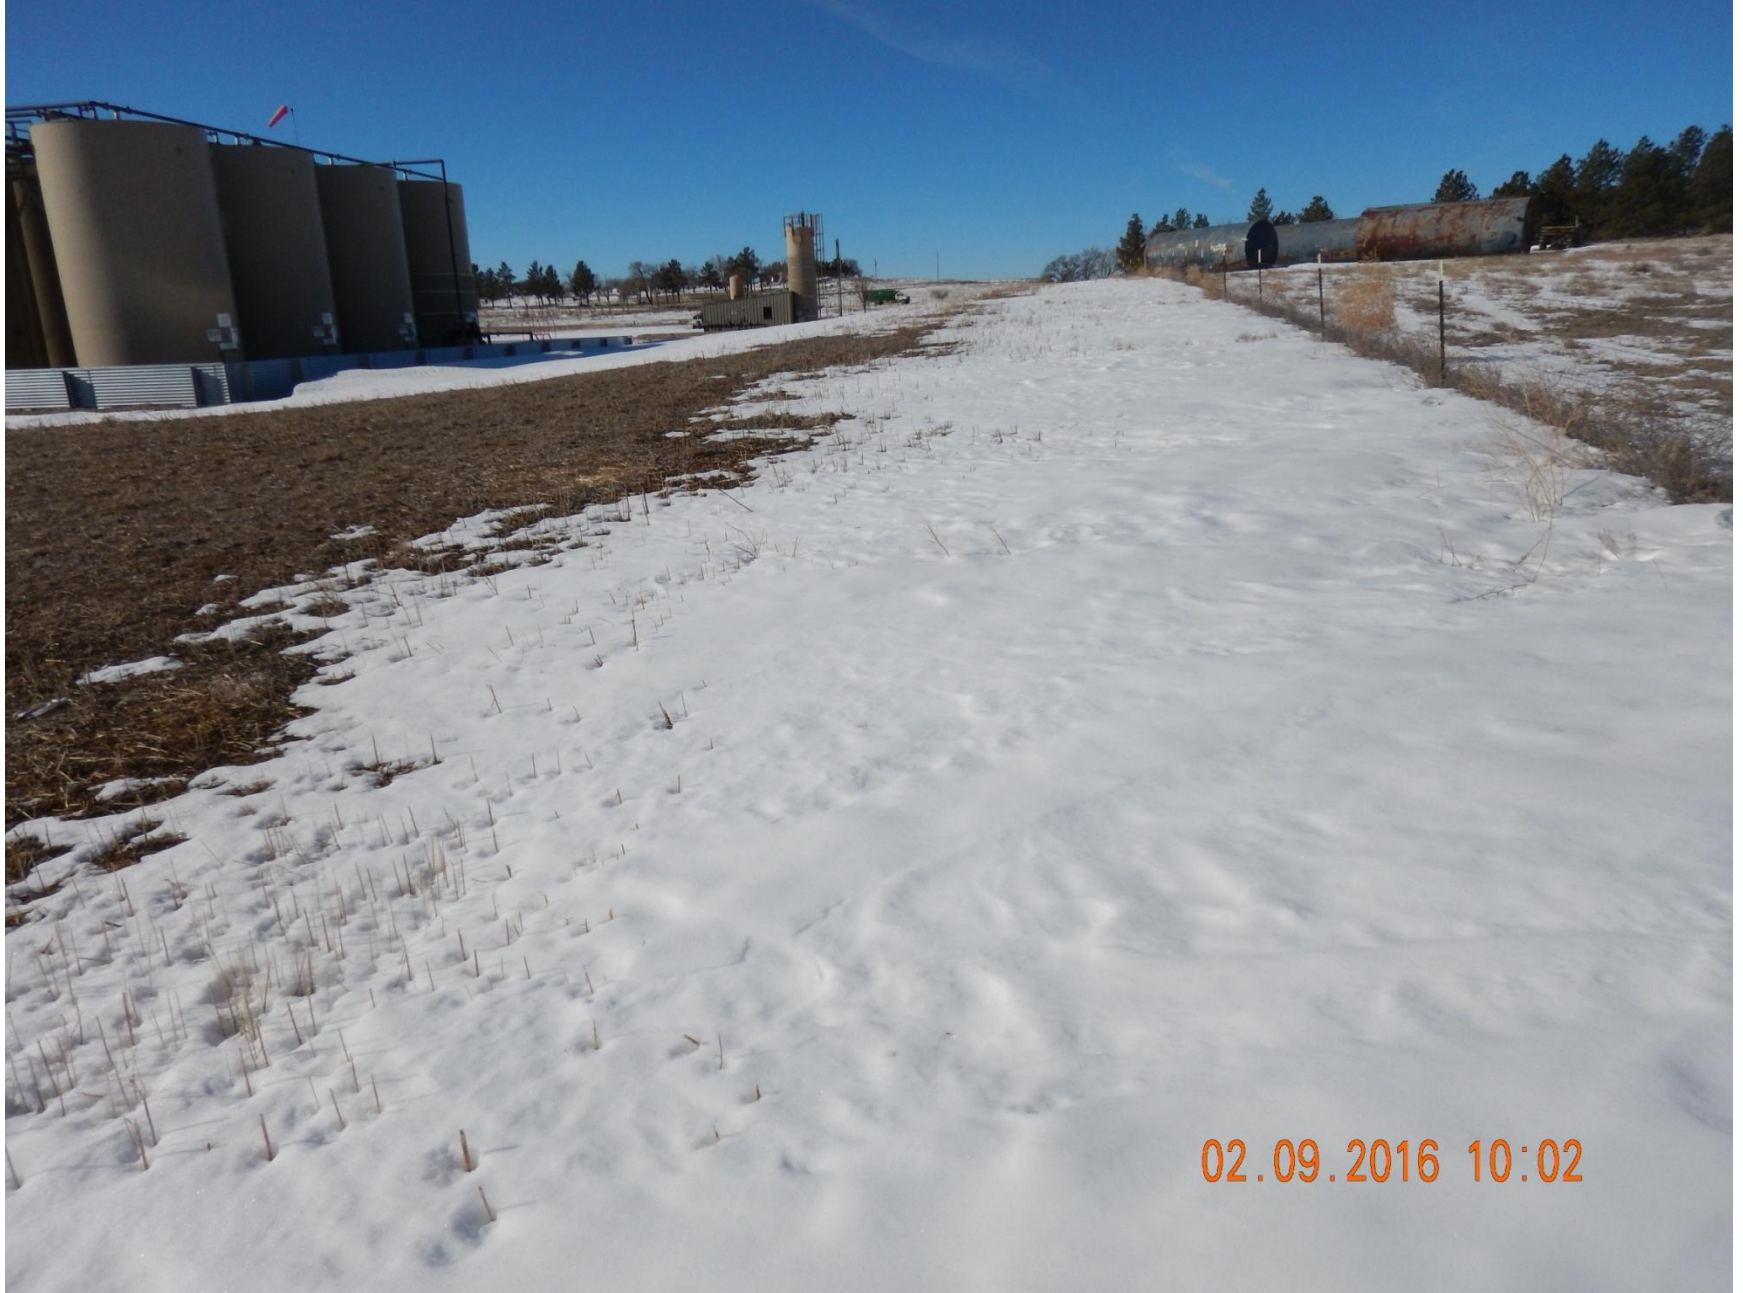
Figure 10: Photo taken from northeast end of location, facing west. Photo shows interim and project area.
