Interim Reclamation Inspection

2/9/2016

Operator: Whiting Oil and Gas

Location ID: 431632

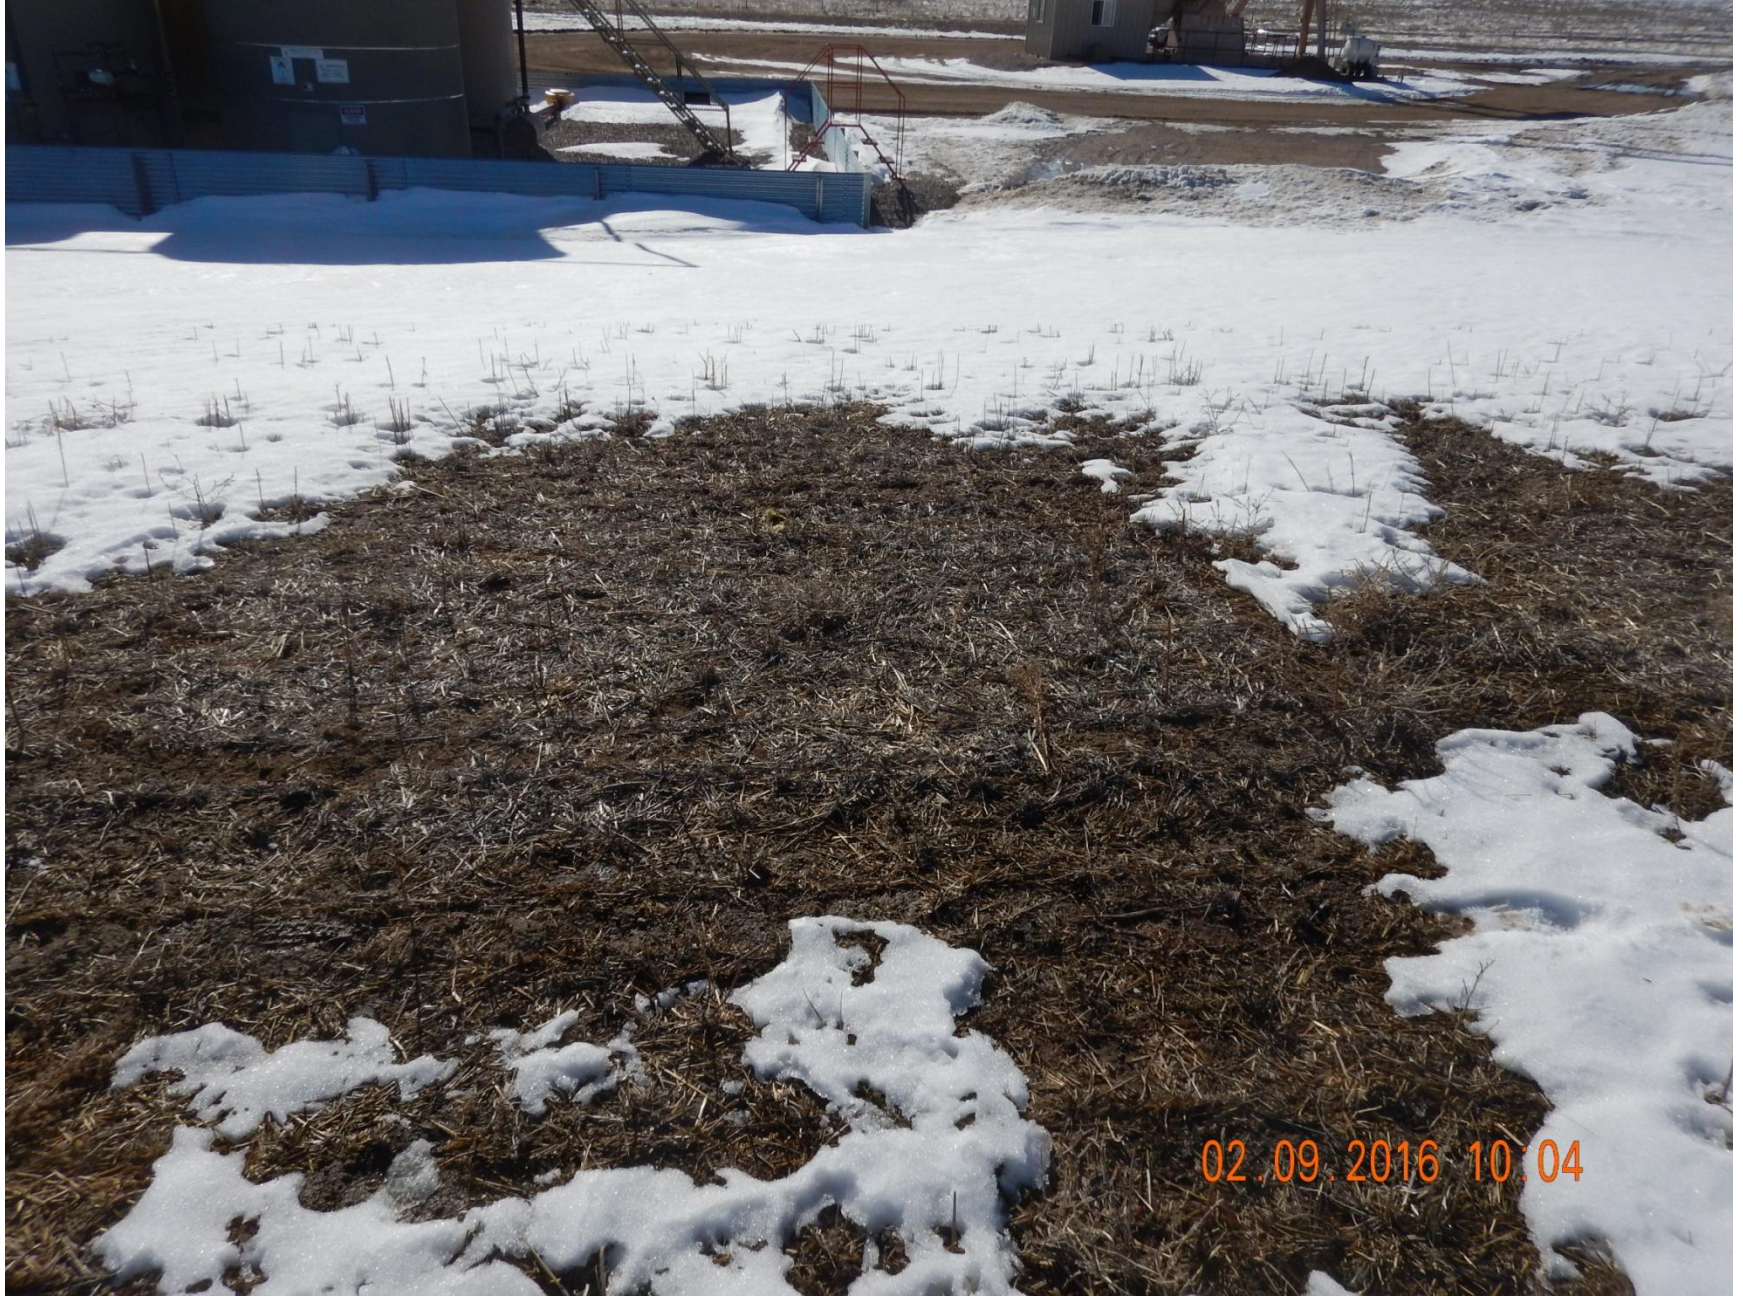
Figure 11: Photo taken from north end of location, facing south. Photo shows vegetation on north end of interim area.

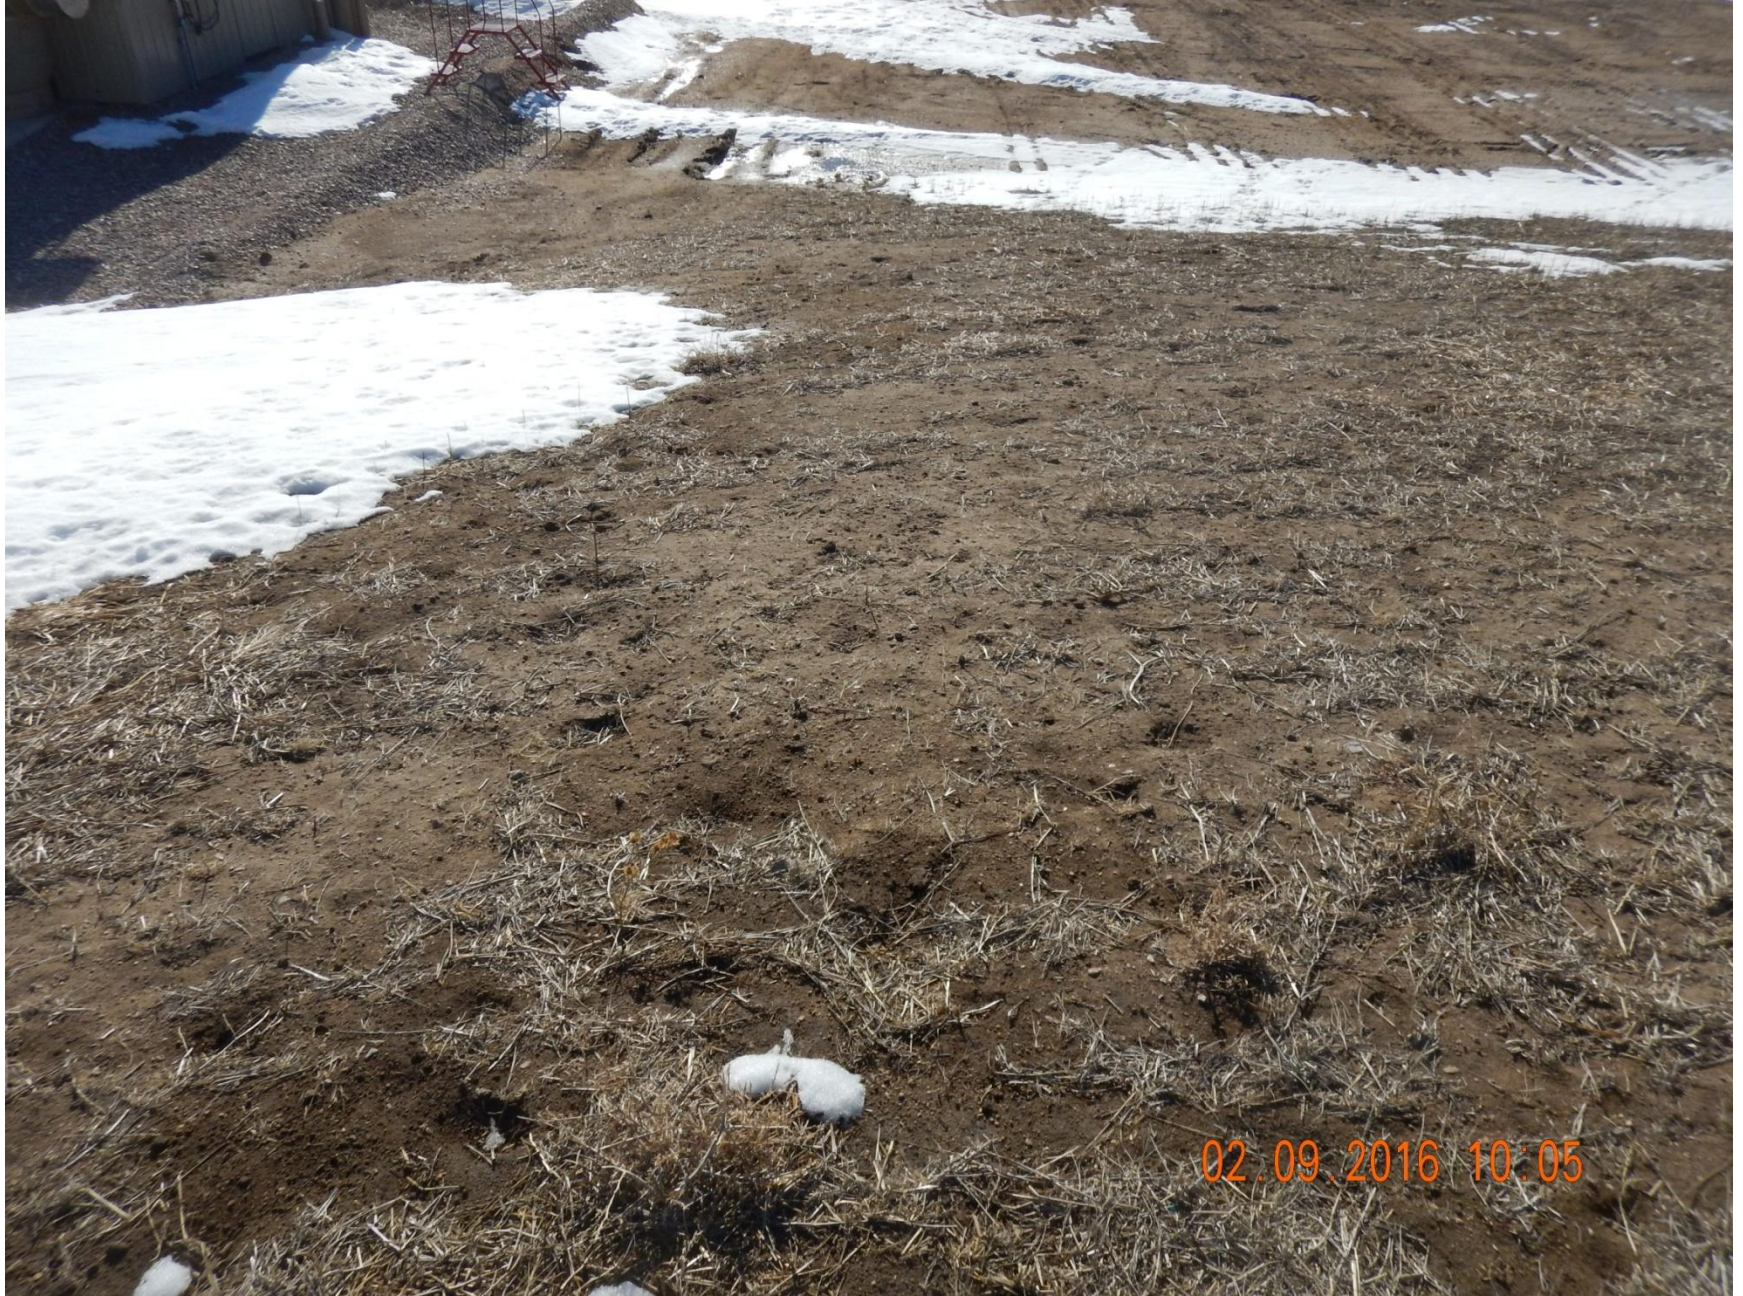
Figure 12: Photo taken from north end of location, facing south. Photo shows vegetation on north end of interim area.

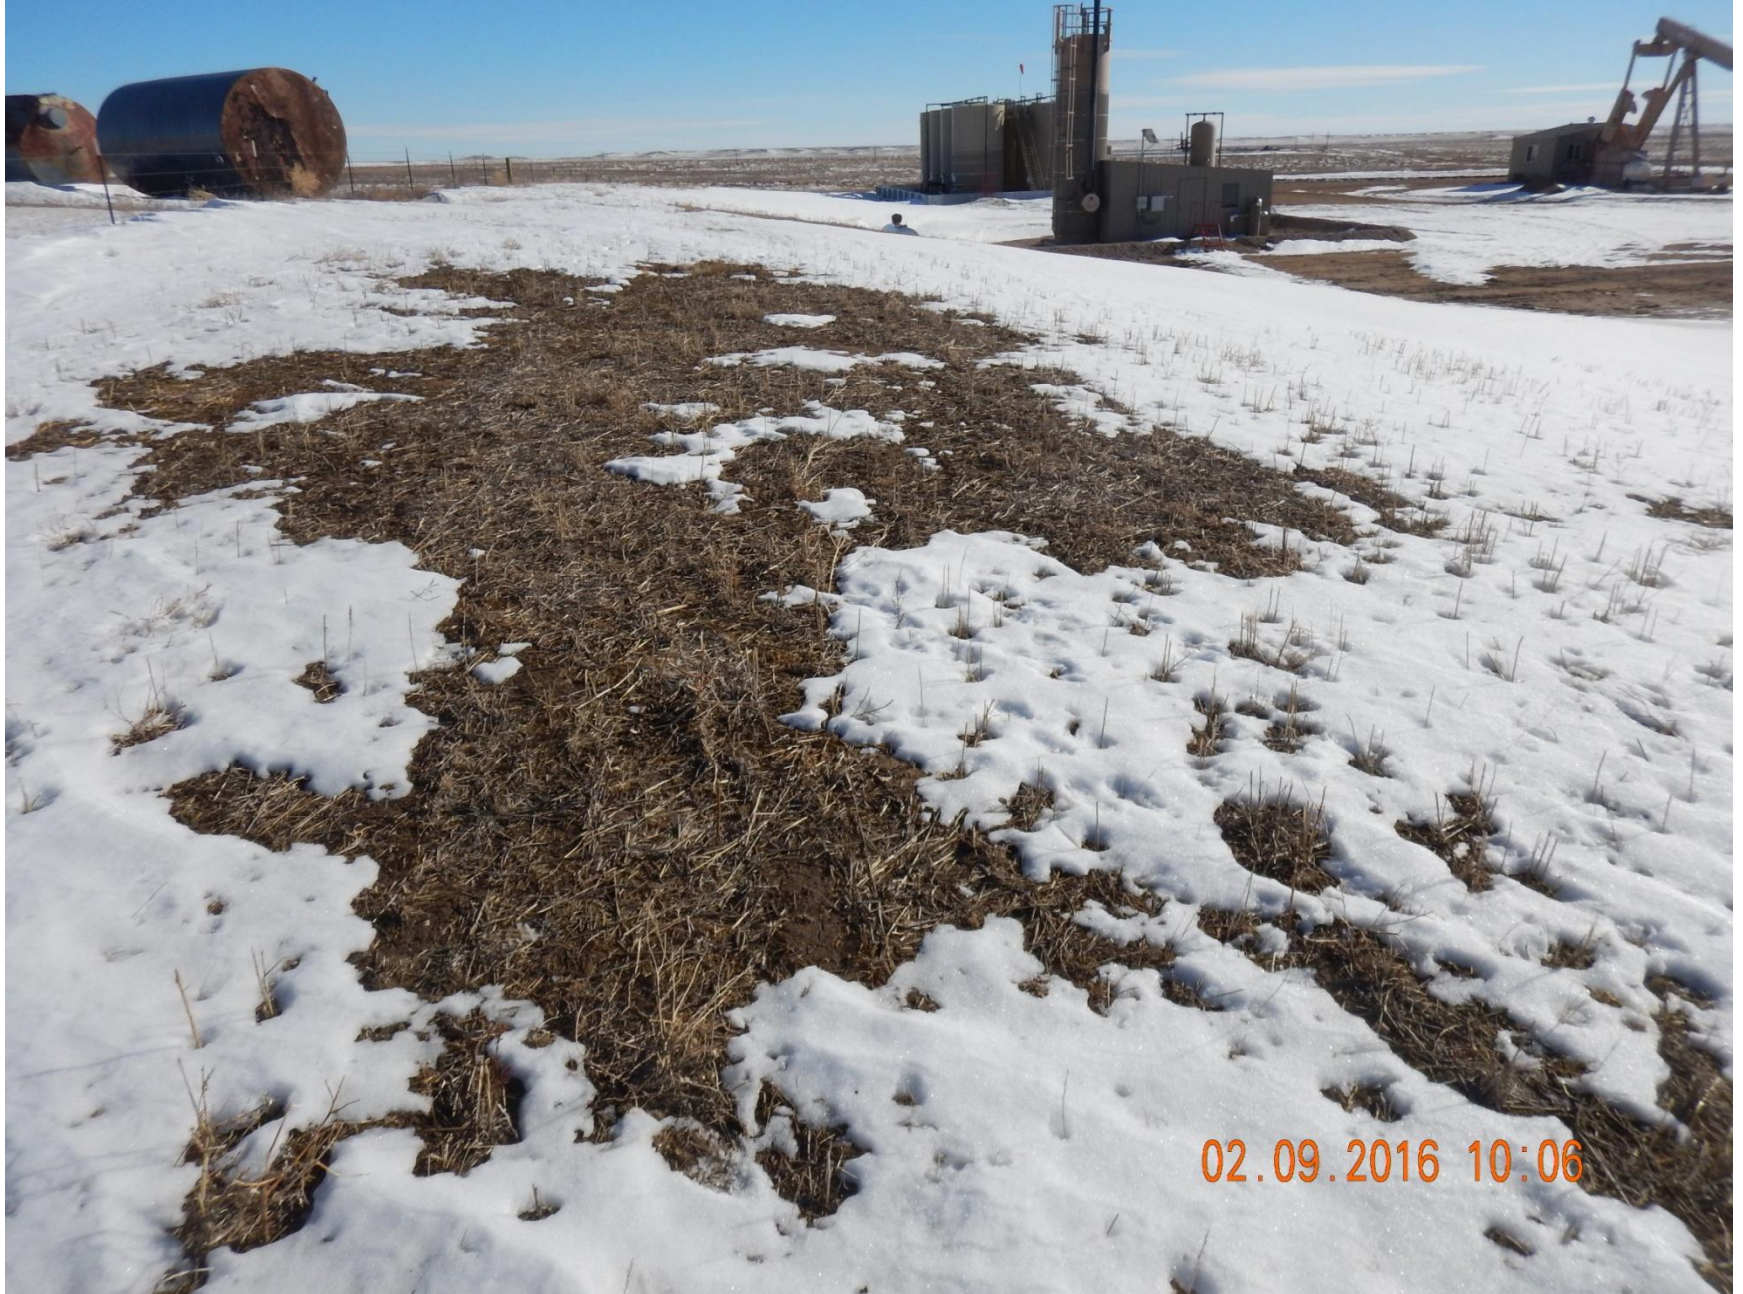
Figure 13: Photo taken from northwest end of location, facing east. Photo shows interim and project areas.

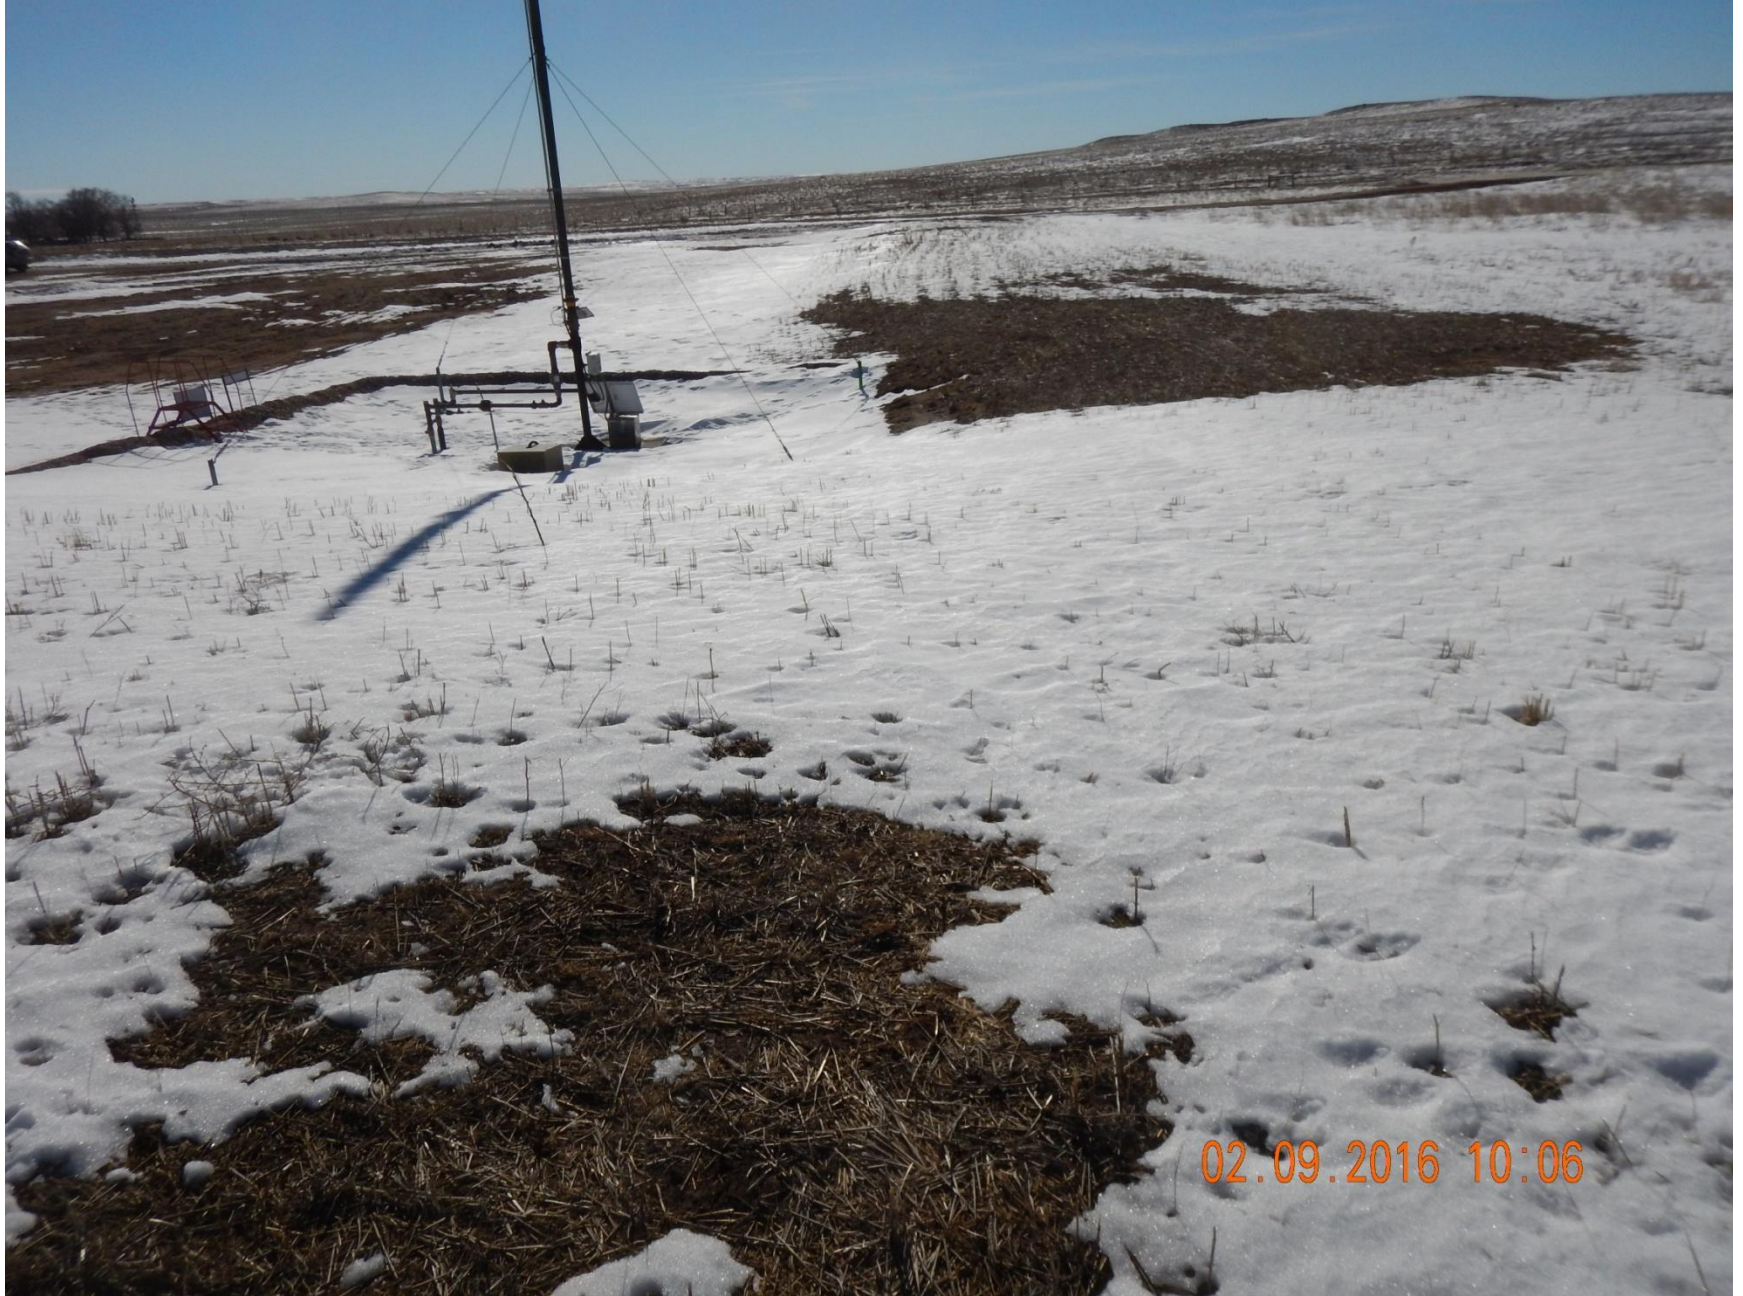
Figure 14: Photo taken from northwest end of location, facing south. Photo shows interim and project areas.

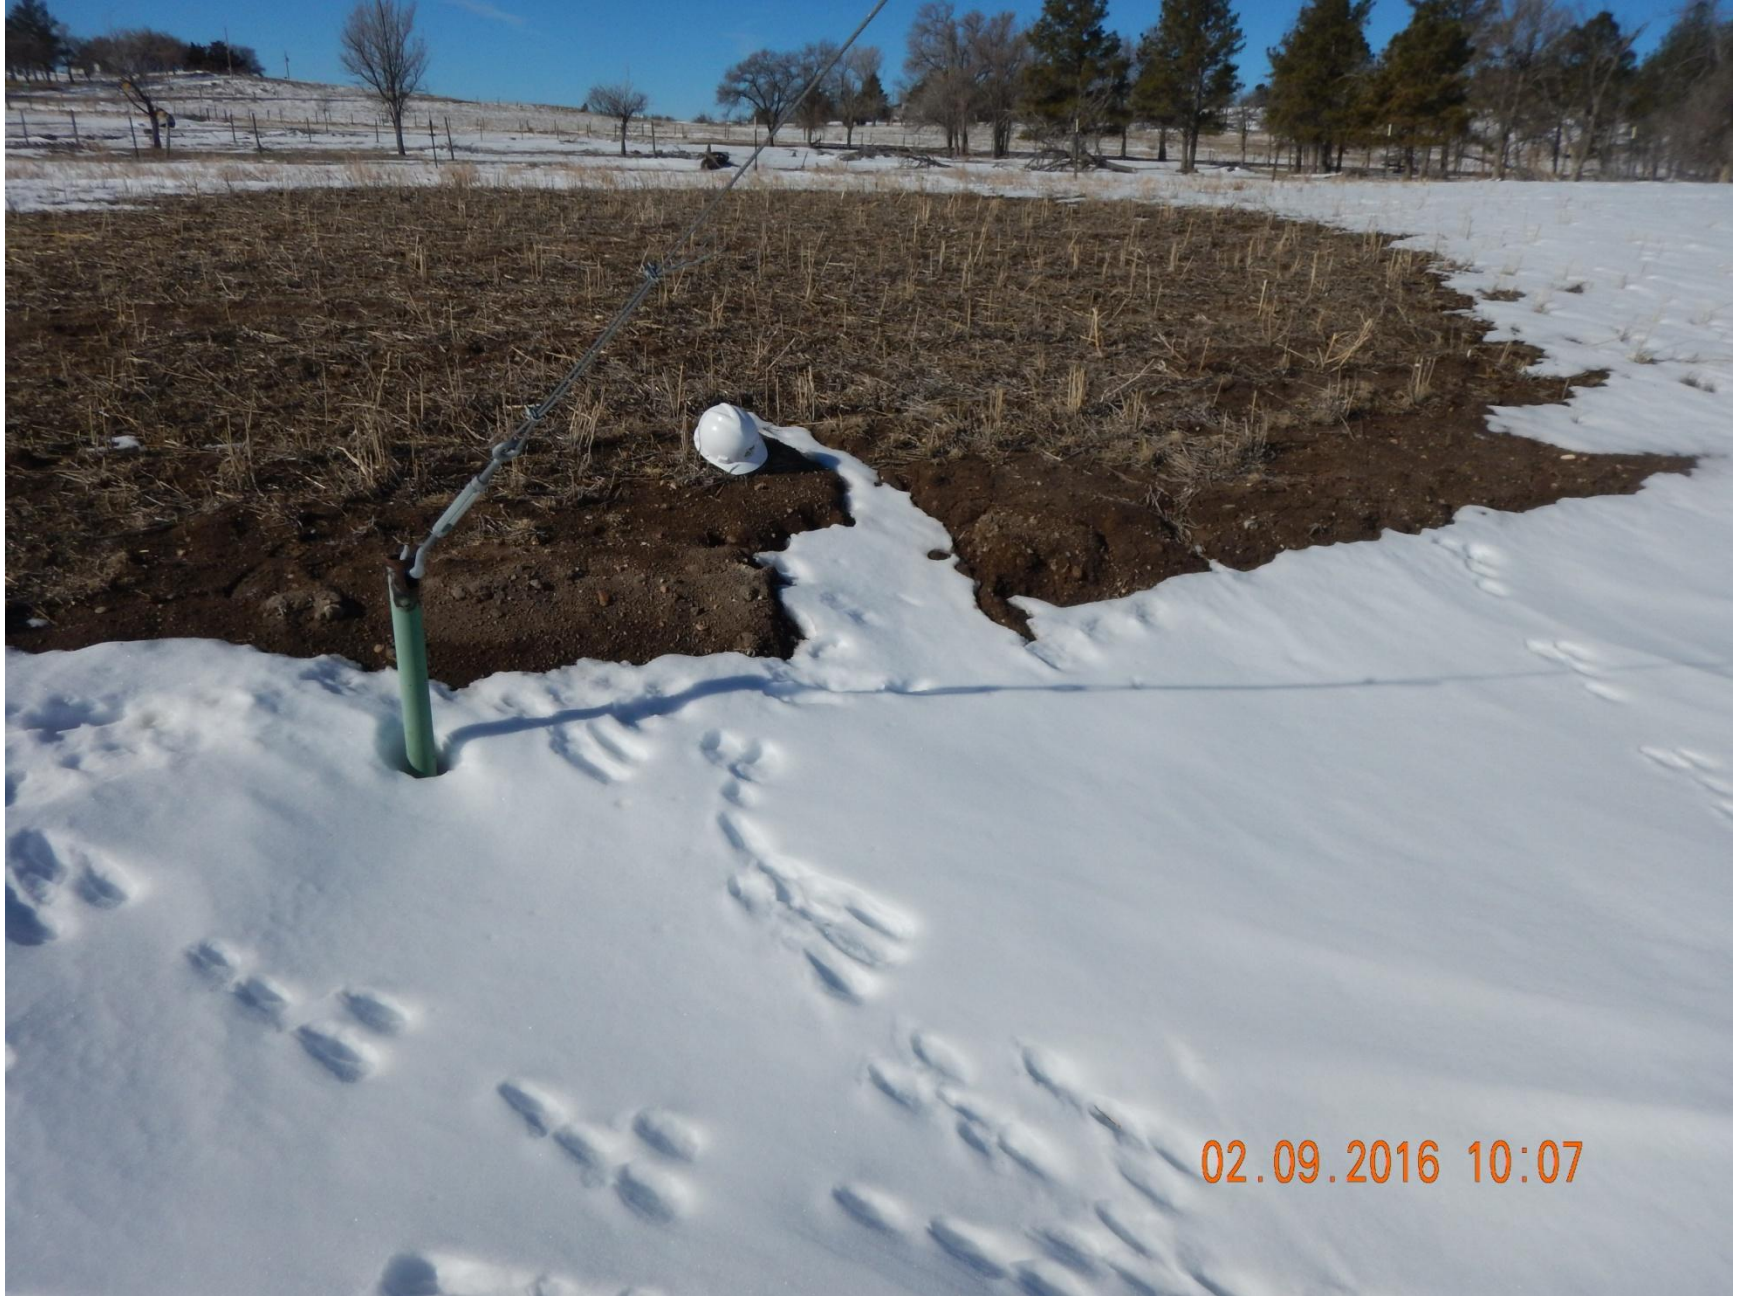
Figure 15: Photo taken from northwest end of project area. Photo of erosion forming on berm.

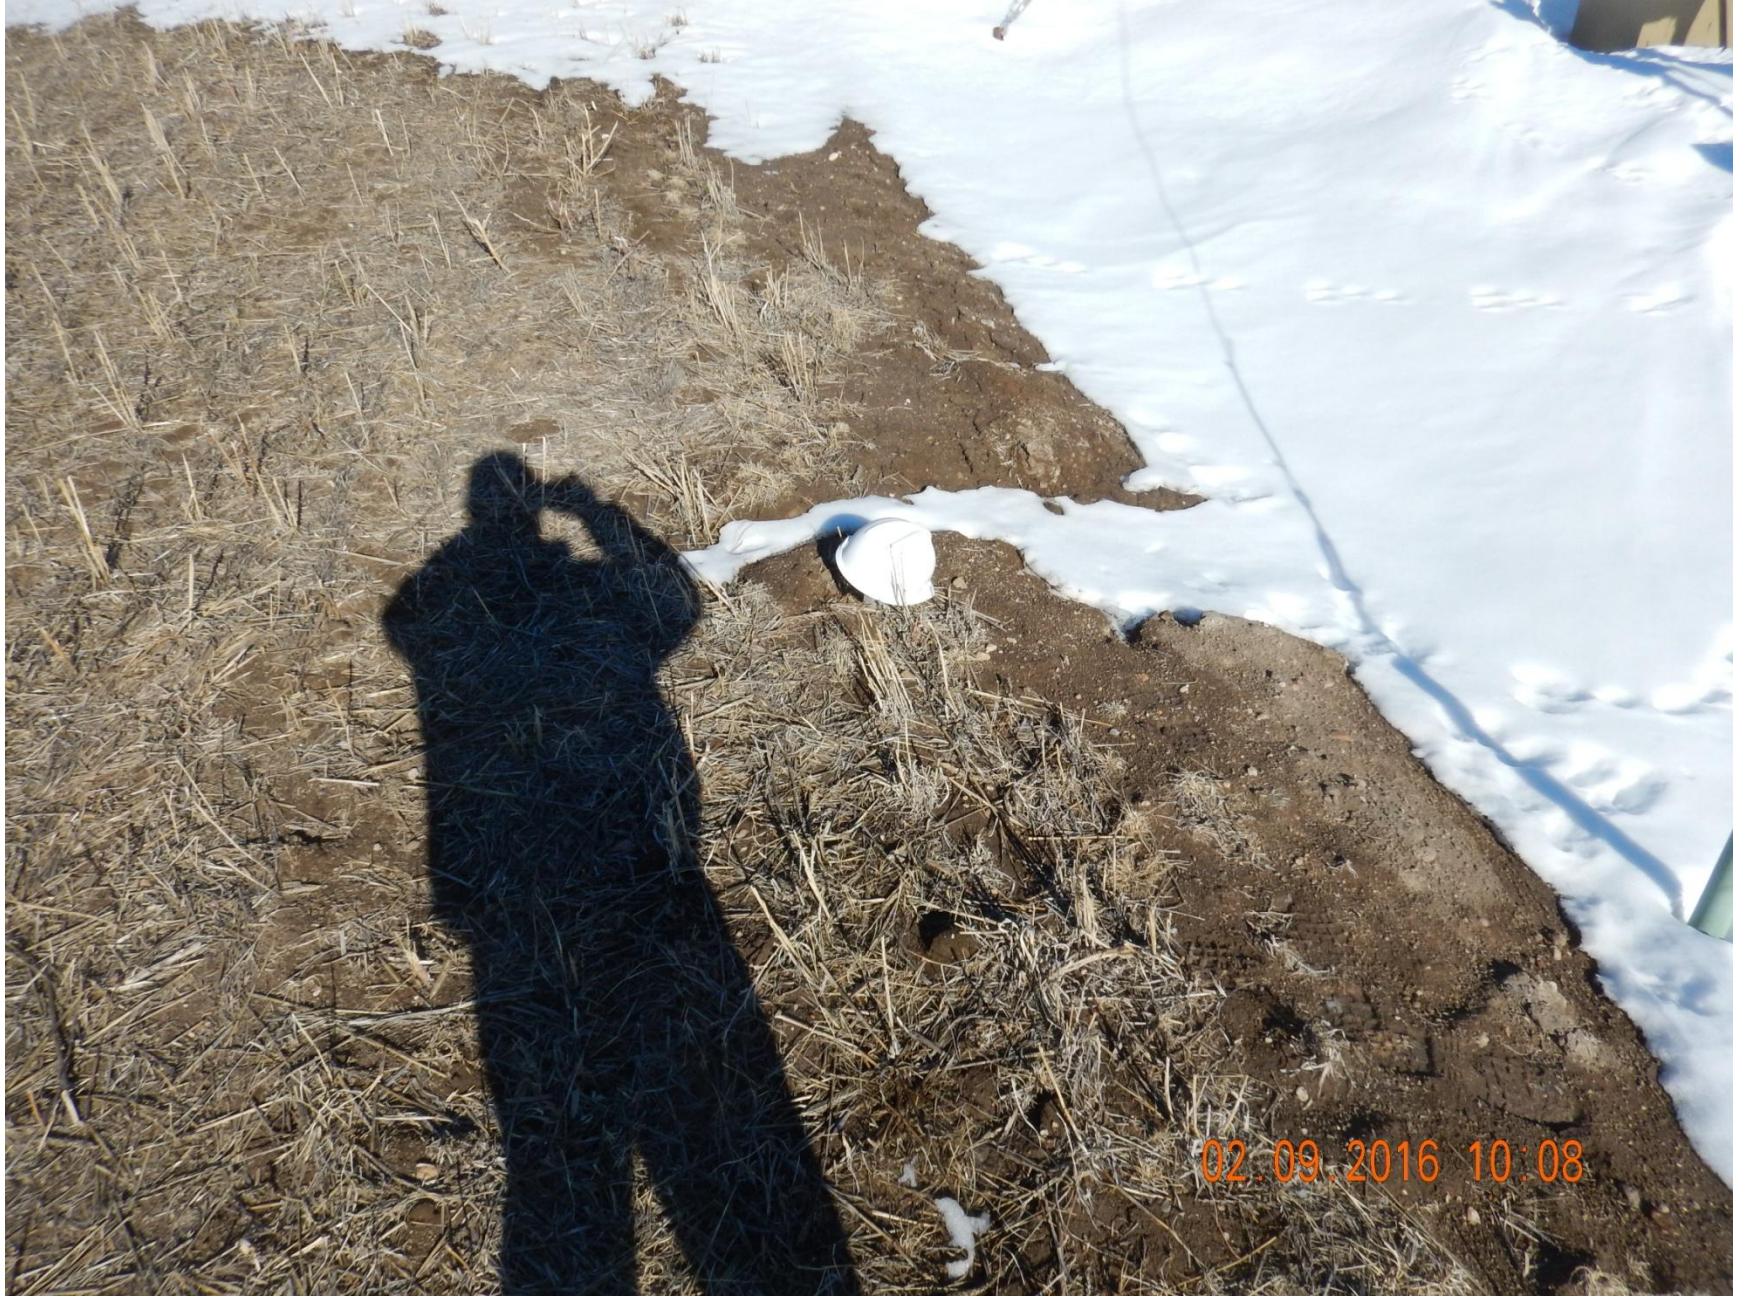
Figure 16: Photo taken from northwest end of project area. Photo of erosion forming on berm.
