Interim Reclamation Inspection

2/9/2016

Operator: Whiting Oil and Gas

Location ID: 433919

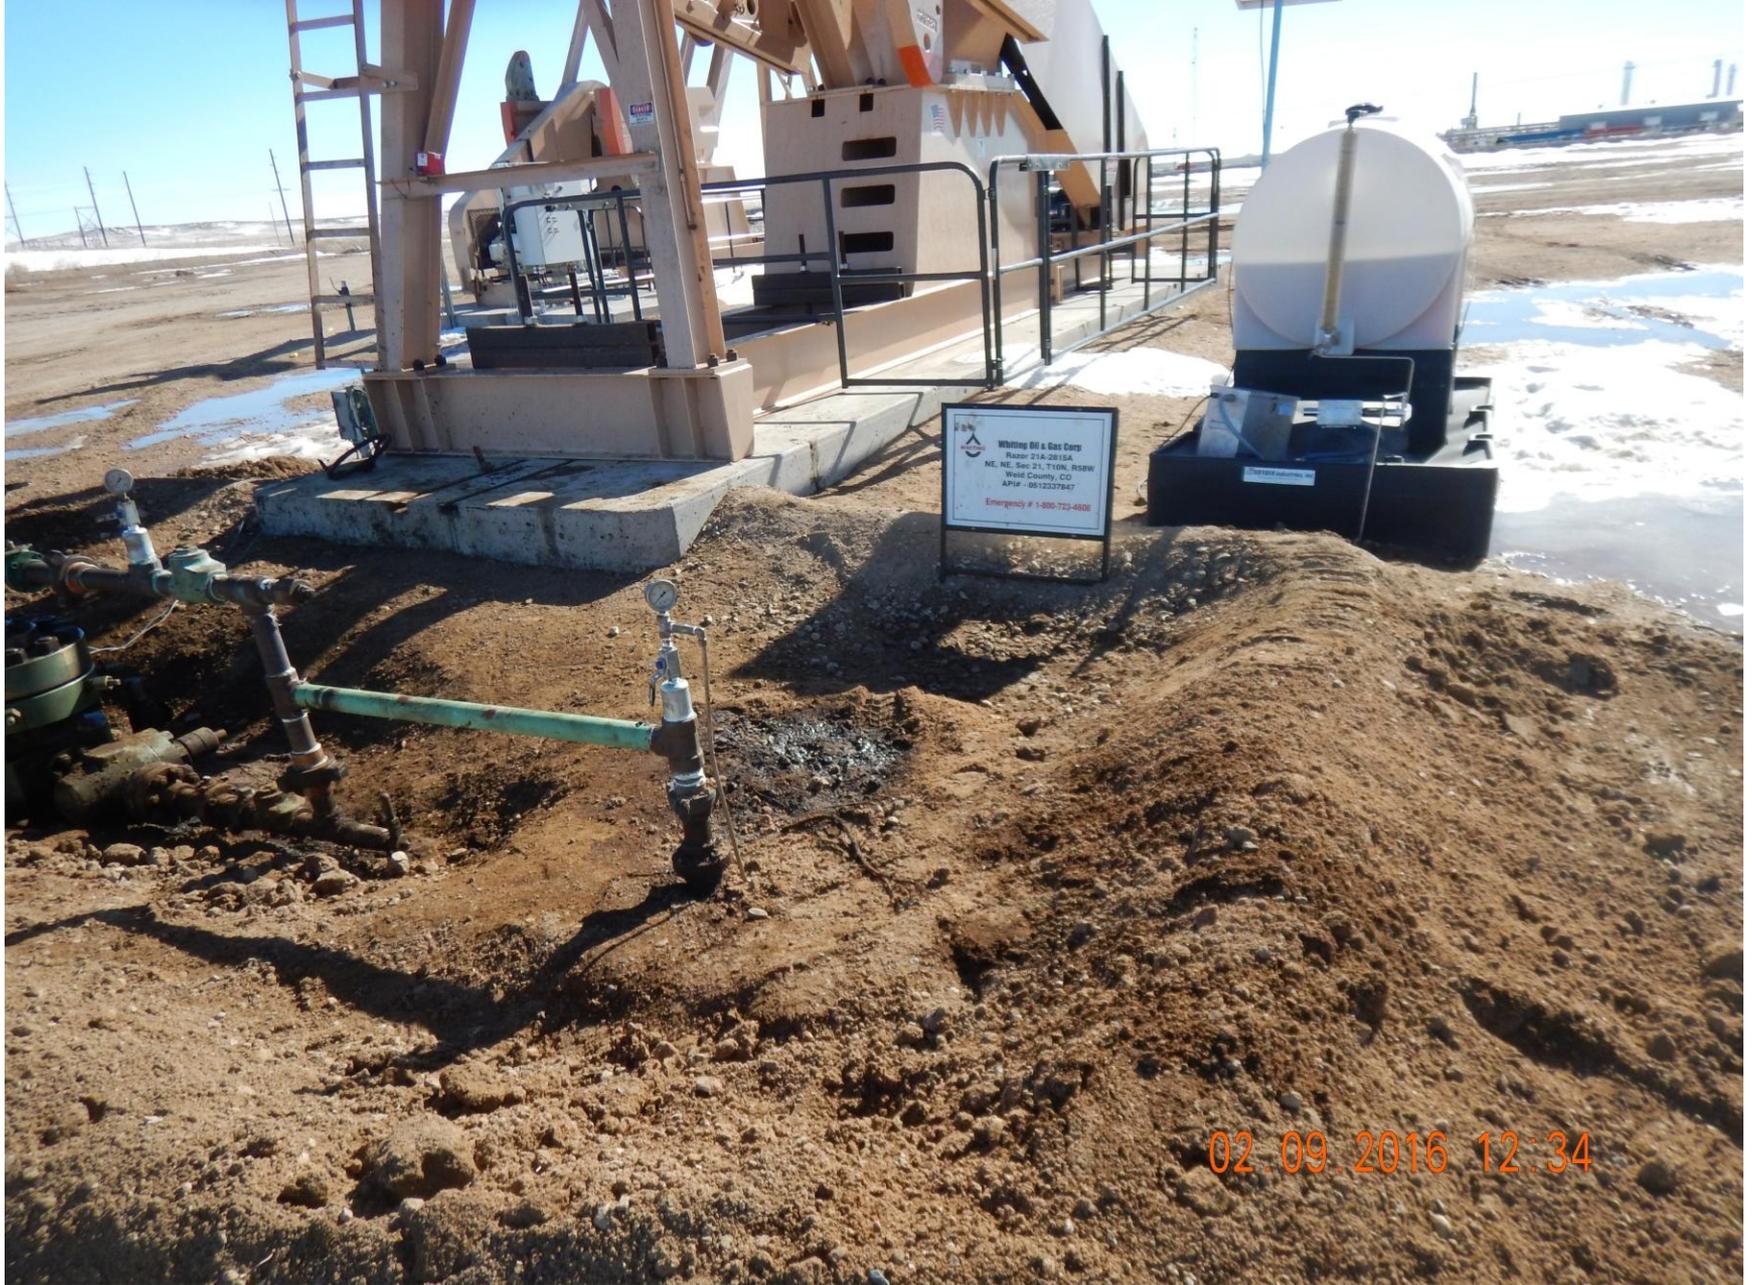
Figure 1: Photo well sign at 123-37847.

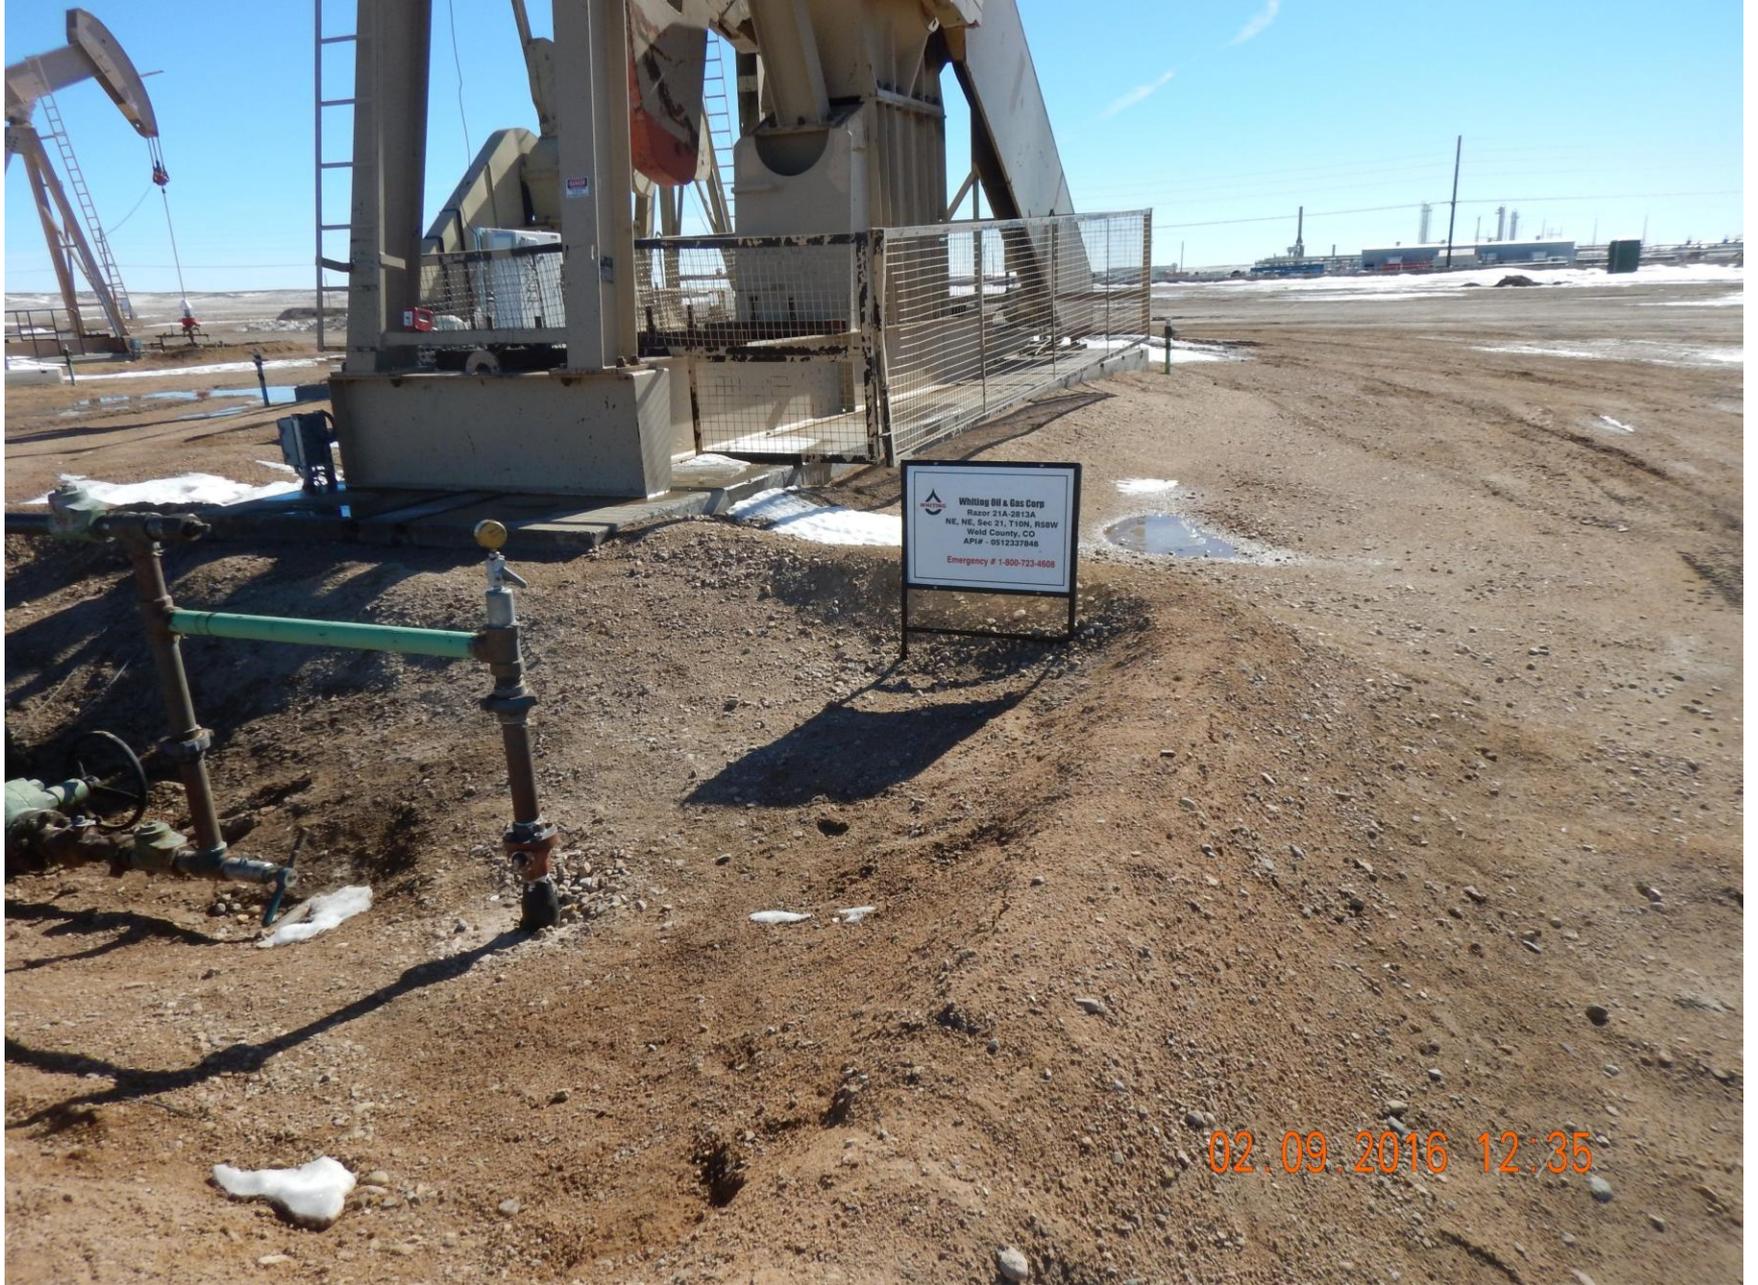
Figure 2: Photo of sign at well 123-37848

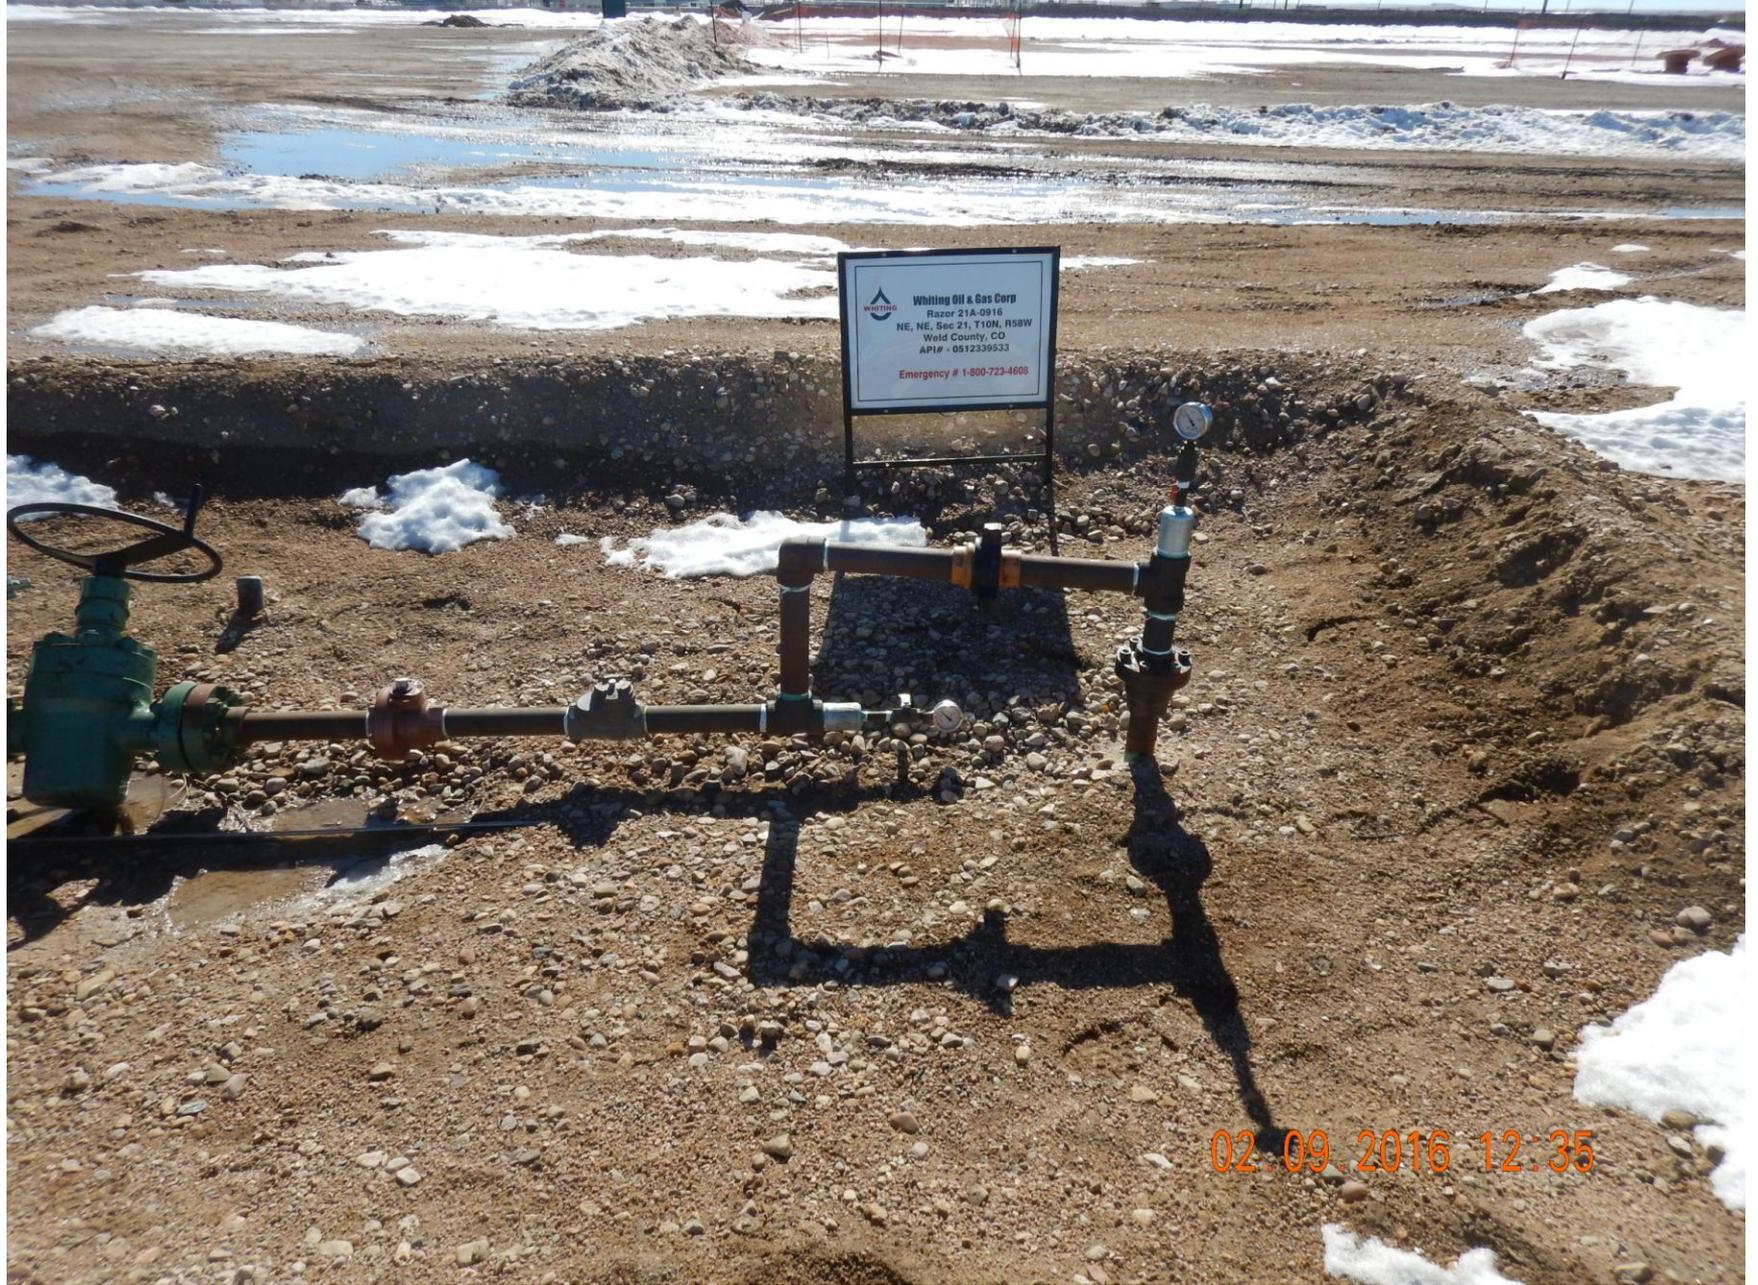
Figure 3: Photo of sign at well 123-39533

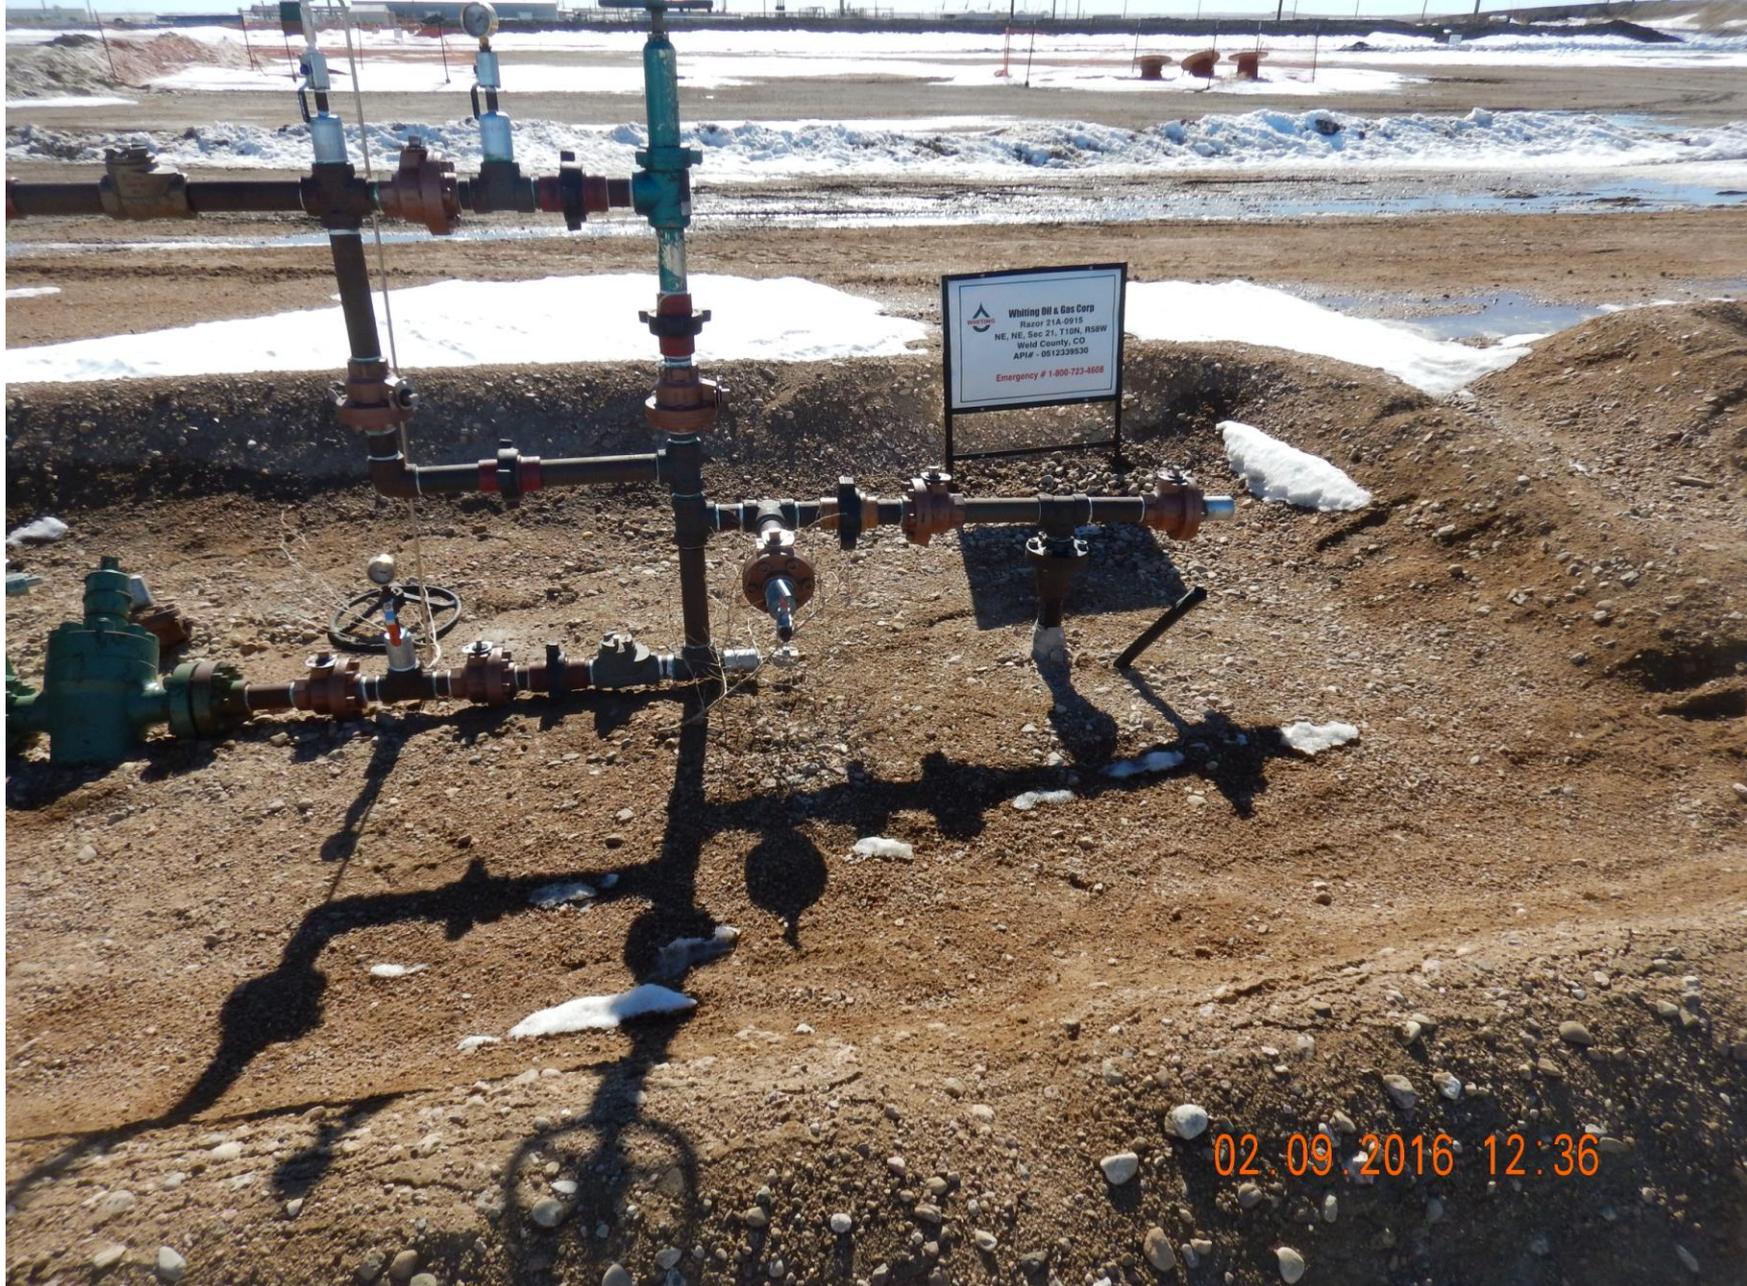
Figure 4: Photo of sign at 123-39530.

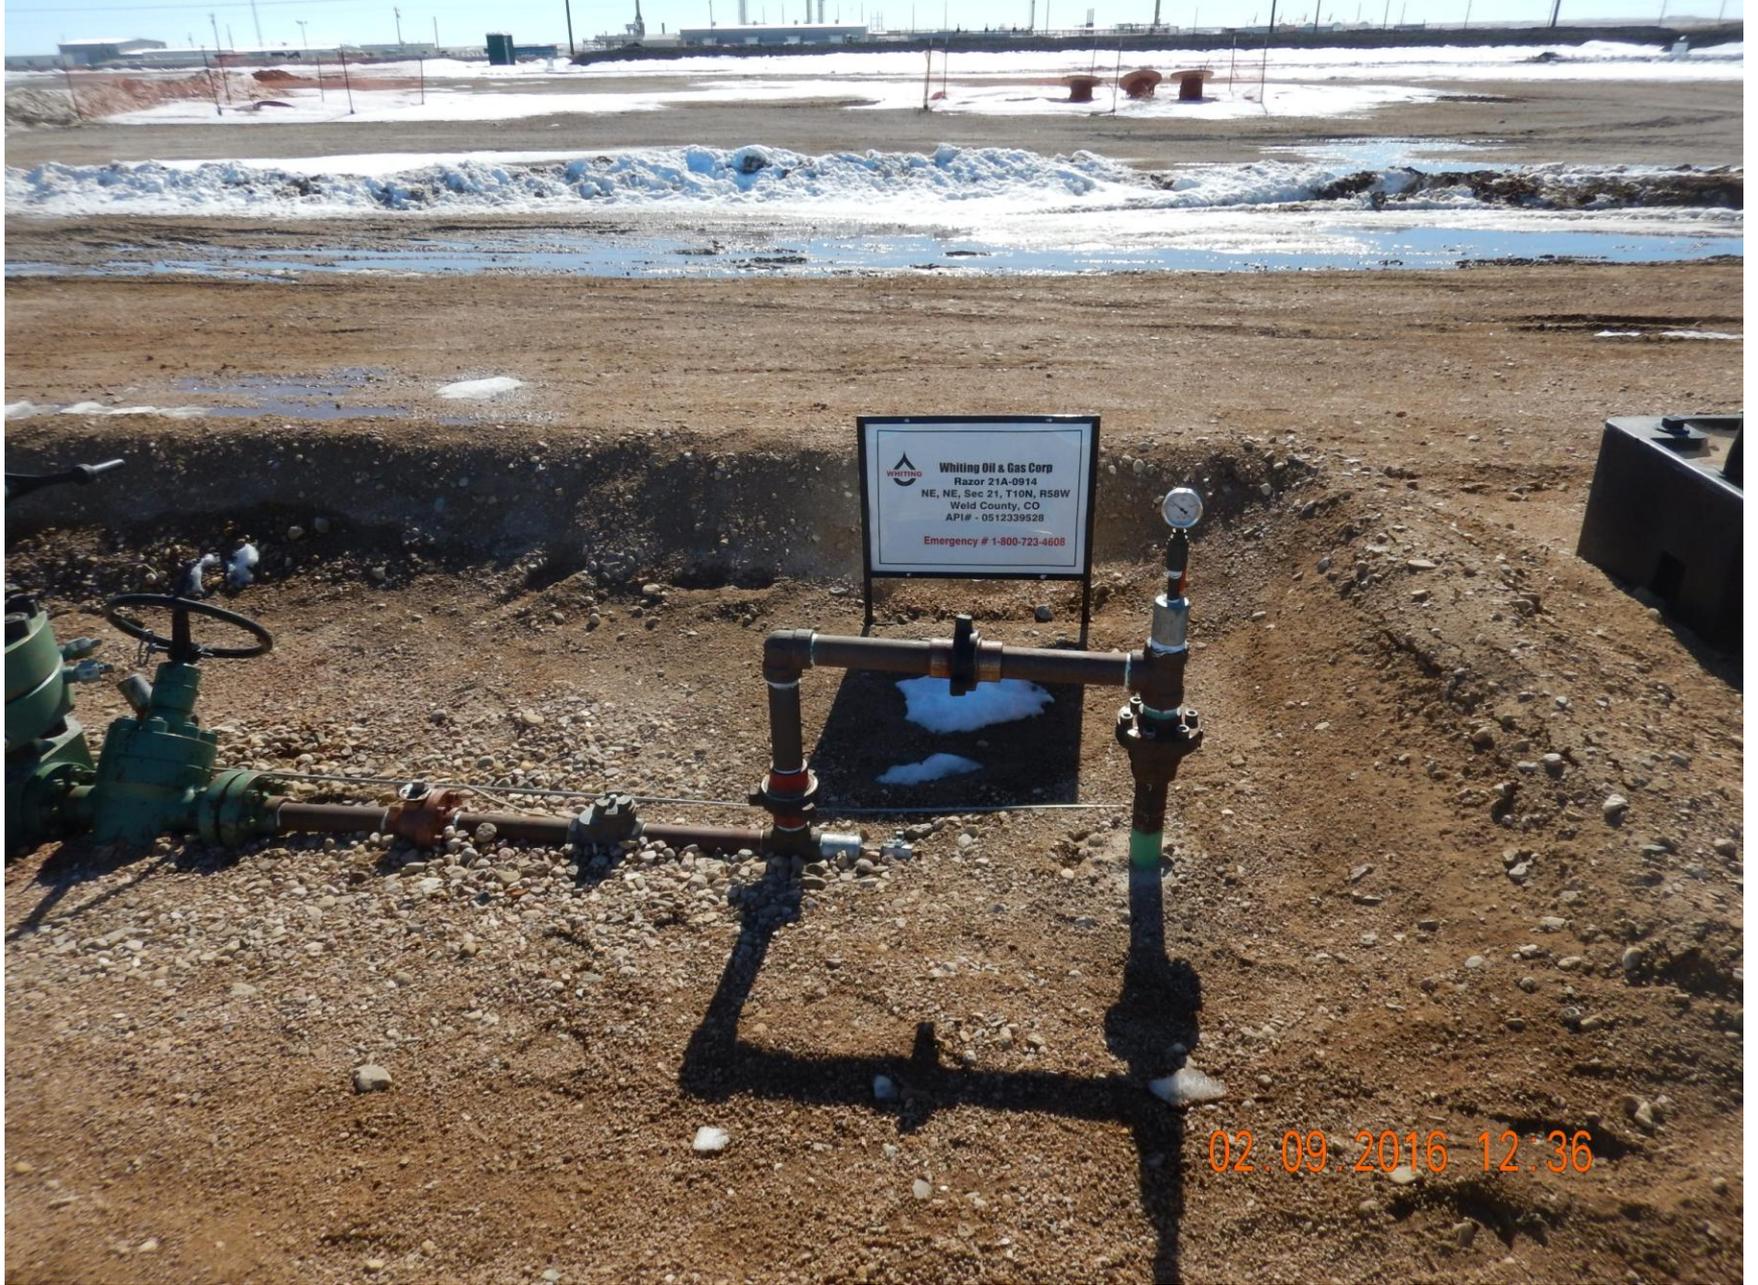
Figure 5: Photo of sign at 123-39528

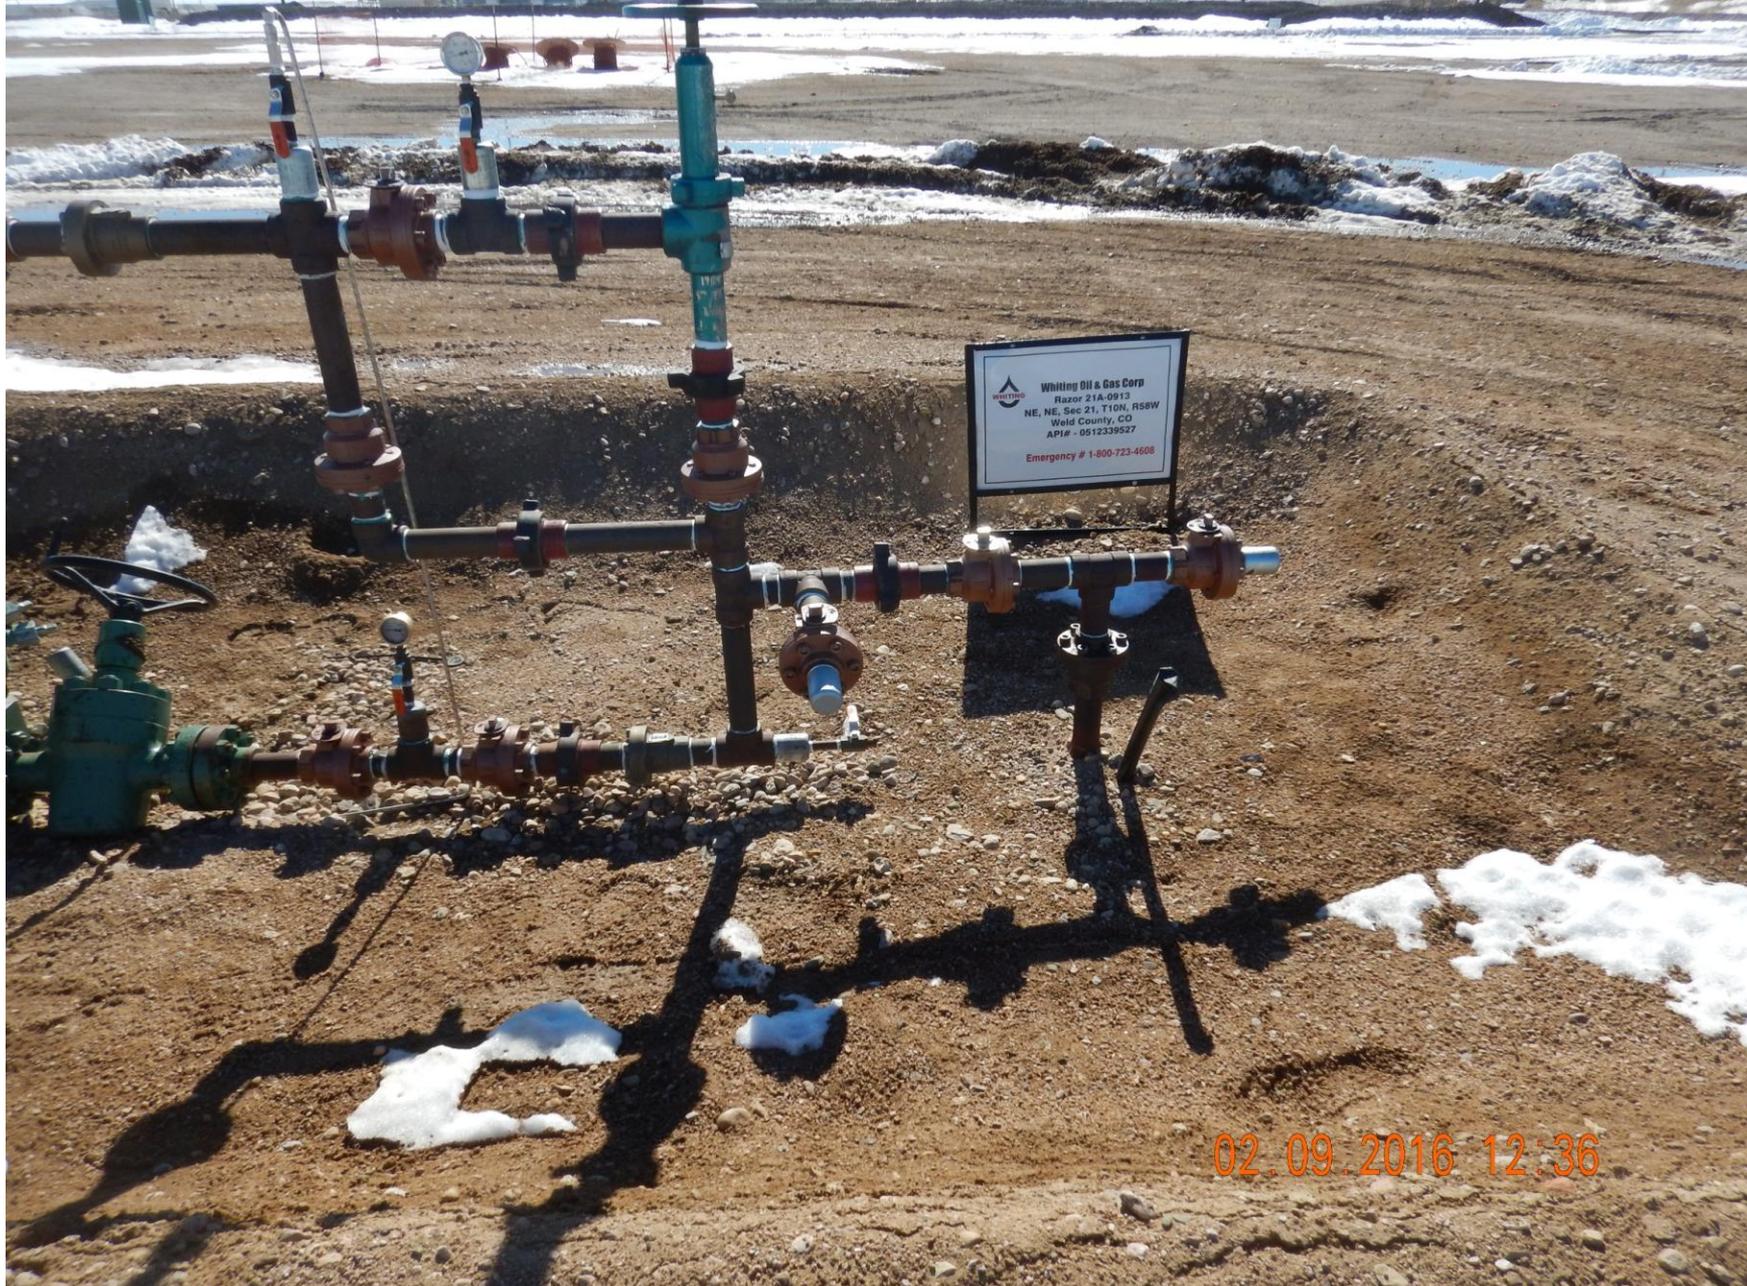
Figure 6: Photo of sign at 123-39527

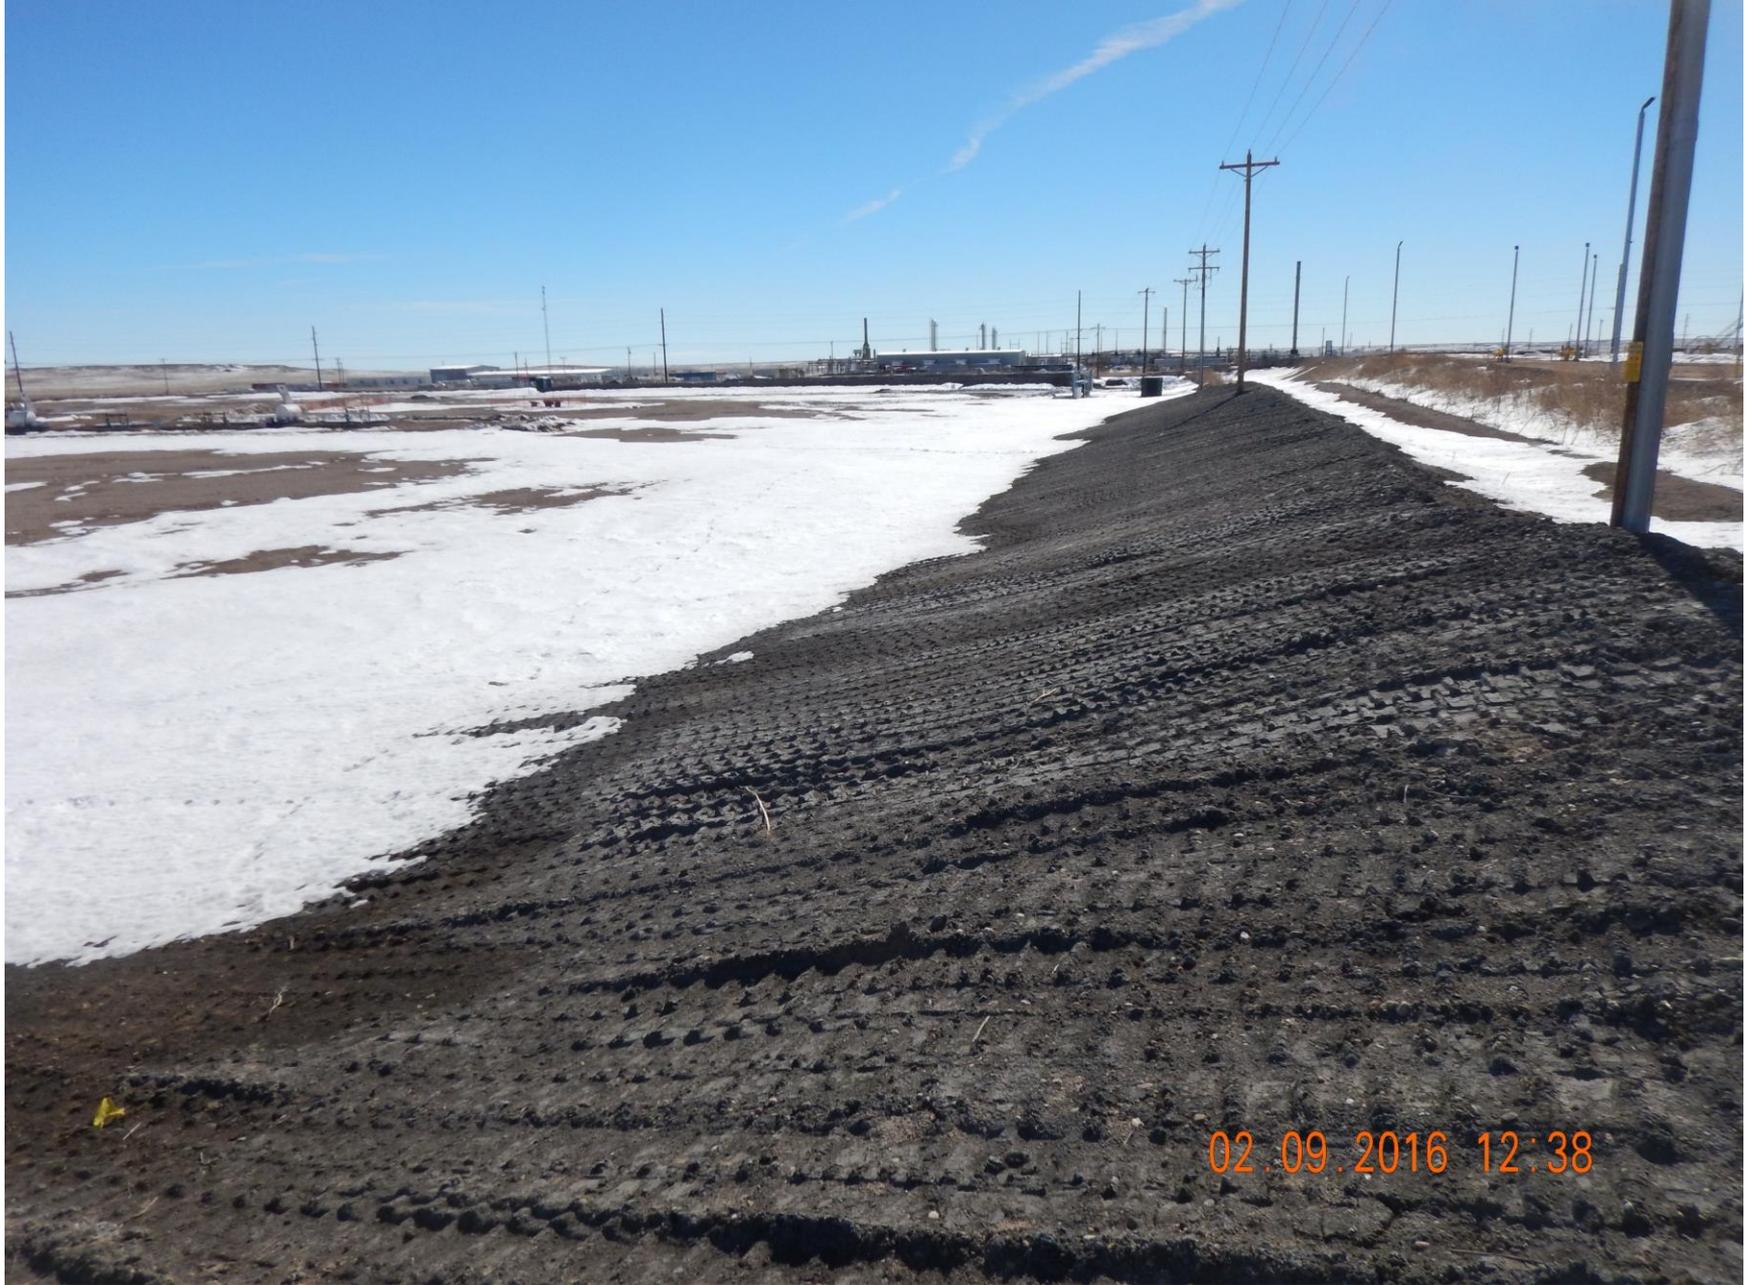
Figure 7: Photo taken from northwest end of location, facing south.

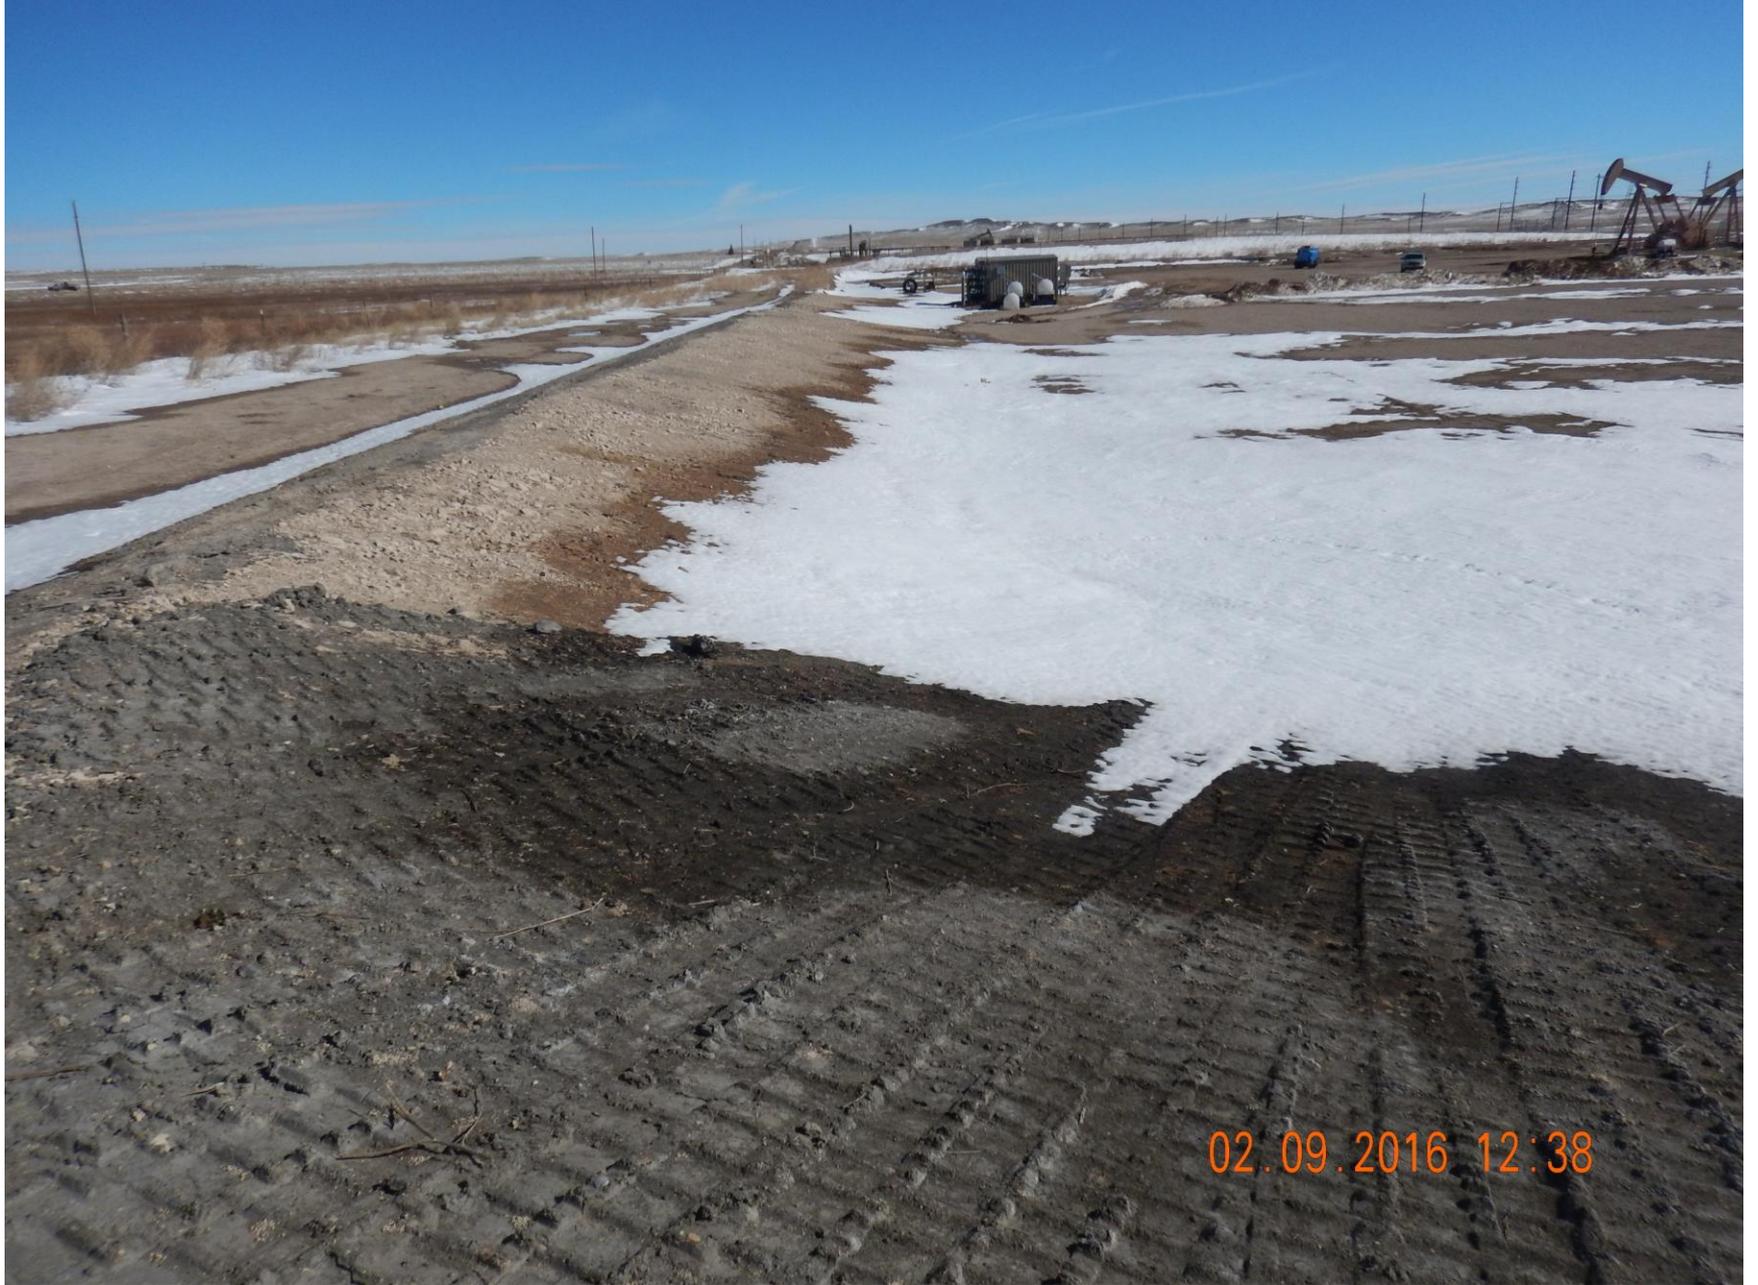
Figure 8: Photo taken from northwest end of location, facing east.

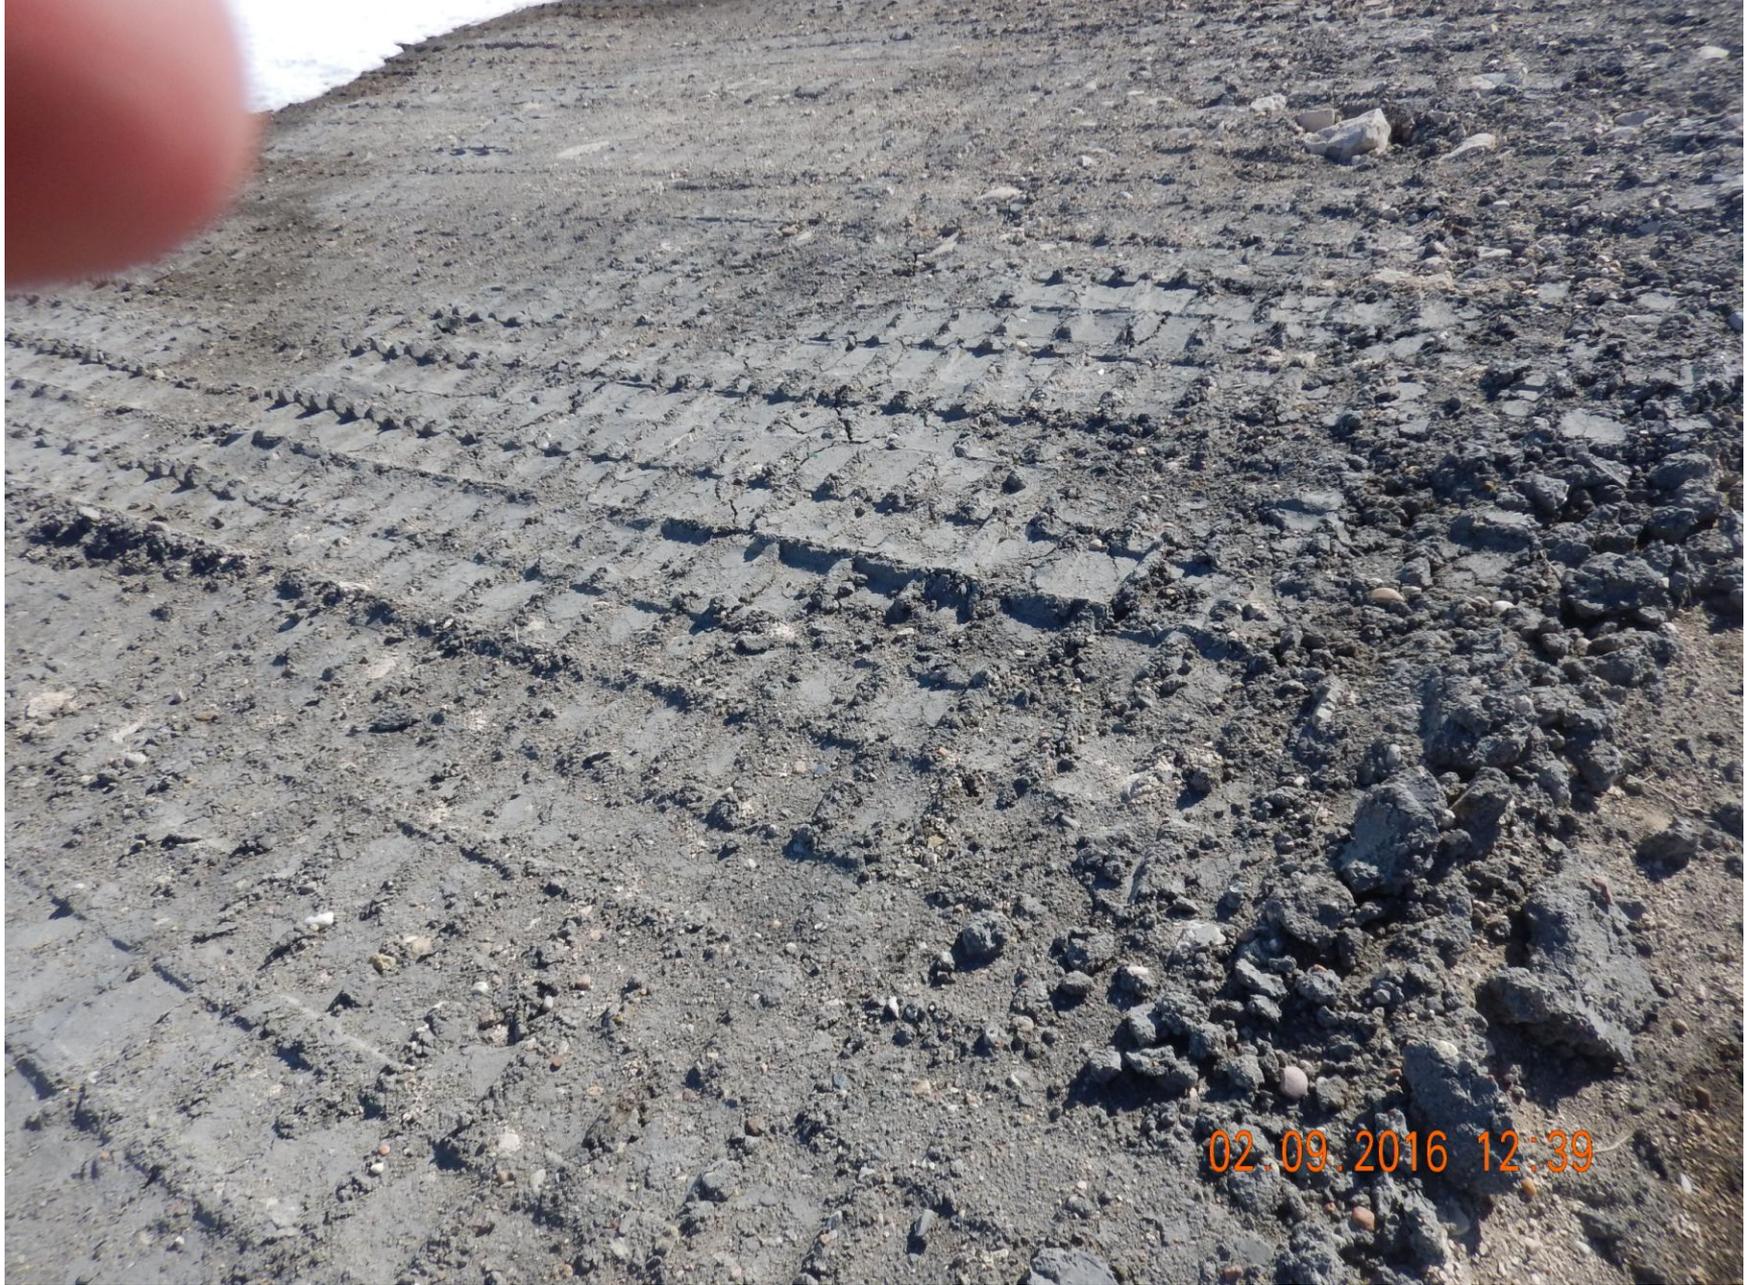
Figure 9: Photo of slope on west end of location. Soil appears to be drill cuttings.

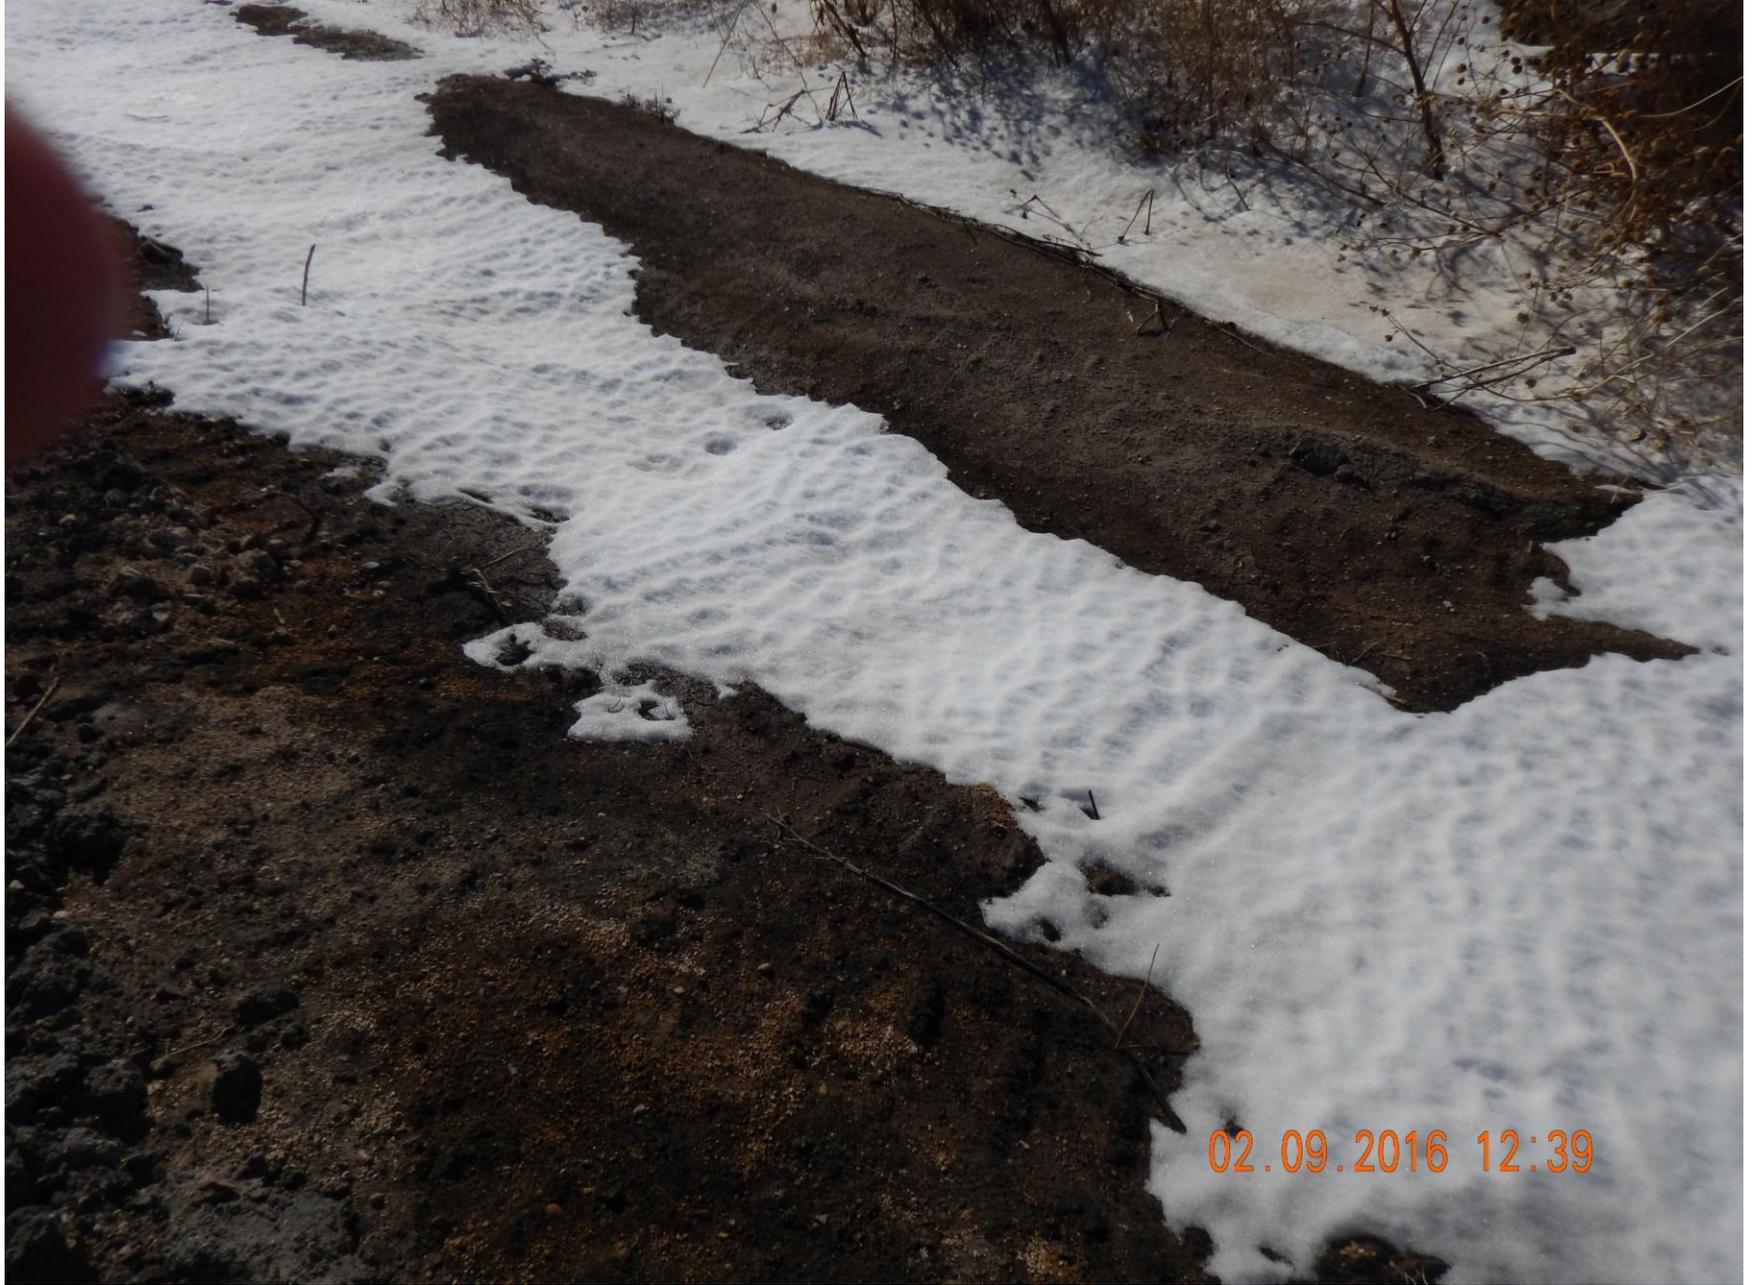
Figure 10: Photo of stormwater ditch on west end of location.
