Interim Reclamation Inspection

2/9/2016

Operator: Whiting Oil and Gas

Location ID: 433919

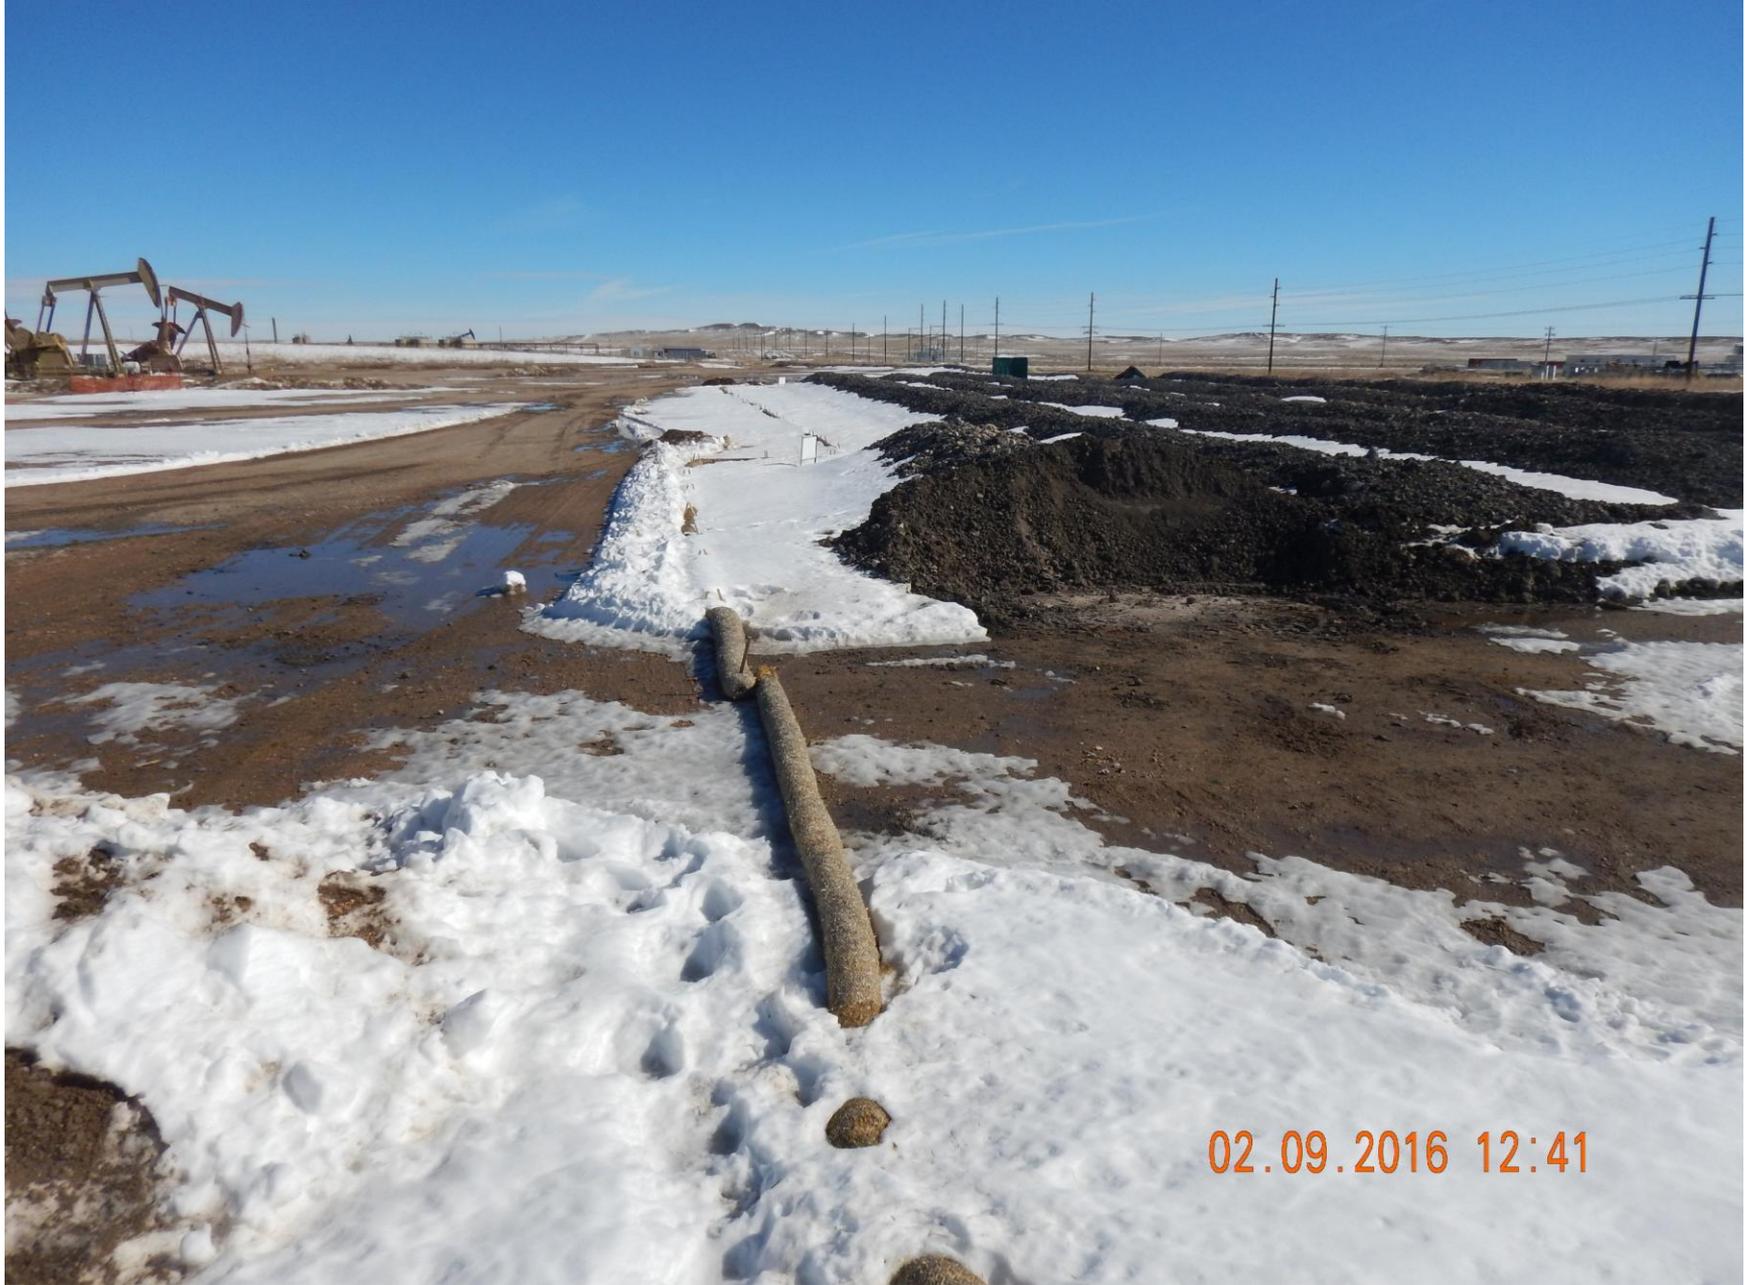
Figure 11: Photo taken southwest end of location, facing east. Photo of drill cuttings stored on location, and stormwater waddles.

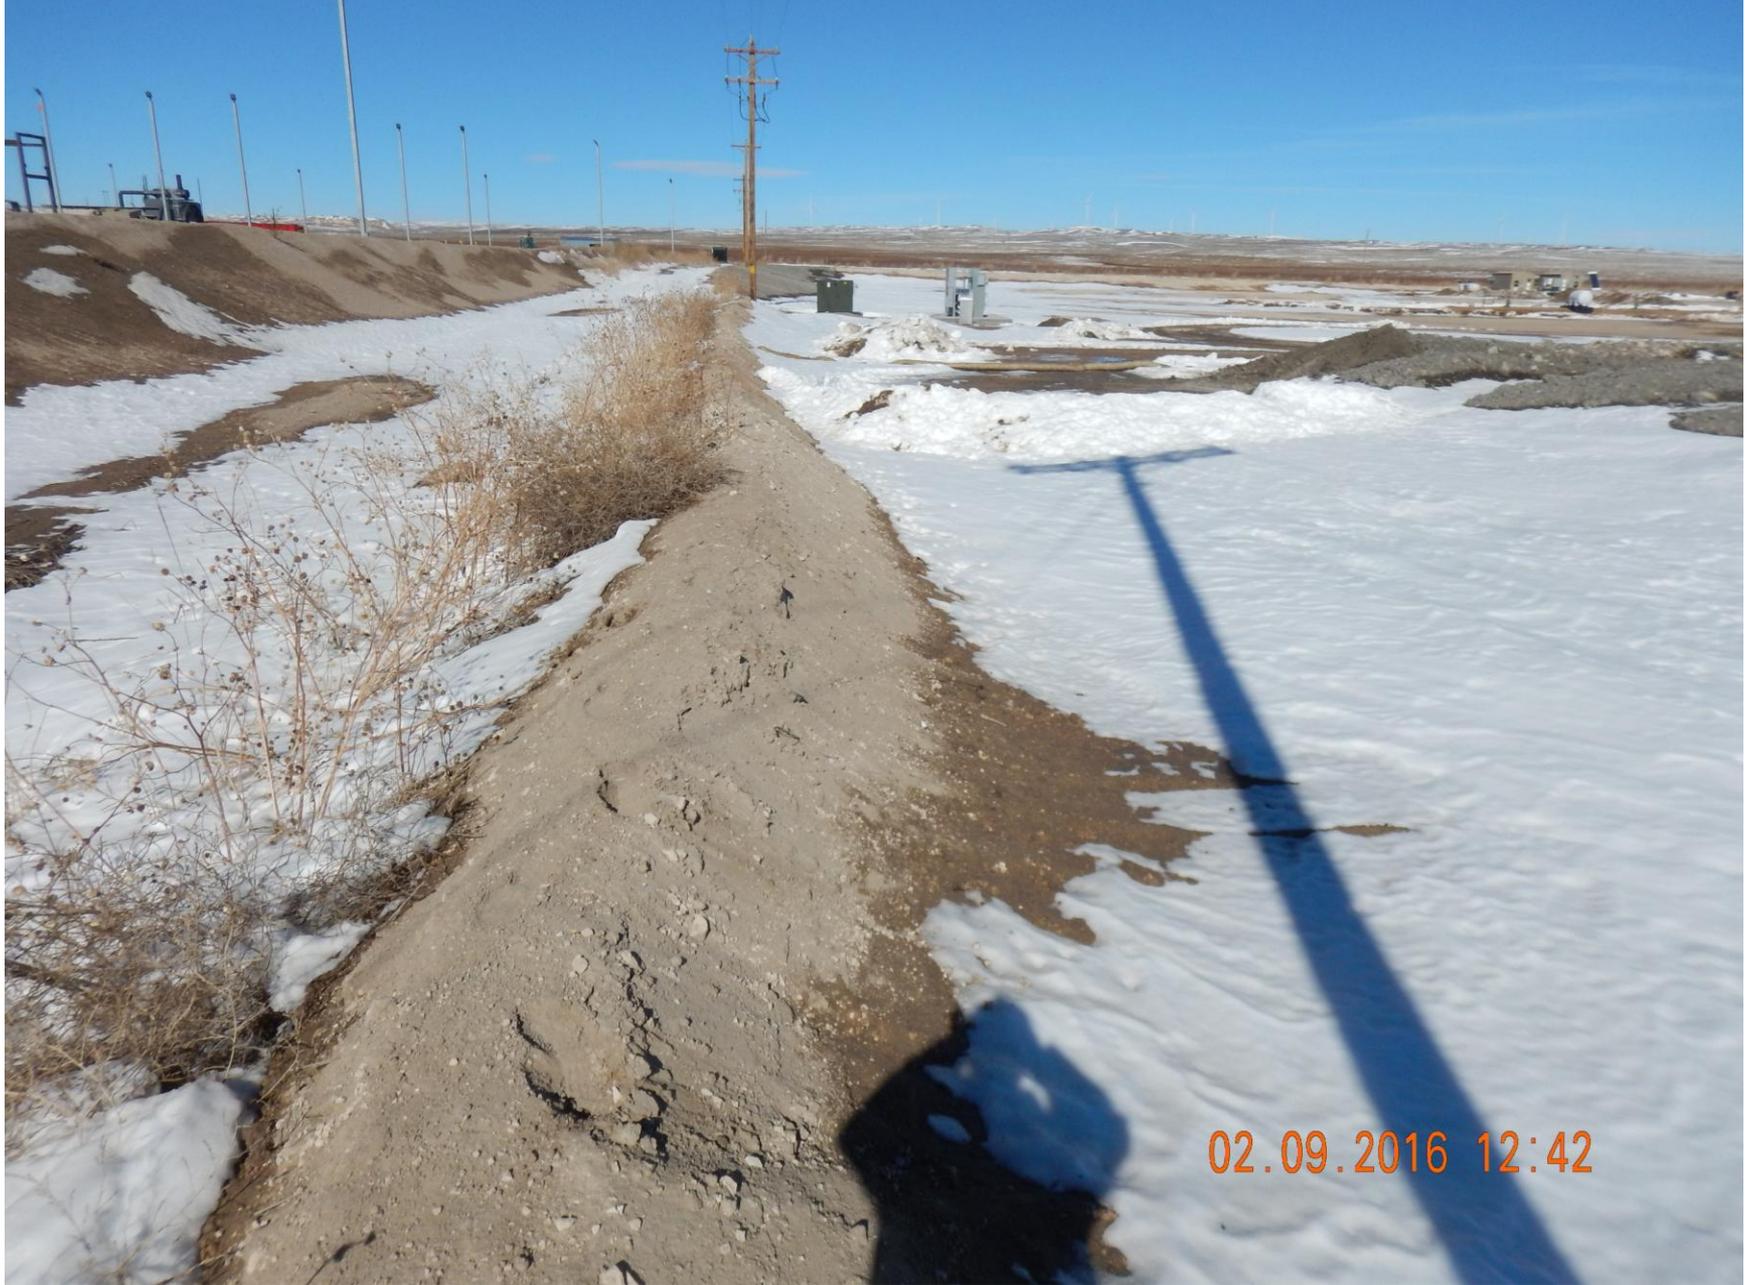
Figure 12: Photo taken southwest end of location, facing north. Photo of stormwater control berm.

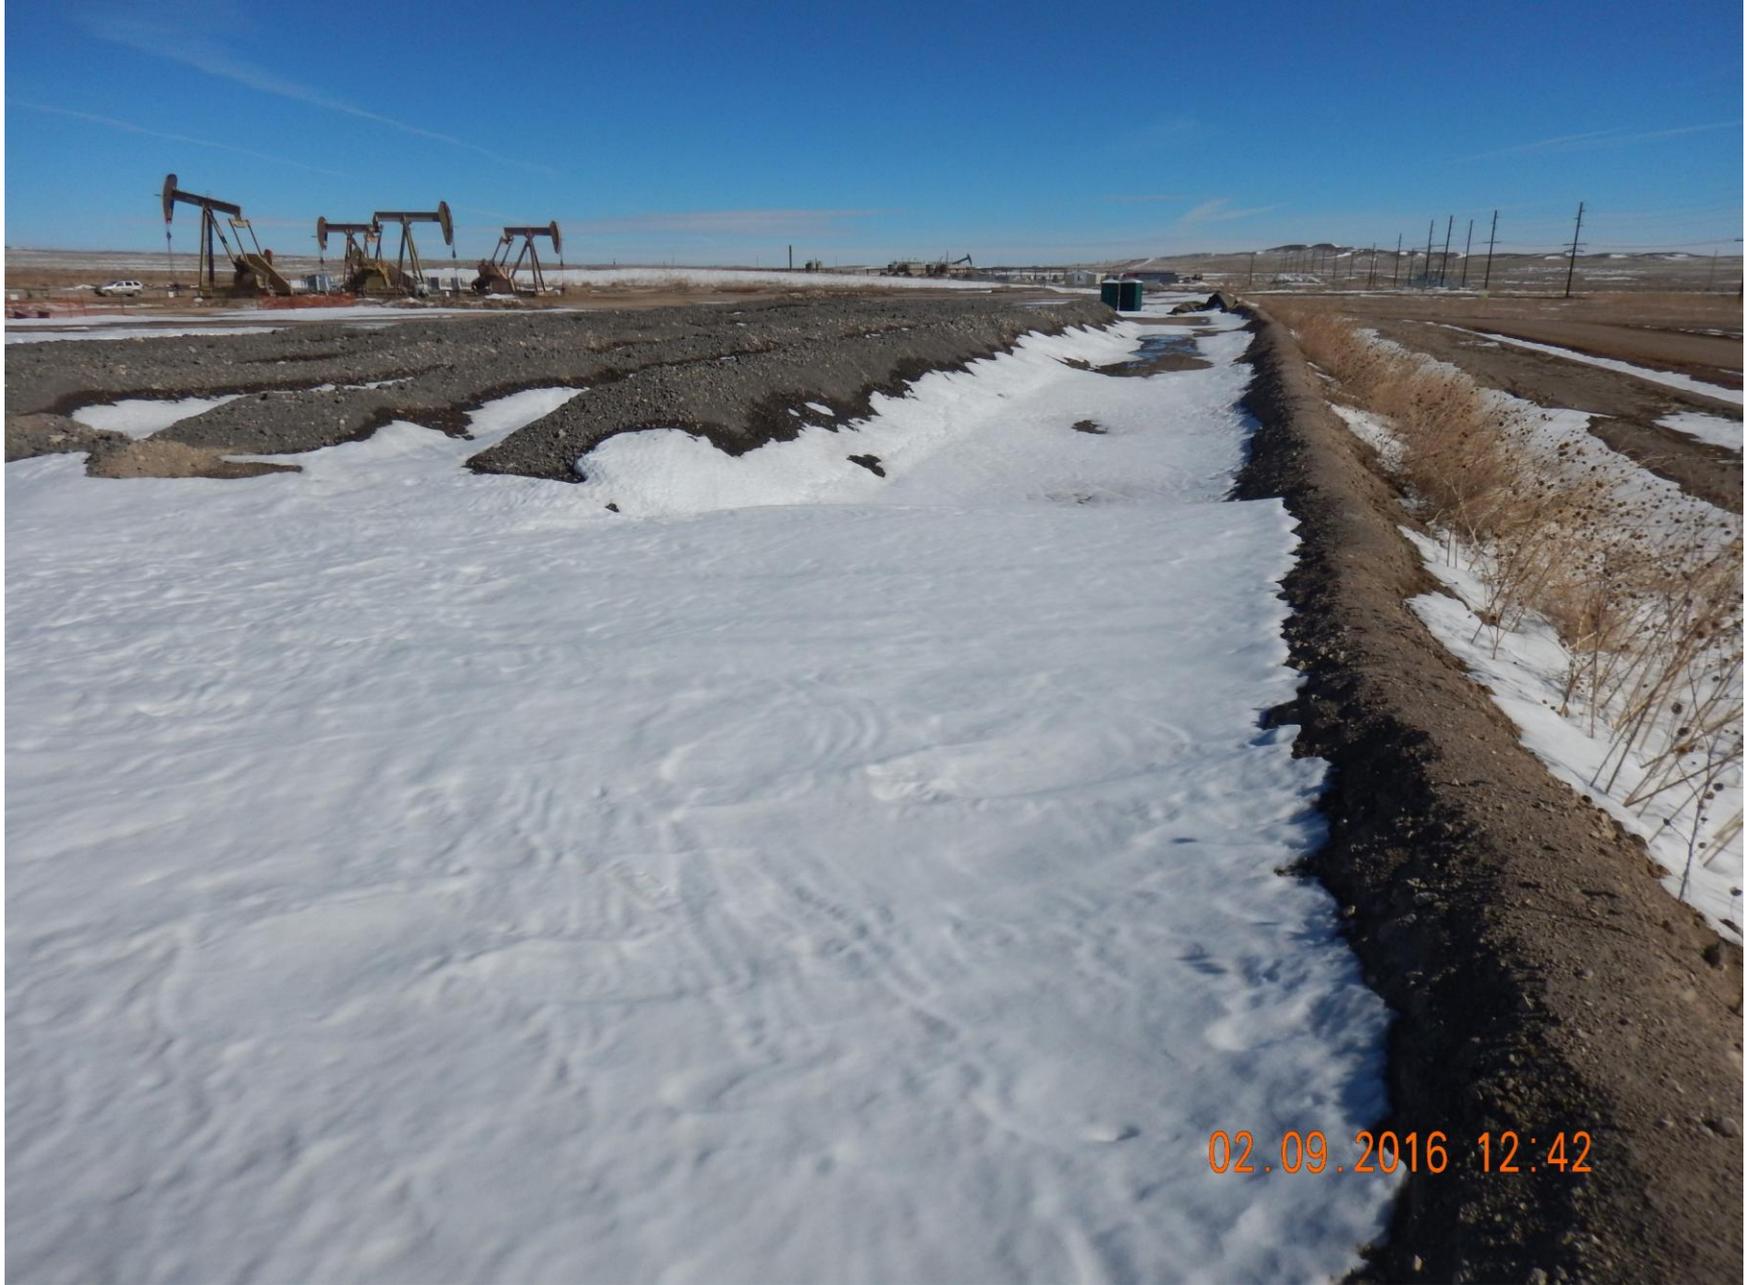
Figure 13: Photo taken southwest end of location, facing east. Photo of drill cuttings stored on location, and stormwater berm.

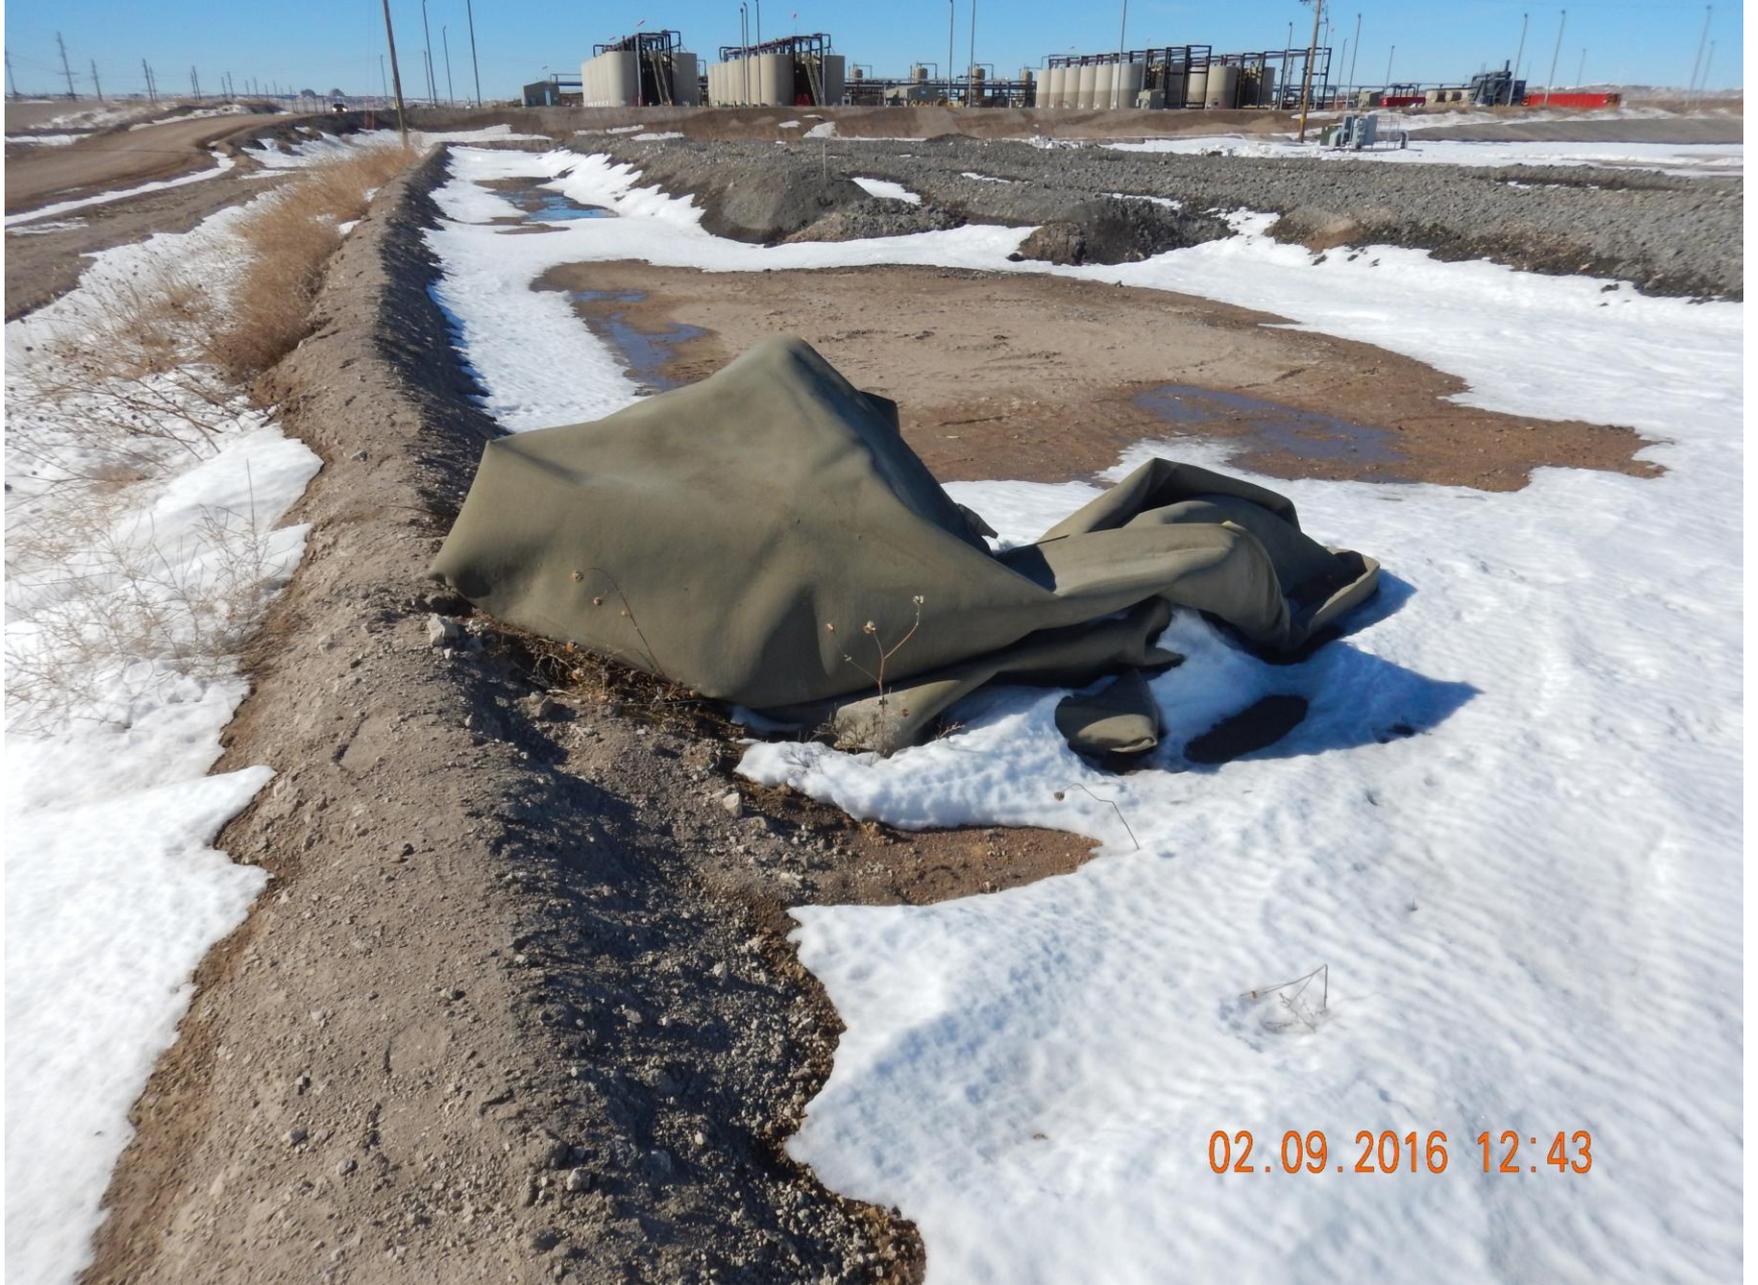
Figure 14: Photo taken from southern end of location. Photo of what appears to be a tarp on project area.

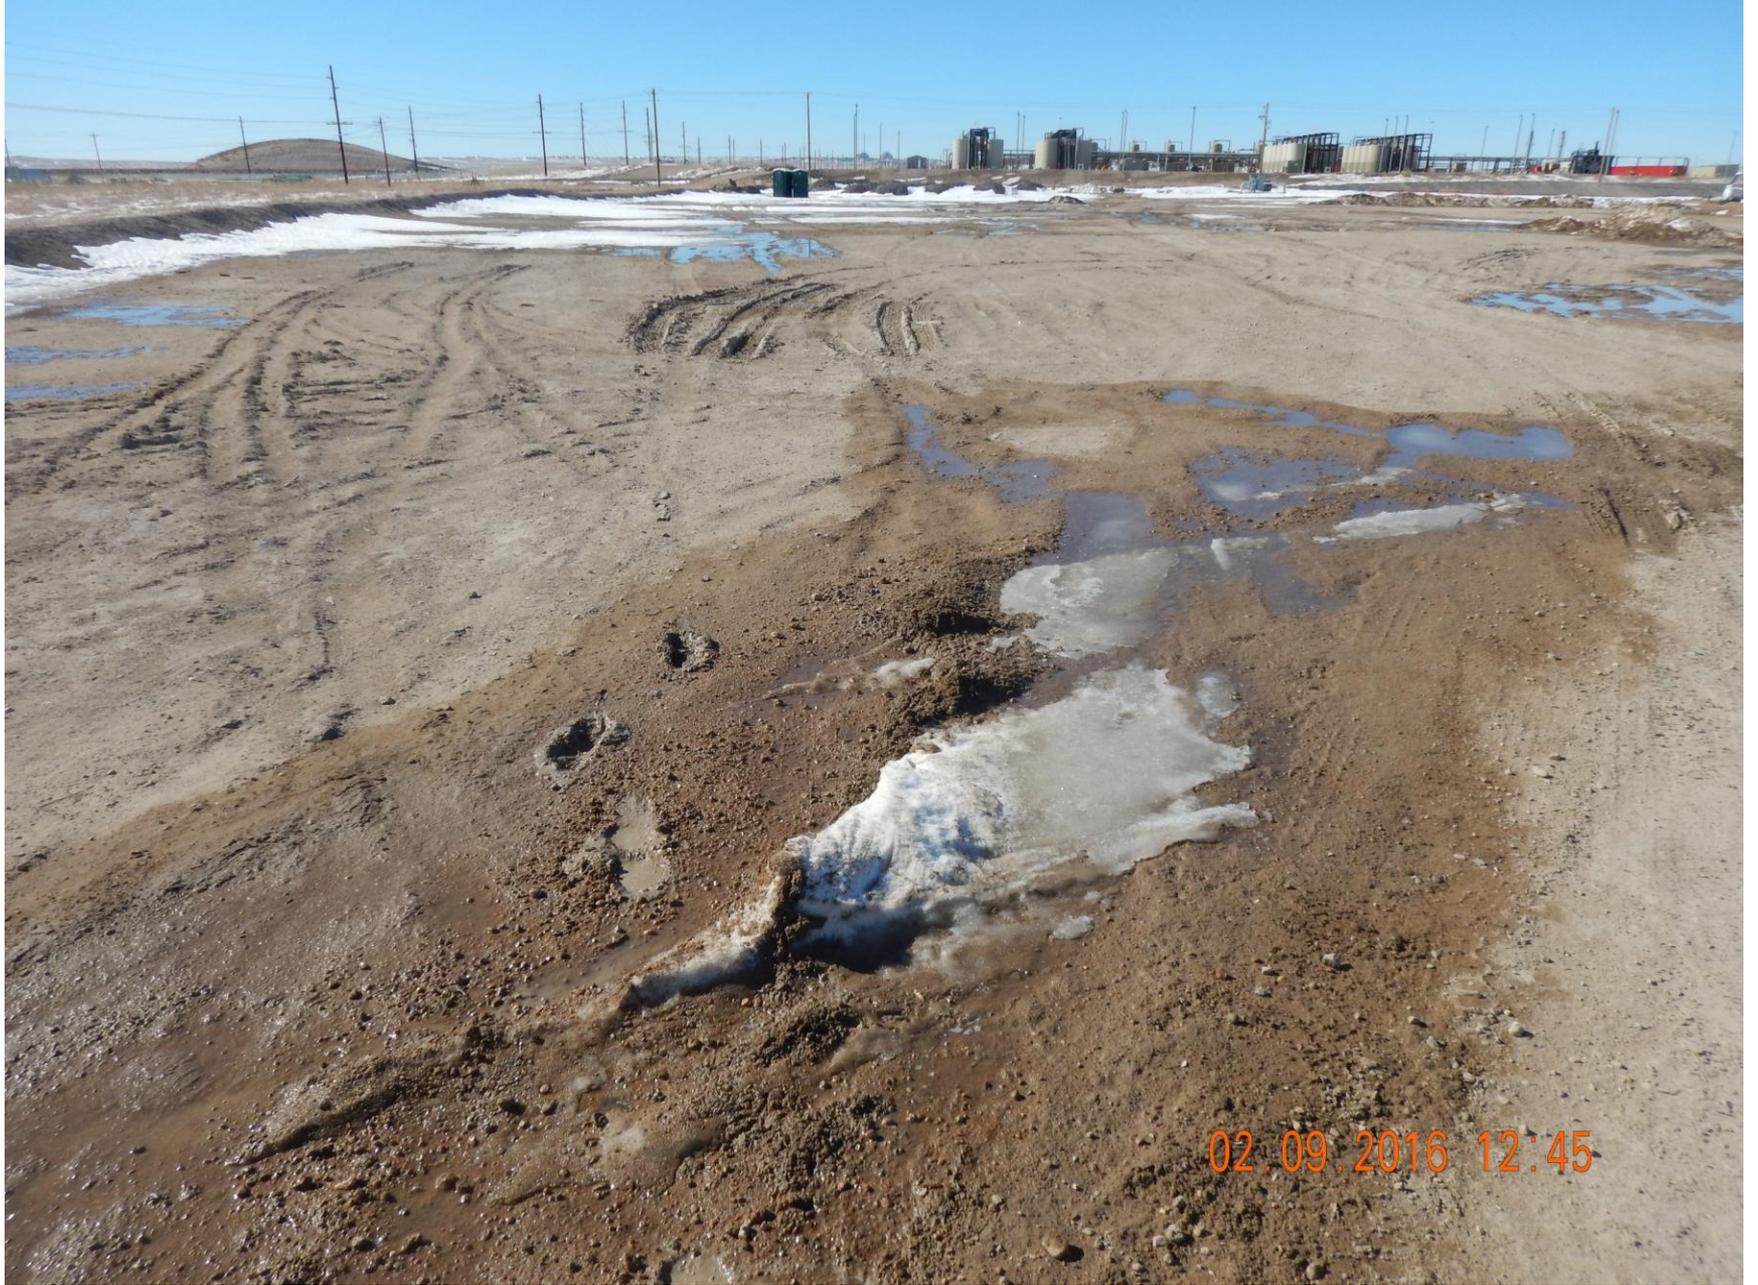
Figure 15: Photo taken from southeast end of location, facing west. Photo of project area.

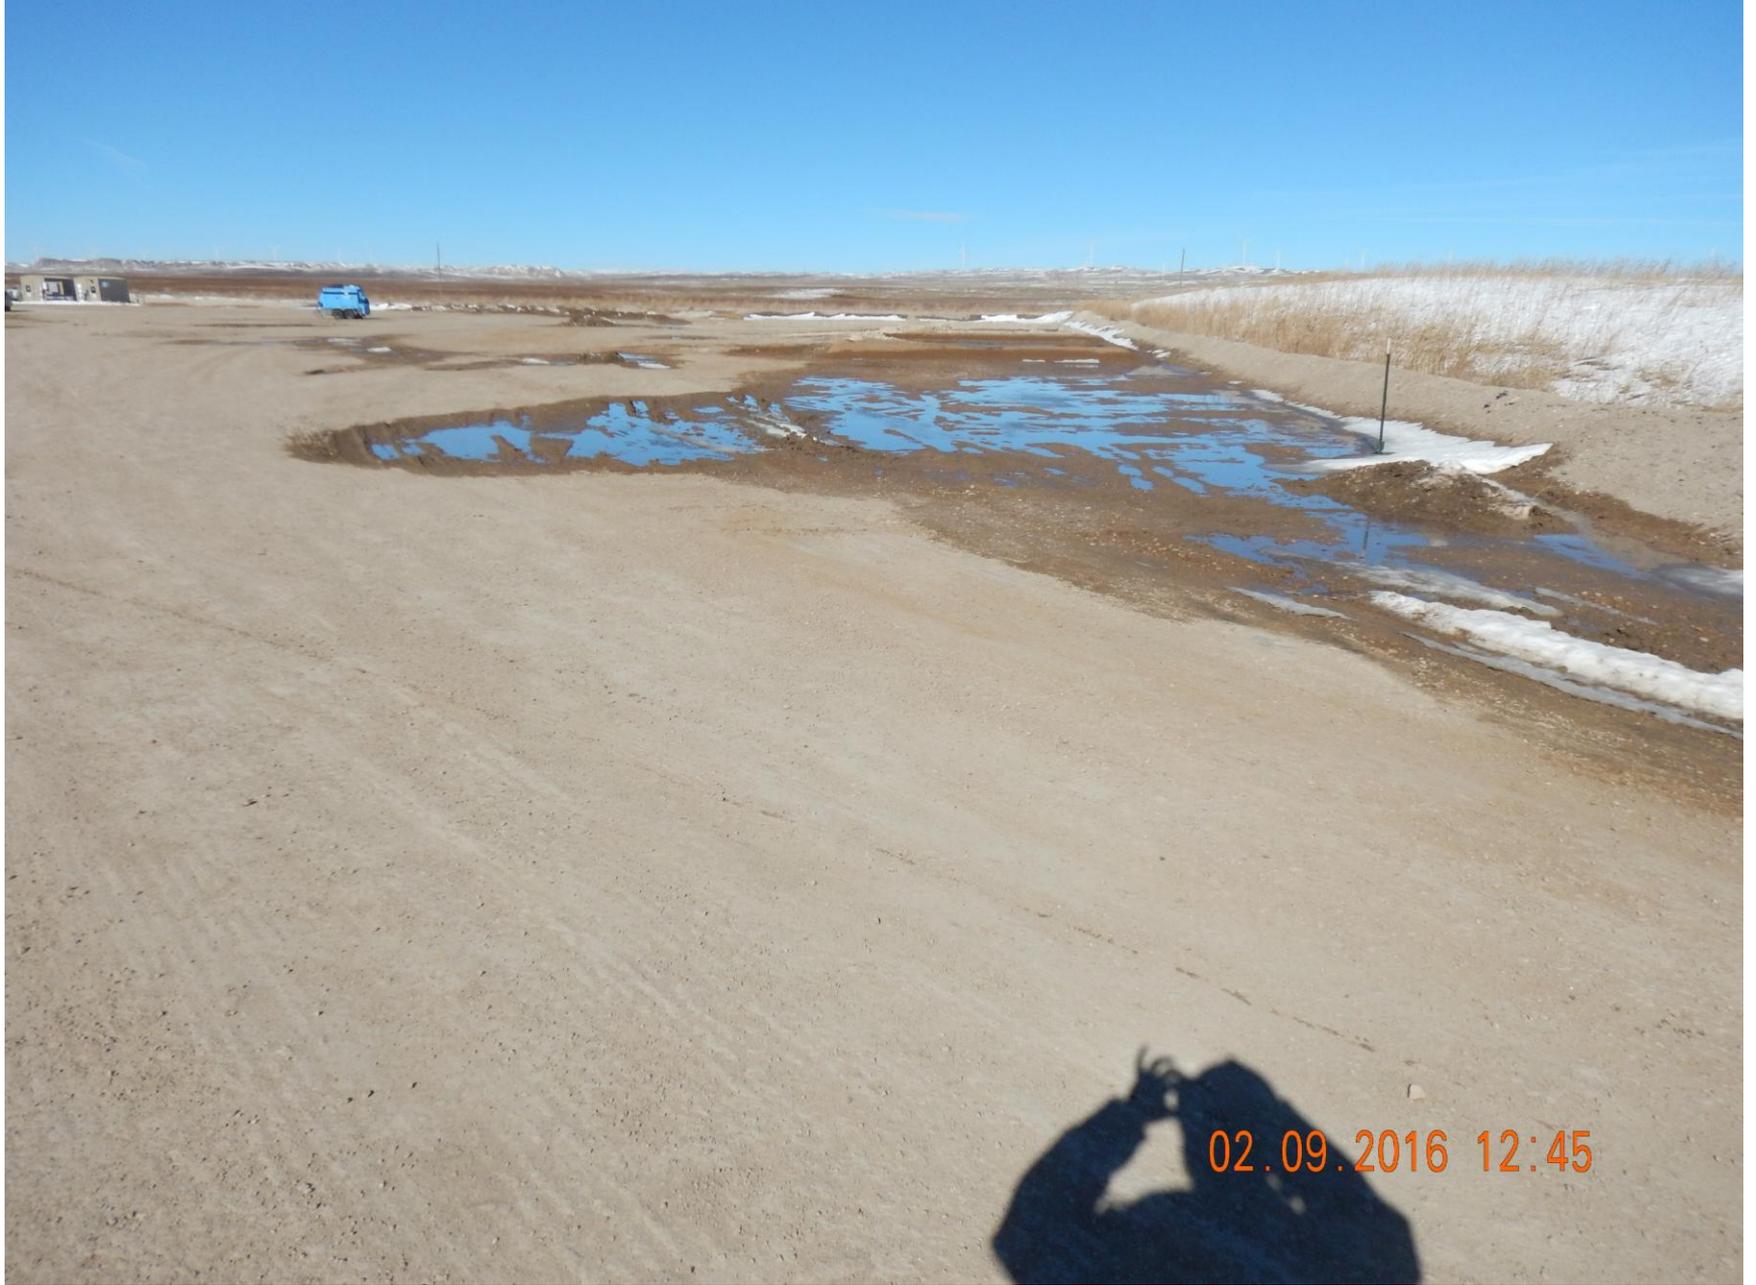
Figure 16: Photo taken from southeast end of location, facing north. Photo shows interim and project areas, and stormwater control berm.

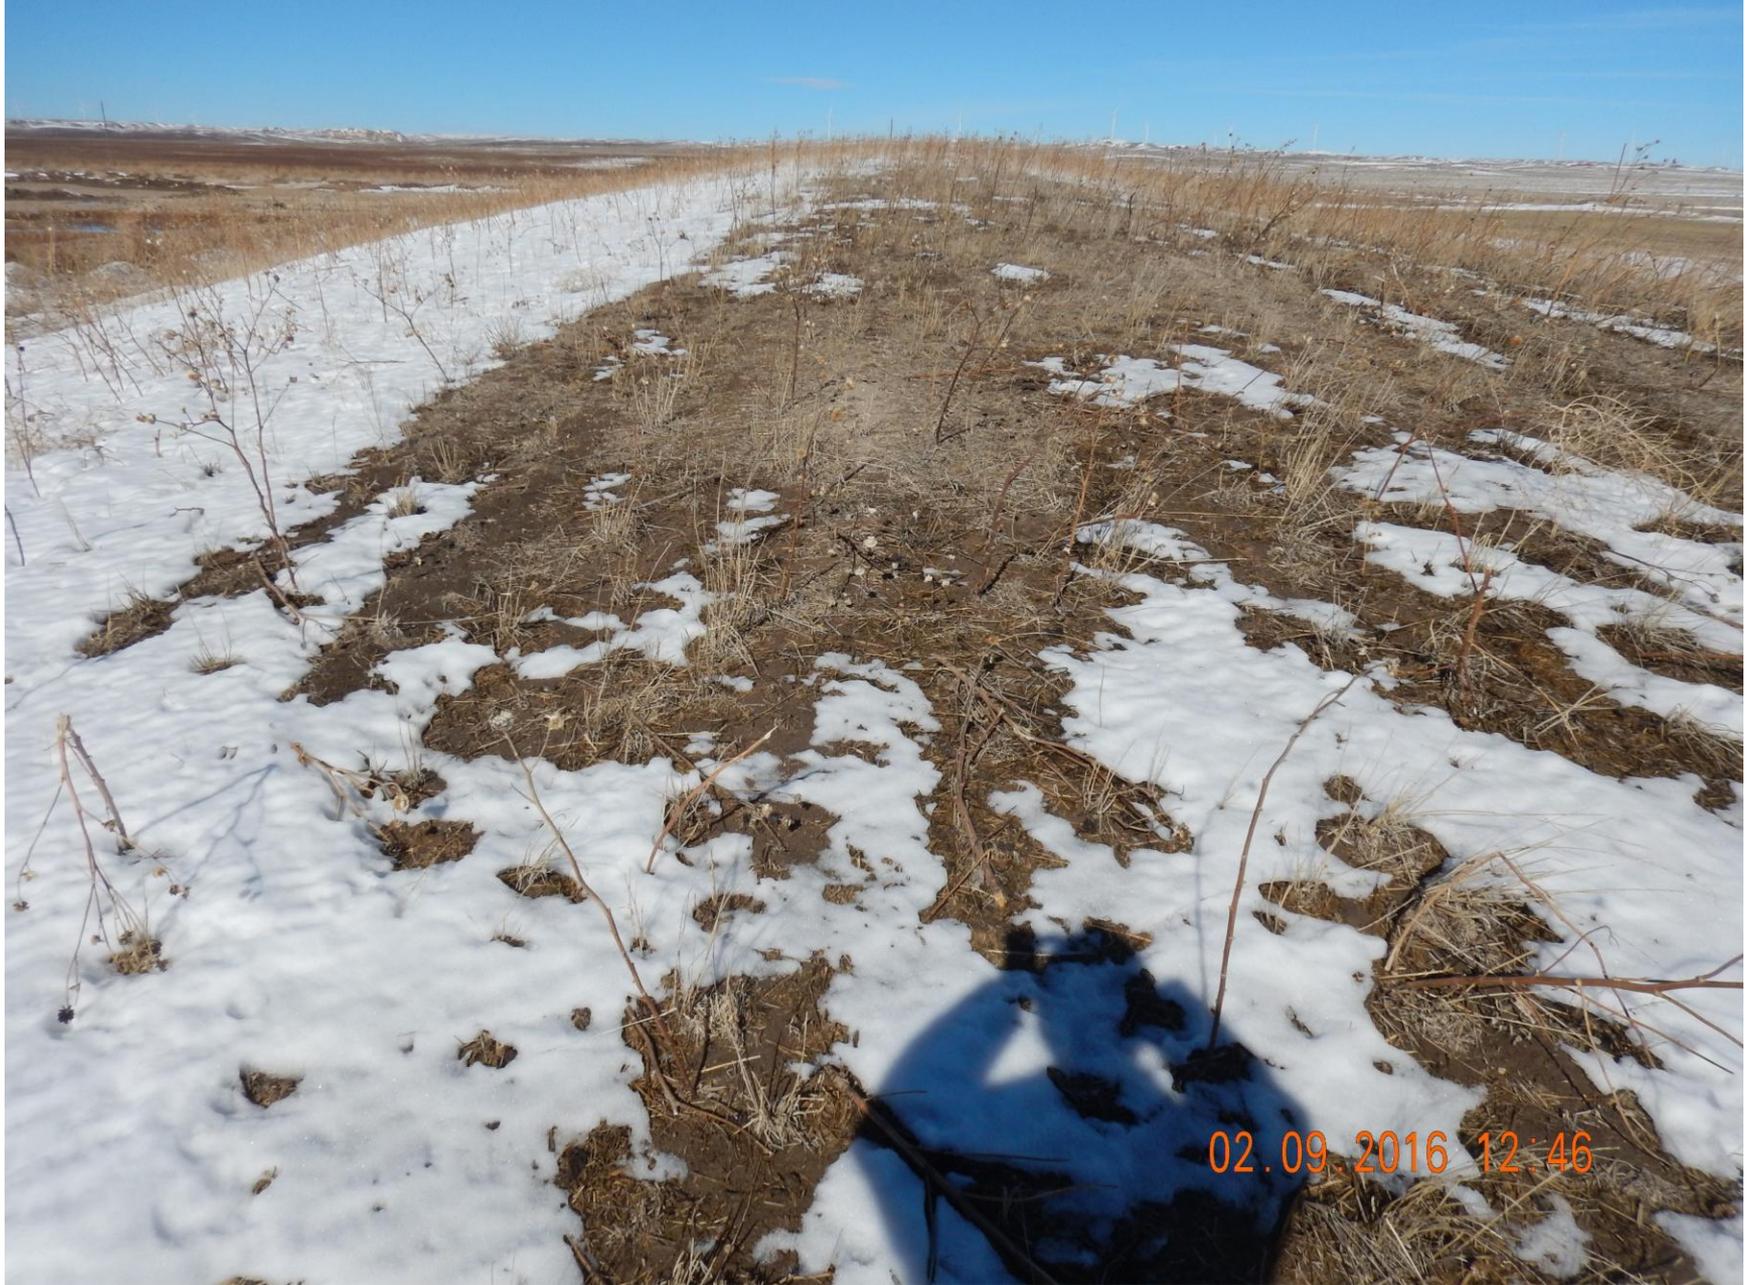
Figure 17: Photo taken from east end of location on topsoil berm, facing north. Photo shows sparse desirable vegetation on interim area.

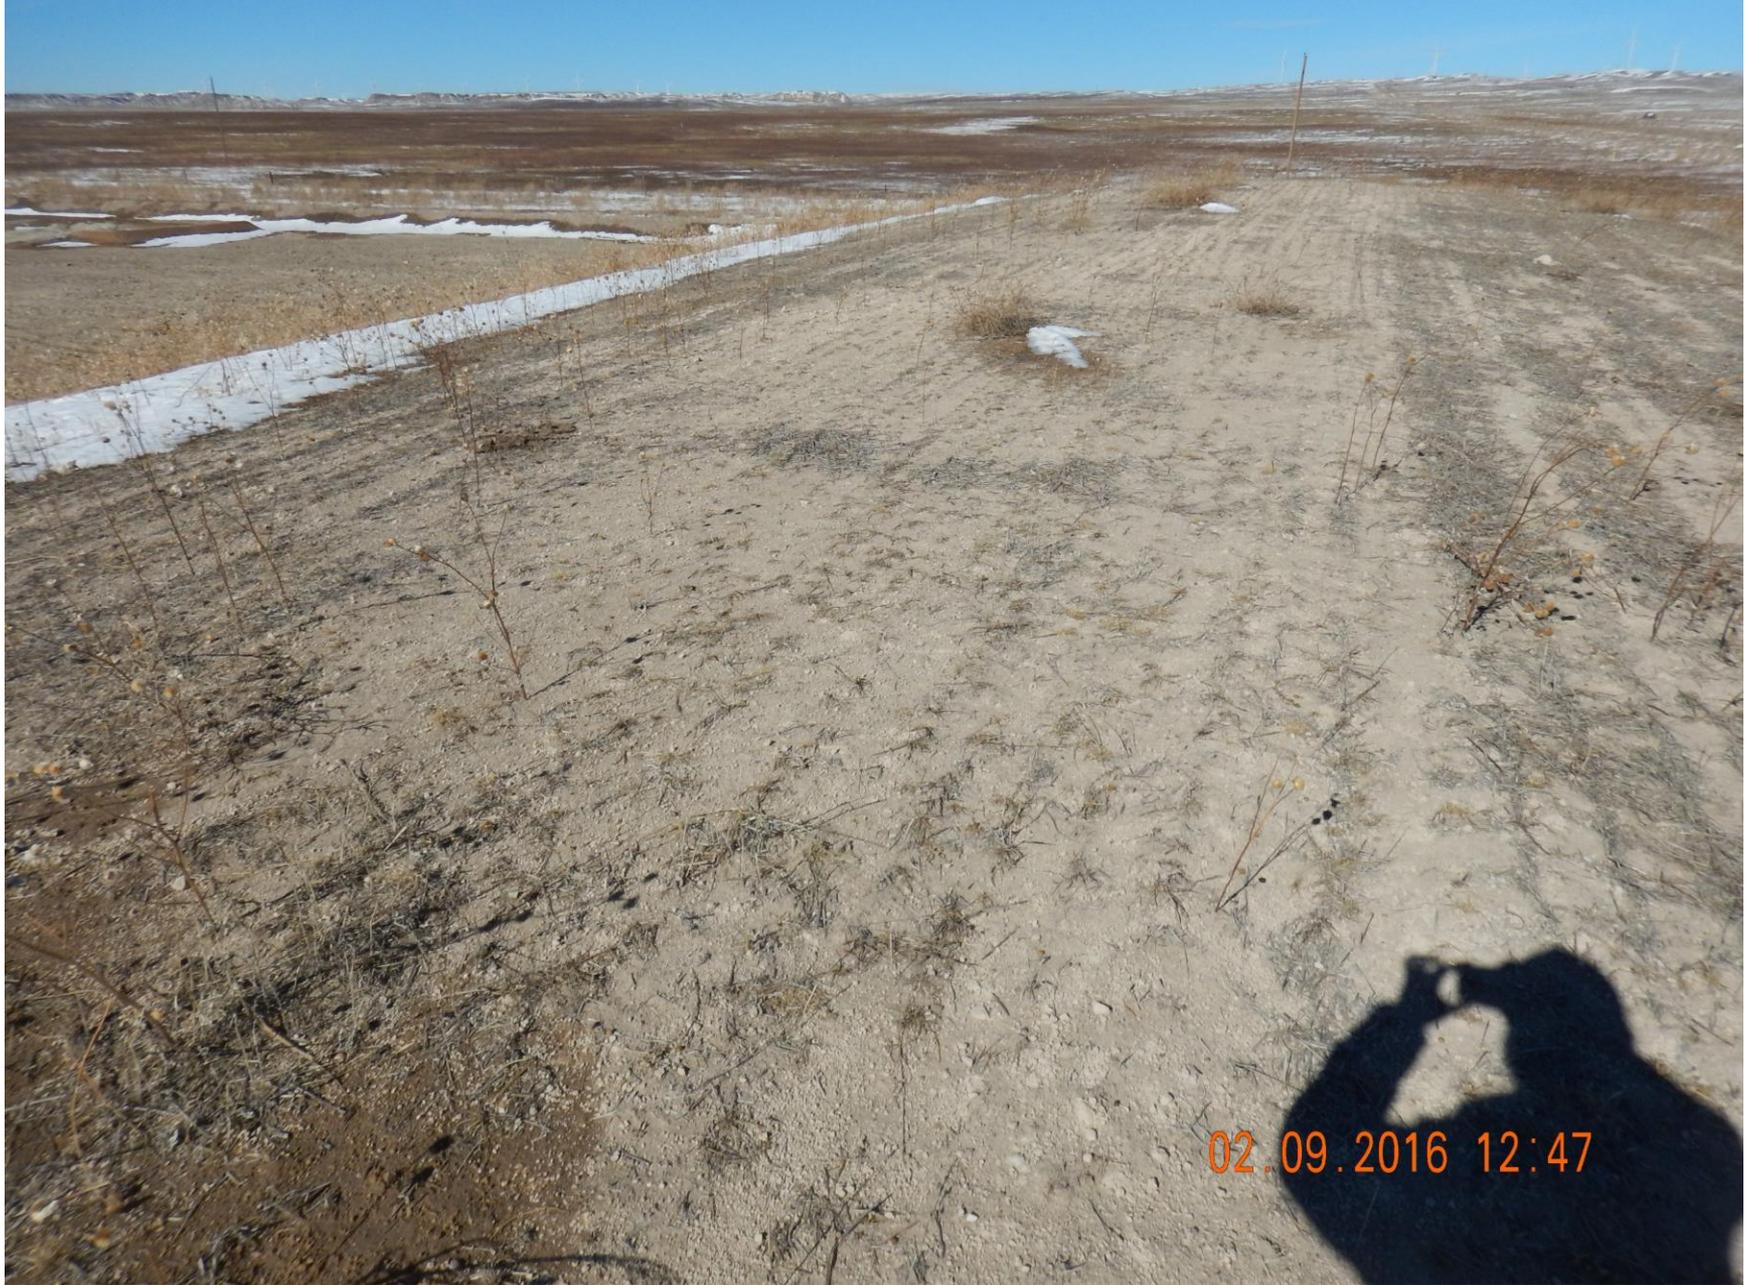
Figure 18: Photo taken from east end of location on topsoil berm, facing north. Photo shows sparse desirable vegetation on interim area.

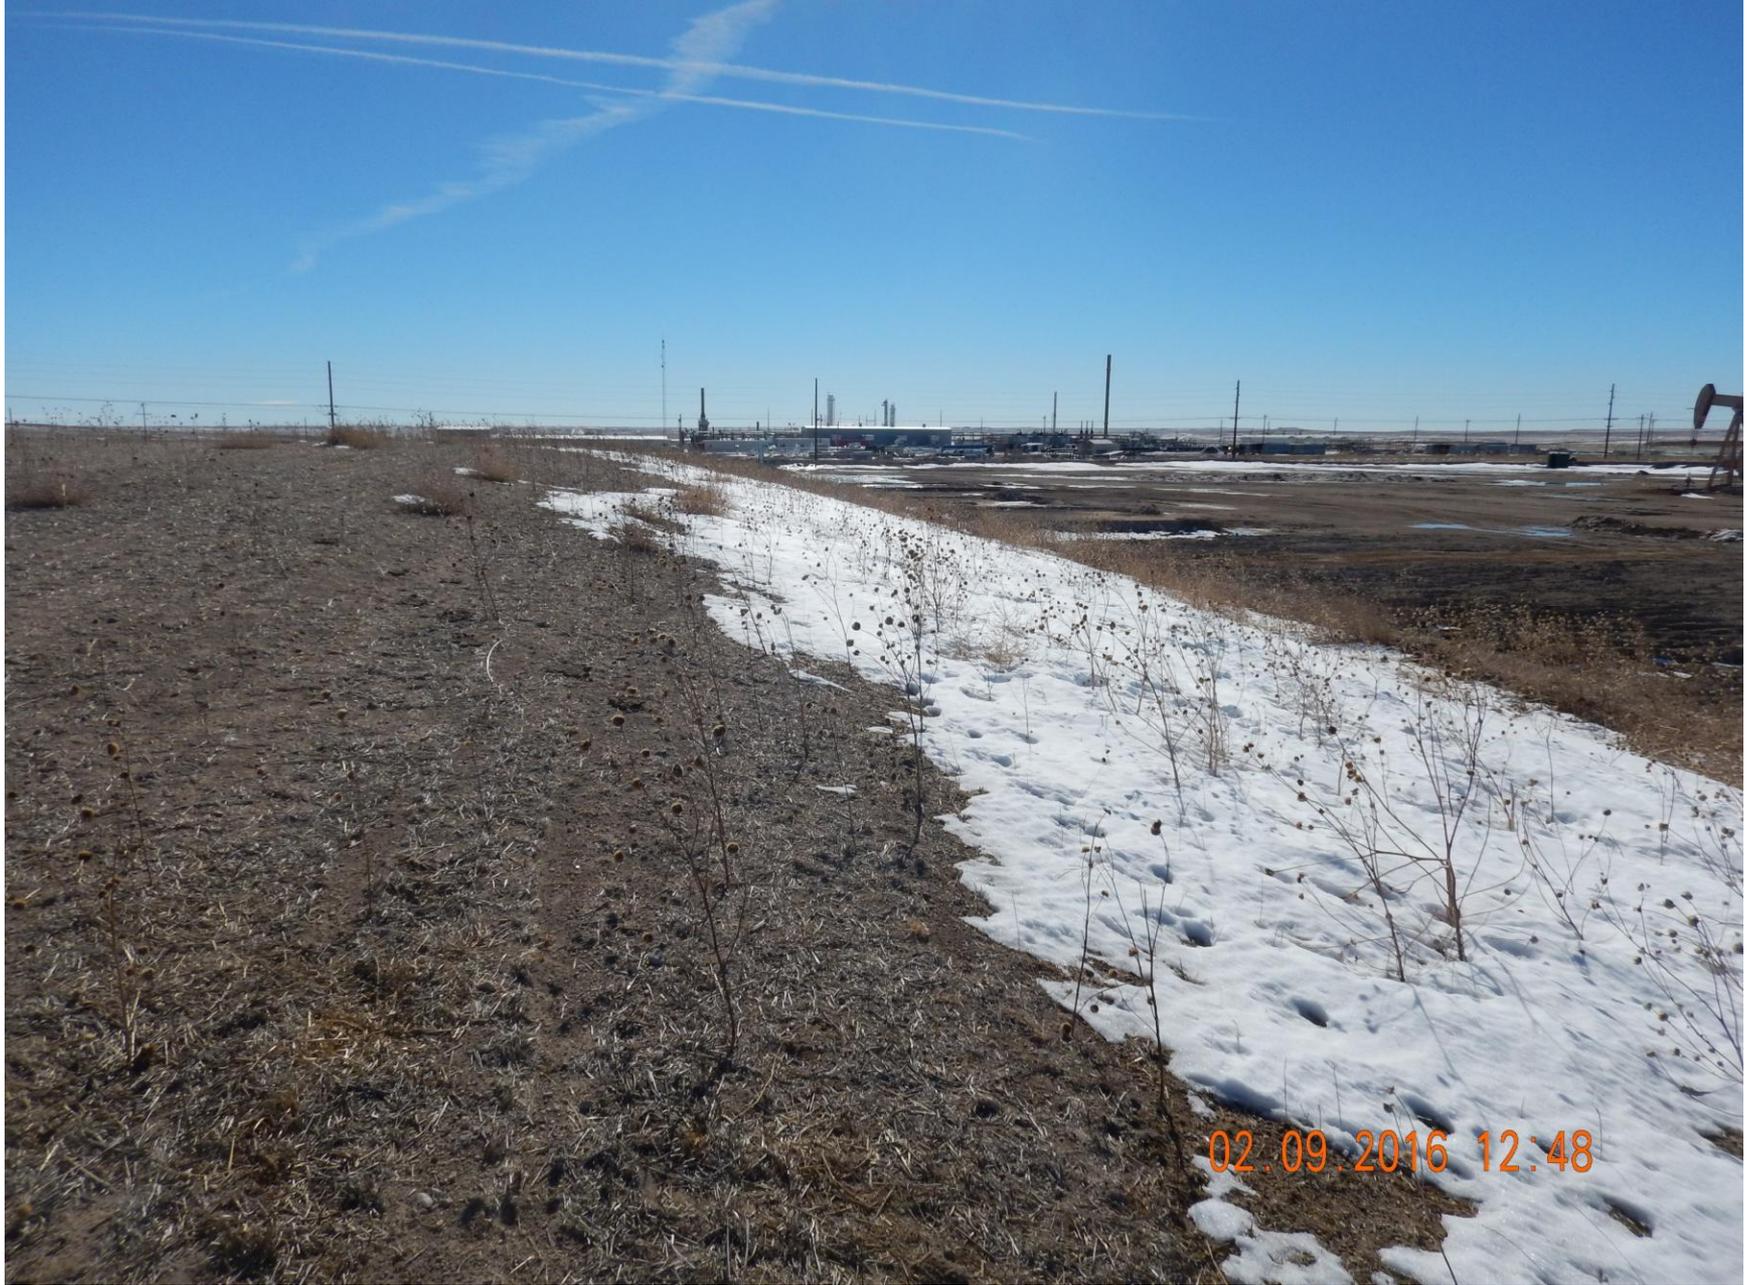
Figure 19: Photo taken from east end of location on topsoil berm, facing south. Photo shows interim and project area.

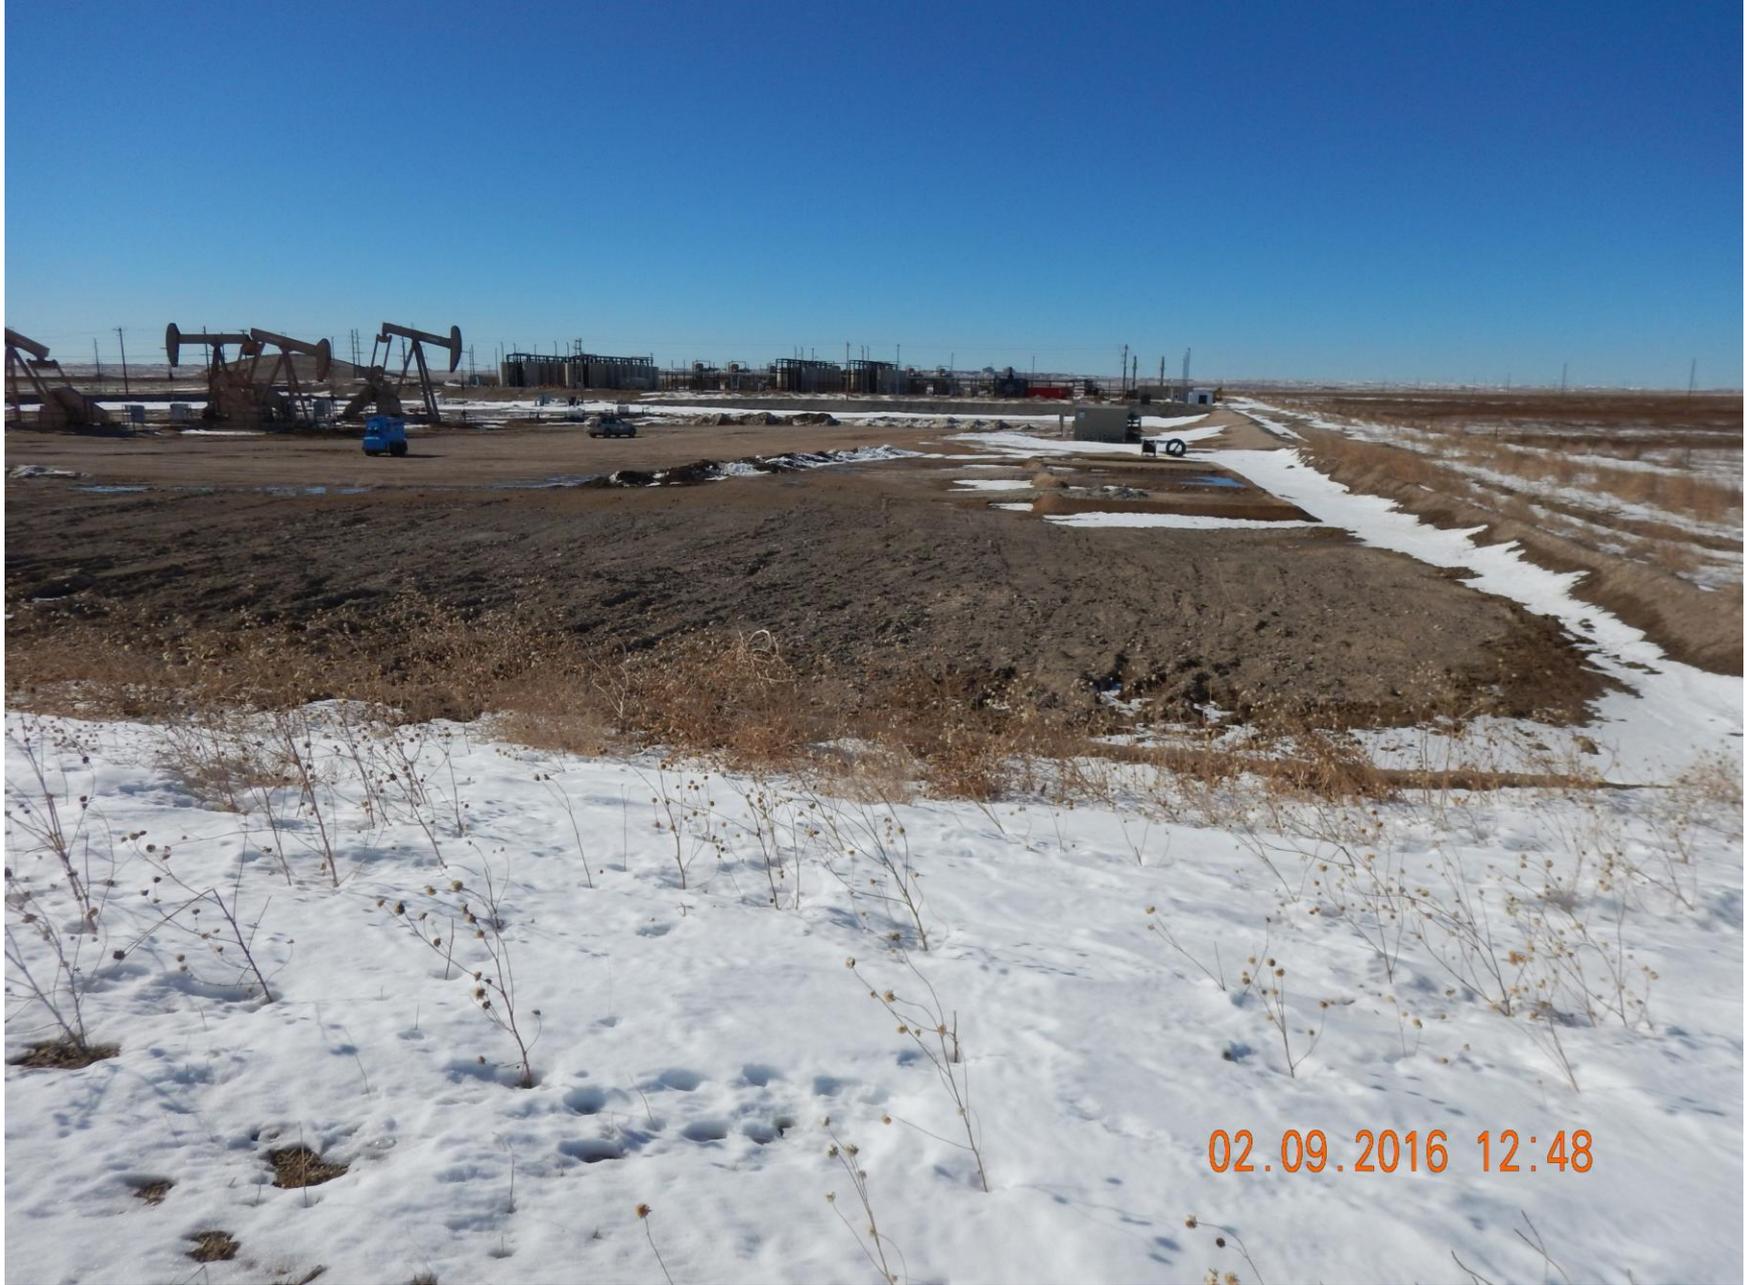
Figure 20: Photo taken from east end of location on topsoil berm, facing west. Photo shows interim and project areas.
