## Construction Inspection

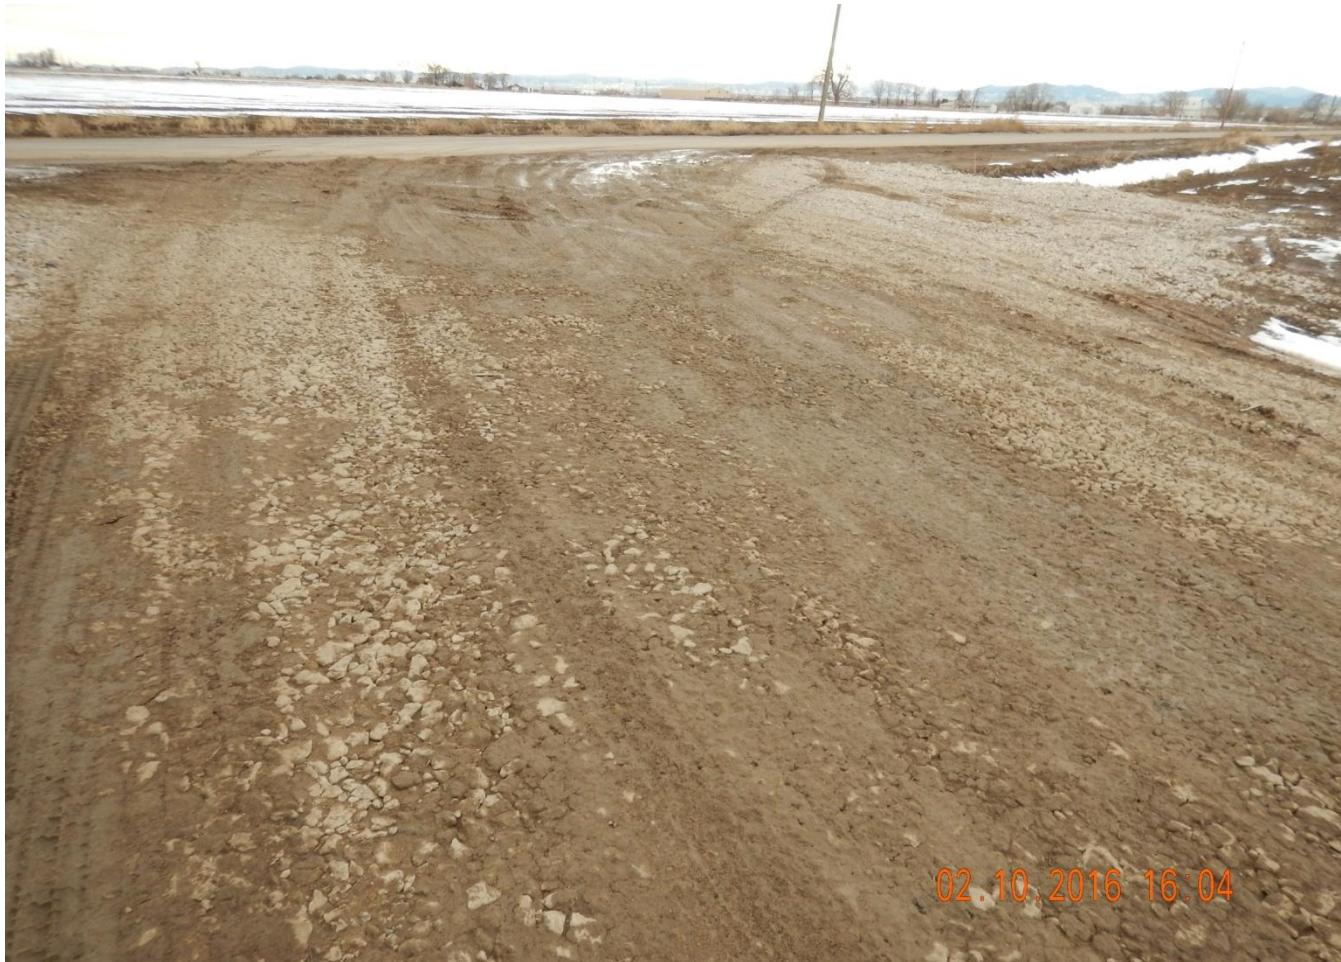
**Photo 1.** Photo taken from entrance of location, facing South. Tracking device installed to prevent sediment leaving location. Operator said gravel will be fluffed up to maintain proper functional use.

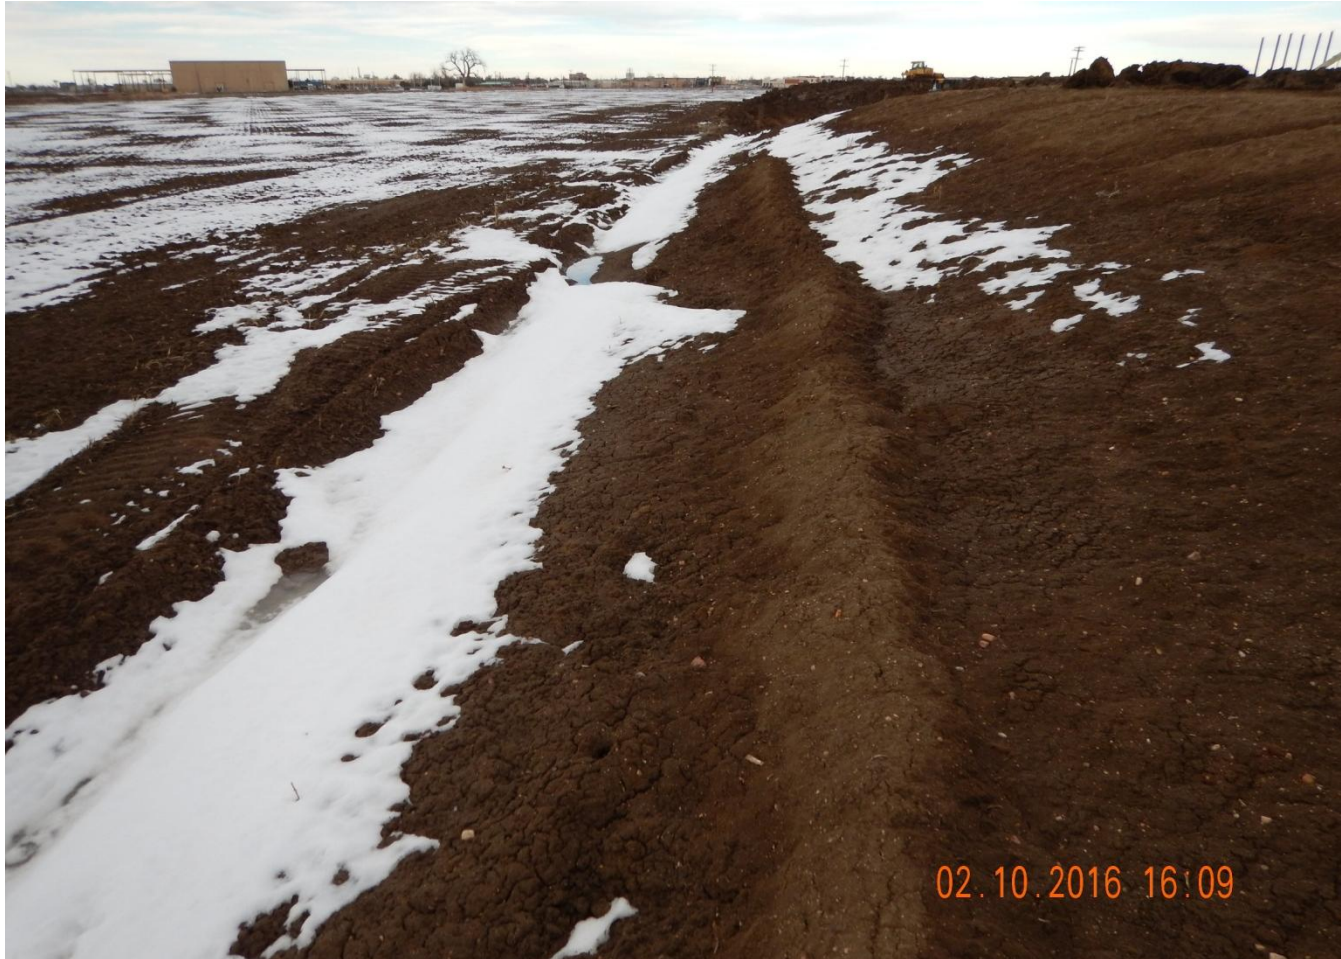
**Photo 3.** Photo taken from southwest location, facing North. Topsoil stockpile in center of photo and stormwater and sediment BMP along west-facing toe.

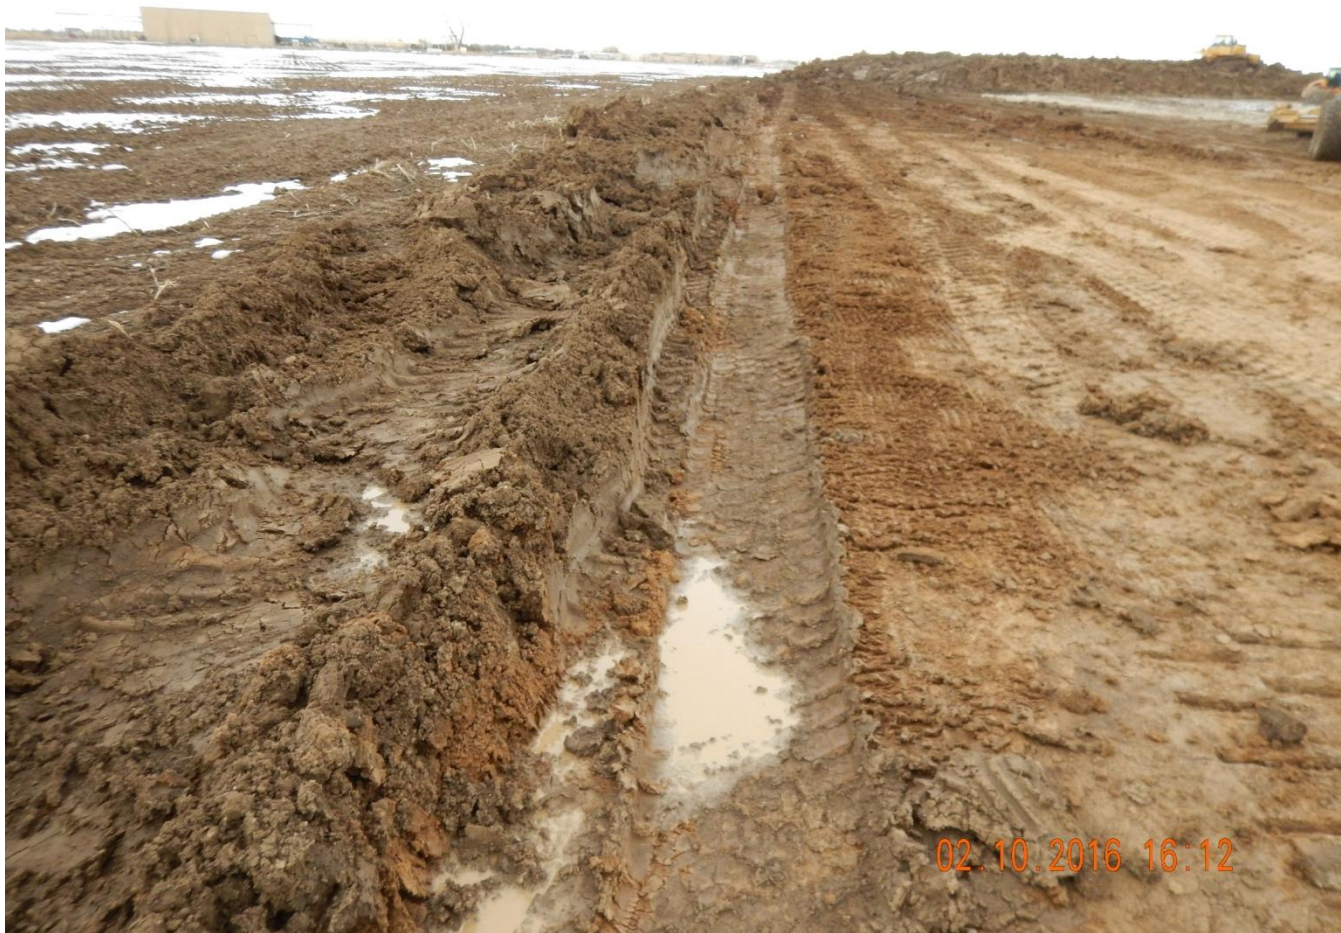
**Photo 4.** Photo taken from western location, facing North. Stormwater BMP installed along perimeter of location.

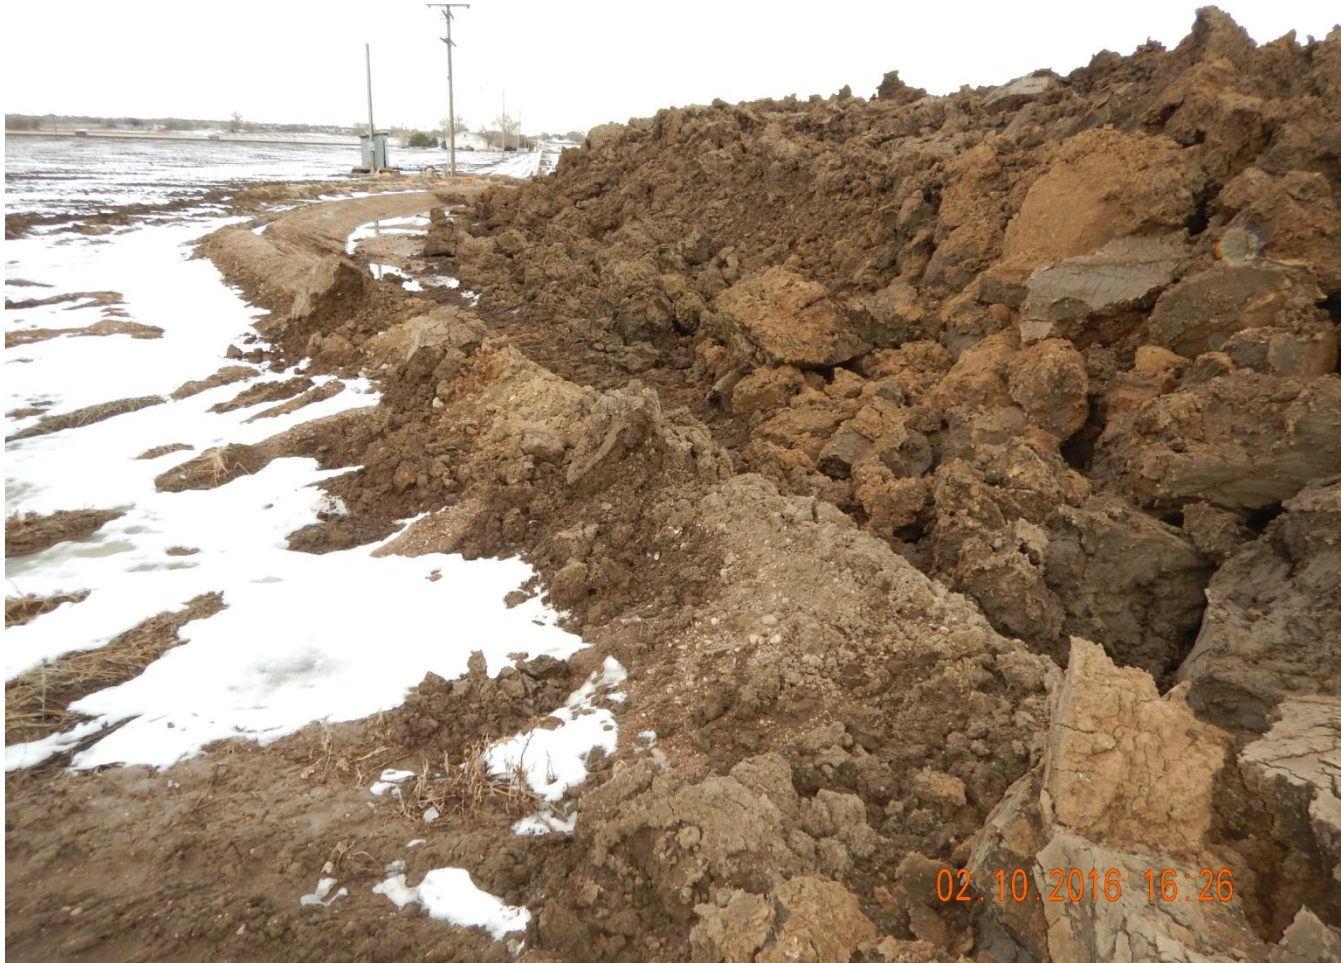
**Photo 5.** Photo taken from northwest location, facing East. Stormwater BMP installed along perimeter of location. Need to stabilize topsoil stockpile and prevent soil leaving location. Operator said topsoil stockpile is in process of being moved from the western area to create space for operations.

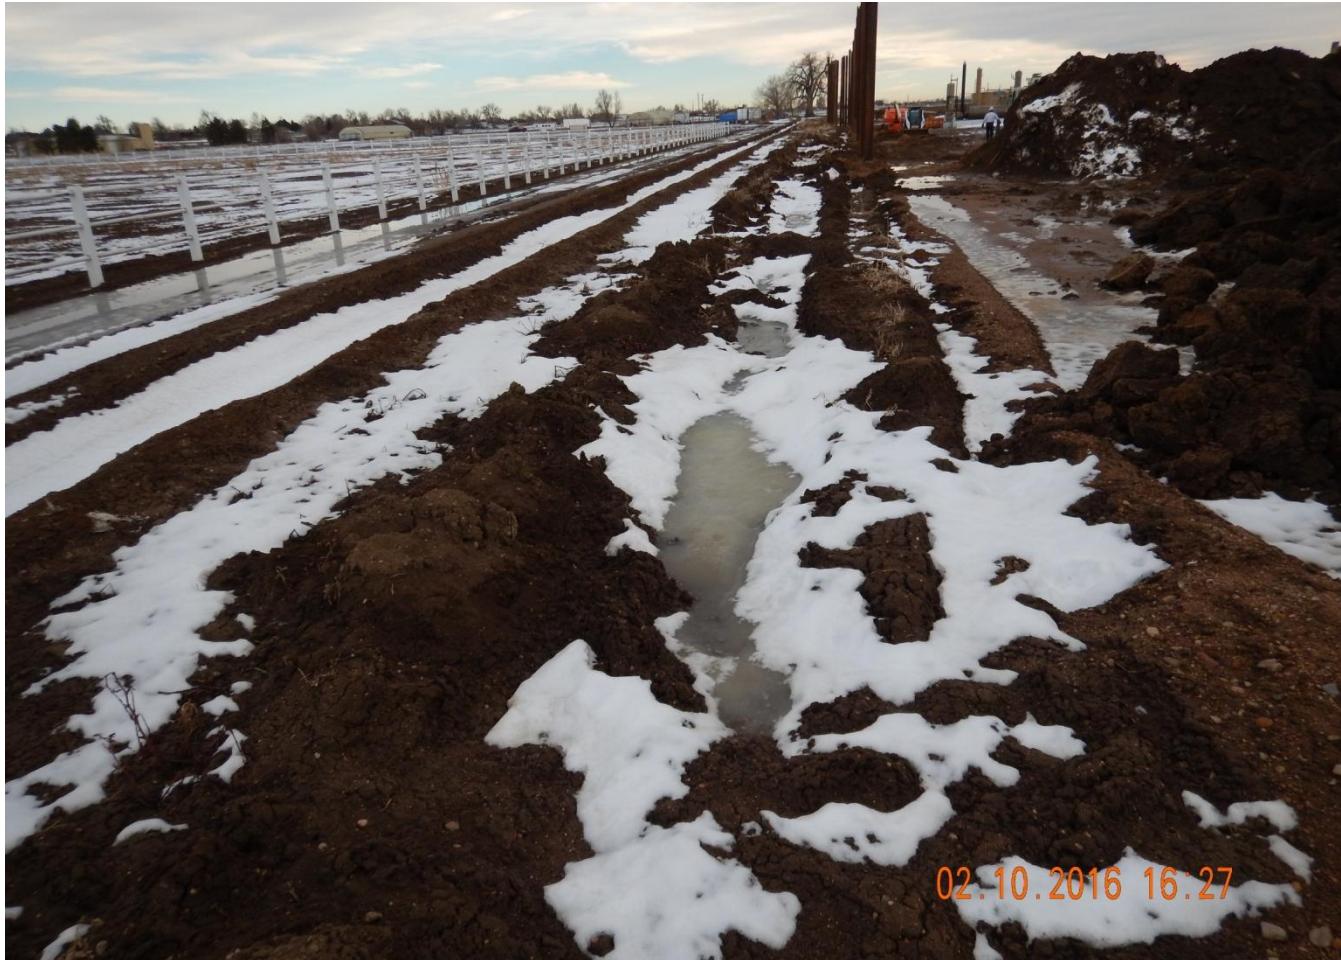
**Photo 6.** Photo taken from northeast location, facing South. Stormwater BMP installed along perimeter of location. Need to stabilize topsoil stockpile and prevent soil leaving location. Operator said topsoil stockpile is in process of being moved from the western area to create space for operations.

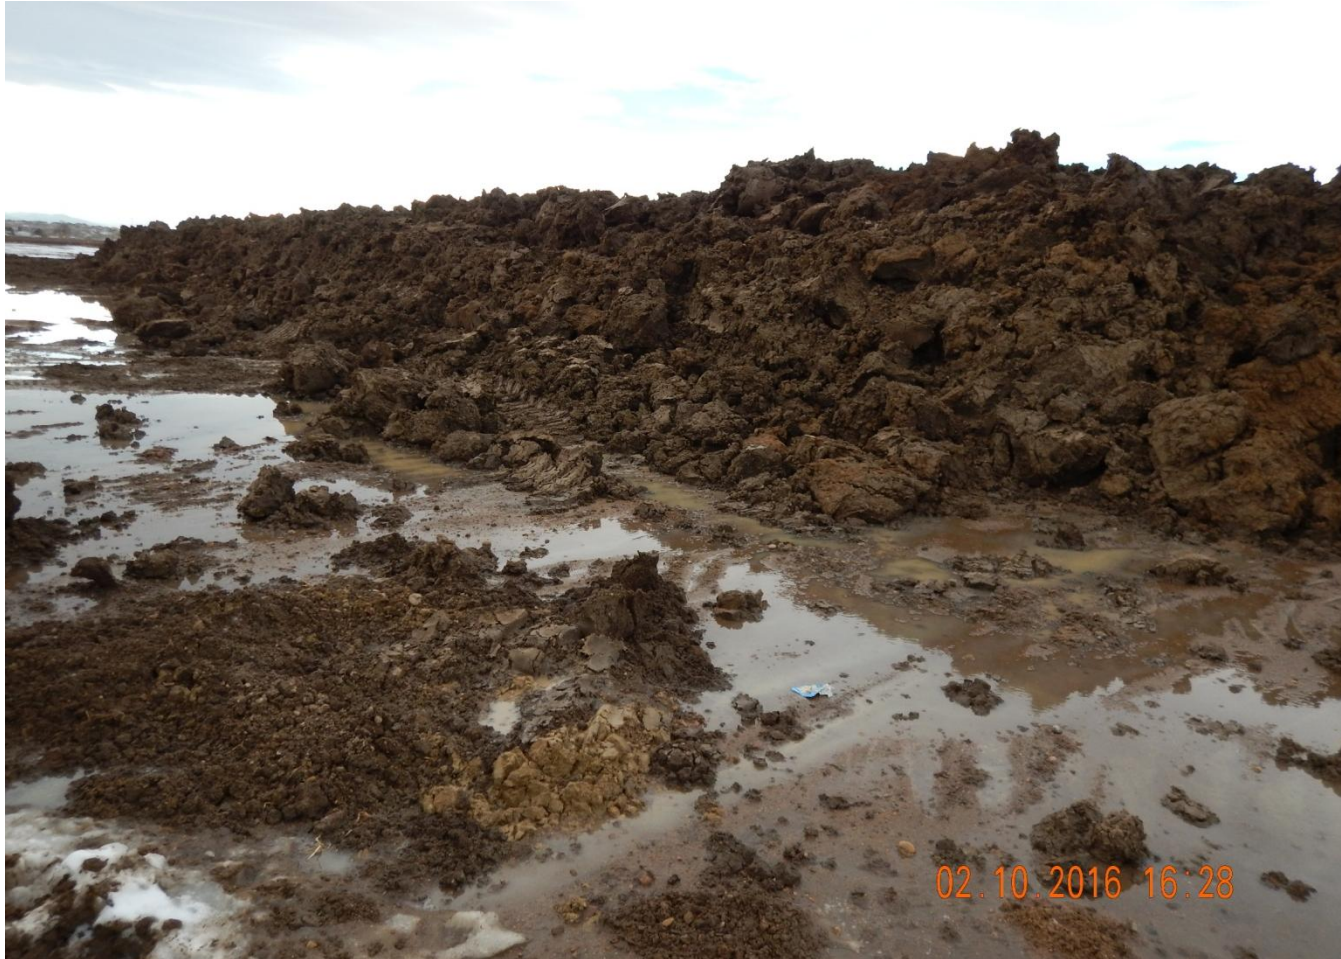
**Photo 7.** Photo taken from northeast location, facing West. Need to stabilize topsoil stockpile and prevent soil leaving location. Operator said topsoil stockpile is in process of being moved from the western area to create space for operations.
