Interim Reclamation Inspection

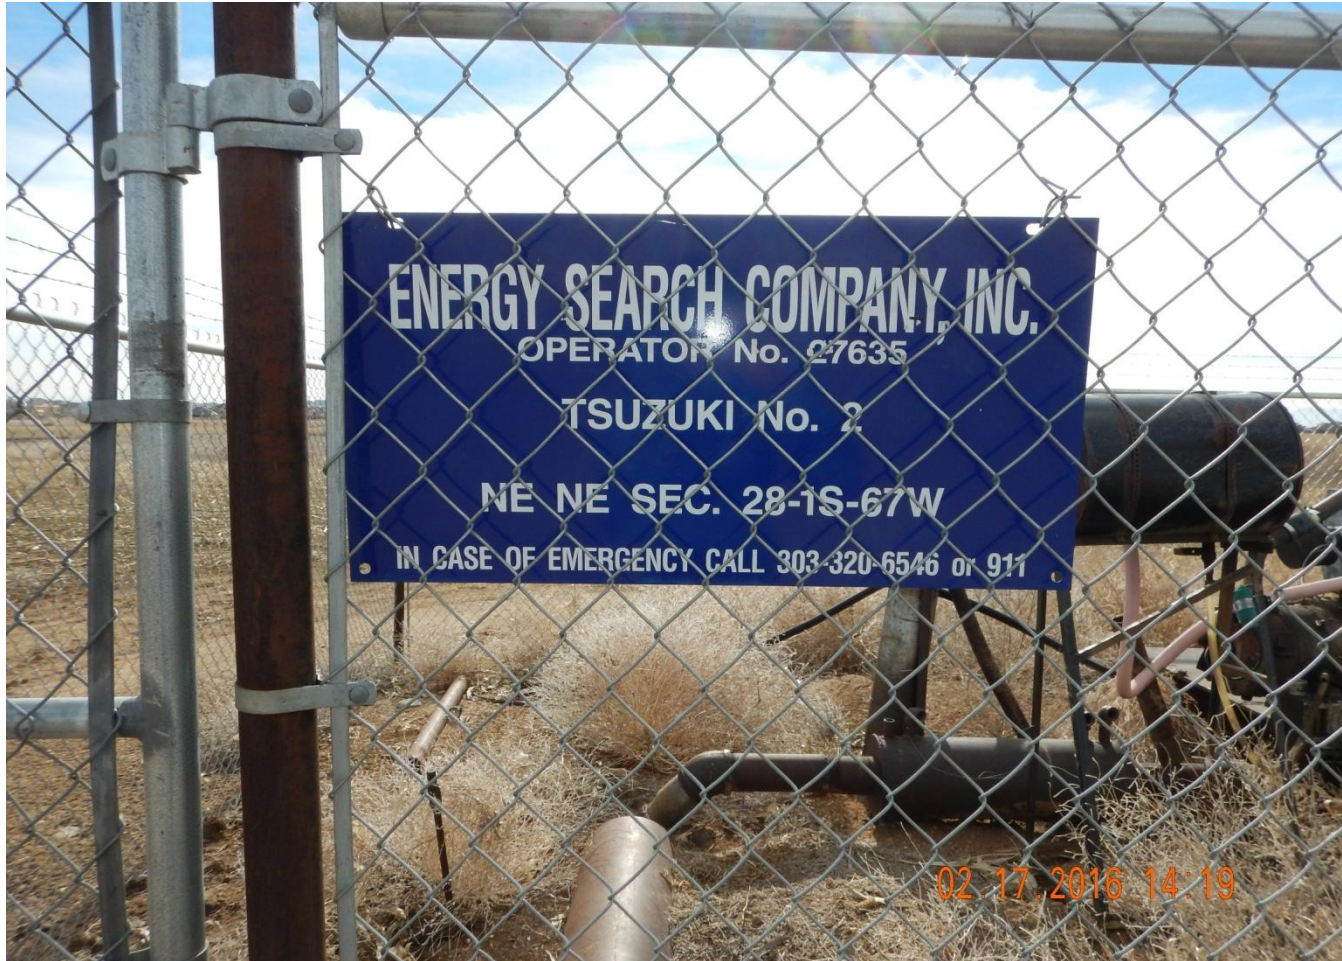
Photo 1. Photo taken of Tank Battery location sign, facing South.

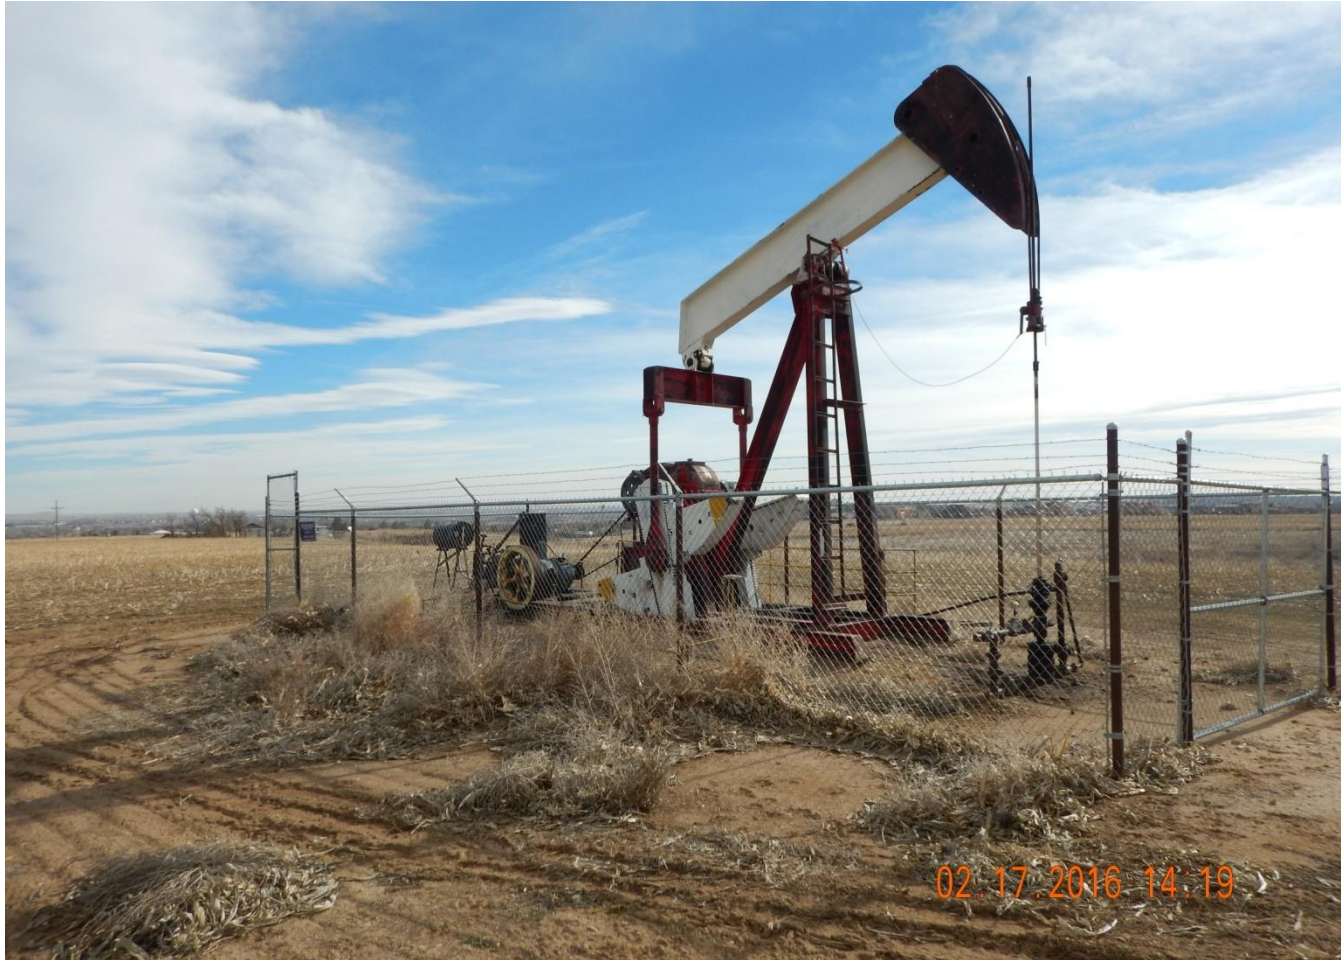
Photo 2. Photo taken from northern location, facing Southeast. Need to remove weeds around all operating oil and gas equipment on location.

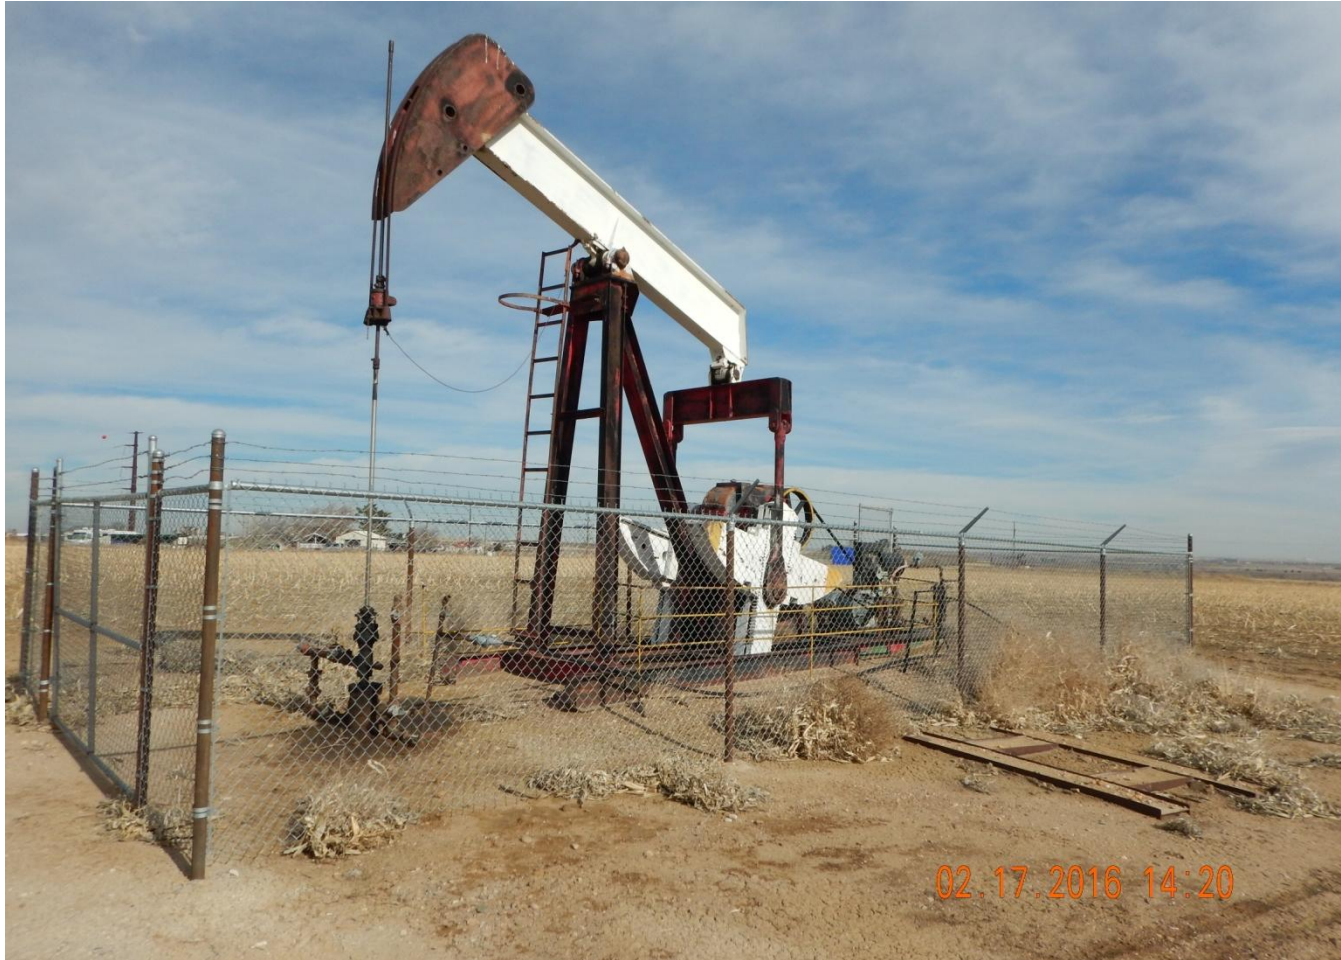
Photo 3. Photo taken from southern location, facing Northeast. Need to remove weeds around all operating oil and gas equipment on location.

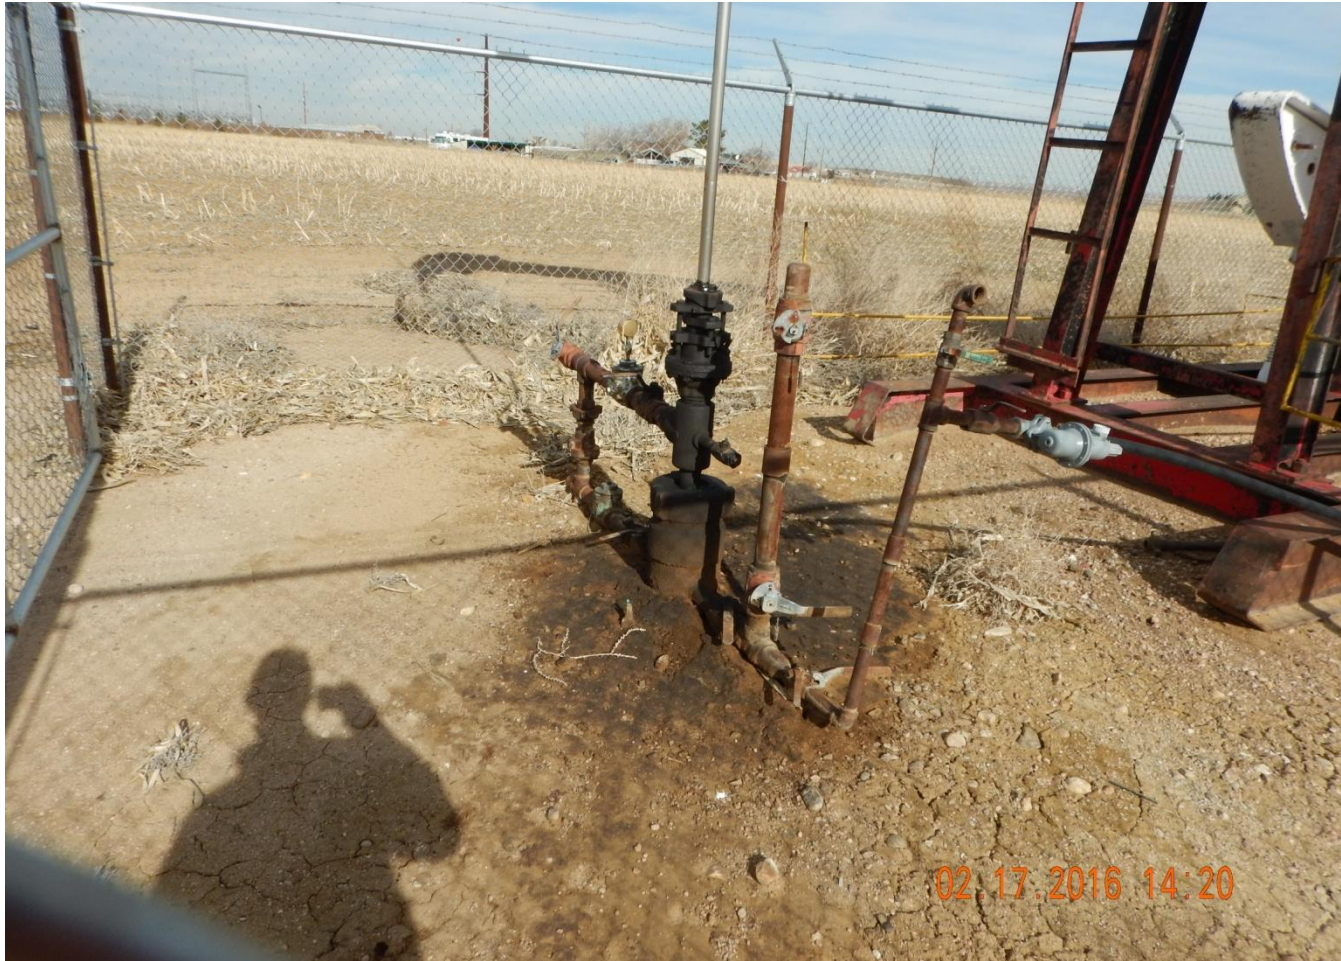
Photo 4. Photo taken from pump jack, looking at the wellhead. Remove or remediate stained soil (<1 bbl) around wellhead.

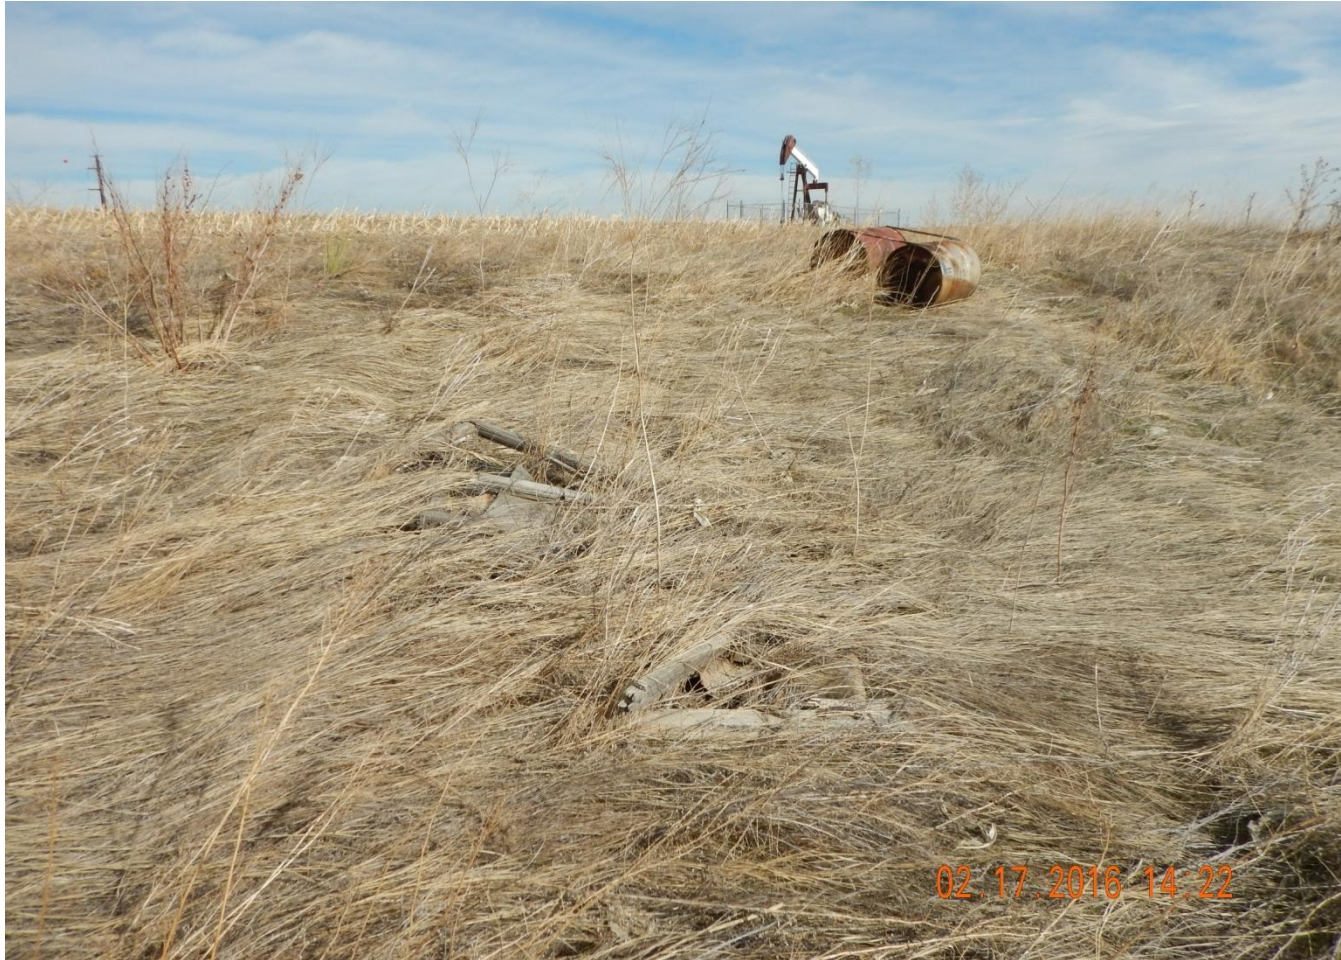
Photo 5. Photo taken from southern access road, facing East. Need to remove waste material from location.

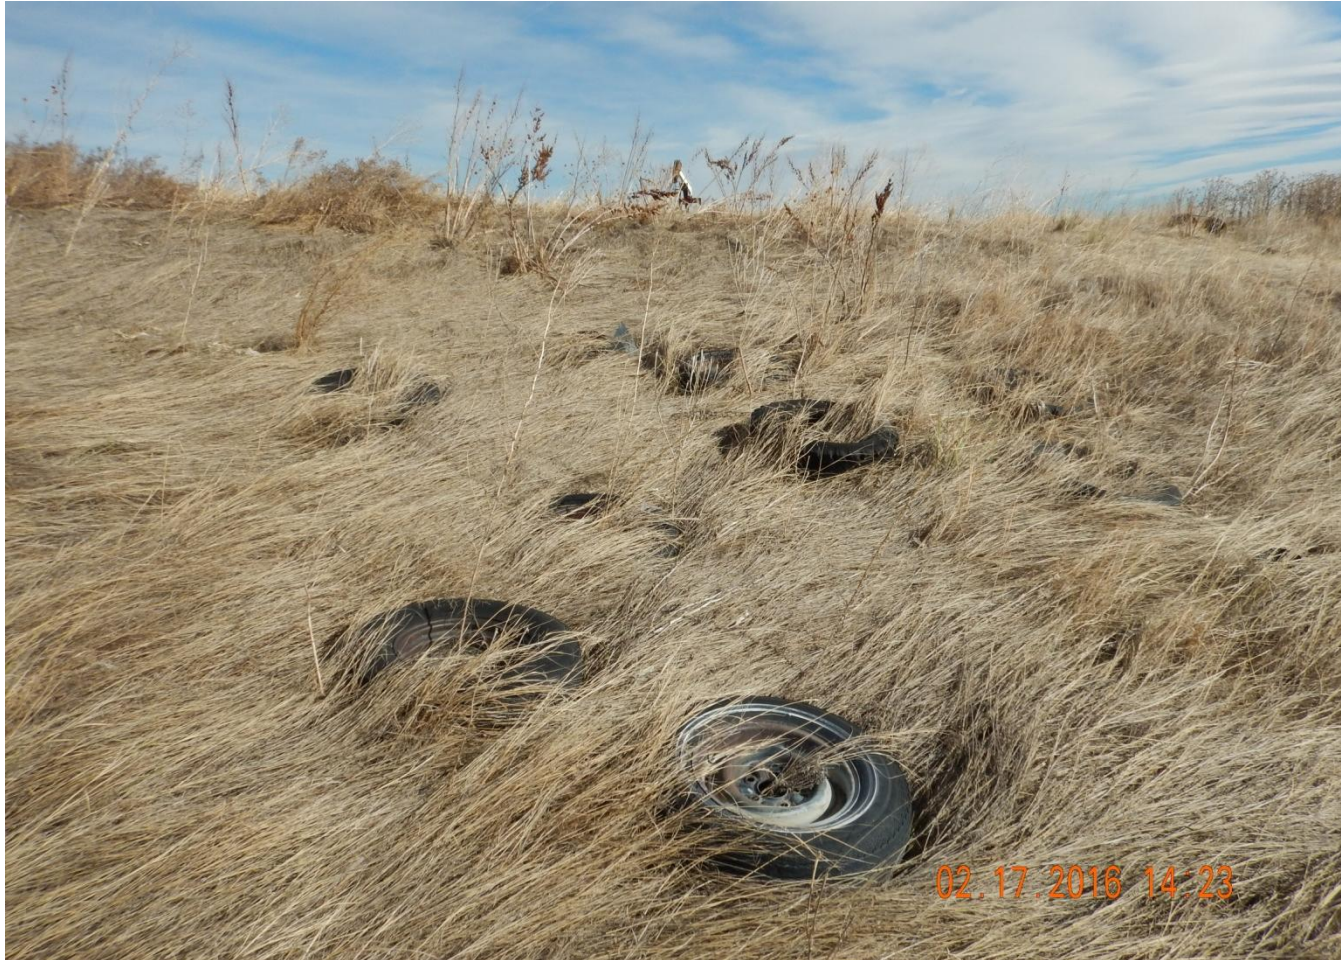
Photo 6. Photo taken from southern access road, facing East. Need to remove waste material from location.

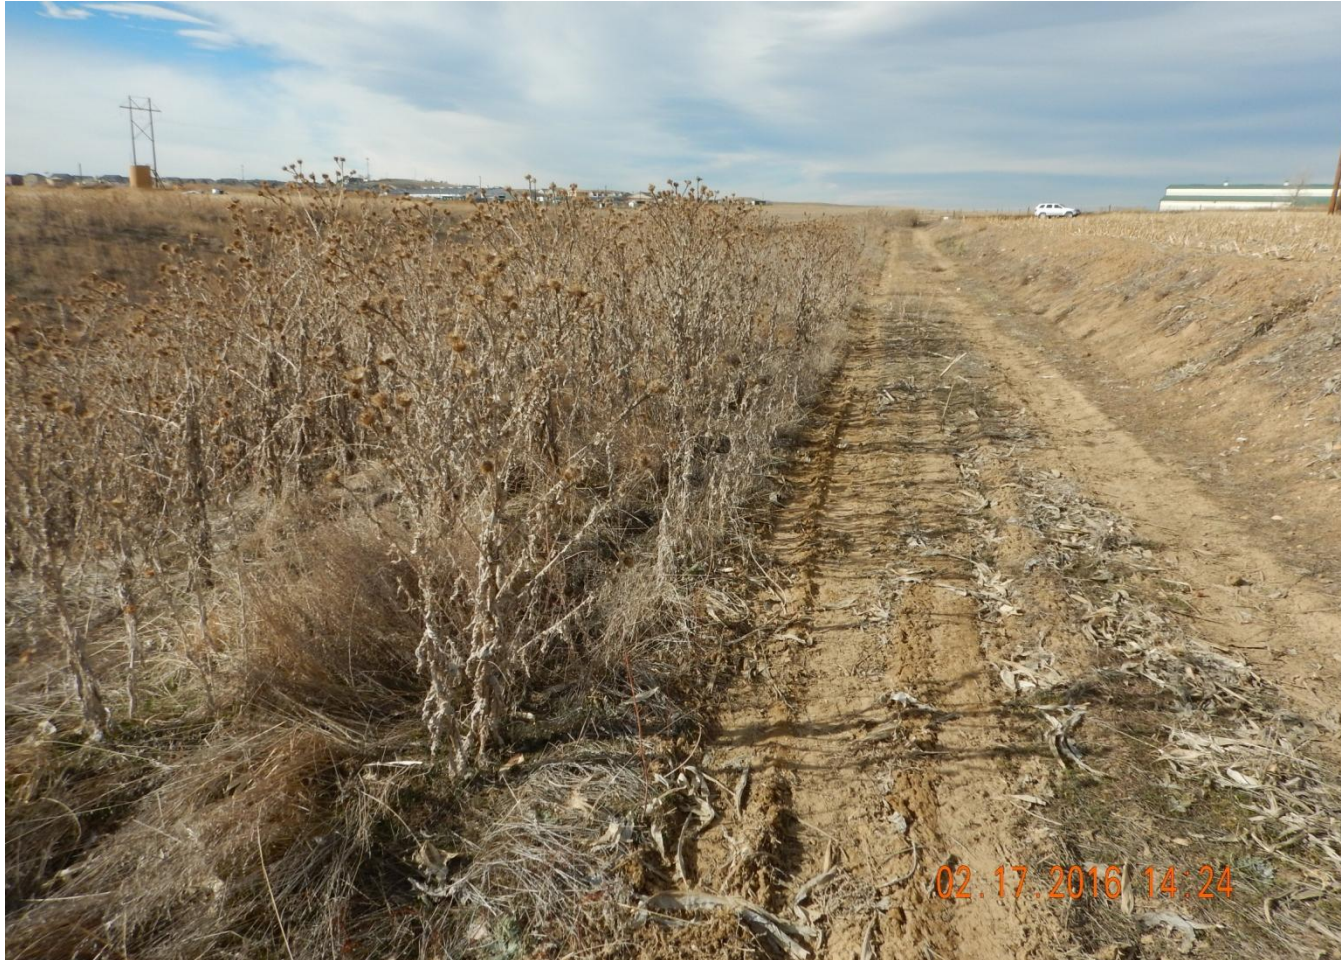
Photo 7. Photo taken along access road, facing North. Need to control noxious weeds (Bull thistle-*Cirsium vulgare*) along west access road.
