Interim Reclamation Inspection

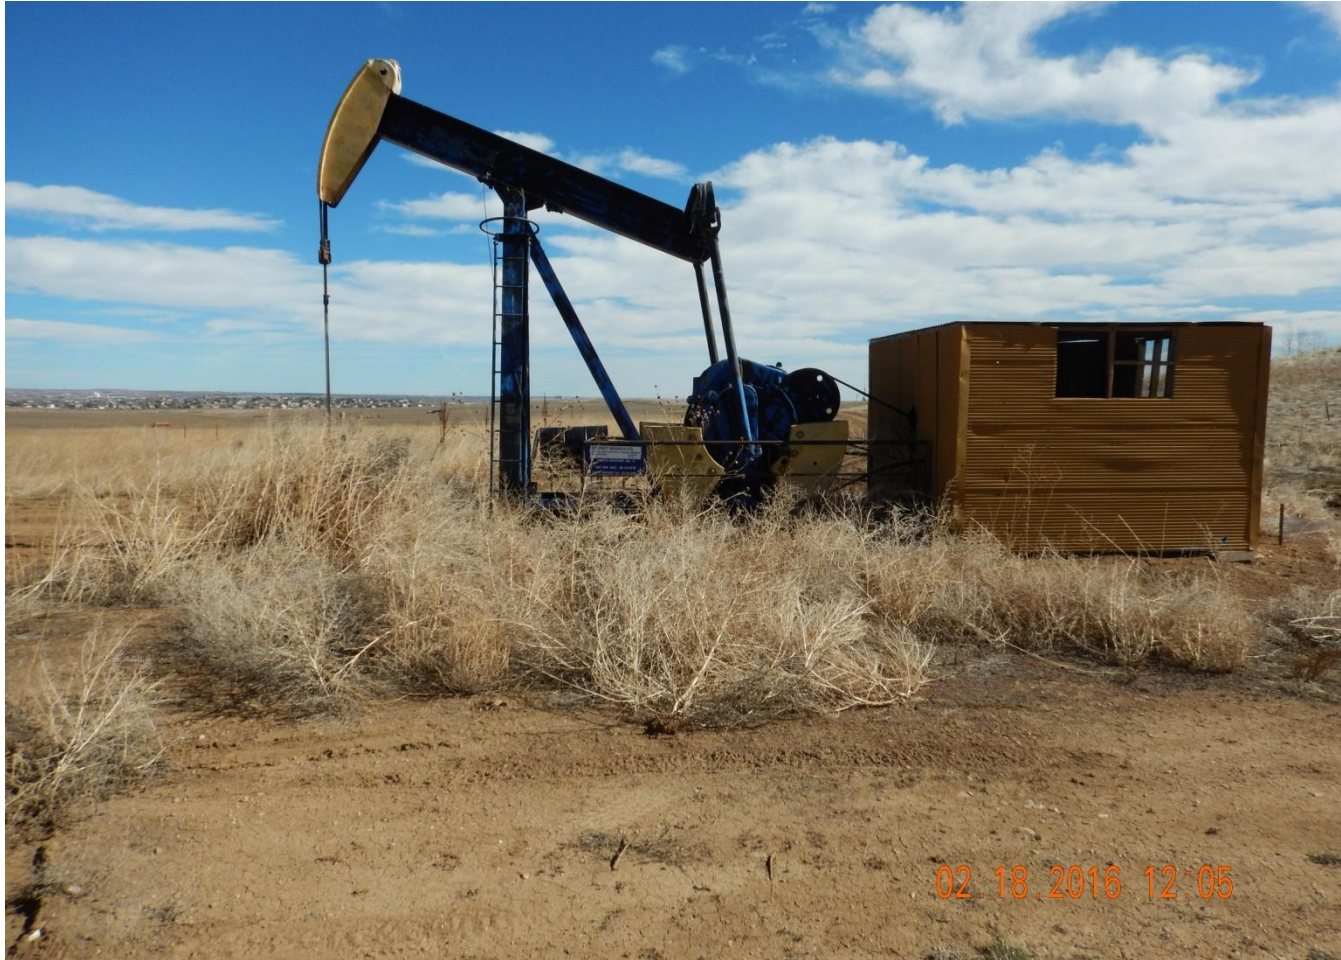
Photo 2. Photo taken from central location, facing East. Need to remove weeds around all operating oil and gas equipment on location.

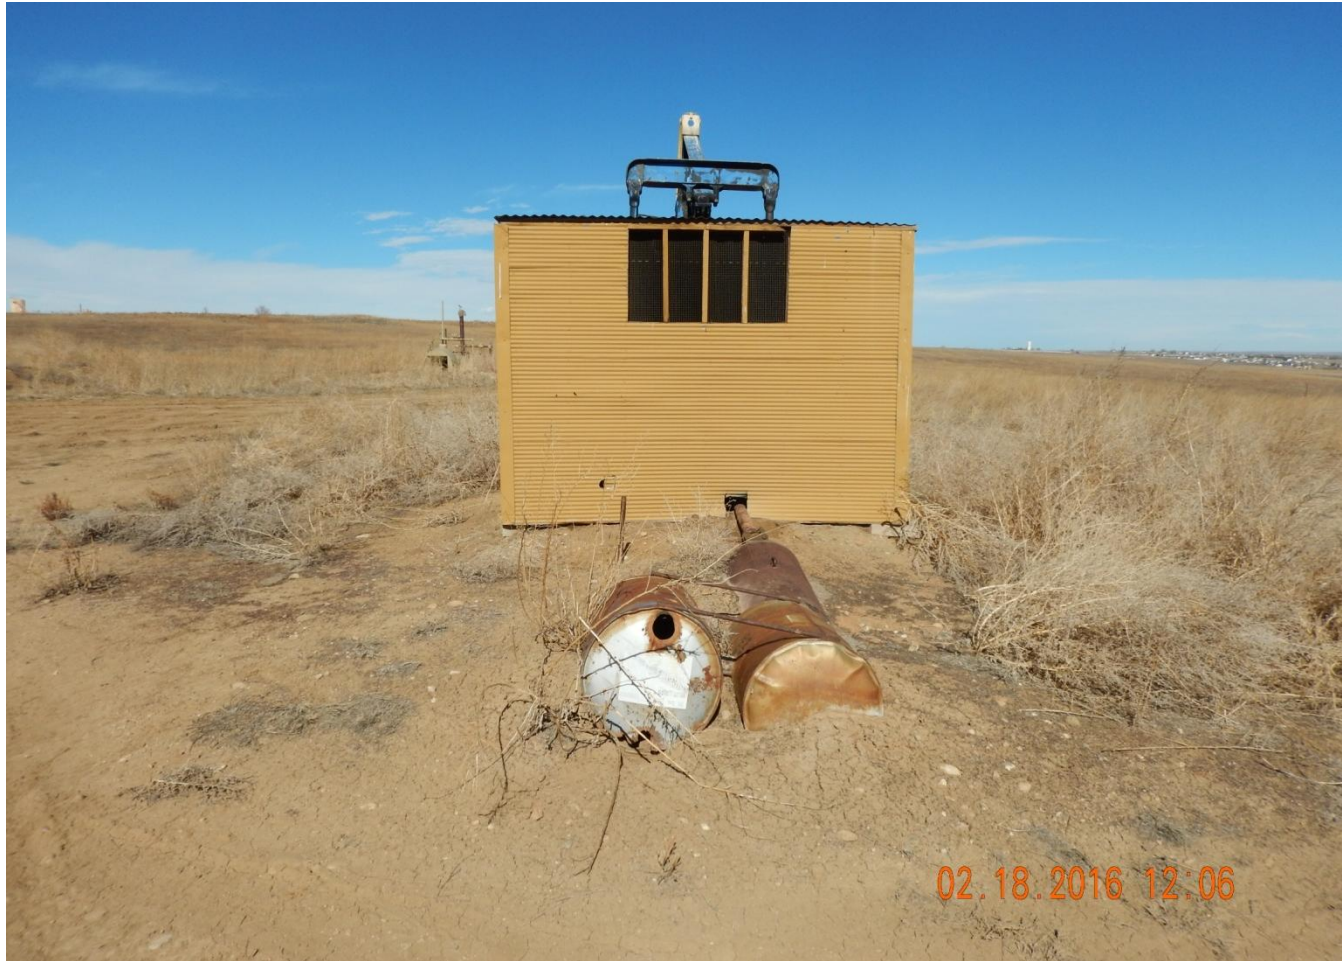
Photo 3. Photo taken from southwest location, facing North. Need to remove weeds around all operating oil and gas equipment on location.

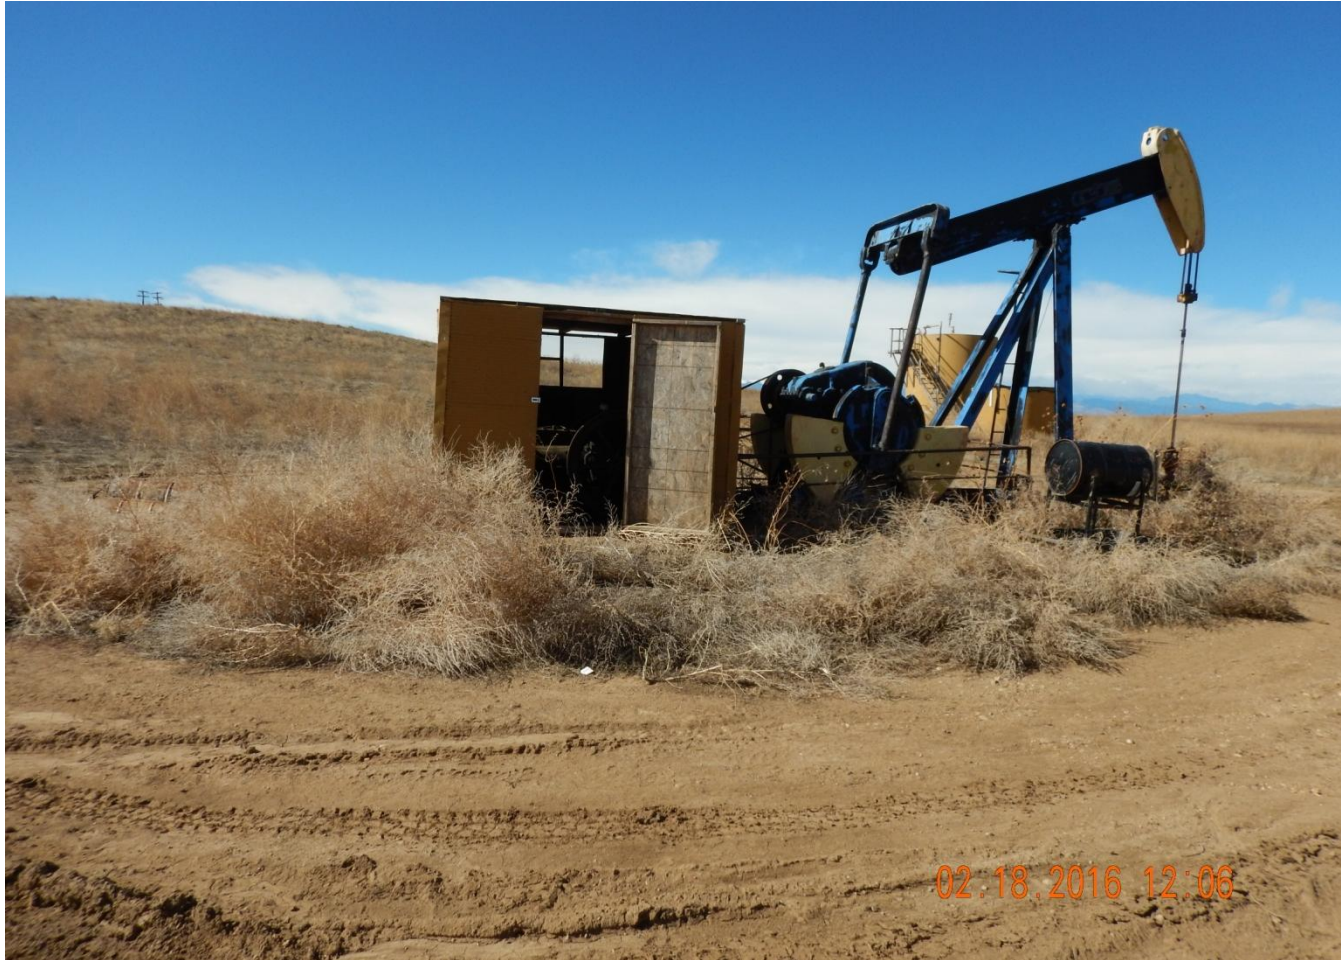
Photo 4. Photo taken from southwest location, facing West. Need to remove weeds around all operating oil and gas equipment on location.

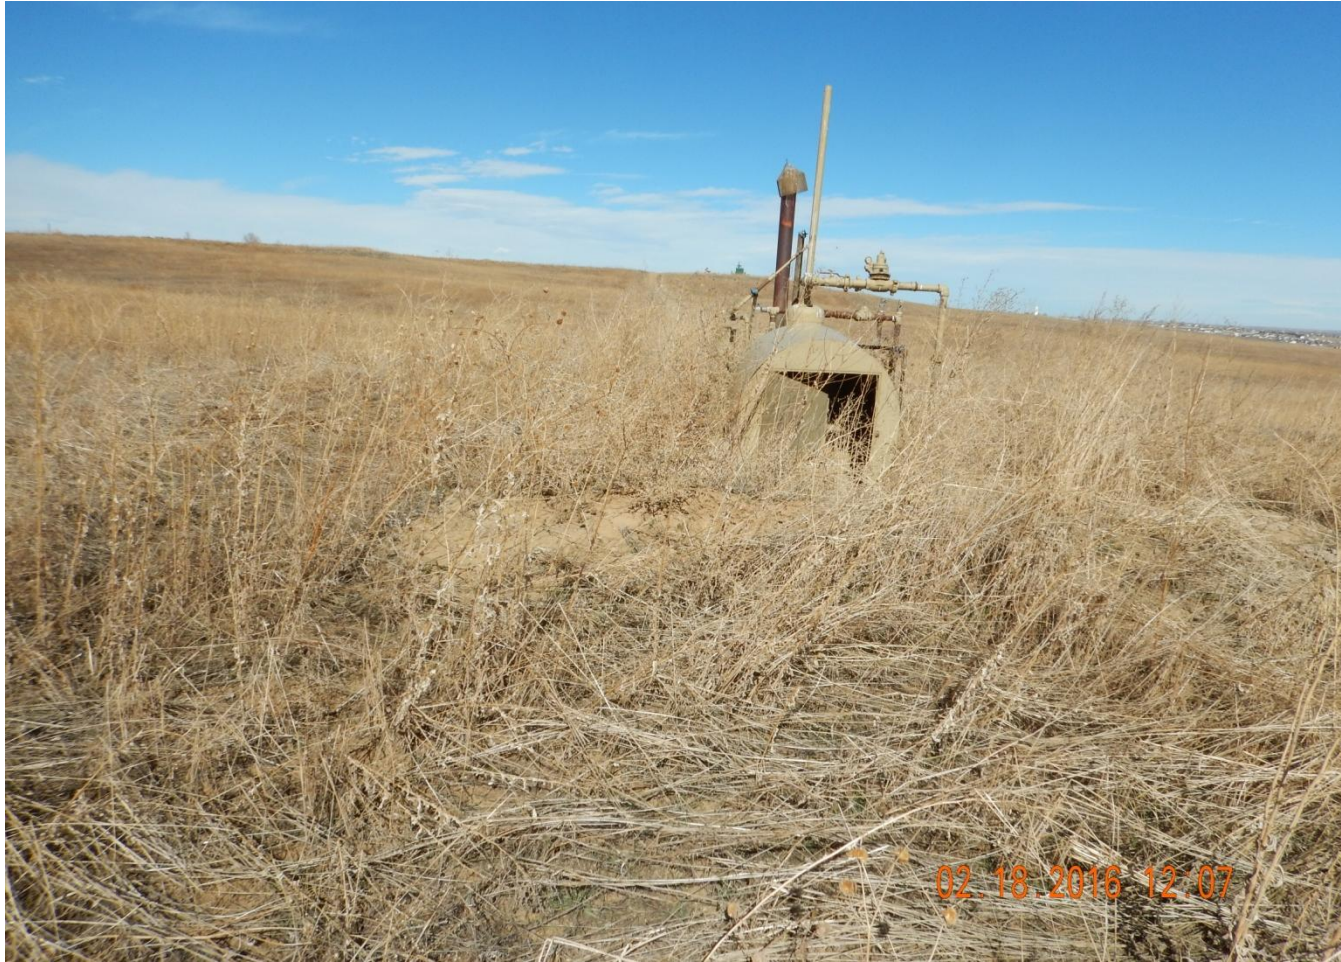
Photo 5. Photo taken from central location, facing North. Need to remove weeds around all operating oil and gas equipment on location.

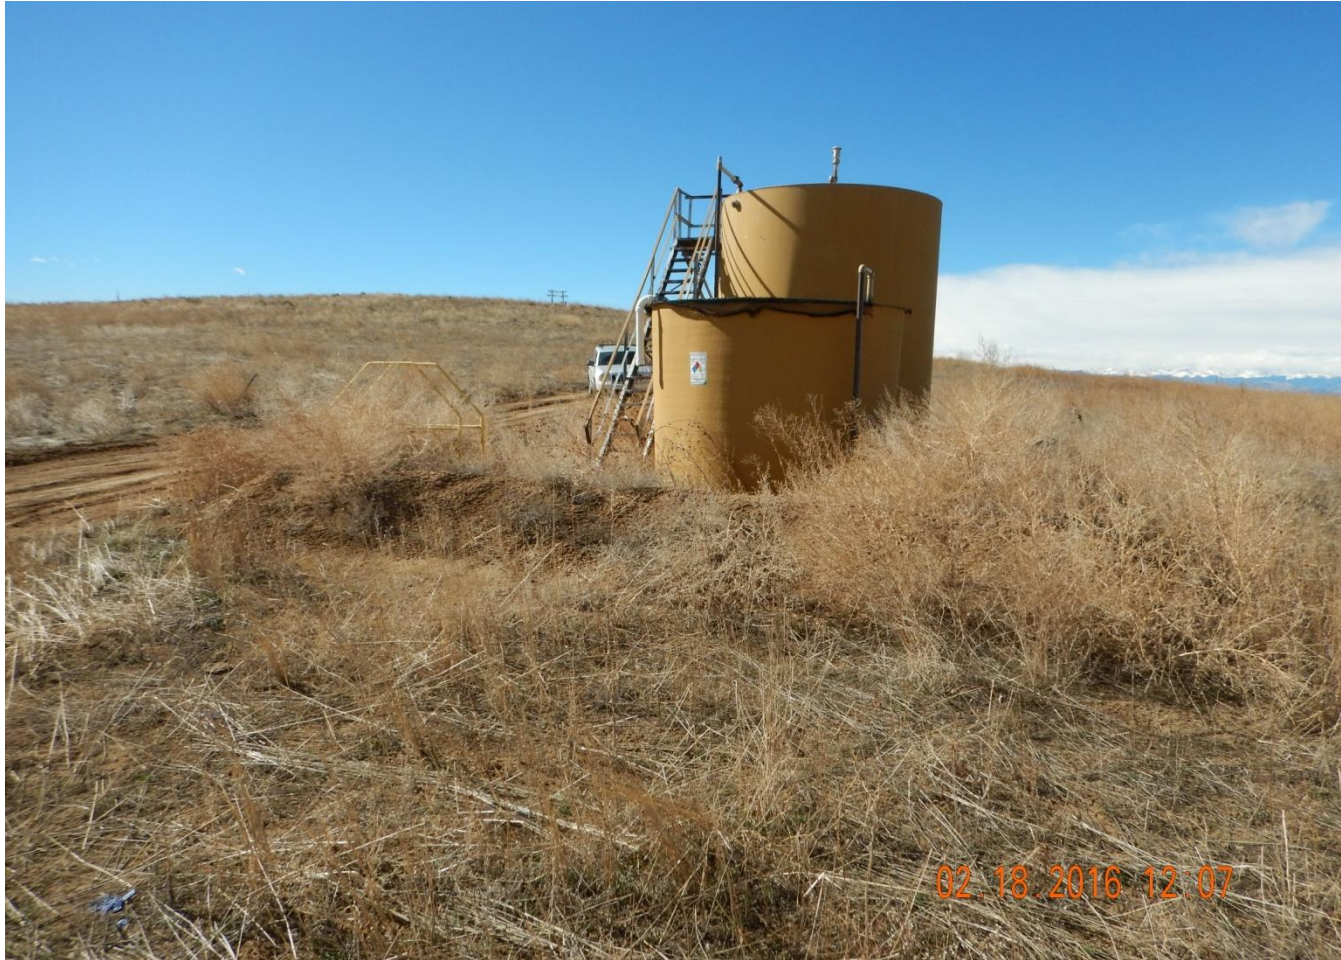
Photo 6. Photo taken from central location, facing Southwest. Need to remove weeds around all operating oil and gas equipment on location.

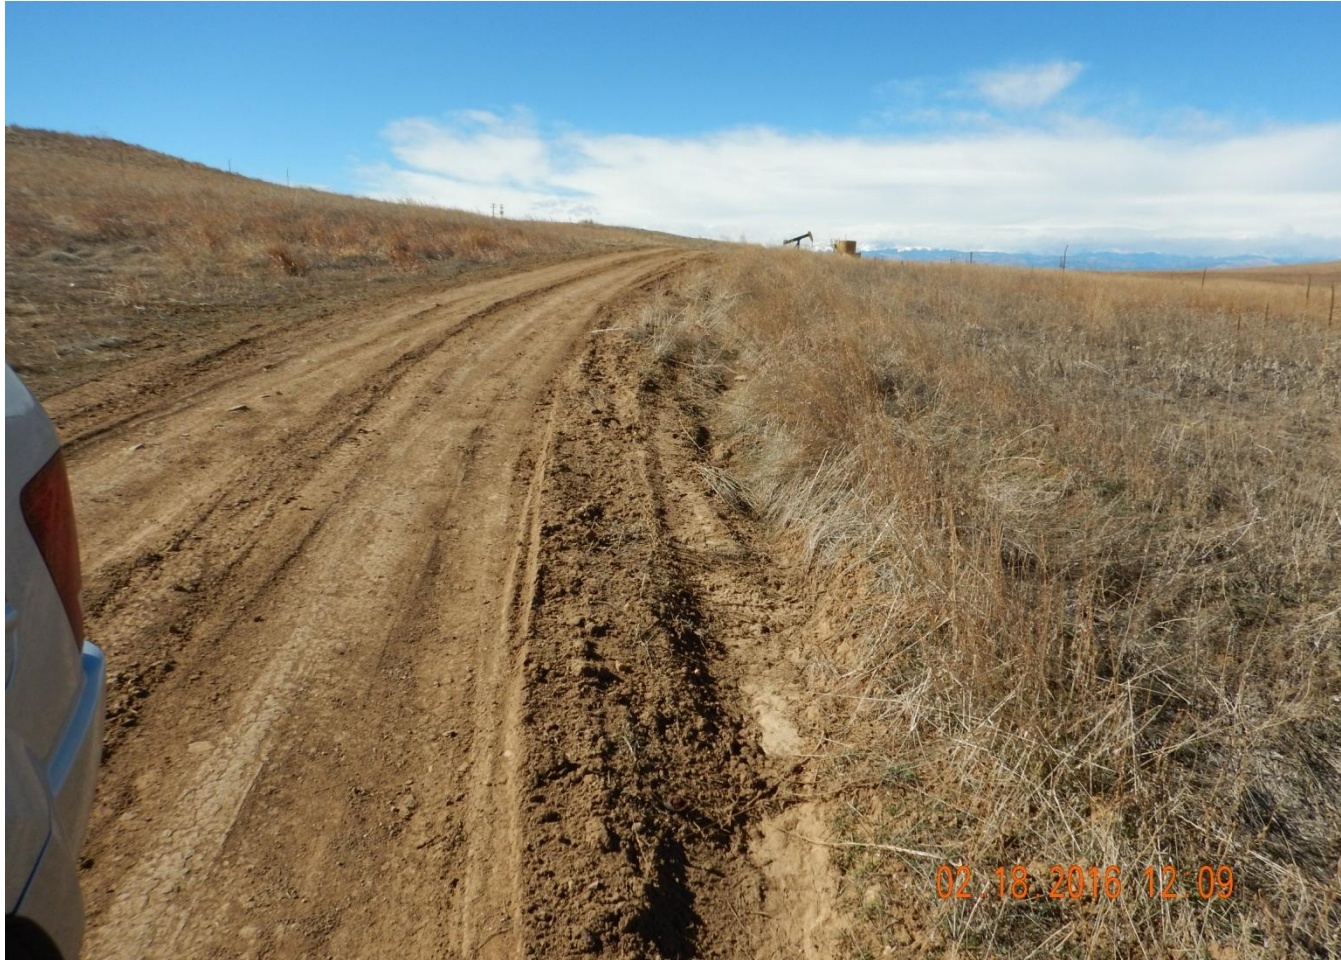
Photo 7. Photo taken from access road east of location, facing West. Appears to be noticeable erosion occurring along both sides of the access road ditch (see following photo).

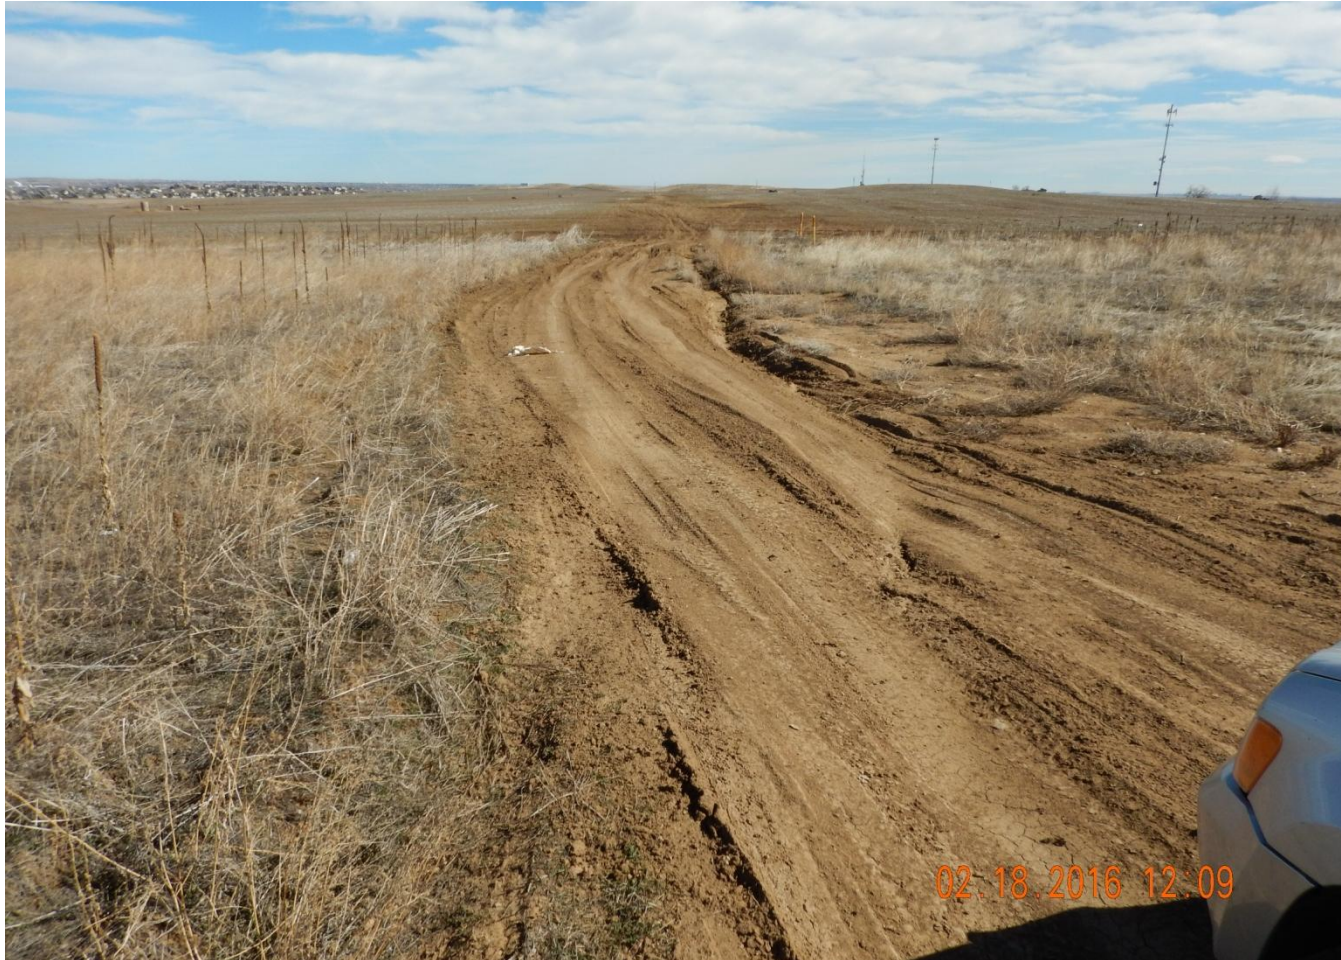
Photo 8. Photo taken from access road east of location, facing East. Appears to be noticeable erosion occurring along both sides of the access road ditch. Sediment traveling east, down slope towards the agricultural field.
