## Construction Inspection

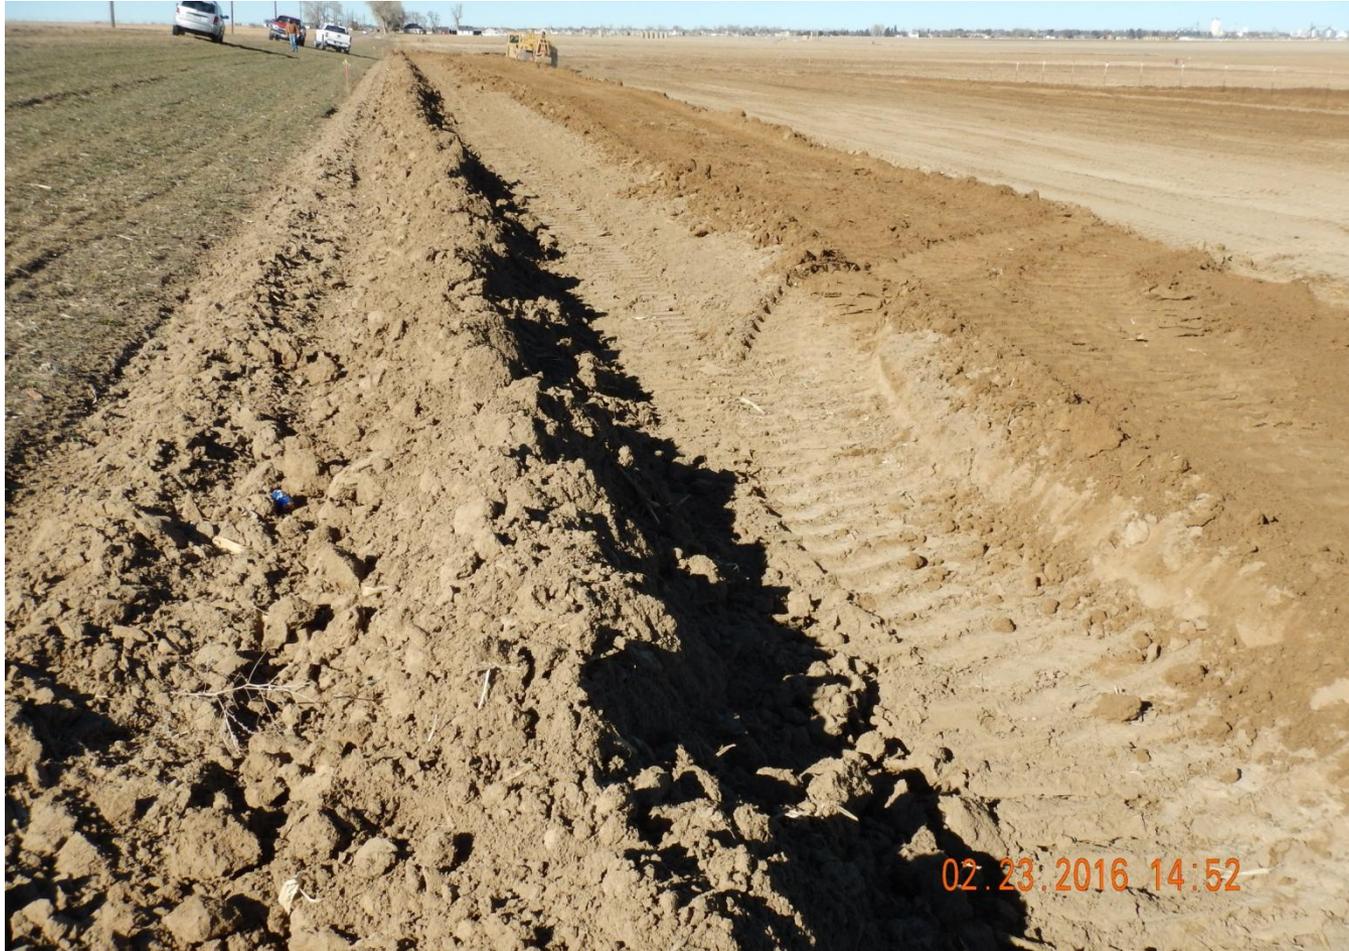
**Photo 1.** Photo taken from western location, facing North. Stormwater and sediment control BMPs installed in center of photo.

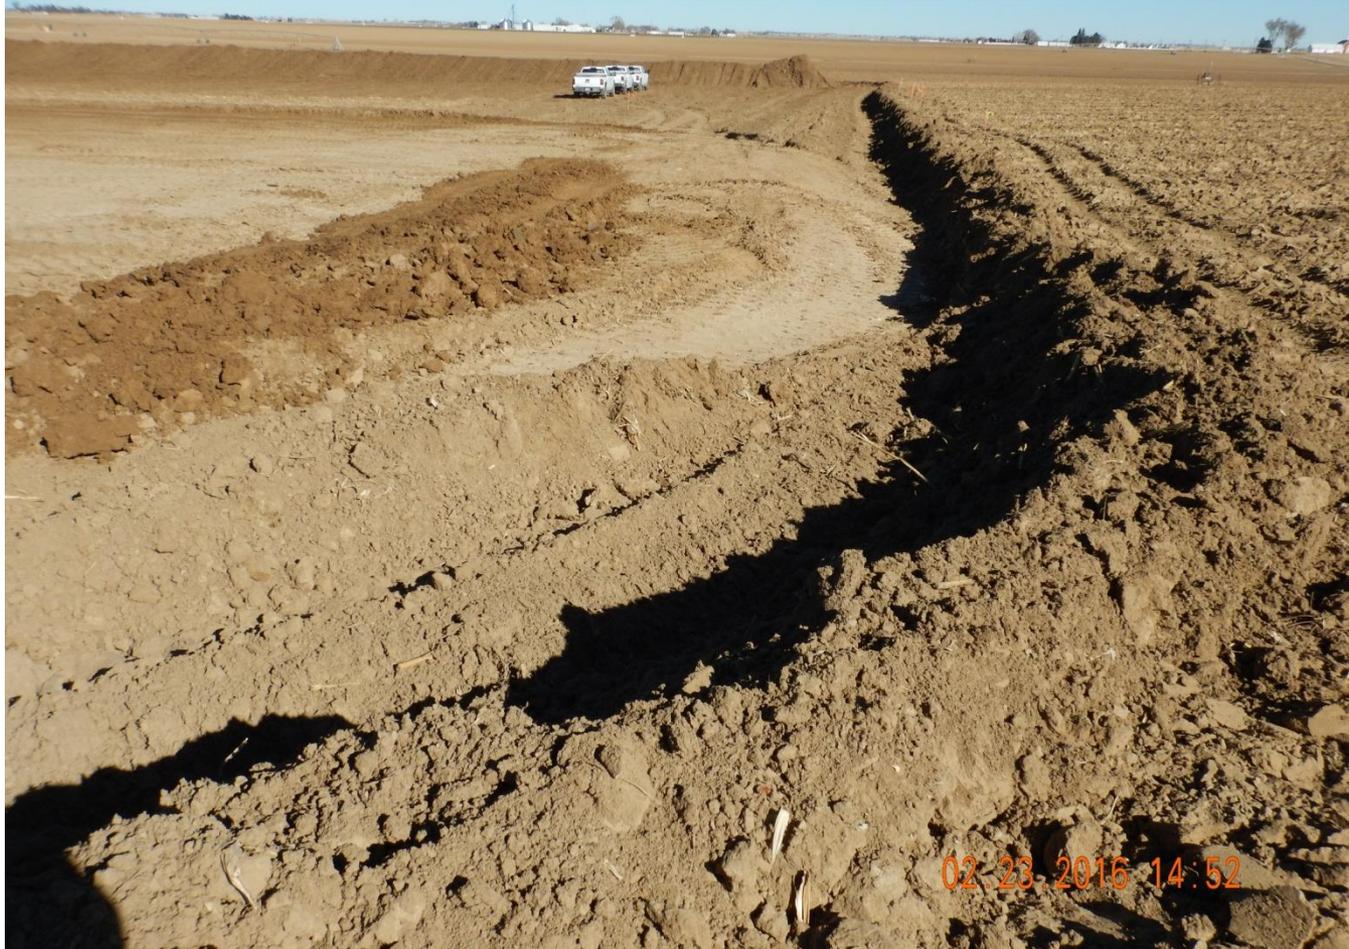
**Photo 2.** Photo taken from southwestern location, facing East. Stormwater and sediment control BMPs installed in center of photo.

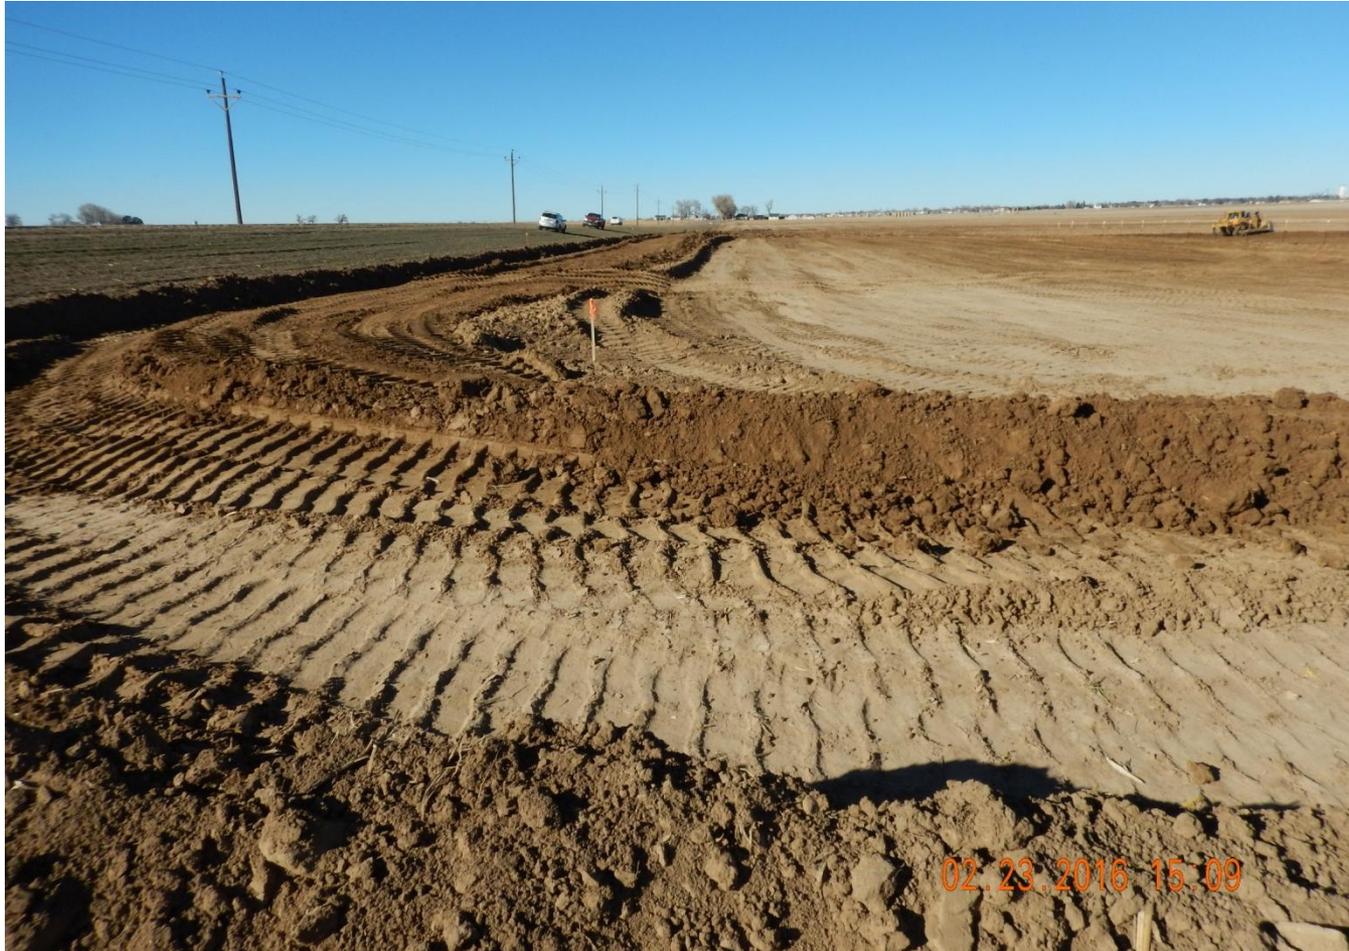
**Photo 3.** Photo taken from southwestern location, facing North. Stormwater and sediment control BMPs installed in center of photo.

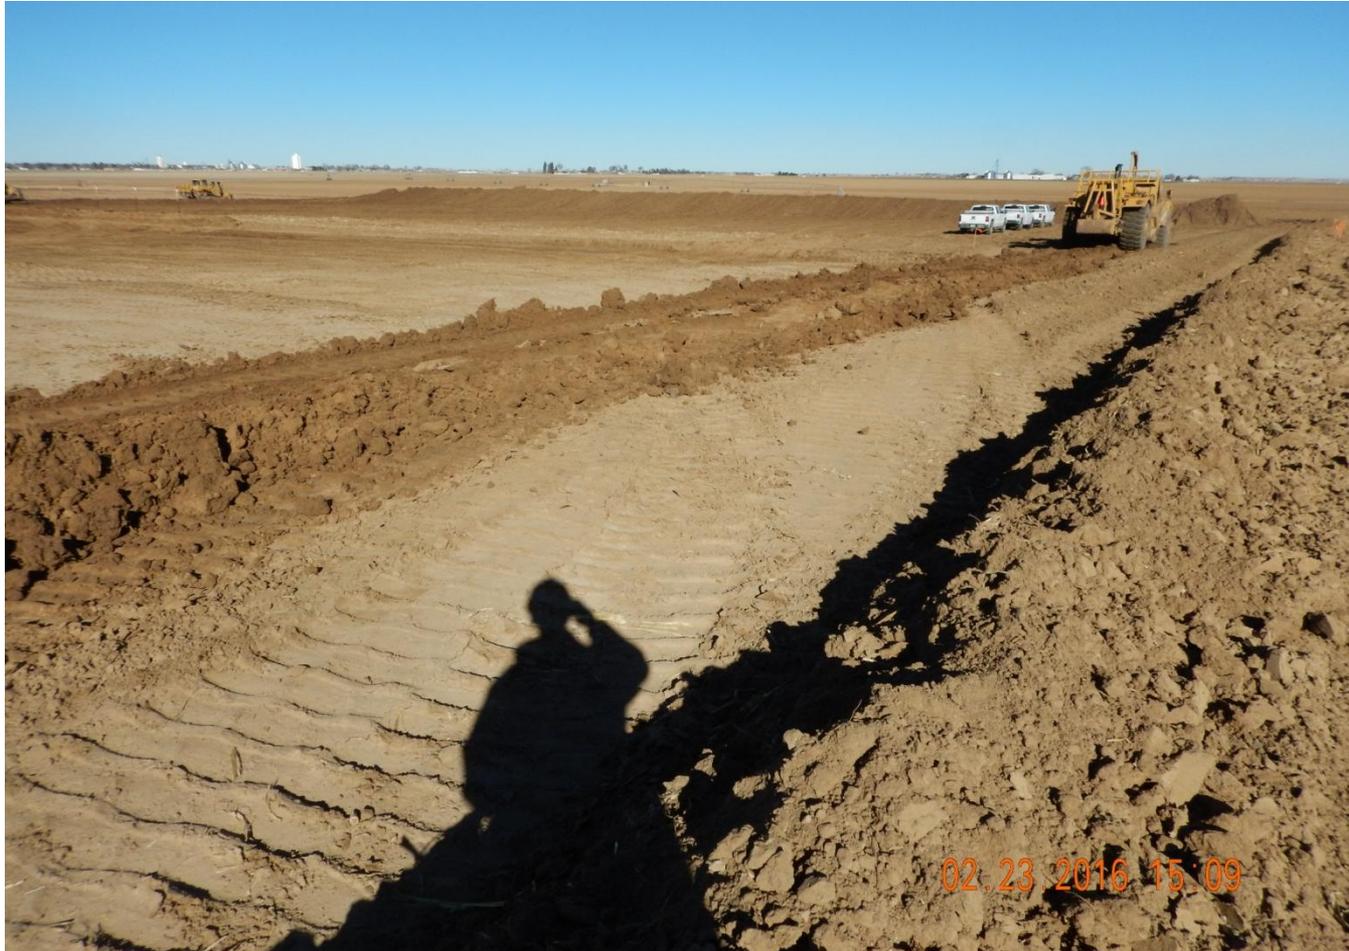
**Photo 4.** Photo taken from southern location, facing Northeast. Stormwater and sediment control BMPs installed in center of photo.

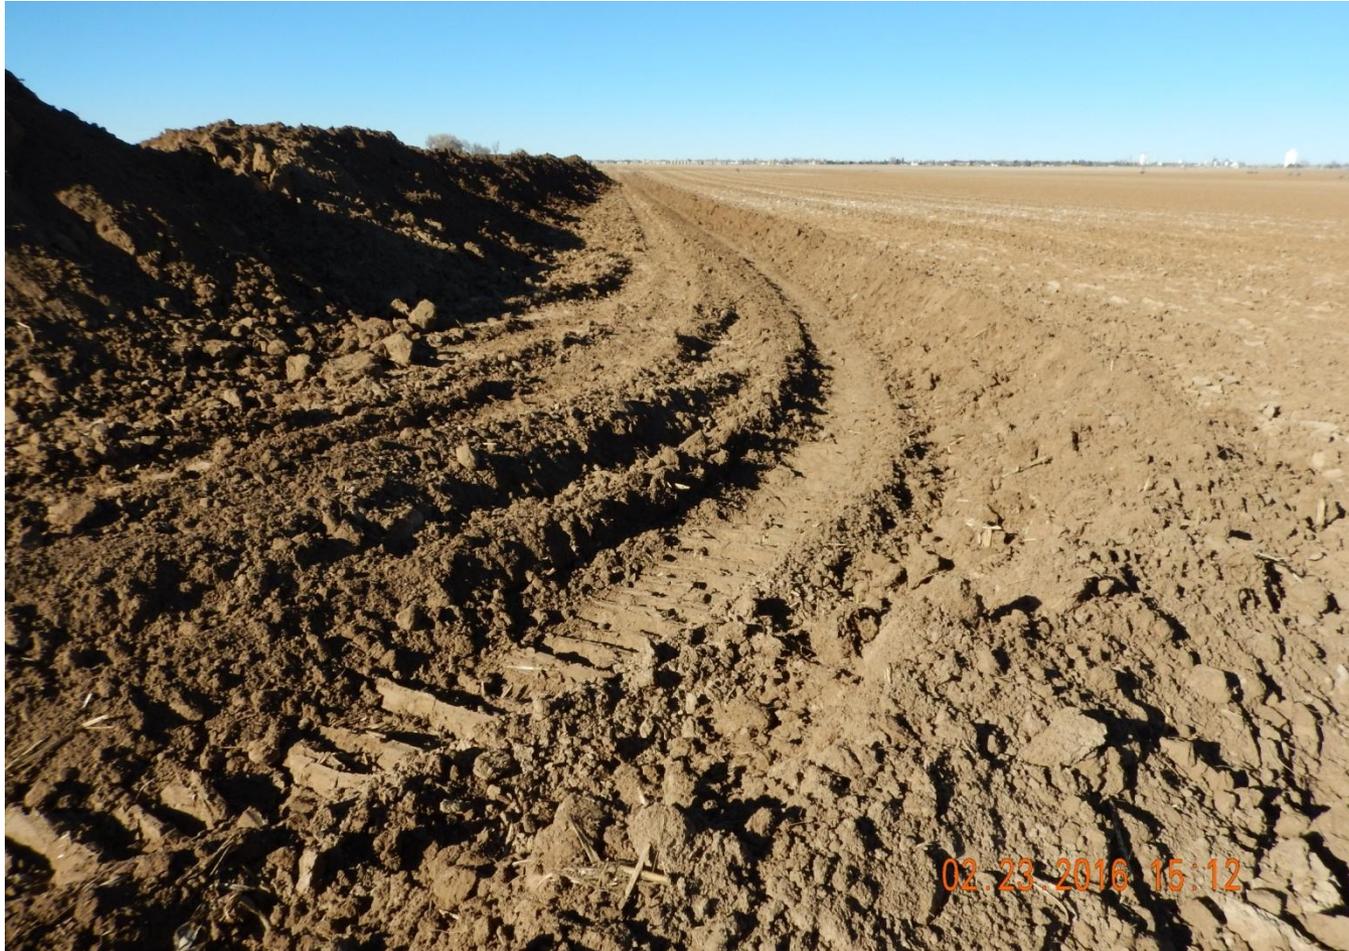
**Photo 5.** Photo taken from southeast location, facing North. Stormwater and sediment control BMPs installed in center of photo.

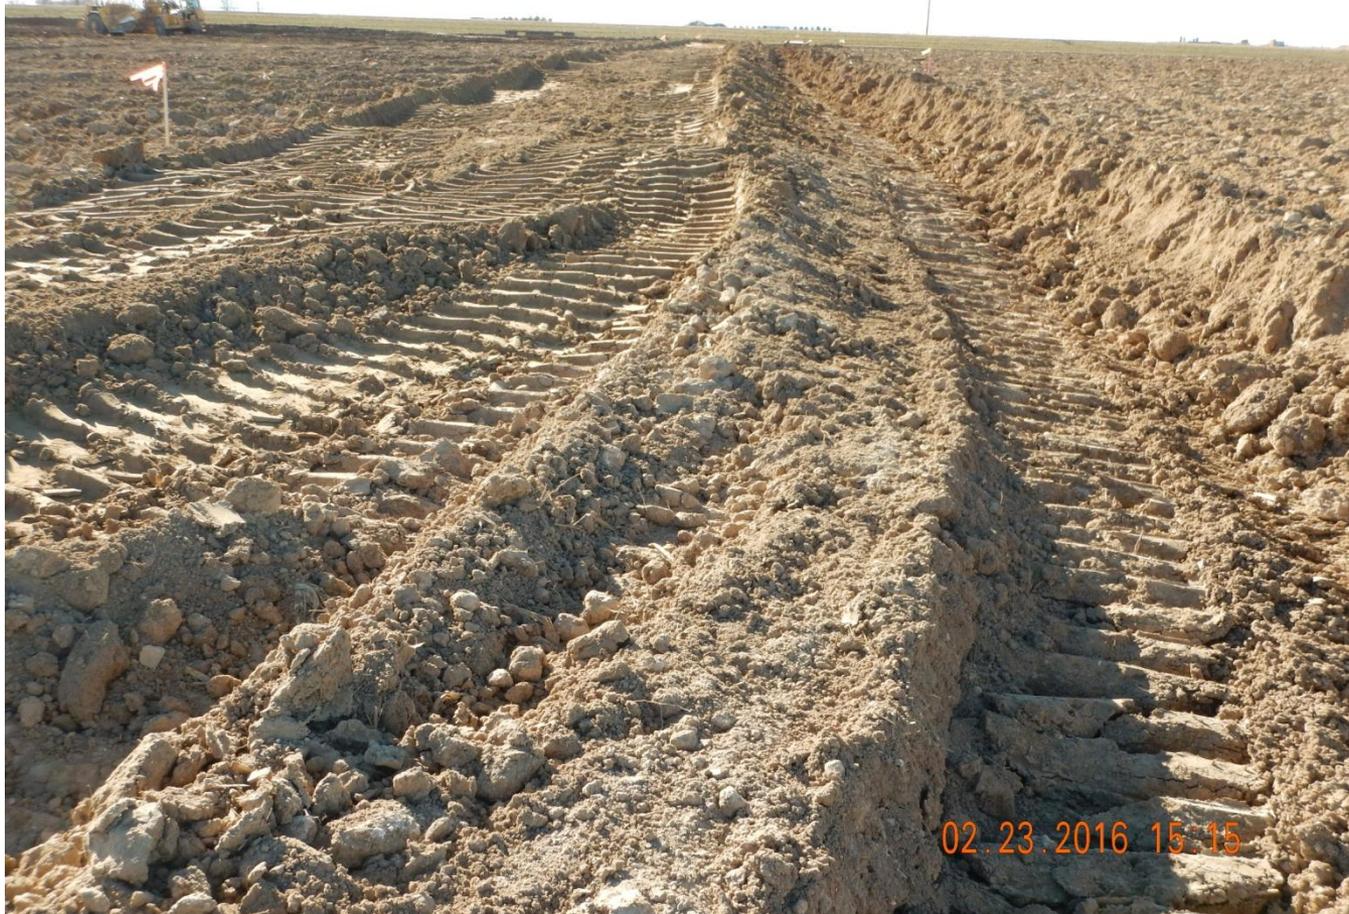
**Photo 6.** Photo taken from northeast location, facing West. Stormwater and sediment control BMPs installed in center of photo.

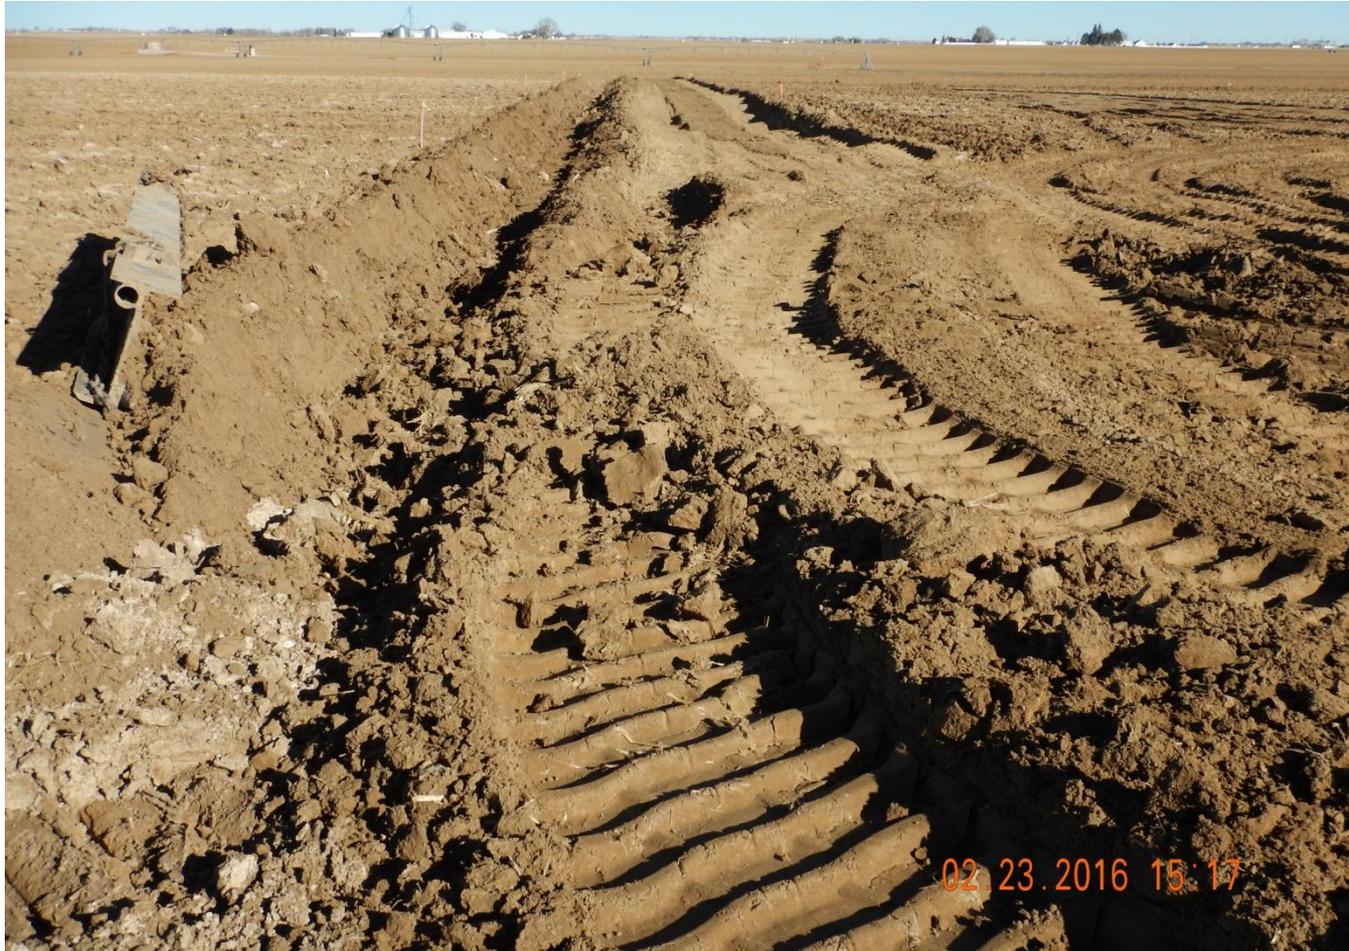
**Photo 7.** Photo taken from northwest location, facing East. Stormwater and sediment control BMPs installed in center of photo.

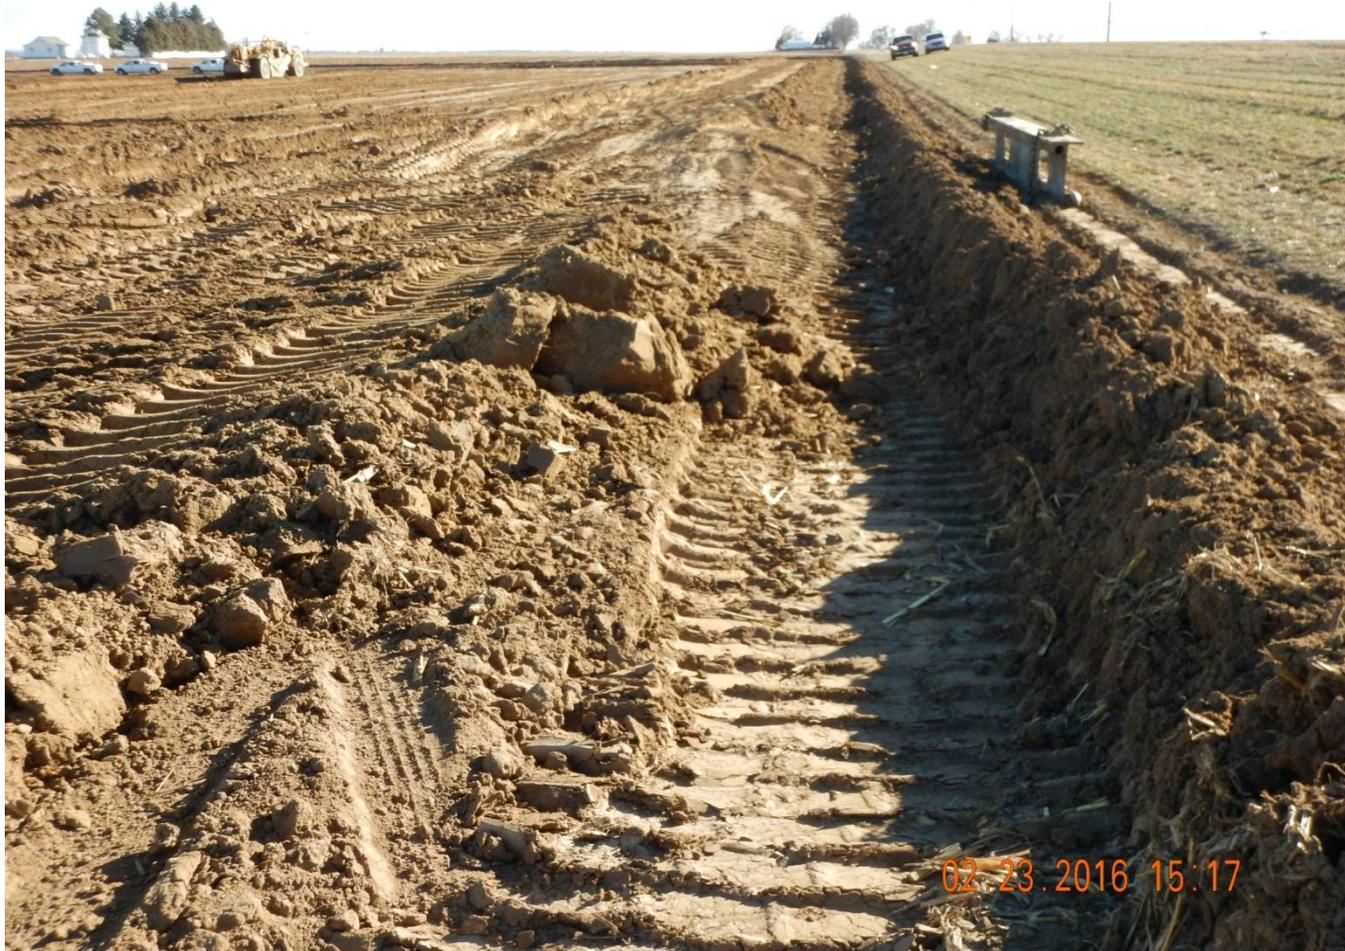
**Photo 8.** Photo taken from northwest location, facing South. Stormwater and sediment control BMPs installed in center of photo.

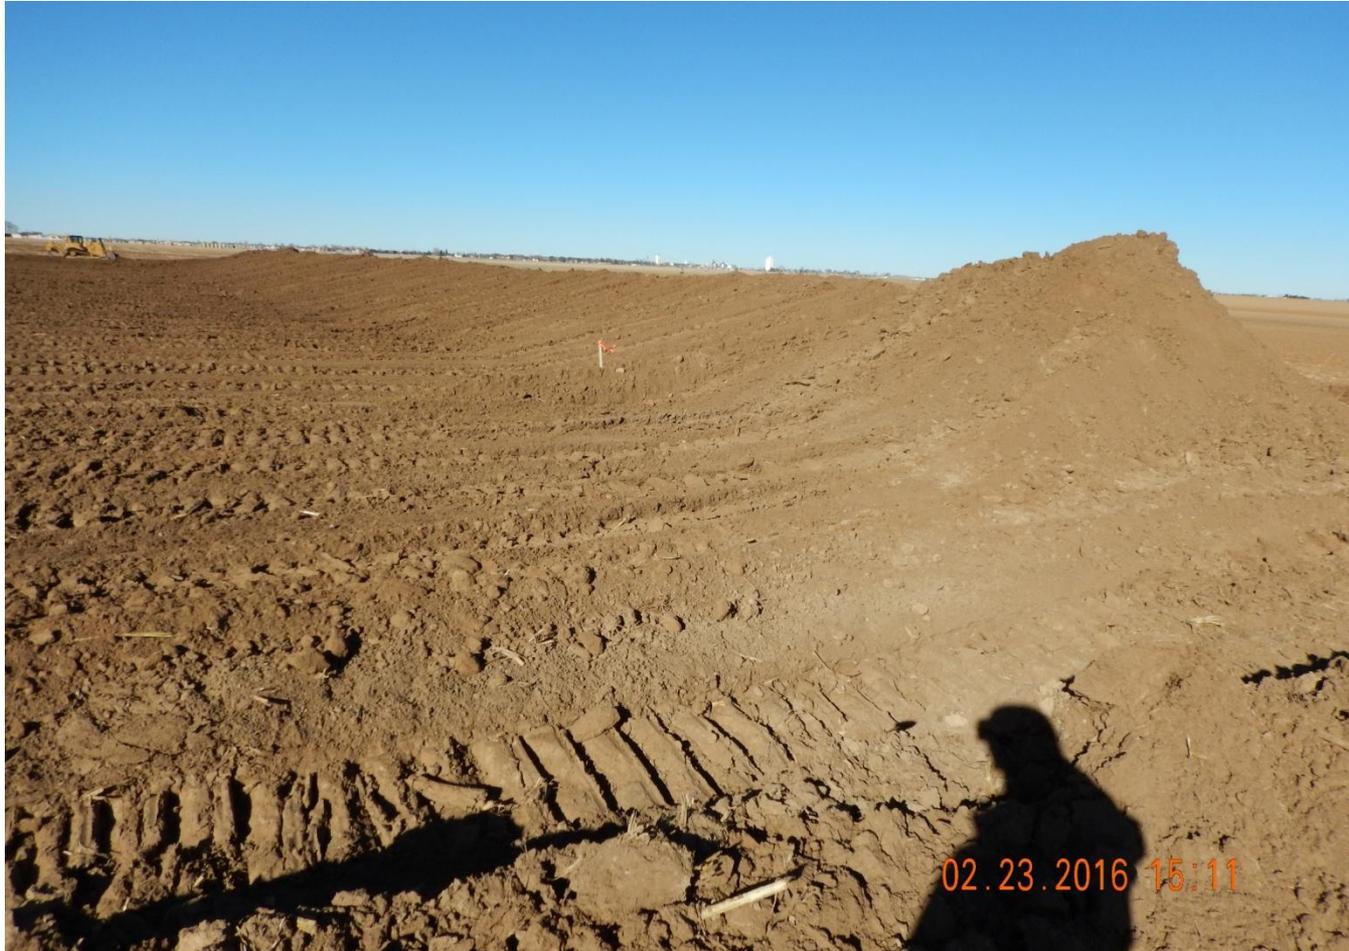
**Photo 9.** Photo taken from the southern location, facing North. Topsoil stockpile in center of photo.

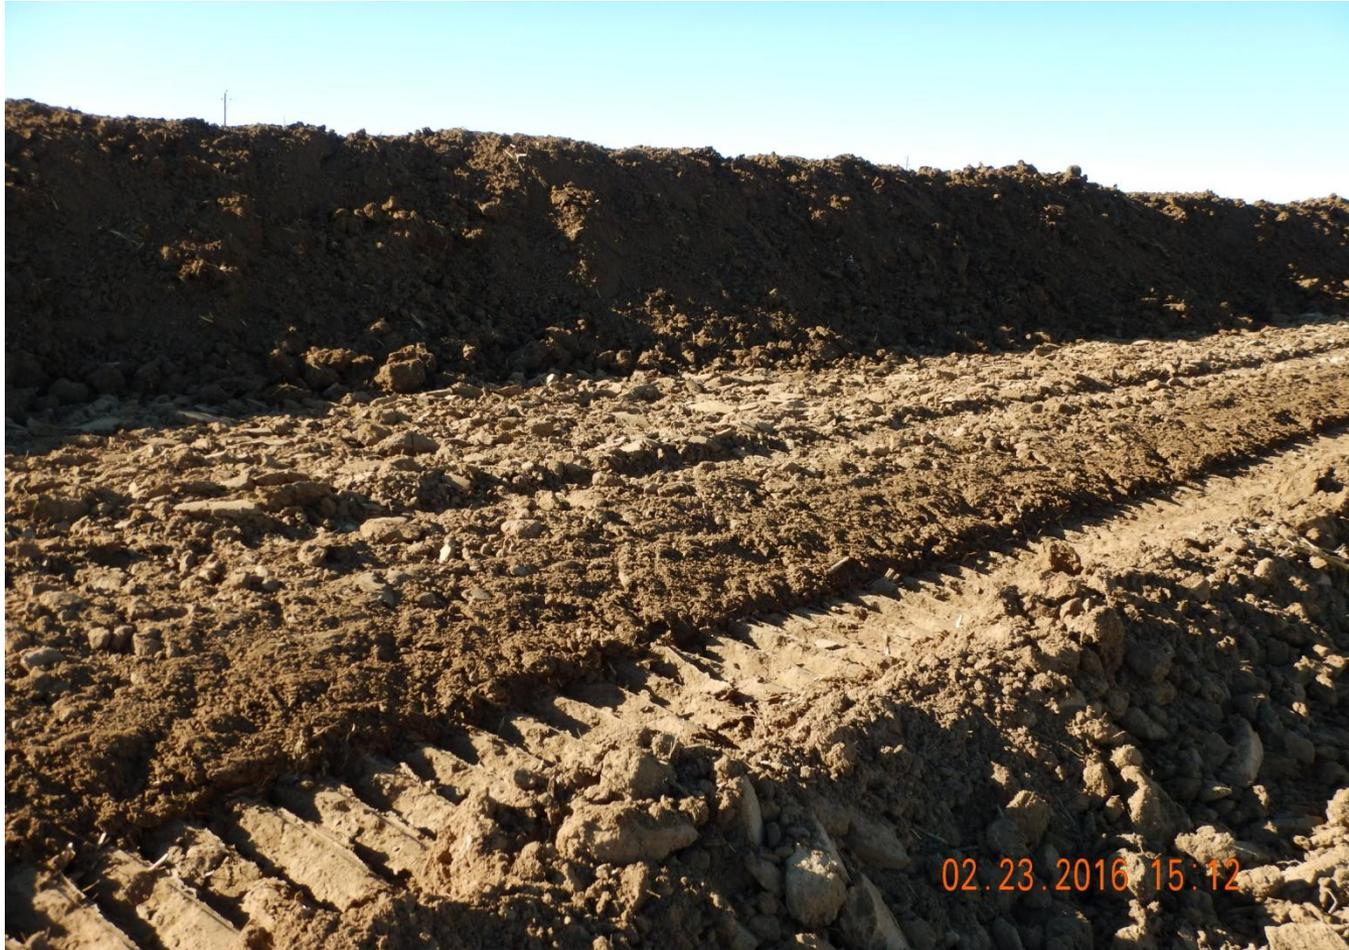
**Photo 10.** Photo taken from the eastern location, facing West. Topsoil stockpile in center of photo. Need to stabilize topsoil stockpile upon completion of topsoil salvage process.

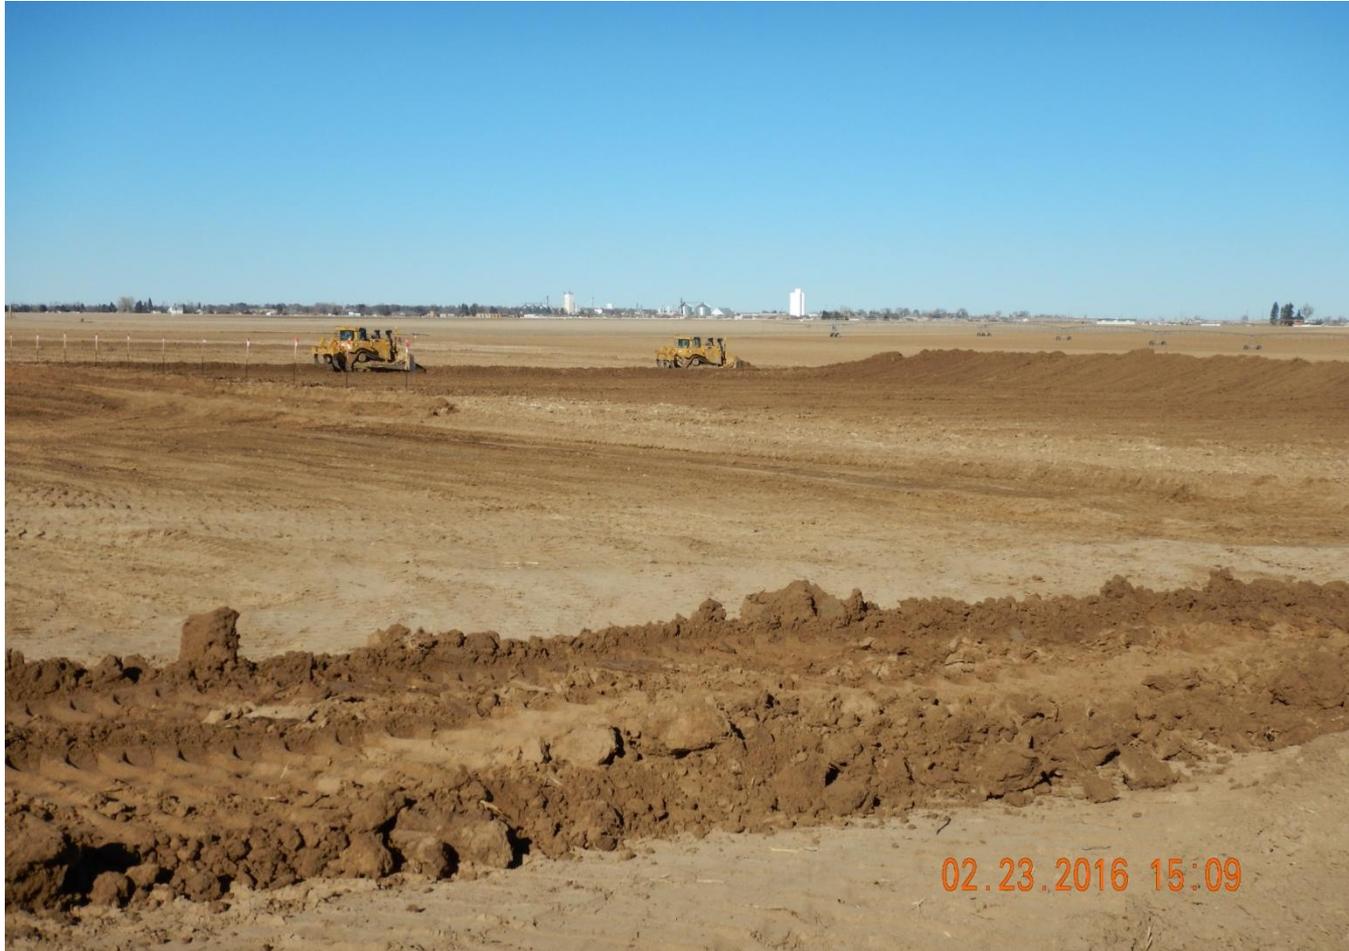
**Photo 11.** Photo taken from the southern location, facing Northeast. Topsoil salvage in process.

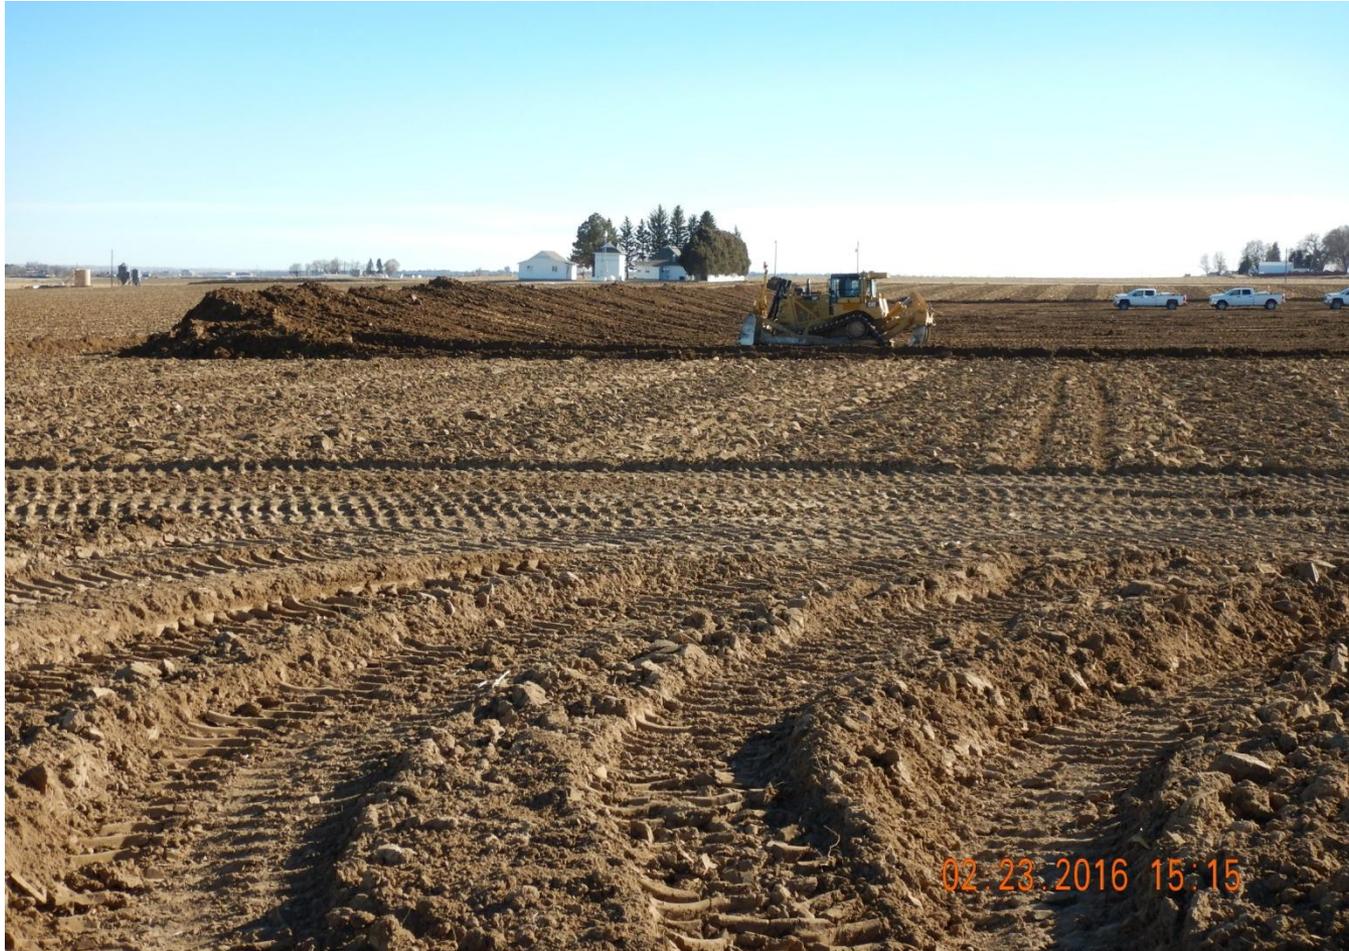
**Photo 12.** Photo taken from the northern location, facing Northeast. Topsoil salvage in process.
