# Interim Reclamation Inspection

3/3/2016

Operator: Whiting Oil and Gas

Location ID: 431782

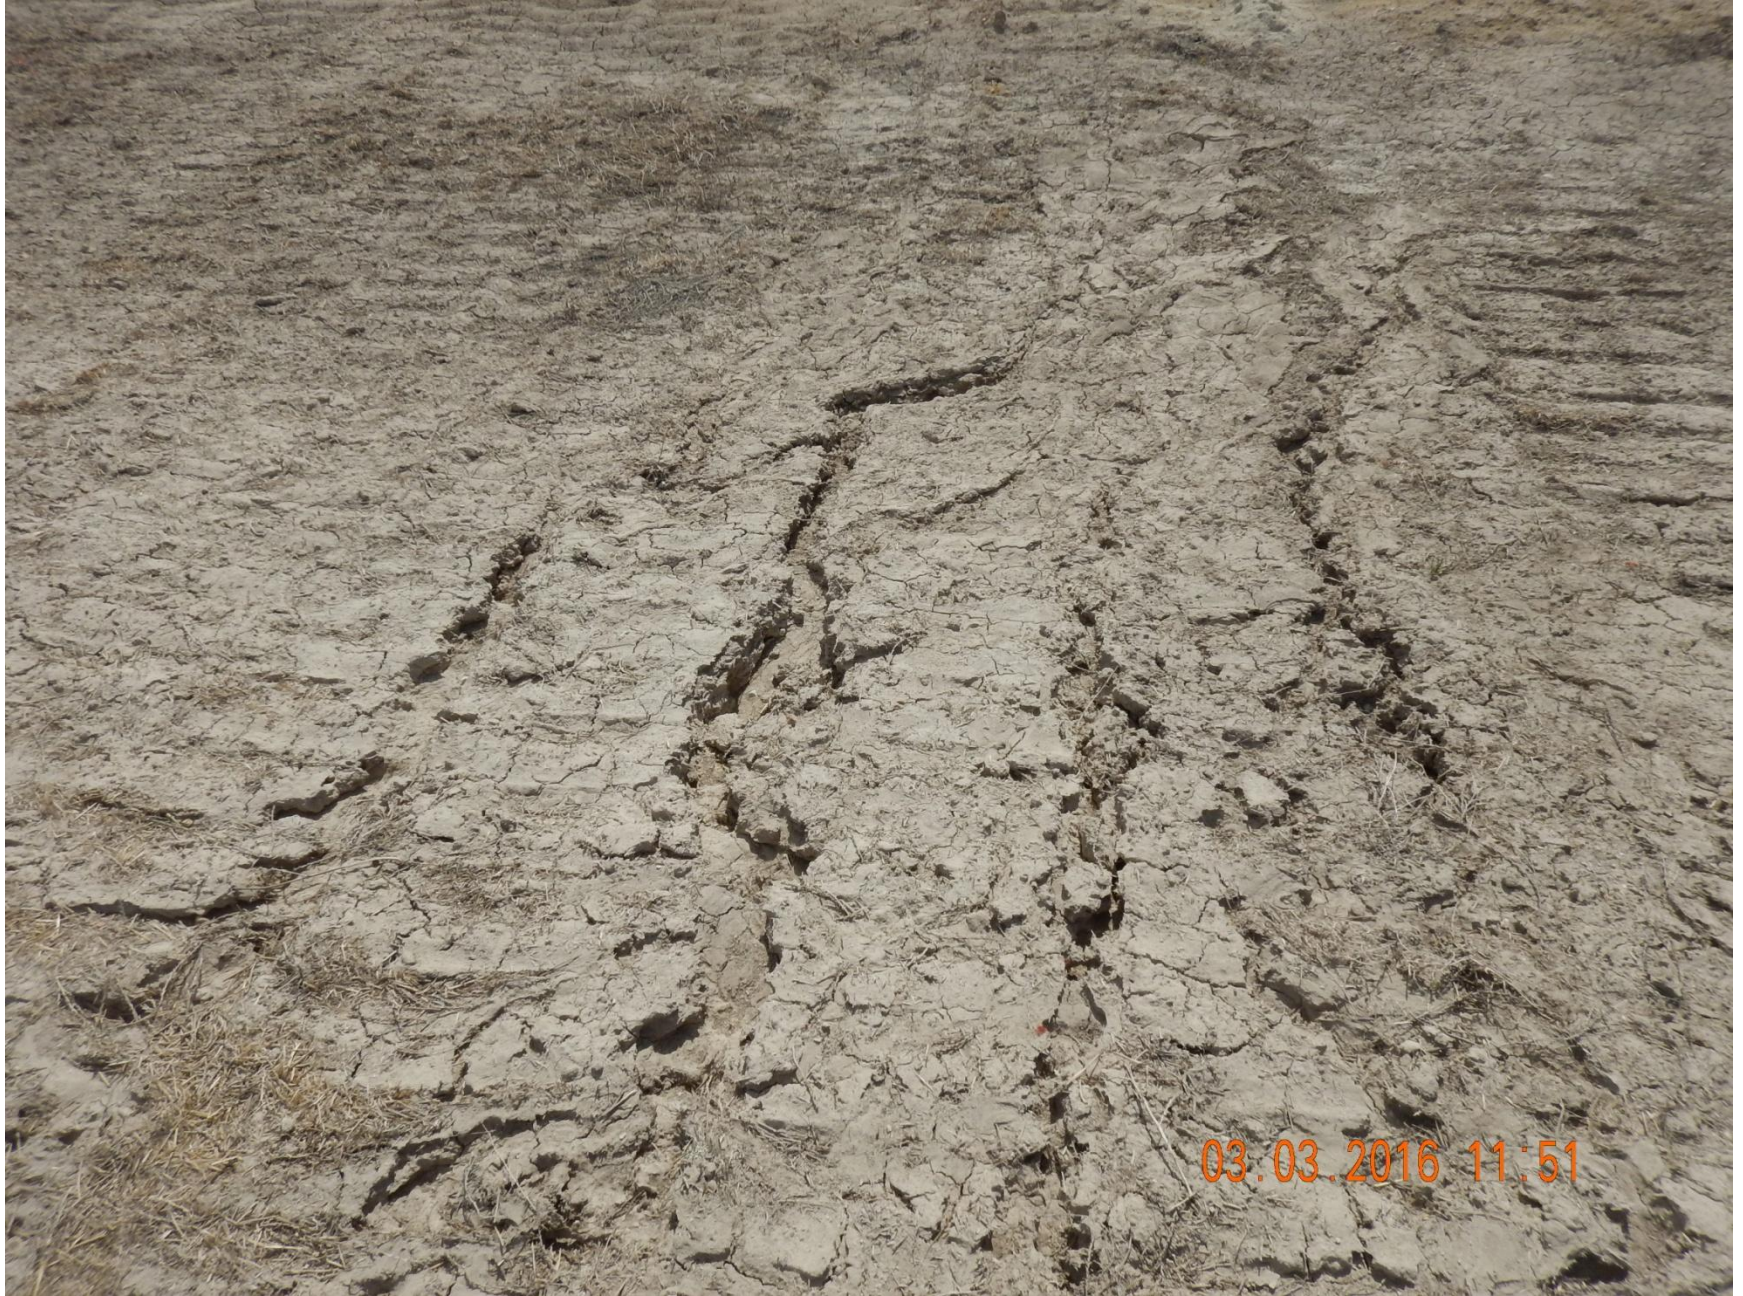
**Figure 13:** Photo taken from the north end of the location. Photo show rill erosion on slope.

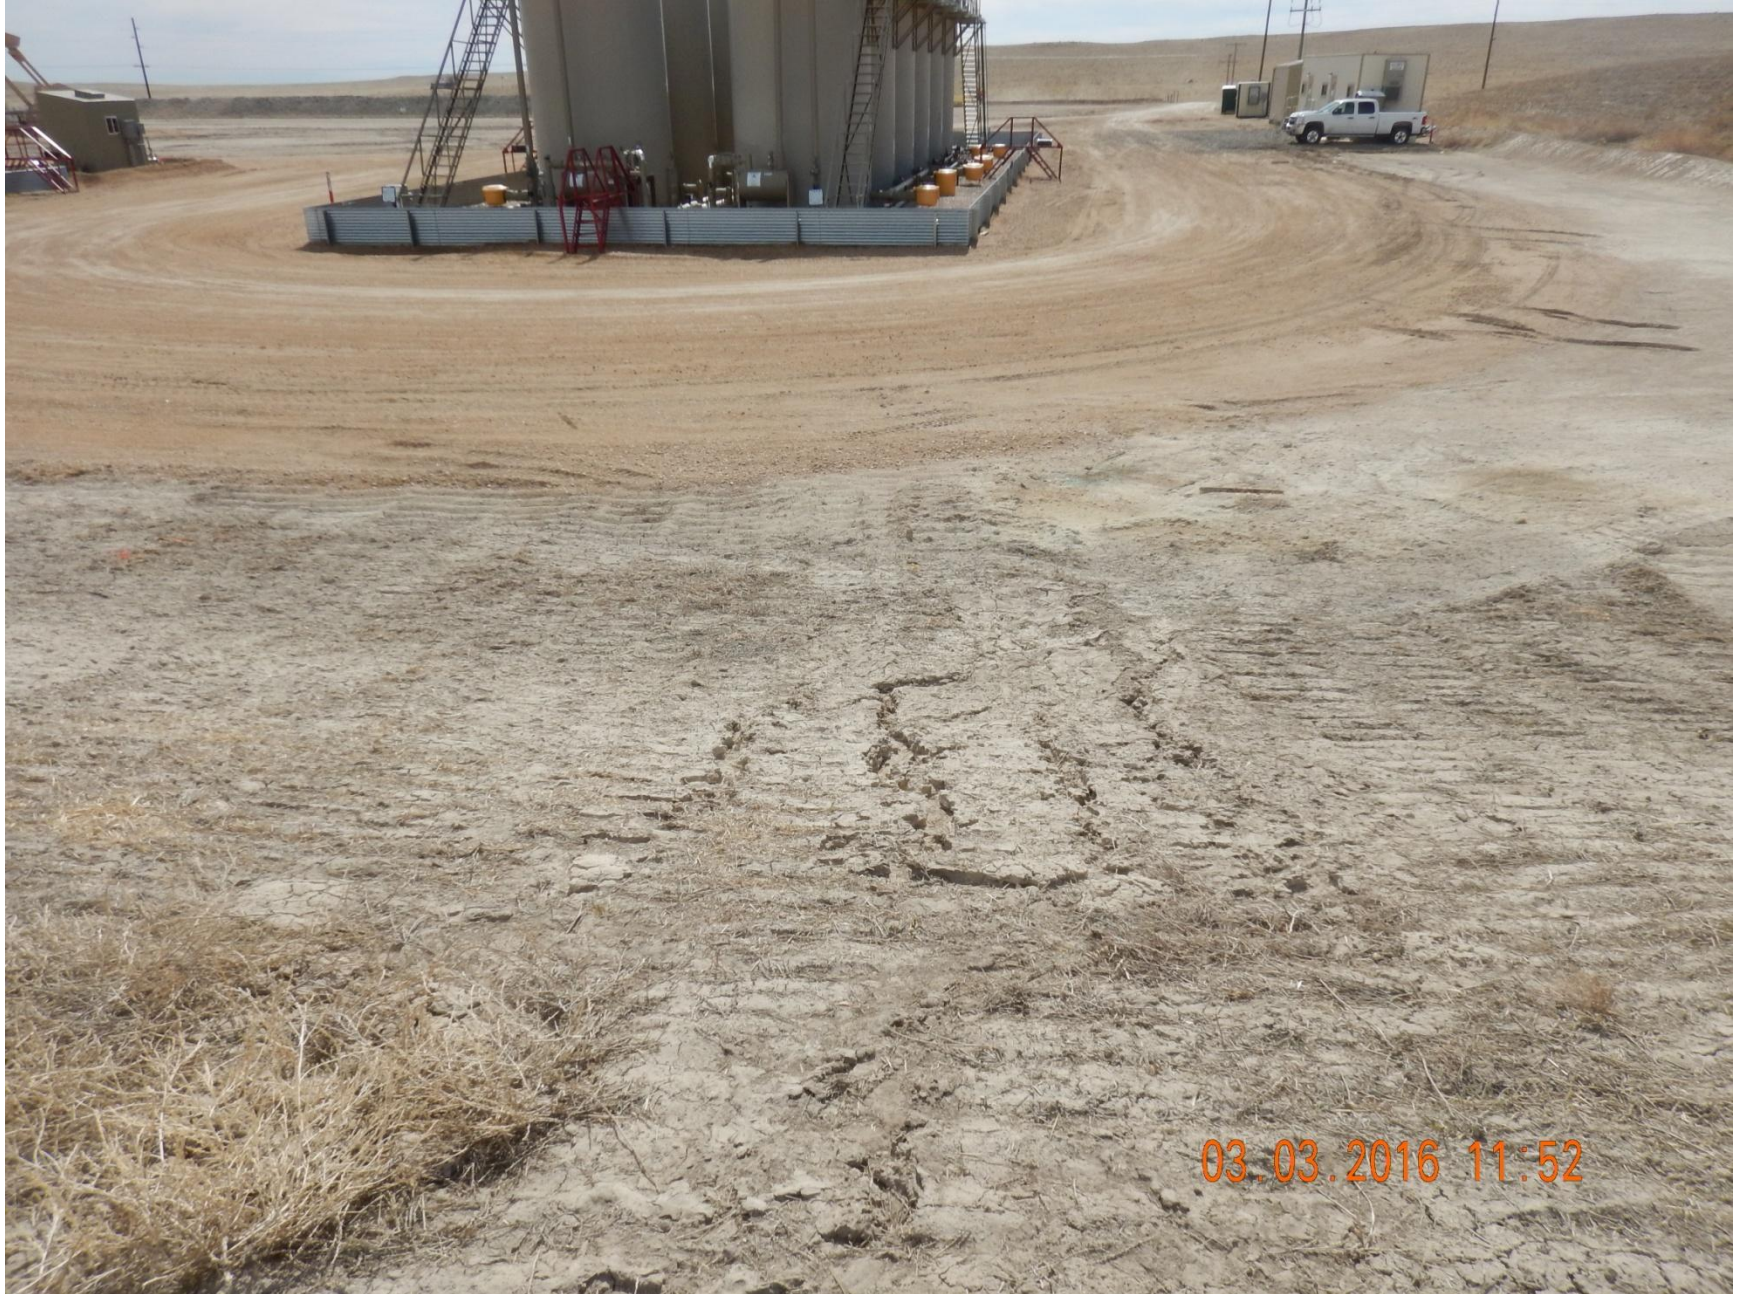
**Figure 14:** Photo taken from the north end of the location, facing south. Photo show rill erosion on slope.

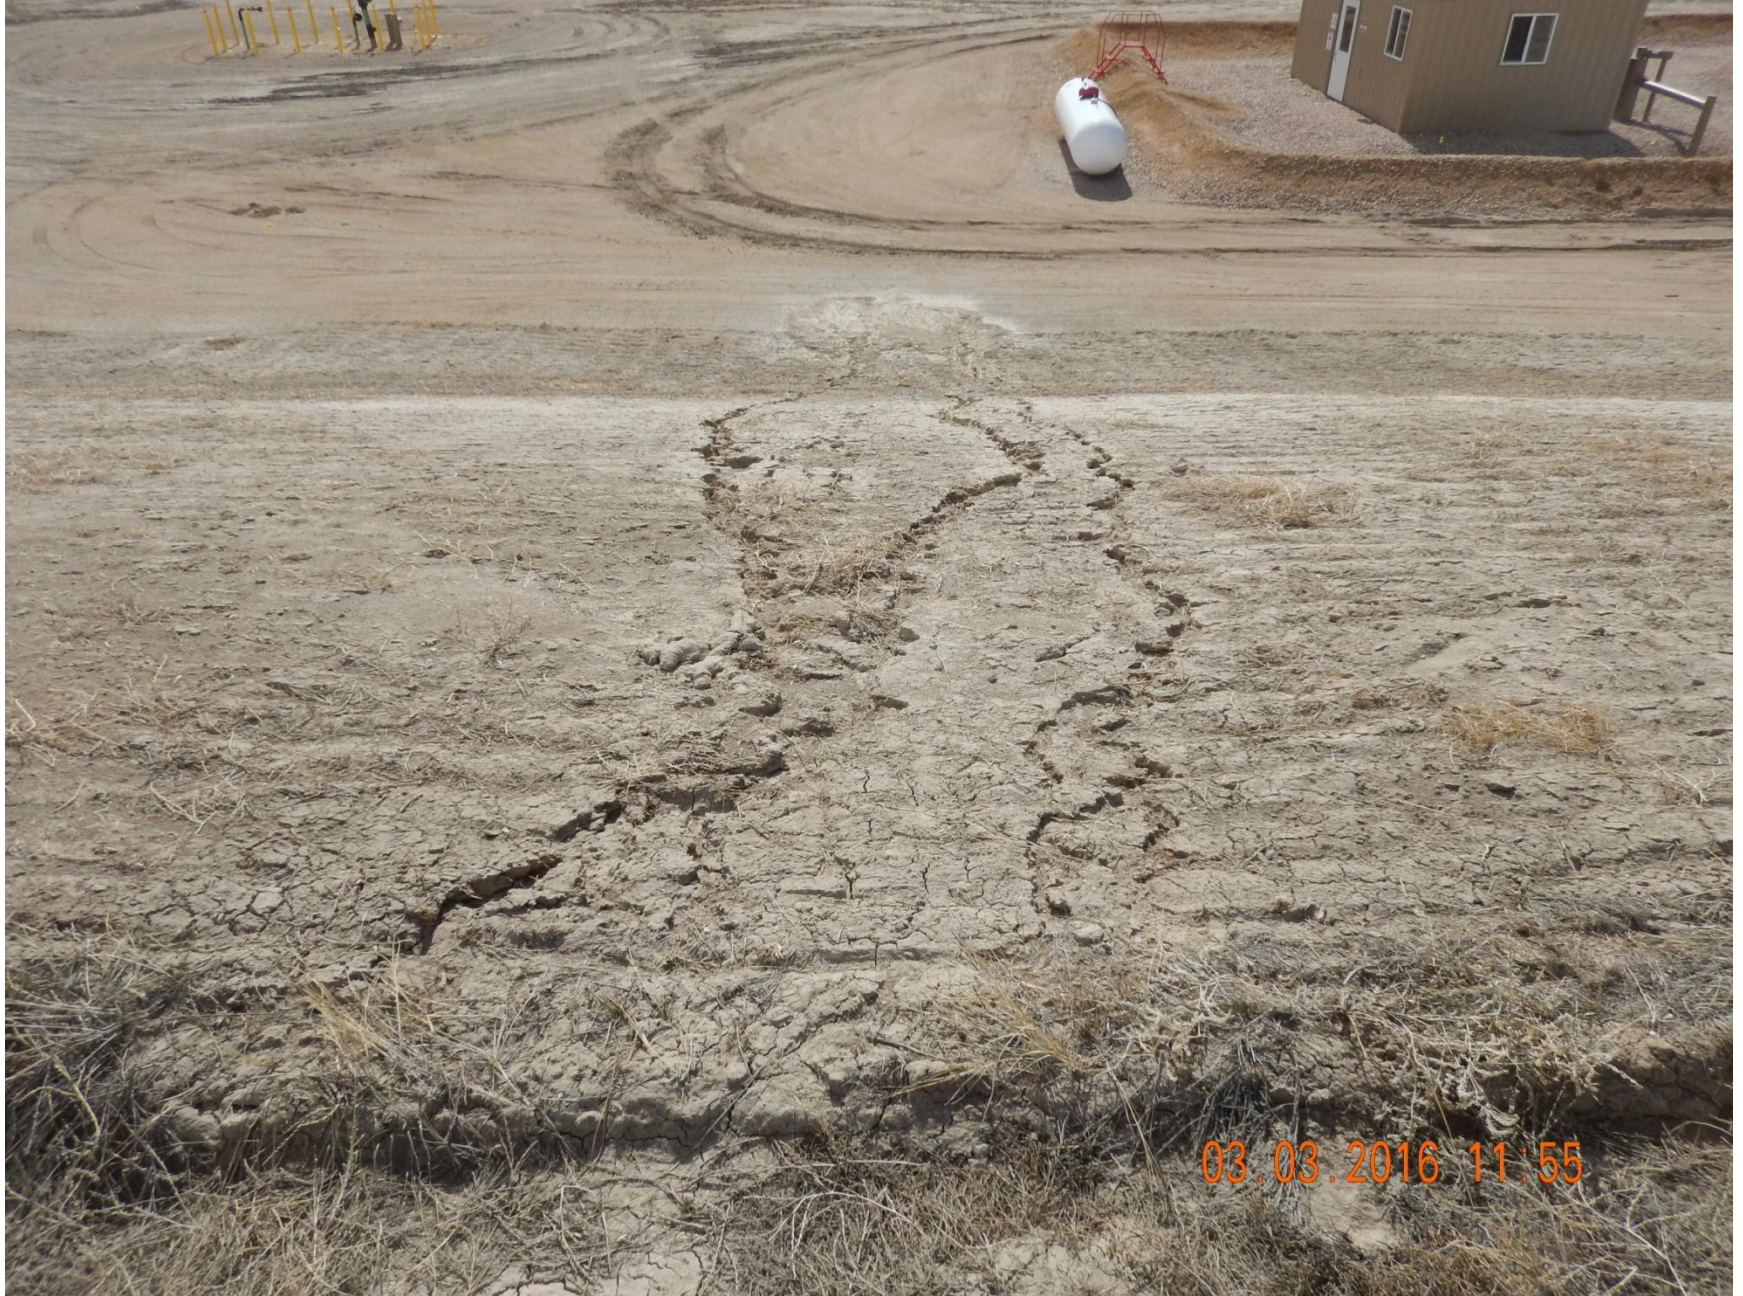
**Figure 17:** Photo taken from the north end of the location, facing south. Photo of rill erosion on slope, and sediment deposition on location. It appears rill erosion originates from the stormwater control ditch.

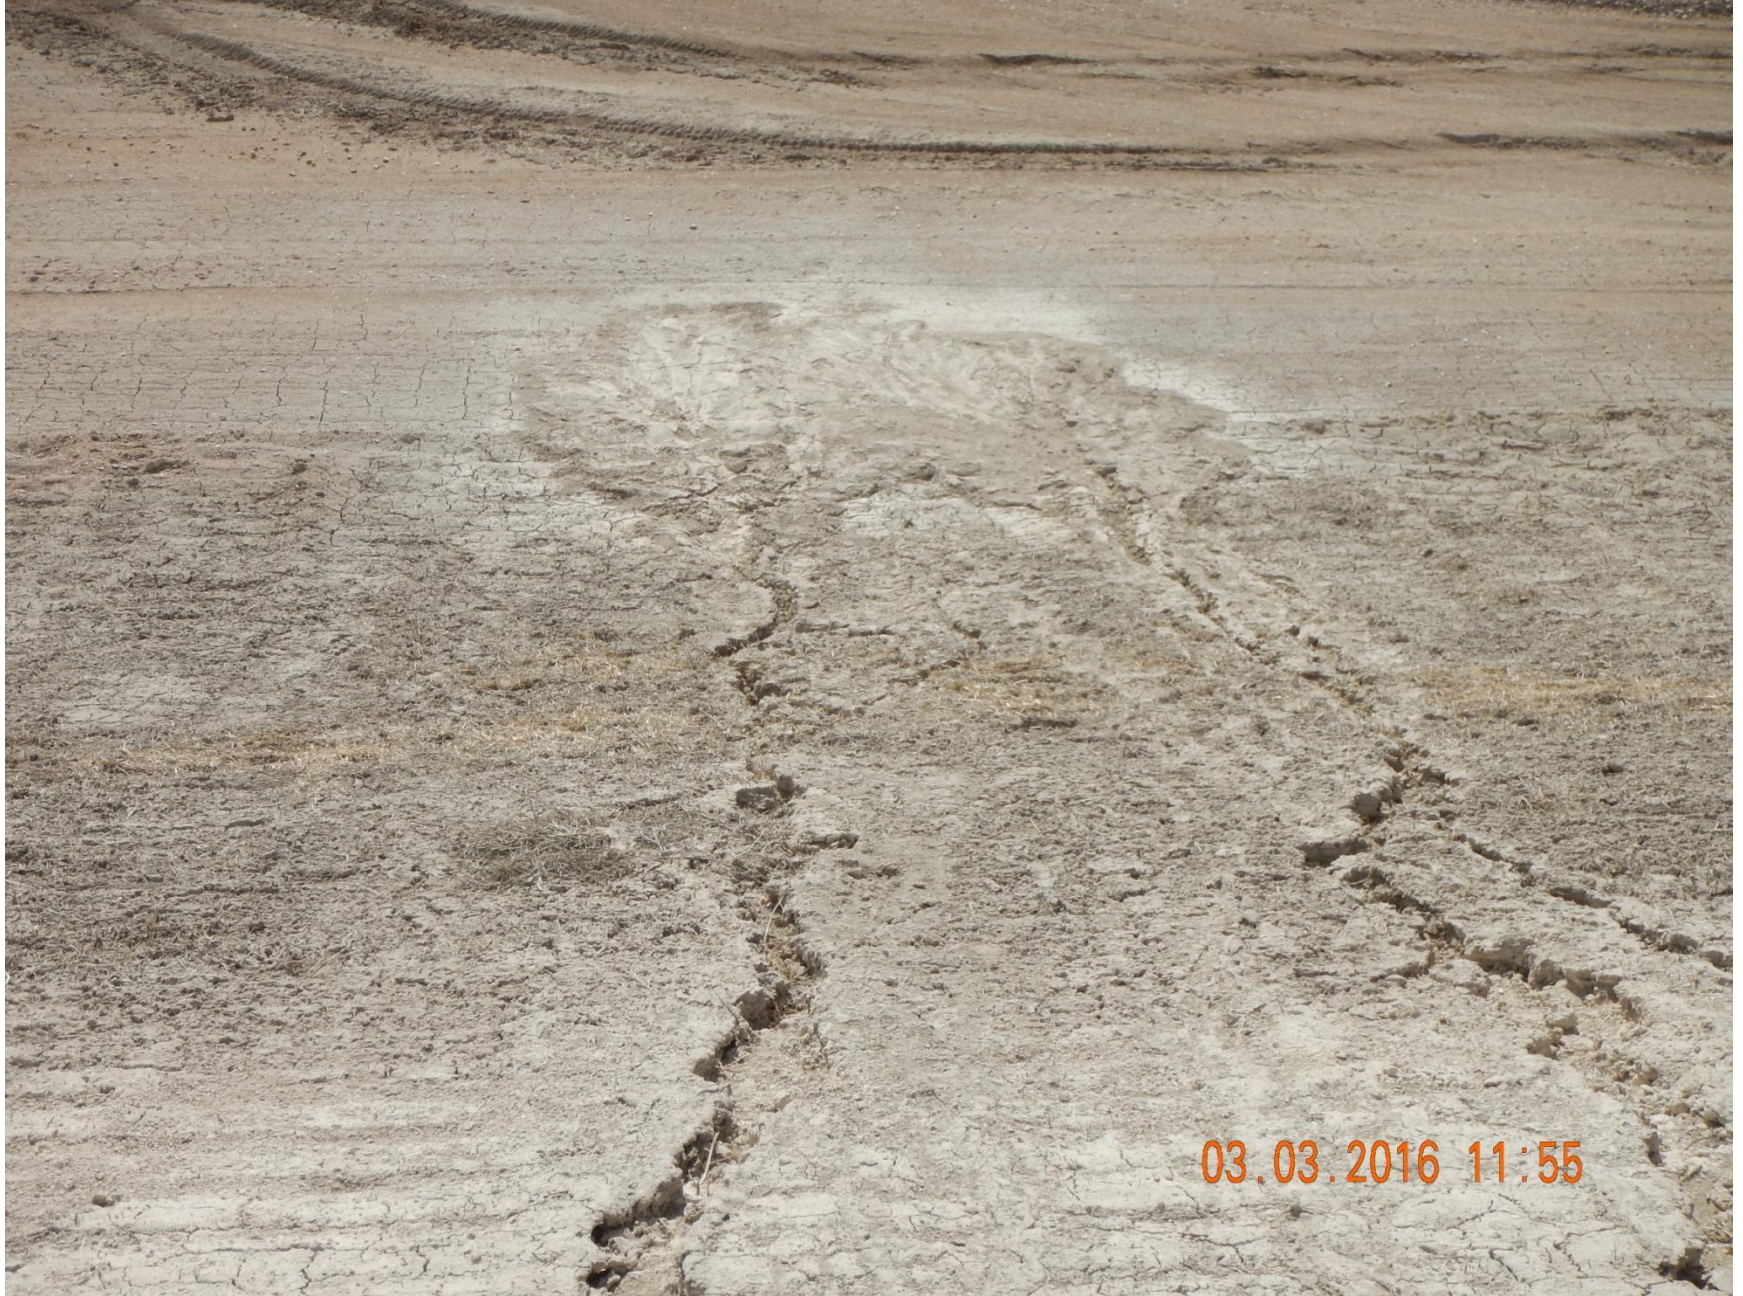
**Figure 18:** Photo taken from the north end of the location, facing south. Photo of rill erosion on slope, and sediment deposition on location. It appears rill erosion originates from the stormwater control ditch.

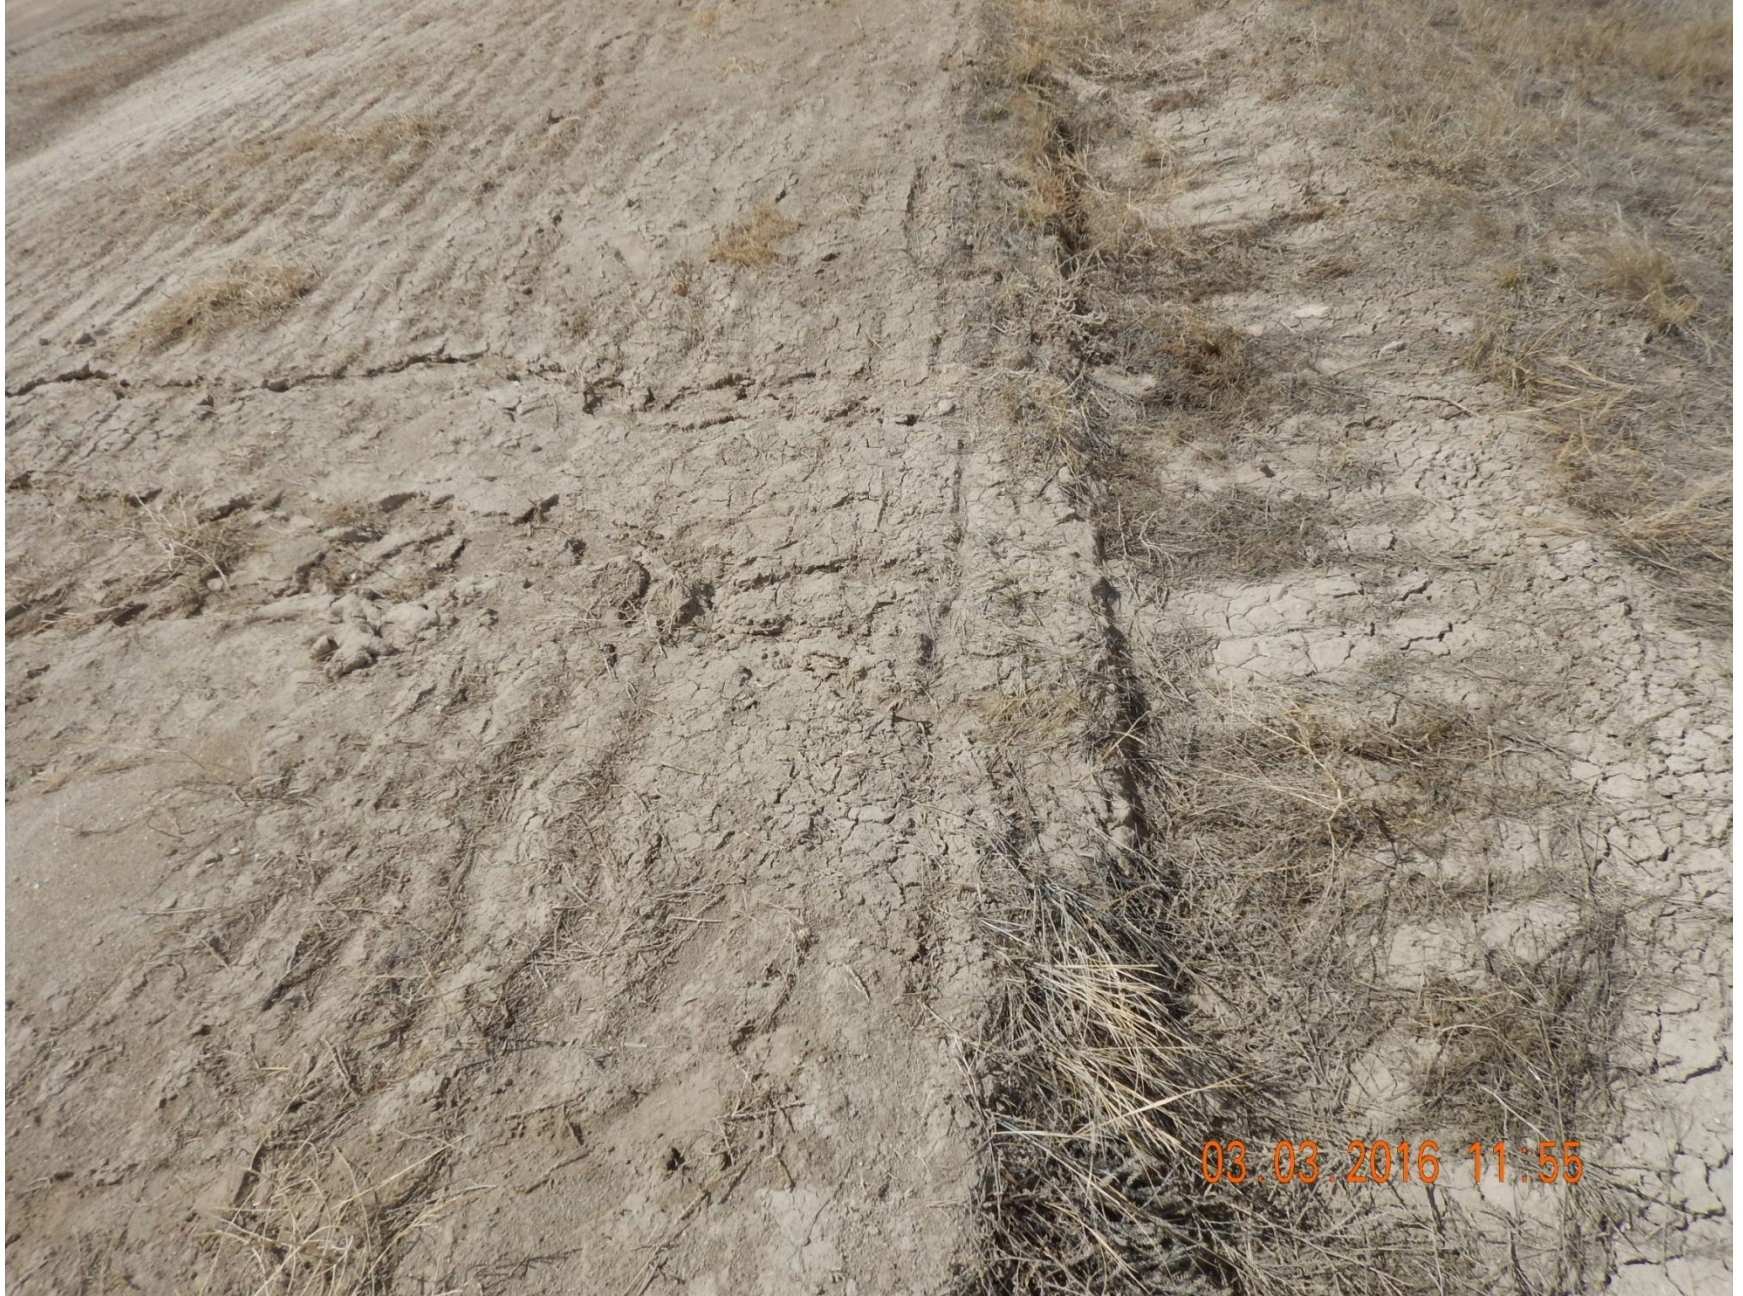
**Figure 19:** Photo taken from the north end of the location. Photo of rill erosion on slope. It appears rill erosion originates from the stormwater control ditch.

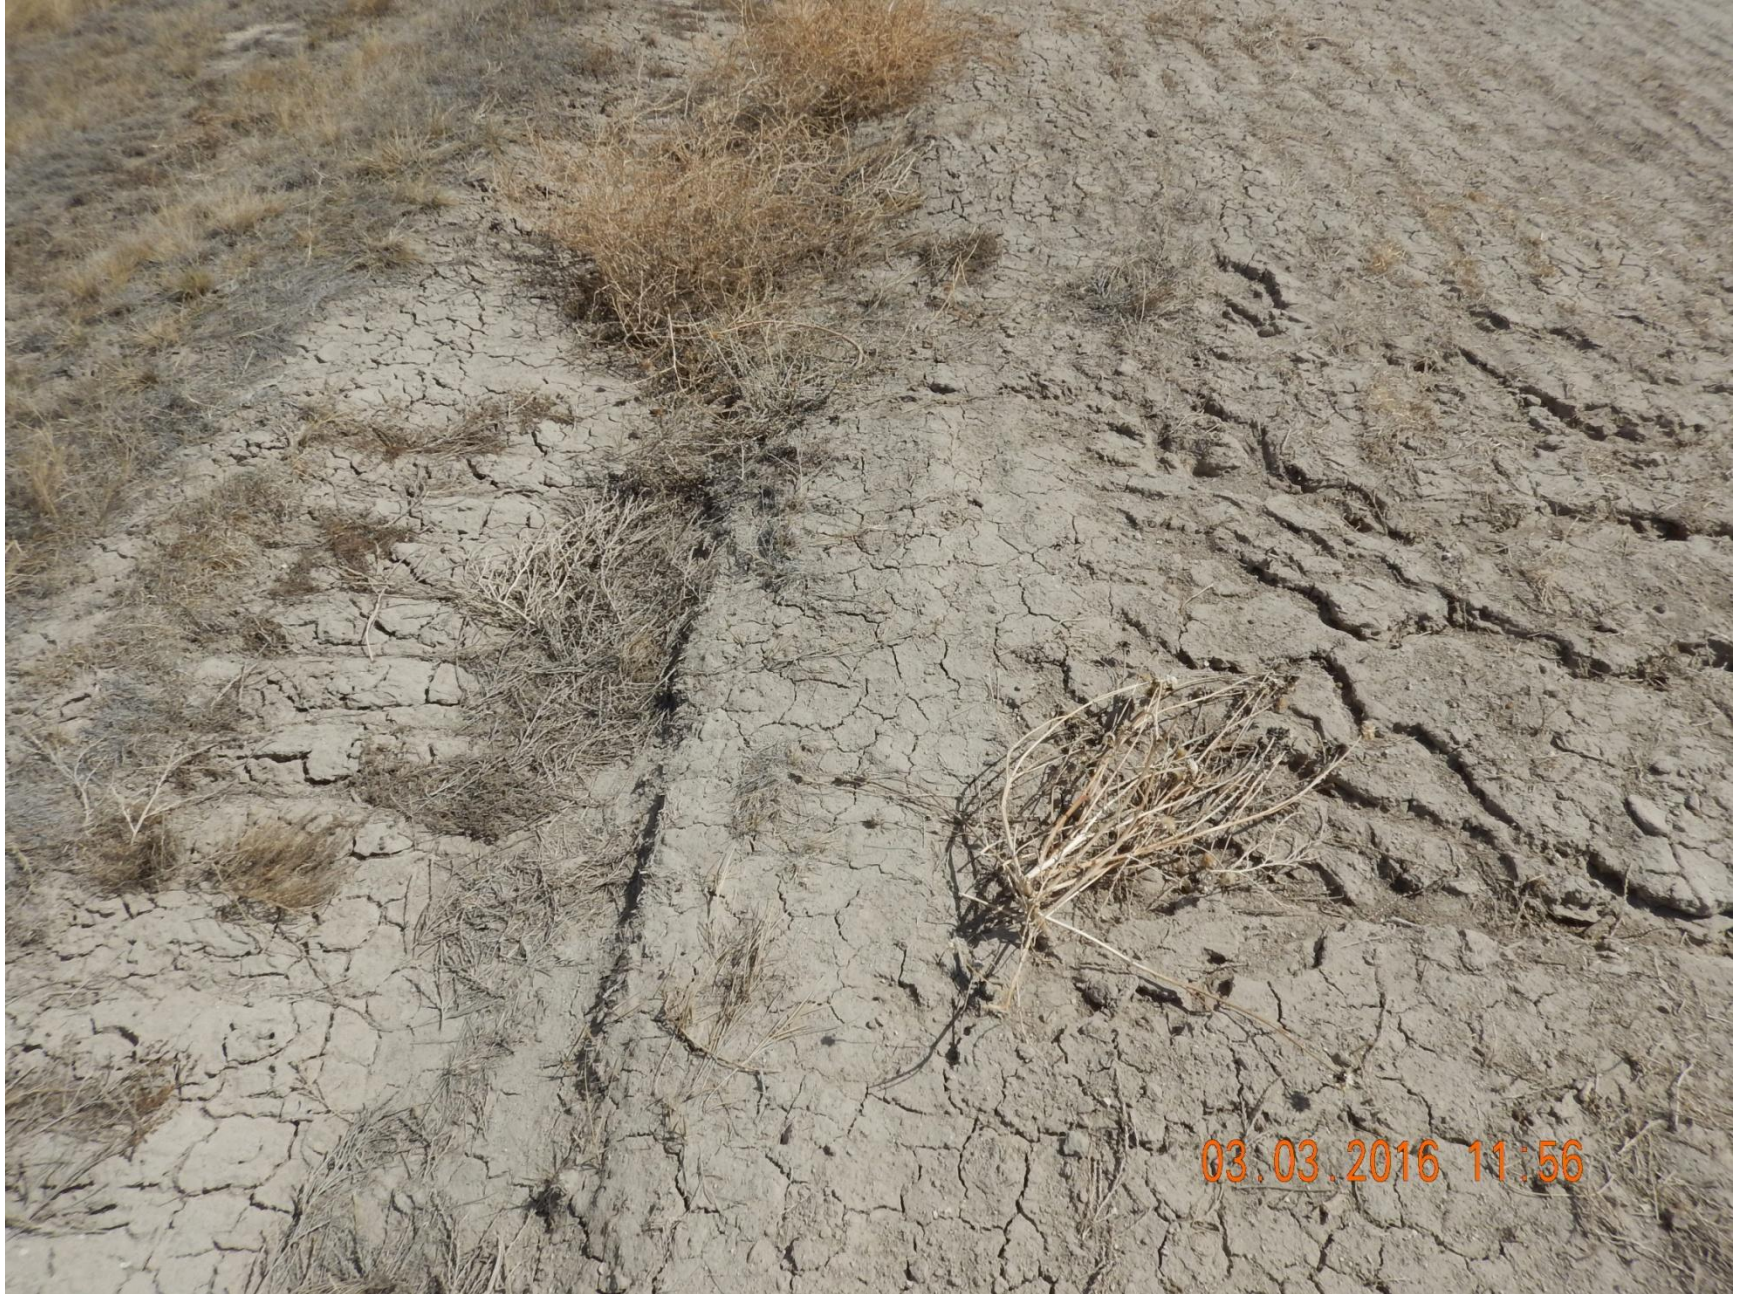
**Figure 20:** Photo taken from the north end of the location. Photo of rill erosion on slope. It appears rill erosion originates from the stormwater control ditch.

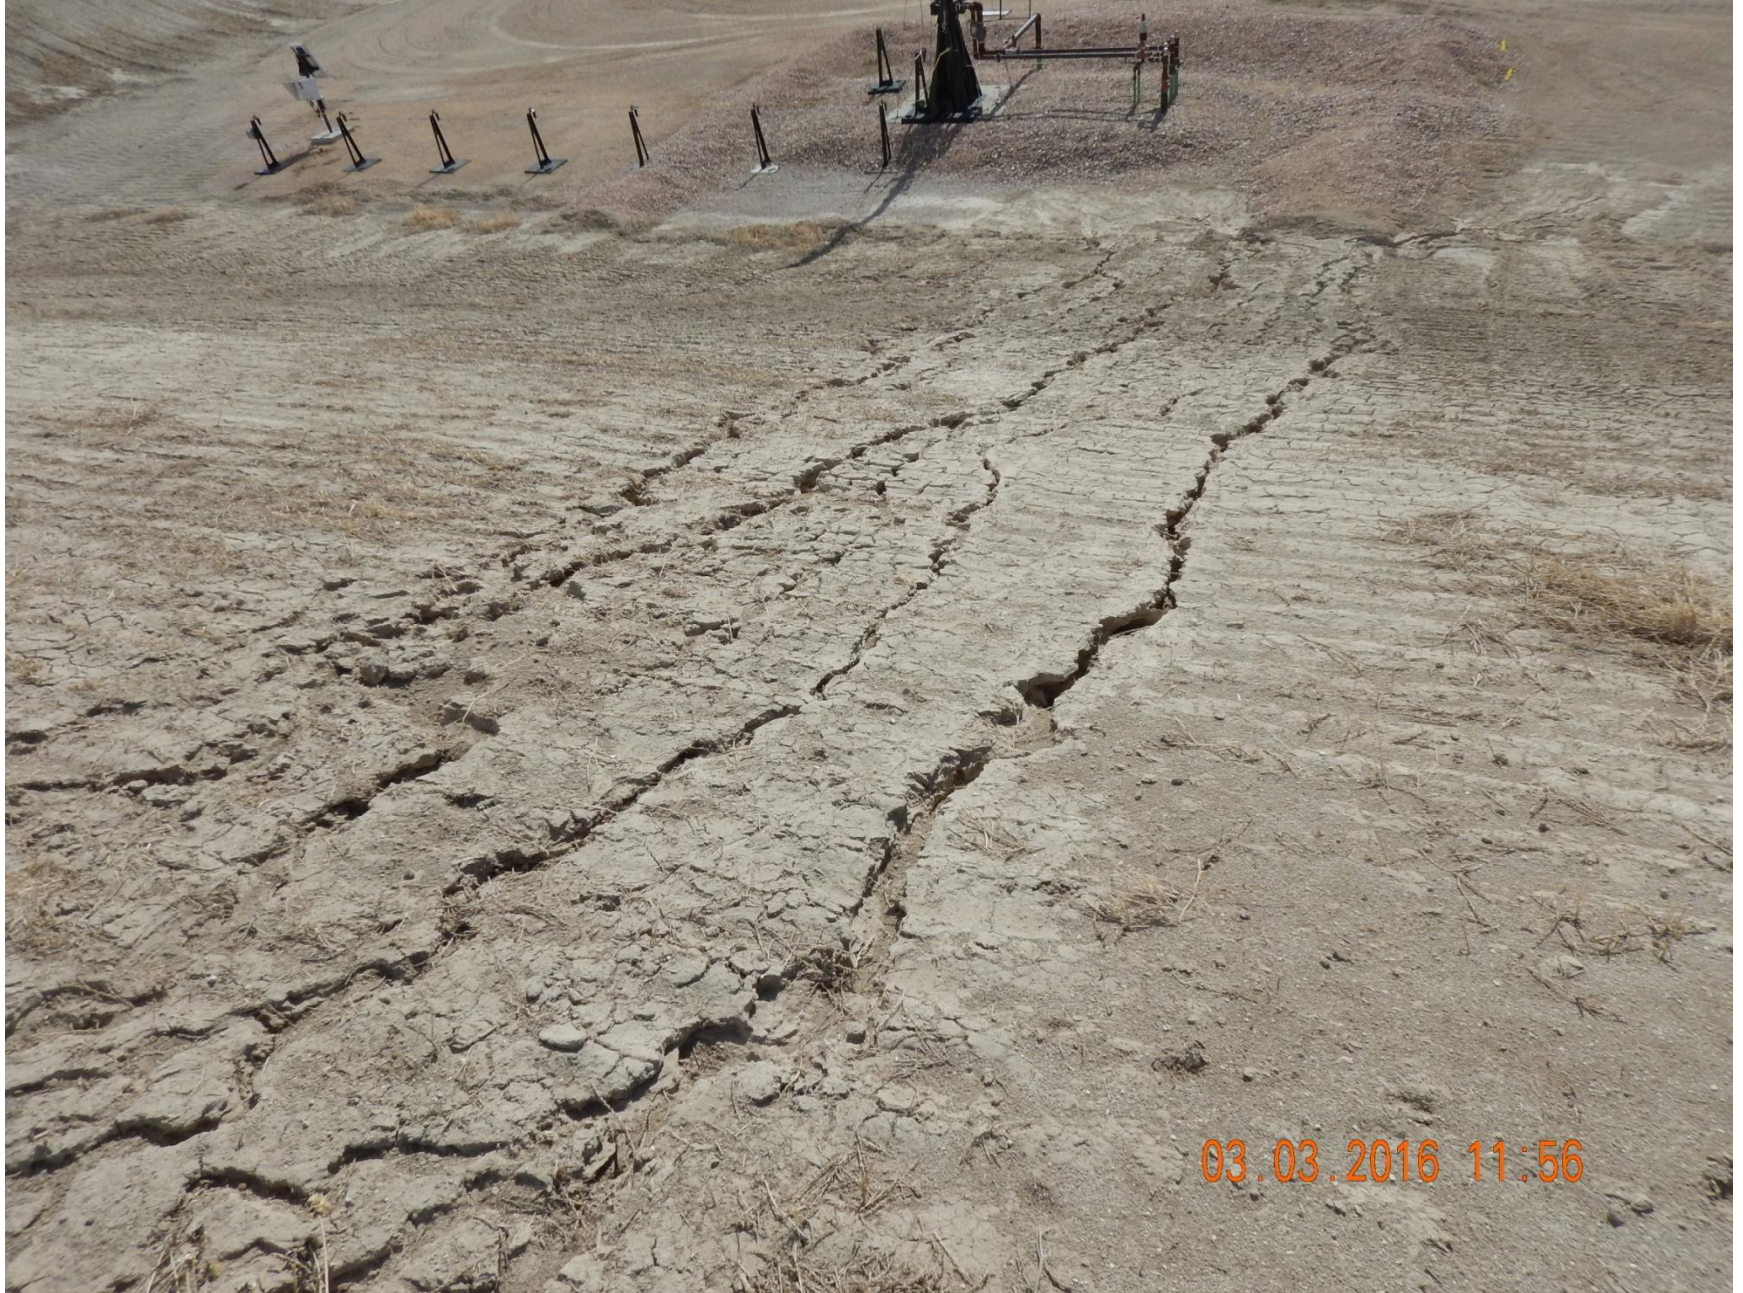
**Figure 21:** Photo taken from the north end of the location, facing south. Photo of rill erosion on slope, and sediment deposition on location.

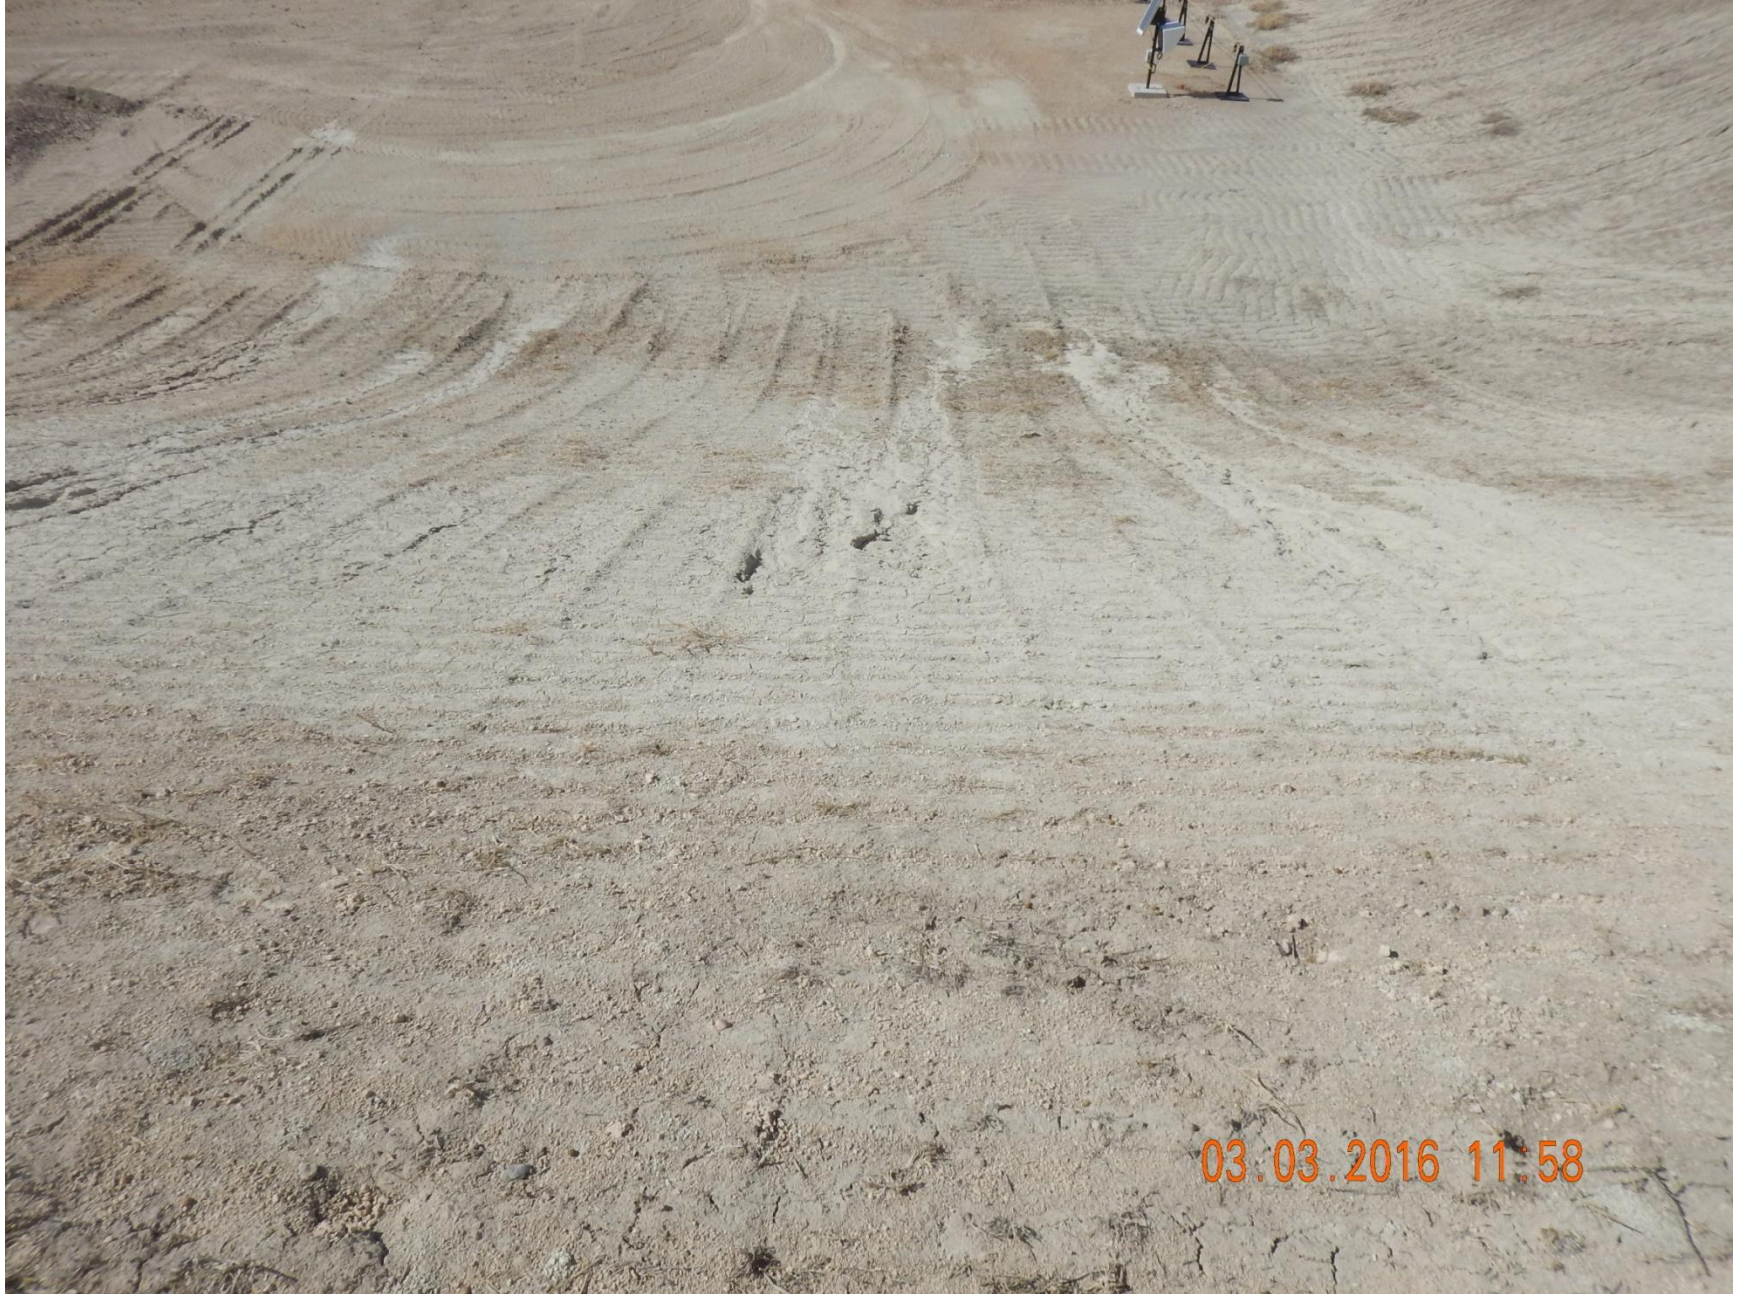
**Figure 24:** Photo taken from the northeast end of the location, facing west. Photo shows rill erosion and sediment deposition on slope.

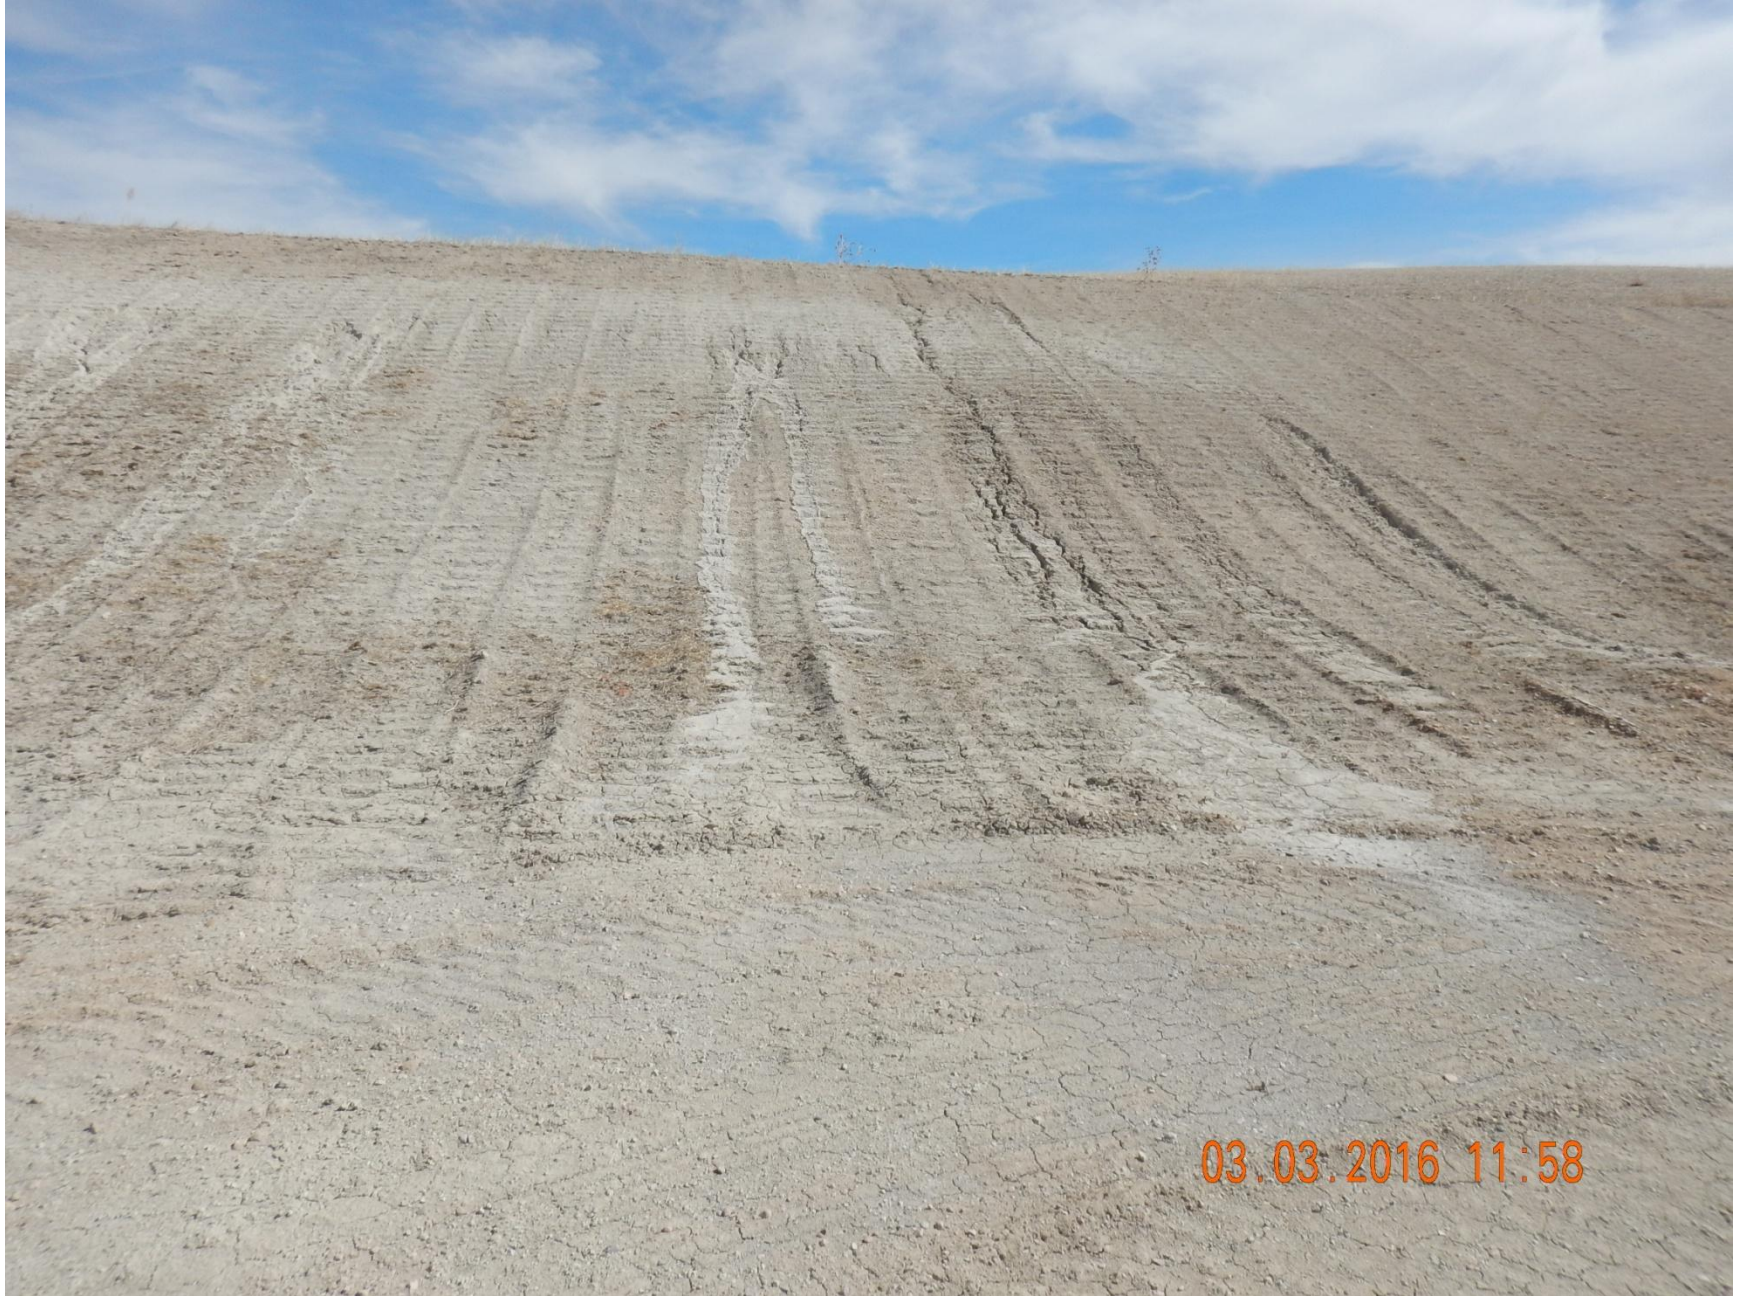
**Figure 25:** Photo taken from the northeast end of the project area, facing east towards the interim area. Photo shows the steep grade of the slope, rill erosion and sediment deposition.

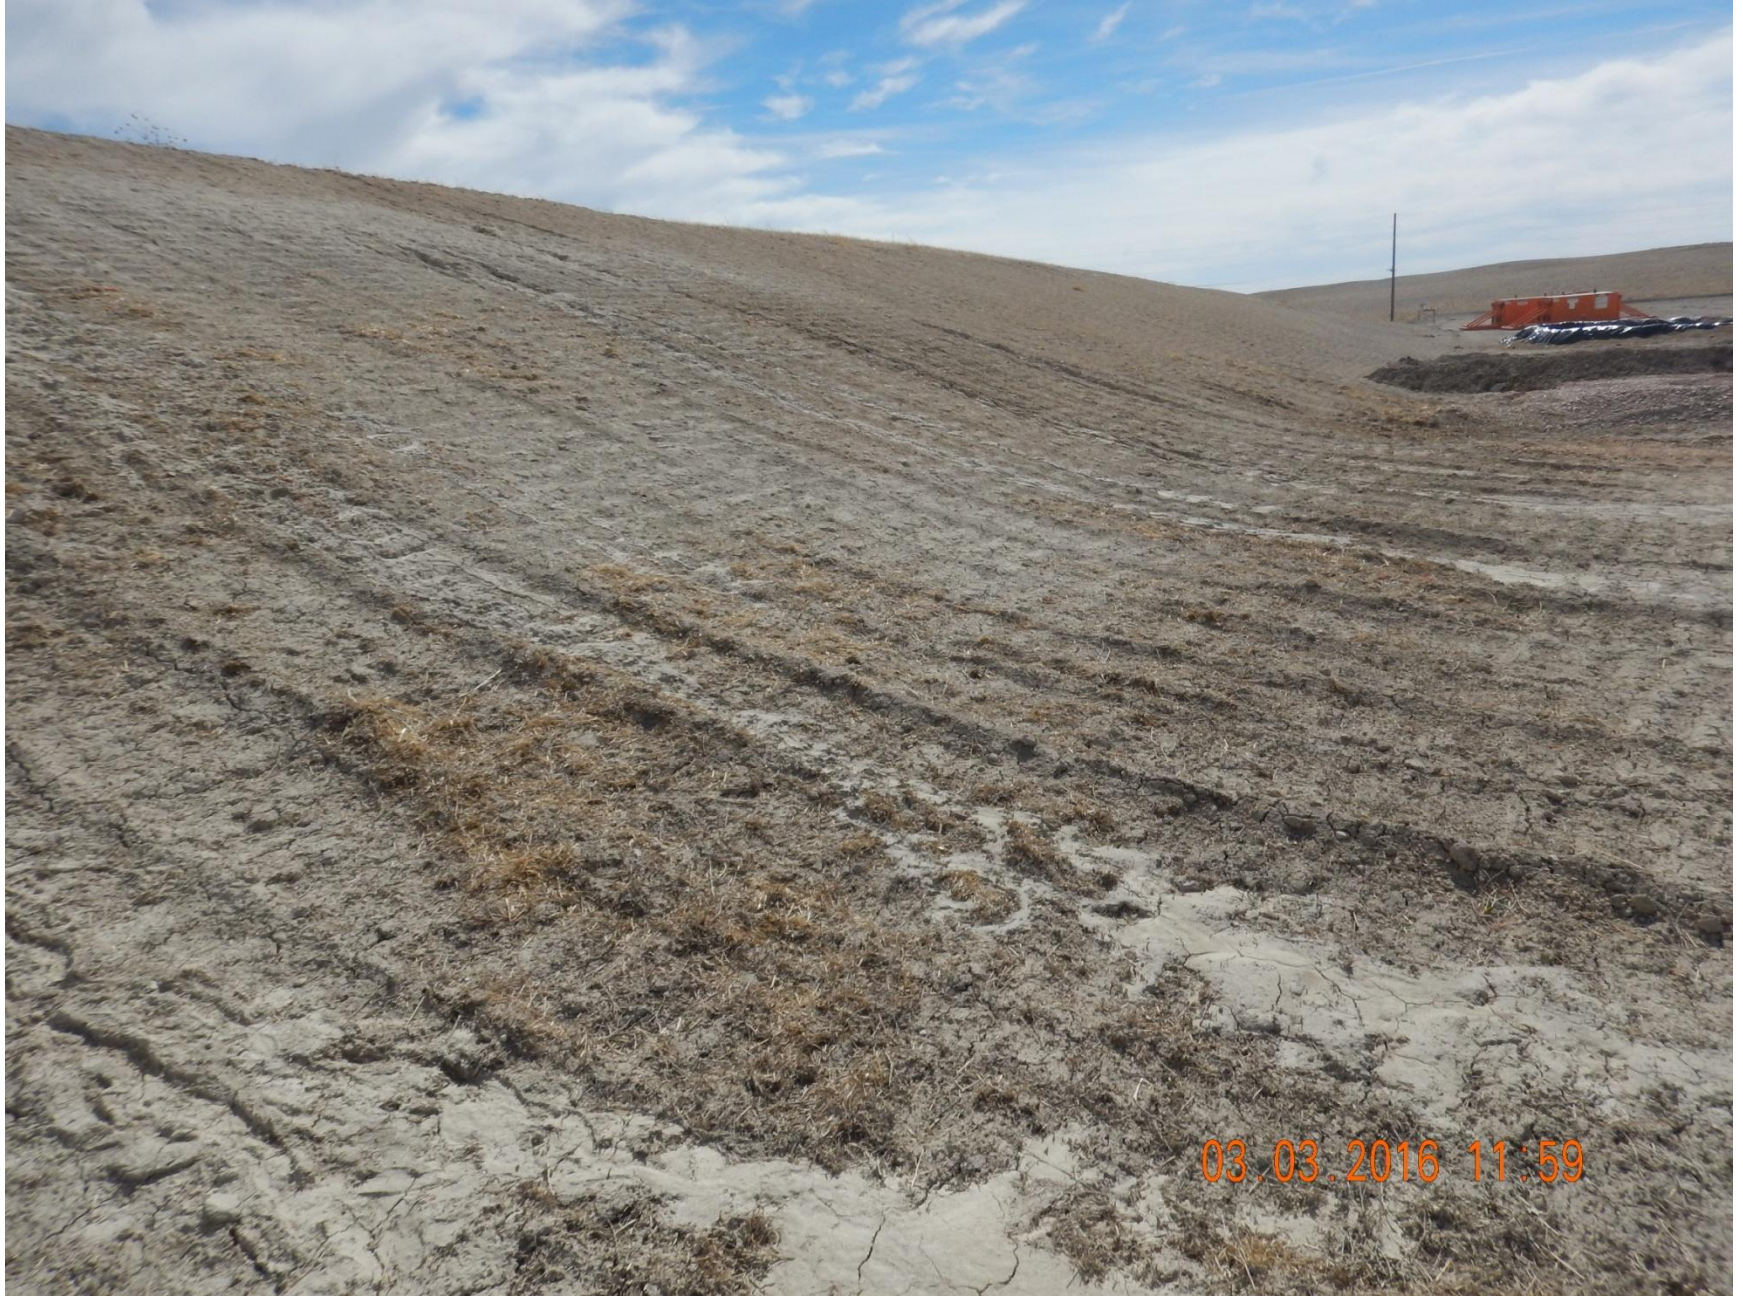
**Figure 26:** Photo taken from the northeast end of the project area, facing southeast towards the interim area. Photo shows the steep grade of the slope, rill erosion and sediment deposition.
