# Interim Reclamation Inspection

3/3/2016

Operator: Whiting Oil and Gas

Location ID: 431782

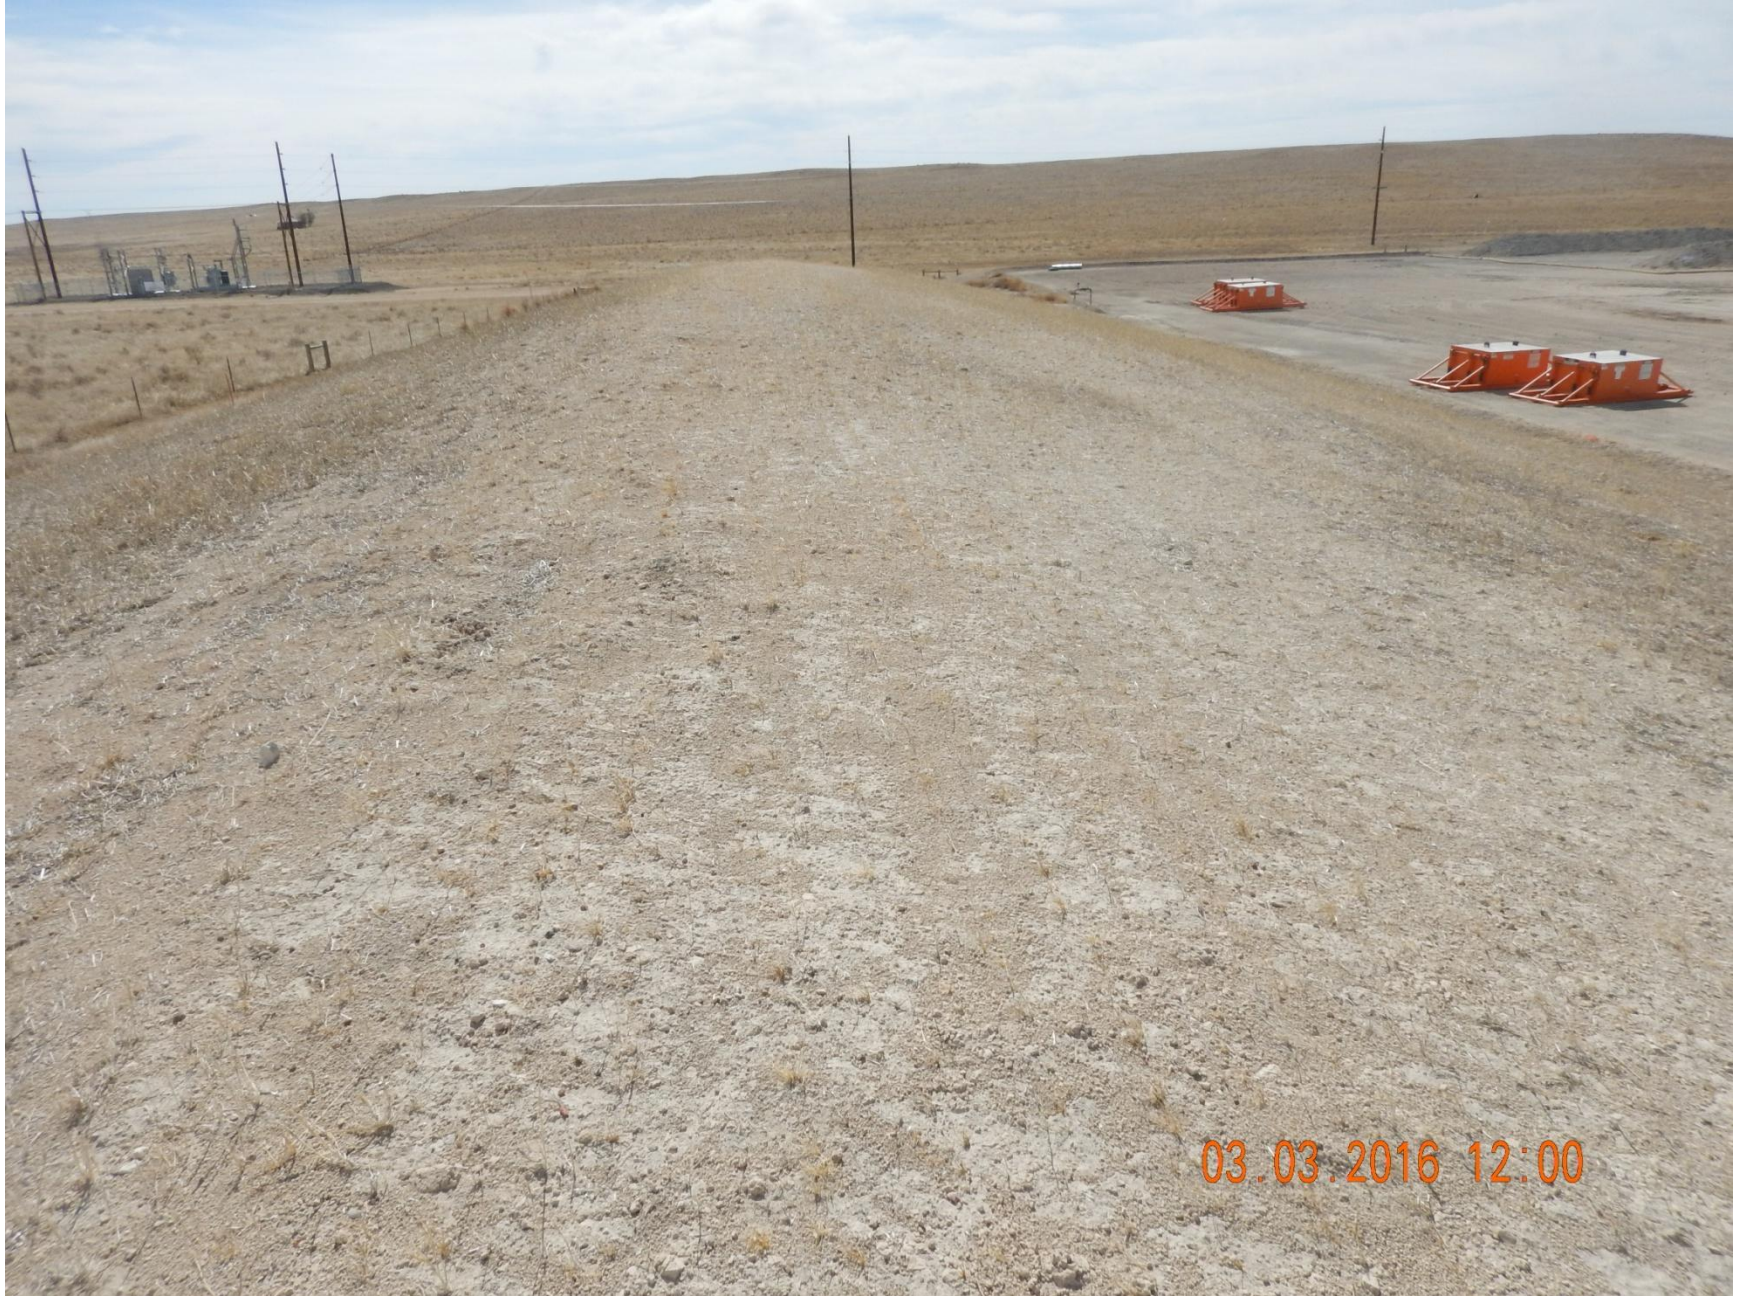
**Figure 27:** Photo taken from the east end of the project area, facing south. Photo shows portion of the interim lacking uniform vegetation. Note the left and right side of the photo shows vegetative growth.

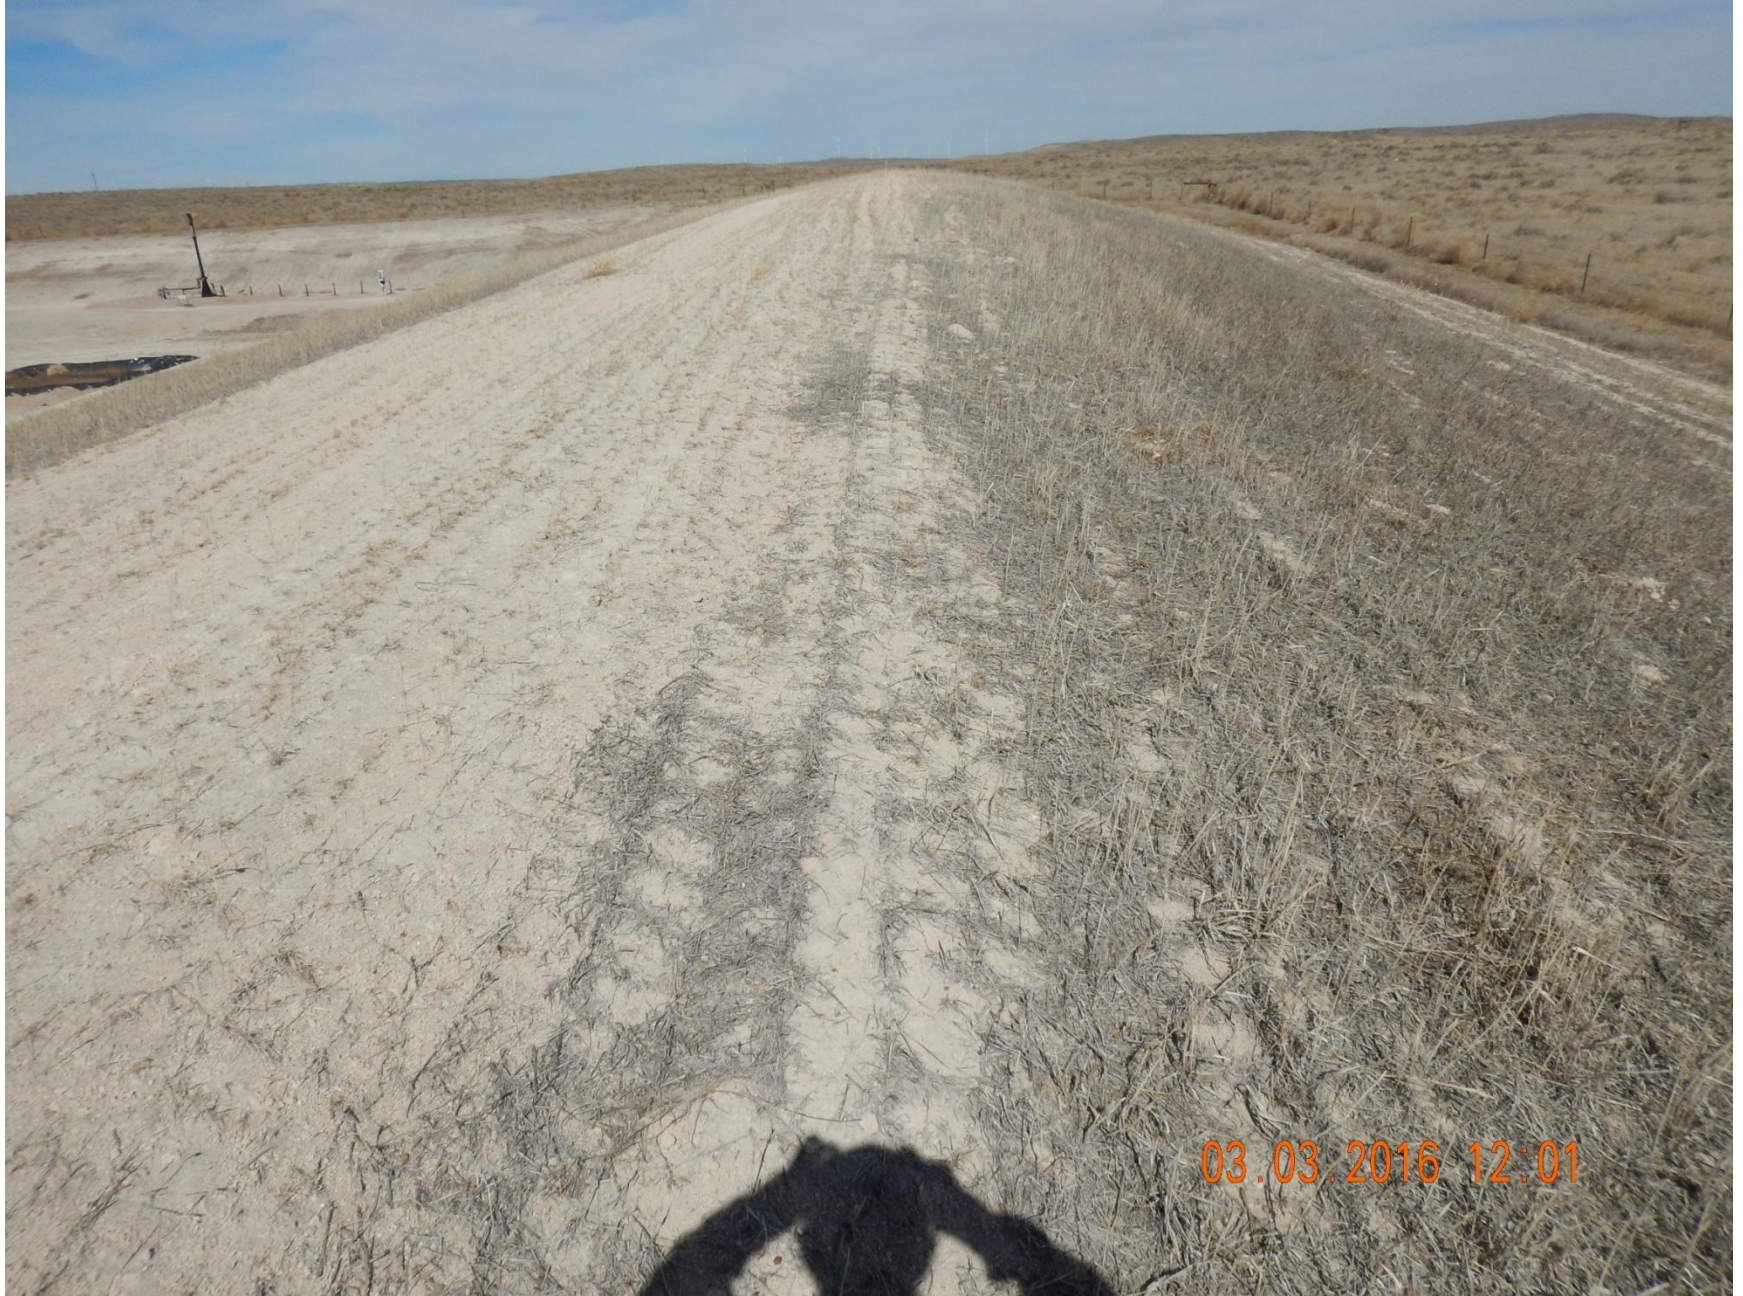
**Figure 28:** Photo taken from the east end of the project area, facing north. Photo shows portion of the interim lacking uniform vegetation.

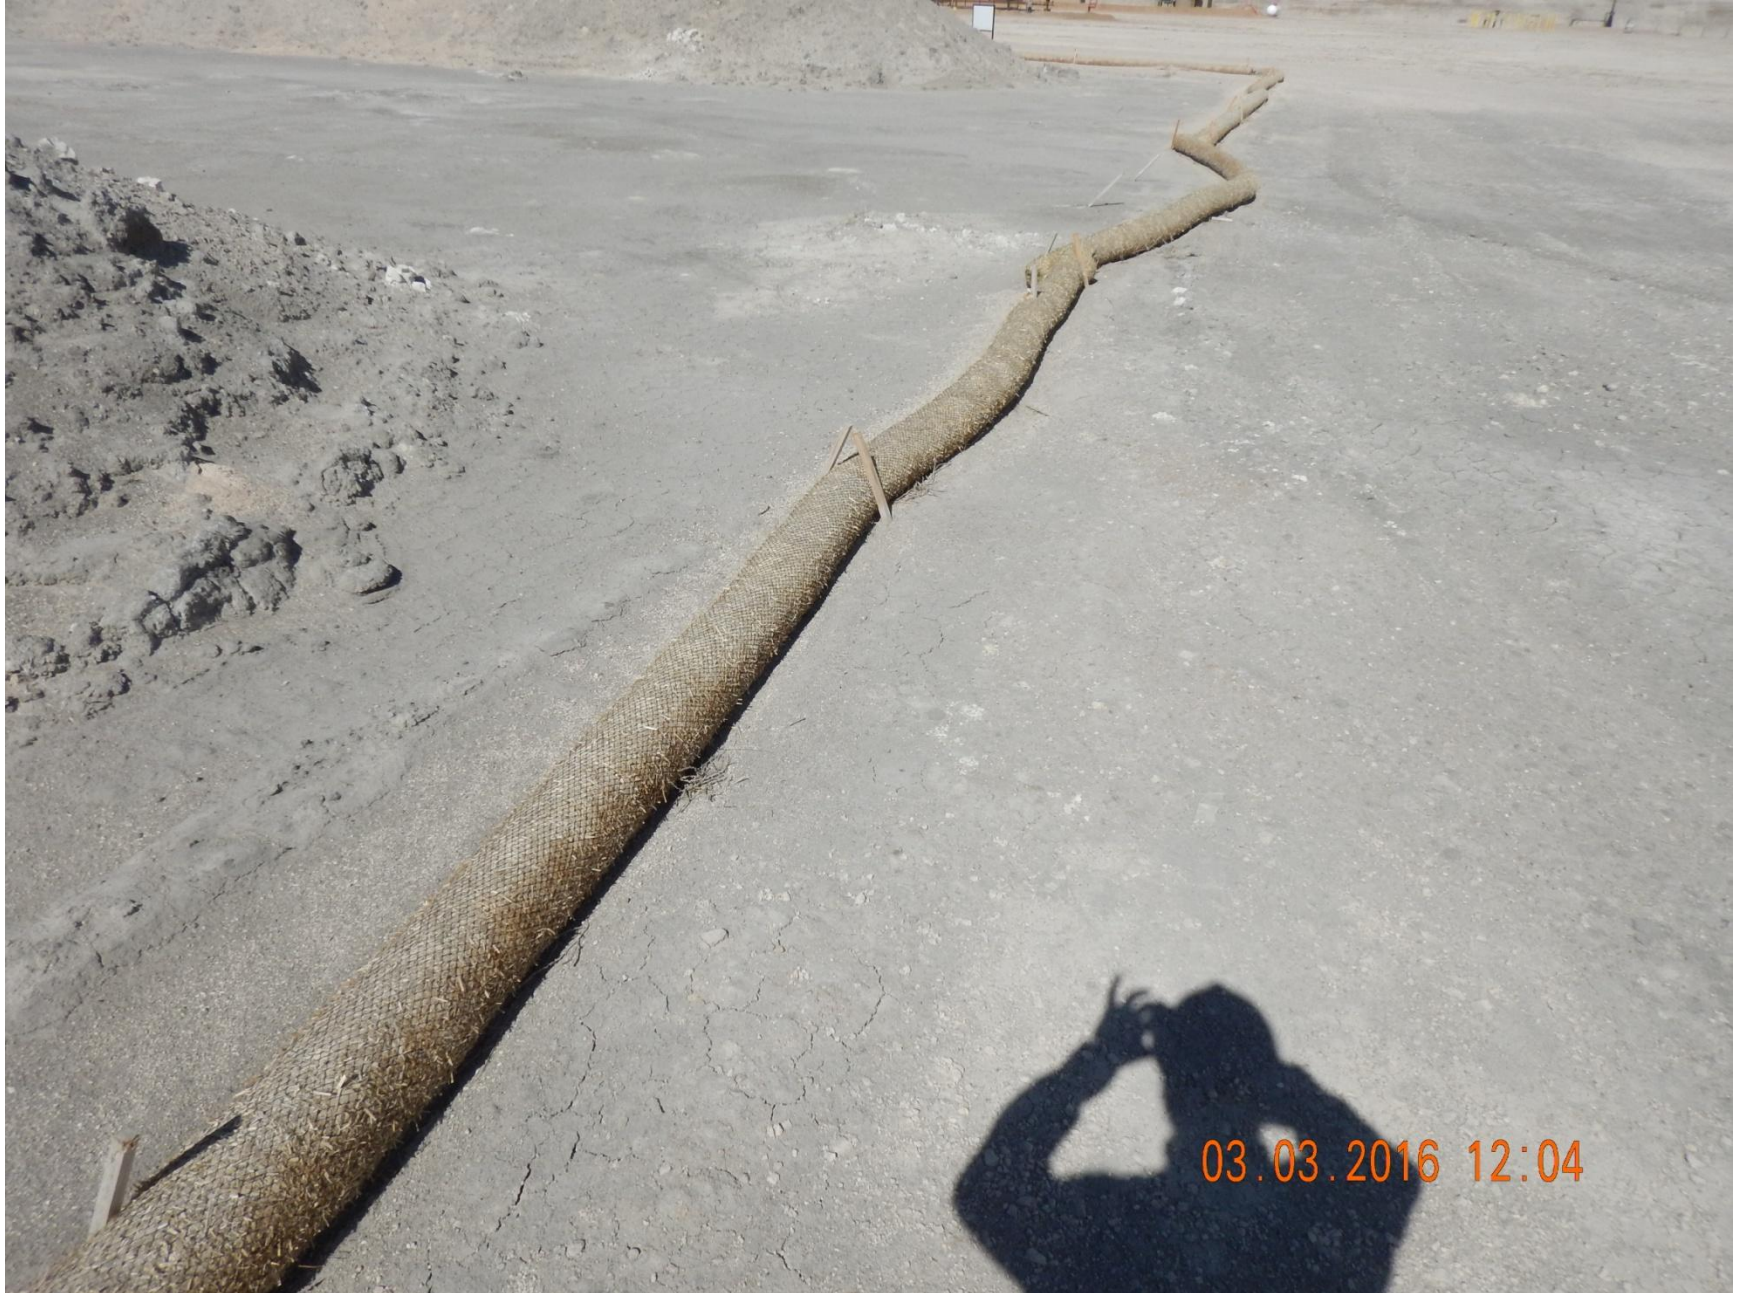
**Figure 32:** Photo taken from the southeast end of project area, facing north. Photo of straw wattle; wattle does not appear to be properly installed, and it appears water movement has dislodged the BMP. Straw wattle not in proper functioning condition.

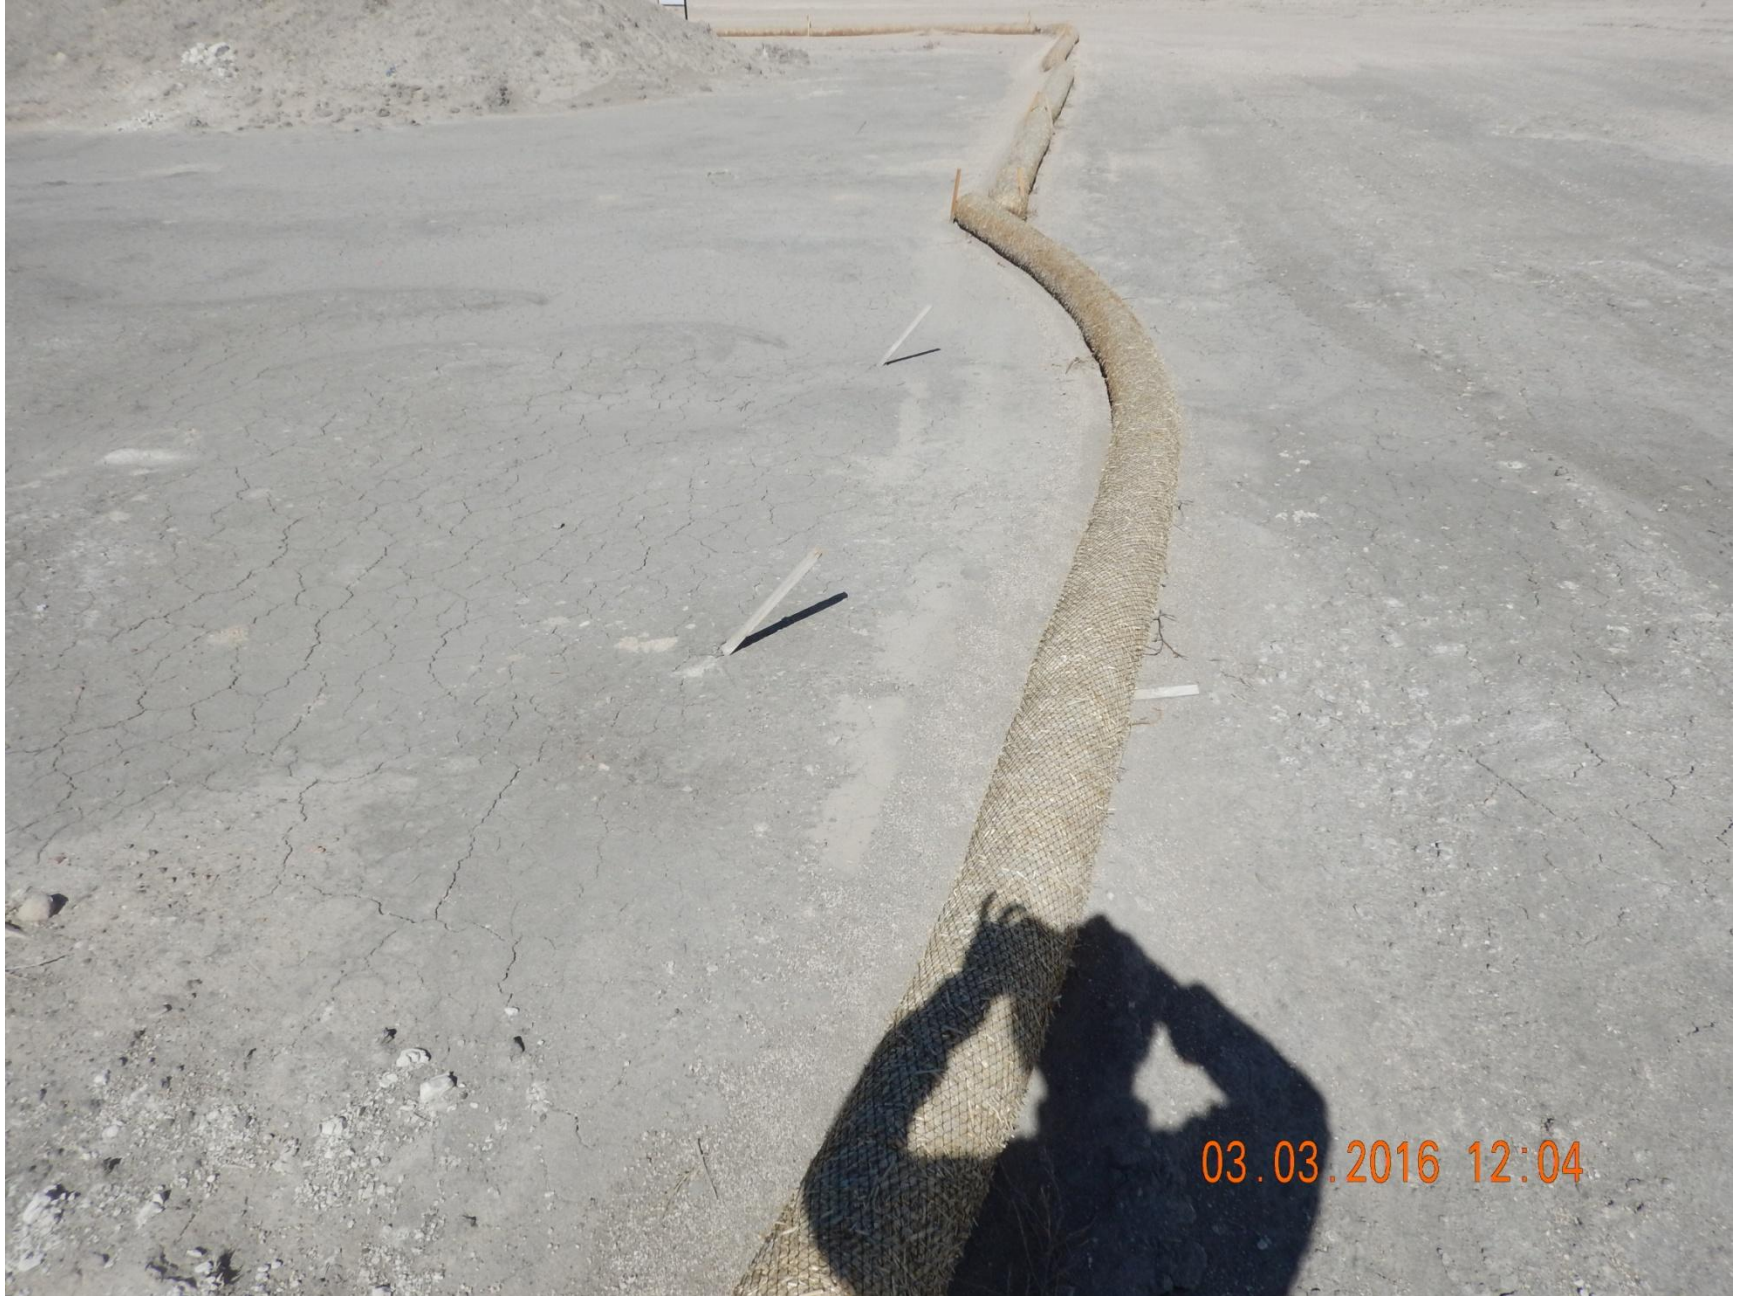
**Figure 35:** Photo taken from the southeast end of project area, facing north. Photo of straw wattle; wattle does not appear to be properly installed, and it appears water movement has dislodged the BMP. Straw wattle not in proper functioning condition.

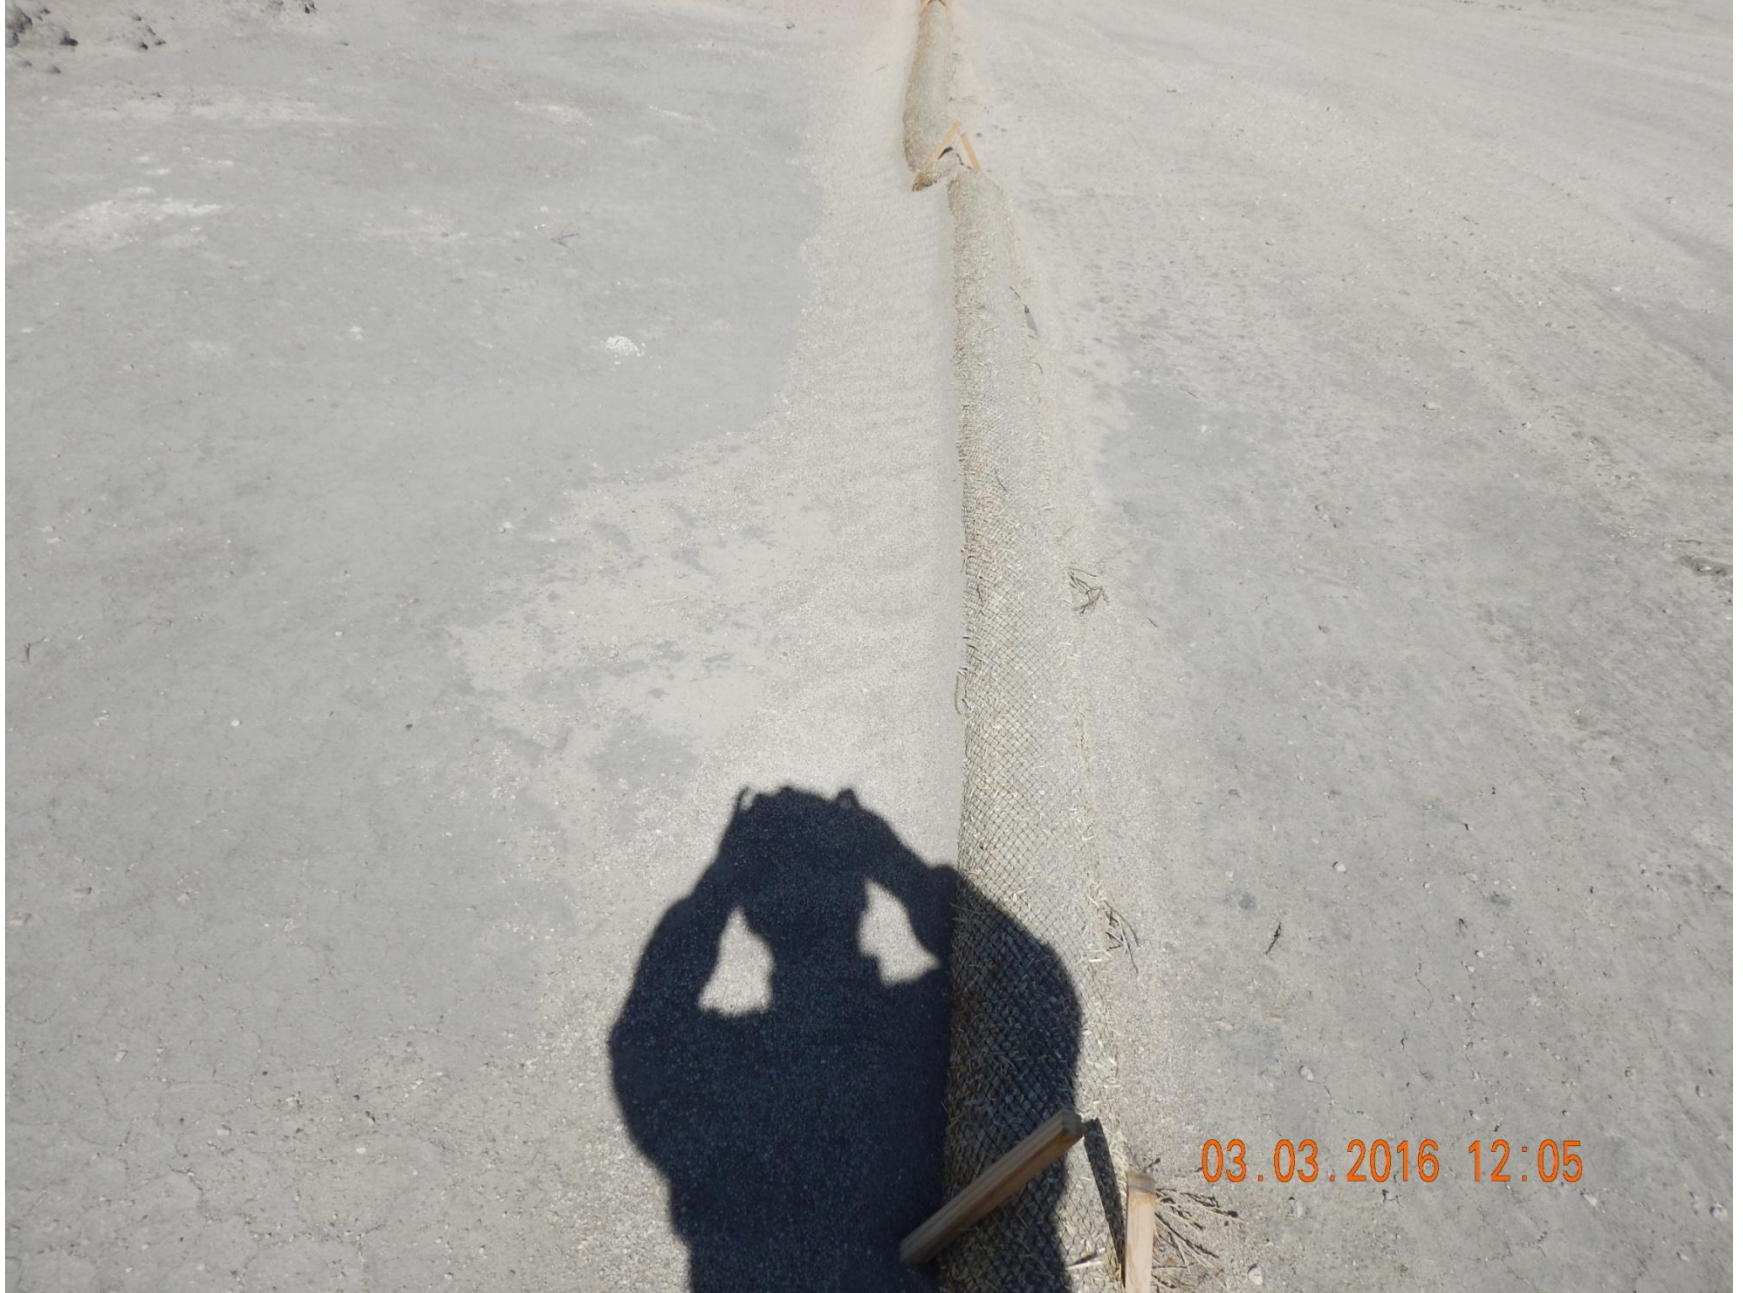
**Figure 36:** Photo taken from the south east end of project area. Photo shows straw wattle used as a sediment control BMP filled in with sediment. Will require cleaning or replacement in order to function properly.

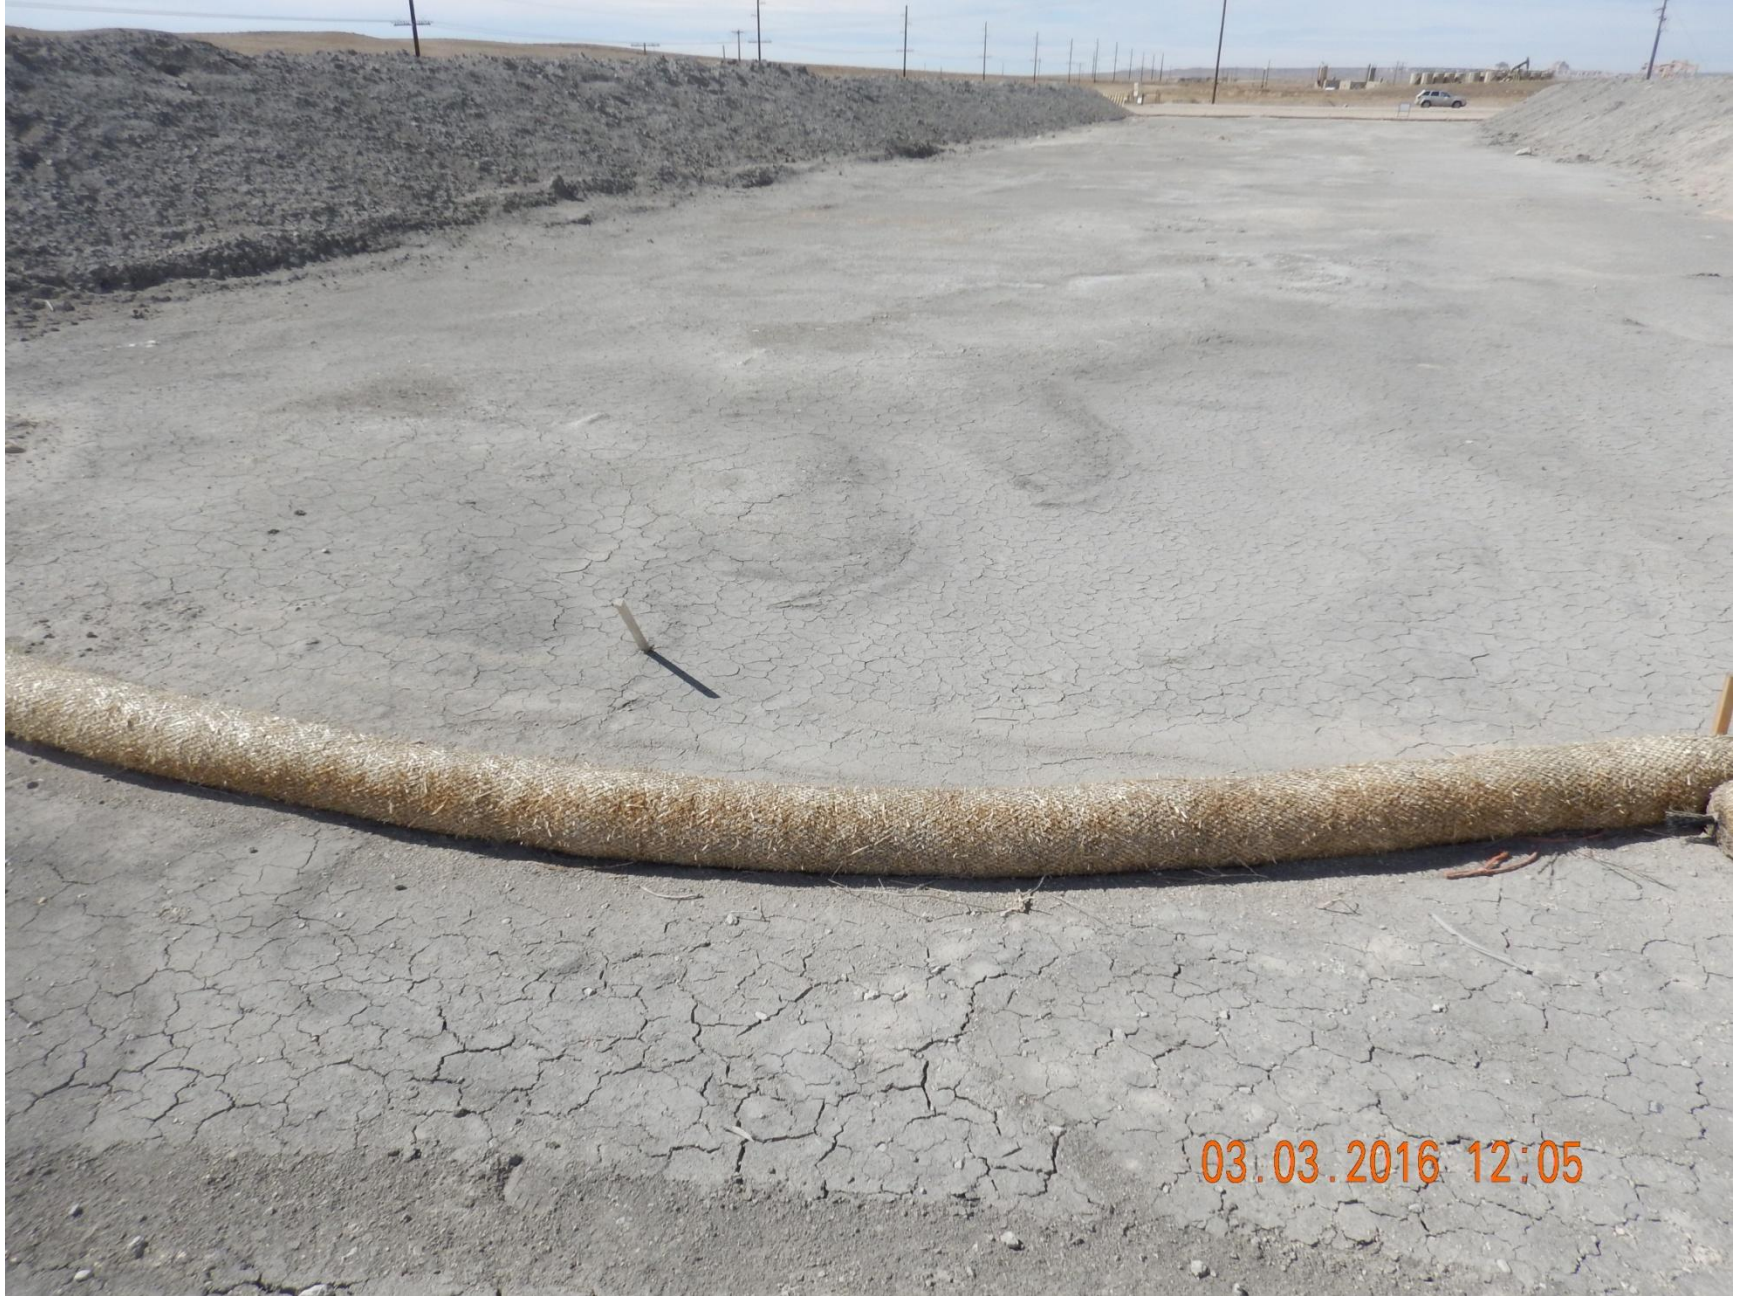
**Figure 37:** Photo taken from the southeast end of location, facing west. Photo shows straw wattle not in proper functioning condition.

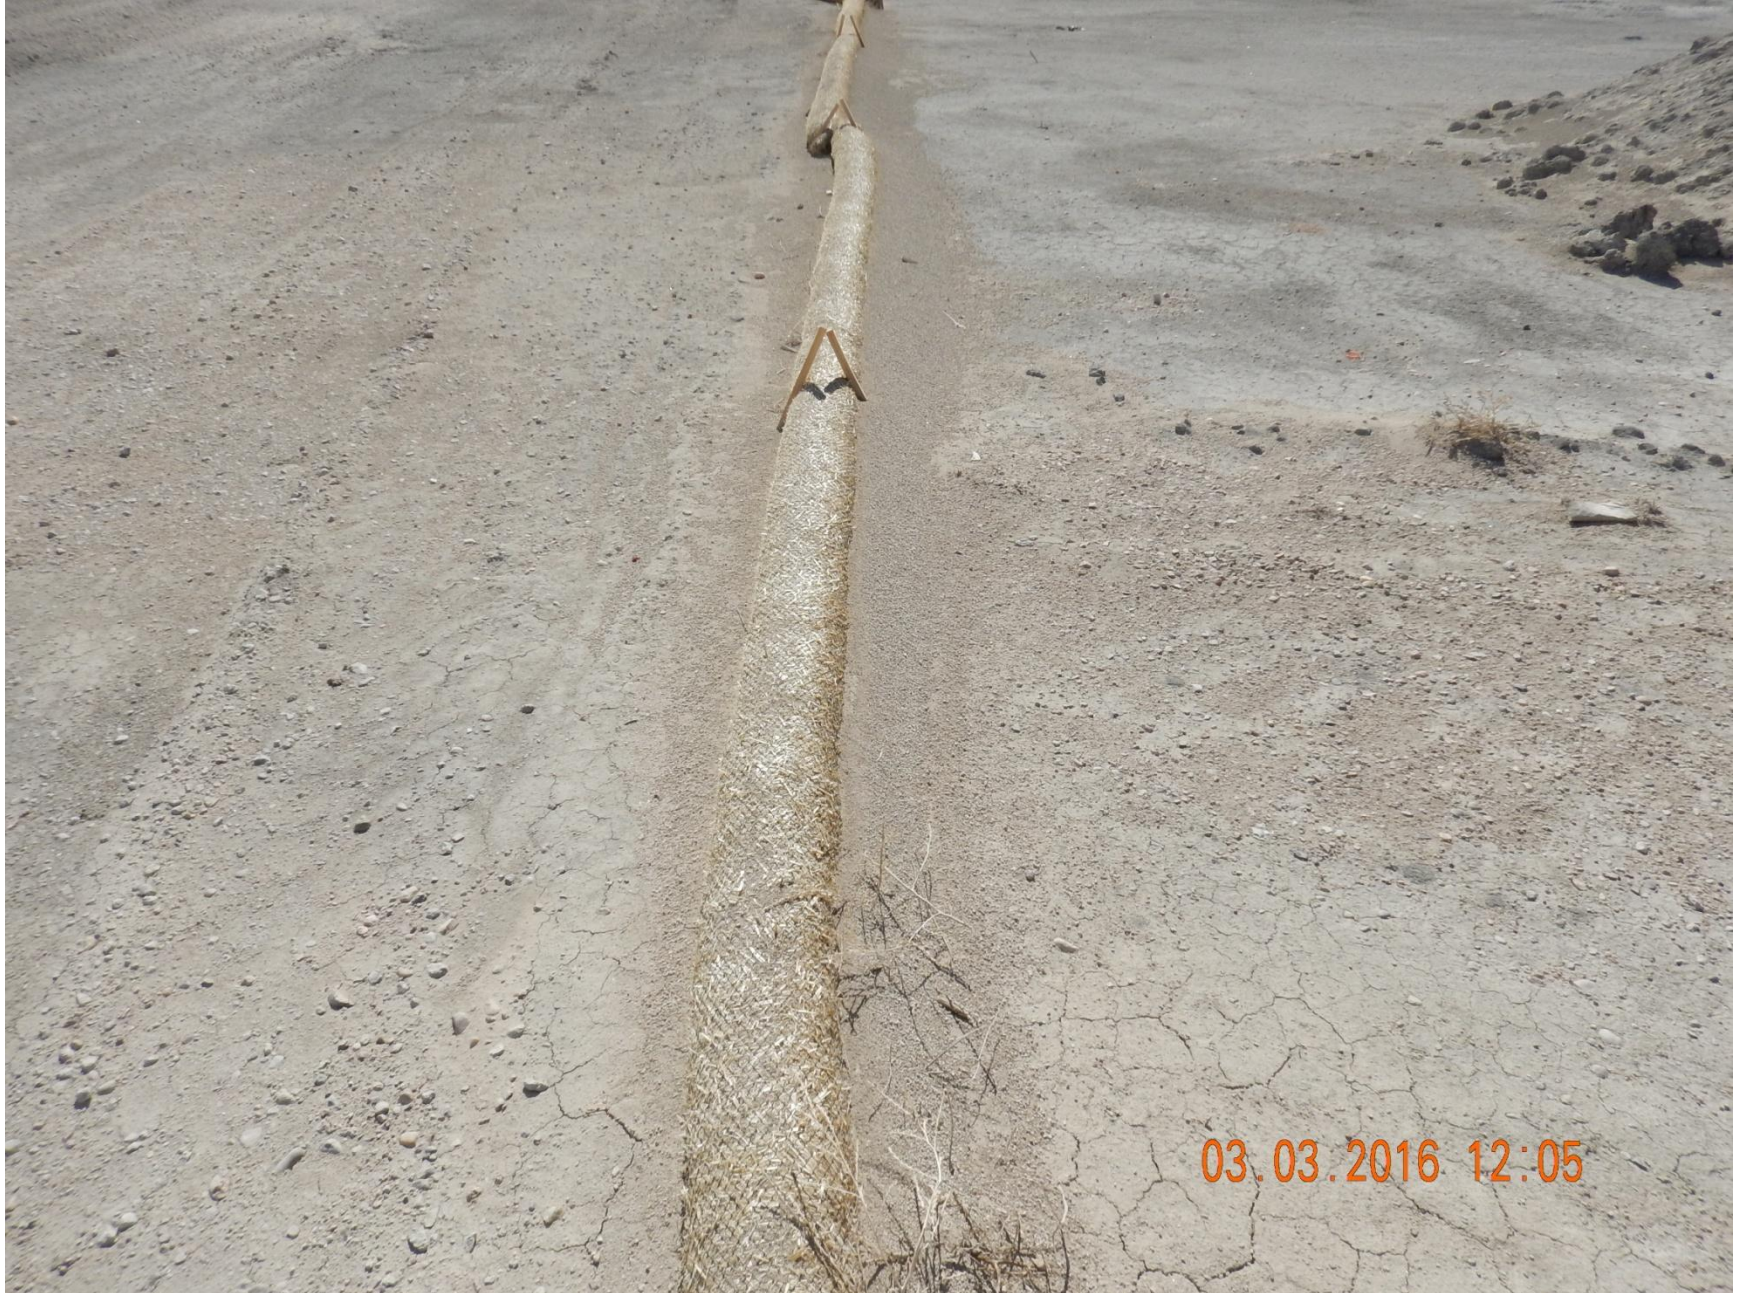
**Figure 38:** Photo taken from the south east end of project area. Photo shows straw wattle used as a sediment control BMP filled in with sediment. Will require cleaning or replacement in order to function properly.

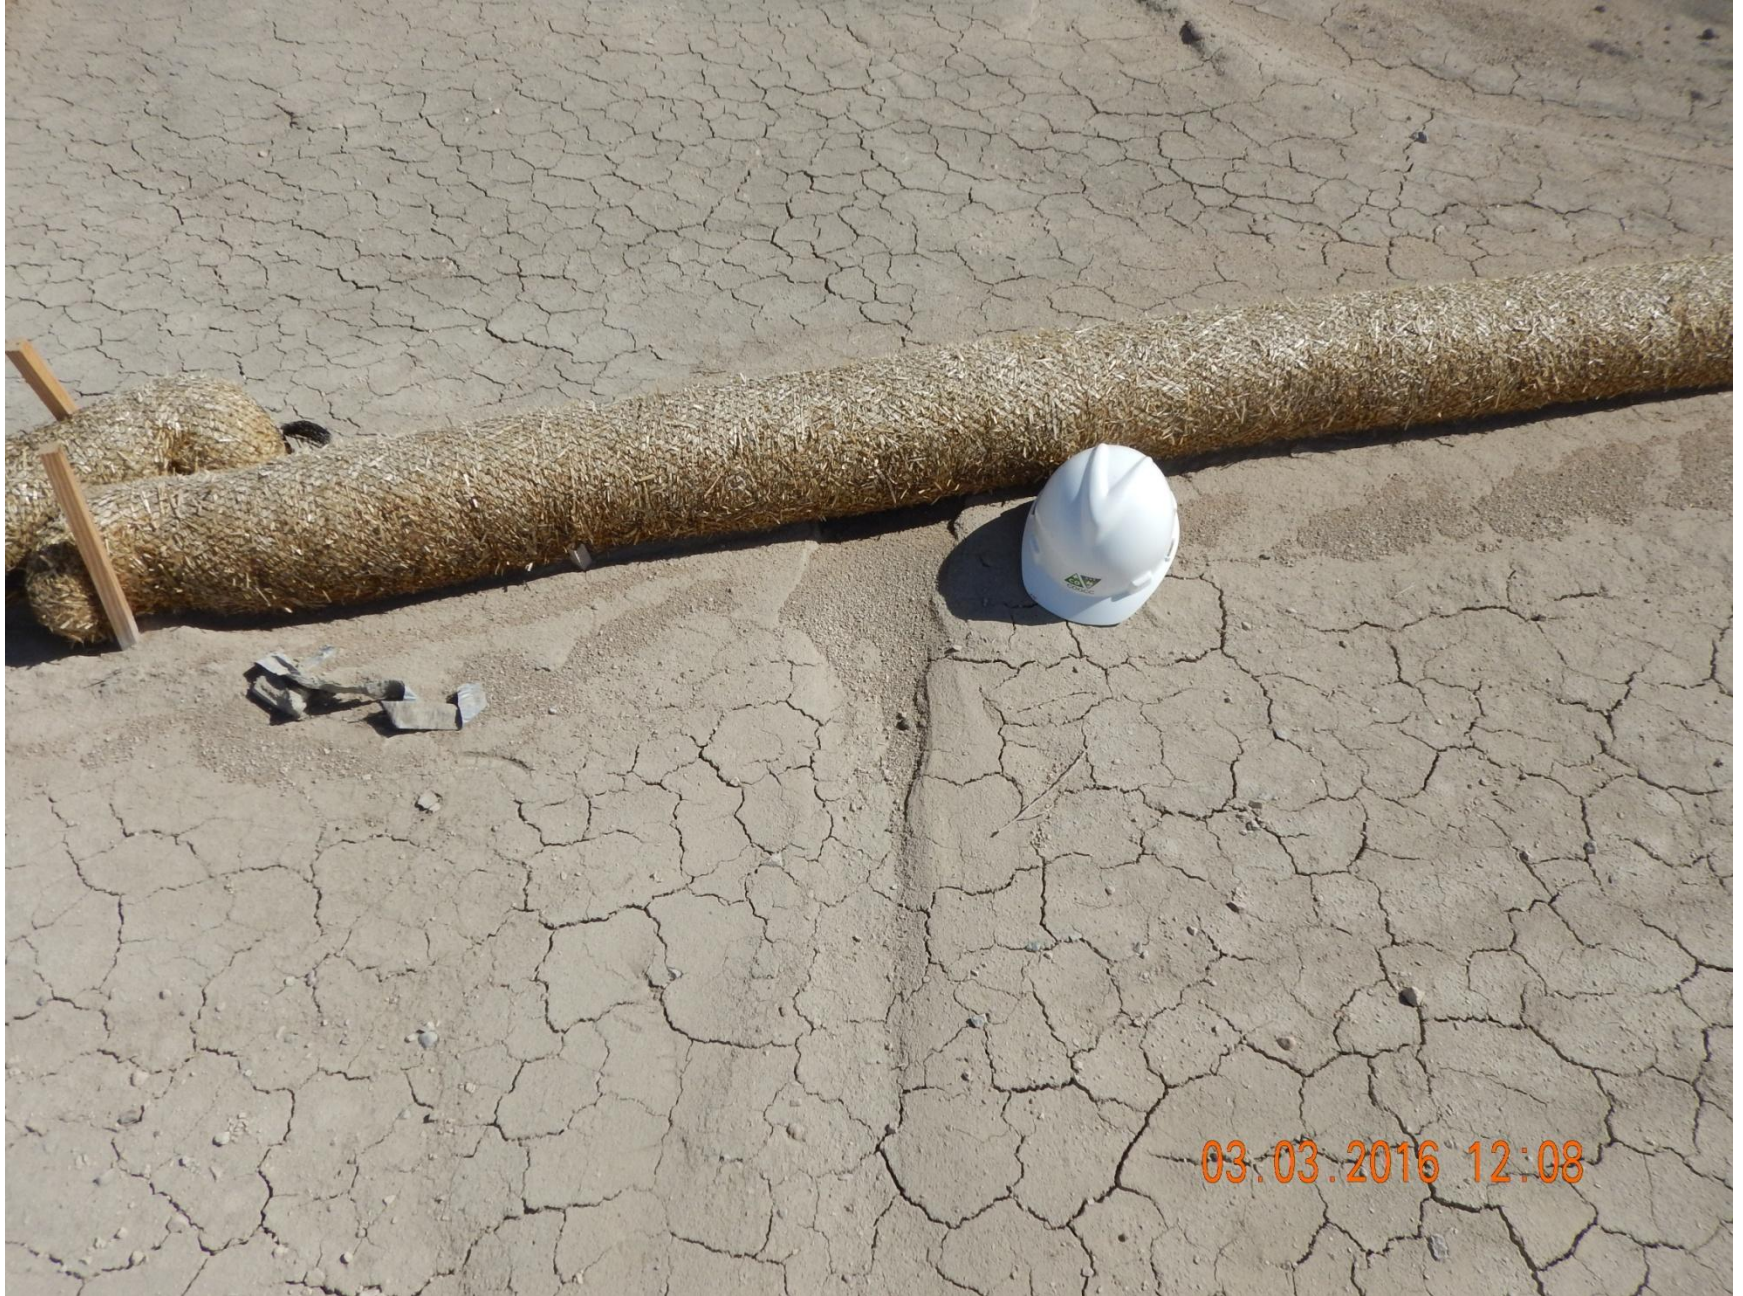
**Figure 41:** Photo taken from the southwestern end of location, facing east. Photo of straw wattles used as a stormwater and sediment control BMP not in proper functioning condition. Photo shows stormwater and sediment travel beneath the straw wattle.

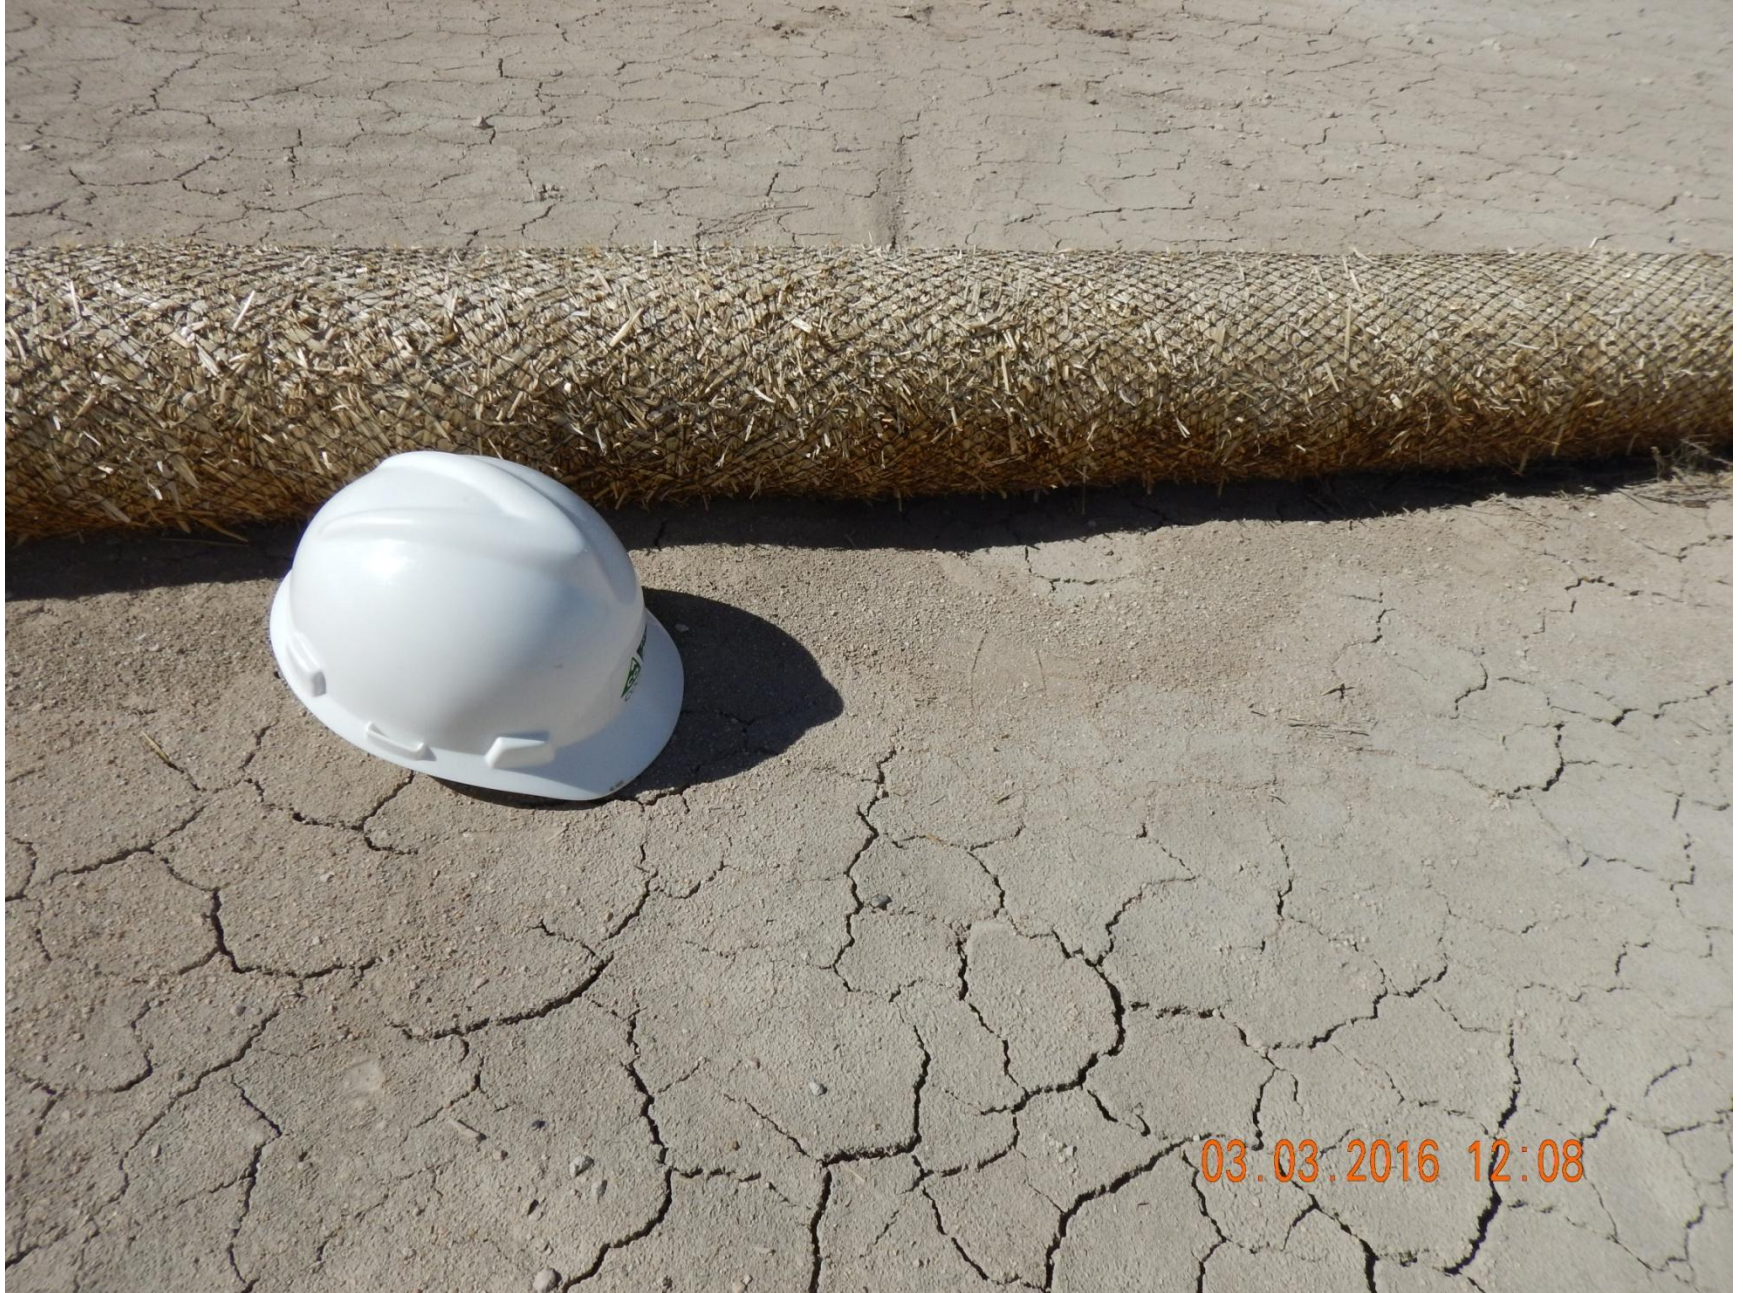
**Figure 42:** Photo taken from the southwestern end of location, facing west. Photo of straw wattles used as a stormwater and sediment control BMP not in proper functioning condition. Photo shows stormwater and sediment travel beneath the straw wattle.
