Bird State 32-8 Tank Battery and Separator Shed. March 1, 2016 COGCC Environmental Inspection – S.Arauz

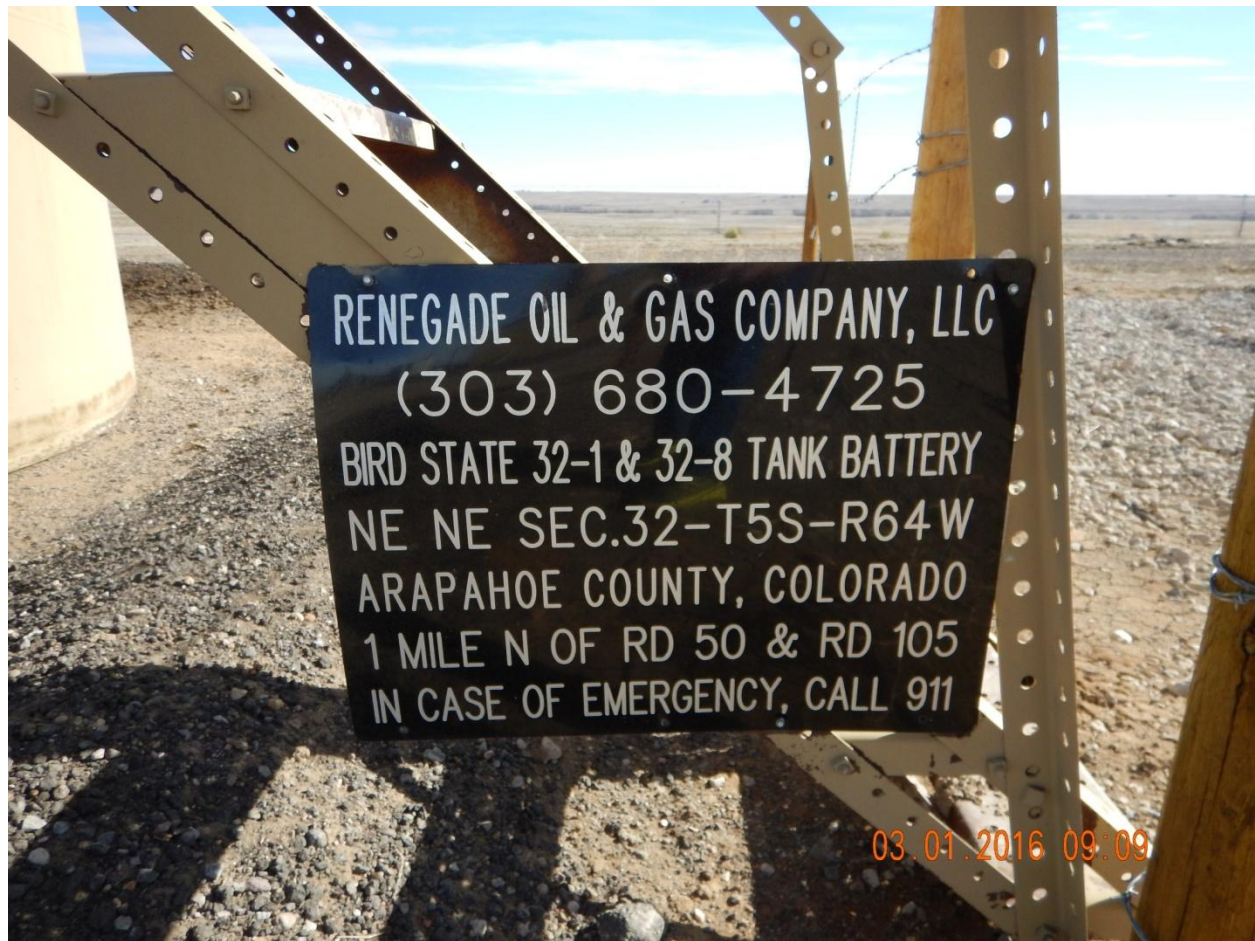
Figure 1 - Tank Battery sign

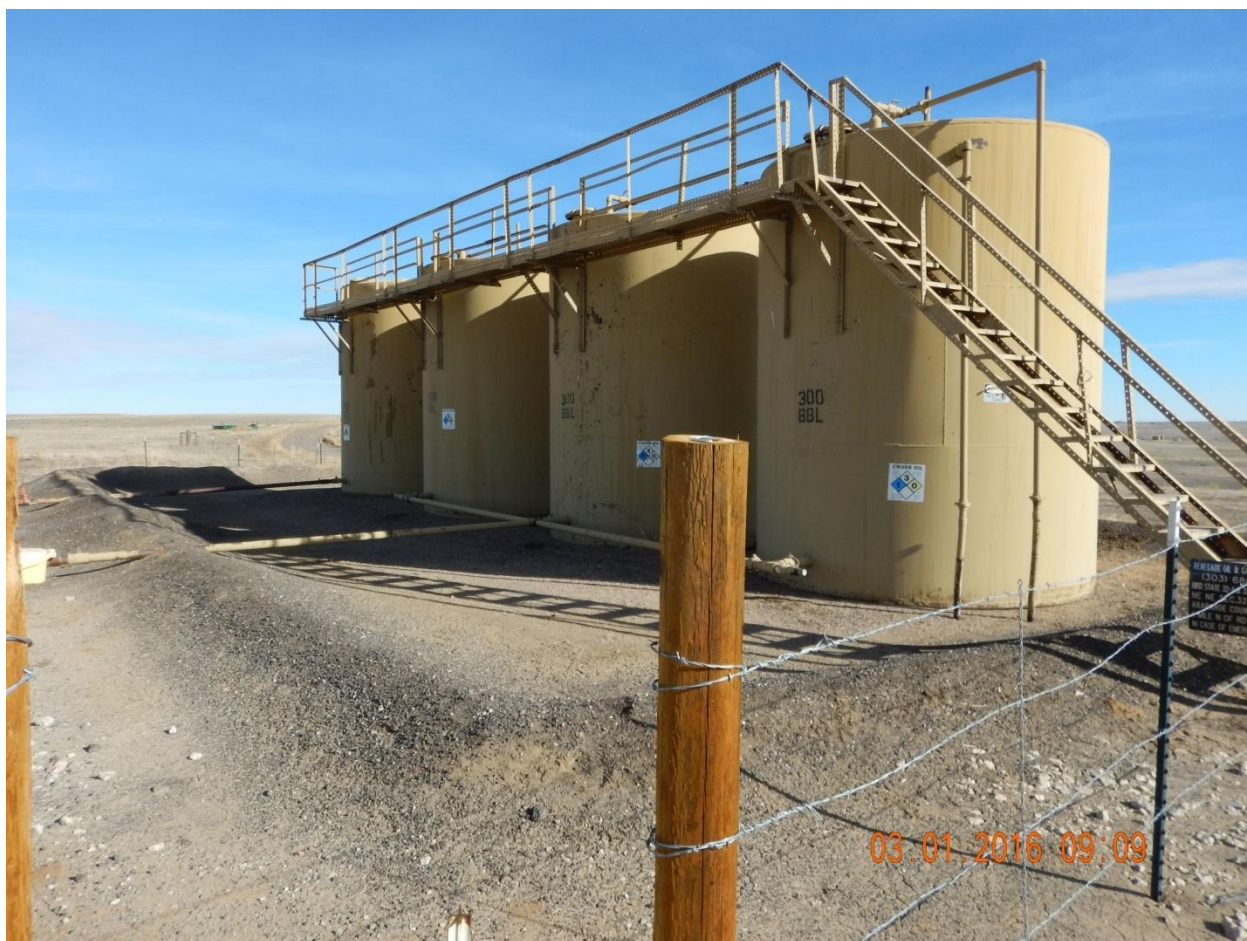
Figure 2 - Steel ASTs at tank battery, earthen berm appears to be too shallow/eroded to provide adequate containment volume.

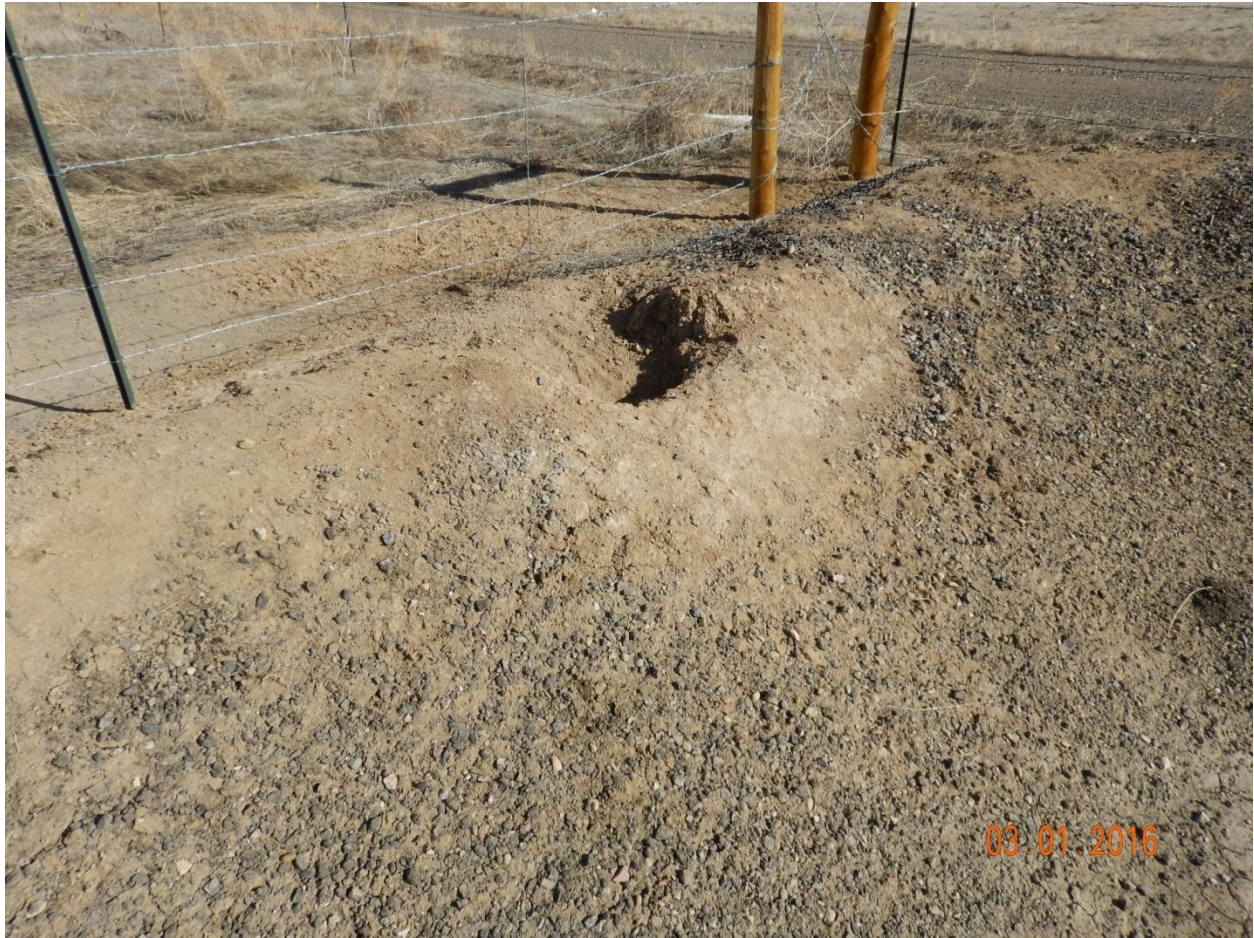
Figure 3 – Damage to berm at northwest corner of tank battery.

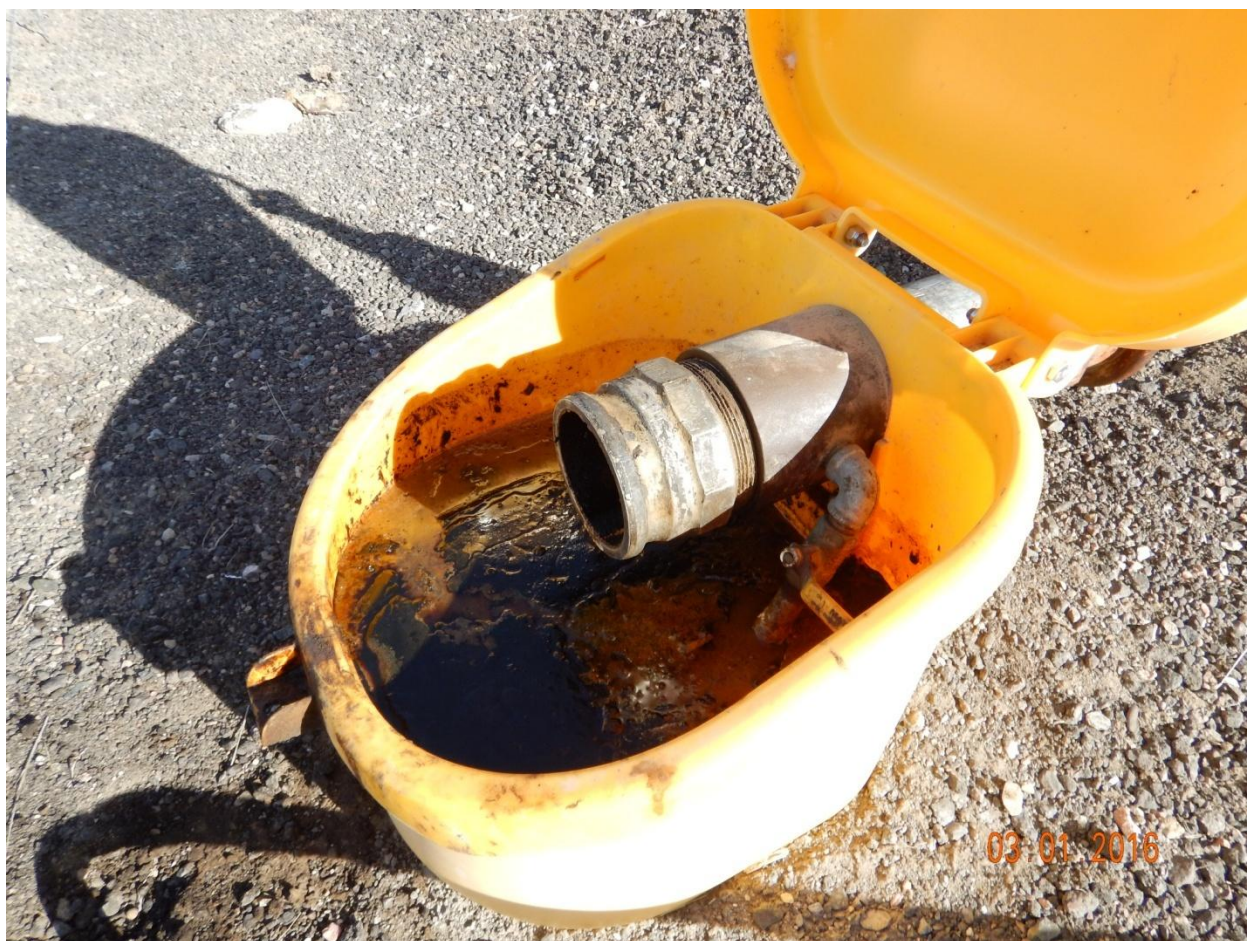
Figure 4 - North tank loadout within 1-2" of overflowing with crude oil. Oil should be removed and properly disposed of during routine maintenance to prevent a spill.

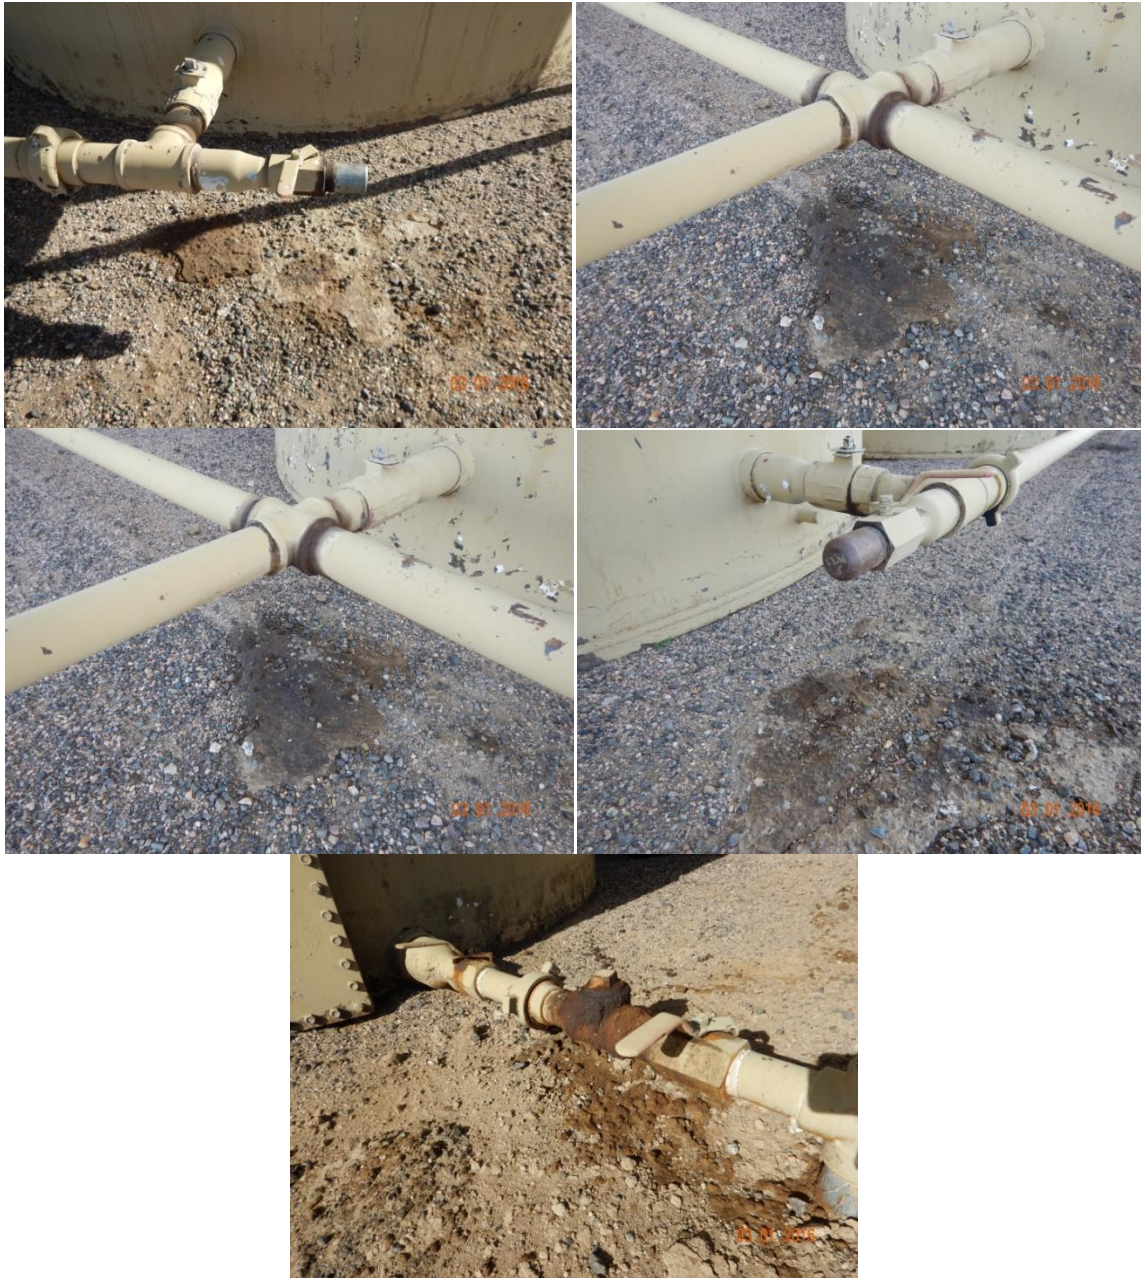
Figure 5 - Localized oil-stained/saturated soil beneath various pipe fittings around the tank battery.

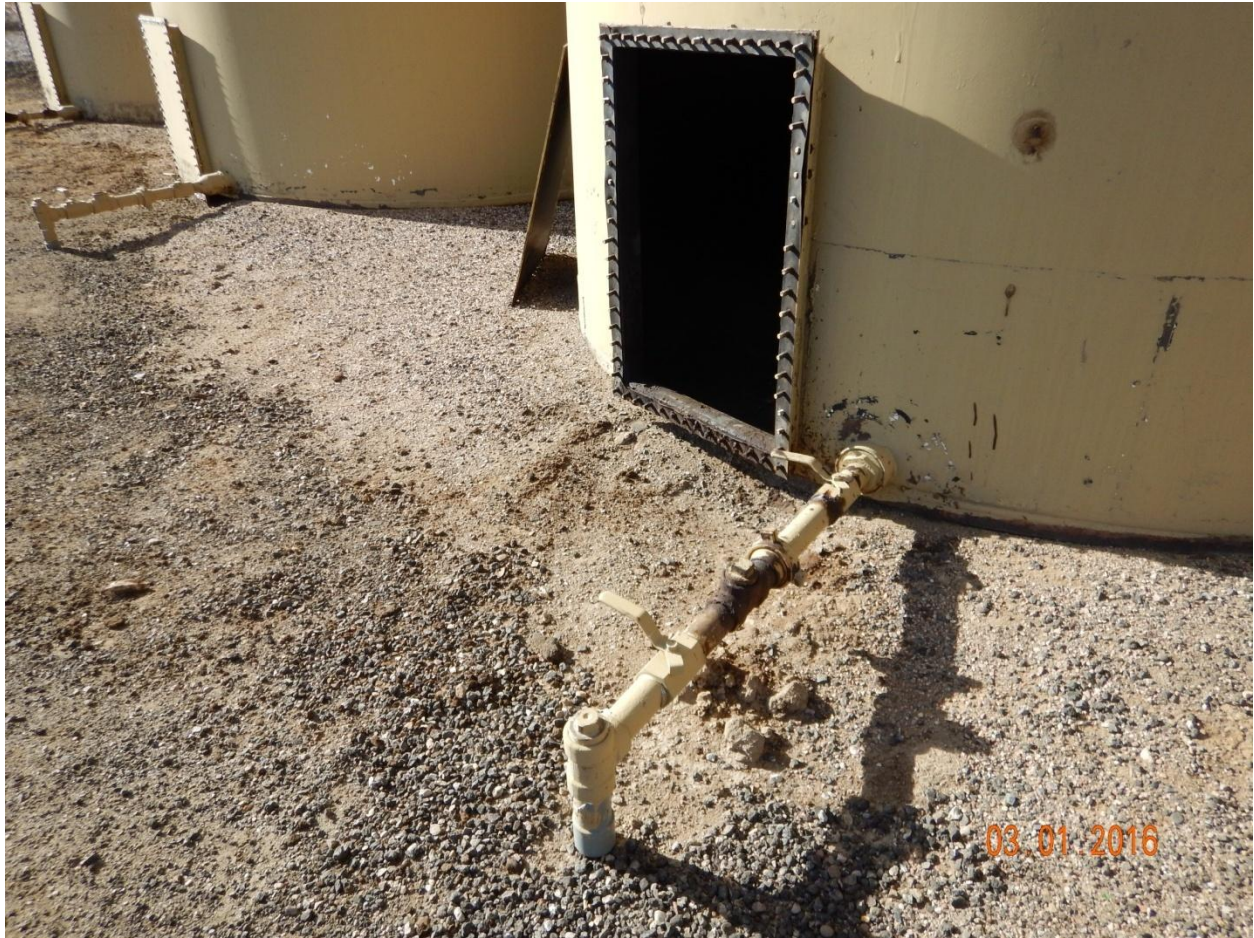
Figure 6 - Open access panel, leaking pipe fittings, and stained soil at south produced water tank.

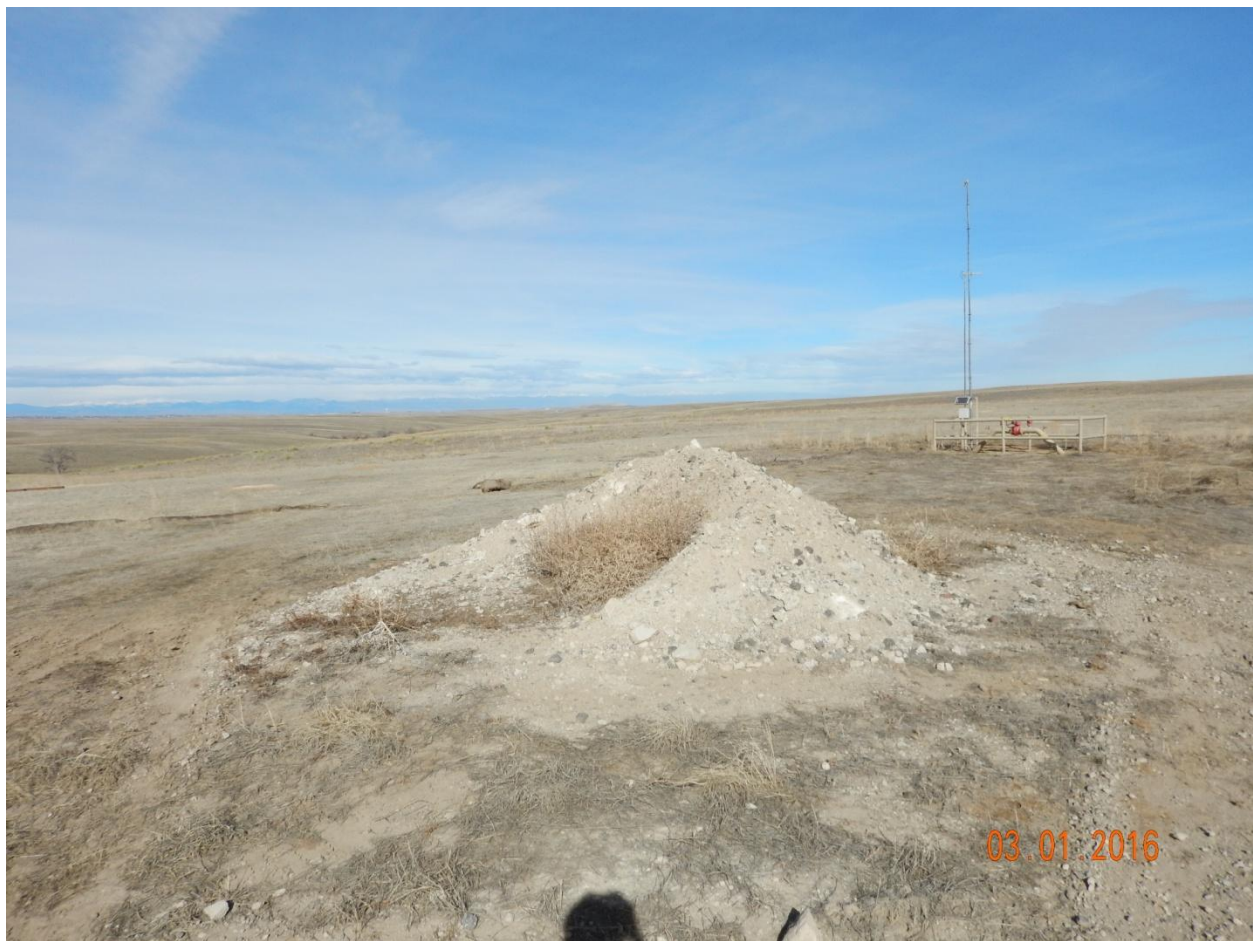
Figure 7 - Mound of unused material with vegetation growth northwest of tank battery.

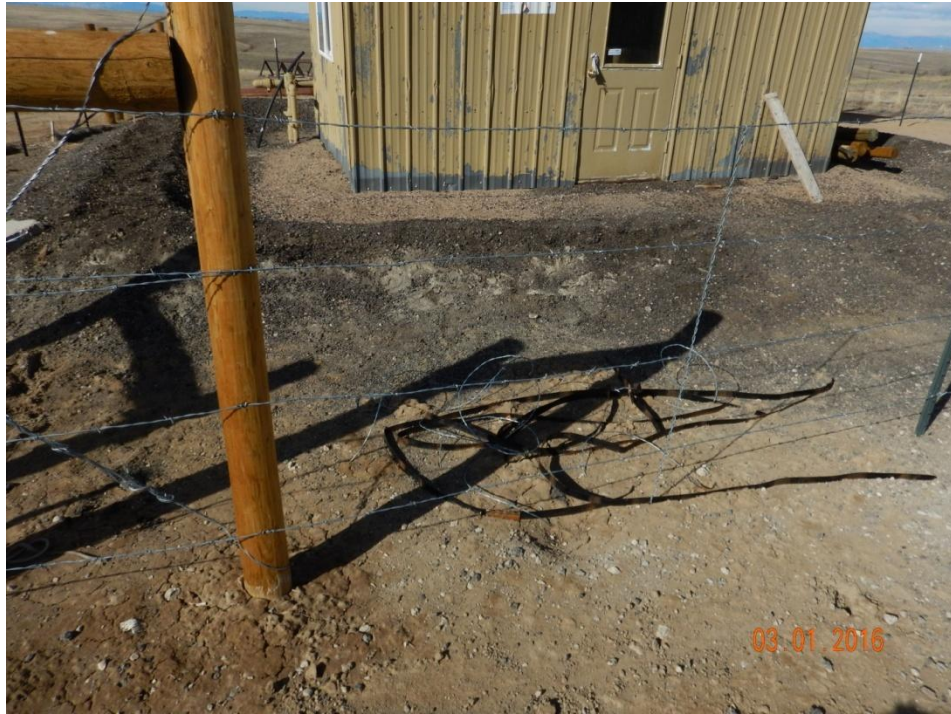
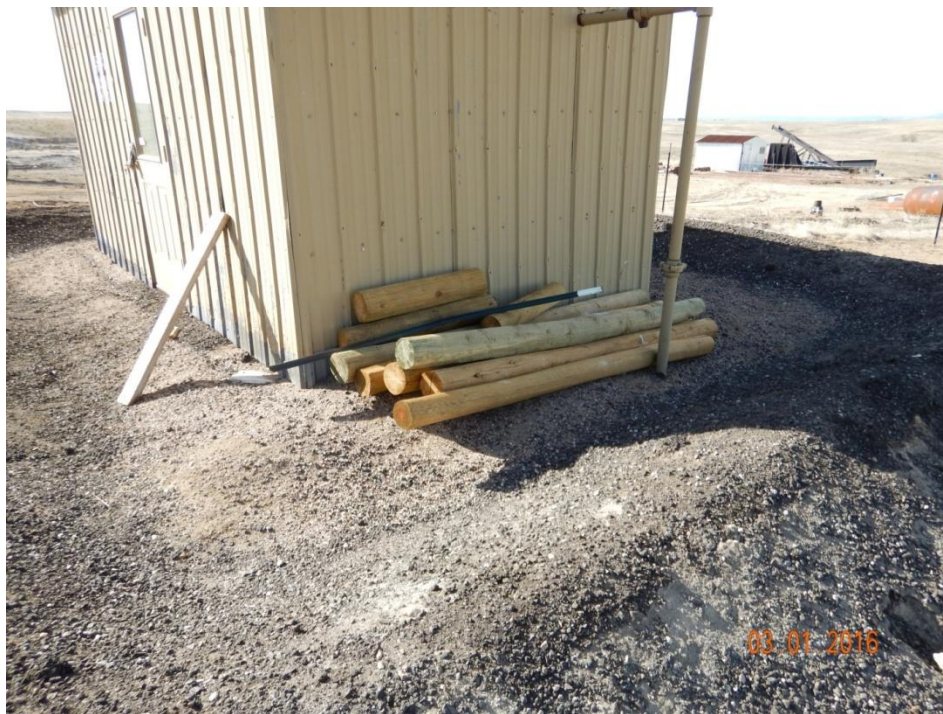
Figure 8 - Unused fencing material (barbed wire and wooden posts) at separator shed.

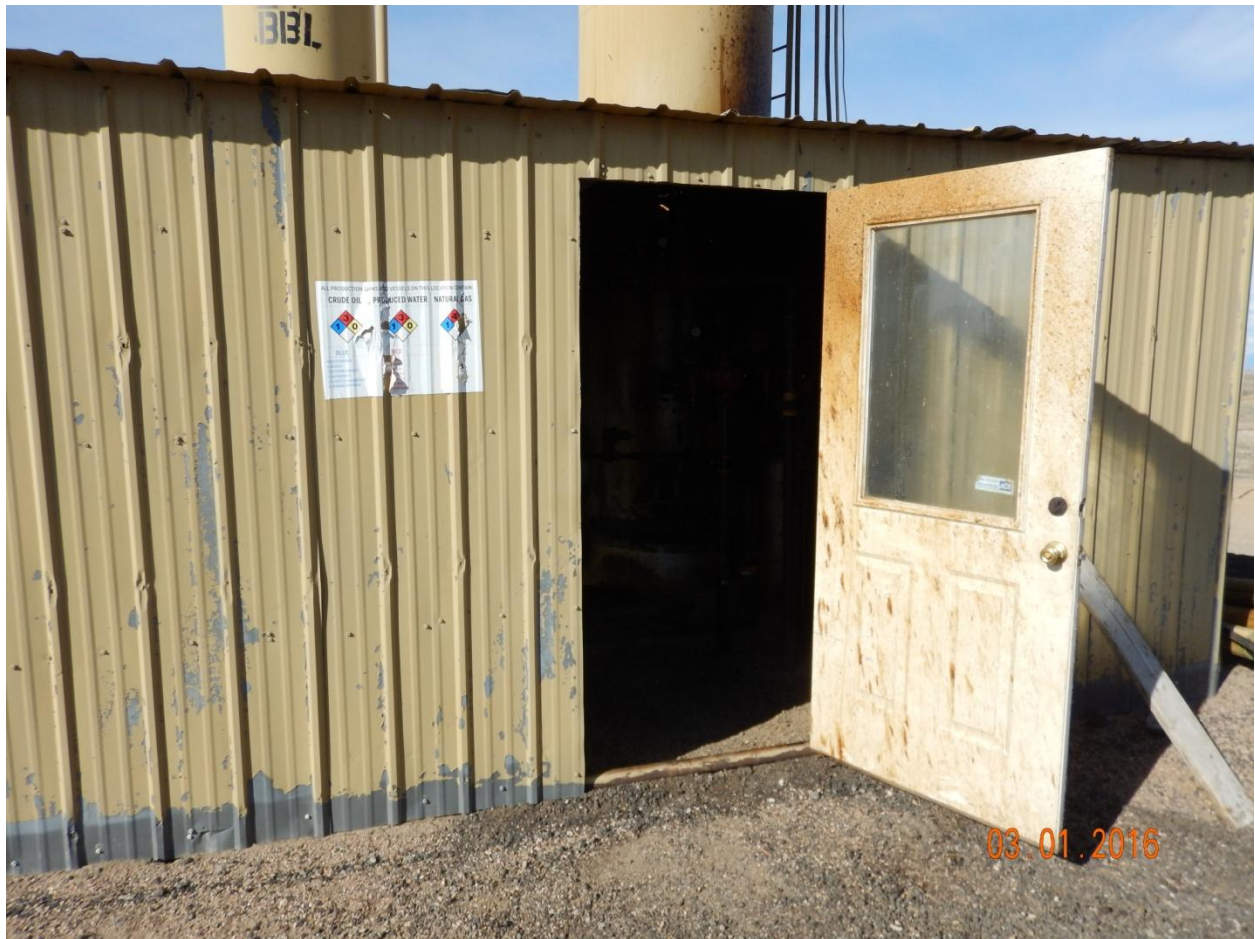
Figure 9 - Oil-staining inside door to separator shed.

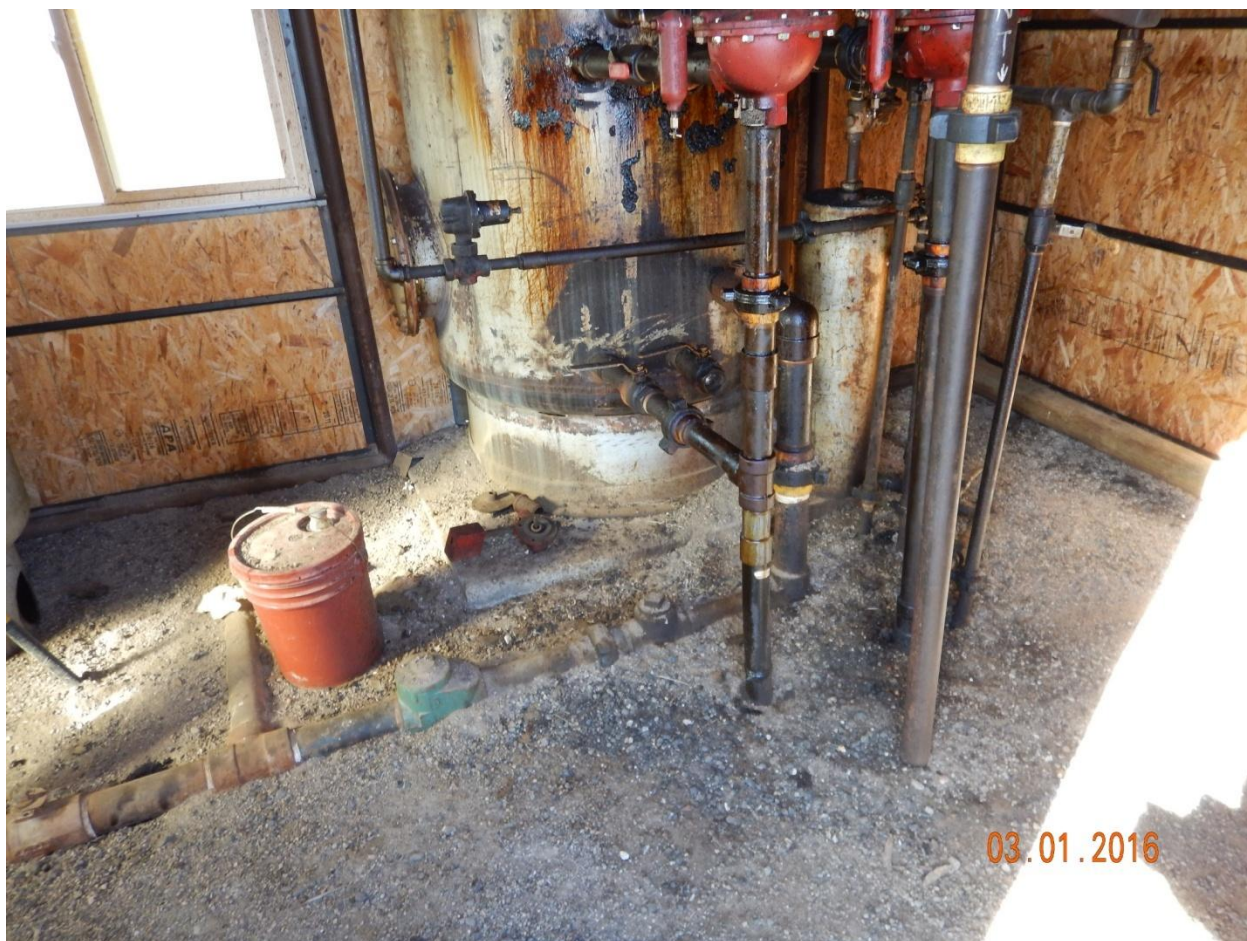
Figure 10 - Oil-stained soil and equipment (and unlabeled bucket) inside of separator shed.
