Interim Reclamation Inspection

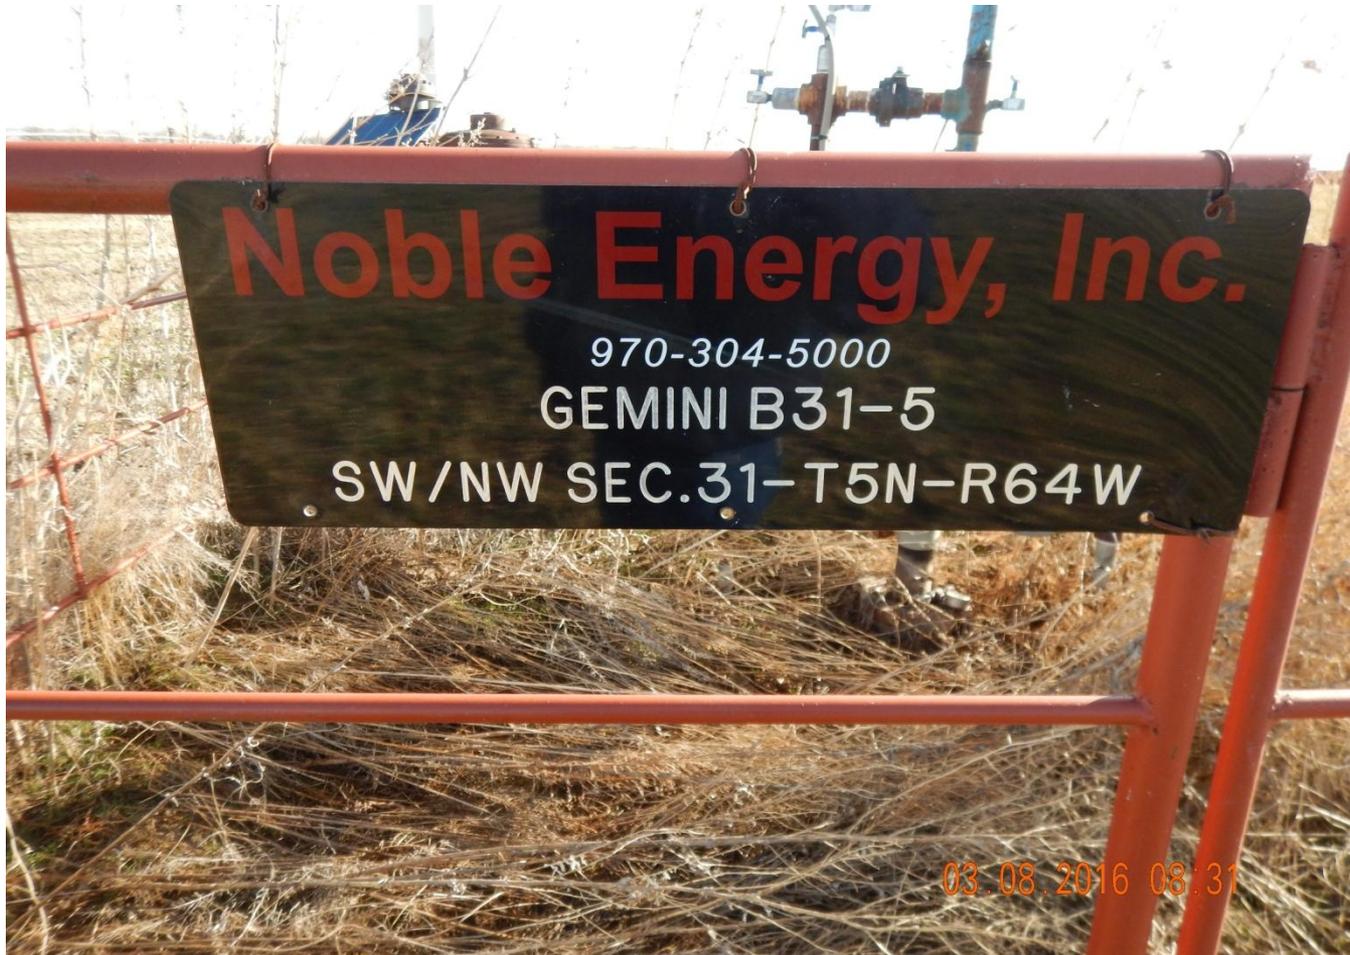
Photo 1. Photo taken of PR well sign for API 123-13722.

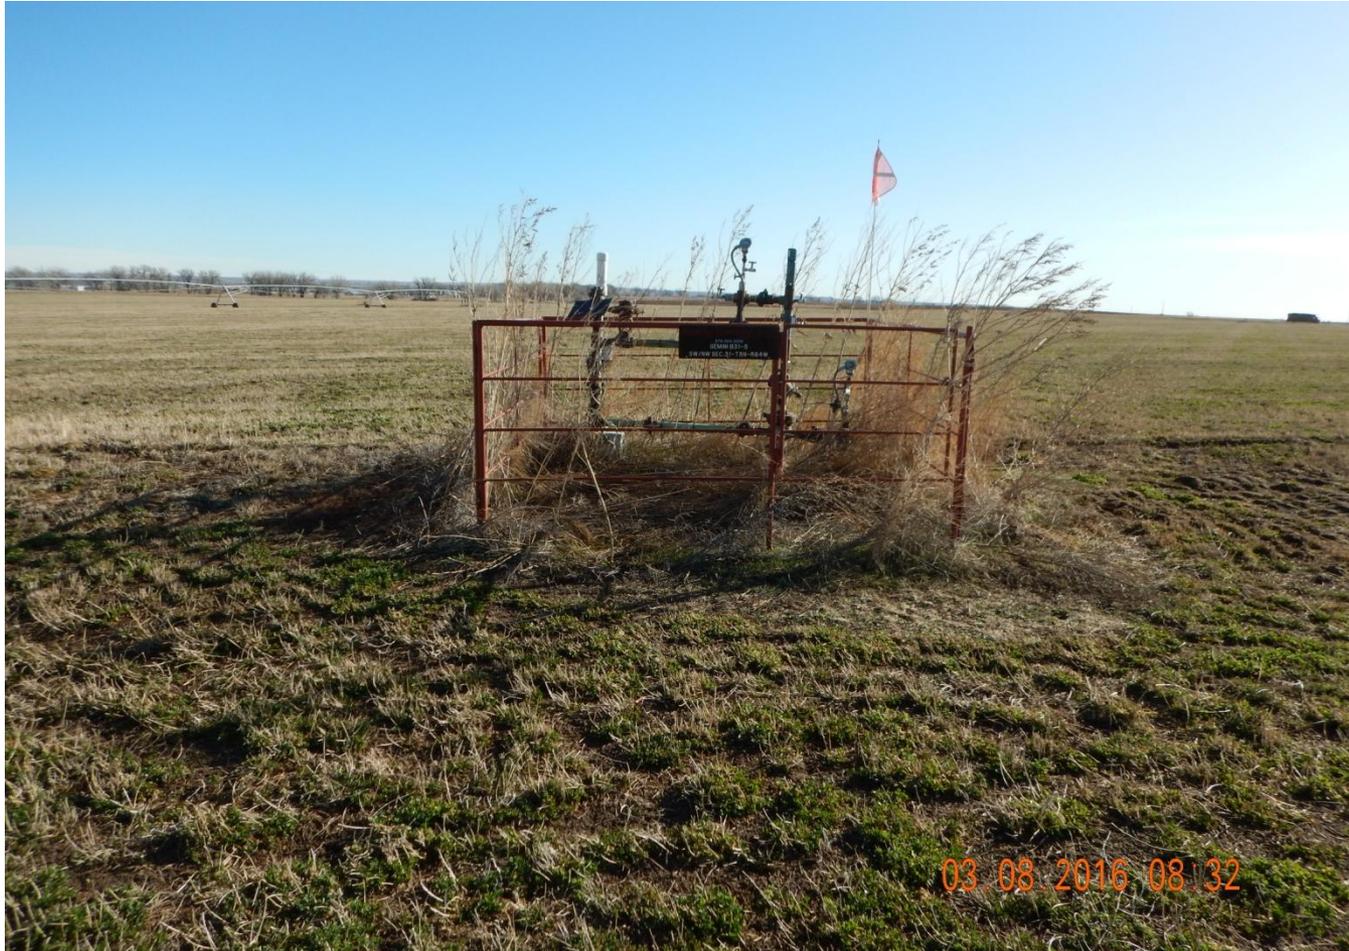
Photo 2. Photo taken from west of location, facing East. Remove weeds around wellhead. Weeds within 25 feet of operating oil and gas equipment are a potential safety or fire concern.

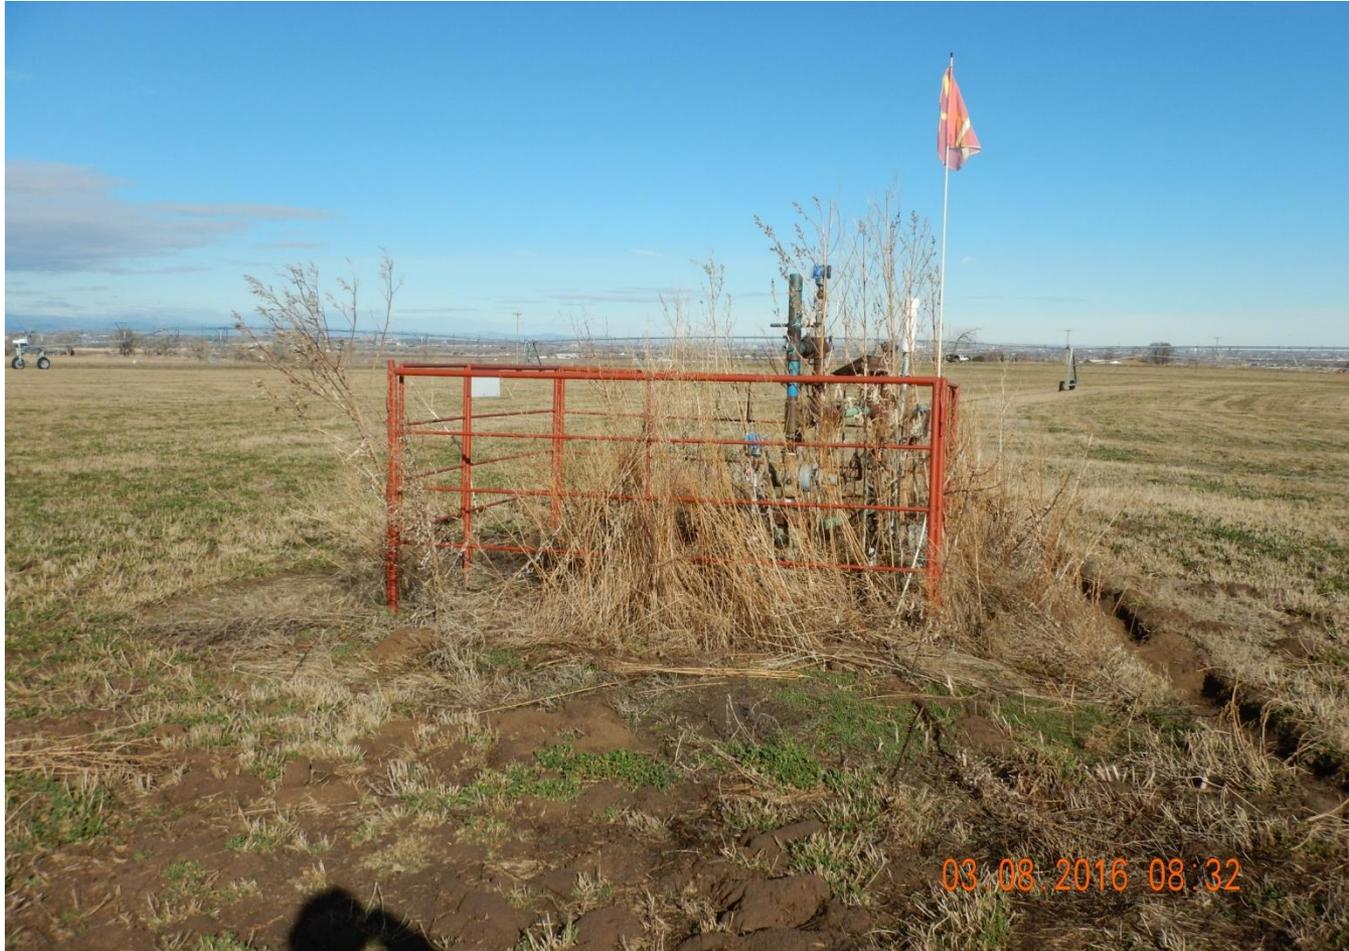
Photo 3. Photo taken from south of location, facing North. Remove weeds around wellhead. Weeds within 25 feet of operating oil and gas equipment are a potential safety or fire concern.
