Photo#1: Overview of Location from reclaimed Access Road to NW

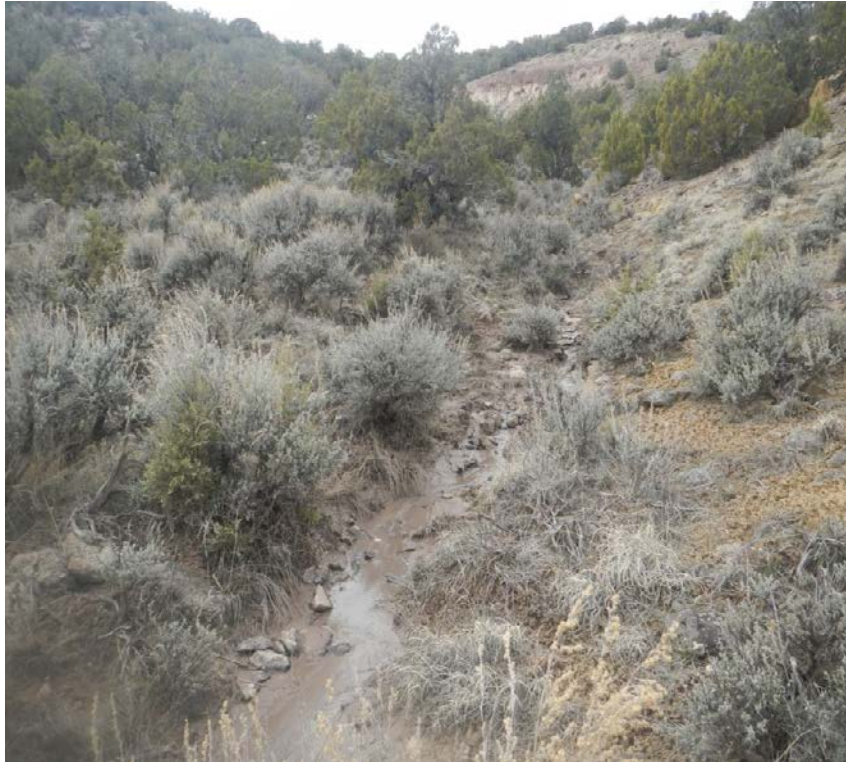
Photo#2:

Drainage flowing from North

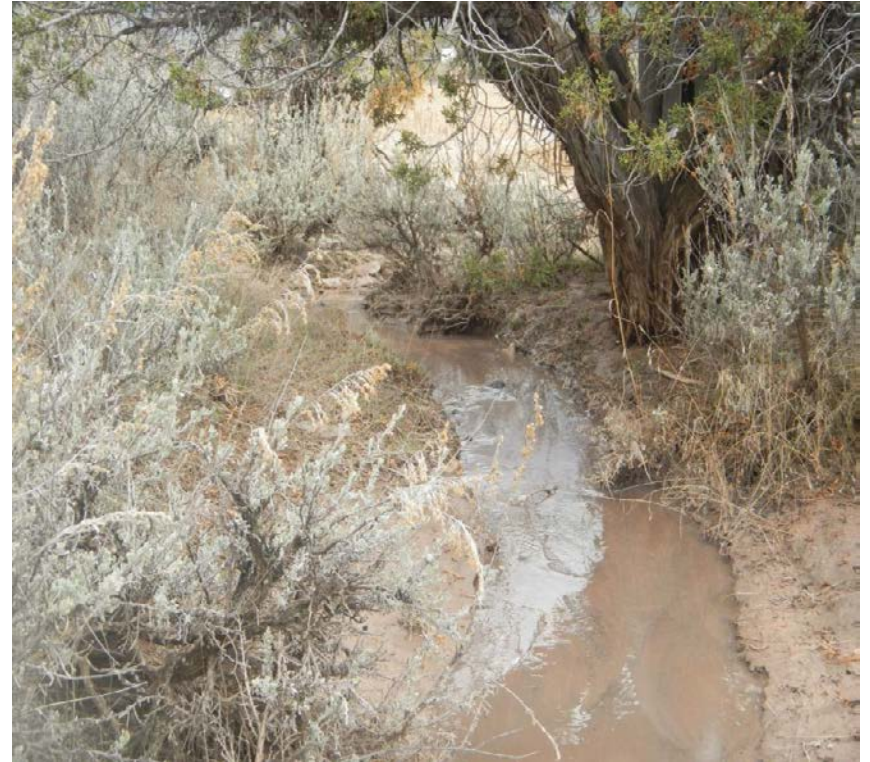
Photo#3:

Into Location, view to SW

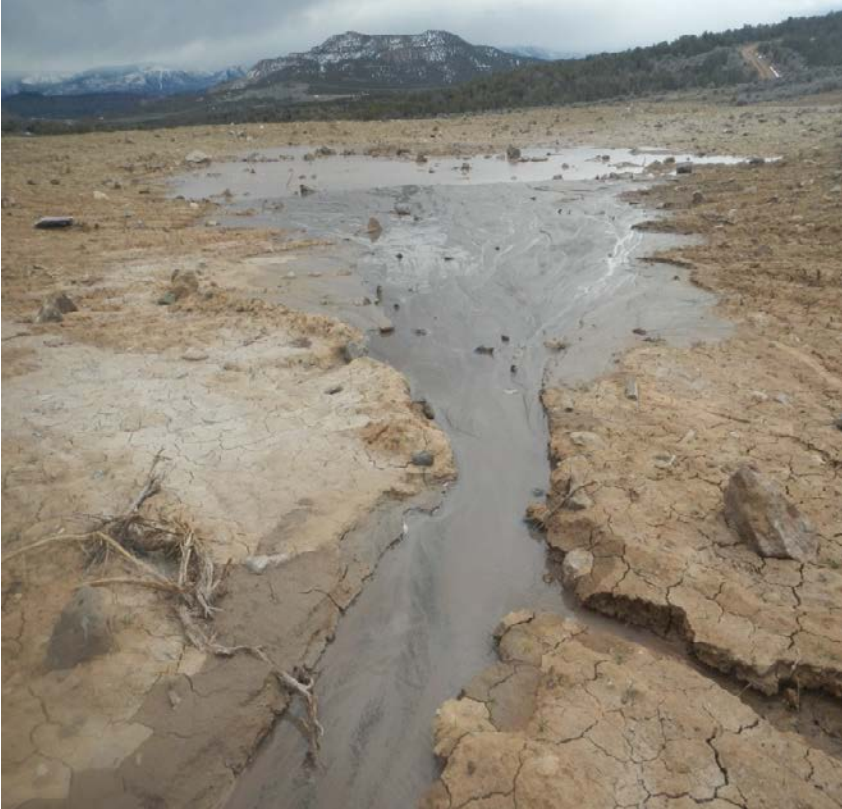
Drainage Water flowing across Pad working its way to SE End of Location

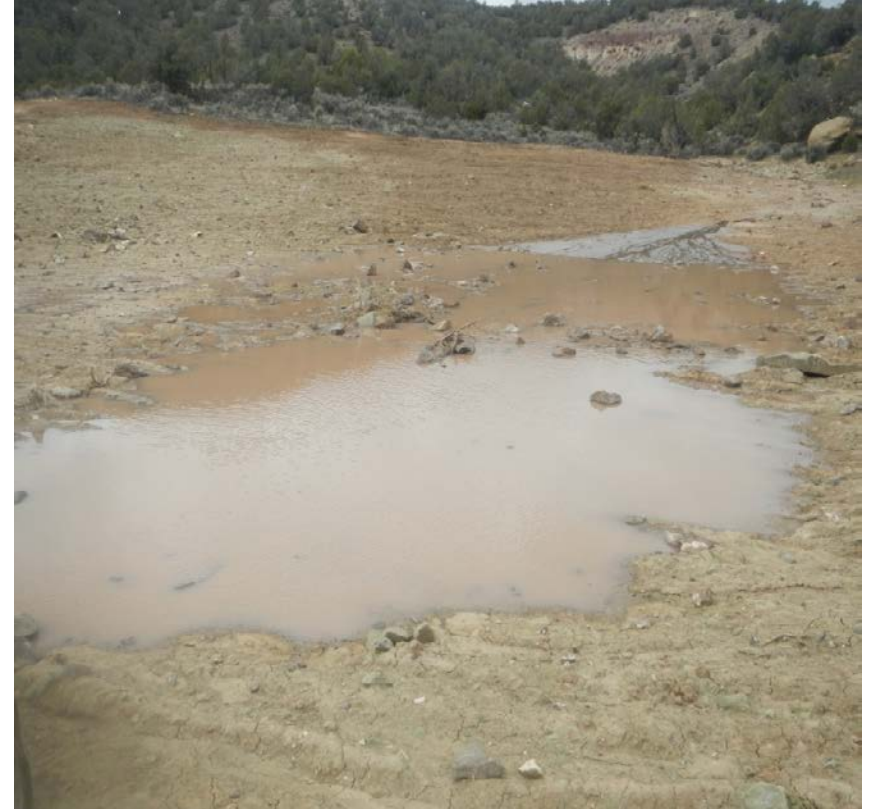
Photo#6:

Sediment migrating and Stormwater eroding channels at Southern Perimeter of Location

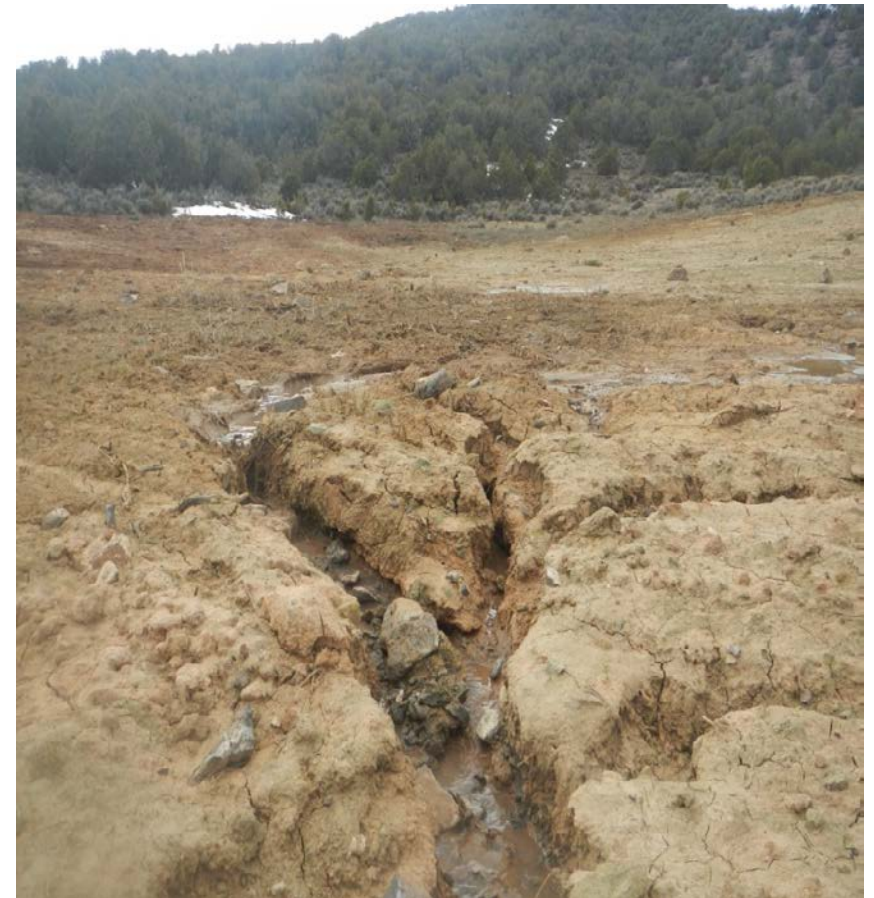
Portion of Water from Natural Drainage cuts around the NW corner, and channels to exit at NE corner of Location.

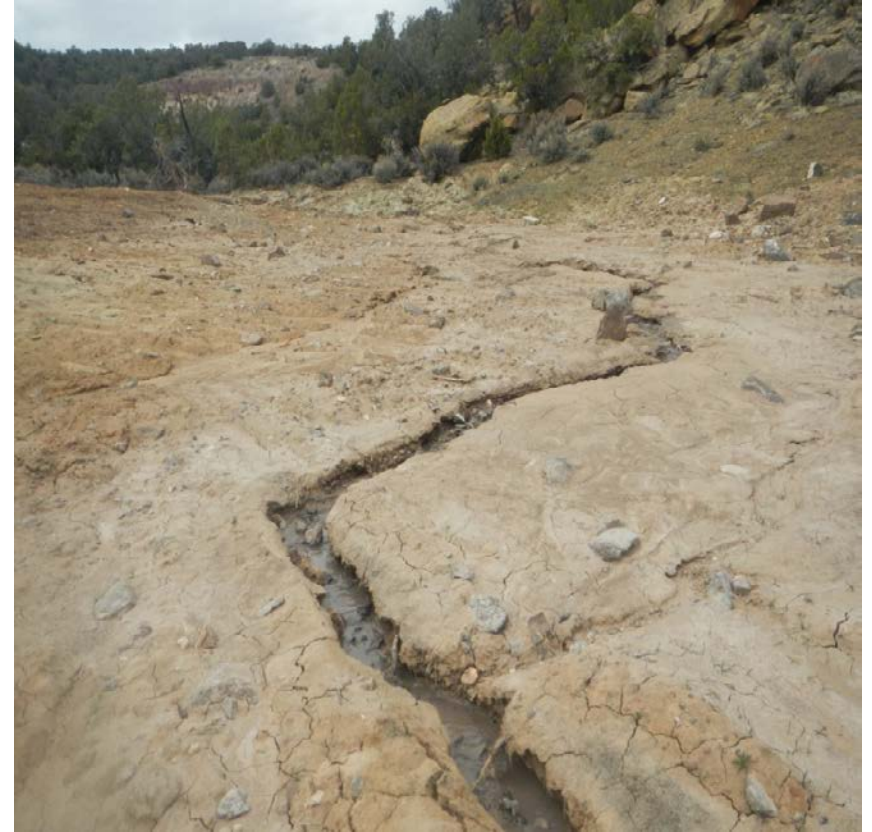
Wattles need Maintenance
