Final Reclamation Inspection

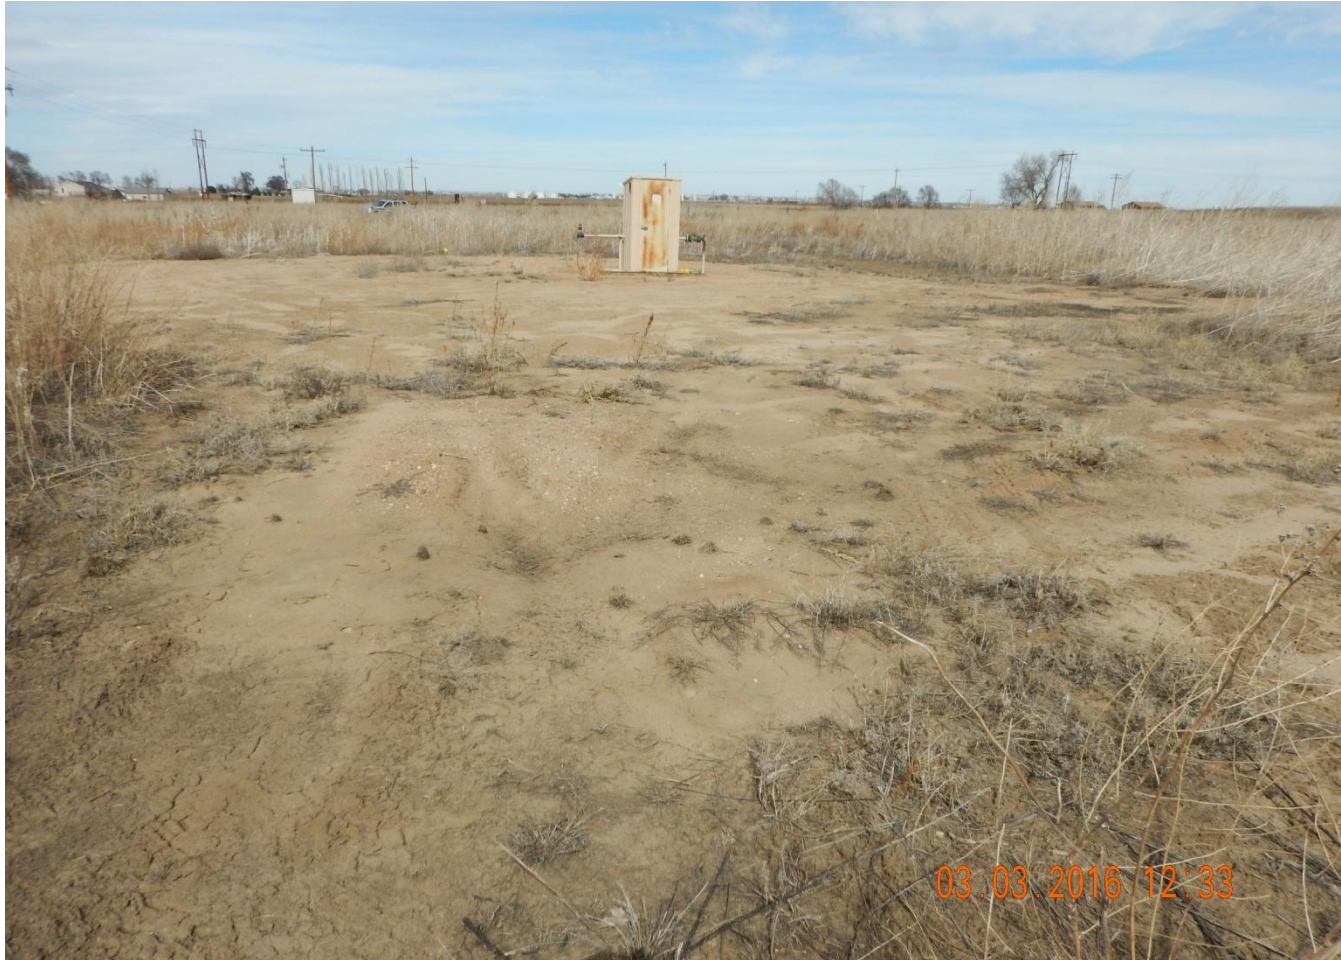
Photo 1. Photo taken from entrance of location, facing North. It does not appear final reclamation has been conducted. Comply with Rule 1004- remove all surface equipment, abandoned gathering line risers and flowline risers, compaction alleviation, and revegetation.

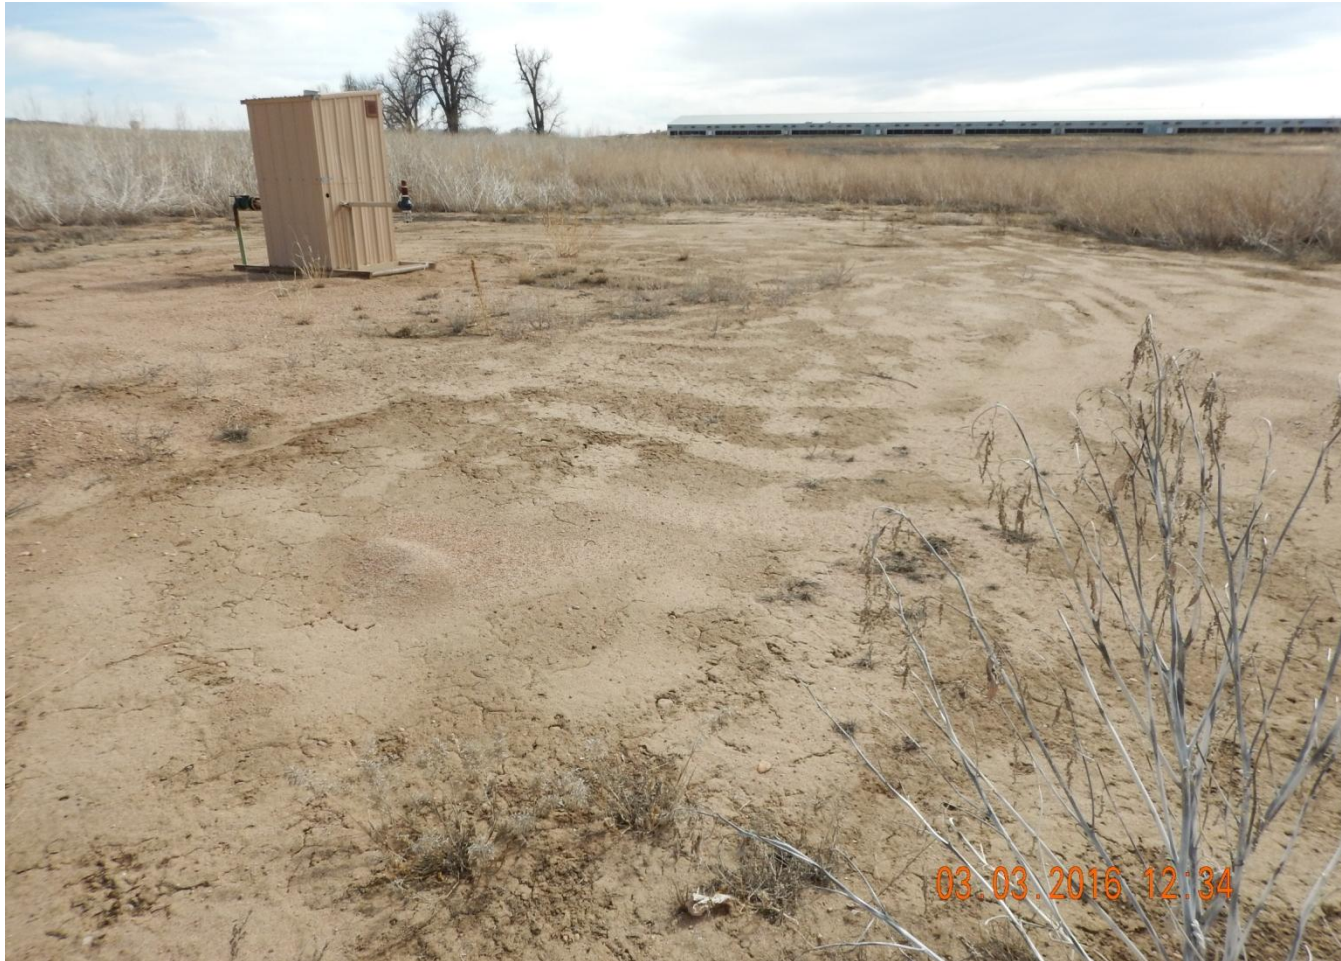
Photo 2. Photo taken from northern location, facing South. It does not appear final reclamation has been conducted. Comply with Rule 1004- remove all surface equipment, abandoned gathering line risers and flowline risers, compaction alleviation, and revegetation.

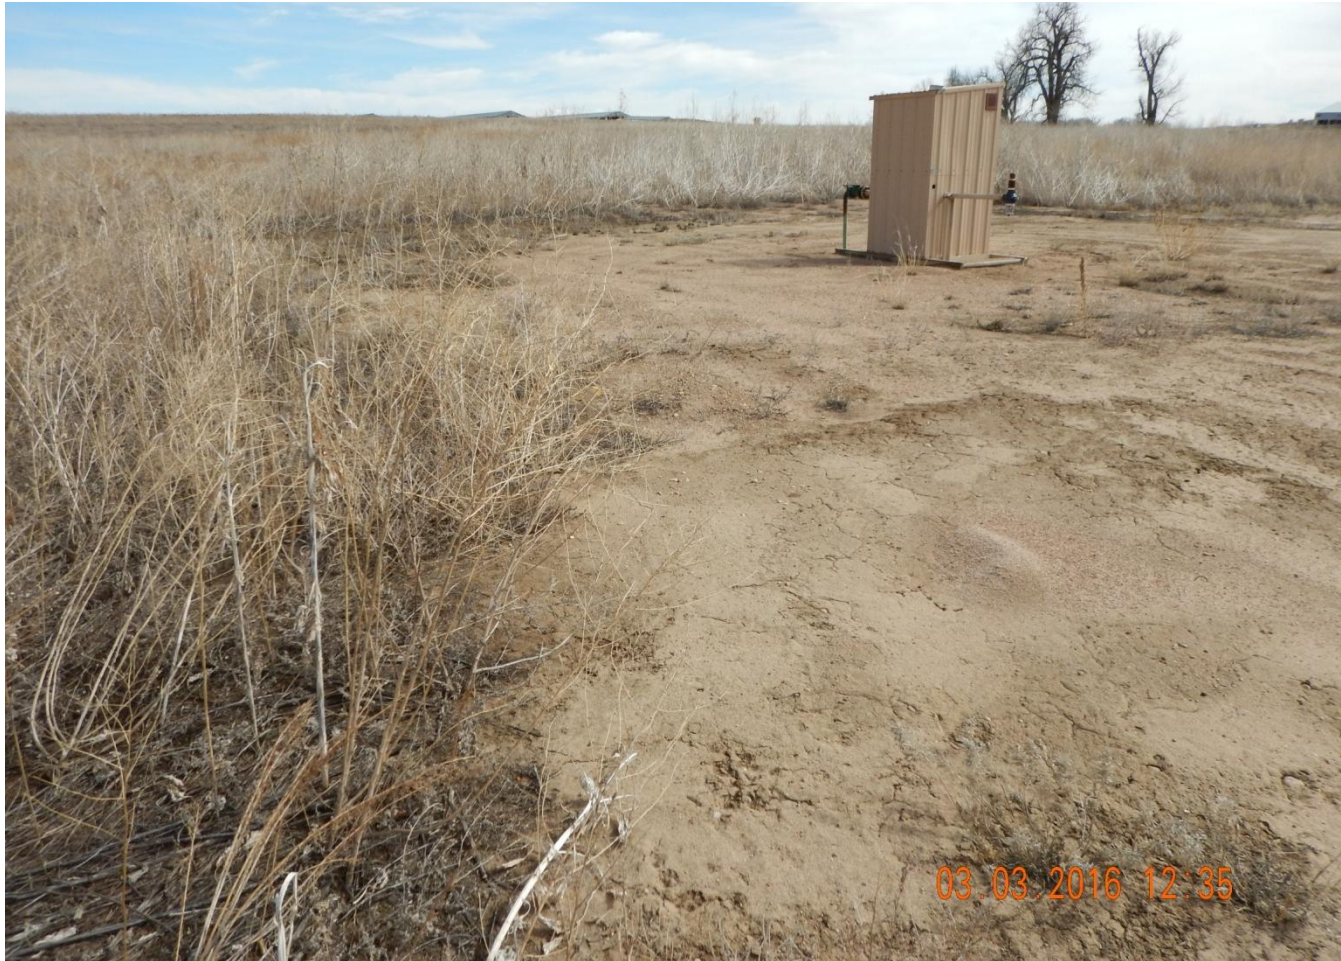
Photo 3. Photo taken from northern location, facing East. It does not appear final reclamation has been conducted. Comply with Rule 1004- remove all surface equipment, abandoned gathering line risers and flowline risers, compaction alleviation, and revegetation.

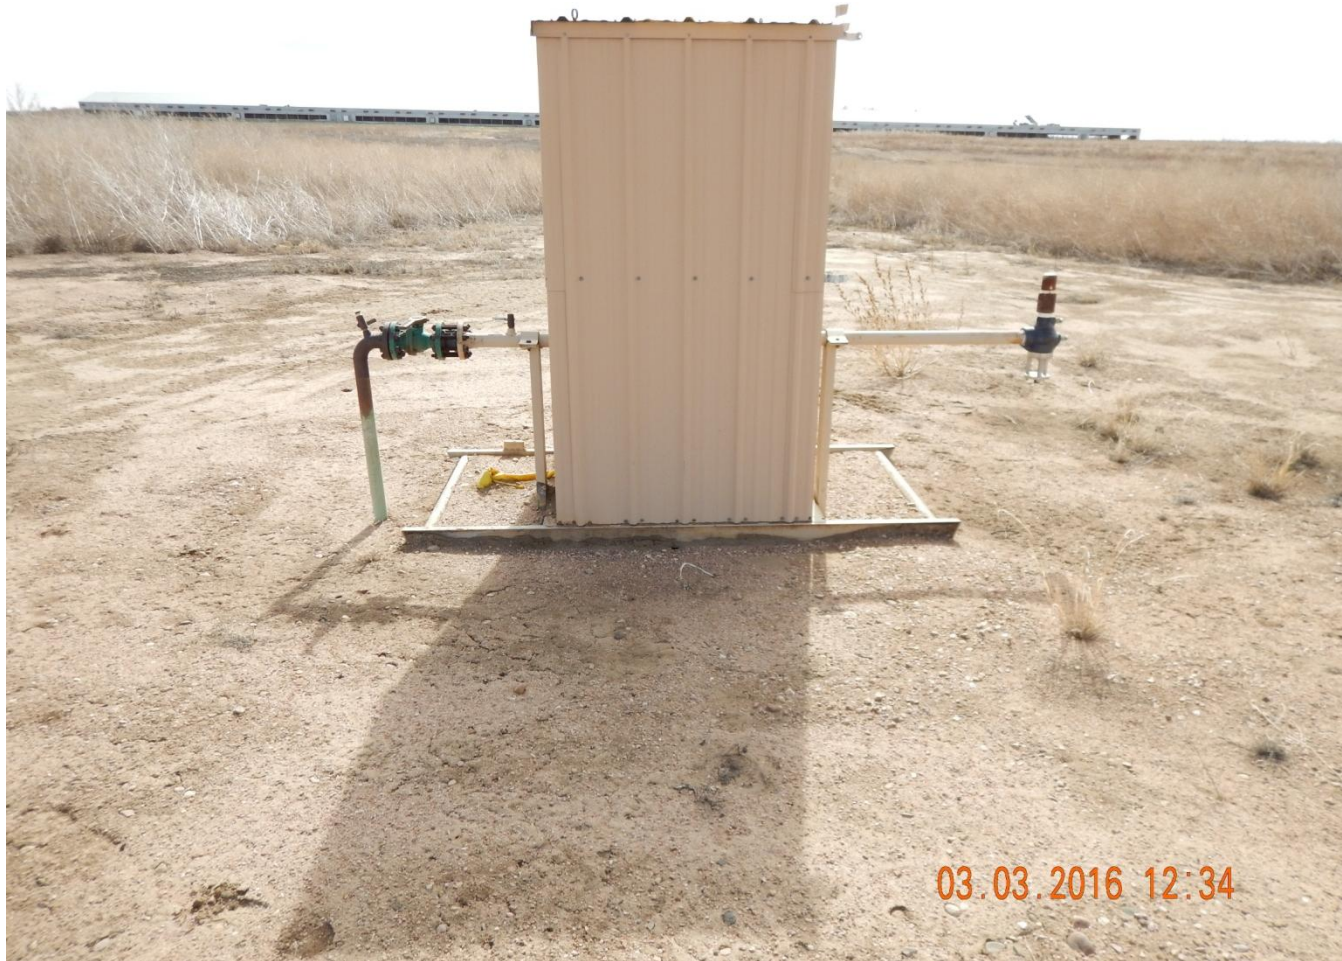
Photo 4. Photo taken from northern location, facing South. Comply with Rule 1004- remove all surface equipment, abandoned gathering line risers and flowline risers, compaction alleviation, and revegetation.
