Inspection Photos
3/22/16
Facility #285505
BEARLY 24-29 ONSITE

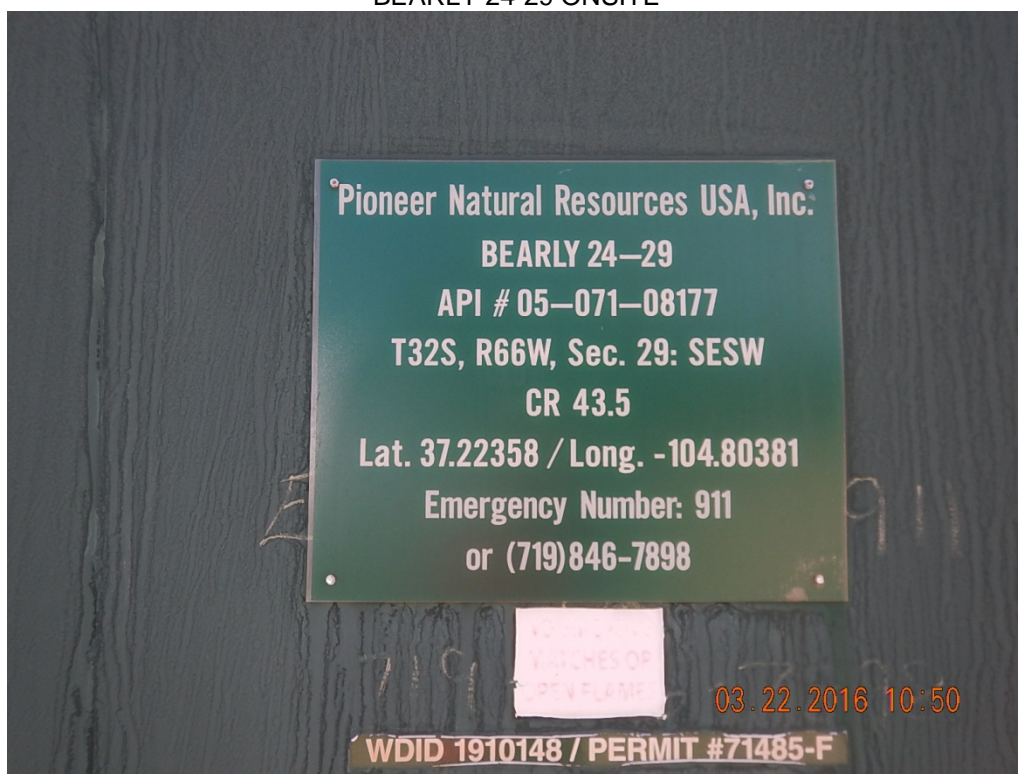
Figure 1 – Lease sign.

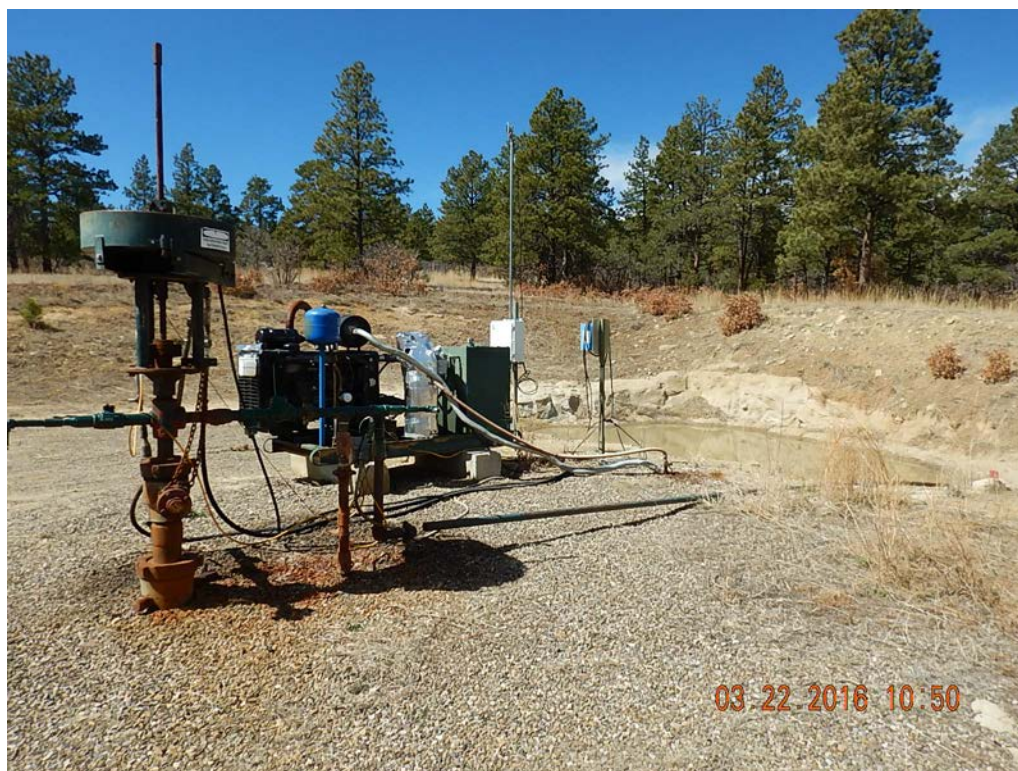
Figure 2 – Wellhead and pit.

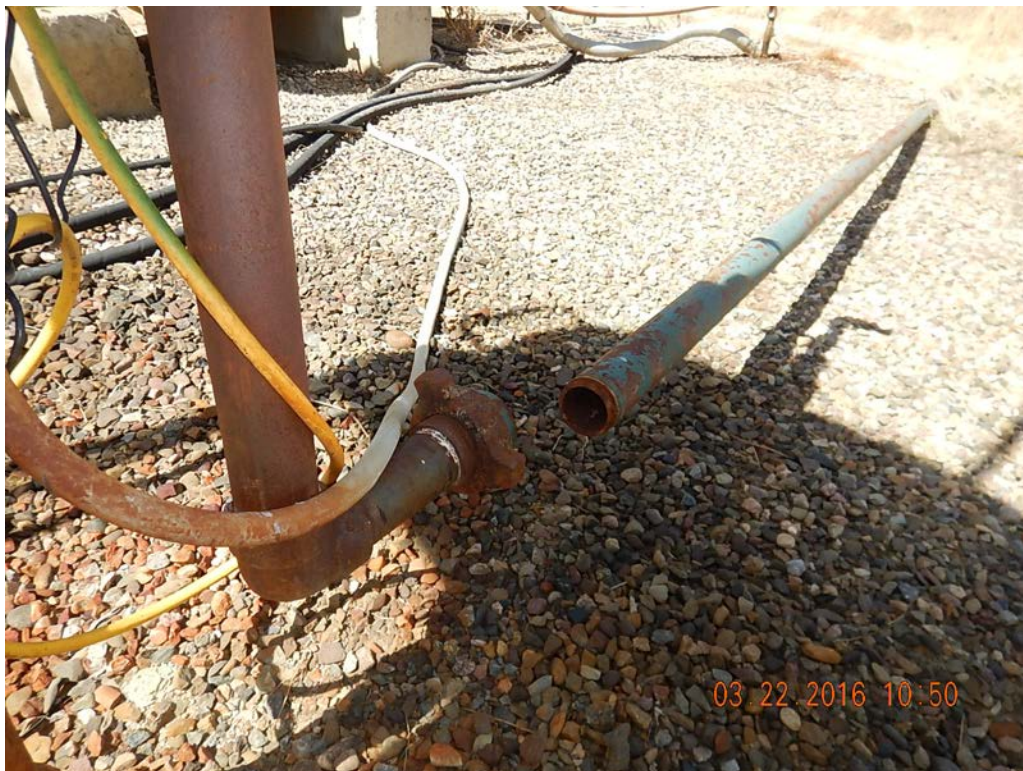
Figure 3 – Pipe to pit is currently disconnected.

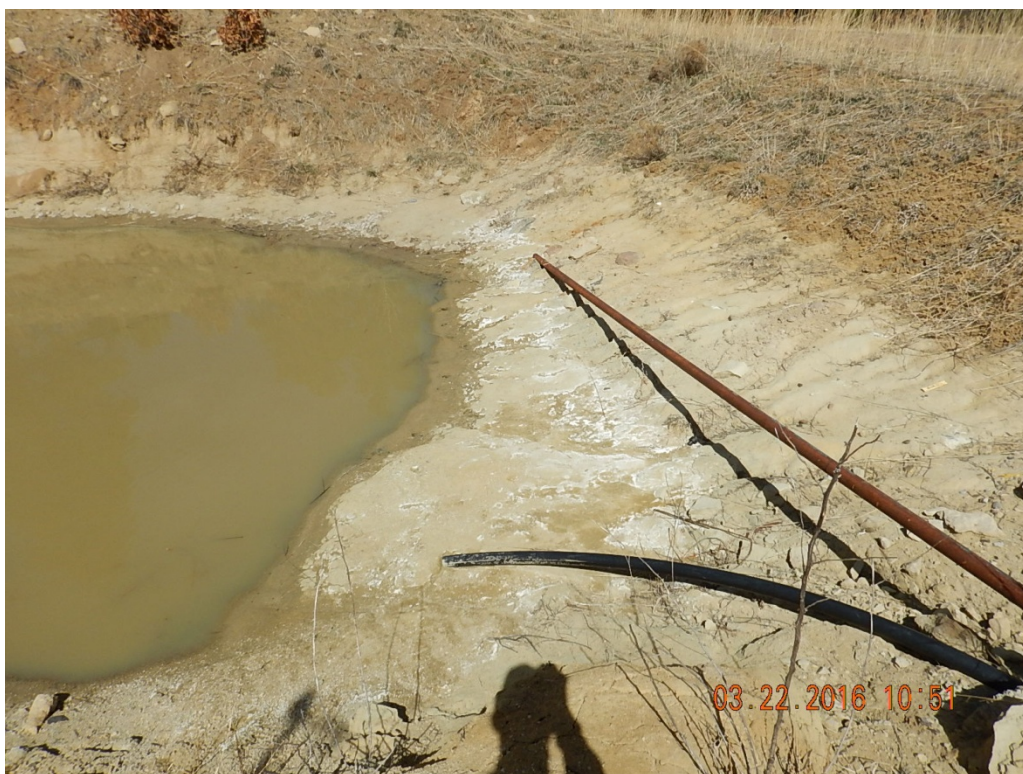
Figure 4 – Piping from wellhead to pit. Metal pipe is disconnected.

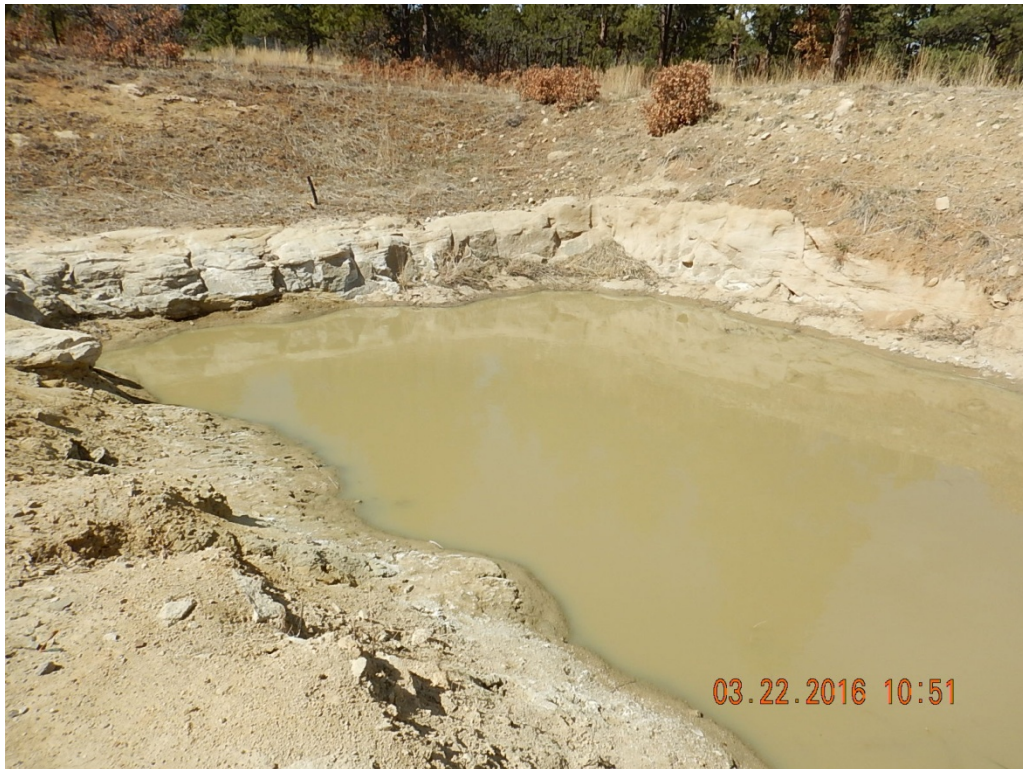
Figure 5 – West side of pit.
