Inspection Photos  
3/28/16  
Facility #436580  
Aloha Mula #16 API 05-073-06590

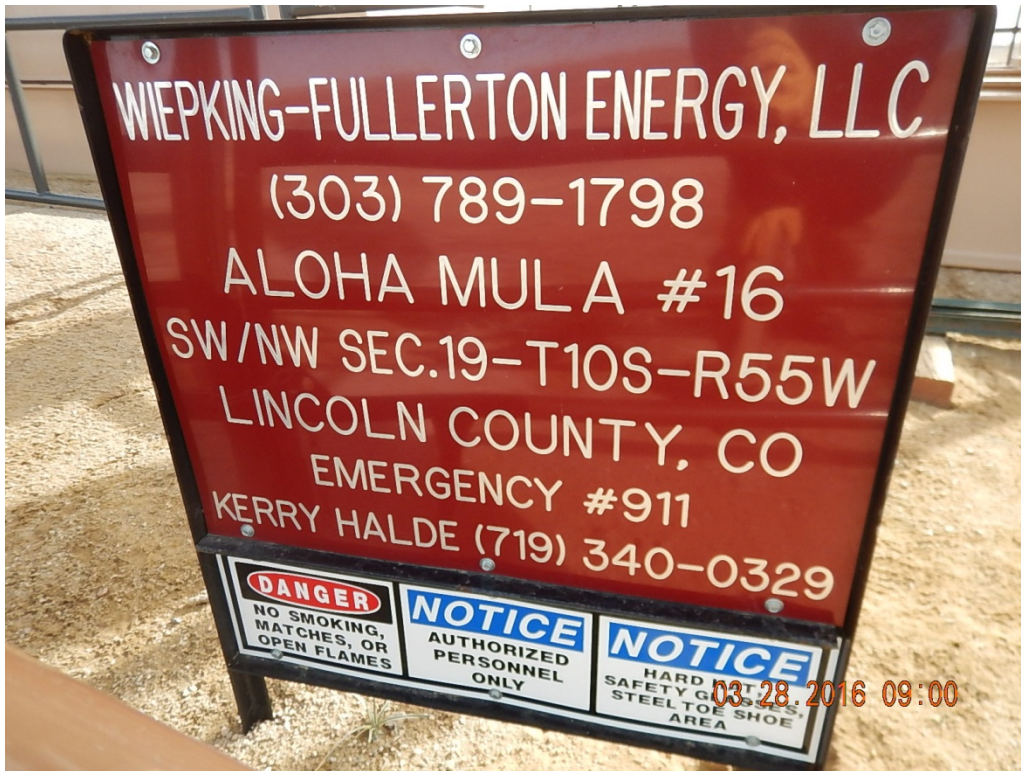
Figure 1 – Lease sign.

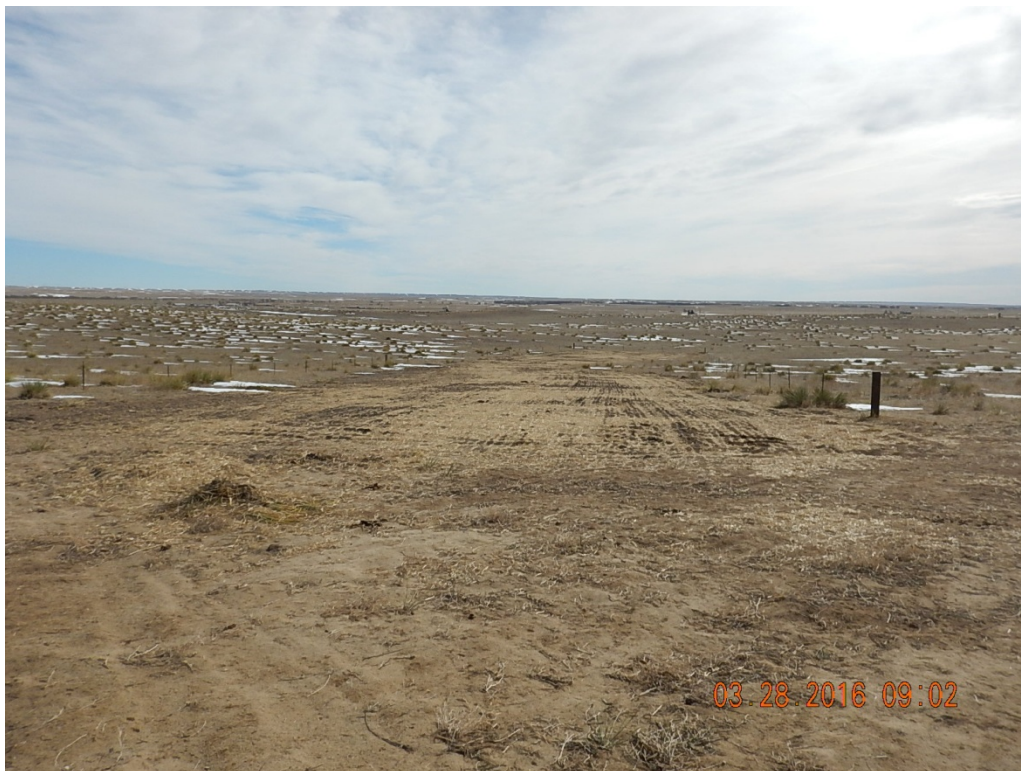
Figure 2 – Looking from well pad to spill reclamation area.

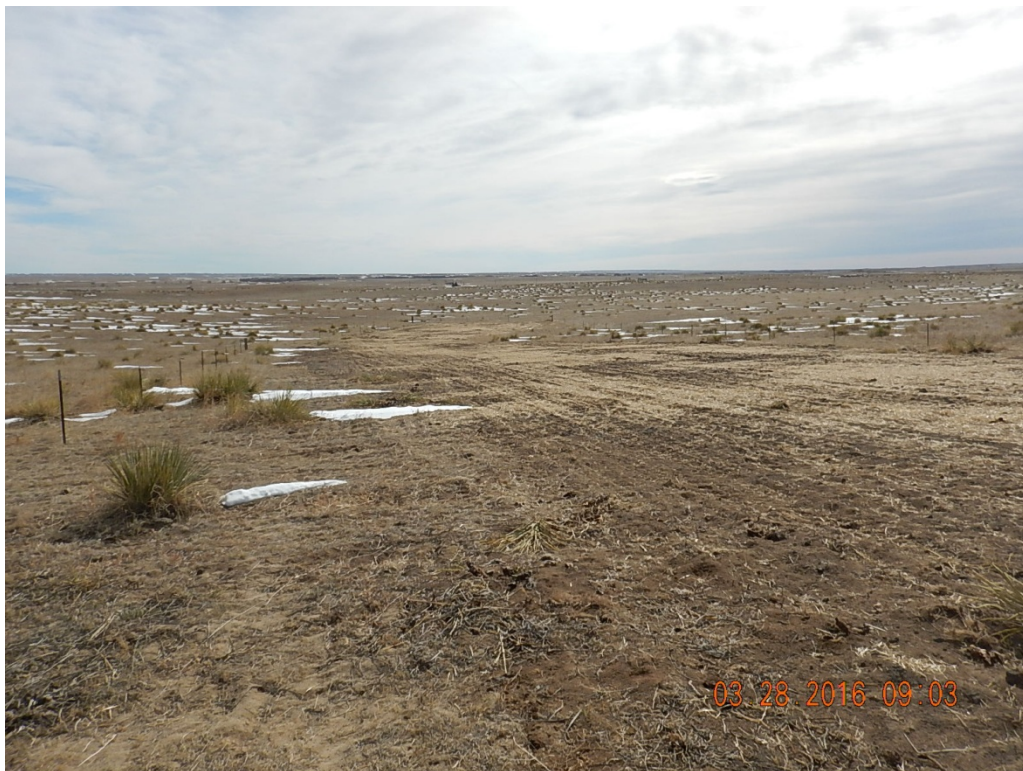
Figure 3 – Reclaimed area.

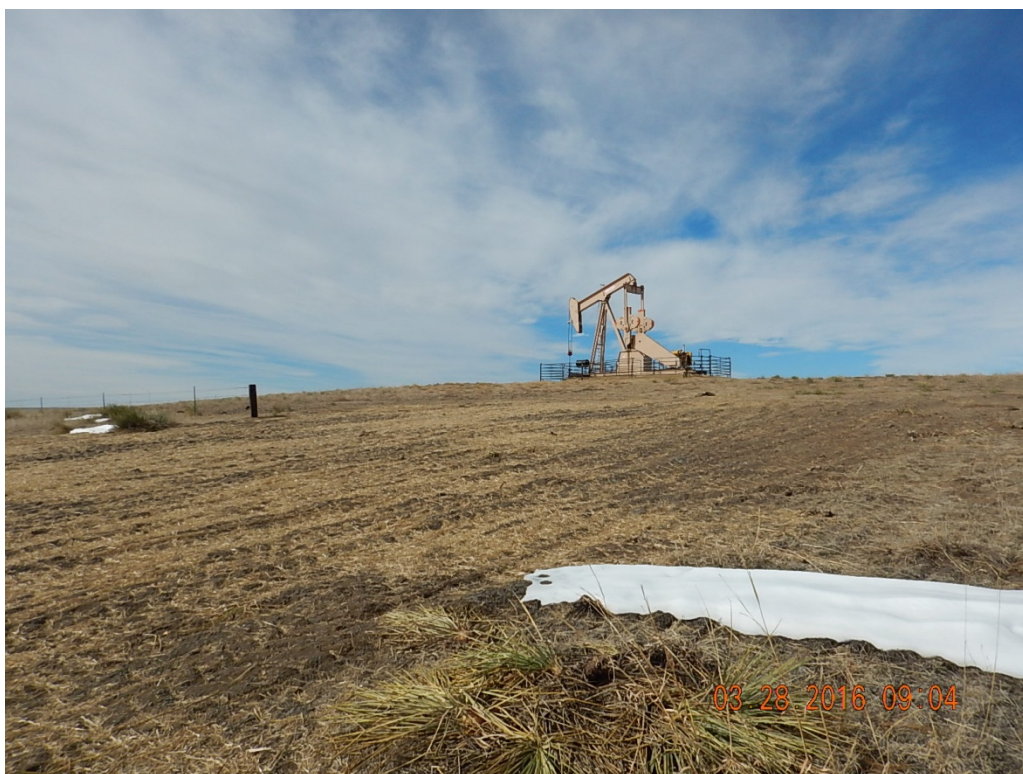
Figure 4 – Reclaimed area and wellhead.
