ALL PHOTOS TAKEN 3/23/2016

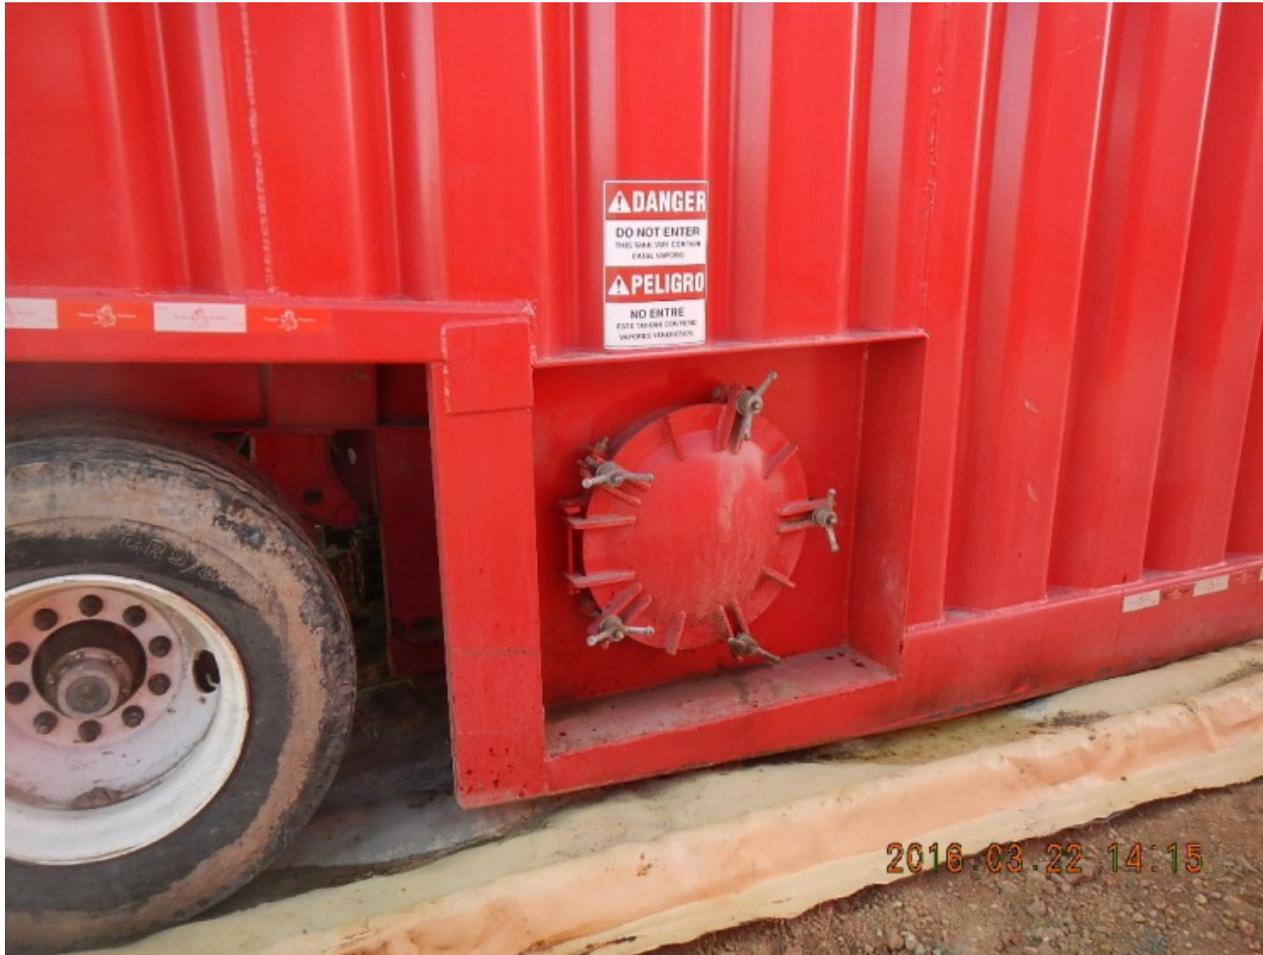
Hatch that was the source of spill, “tee handles” on tank was not tight. Sandridge has adopted the procedure of truck drivers tightening the tee handles upon delivering the tanks, to prevent a similar spill in the future.

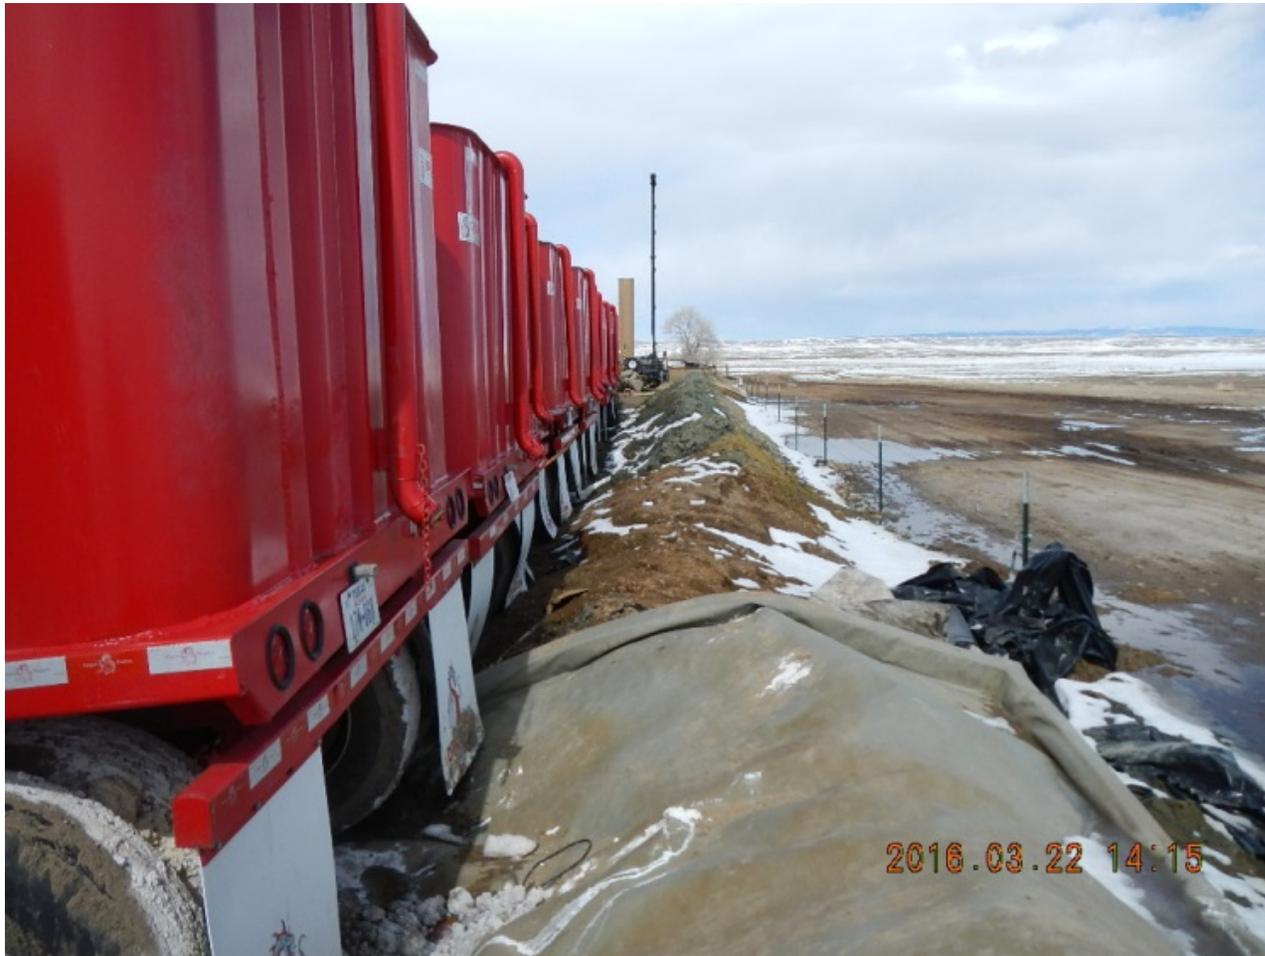
Back of tank that had spill.

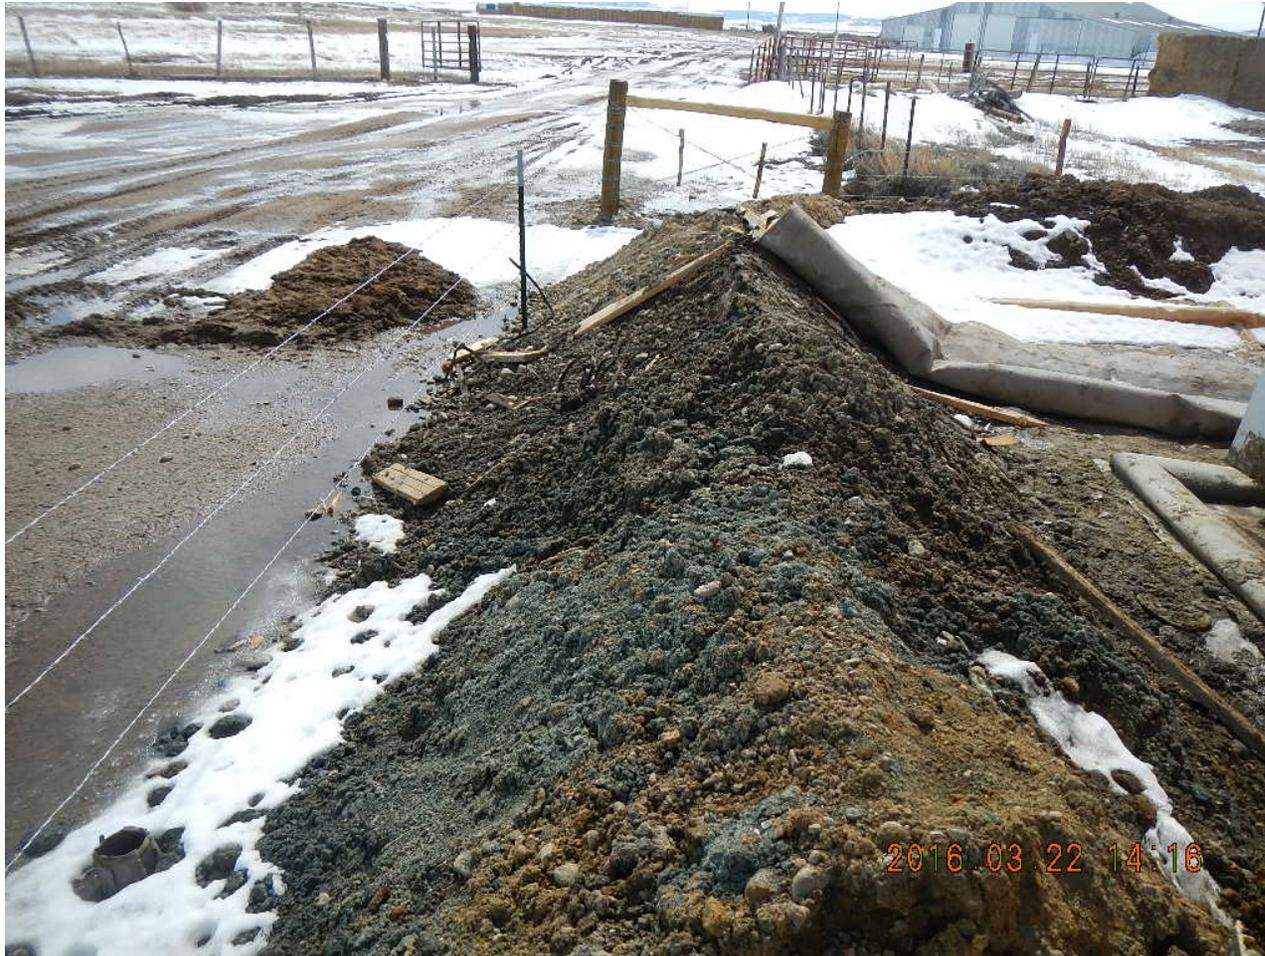
Area behind frac tanks, soil appears that it could be drill cuttings. Operator should investigate the soil and determine proper disposition of soil.

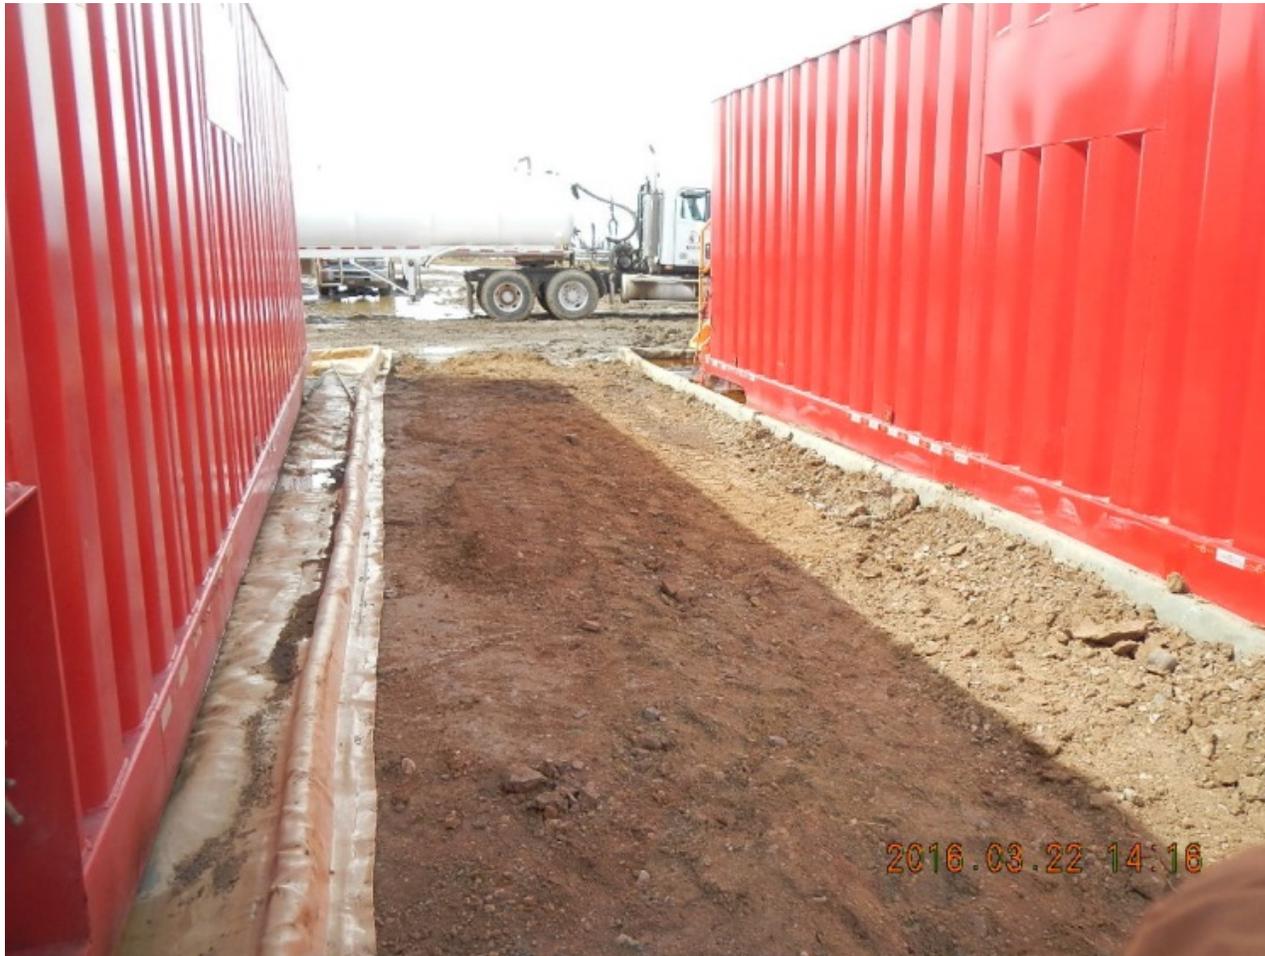
Tank on left had contained spill in liner/secondary containment.

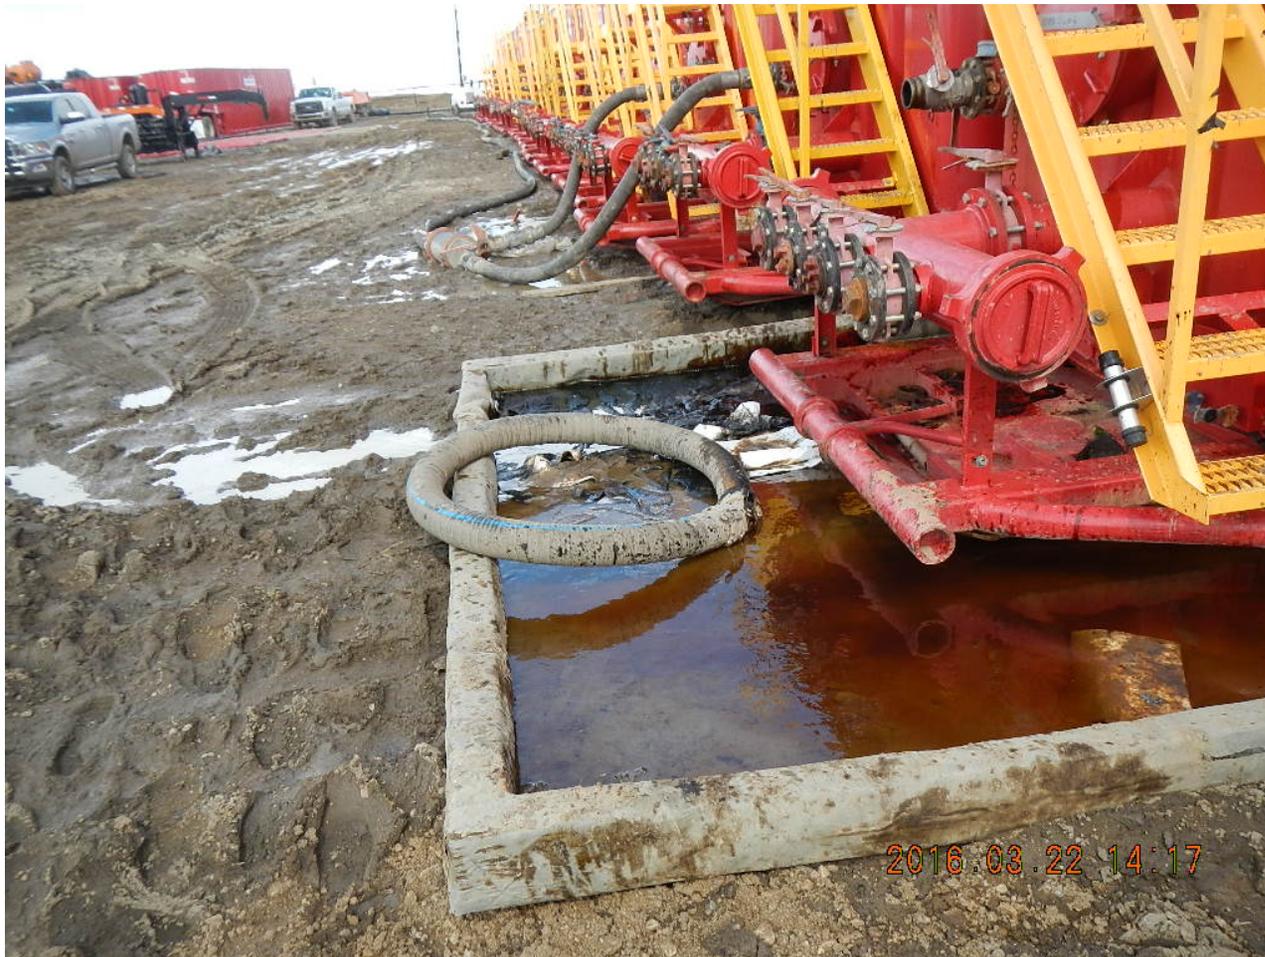
Secondary containment, has some residual water from cleaning the secondary containment.

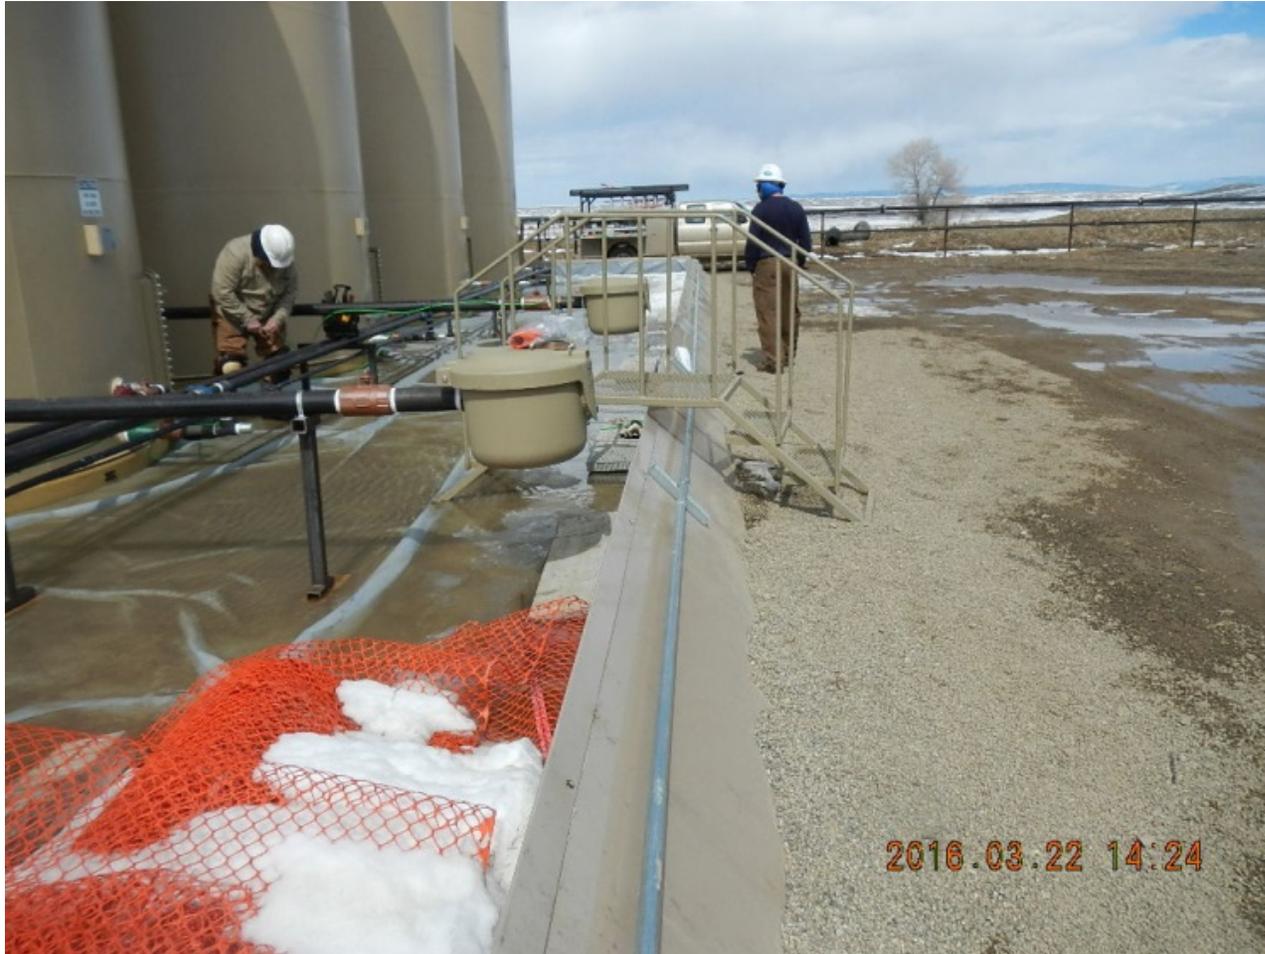
Tank battery, under construction
