**MARATHON OIL COMPANY
NOTICE OF COMPLETION REPORT FOR
INTERIM RECLAMATION OF
697-21A**

January 20, 2012

**InterTech Environmental & Engineering, LLC
743 Horizon Court, Suite 110
Grand Junction, Colorado 81506**

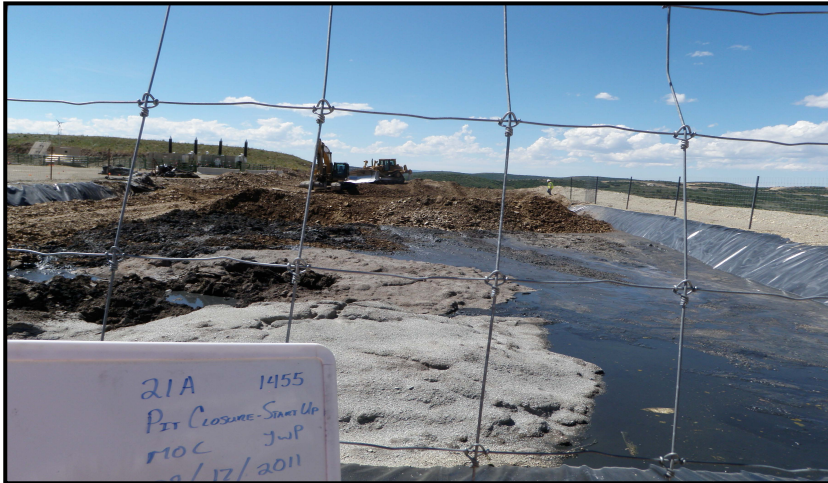
This report covers the activities associated with the closure of the on-site reserve pit at Marathon Oil Company's 697-21A well pad. At the time of the initial site visit, the pit contained what appeared to be drill cuttings and fluid (Photo 1, Appendix A).

Photo 1 – 697-21A reserve pit containing drill cuttings with some fluids.

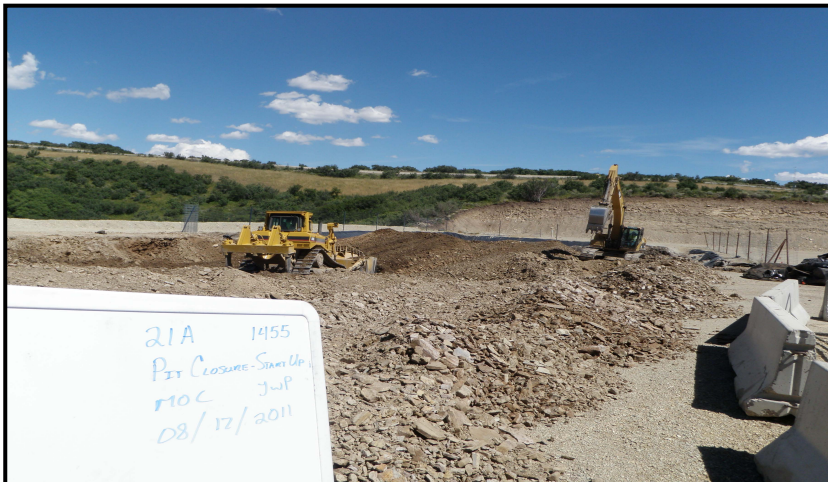
Photo 3 – D8 providing clean fill material from NW corner to track hoe for mixing.

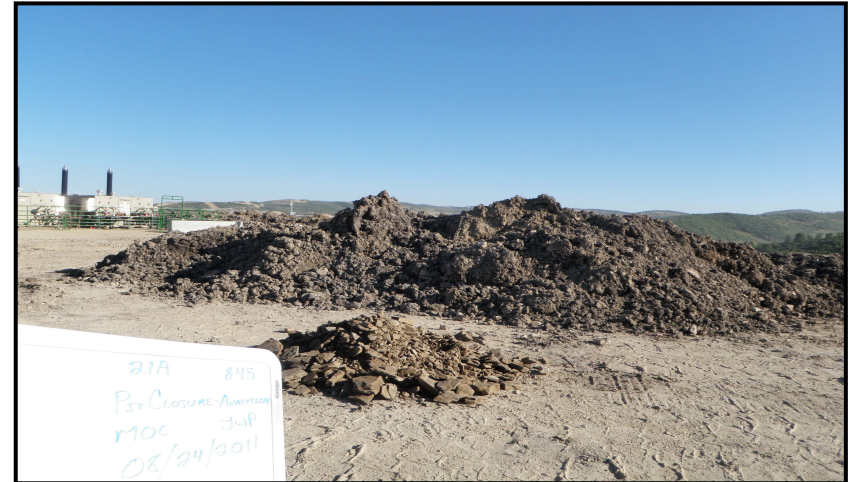
Photo 6 – Mixed material after being rolled with D8 and front end loader.

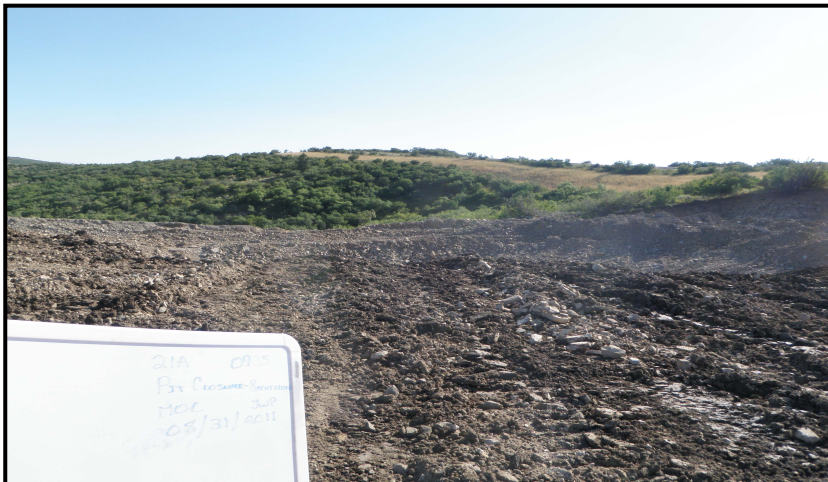
Backfilling of the excavation was achieved by placing the 1.5:1 mixture of clean soil and cuttings back into the excavation (Photo 7). The mixed material was placed load-by-load into the excavation with each load being thoroughly compacted using the tracks of a dozer. This process continued until the excavation was completely filled.

Photo 7 – Pit during backfilling operations.

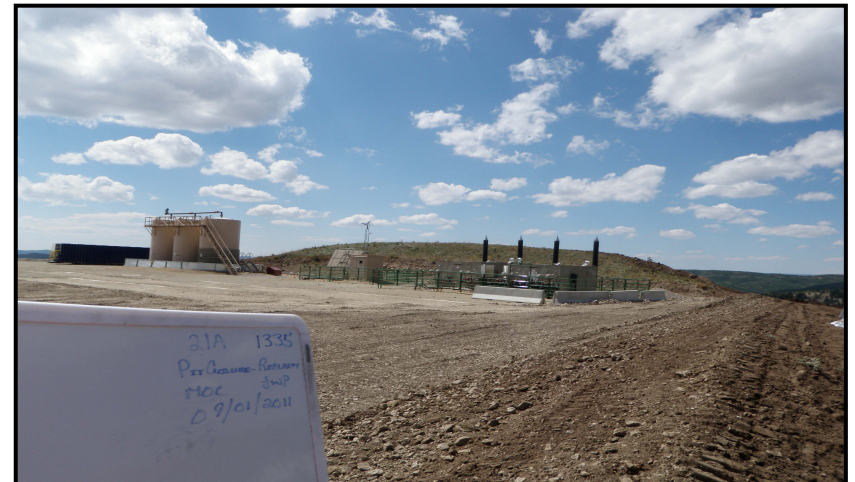
Once the excavation had been backfilled, areas of the well pad no longer required for production were roughly graded to their original contour (Photo 8). These re-contoured areas were then top-soiled, thereby mitigating the potential effects of physical parameters on reclamation success. Backfilling and re-contouring operations concluded on August 24, 2011.

Photo 8 – Well pad after pit closure and reclamation.

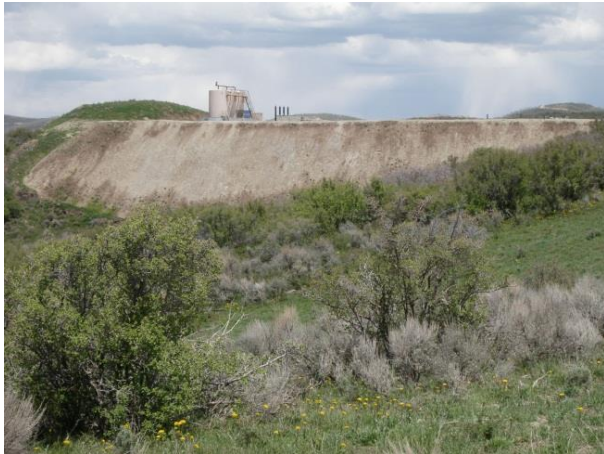
View of south-facing fill slope

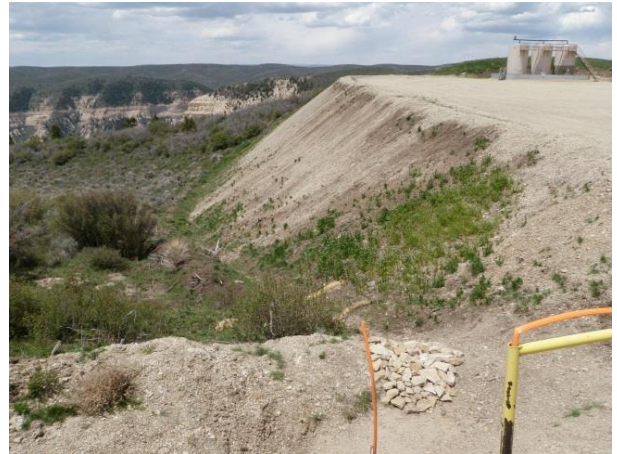
View of south-facing fill slope

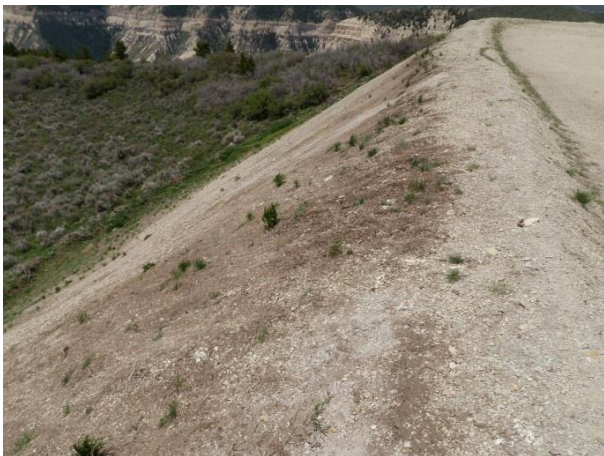
South fill slope

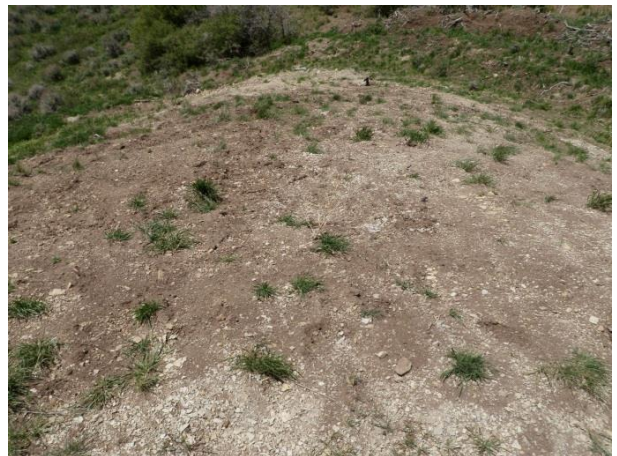
Southwest corner fill slope

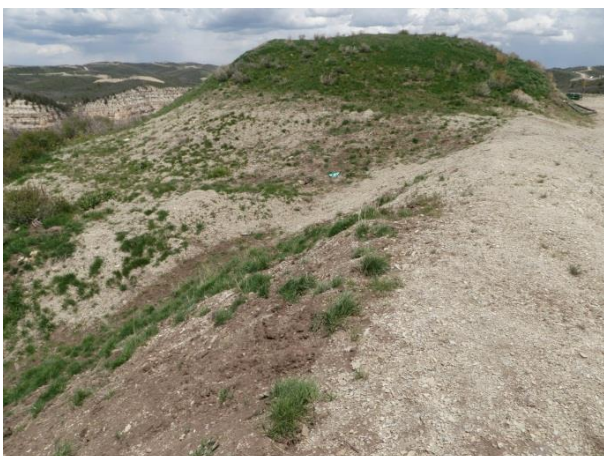
Western edge of pad and top soil pile

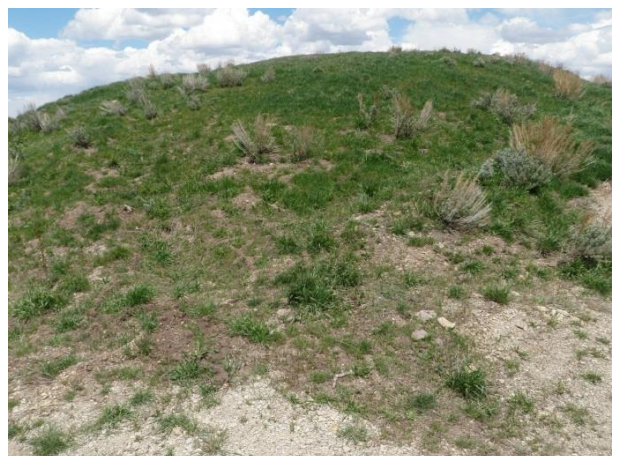
Top soil pile

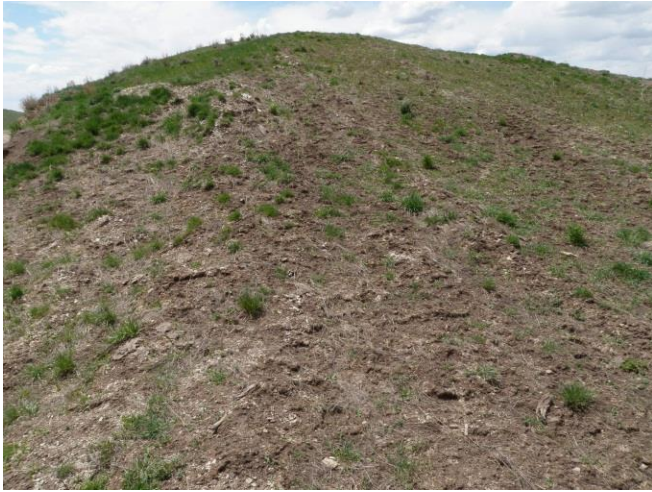
Top soil pile

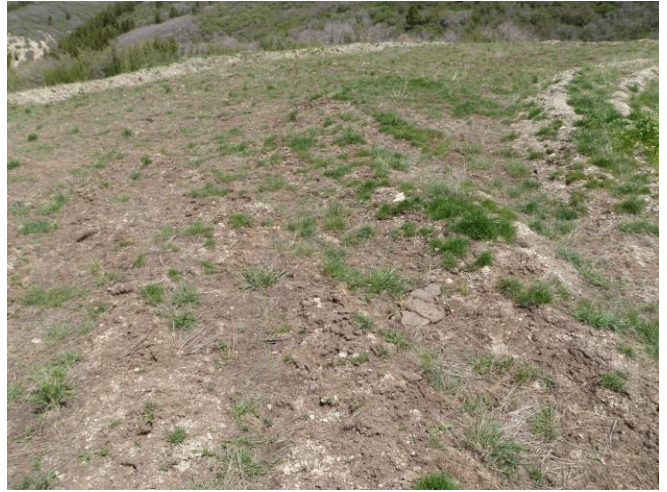
Reclaimed area northwest of pad

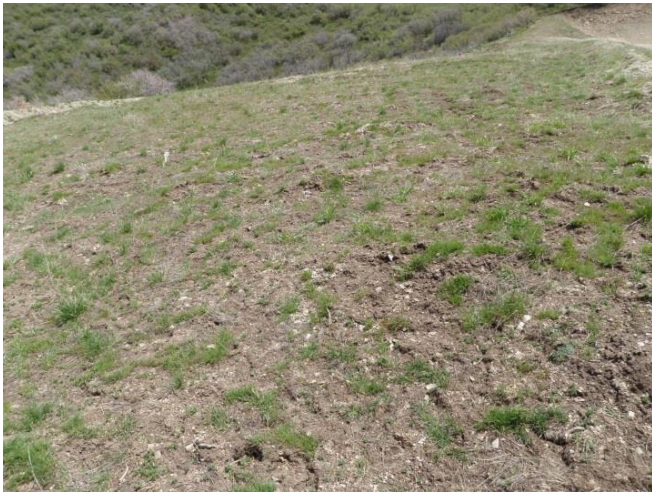
Reclaimed area north of pad

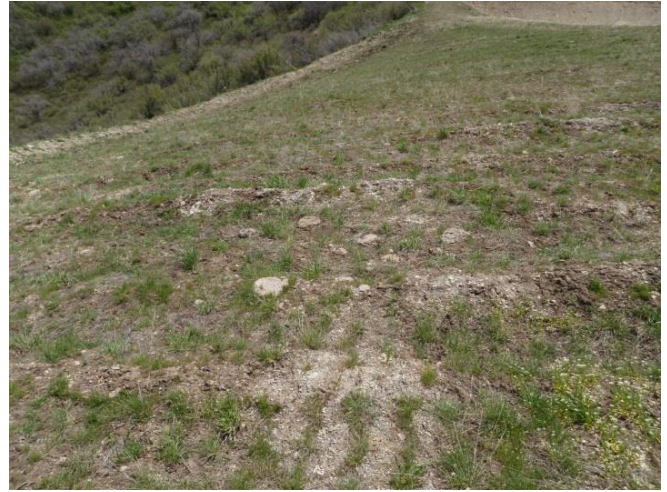
Reclaimed area north of pad

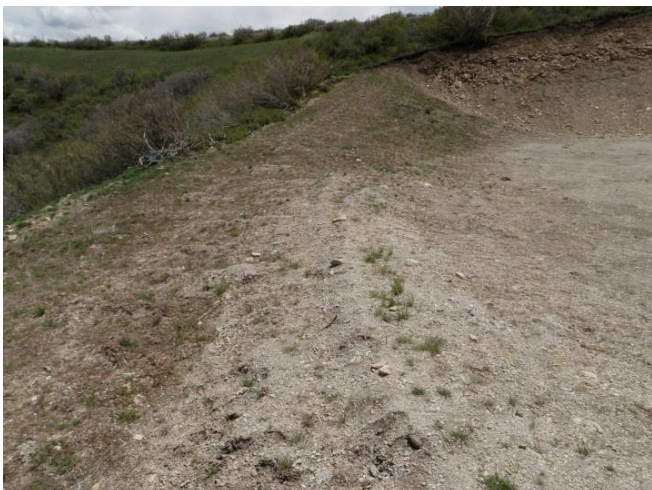
Northern edge of pad

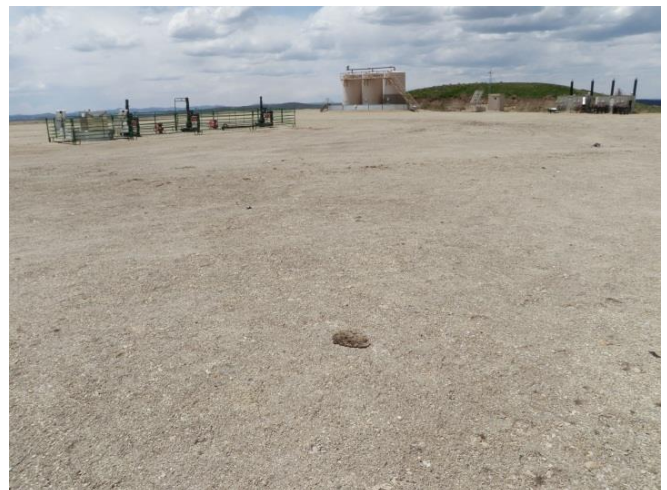
Looking southwest across pad
