## Interim Reclamation Inspection

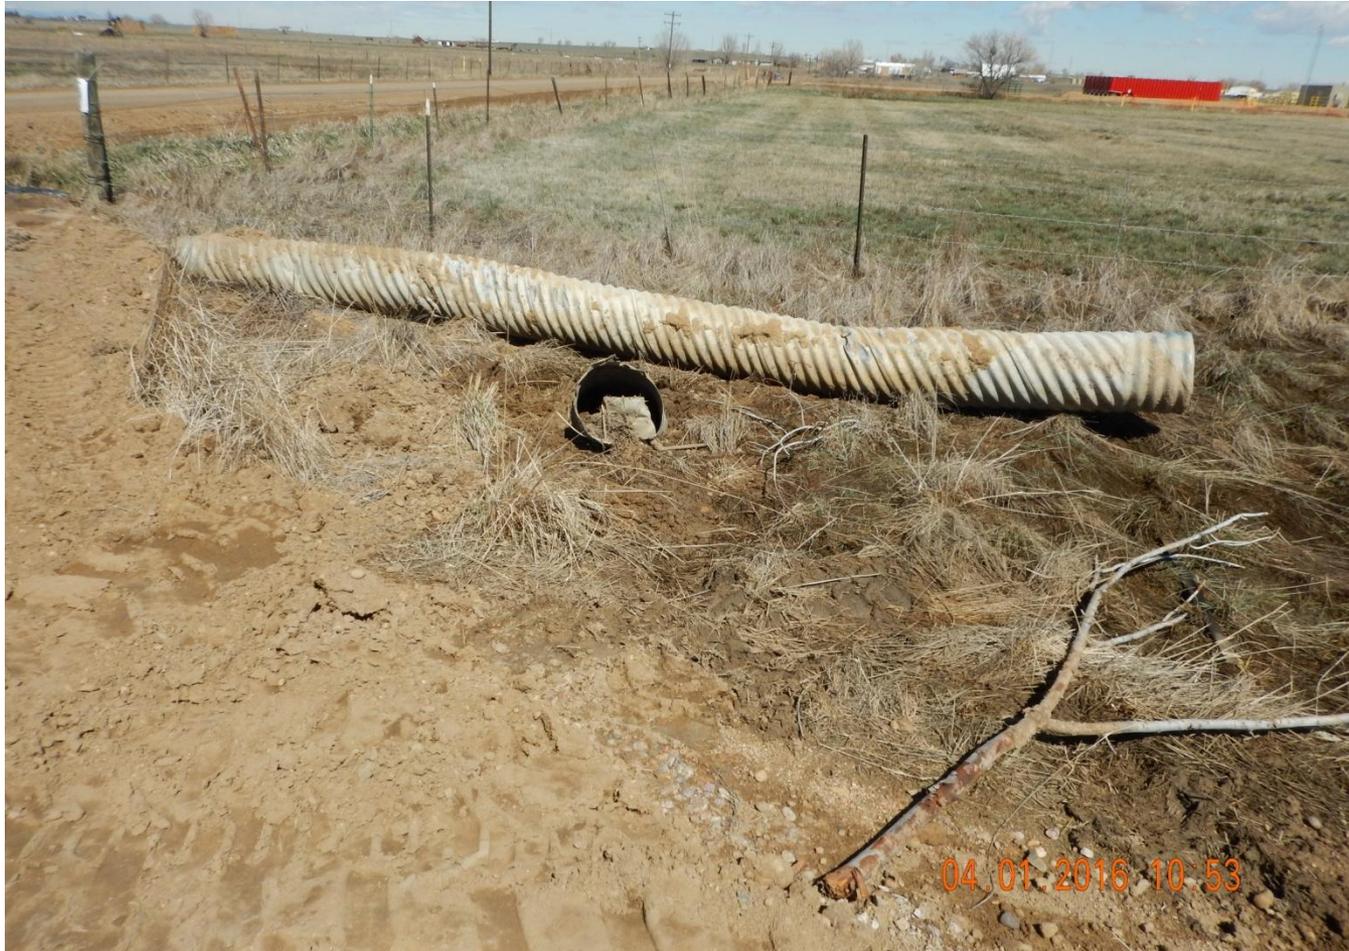
**Photo 1.** Photo taken from Jacobucci 13, 23-32 tank battery, facing North. Need to remove trash per Rule 603.f.

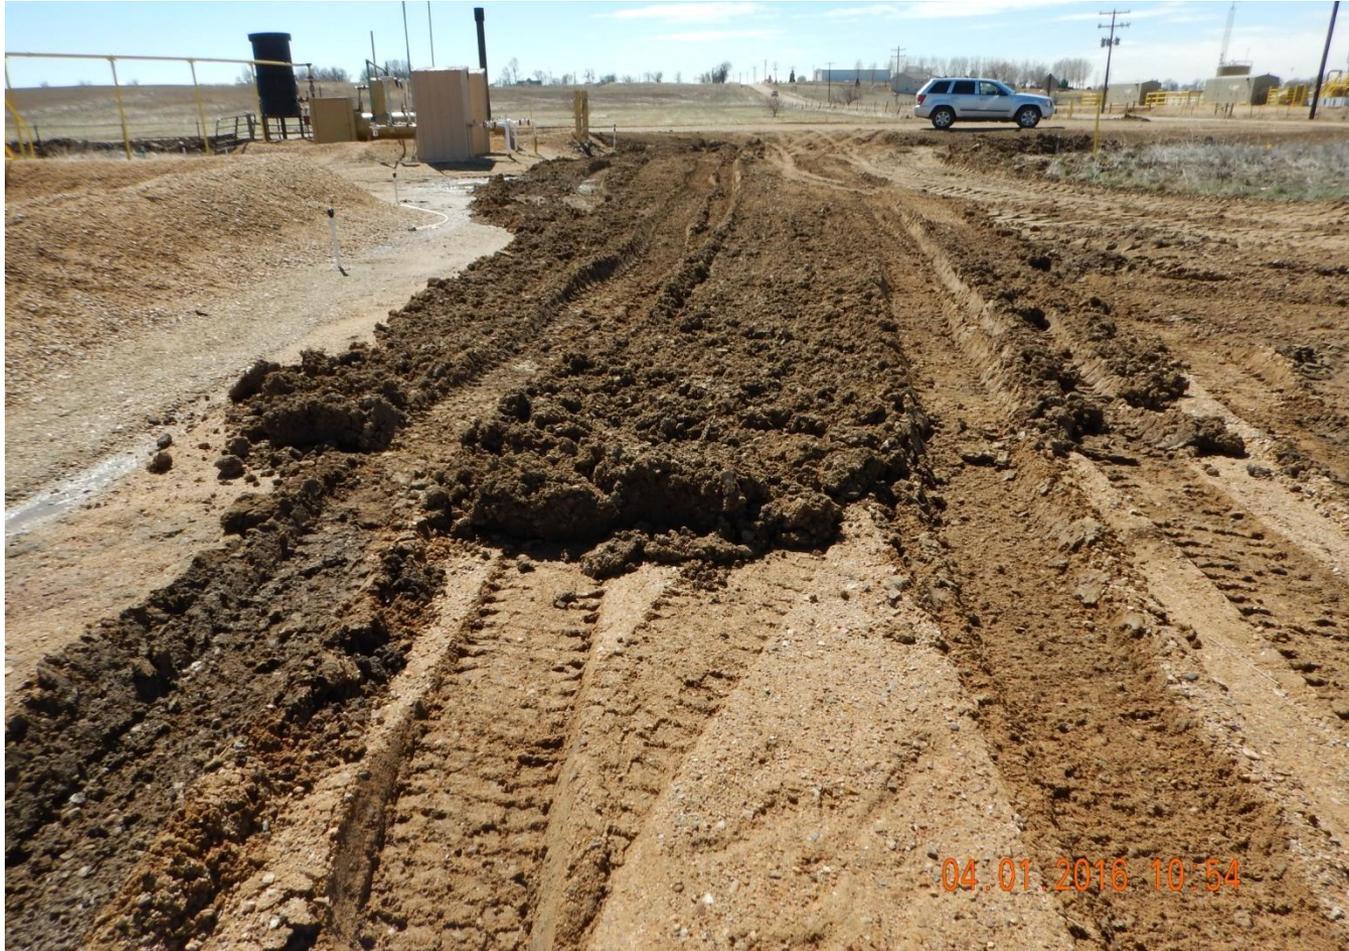
**Photo 2.** Photo taken from Jacobucci 13, 23-32 tank battery, facing South. Need to maintain location to prevent vehicle tracking and rutting.

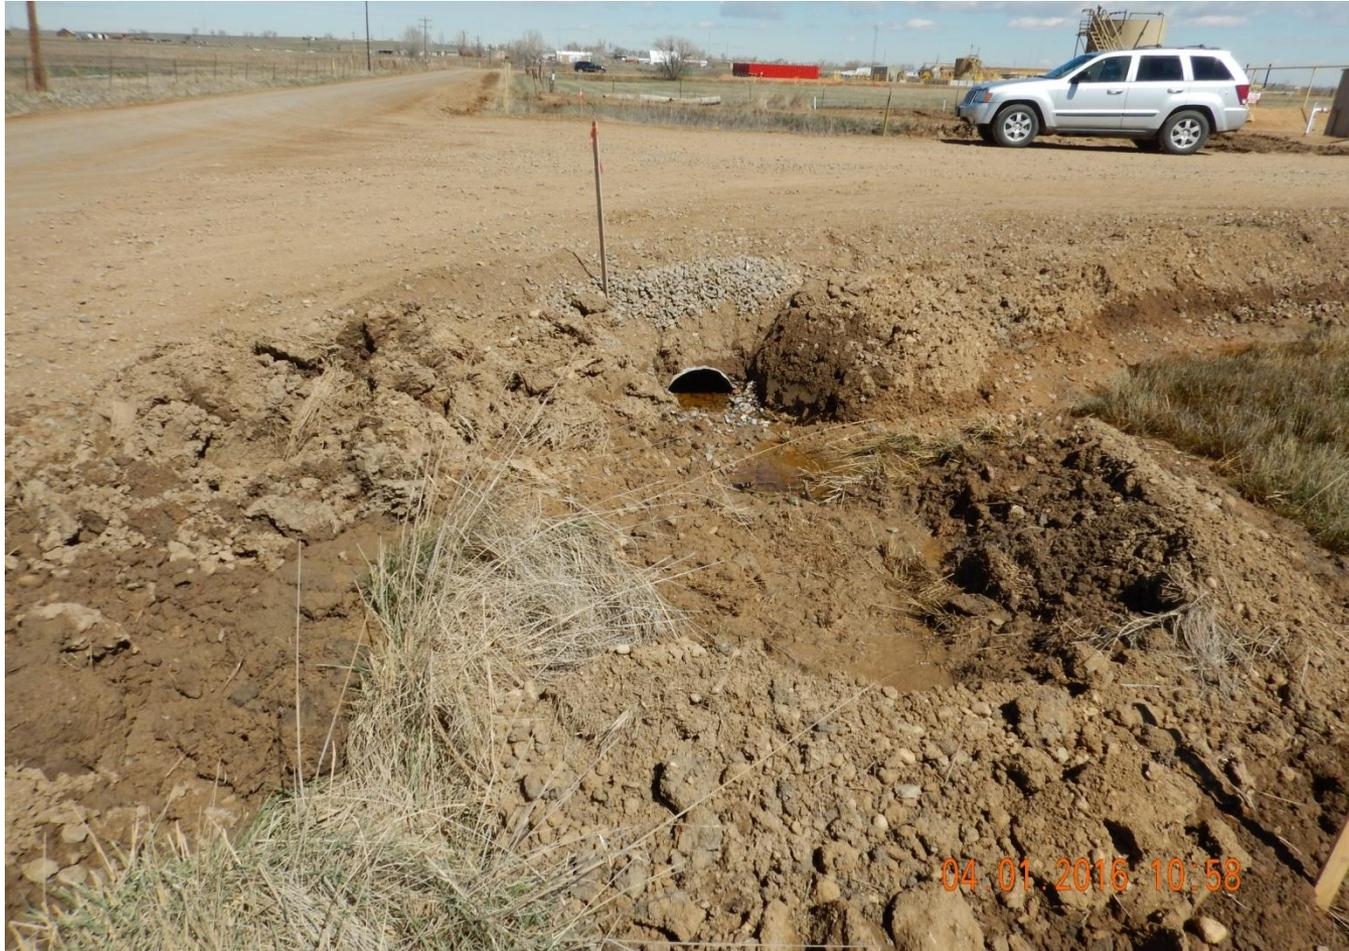
**Photo 3.** Photo taken from entrance of Jacobucci location, facing North. Need to maintain stormwater BMPs. Culvert is already half full.

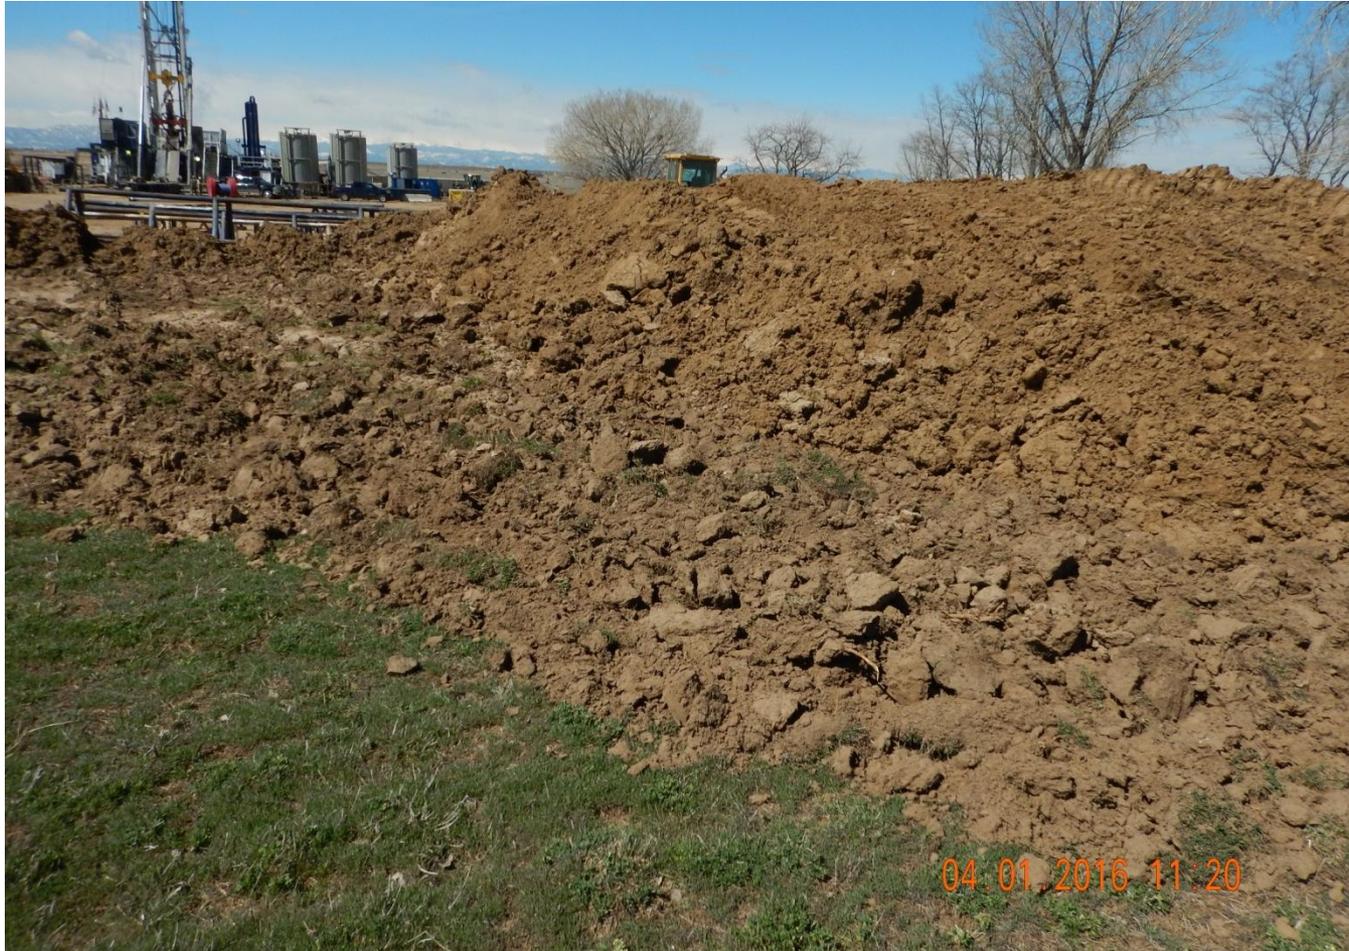
**Photo 4.** Photo taken from northeast Jacobucci well location, facing West. Need to stabilize perimeter of pad.

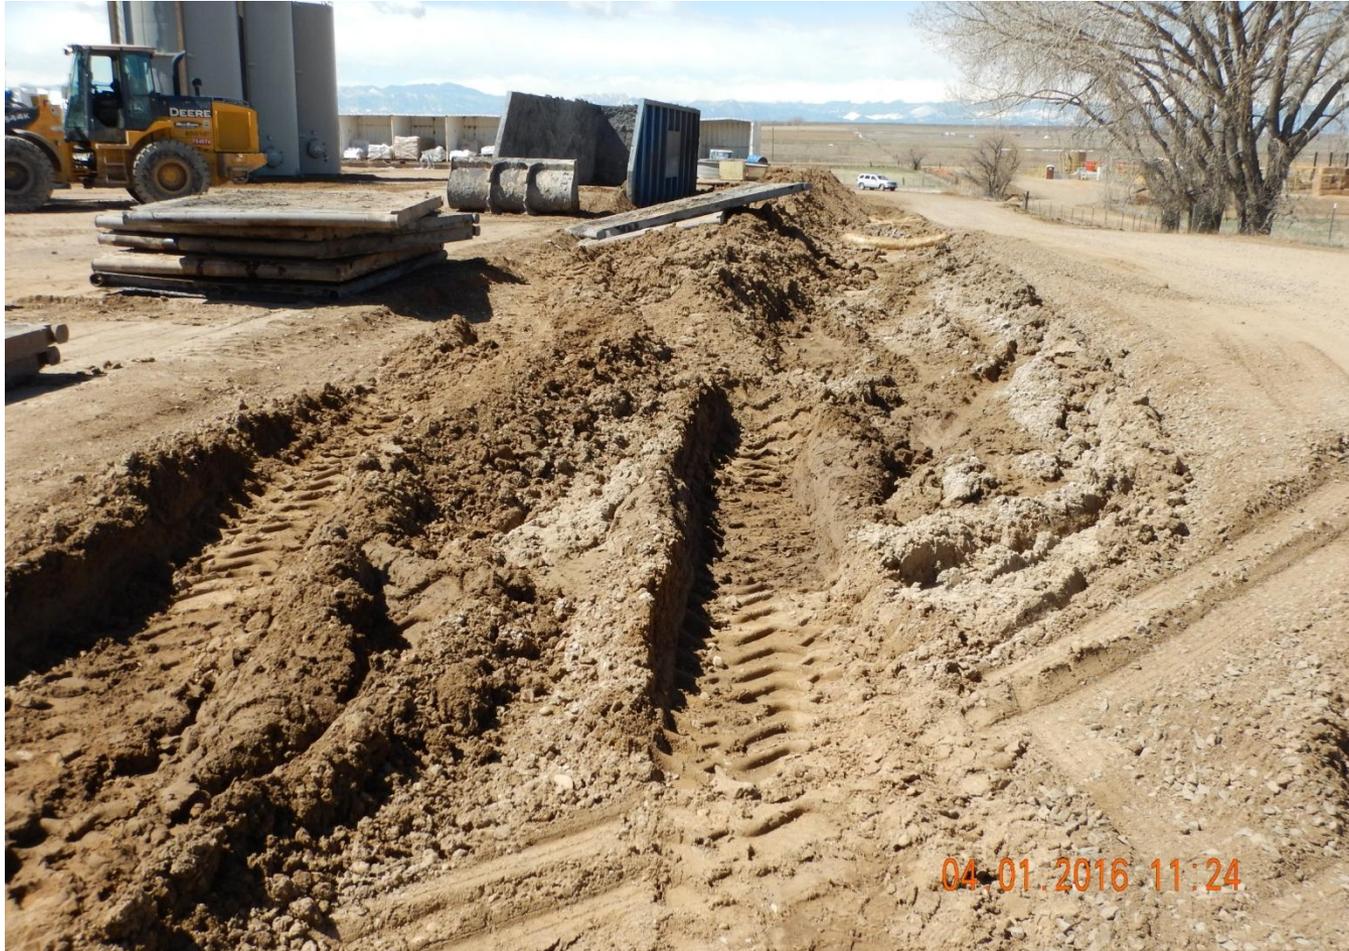
**Photo 5.** Photo taken from northern Jacobucci well location, facing West. Need to stabilize perimeter of pad to prevent erosion off location.

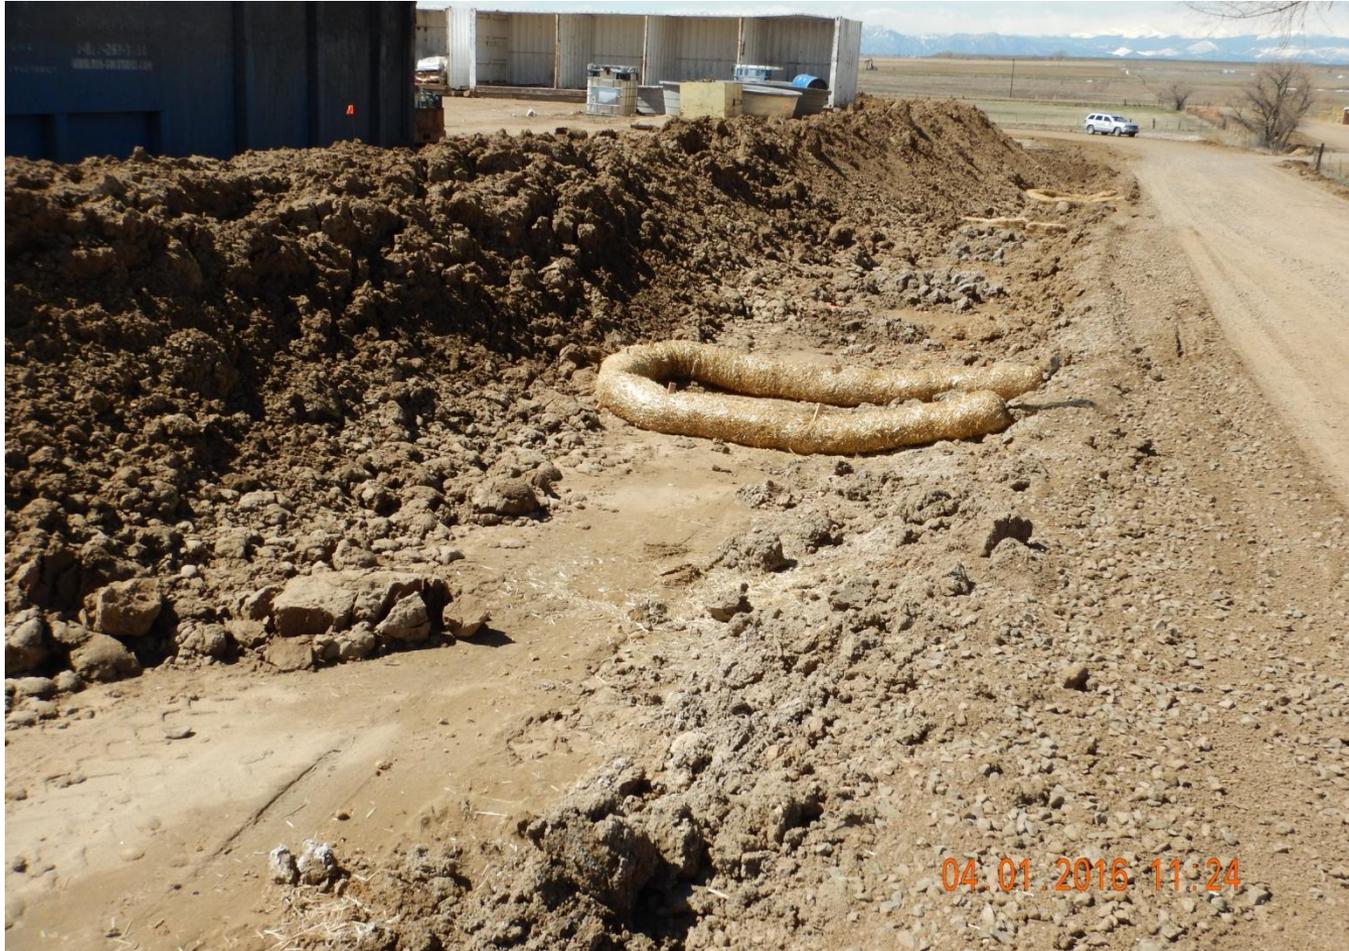
**Photo 6.** Photo taken from northern Jacobucci well location, facing West. Need to stabilize perimeter of pad to prevent erosion off location.

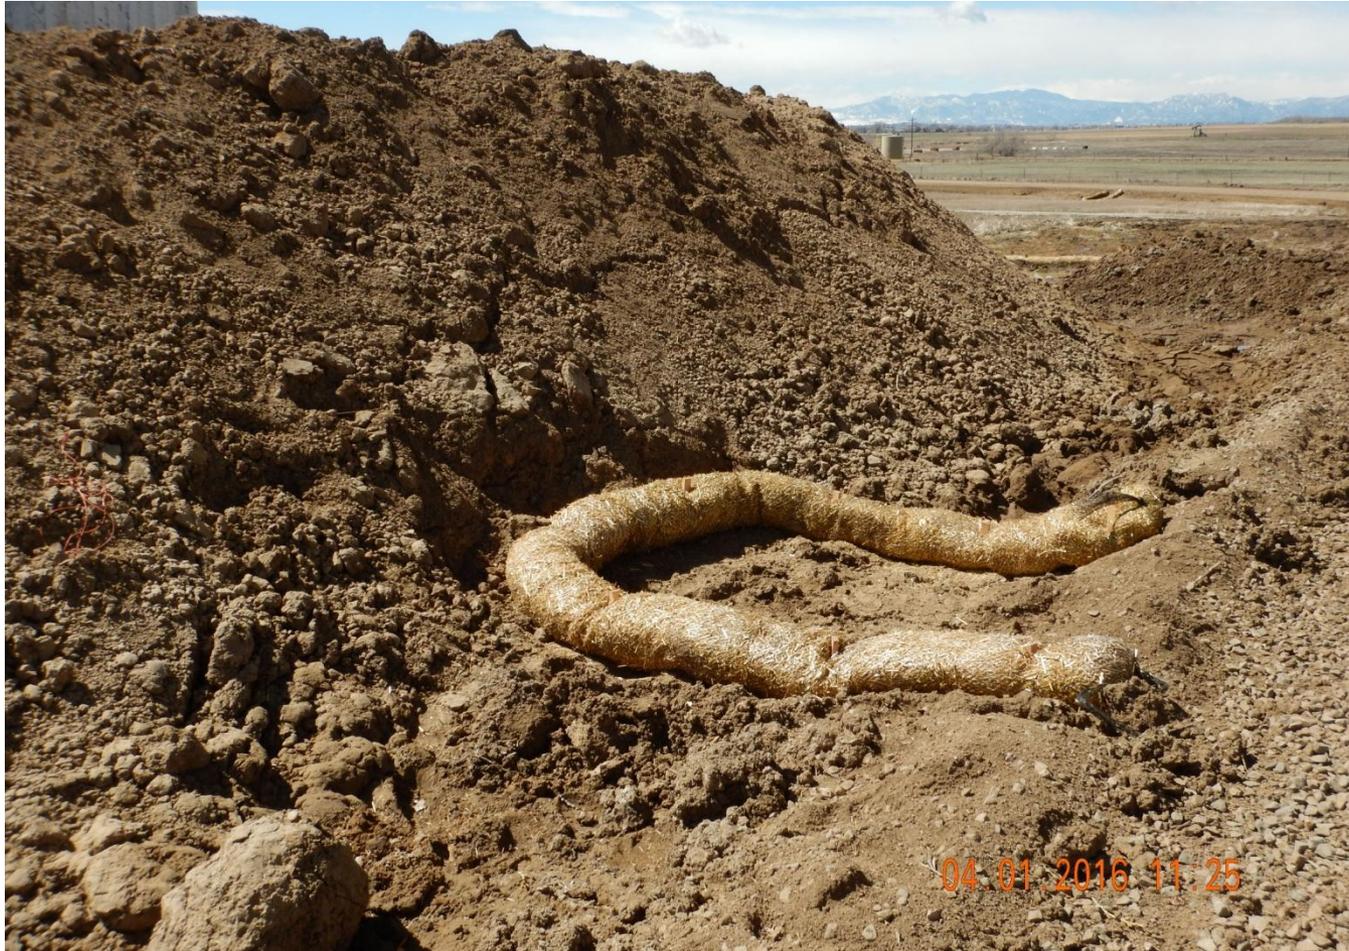
**Photo 7.** Photo taken from northwest Jacobucci well location, facing West. Need to stabilize perimeter of pad to prevent erosion off location.

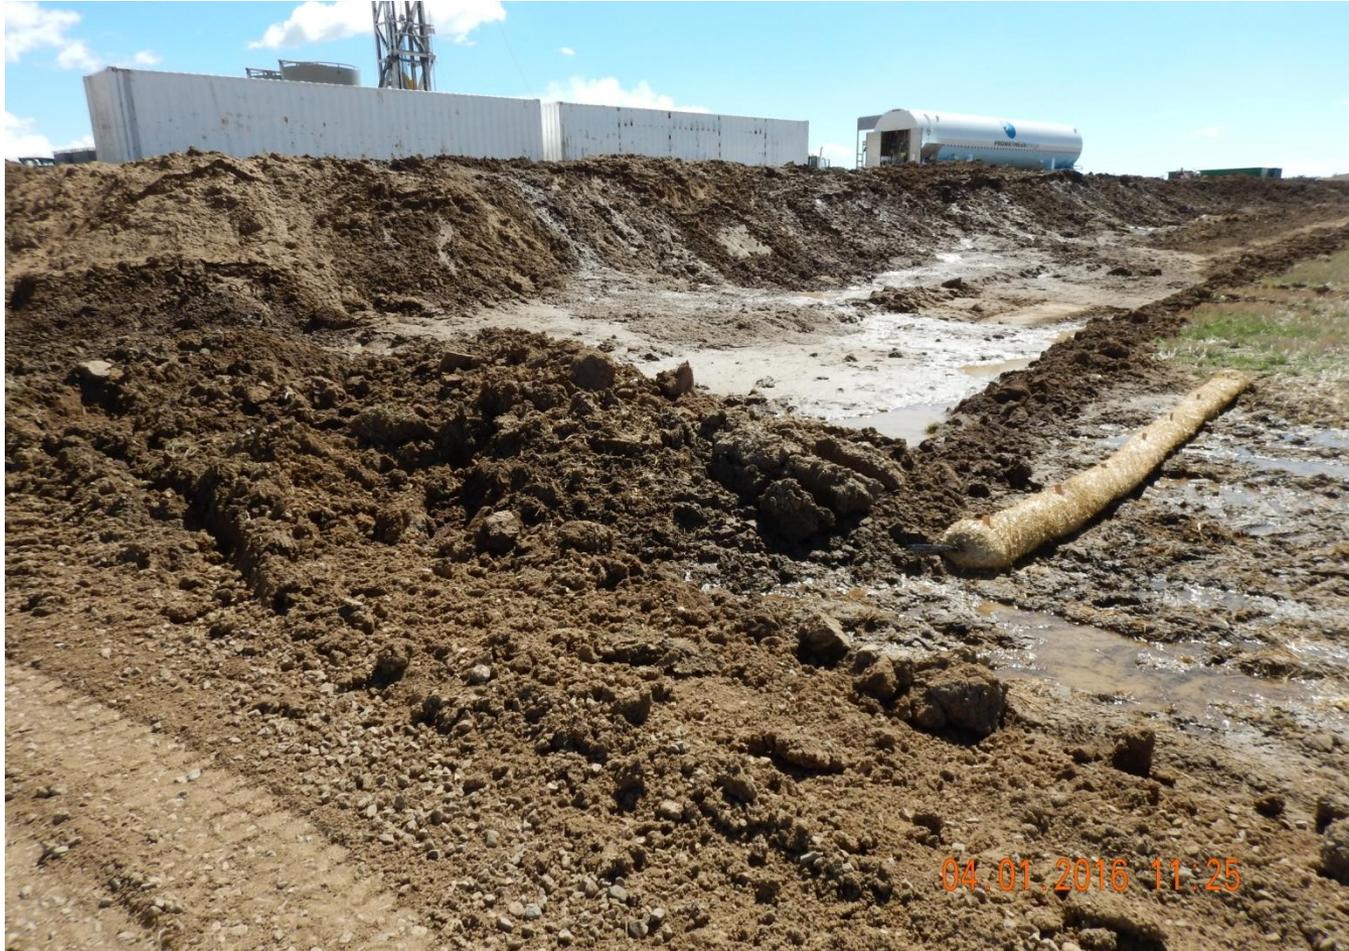
**Photo 8.** Photo taken from northwest Jacobucci well location, facing South. Need to stabilize perimeter of pad to prevent erosion off location.
