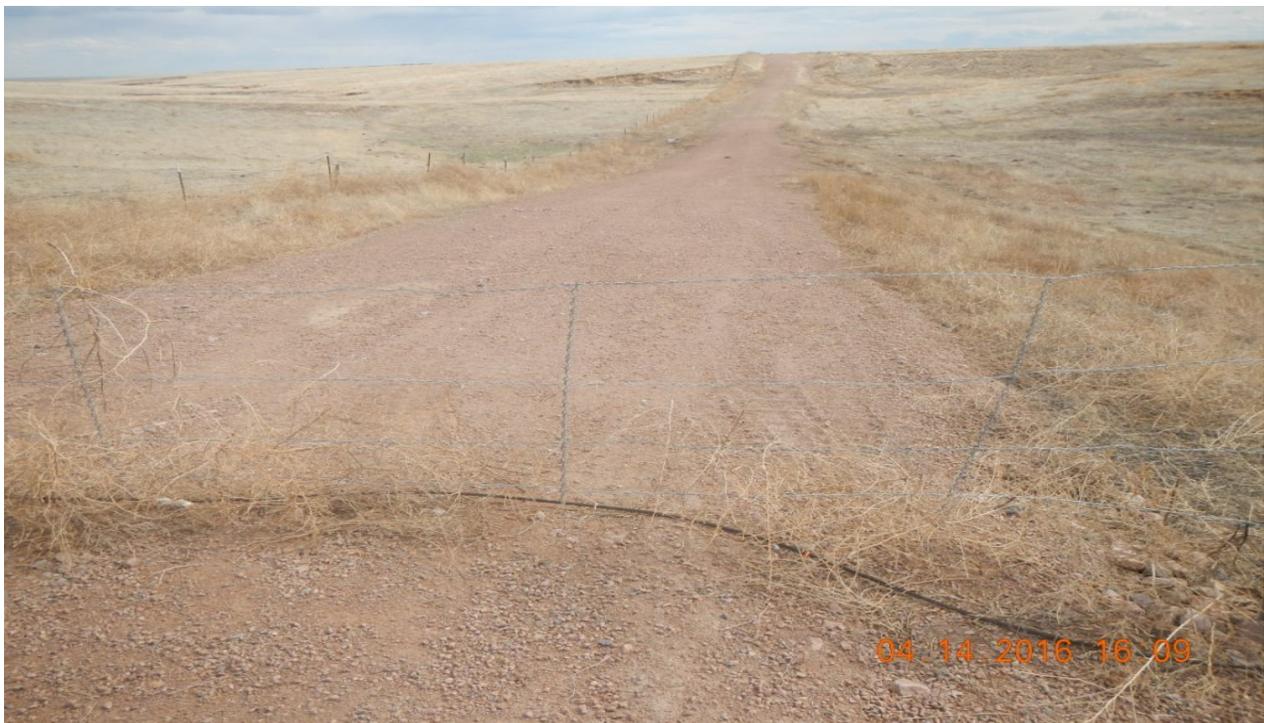
**photo 2:** Facing south along the access road. Metal gate and cattle guard removed which was replaced with a wire gate.

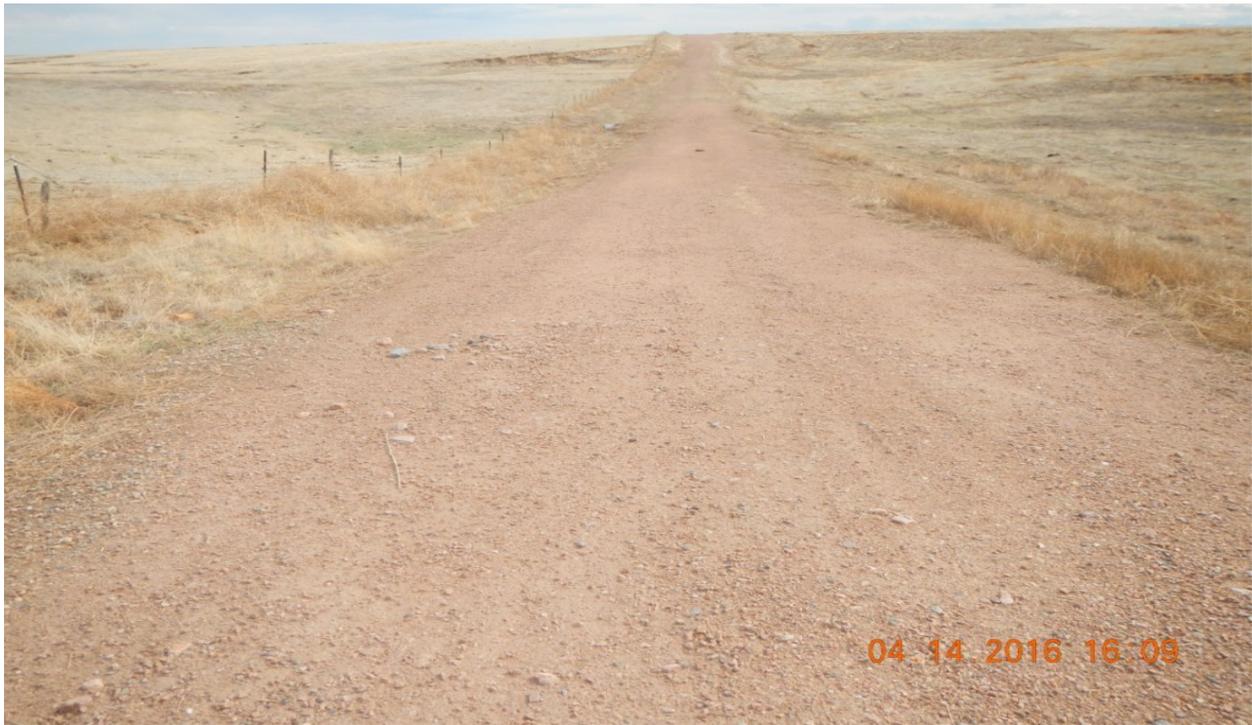
**photo 3:** Facing south along the access road. Weed debris has been removed since the previous inspection.

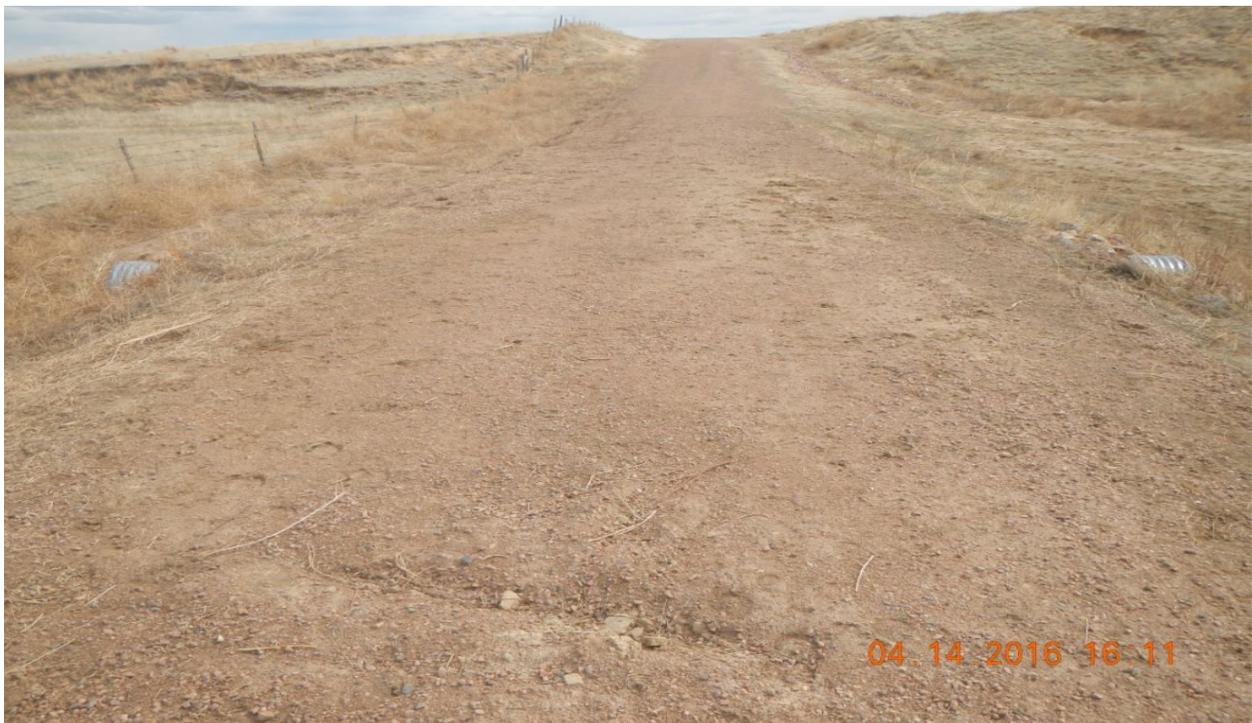
**photo 4:** Facing south along the access road. Area of subsidence and erosion has been repaired at Lat/Long: 38.74998,-104.55221.

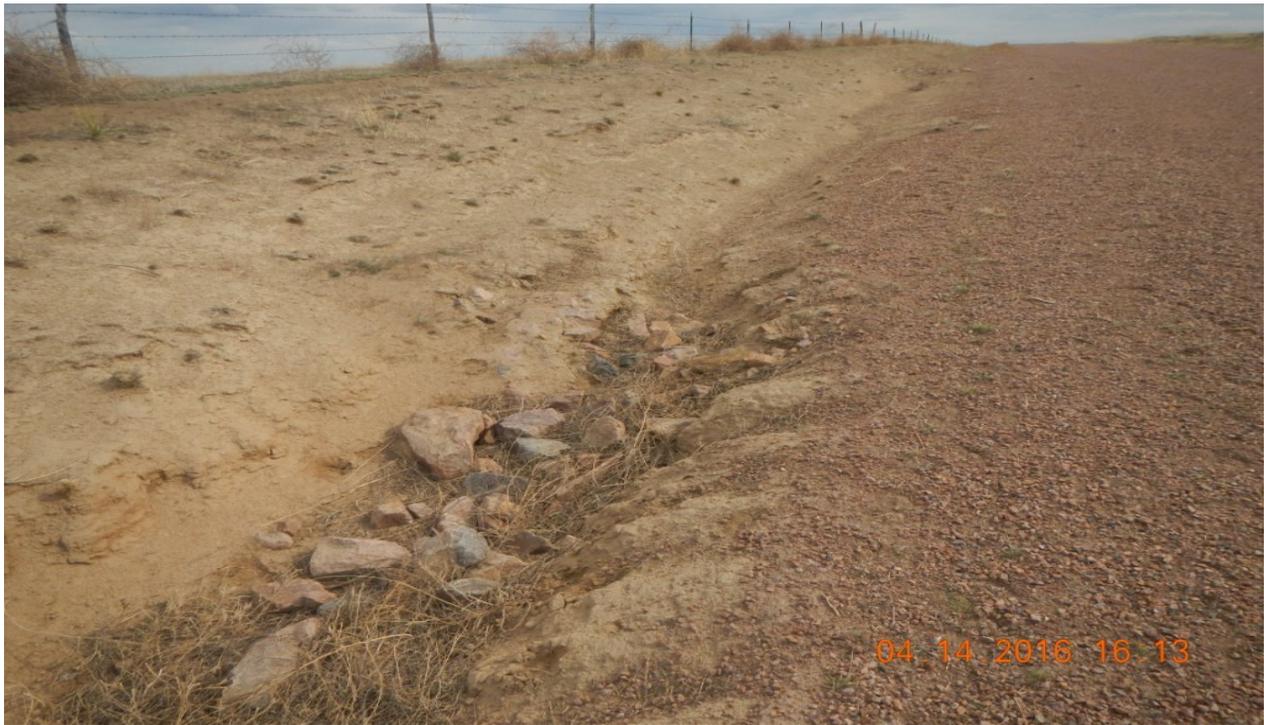
**photo 5:** BMP's have not been installed along the east side of the access road where the slope increases. This area along the access road is susceptible to further erosion.

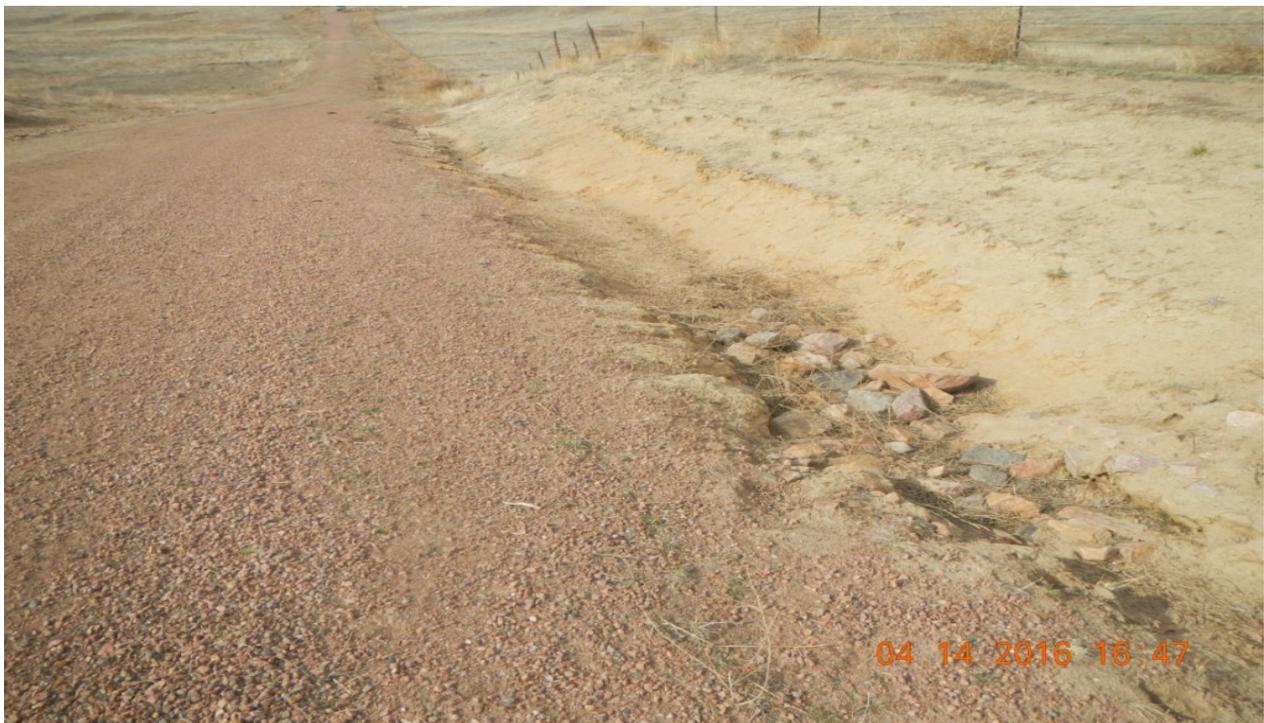
**photo 6:** Facing back north toward the east side of the access road. This area along the access road is susceptible to further erosion.

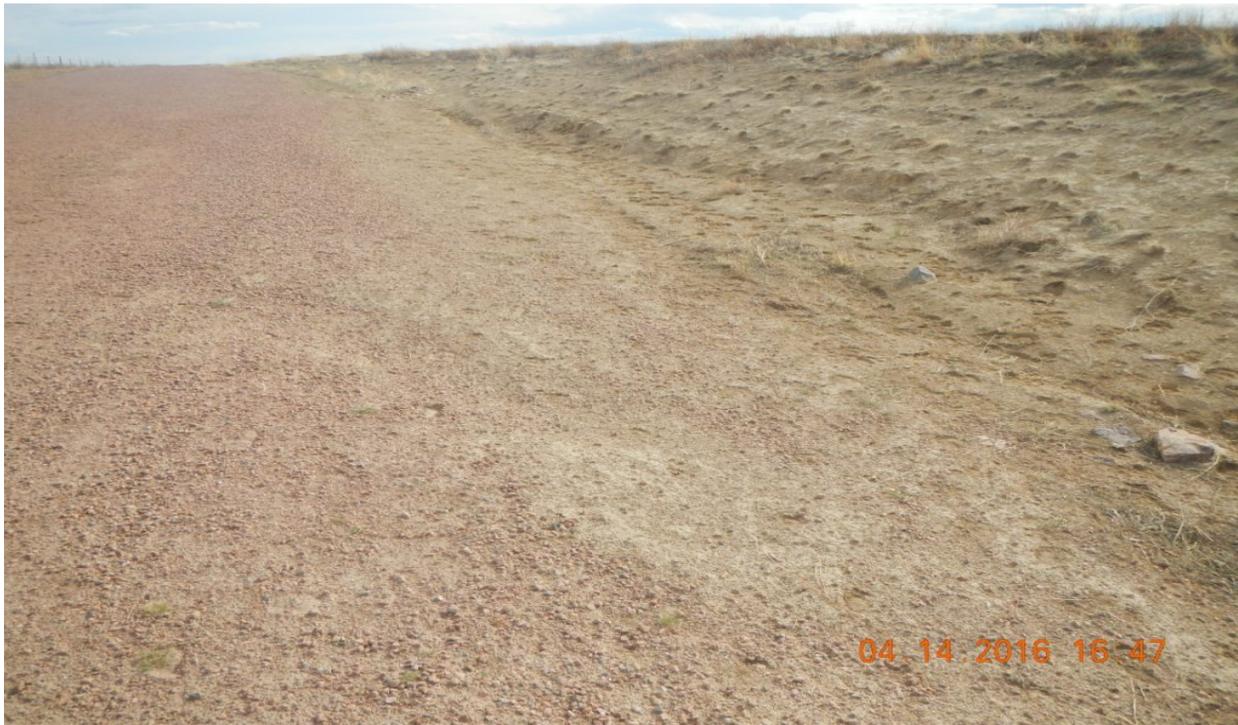
**photo 7:** Facing at the Opposite (west) side of the access road. This area along the access road is susceptible to further erosion.

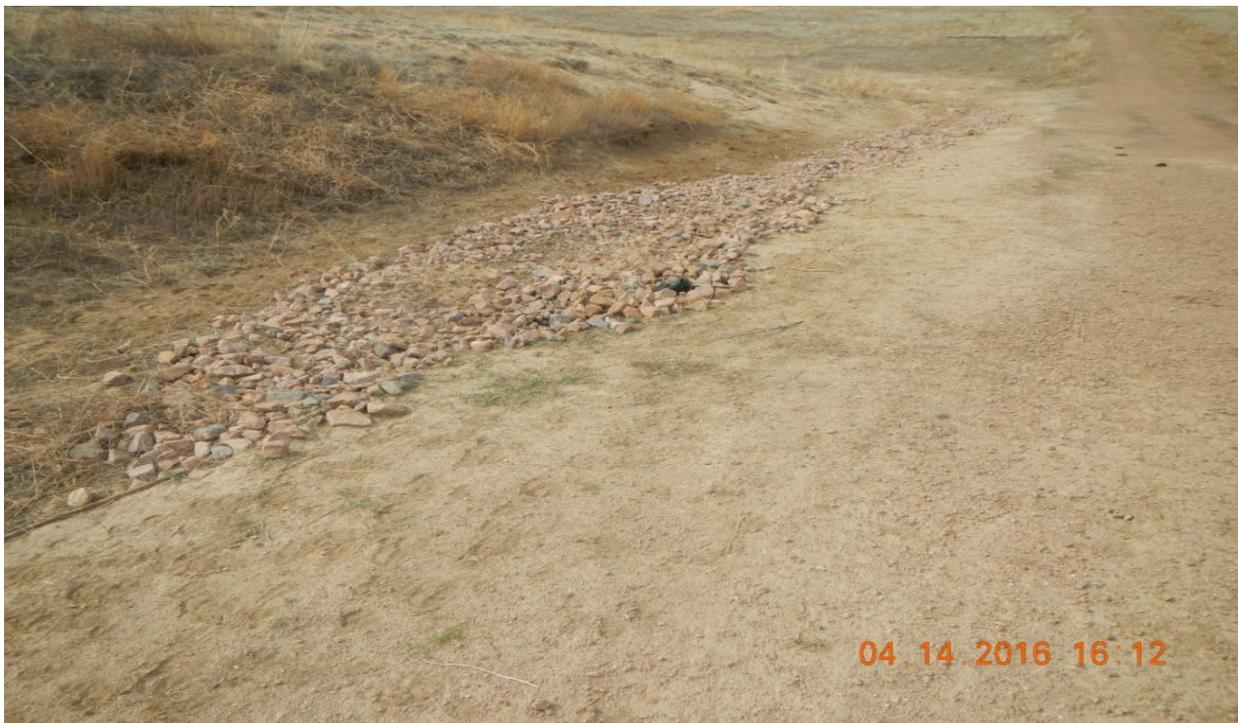
**photo 8:** Facing northwest. It appears rip/rap rock has been placed where erosion was occurring along the west side of the access road. Additional BMP's are needed in this area of the access road.

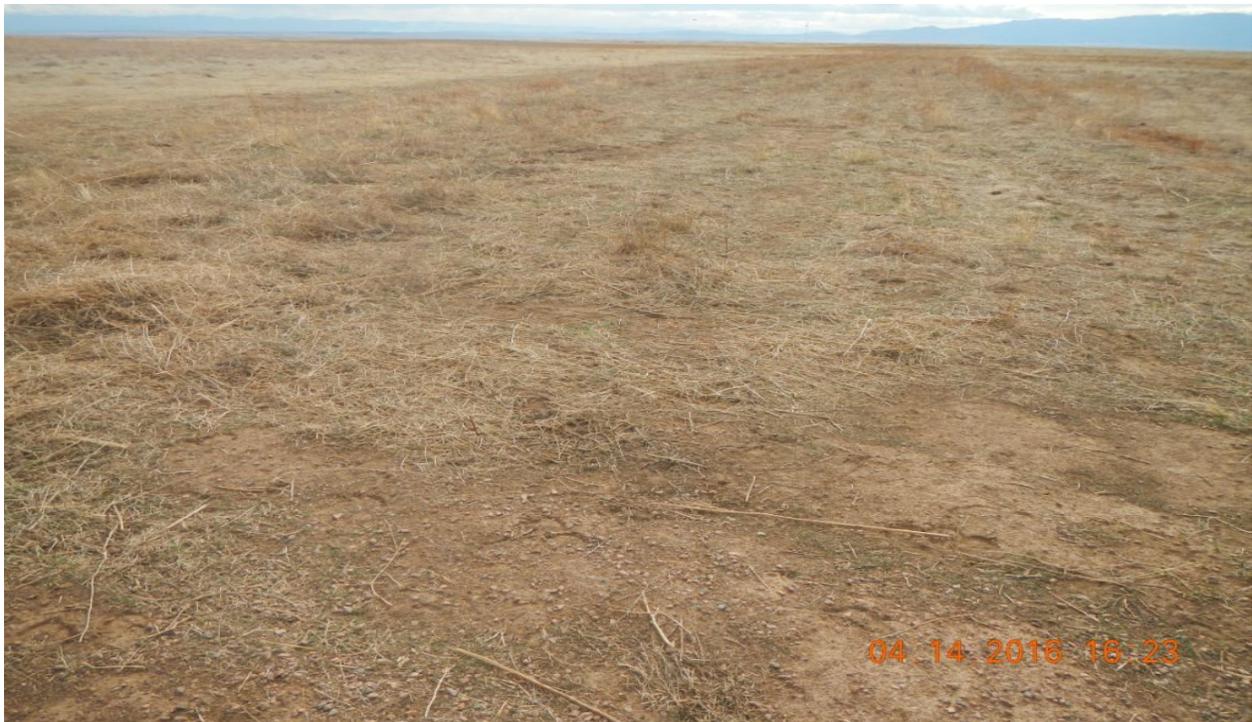
**photo 10:** Facing southwest. Point where access road ends and the reclaimed access road begins. This area has recently been mowed.

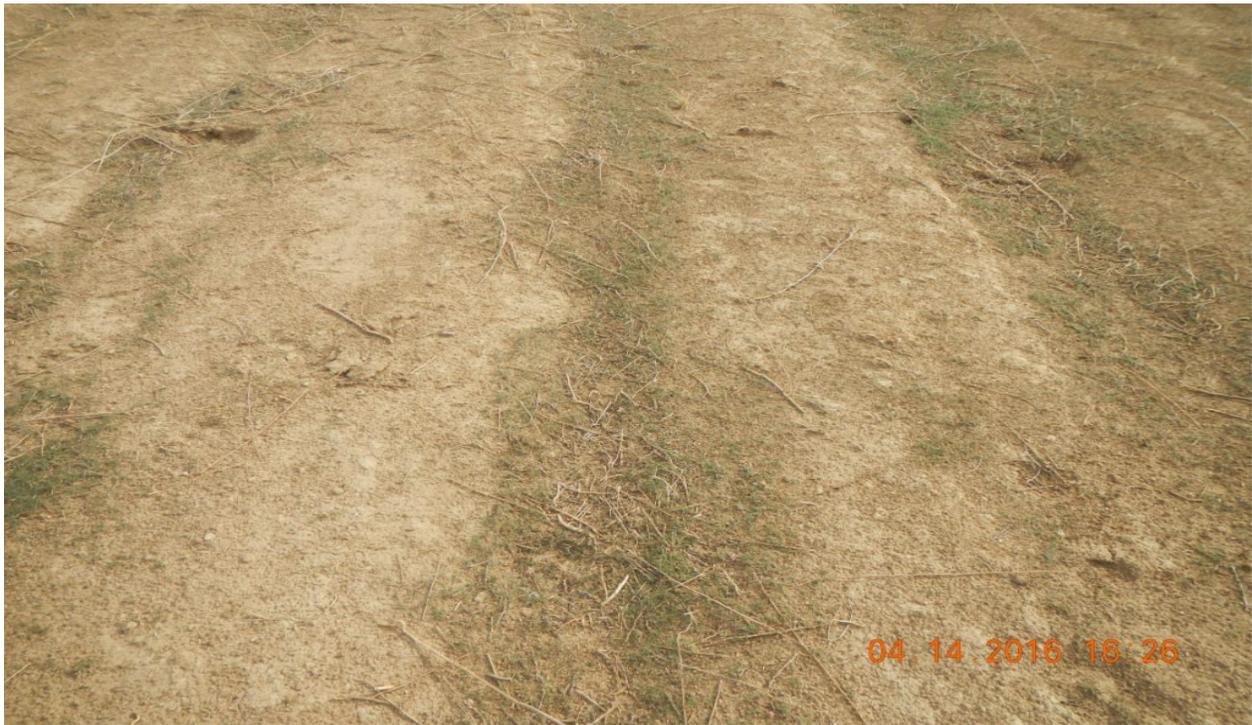
**photo 13:** View of ground cover. The debris noticed in the previous inspection has been mowed and removed. The green vegetation emerging is shown closer in photo 11.

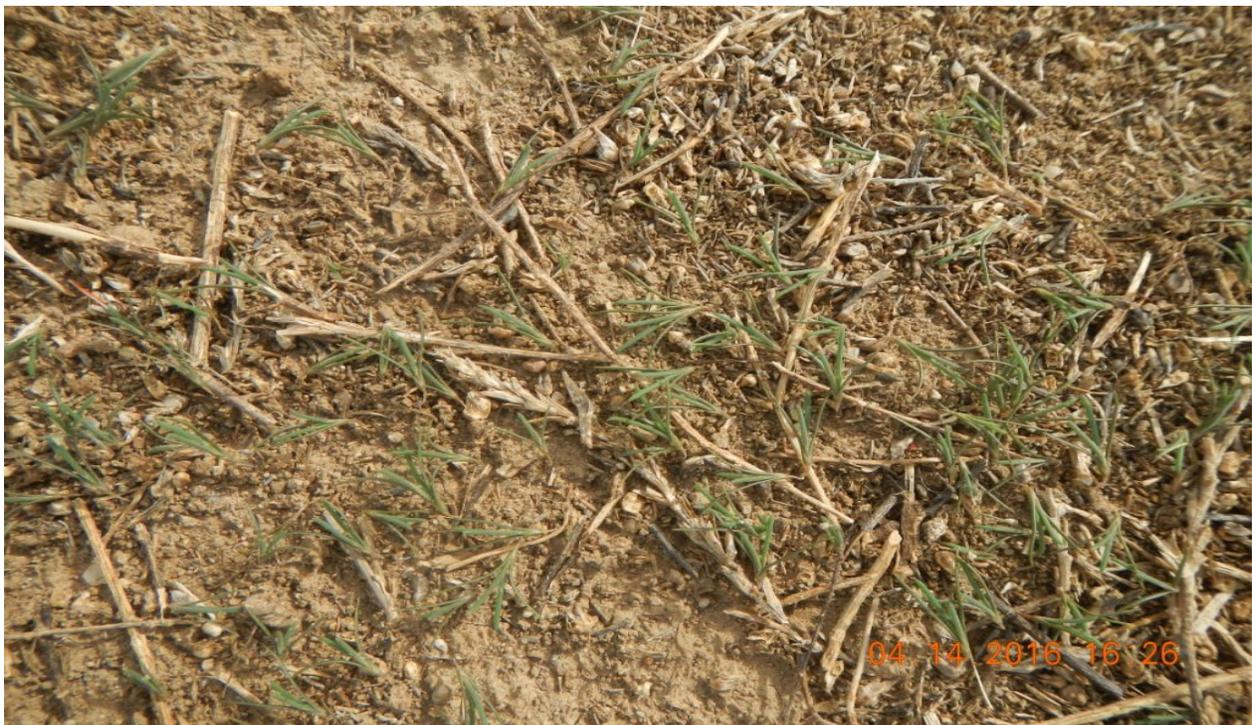
**photo 14:** Noticed undesirable vegetation (russian thistle) beginning to emerge.

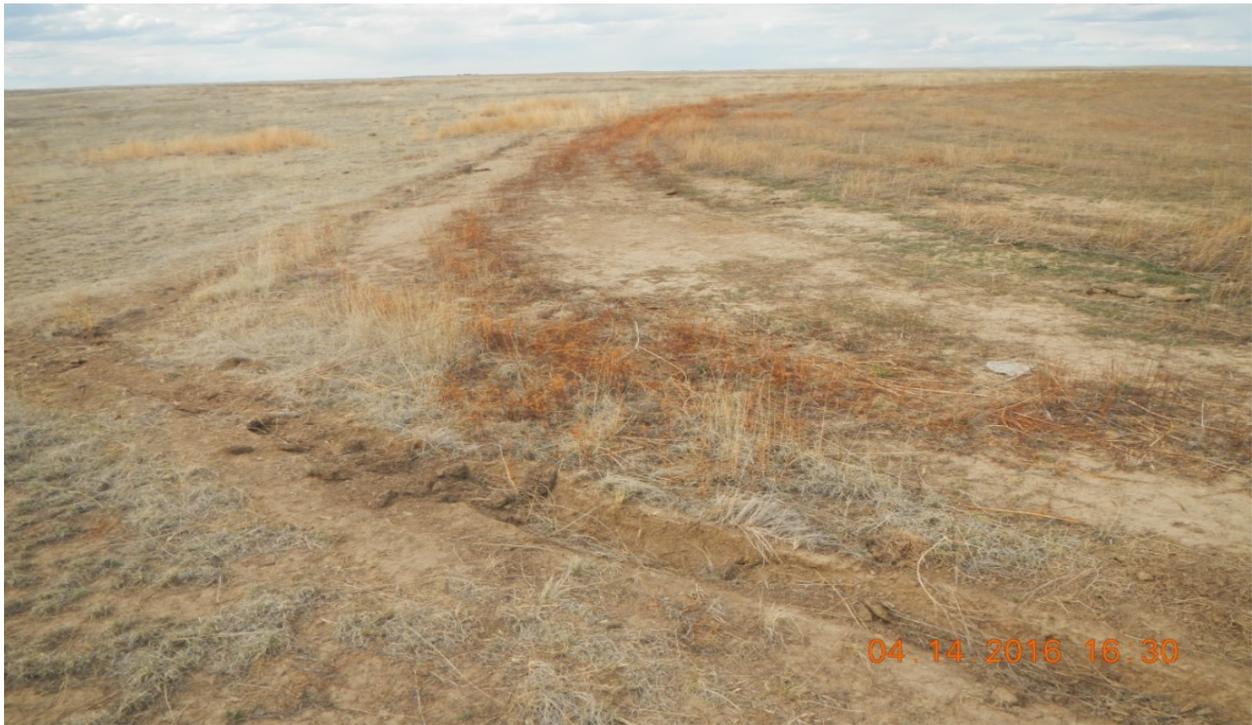
**photo 17:** Facing northwest at the southeast side of the disturbance area The degraded wattle noticed in the previous inspection have been removed..
