SSR 4-13

Inspection Doc# 675202719

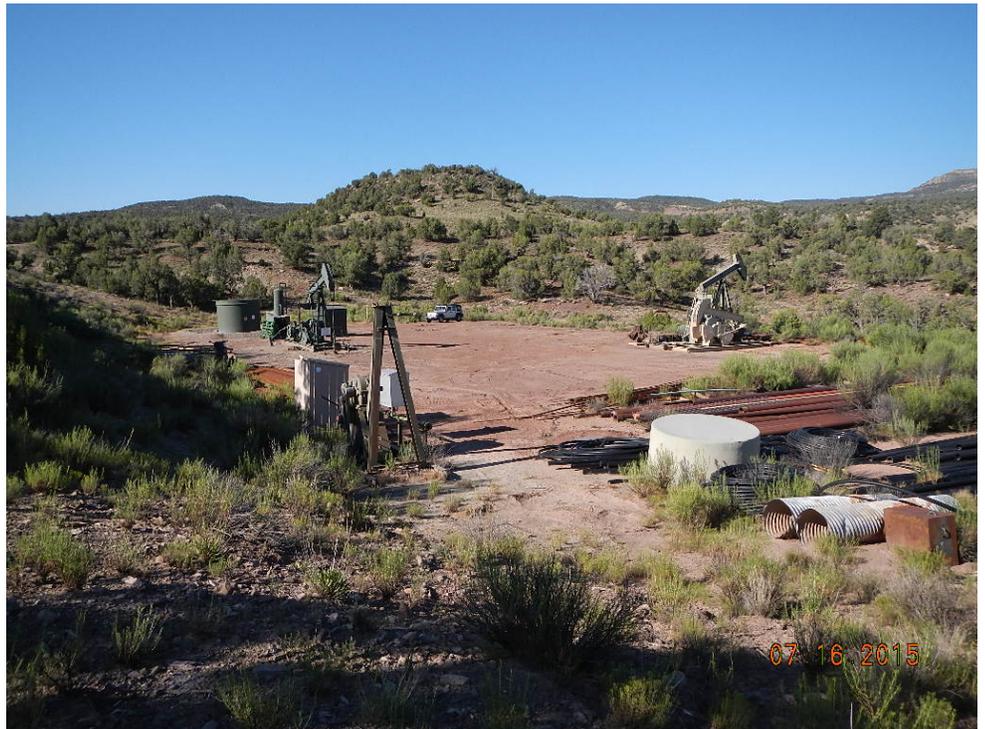
Location on Previous
inspection 7/16/15

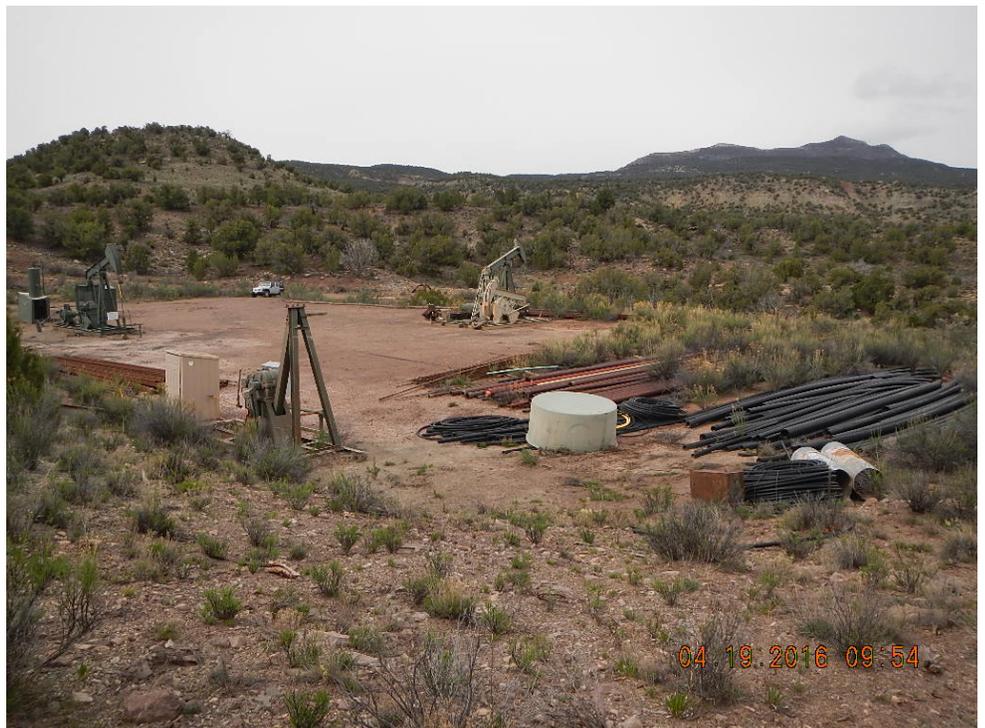
Location during current
inspection 4/19/16

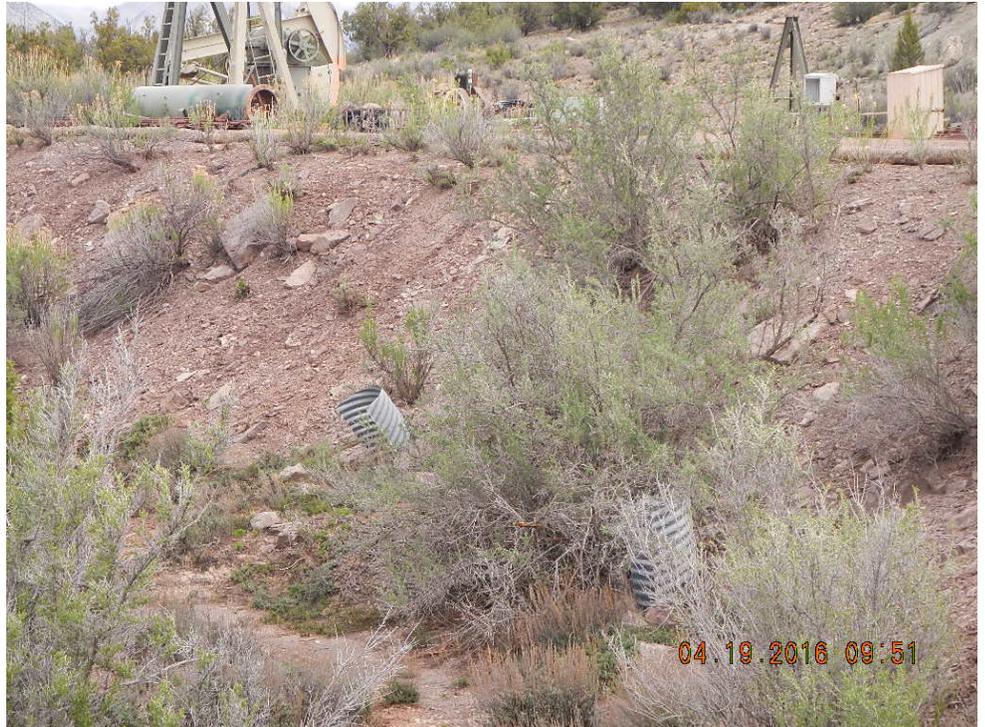
Debris off location.
Identified on previous
inspection.

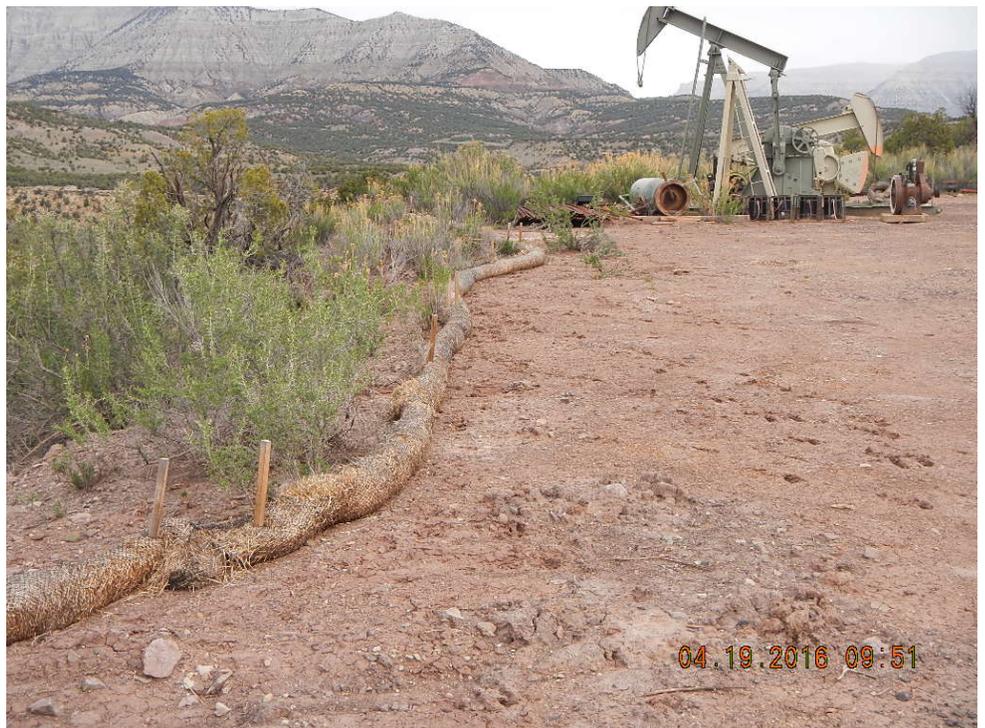
Waddles installed around
section of location.

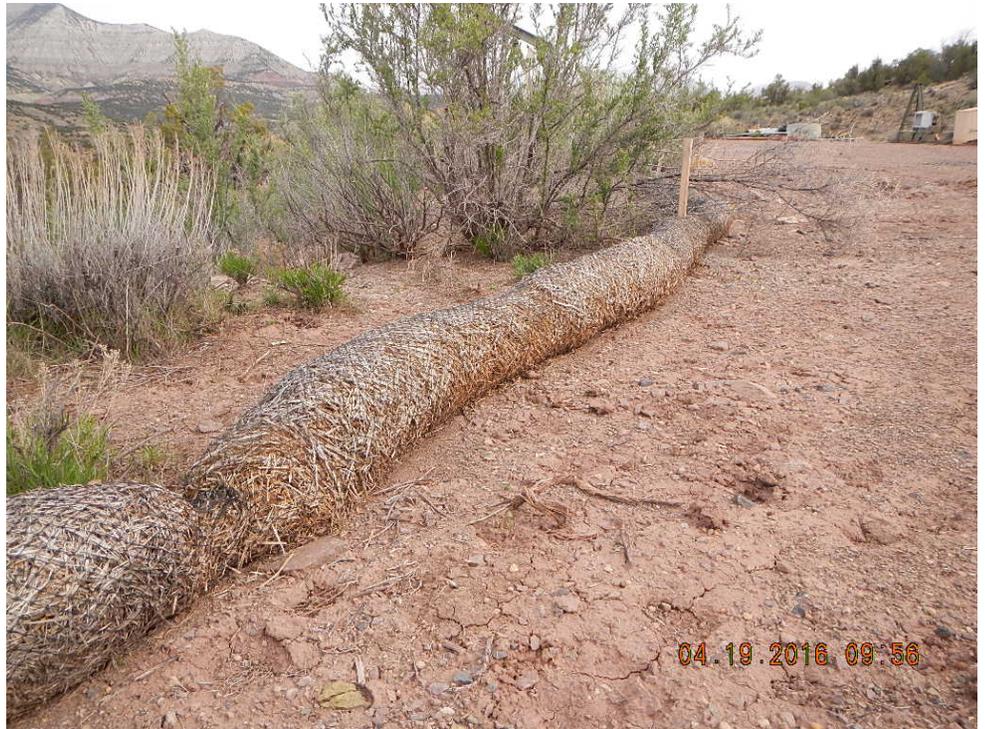
Waddles installed without being trenched in. There is possible water and sediment movement underneath.

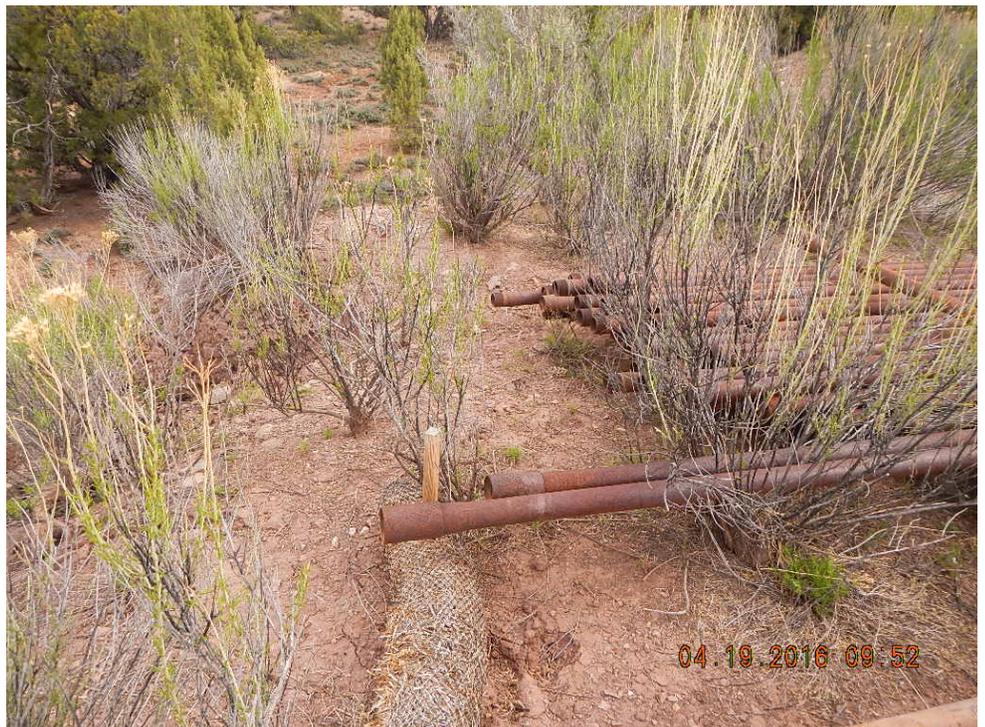
End of waddles, with no stormwater BMPs beyond this point.

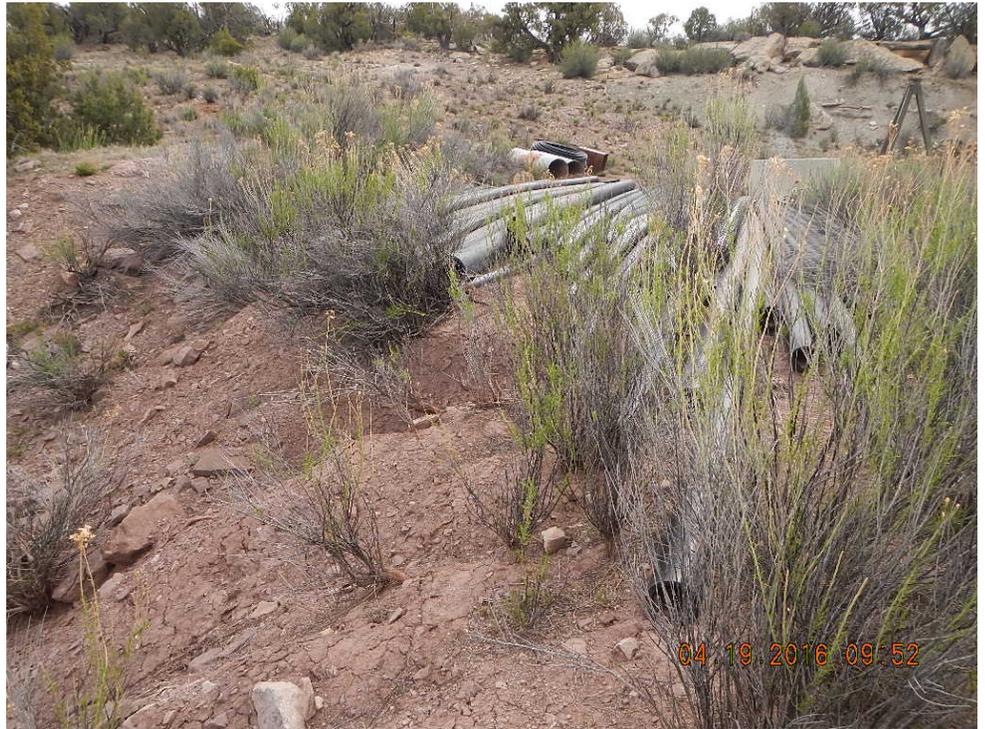
Poly pipe is still off location with no BMPs around them and vegetation growing through it. Noted on previous inspections.

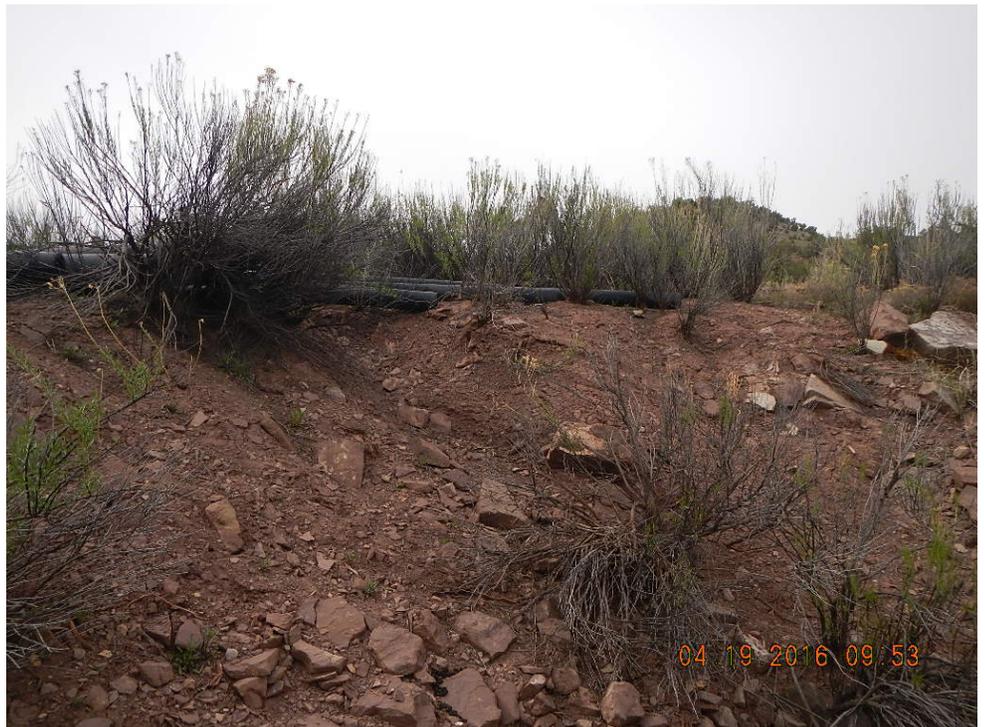
Area of erosion under poly pipe. Noted of previous inspections.

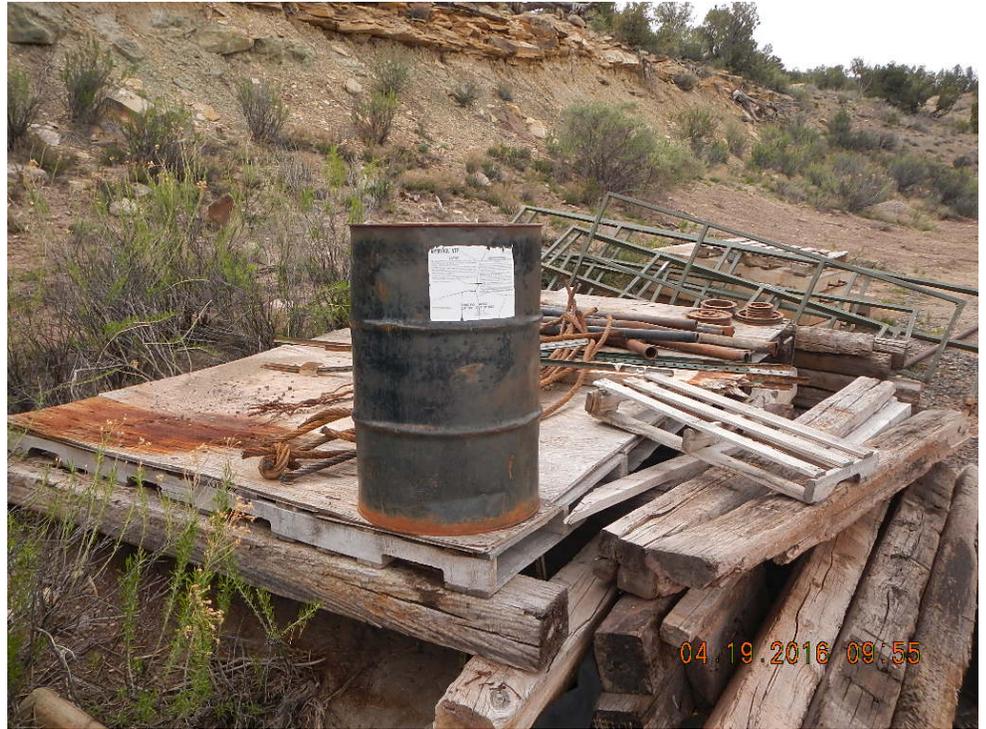
Barrel with no containment.

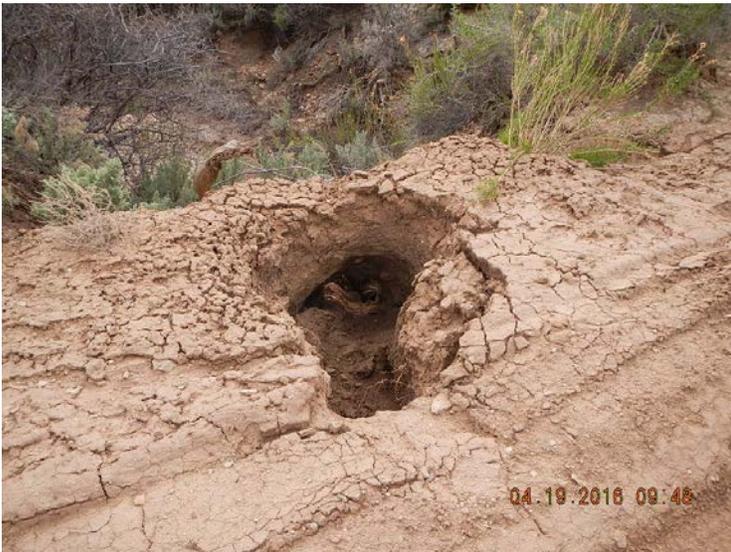
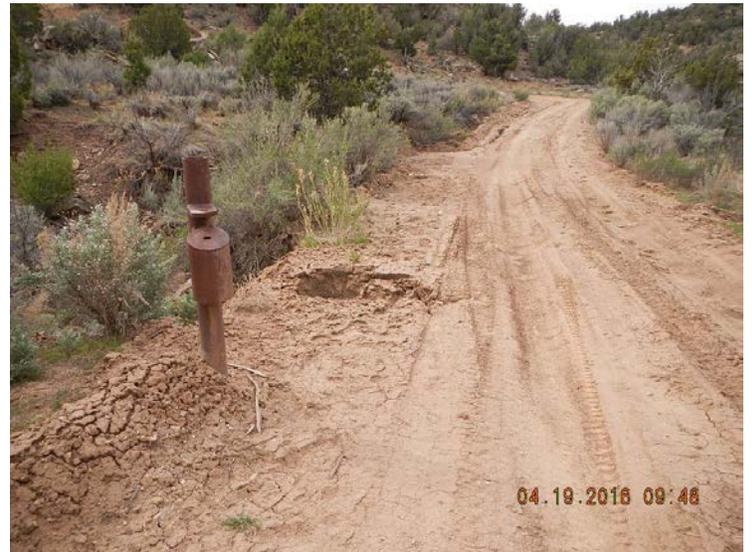
Area of erosion at the gate of the access road. Continued erosion may impede access to locations.
