April 11, 2016

Inspection Photos: Whiting Loc# 398432

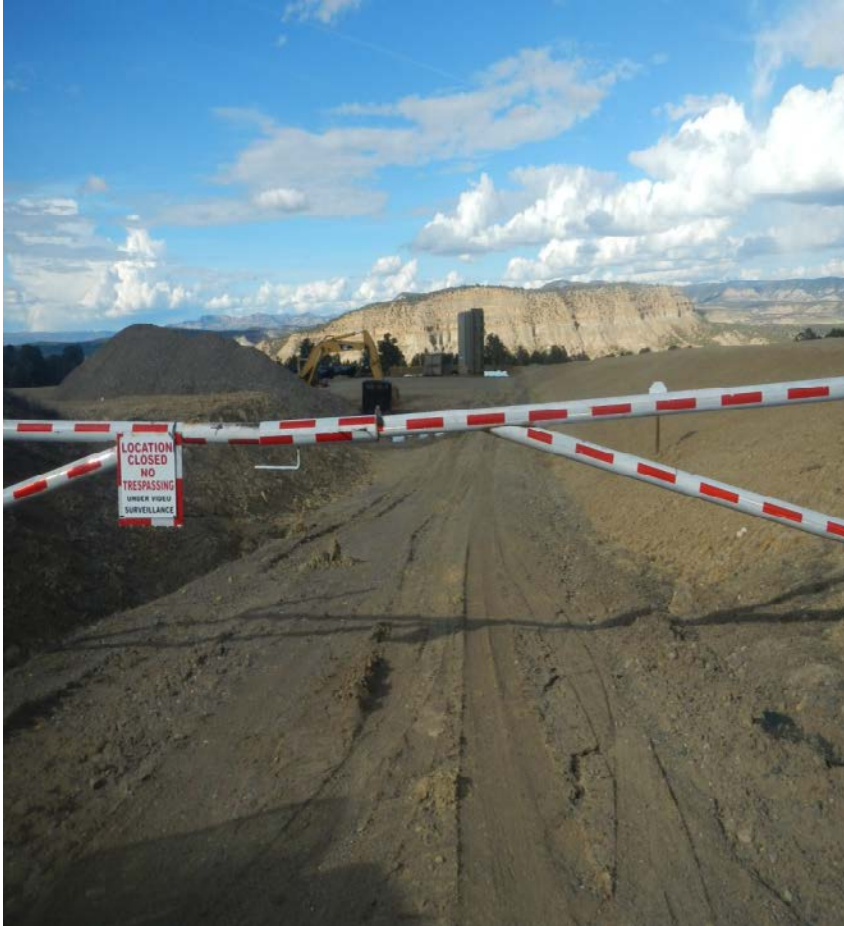
Photo#1:

Entrance to Location

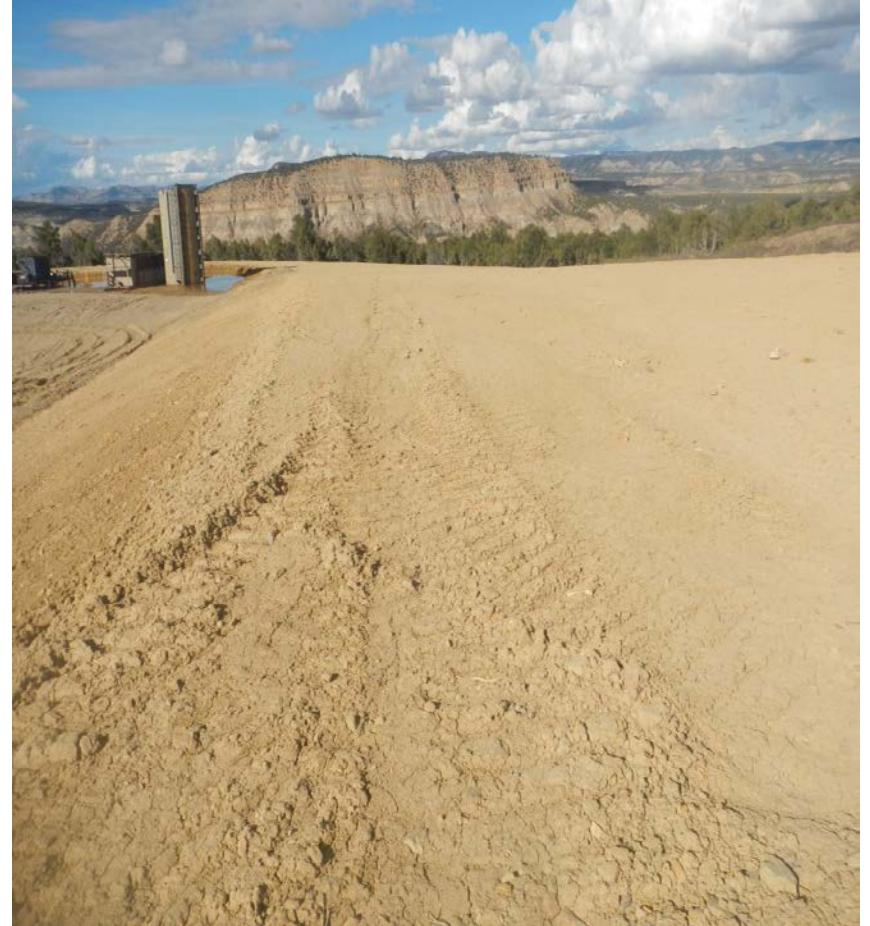
Photo#2:

Reclamation Activities commenced Fall 2015 (?)

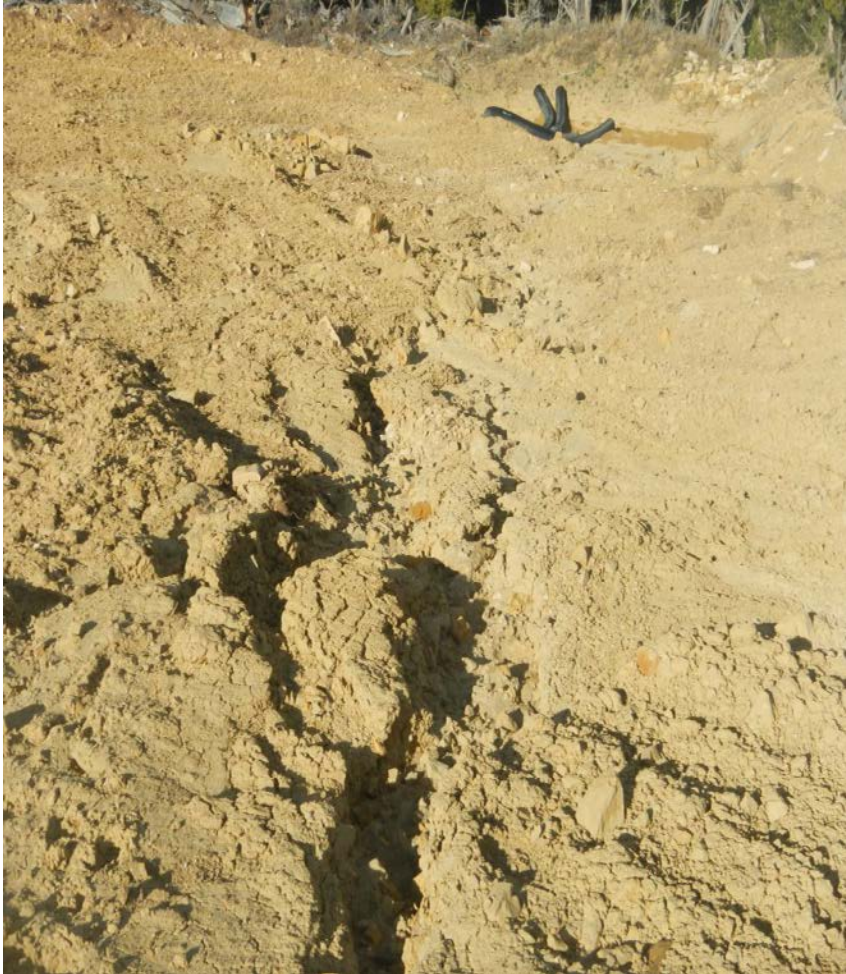
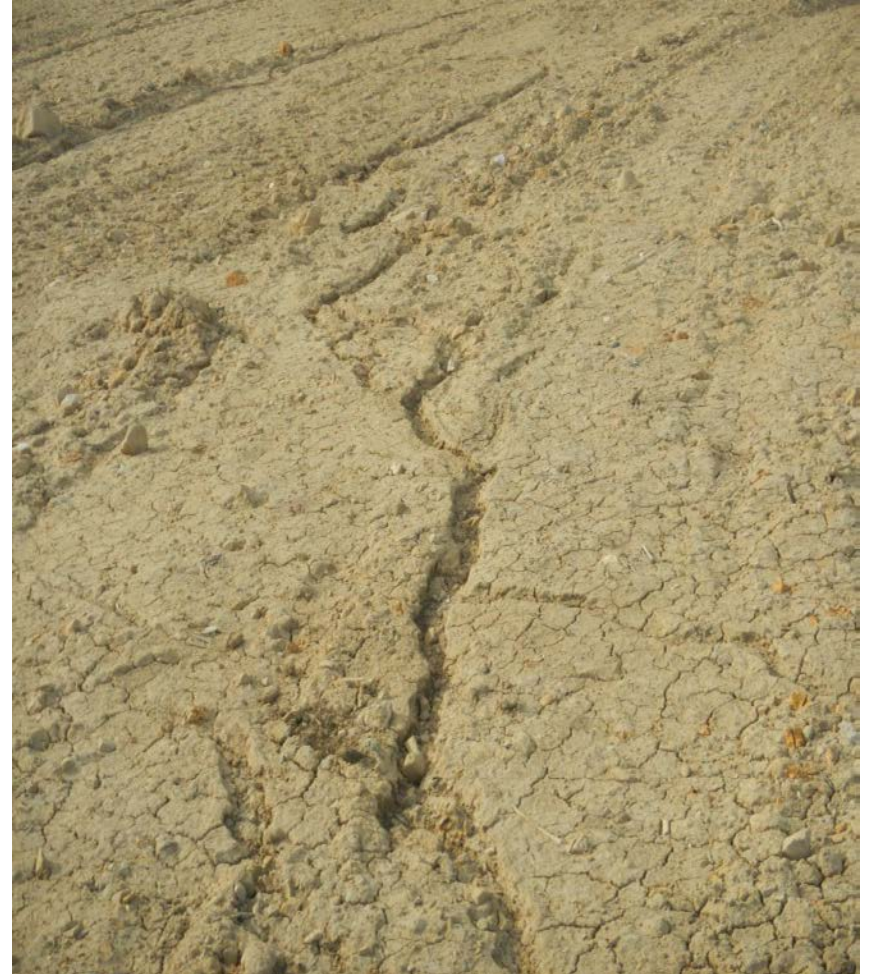
Erosion SW Channels beginning in Project Slope areas

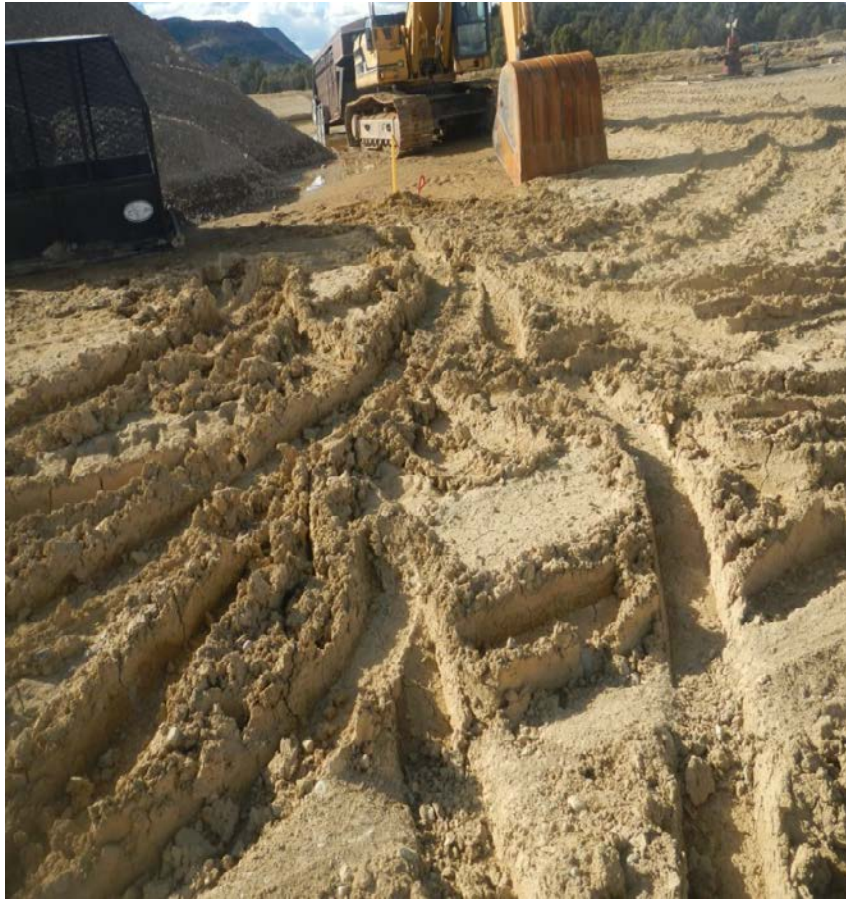
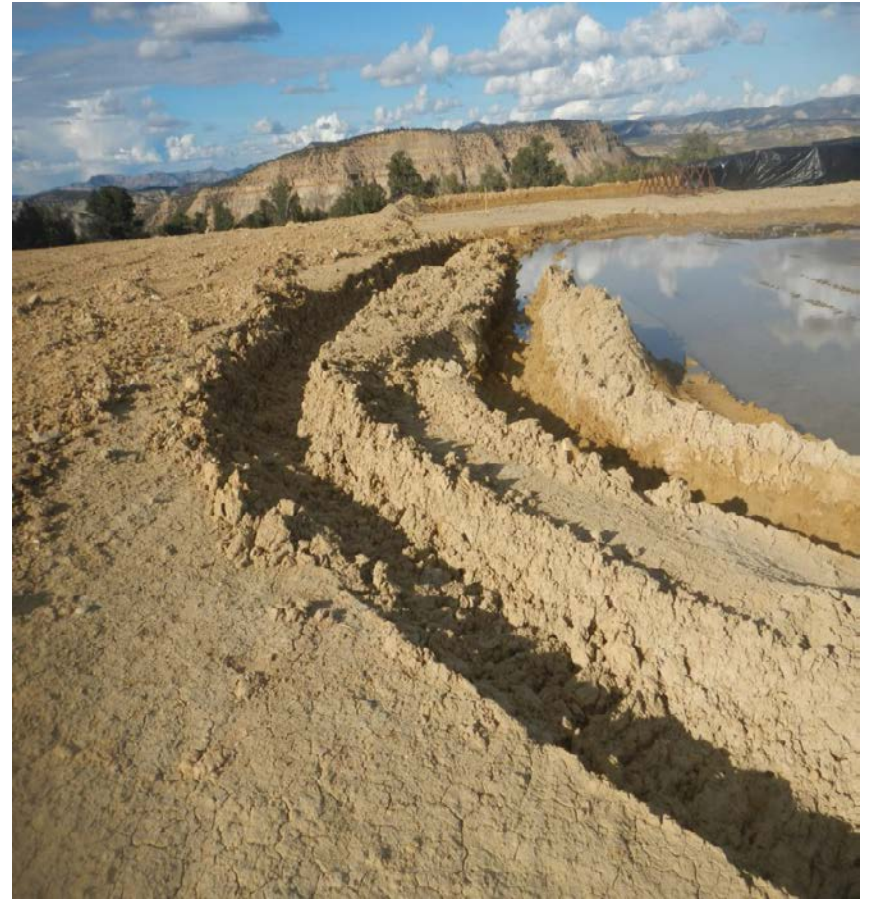
Rutting in work area at Center of Location

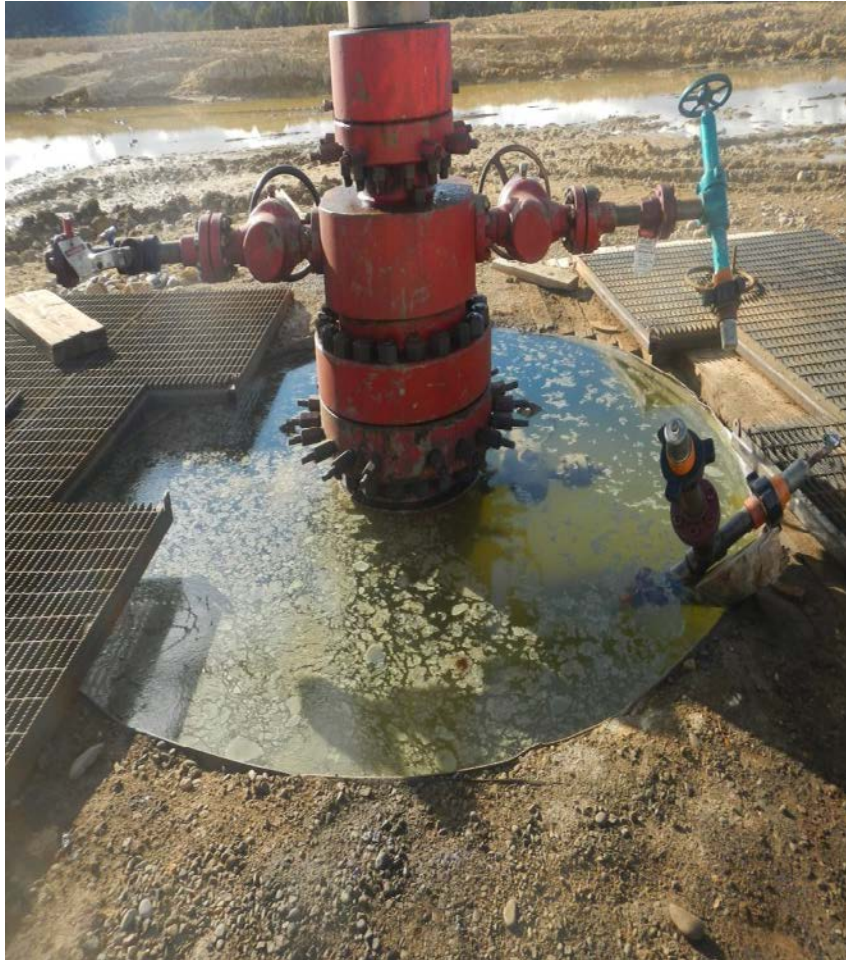
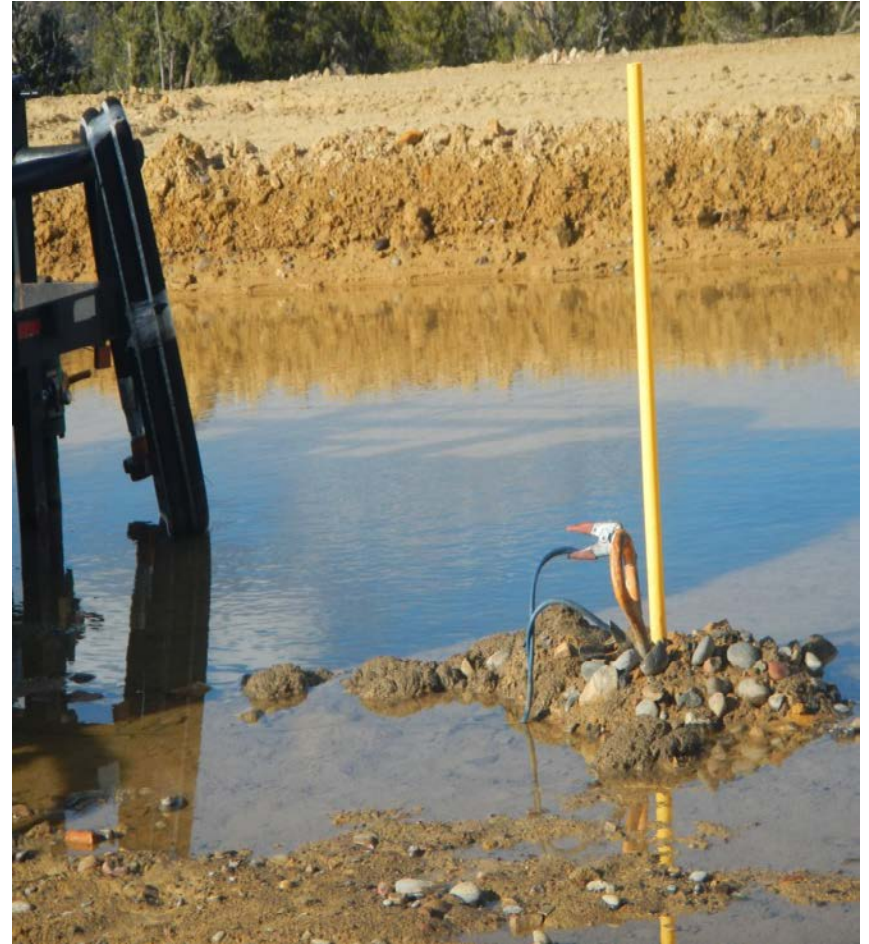
Safety concerns in Project Work area

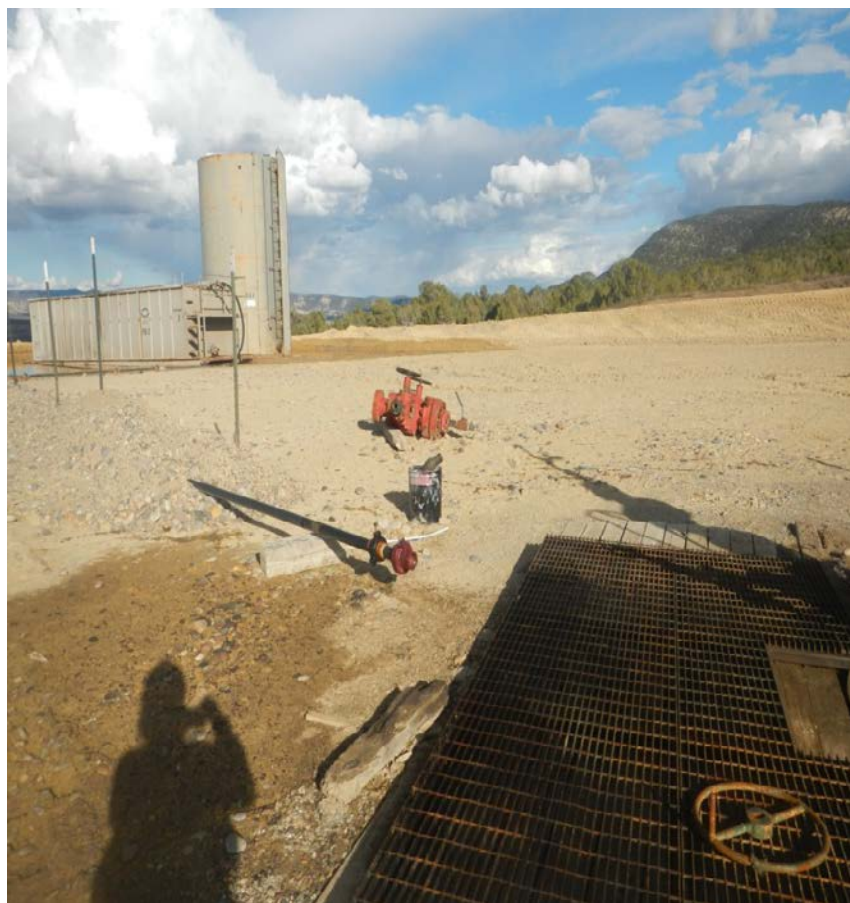
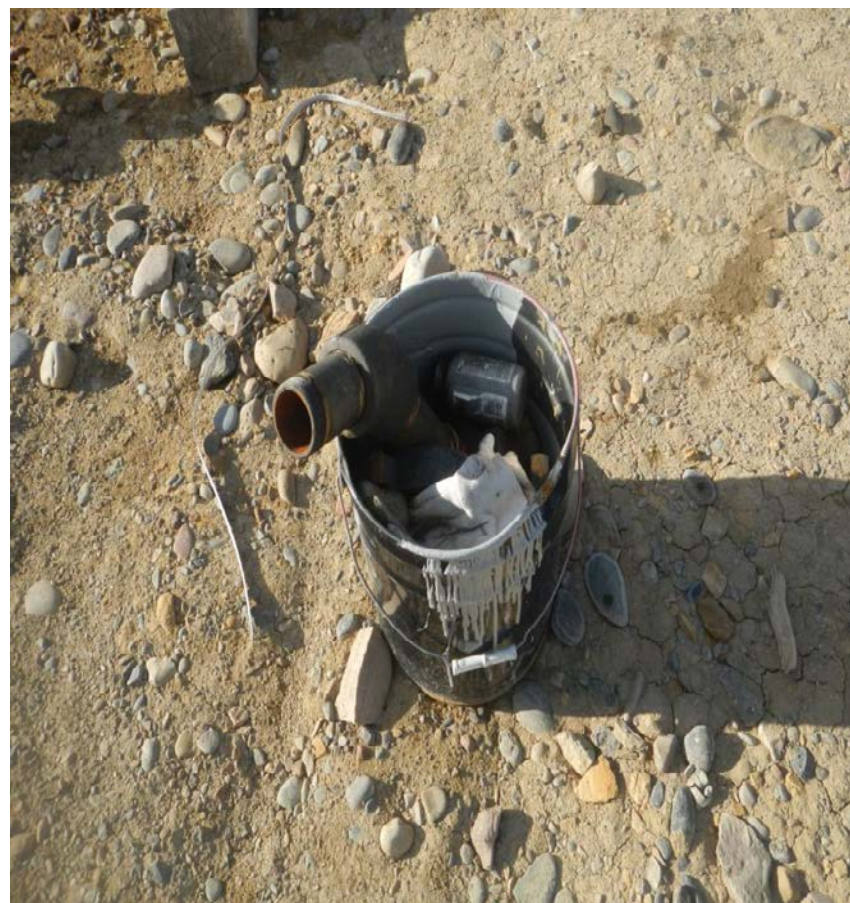
Debris and unused Equipment on work Project area.

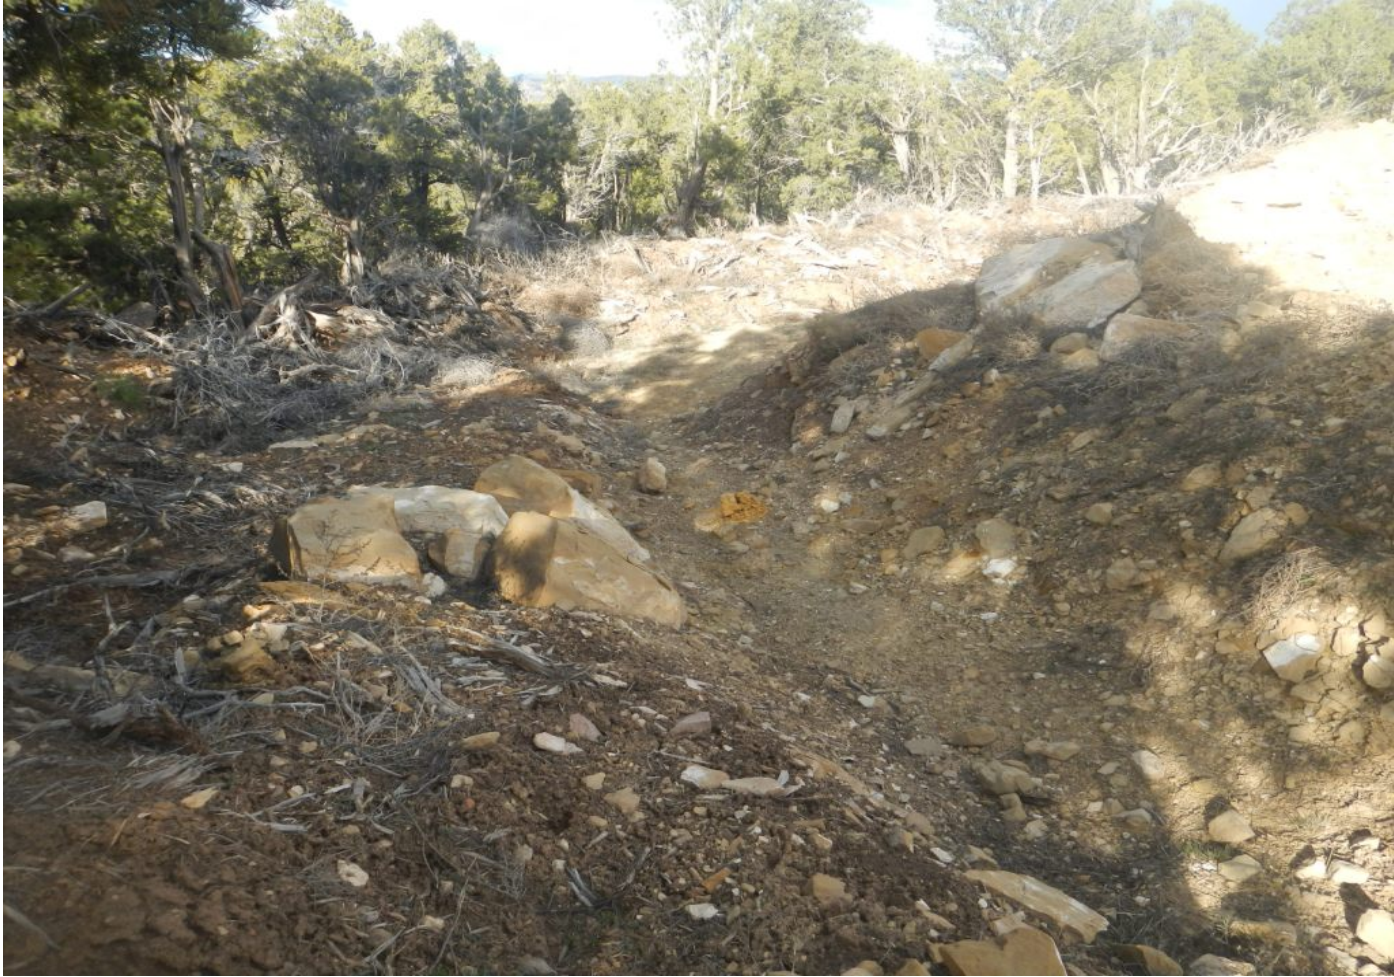
Photo #11: BMPs encircling Location appear to be functioning.
