COGCC Environmental Field Inspection 4/22/2016, Arauza.

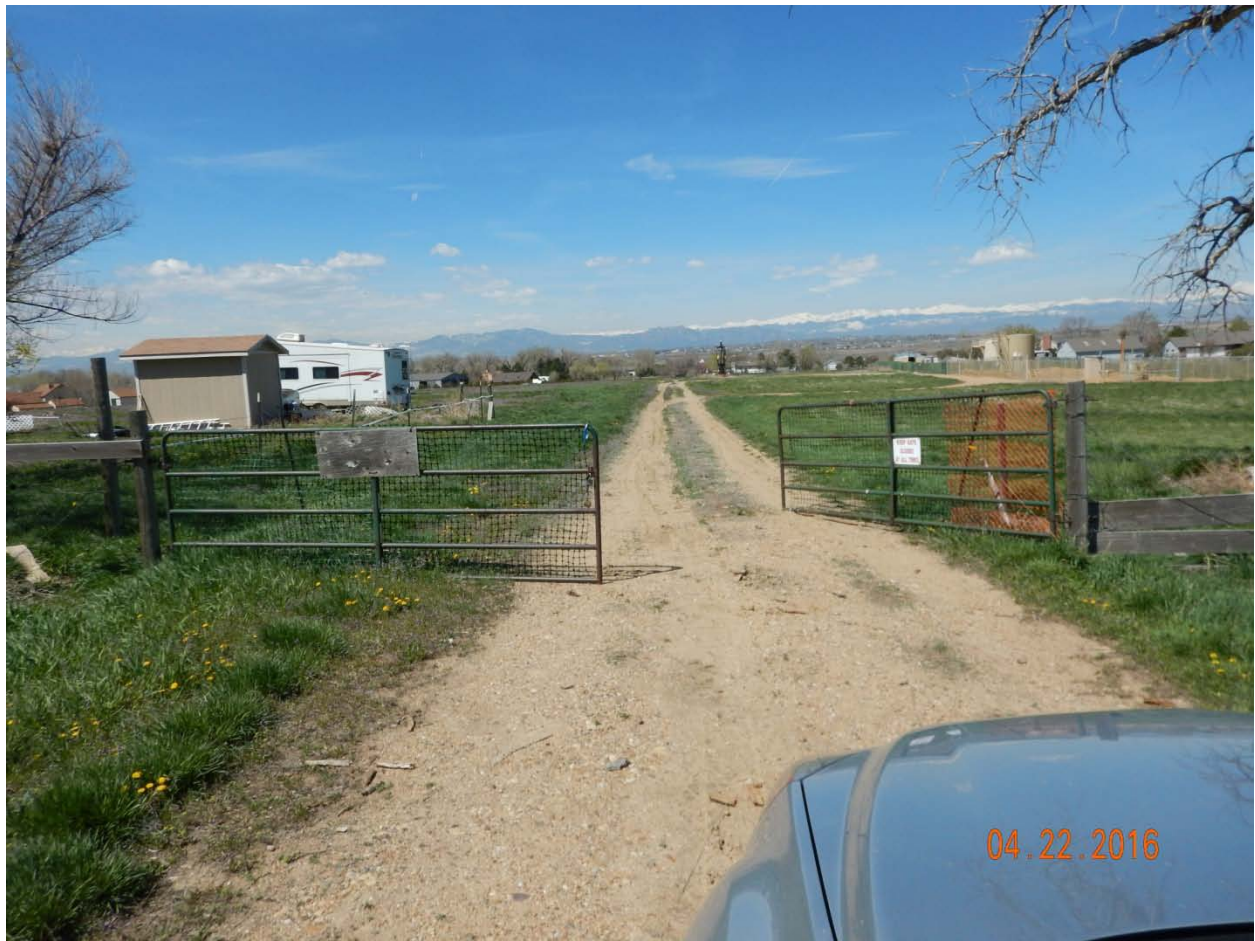
Figure 1 - Access gate from Colorado Blvd had been left open on date of inspection.

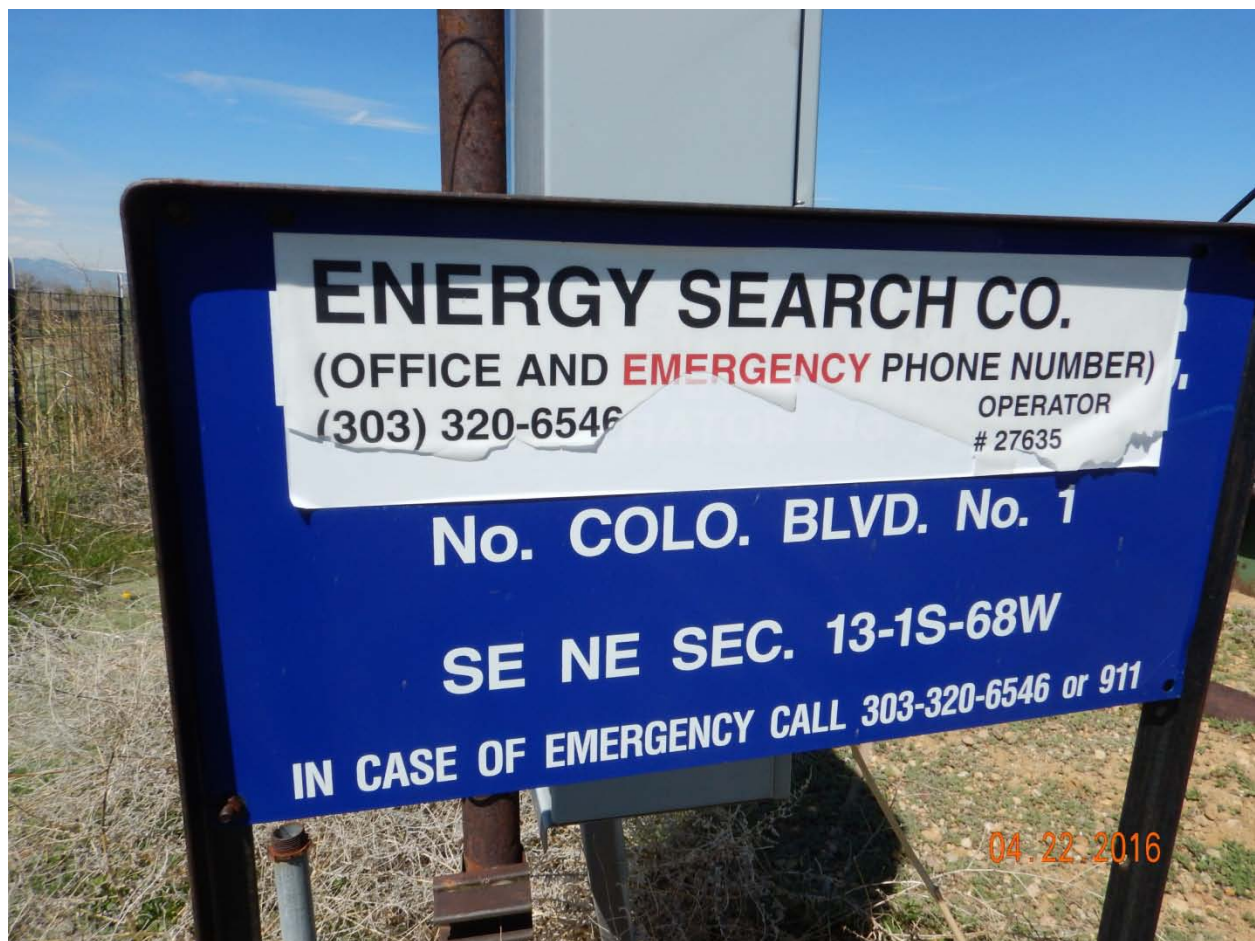
Figure 2 - Well sign.

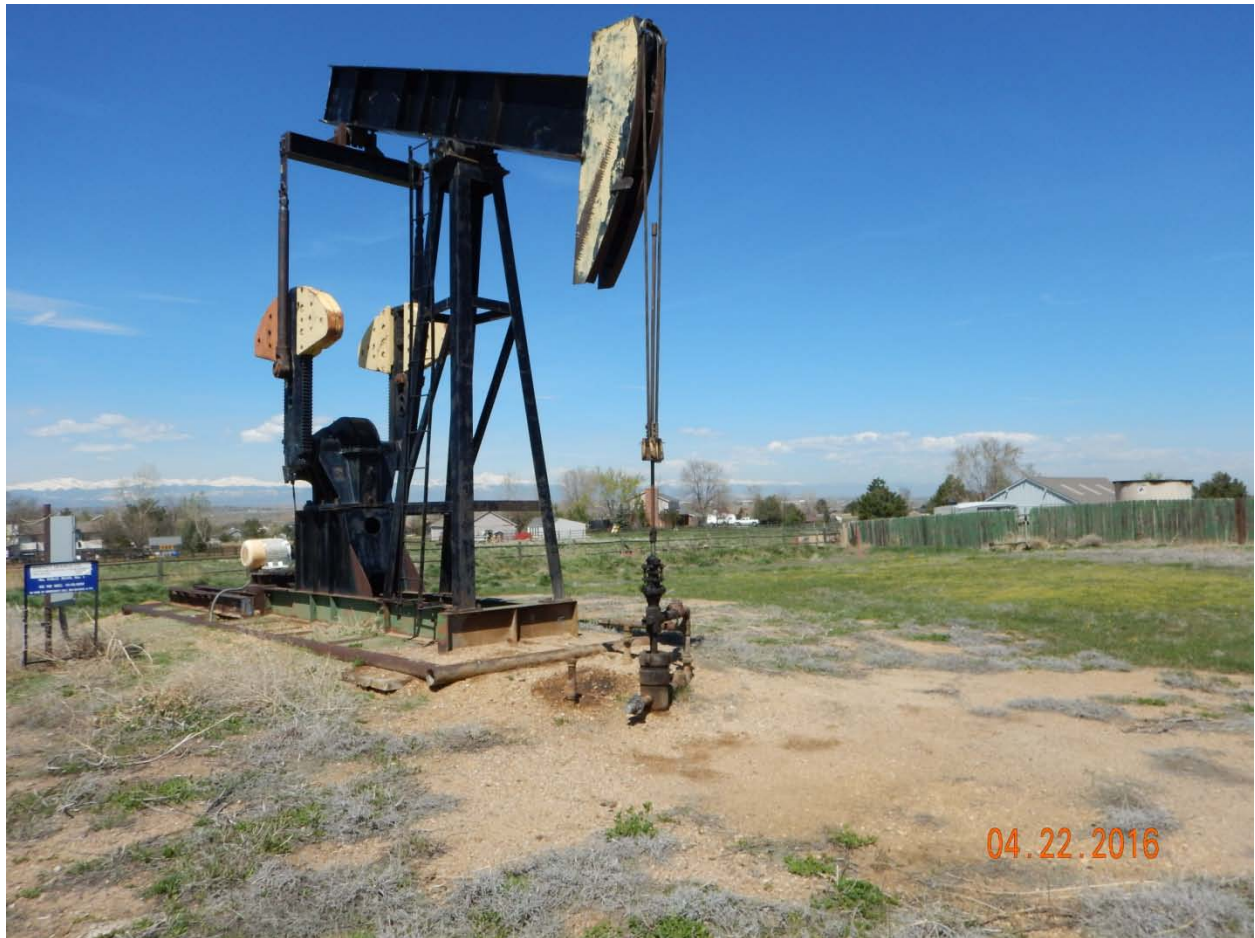
Figure 3 - Oil-stained soil at wellhead.

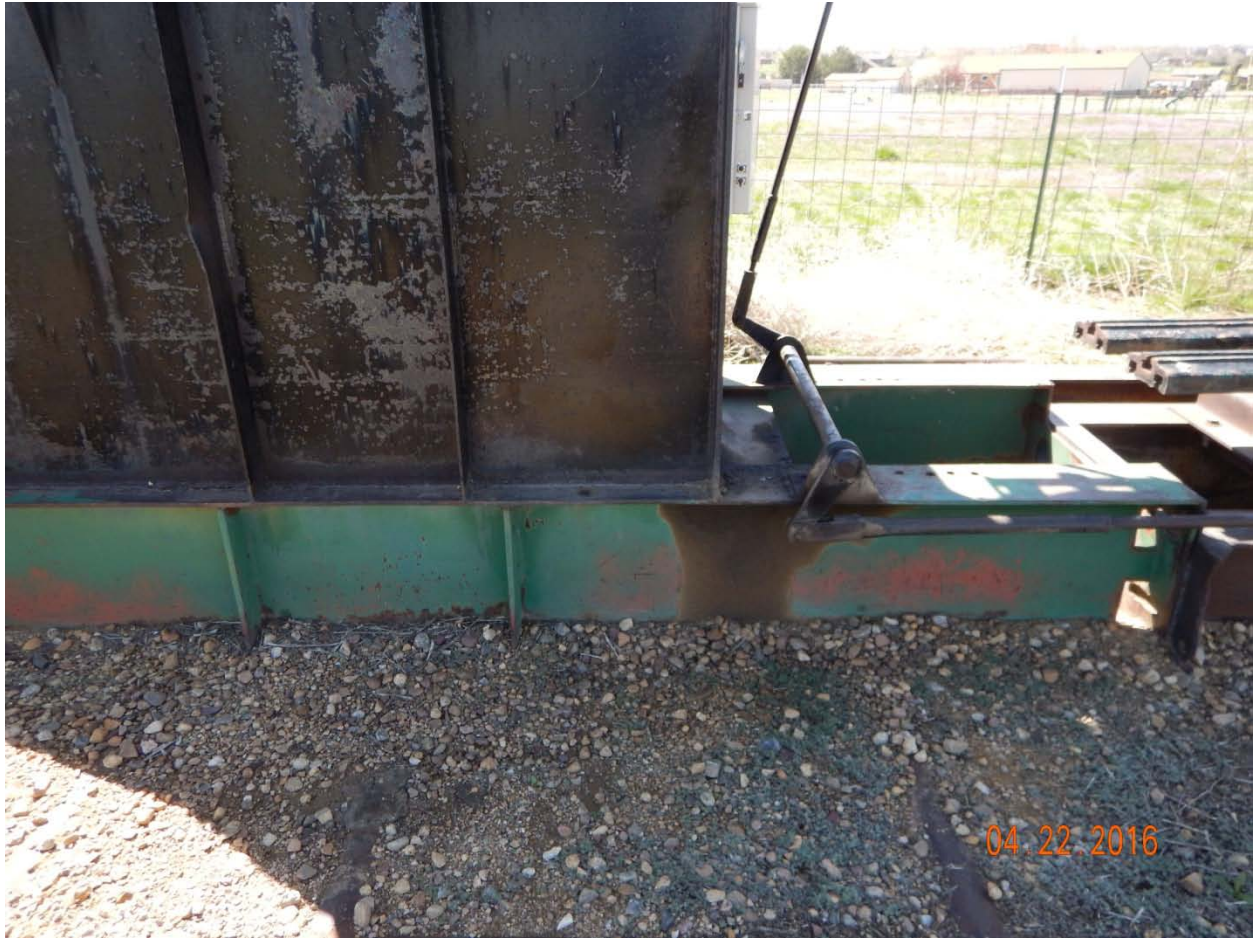
Figure 4 - Grease stain on base of pump jack.

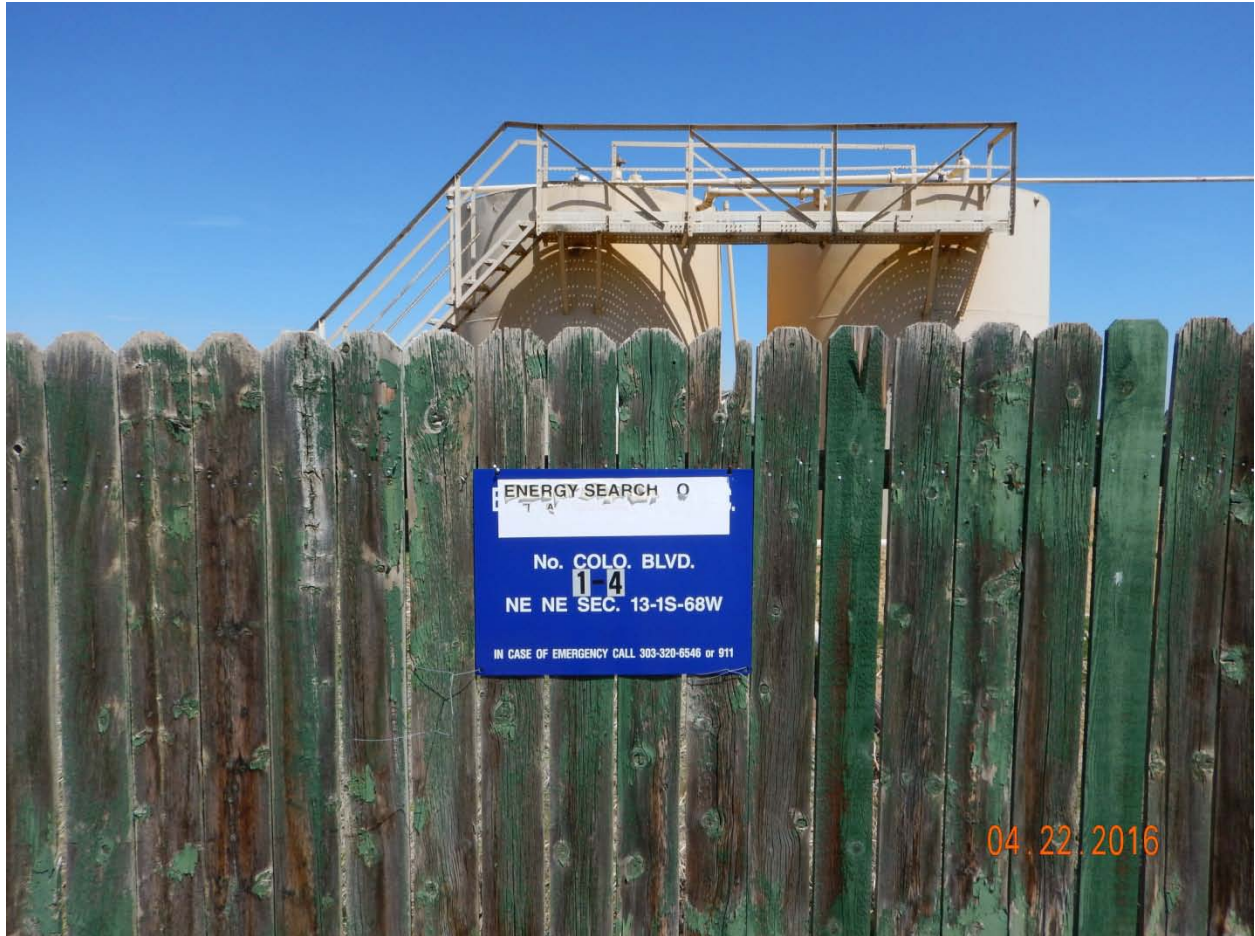
Figure 5 - Tank battery sign in need of repair (operator name is flaking off).

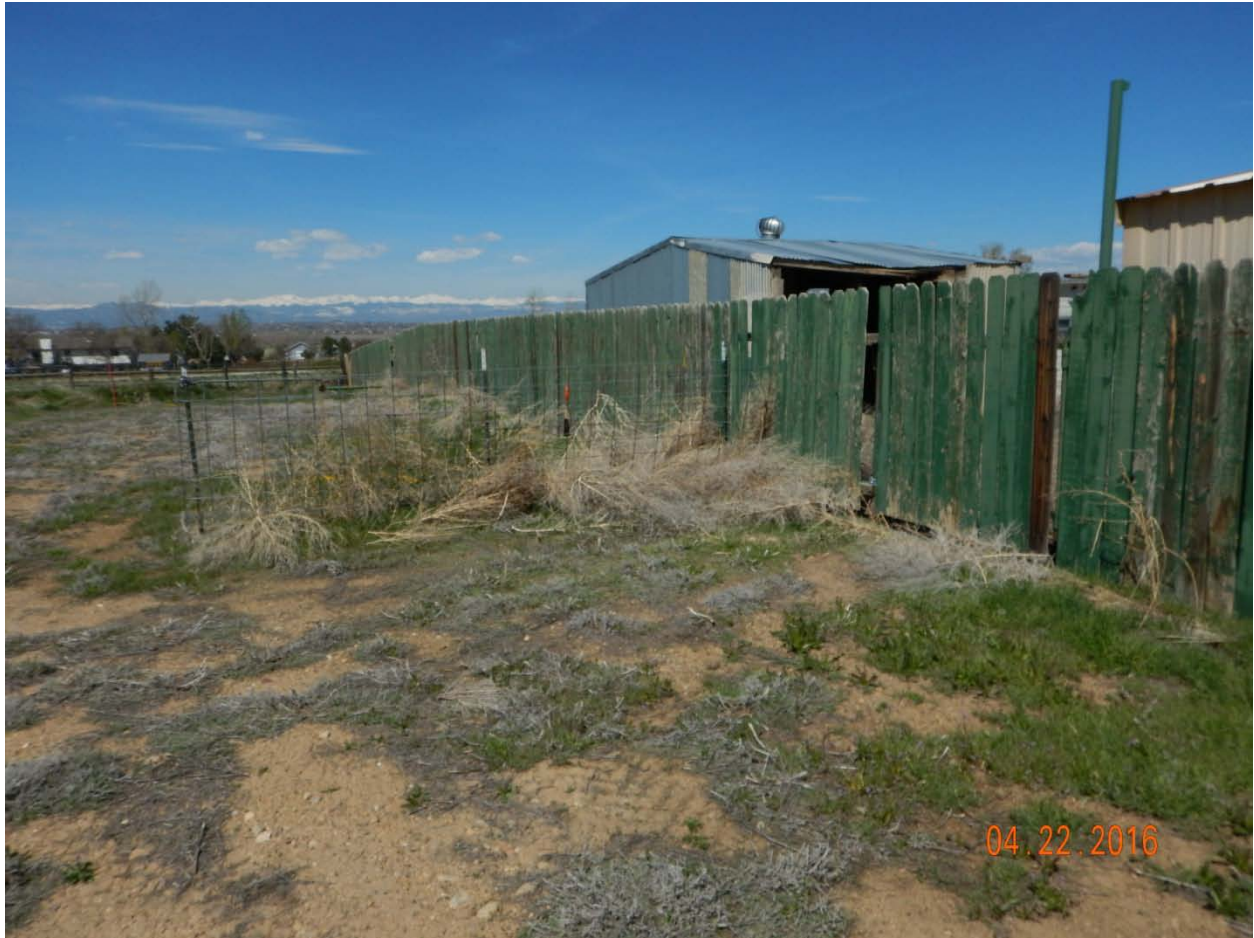
Figure 6 - Accumulation of weeds and gaps in tank battery fence.

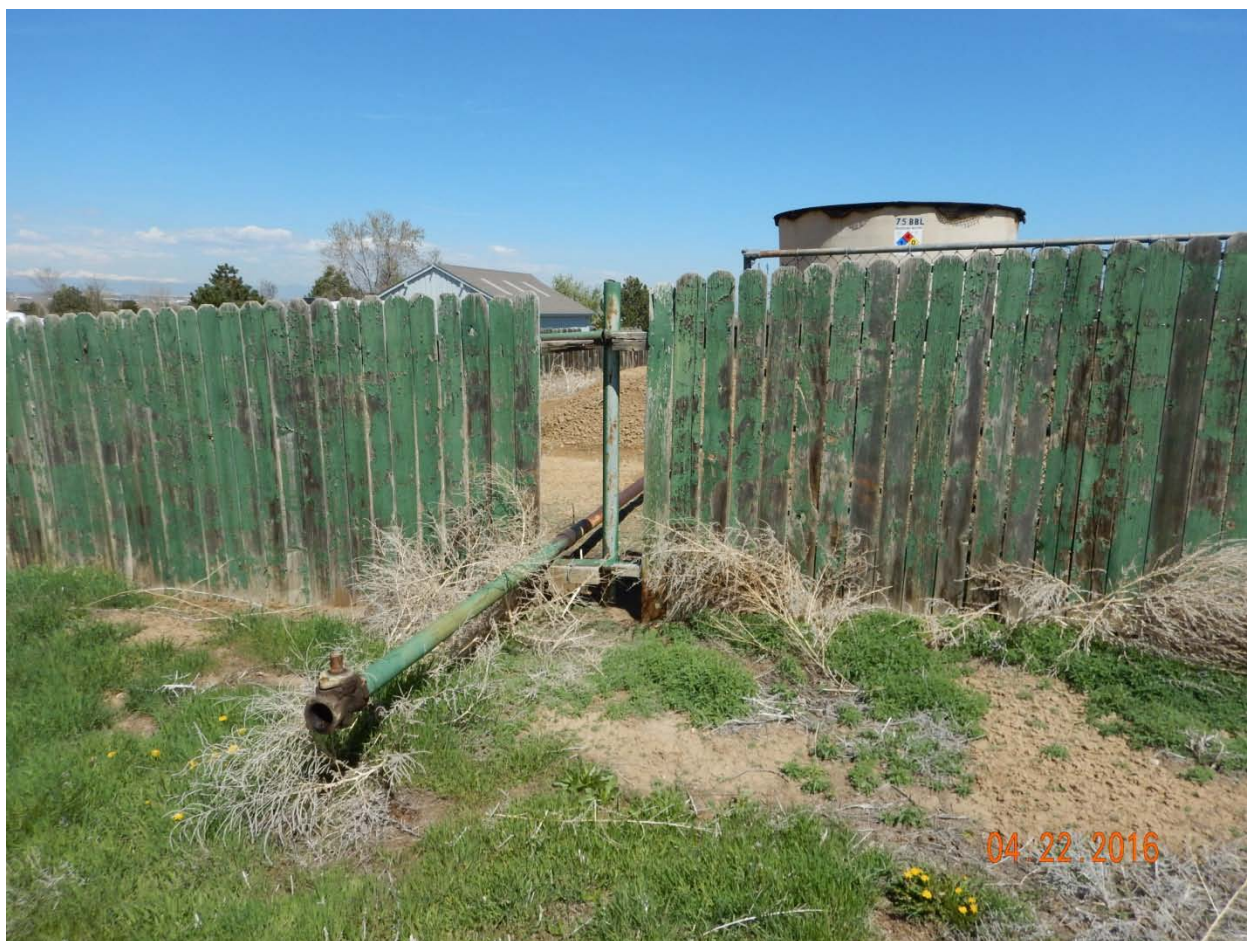
Figure 7 - Produced water tank loadout lacking secondary containment (note weeds and gap in fence).

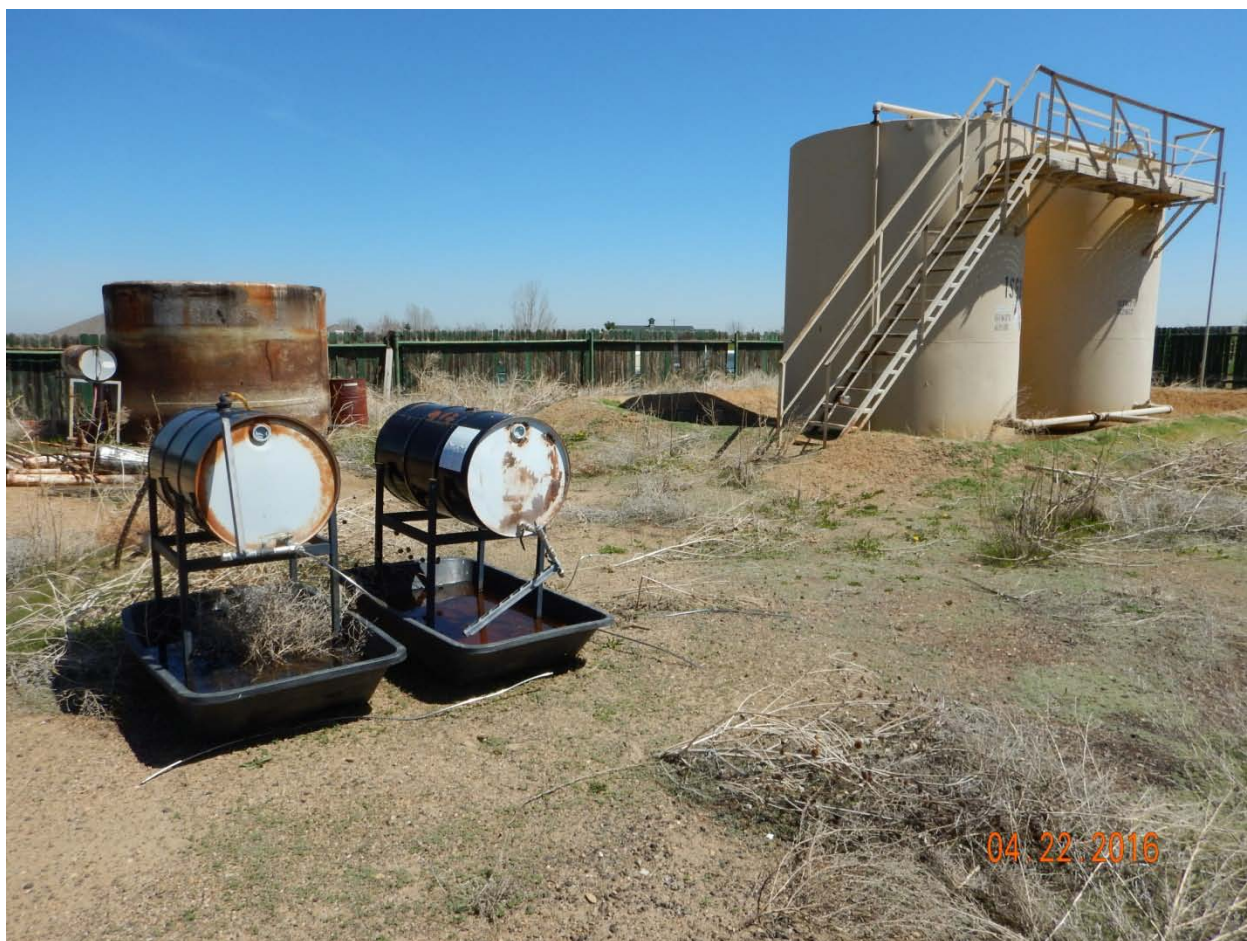
Figure 8 - Crude oil tanks, site-wide weeds/debris/unused equipment, chemical storage drums. Note water inside of secondary containment devices (foreground).

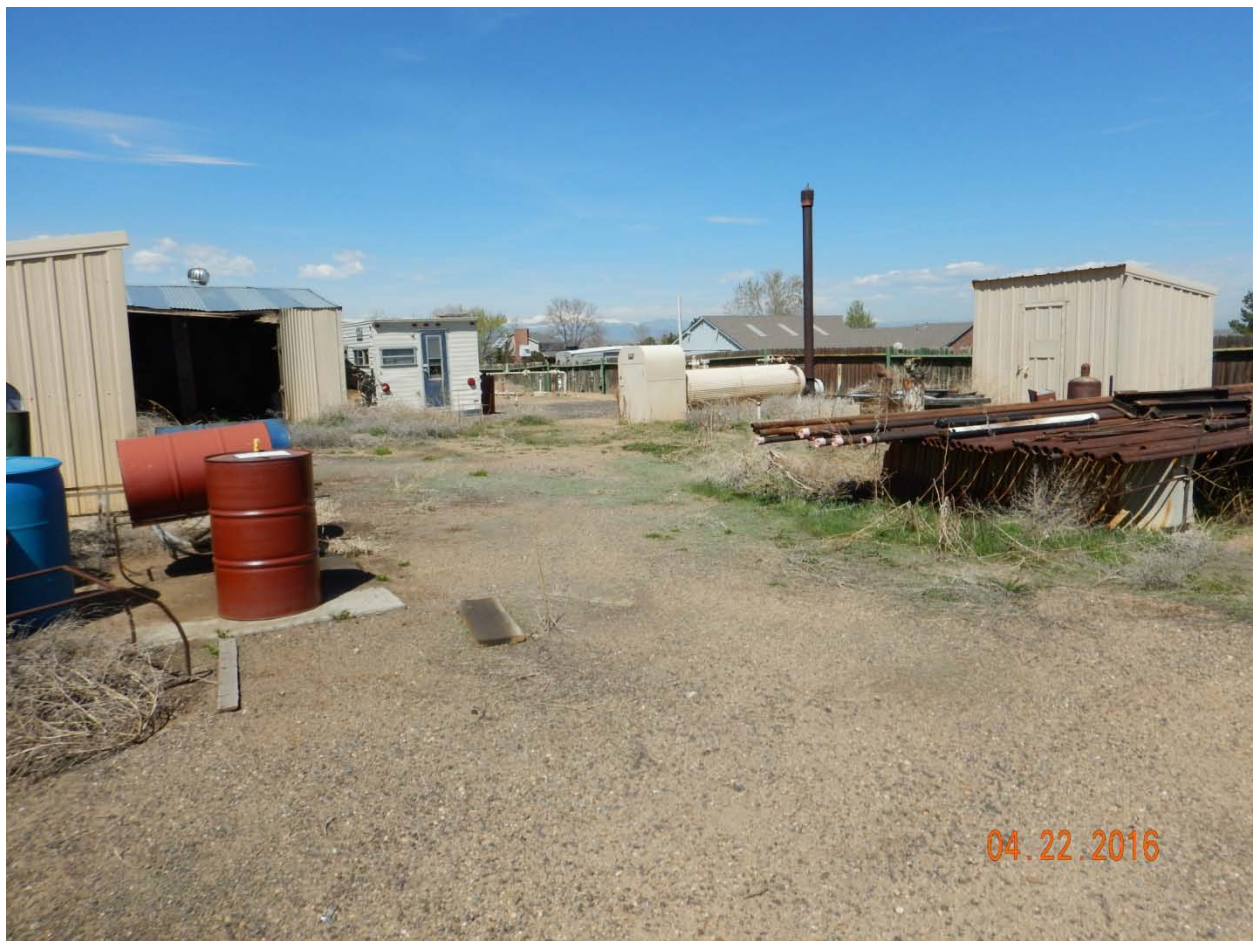
Figure 9 - Site-wide unused equipment, weeds, and debris.

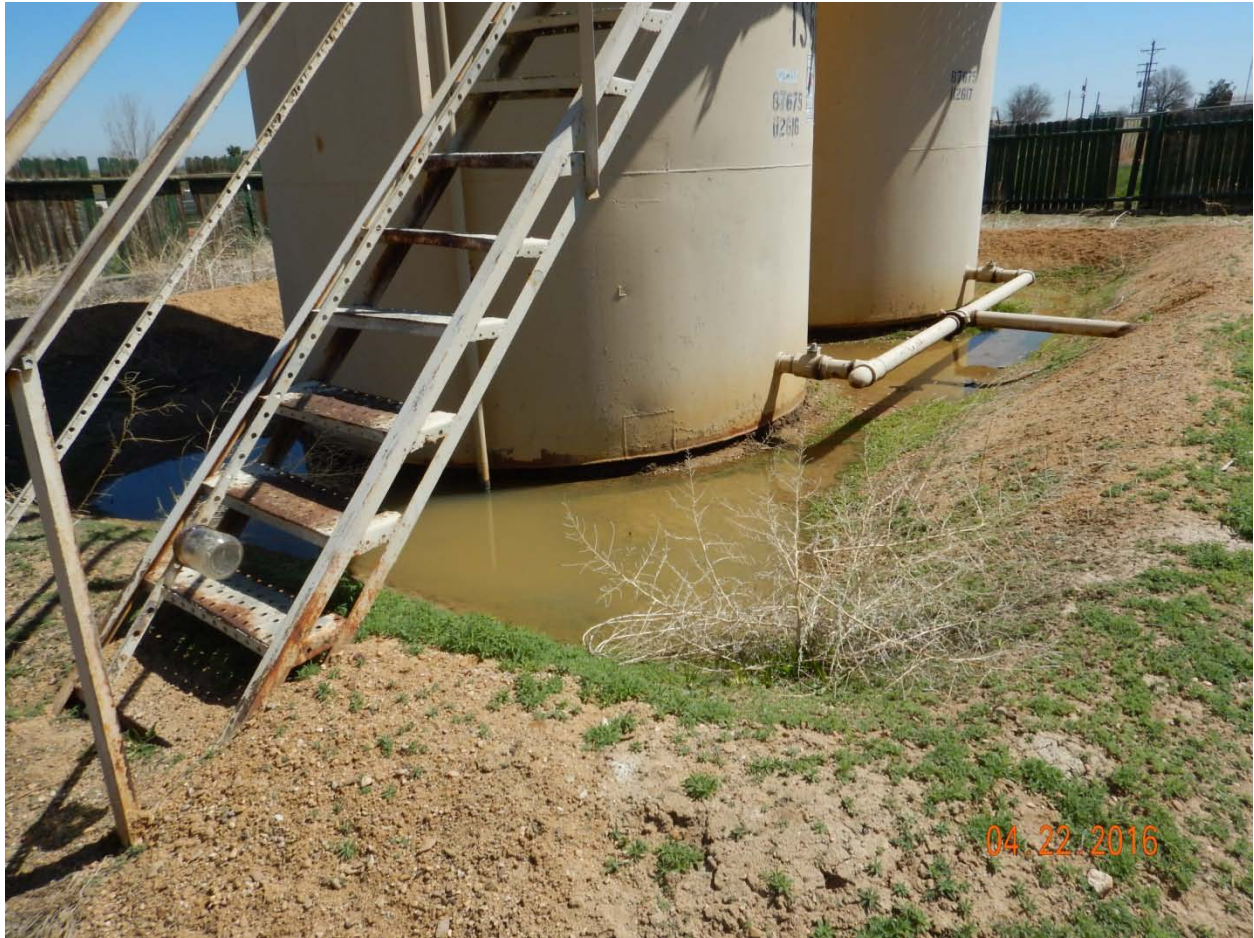
Figure 10 - Water inside of tank berm.

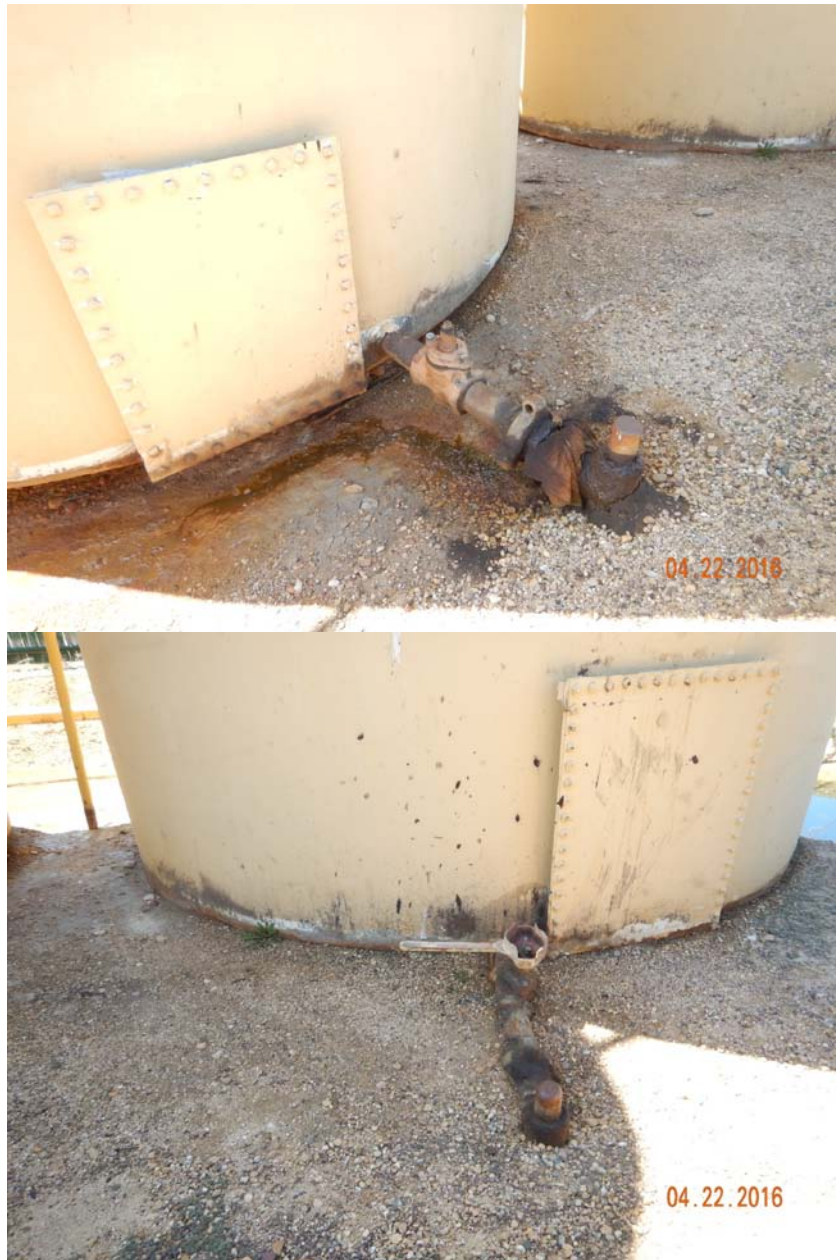
Figure 11 - Localized, oil stained soil at leaking valves on both crude oil tanks.

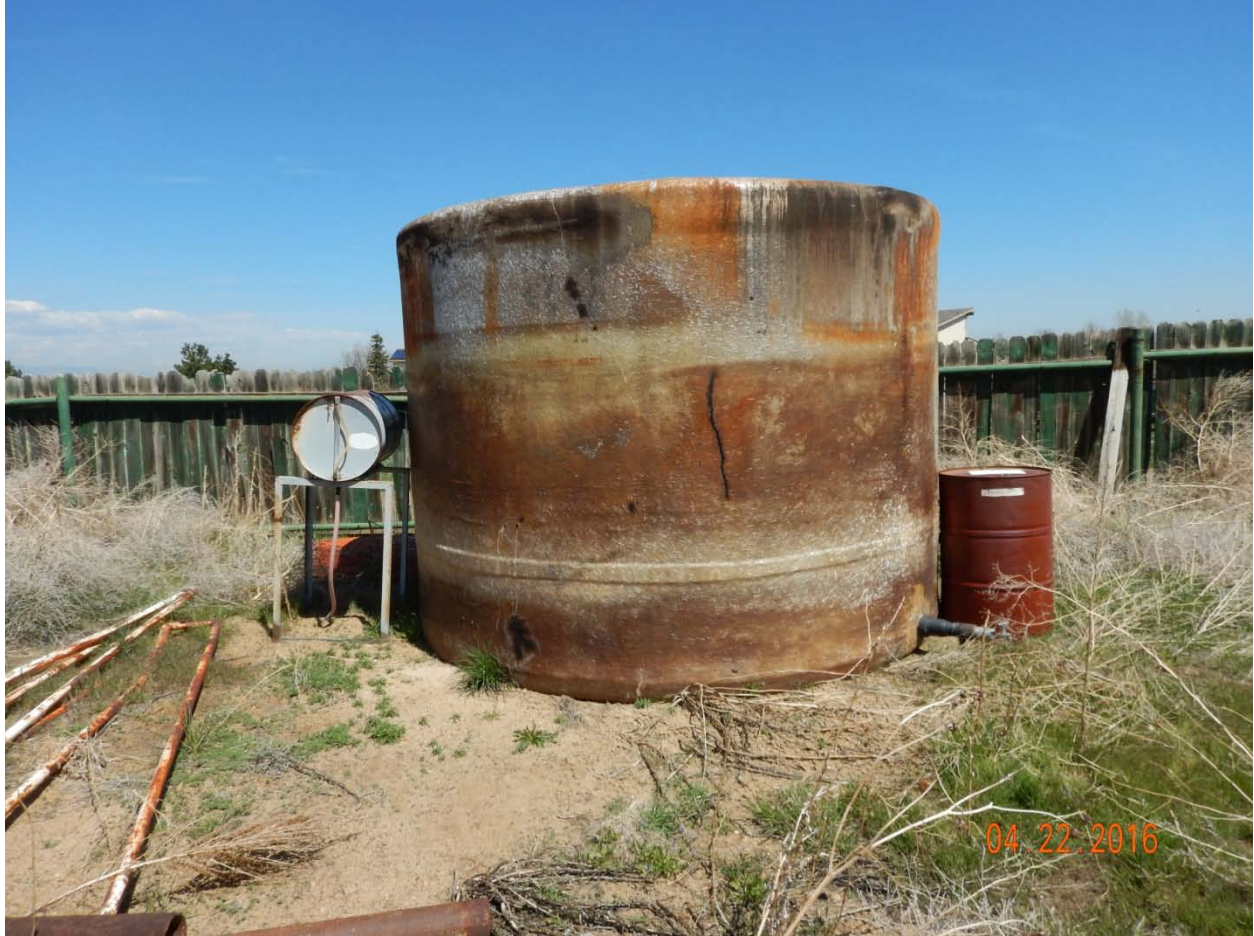
Figure 12 - Unused fiberglass AST.

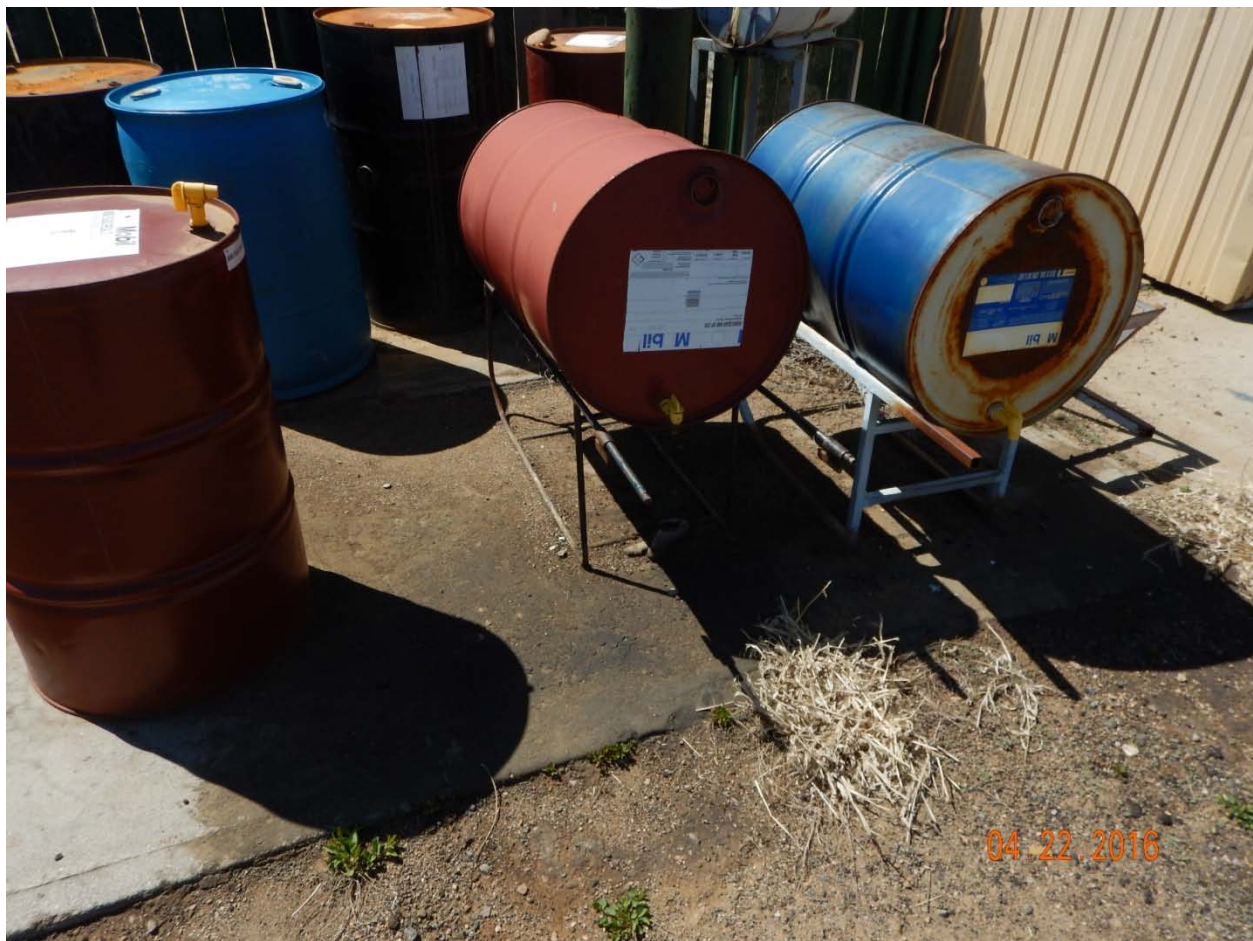
Figure 13 - Localized staining of cement and soil beneath chemical storage drums.

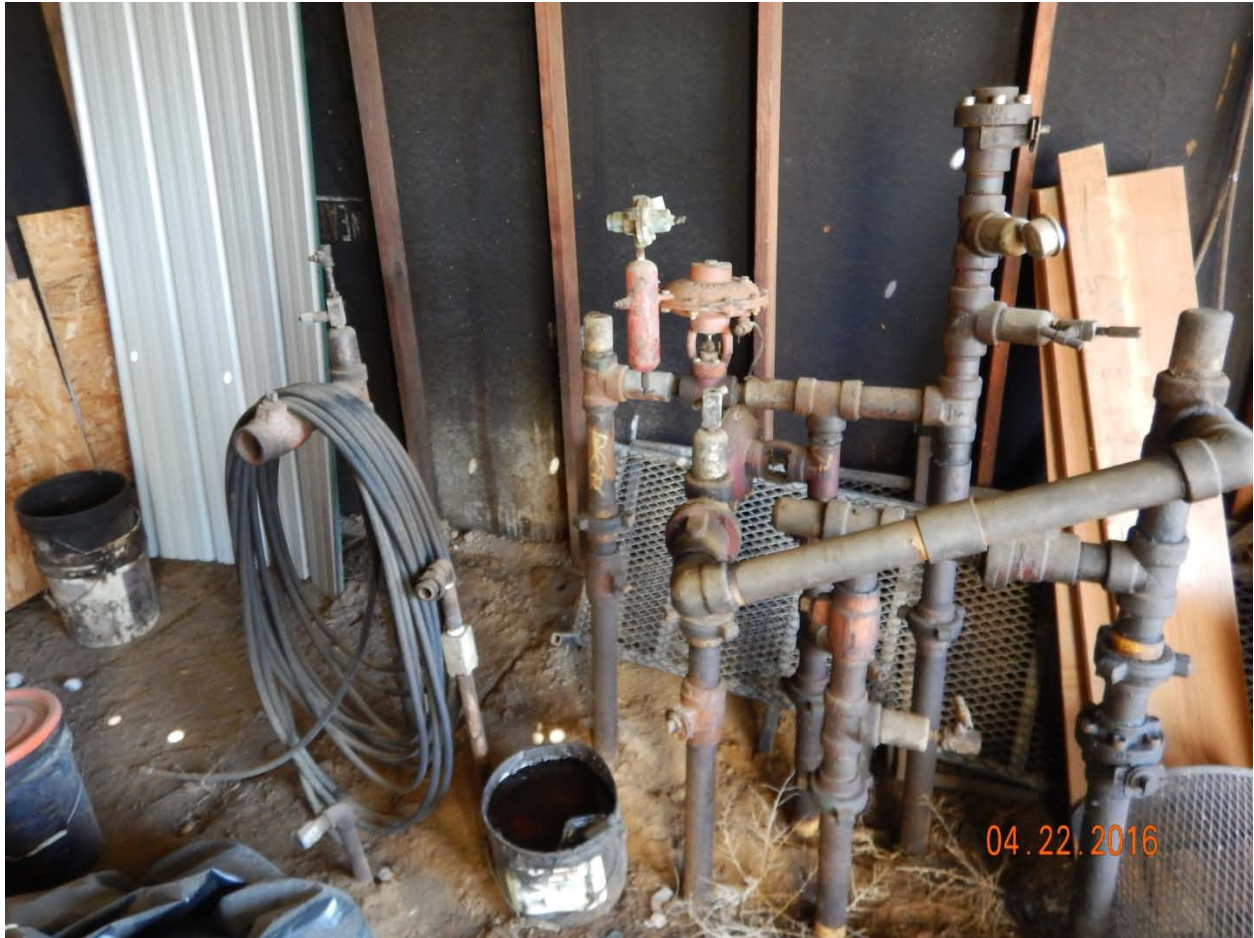
Figure 14 - Oil-stained soil and grease bucket located inside shed.

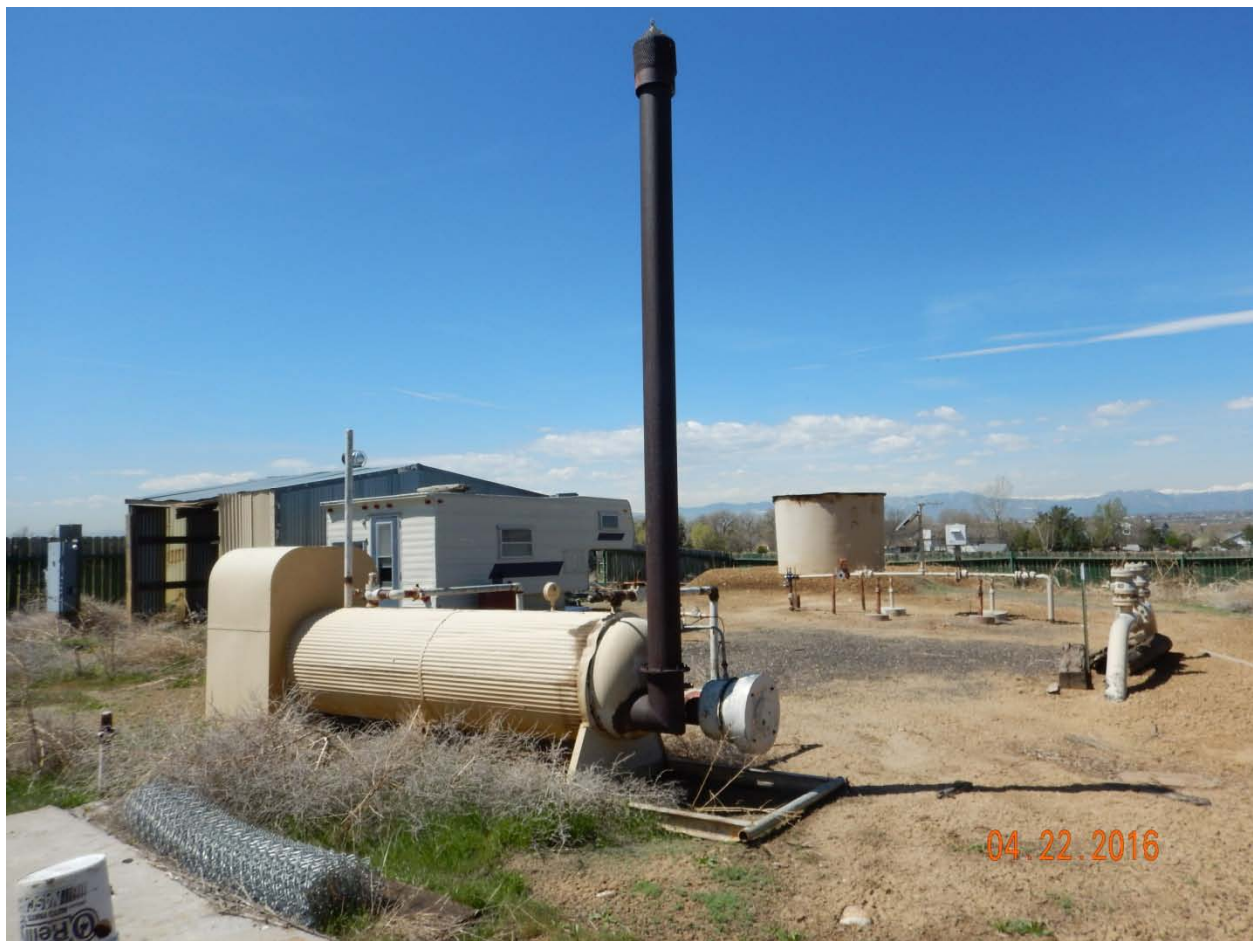
Figure 15 - Heated horizontal separator with view of shed, produced water tank, and pig launcher. Note site-wide weeds, debris, and unused equipment.

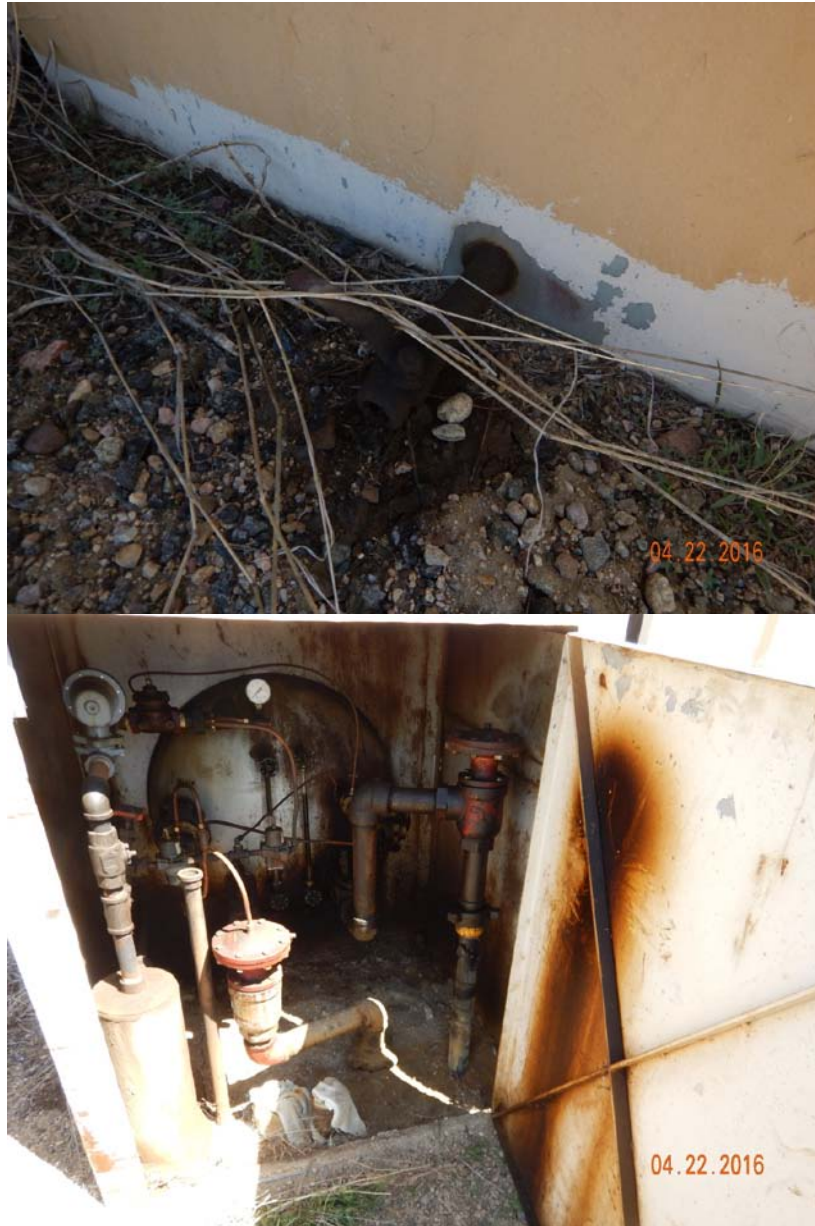
Figure 16 - Localized, oil-stained soil associated with heated horizontal separator.

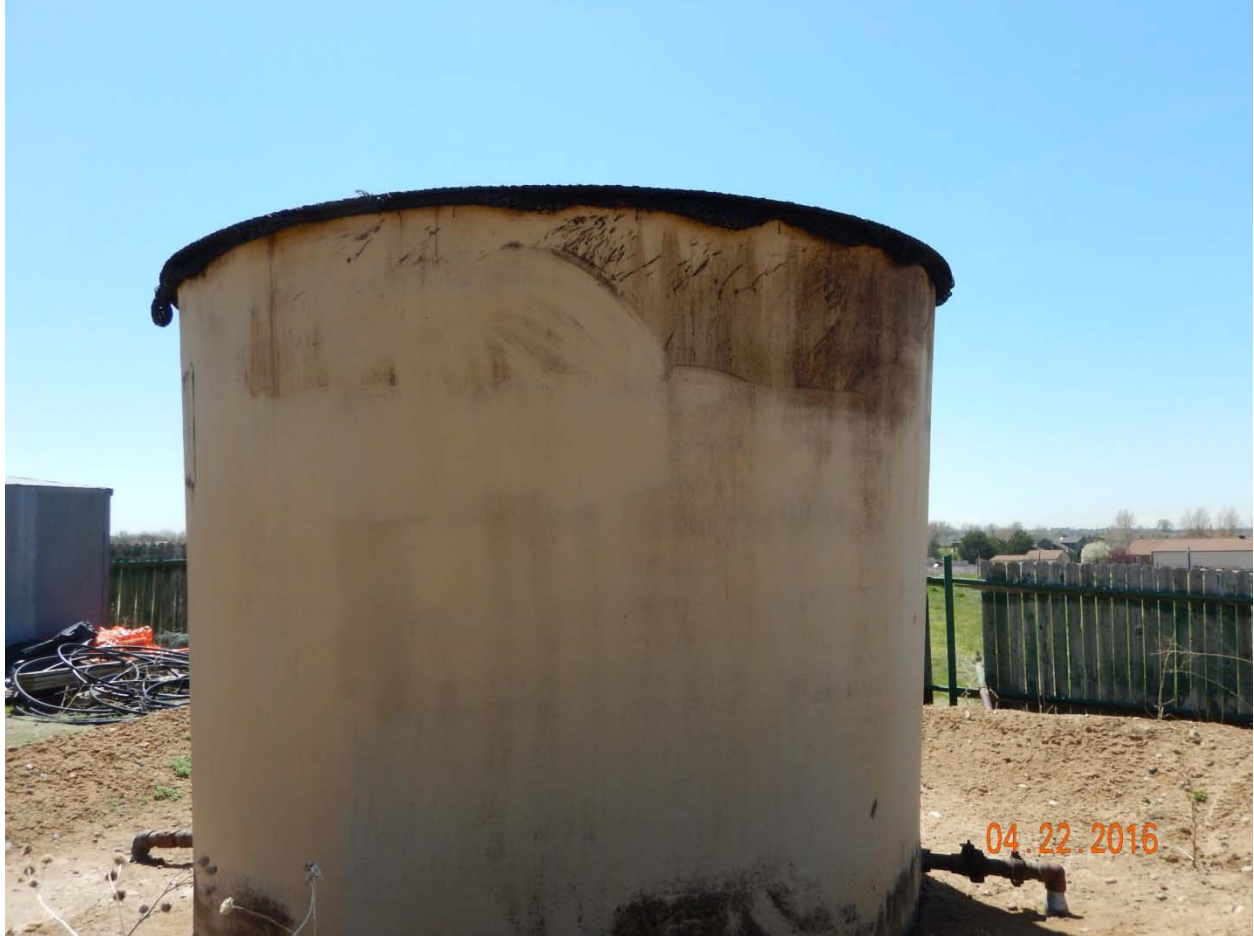
Figure 17 - Oil stains on top and bottom of fiberglass produced water tank.
