## Final Reclamation Inspection- Abandoned Location

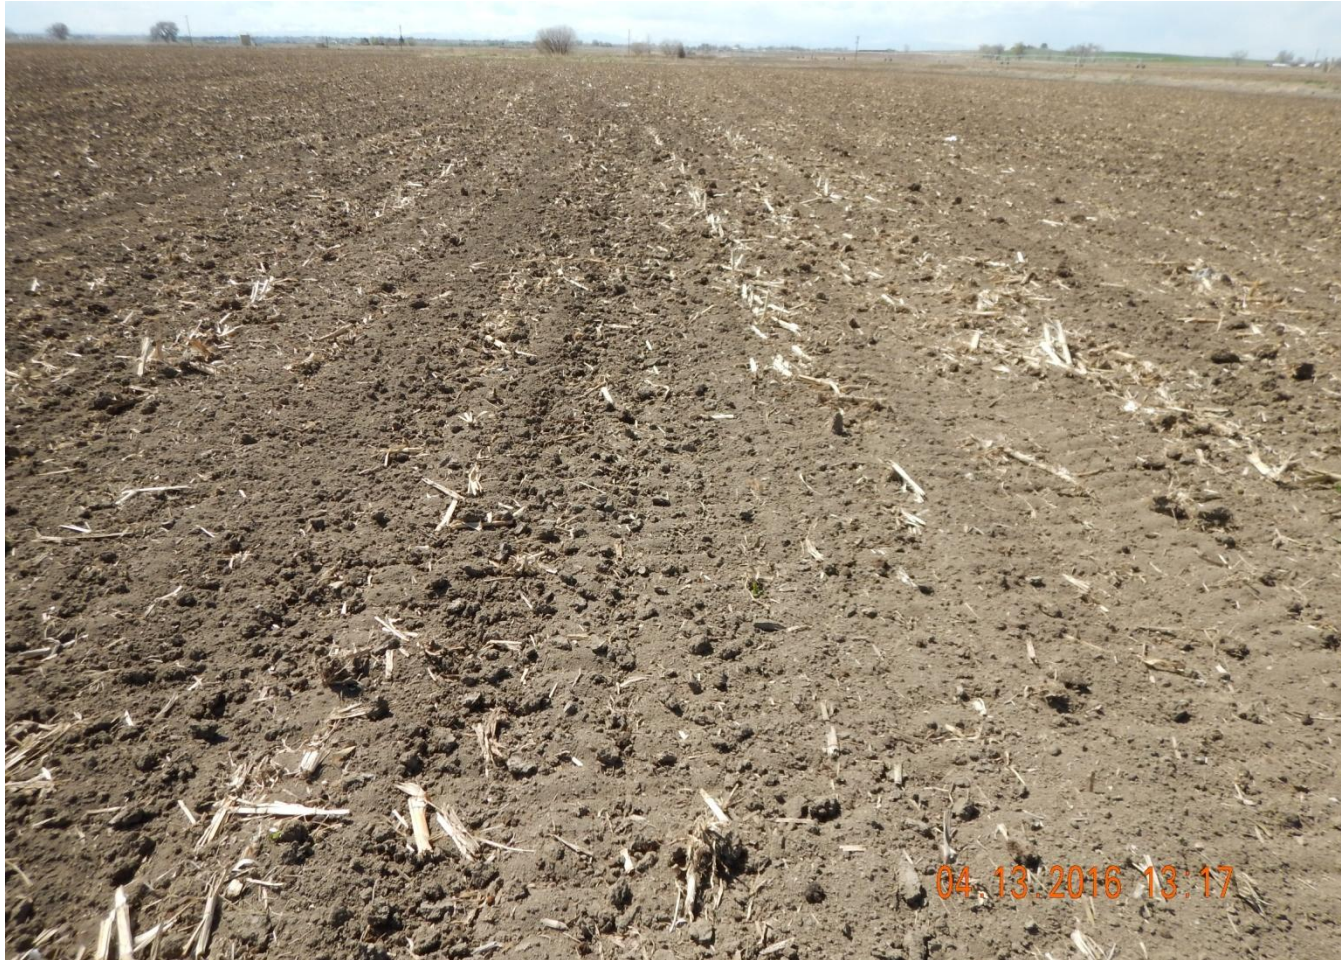
**Photo 1.** Photo taken from center of location, facing West. It appears the location was never built.

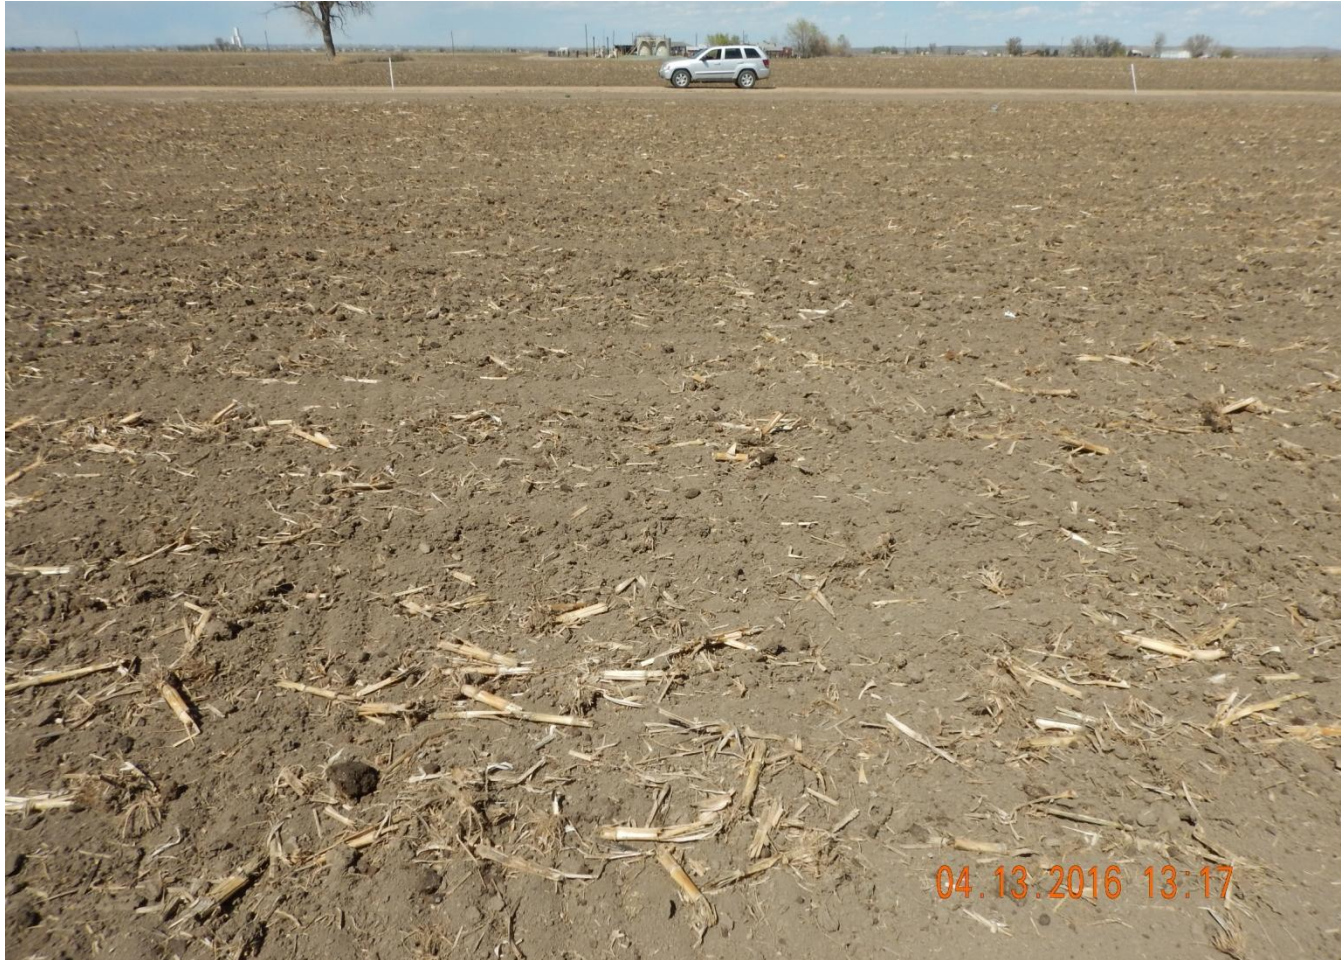
**Photo 2.** Photo taken from center of location, facing North. It appears the location was never built.

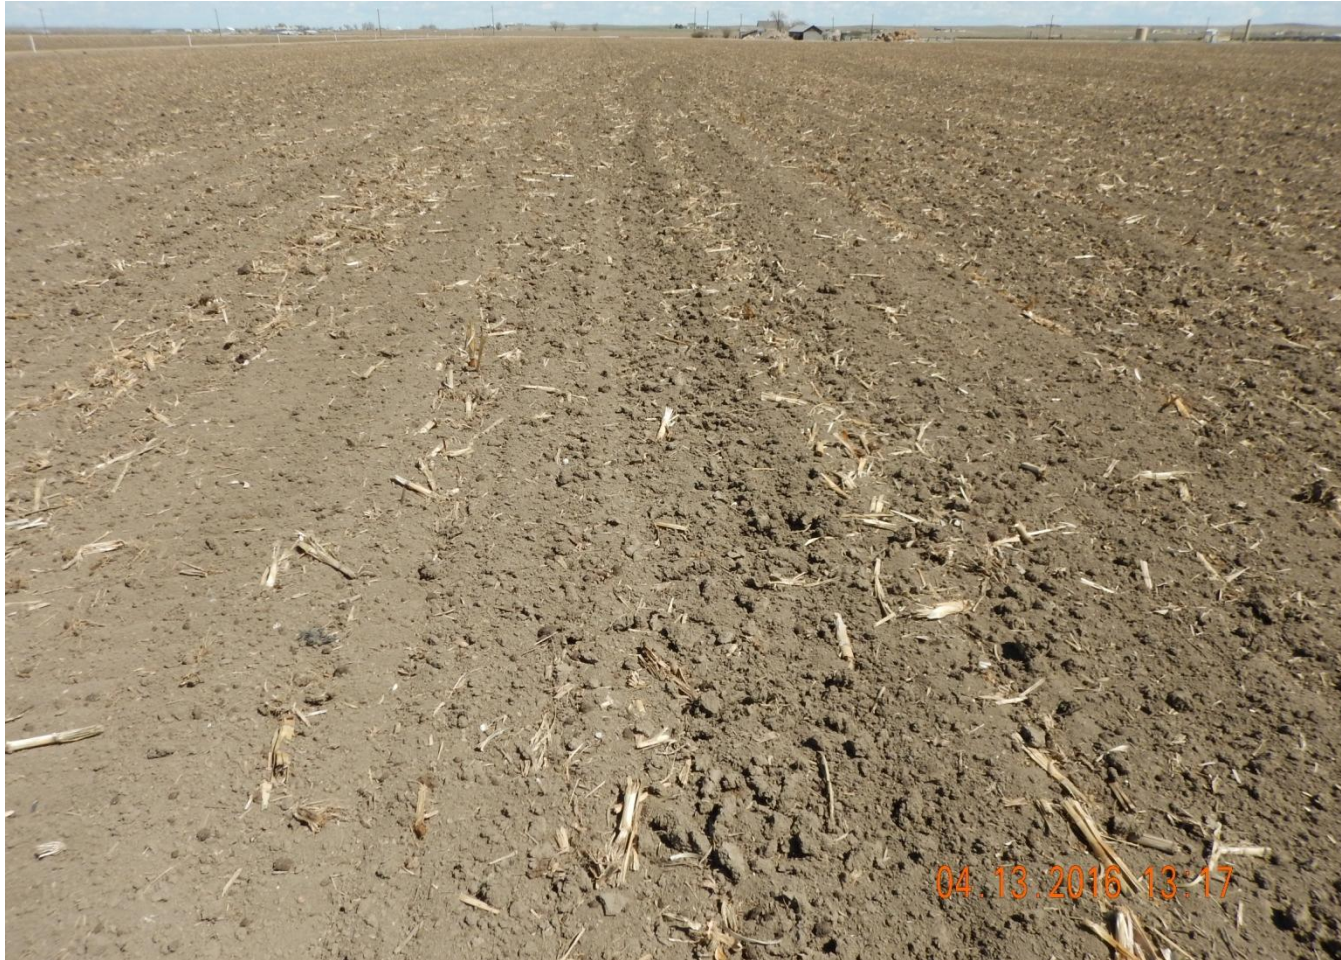
**Photo 3.** Photo taken from center of location, facing East. It appears the location was never built.

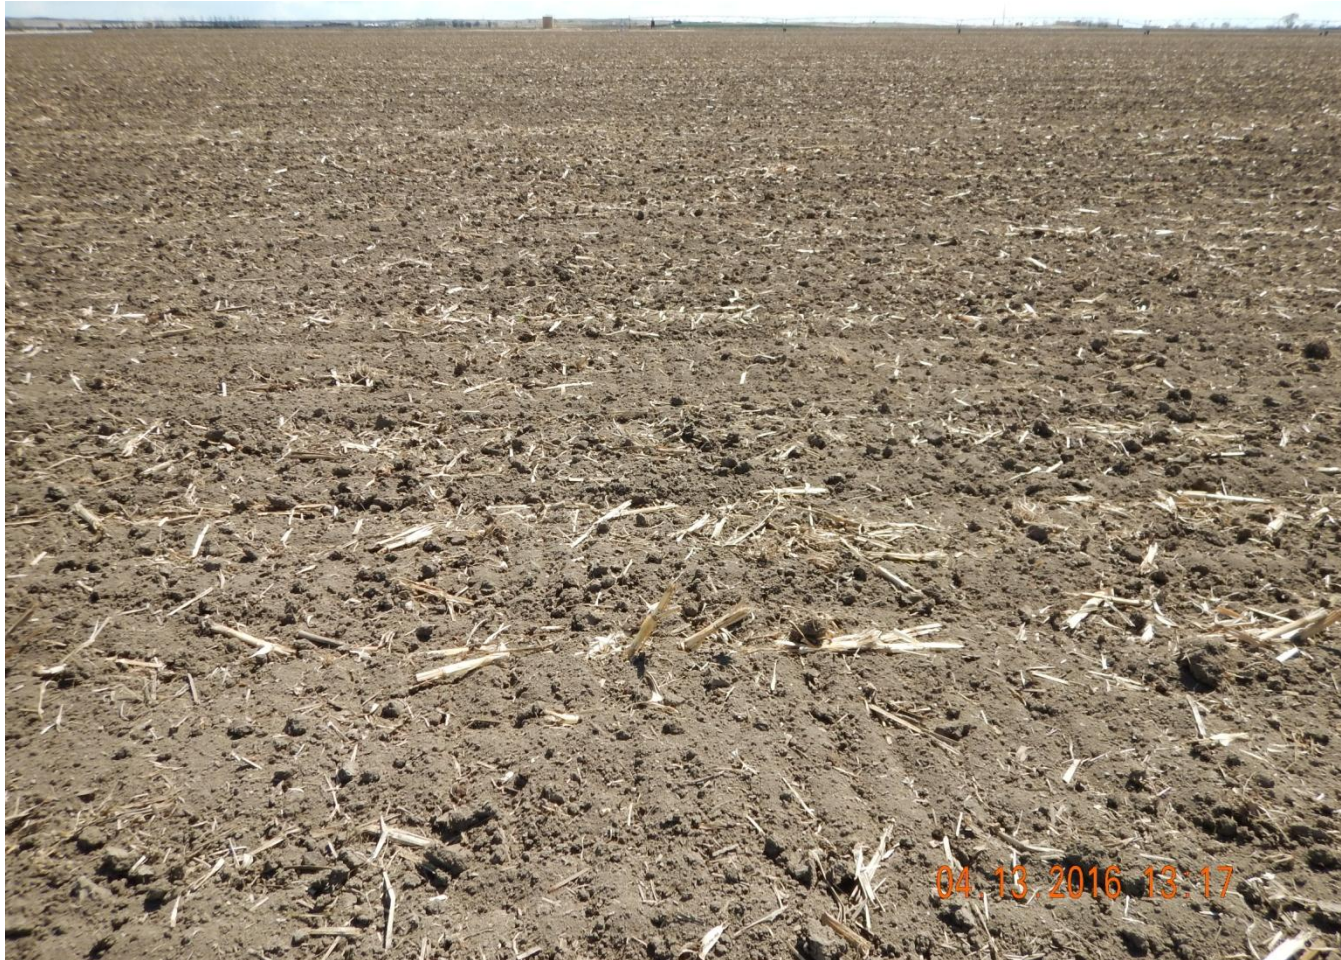
**Photo 4.** Photo taken from center of location, facing South. It appears the location was never built.

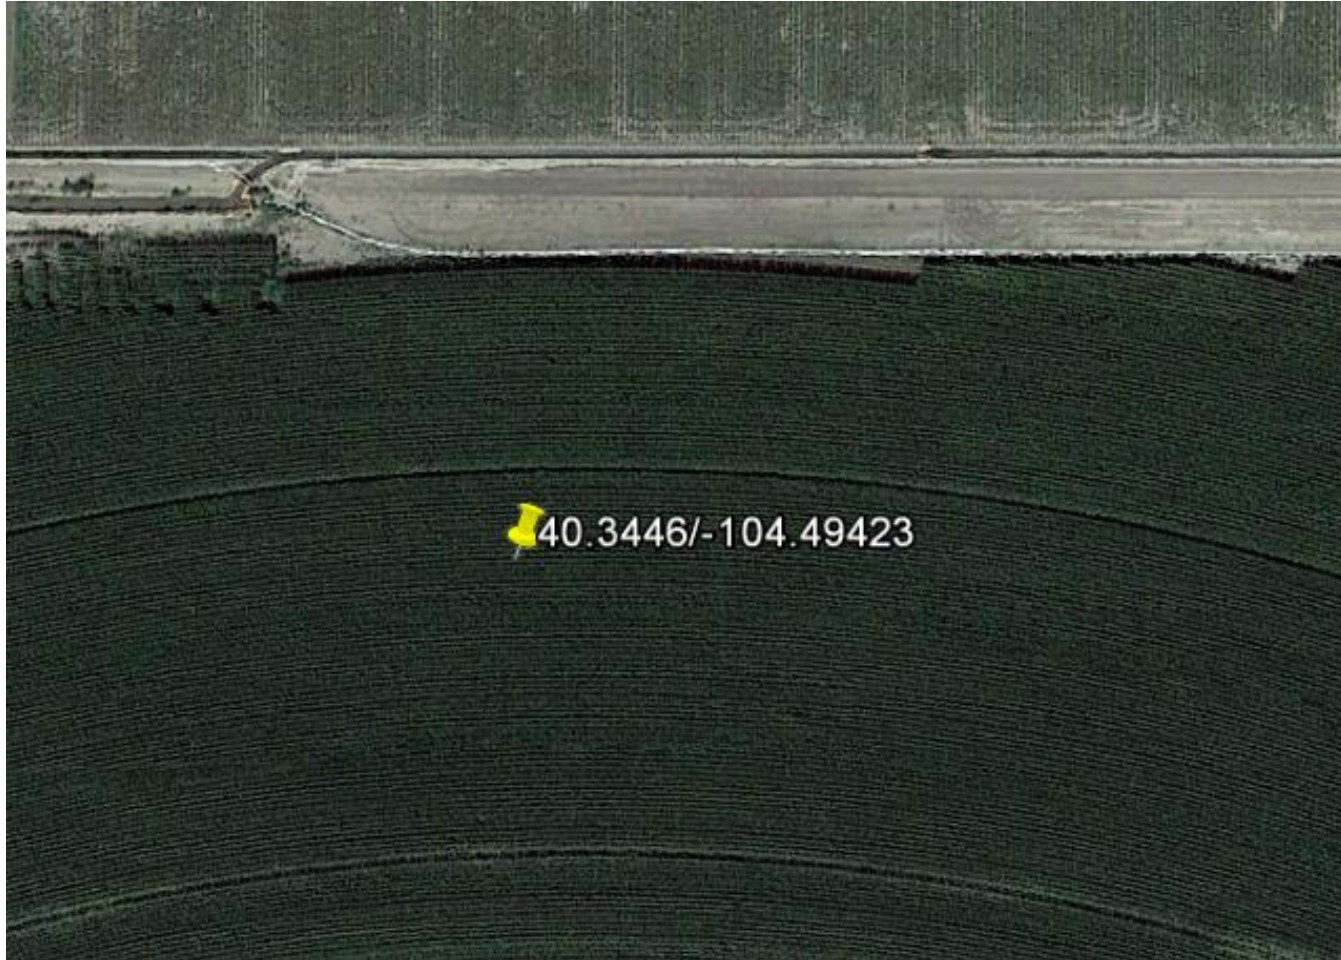
**Photo 5.** Google Earth aerial imagery taken 9/6/2013. It appears the location was never built based off aerial imagery and field observations.
