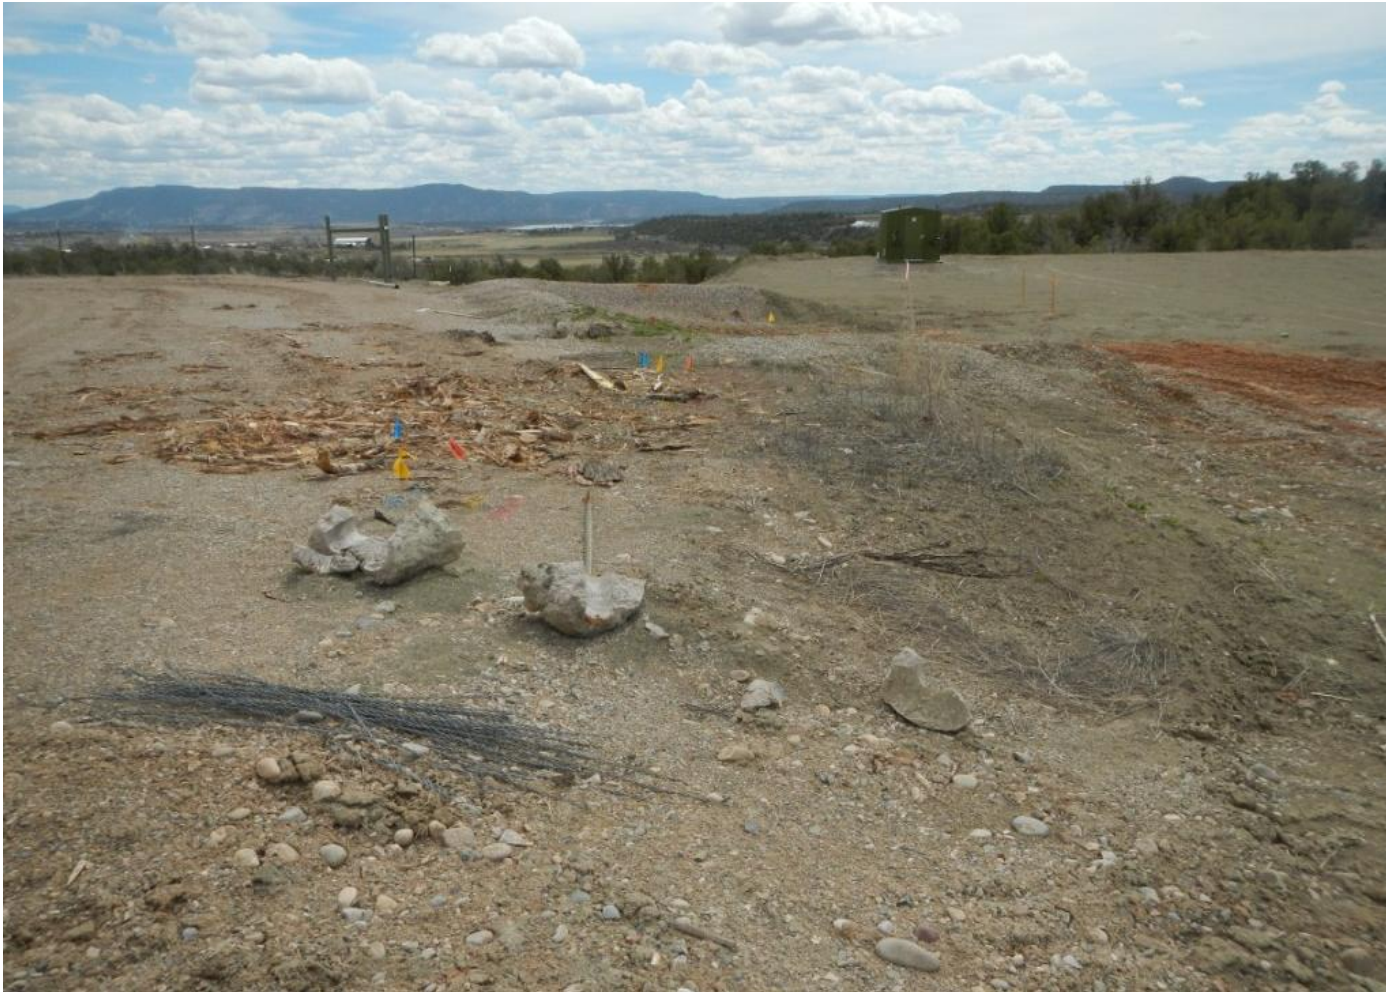
Photo 1. View of the southern portion of the project area from the well pad entrance facing eastward. Wire, cement, wood, etc. debris needs to be removed.

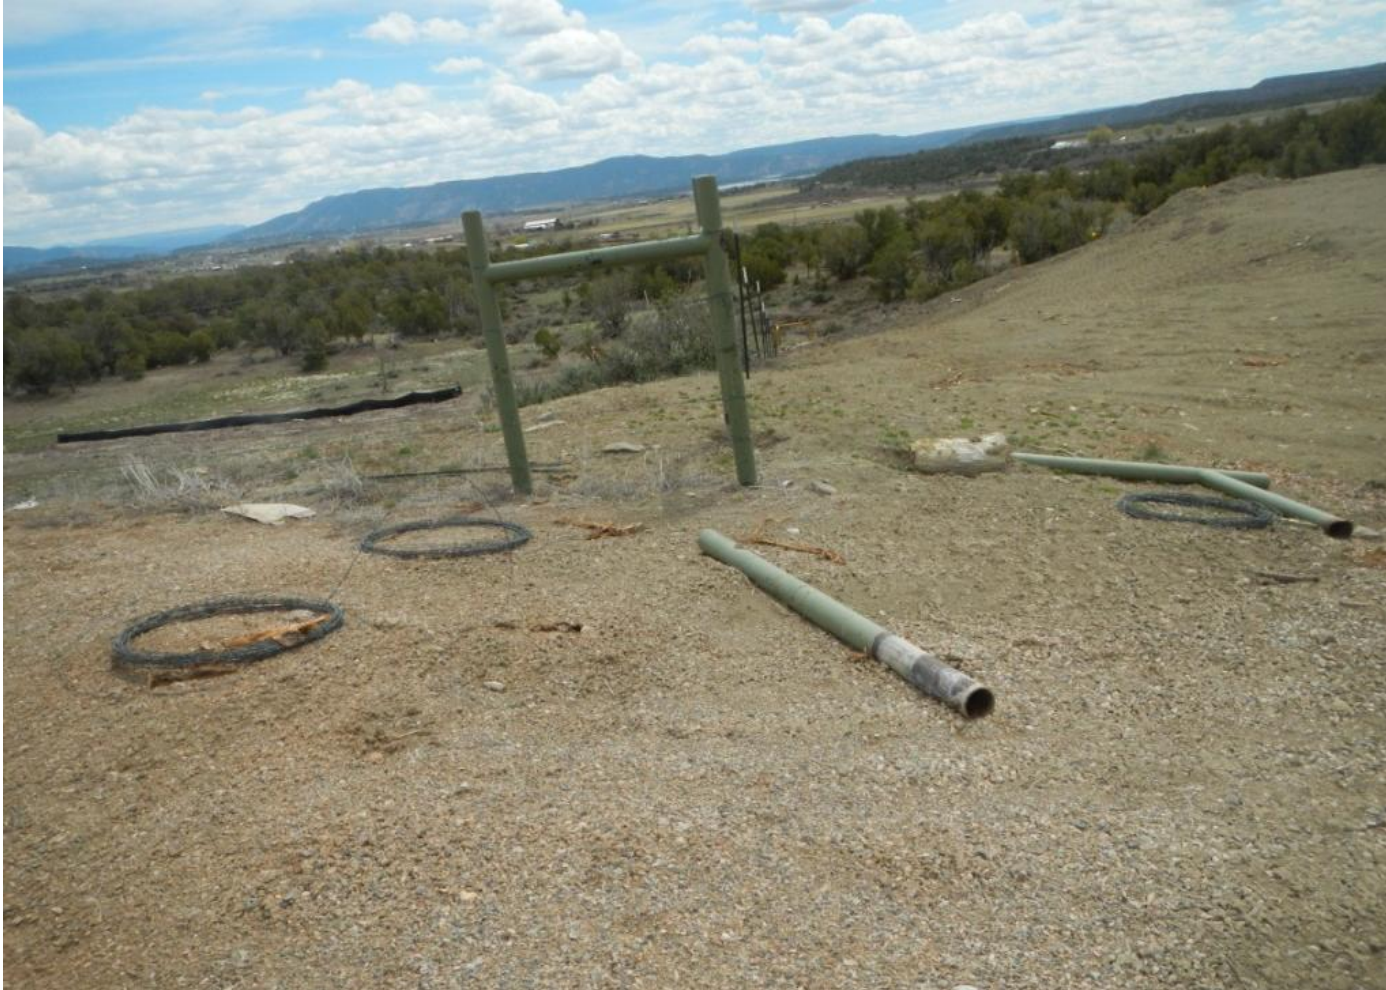
Photo 2. View of fencing debris in the southeastern corner of the project area that needs to be removed.

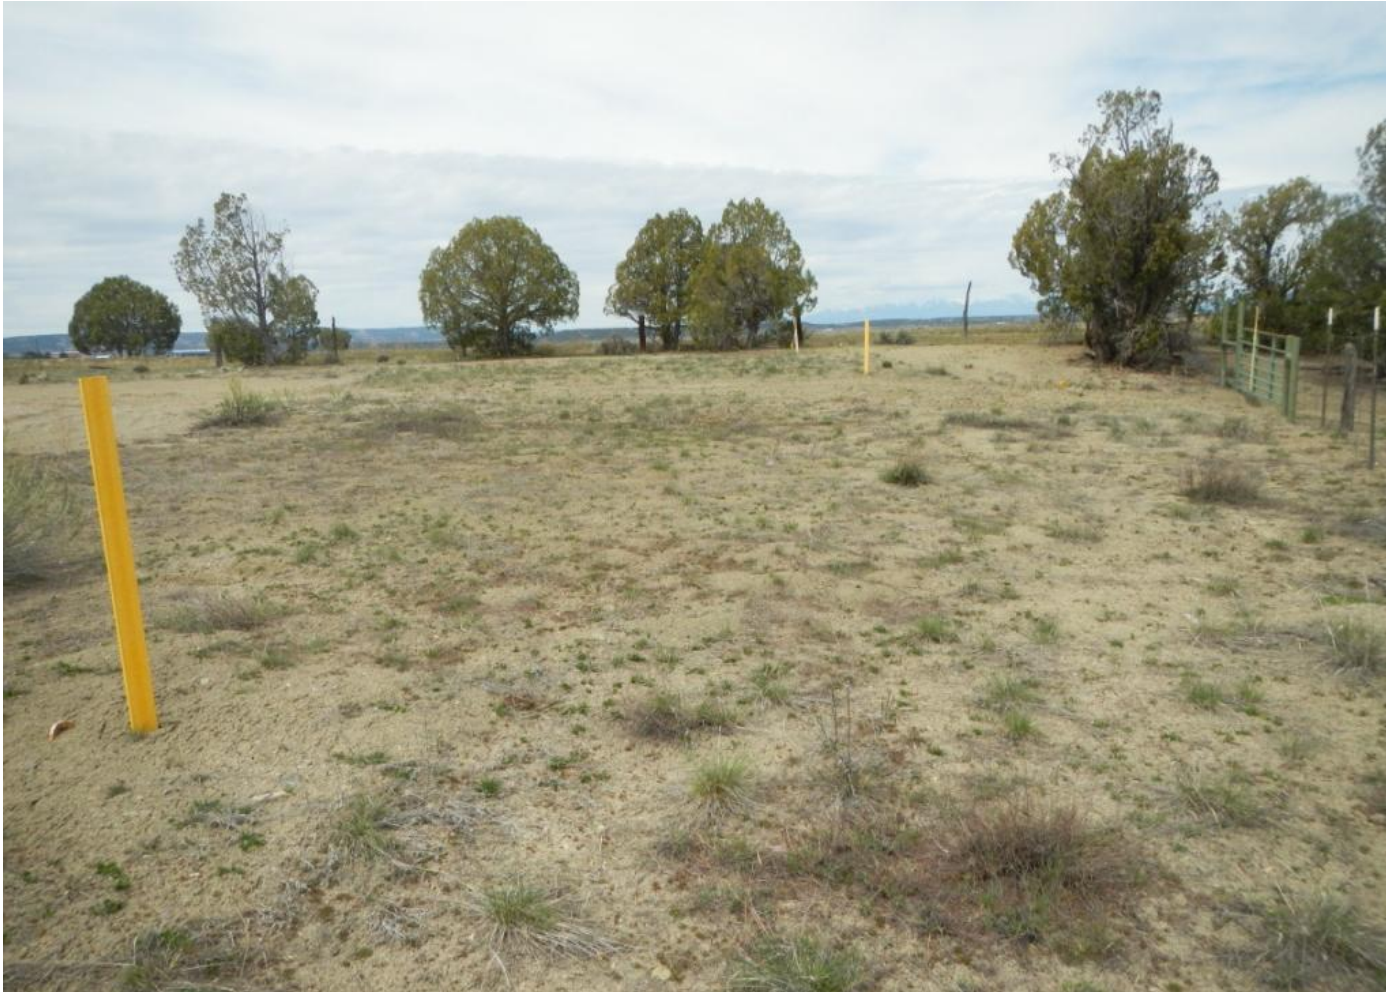
Photo 3. View of the northern portion of the project area from the northeastern corner facing westward. Vegetation in this area is comprised of rubber rabbitbrush (*Chrysothamnus nauseosus*), locoweed (*Astragalus* sp.), Indian ricegrass (*Achnatherum hymenoides*), field bindweed (*Convolvulus arvensis*), and crested wheatgrass (*Agropyron cristatum*).
