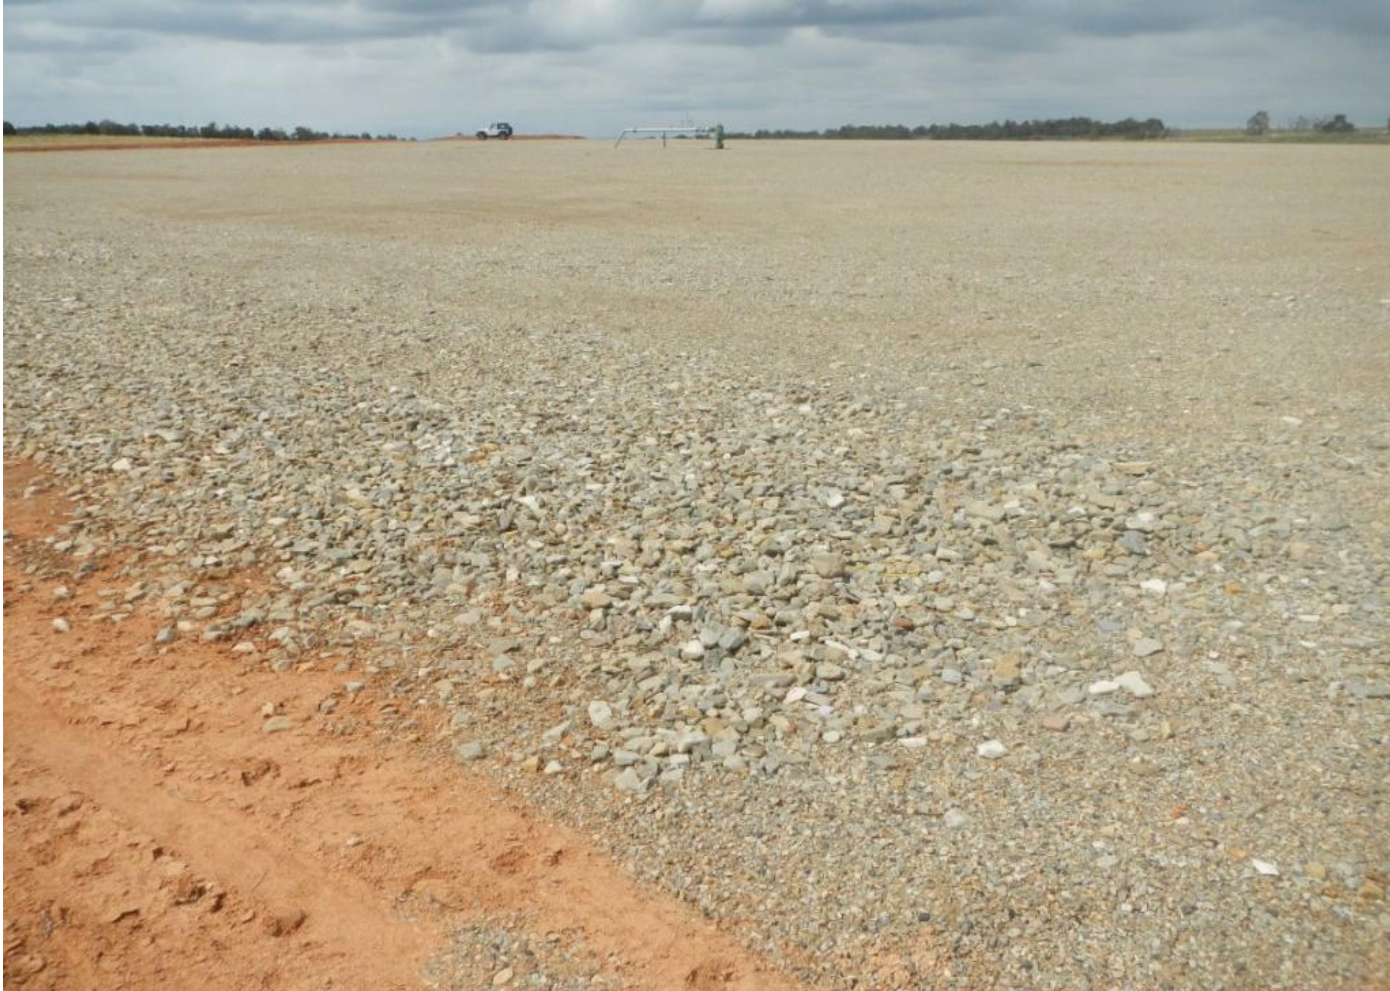
Photo 1. View of the project area from the northeastern corner facing center.

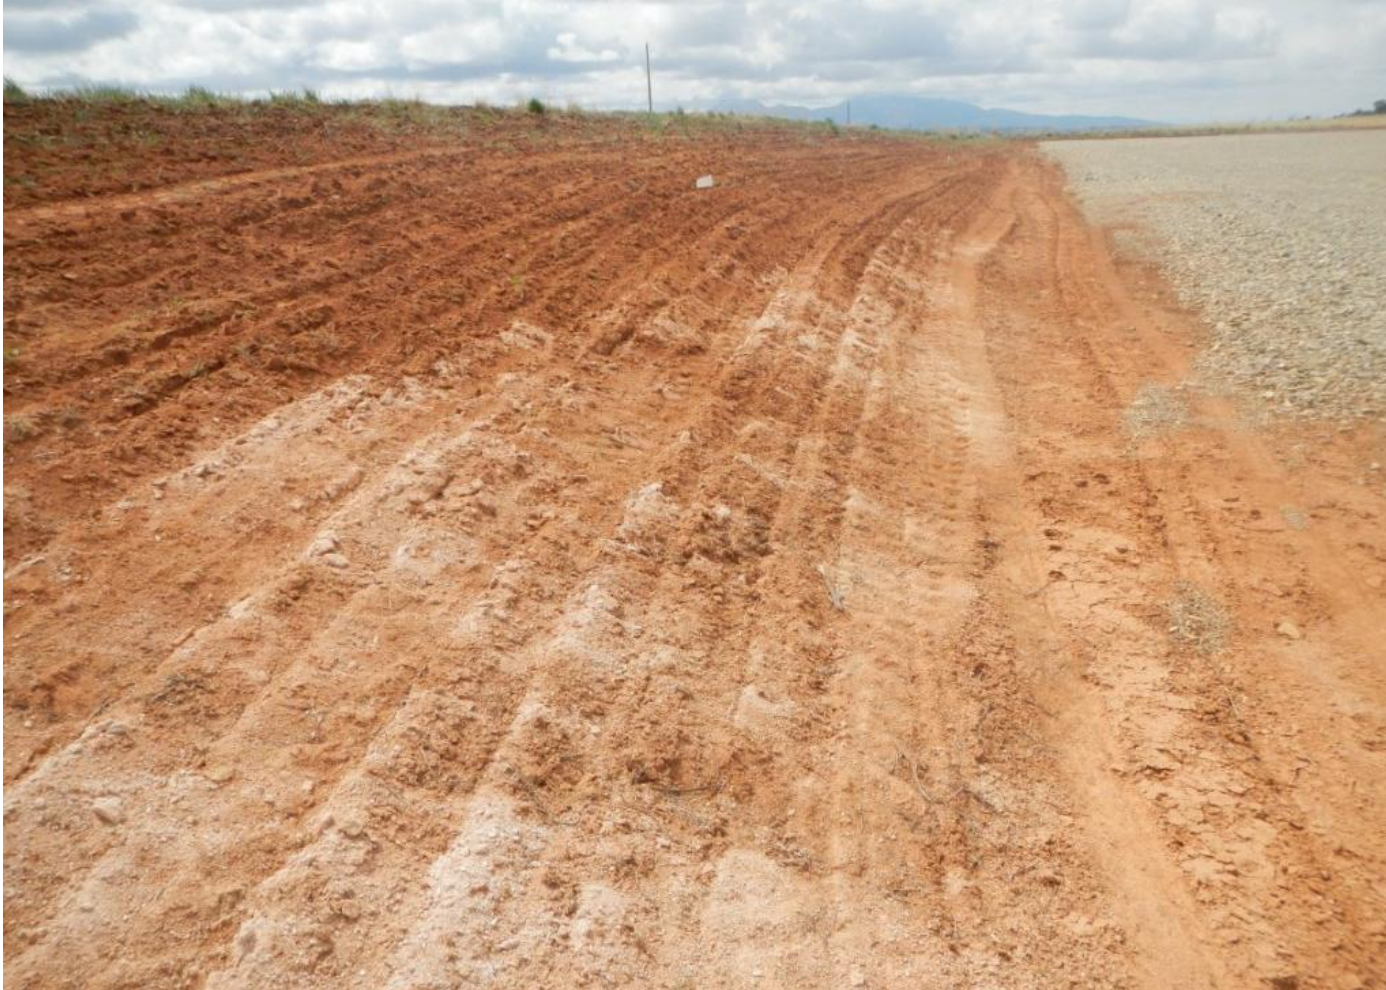
Photo 2. View of the eastern portion of the project area from the northeastern corner facing southward. No revegetation was observed on the majority of the eastern and northeastern cut-slope.

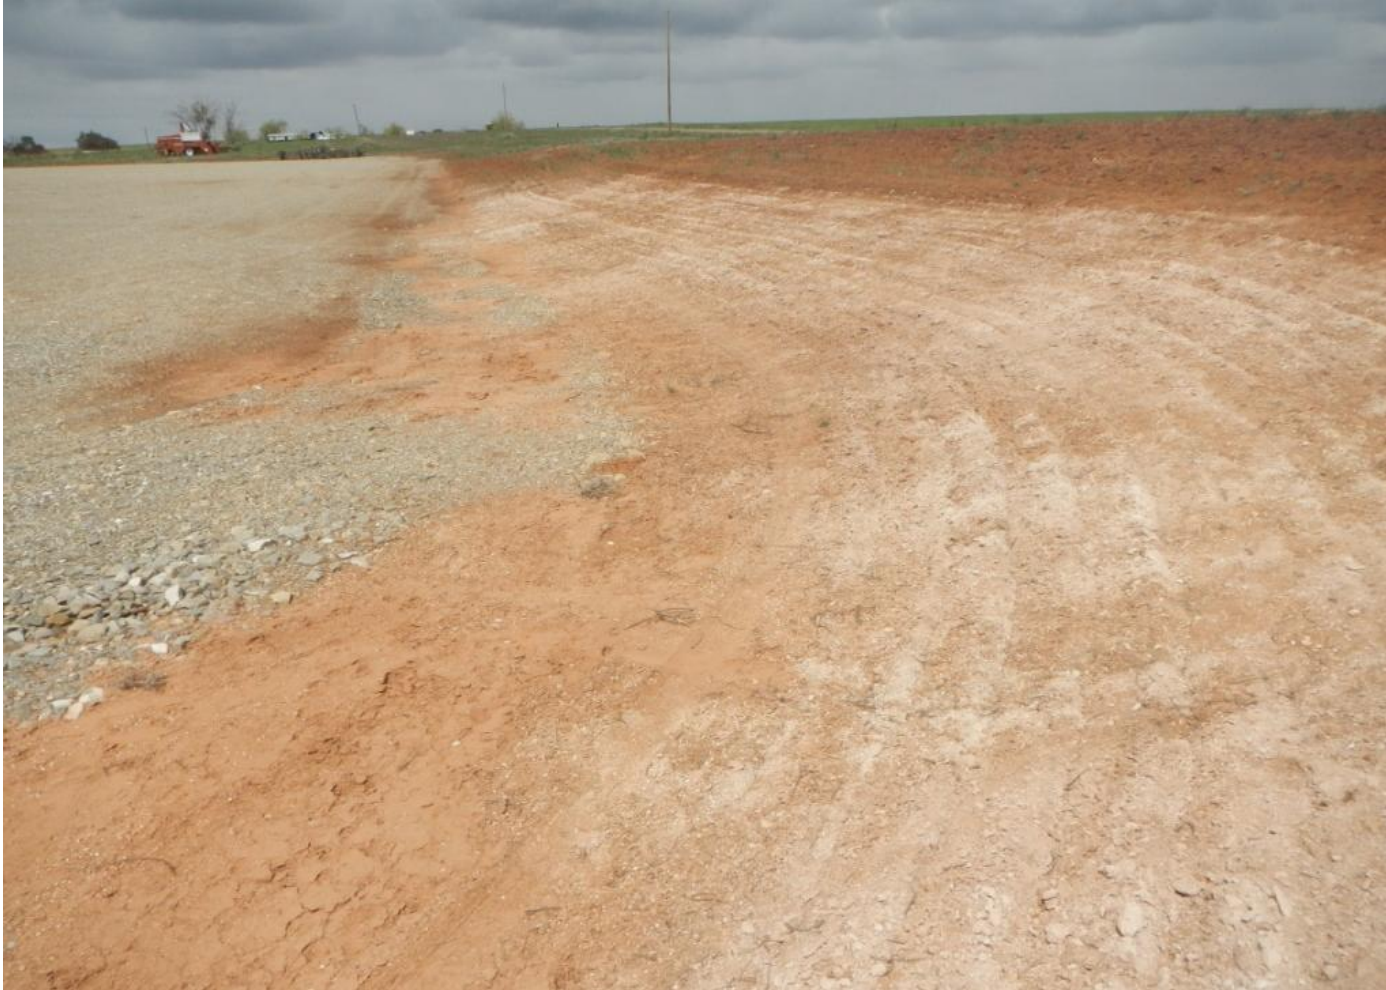
Photo 3. View of northern portion of the project area from the northeastern corner facing westward. Little revegetation on the cut-slope.

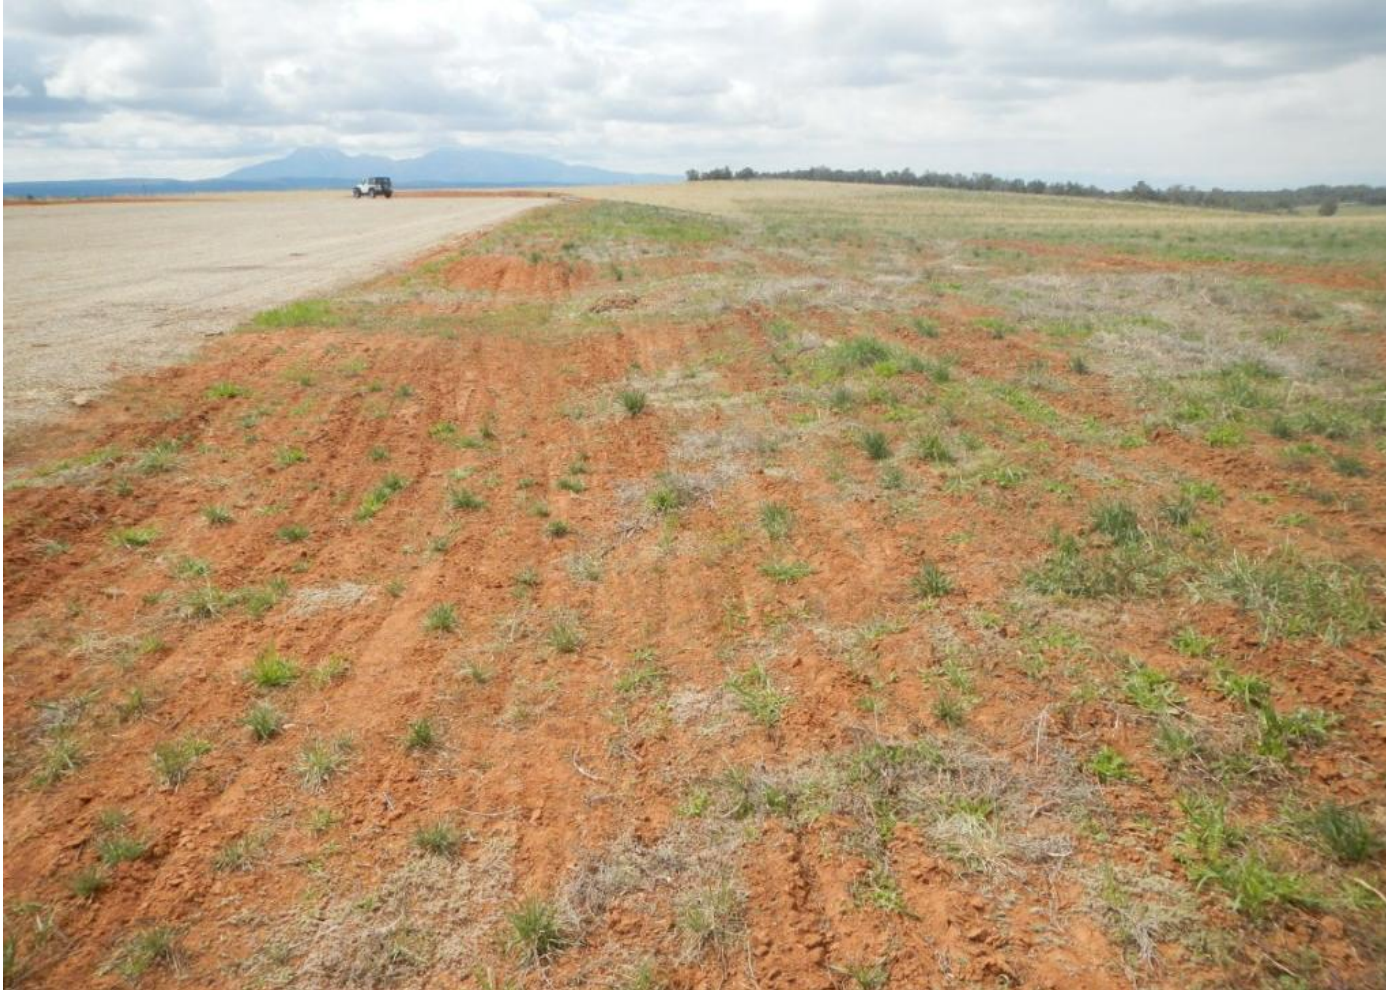
Photo 4. View of the western portion of the project area from the northwestern corner facing southward. Revegetation with perennial grasses appears to be progressing here. There are many weed seedlings of kochia (*Kochia scoparia*) and Russian thistle (*Salsola tragus*).

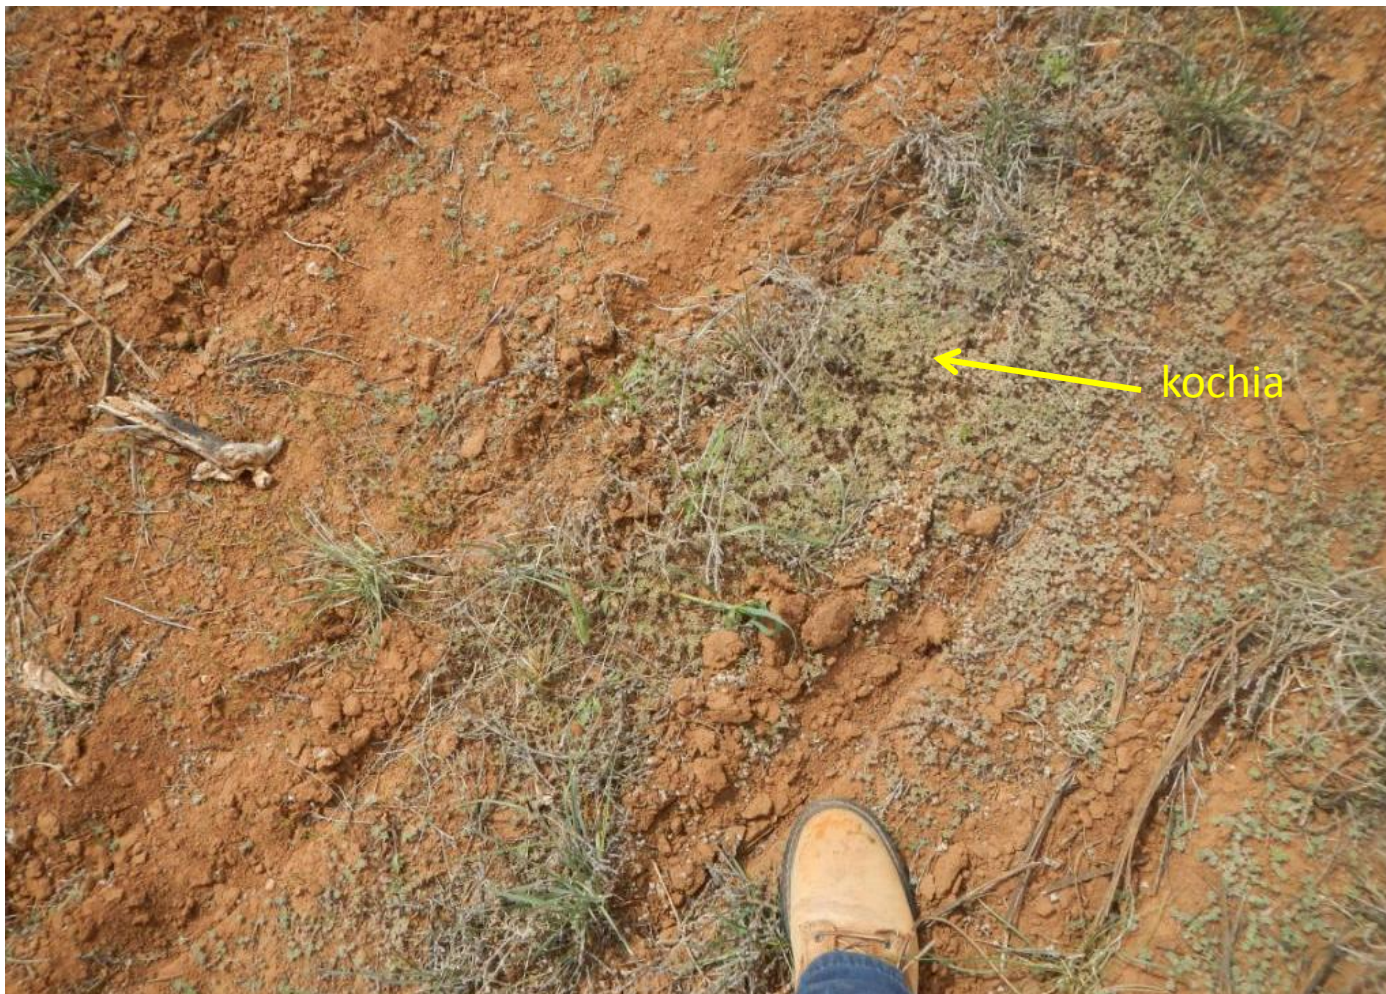
Photo 5. Birdseye view of vegetation within the western portion of the project area. Some perennial grasses are becoming established and a dense population of kochia is present.

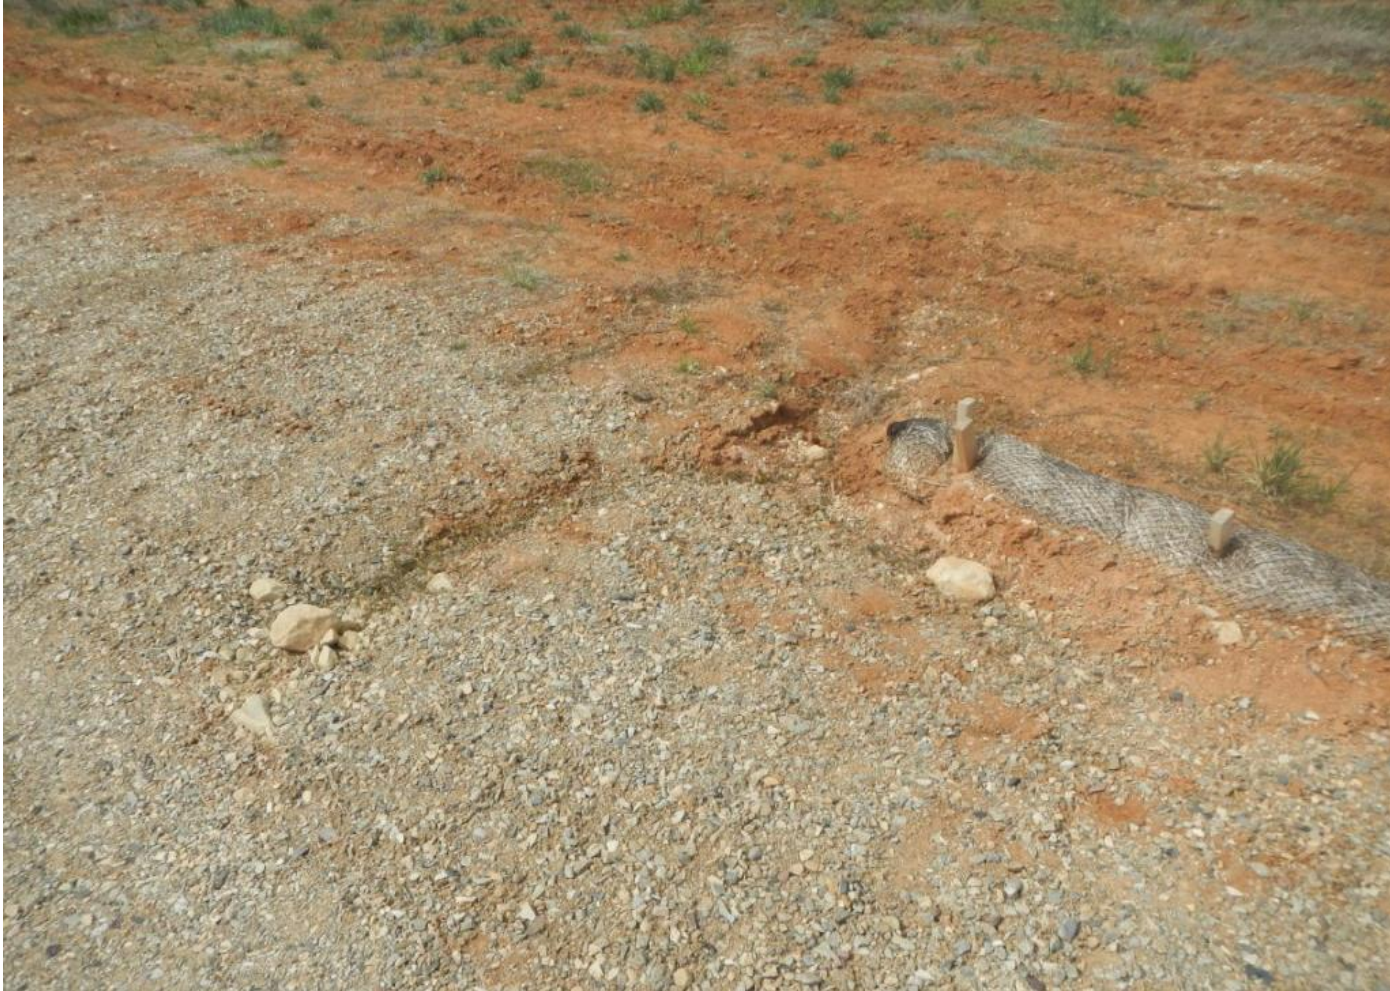
Photo 6. View of erosion occurring along the edge of a wattle on the southwestern edge of the well pad.

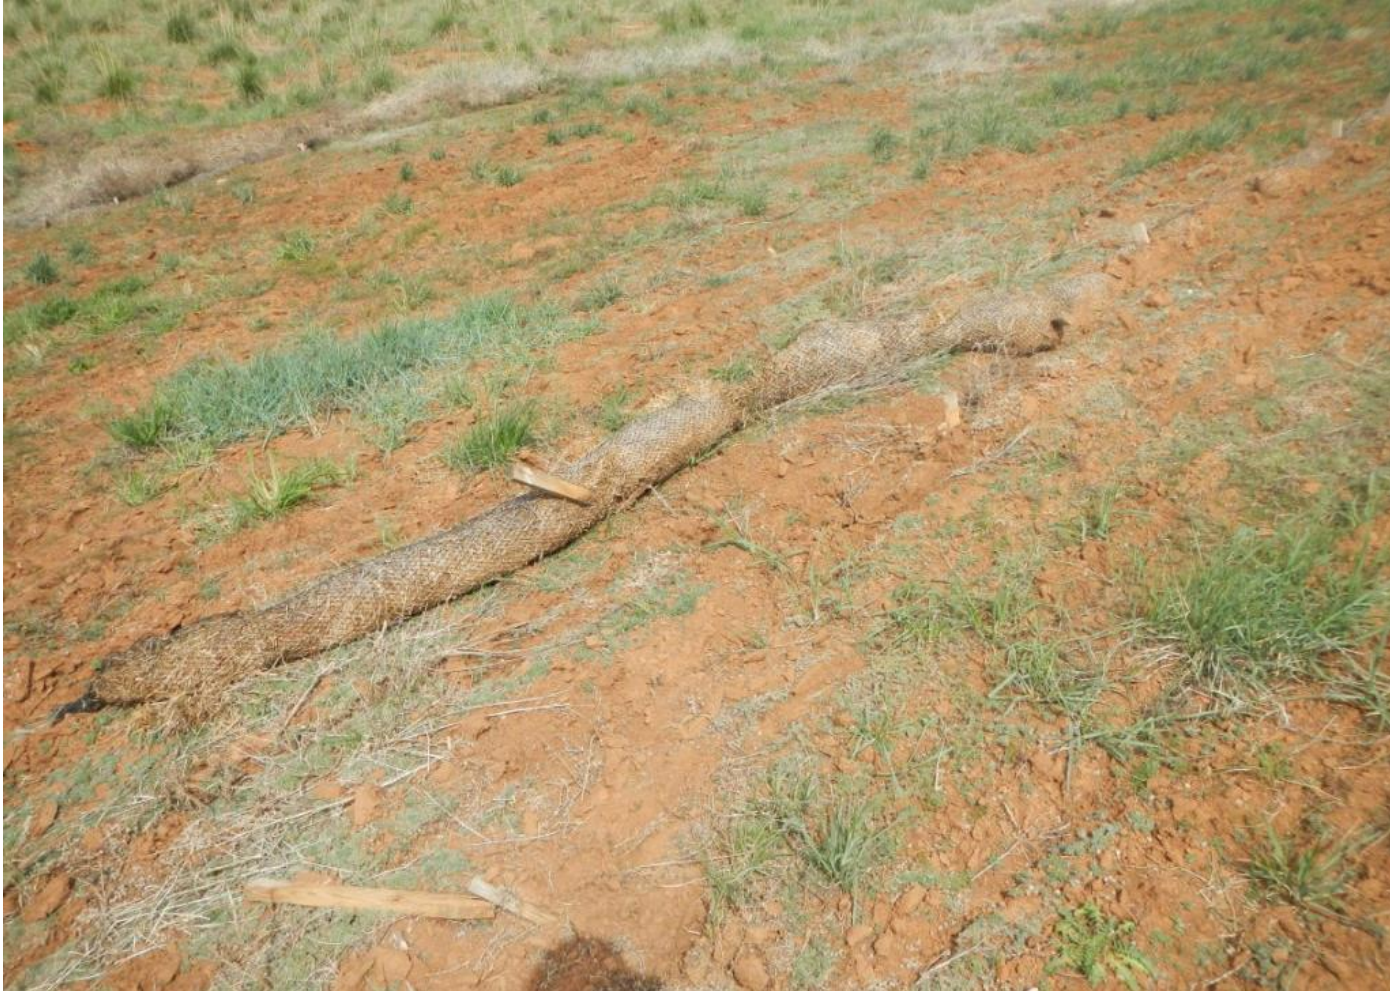
Photo 7. View of wattle in the southwestern portion of the project area that needs maintenance.

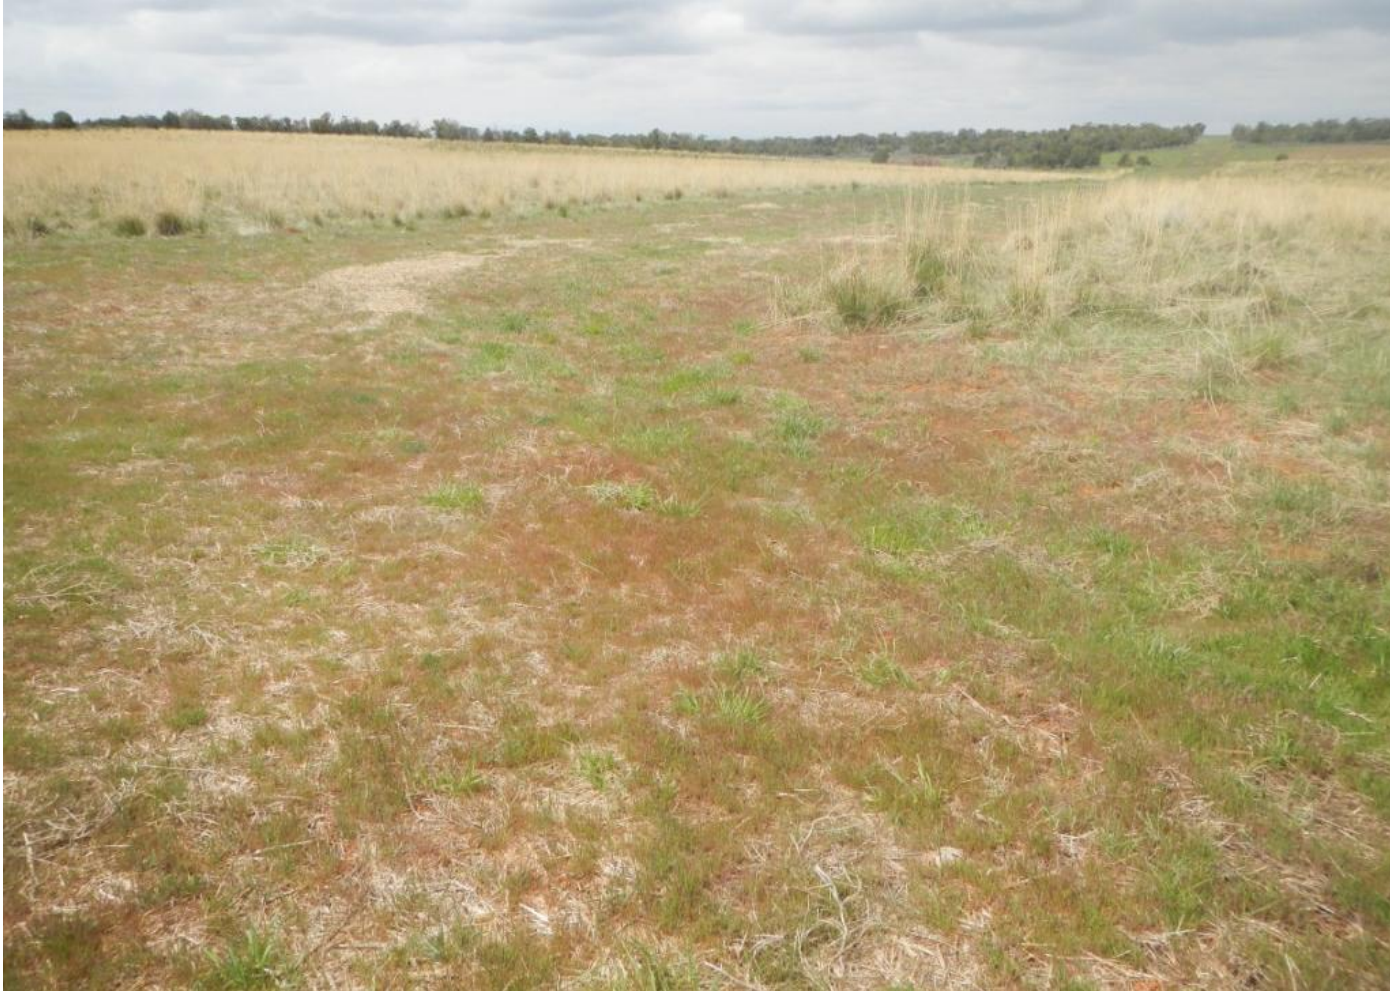
Photo 8. View of the pipeline corridor that appears to have been recently seeded.

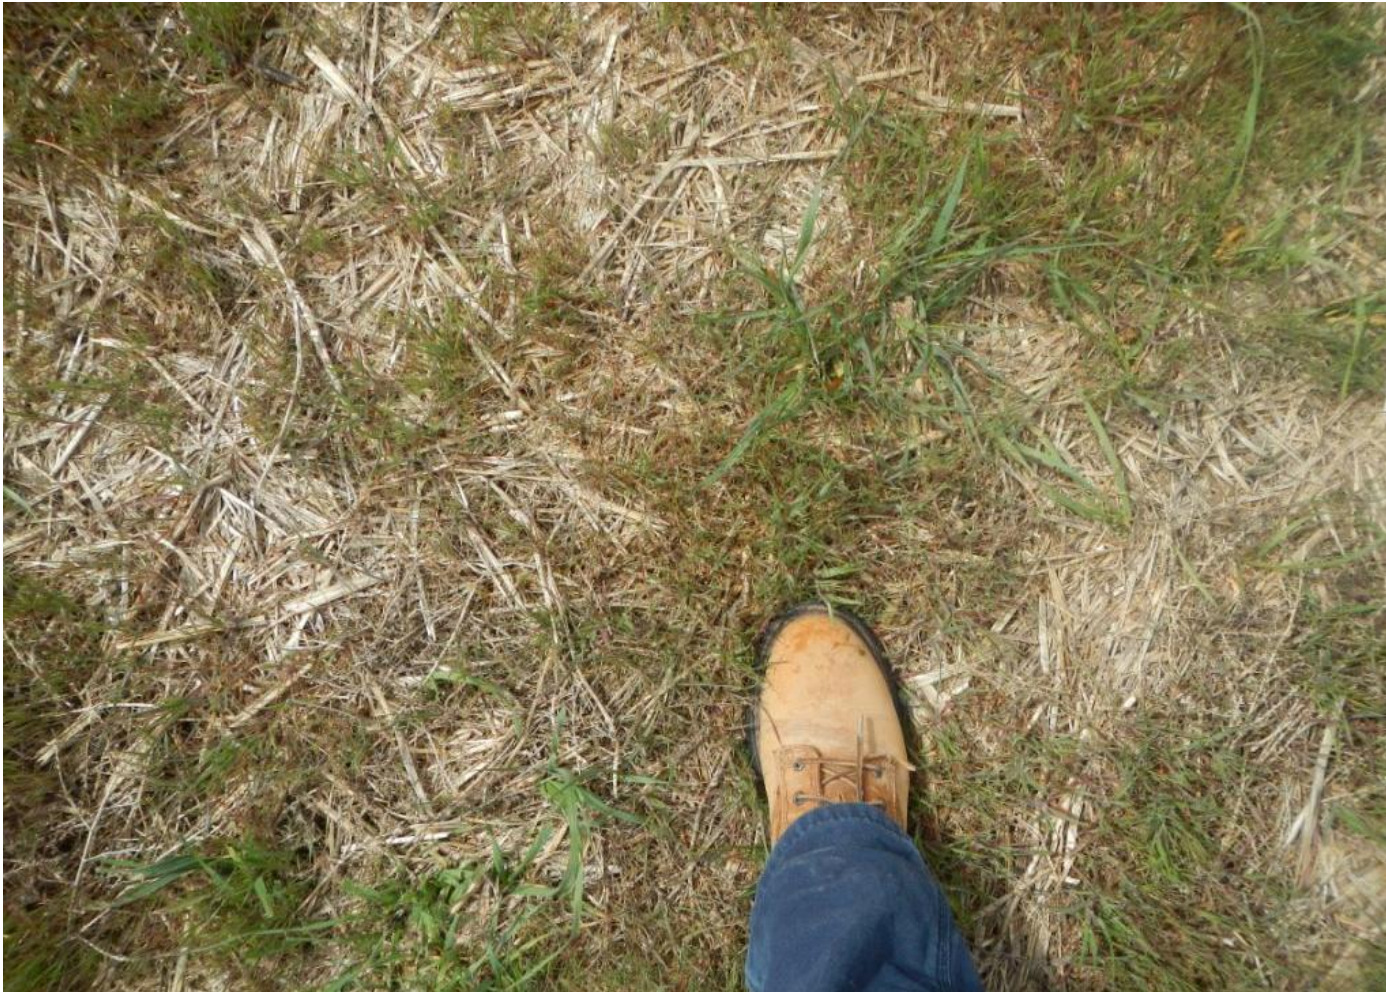
Photo 9. Birdseye view of vegetation within the pipeline tie corridor. Vegetation is largely cheatgrass (*Bromus tectorum*) with scattered perennial grasses that appear to be intermediate wheatgrass (*Thinopyron intermedium*).
