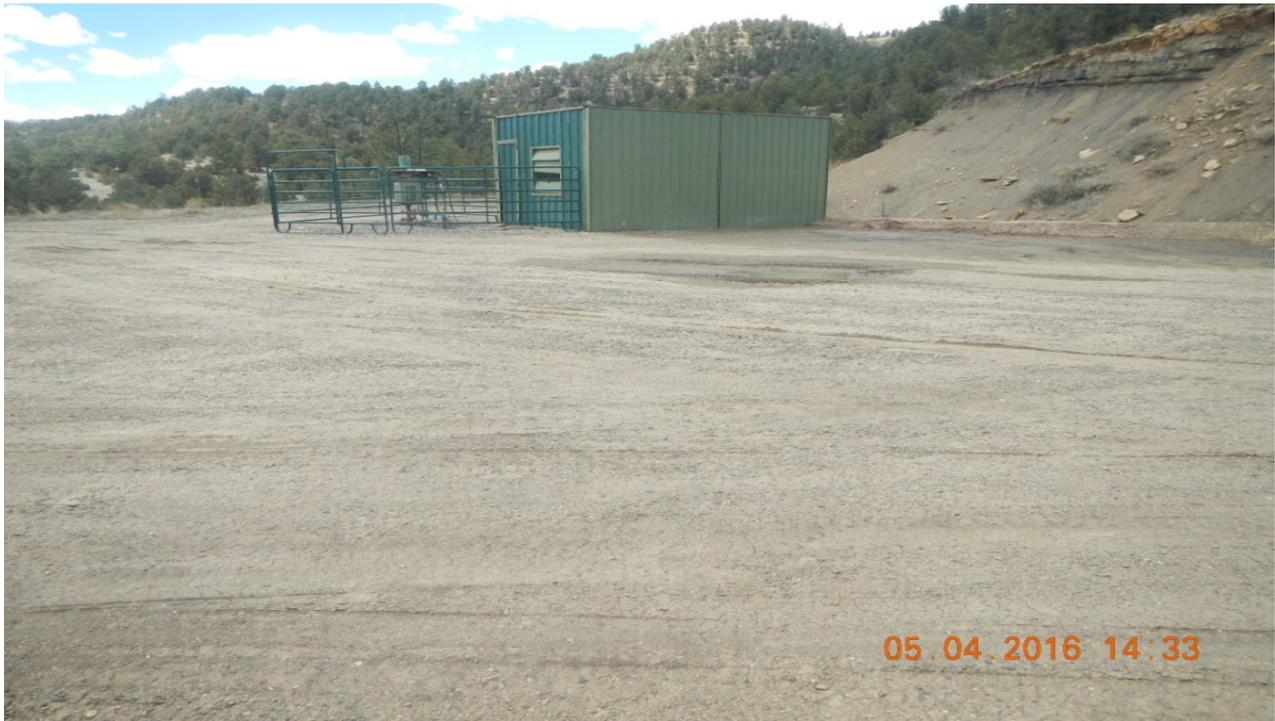
photo 1: Facing northwest at location.

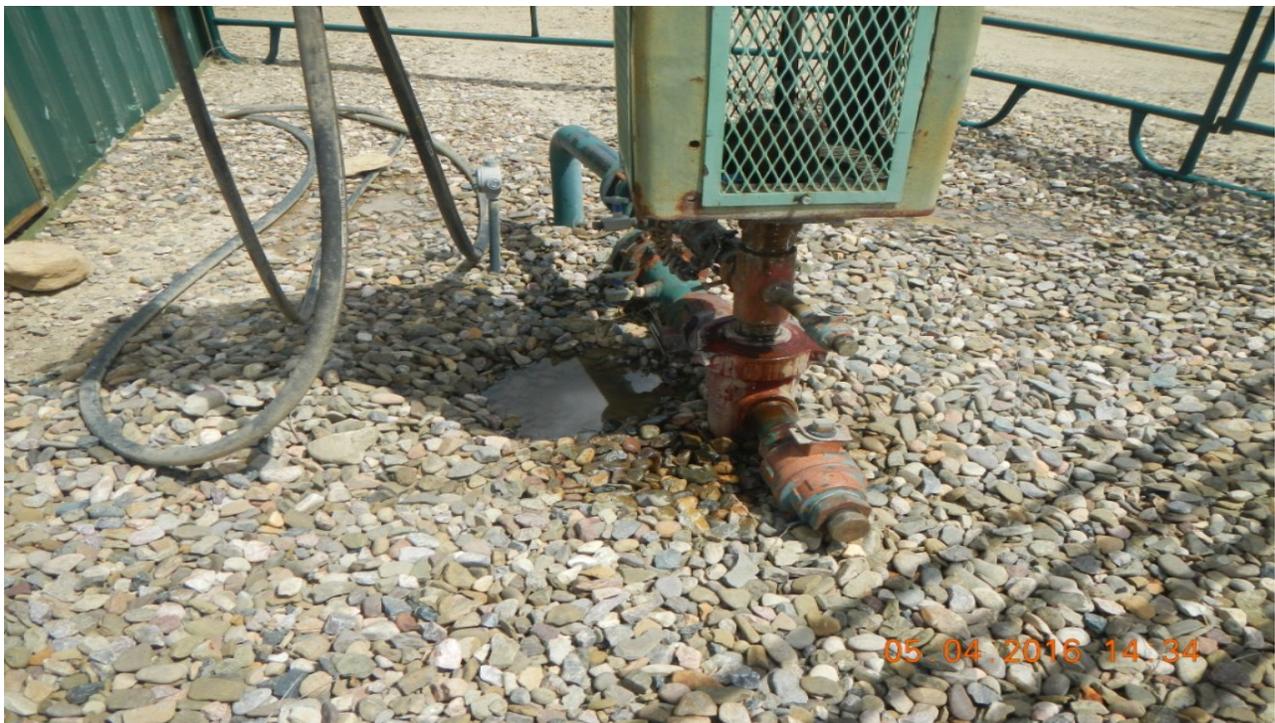
photo 2: There is a dripping water leak from the well which was noticed in the previous inspection.

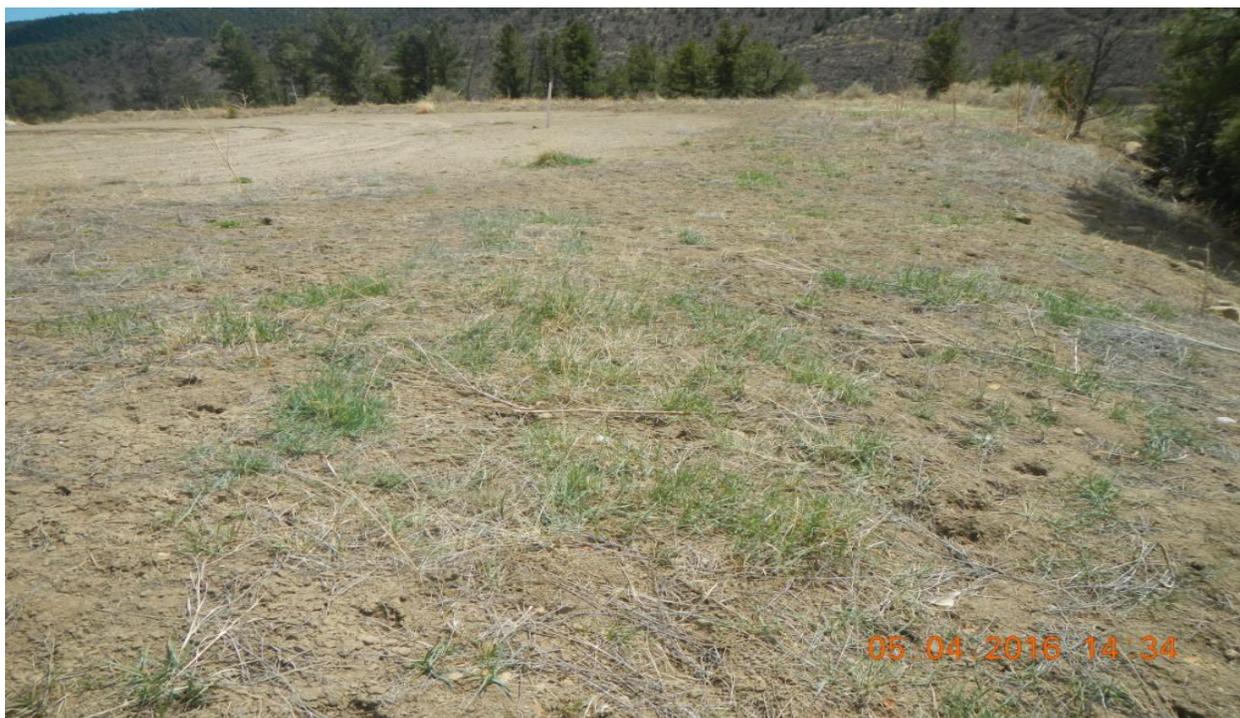
photo 3: Northwest side of the location facing south.

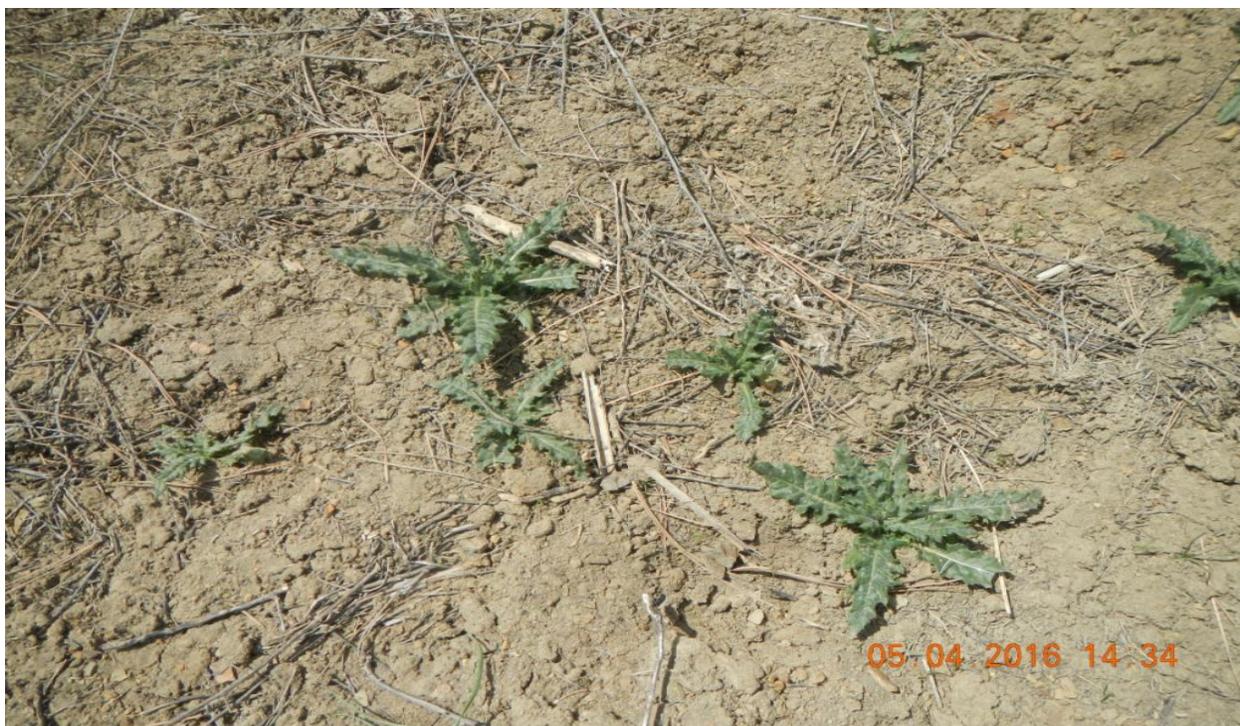
photo 4: Noticed Bull thistle beginning to germinate at the west side of the location.
