Final Reclamation Inspection

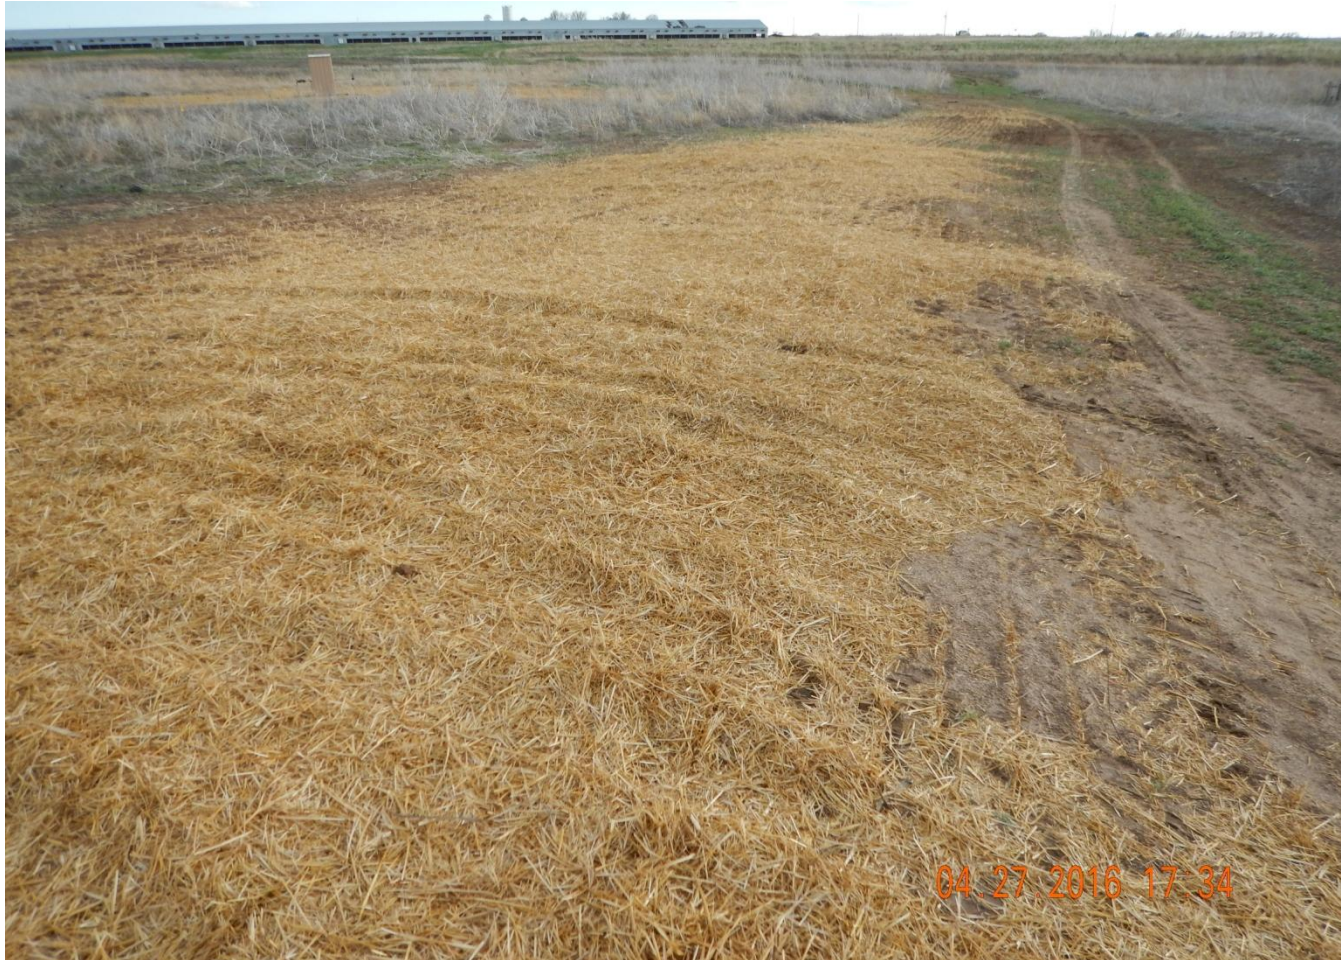
Photo 1. Photo taken from location entrance, facing South. Seeded and mulched along access road.

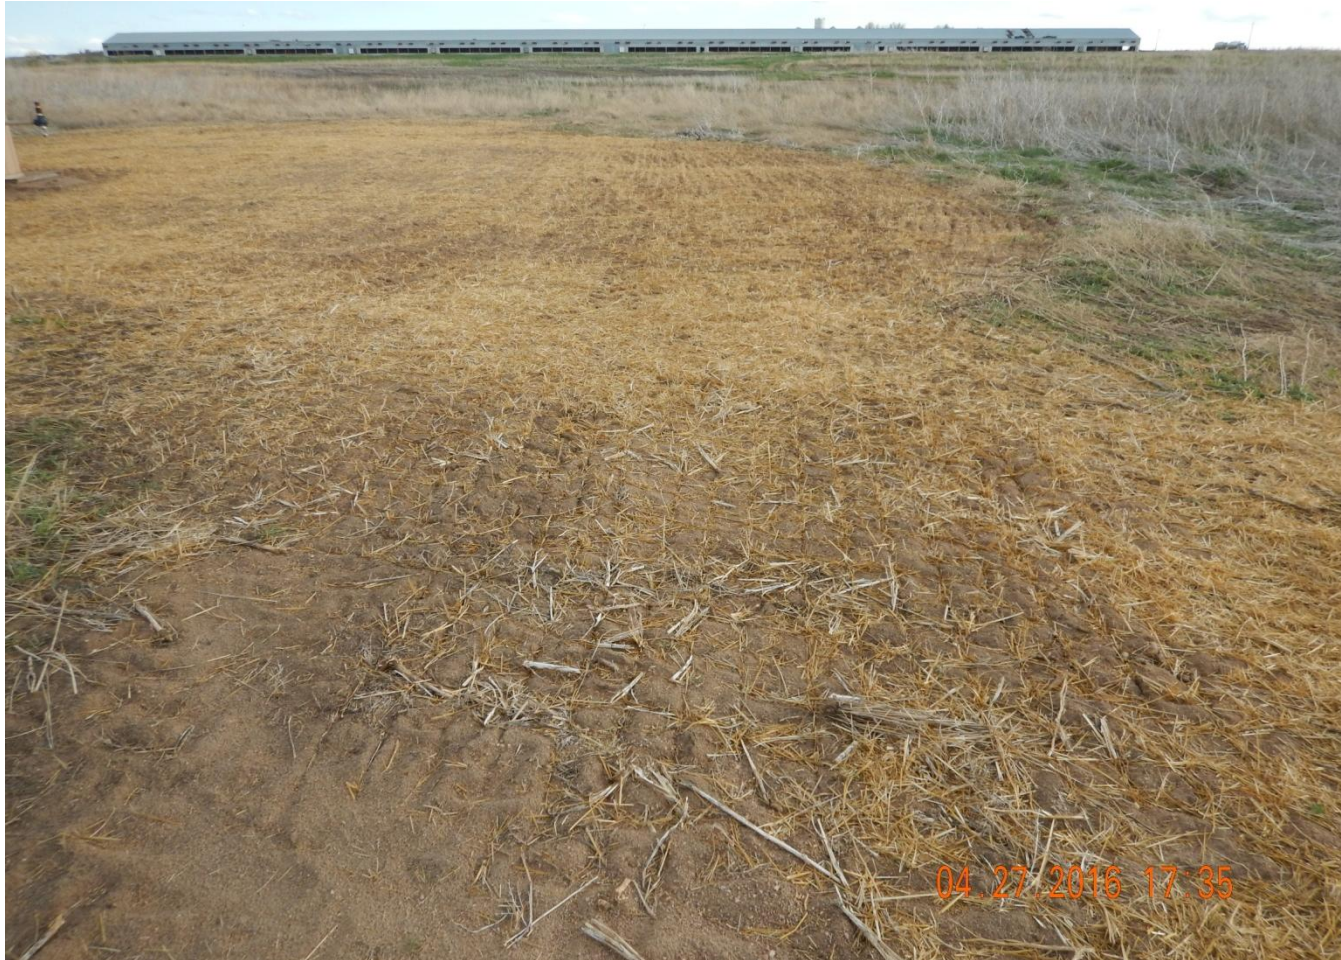
Photo 2. Photo taken from northern location, facing South. Seeded and mulched location.

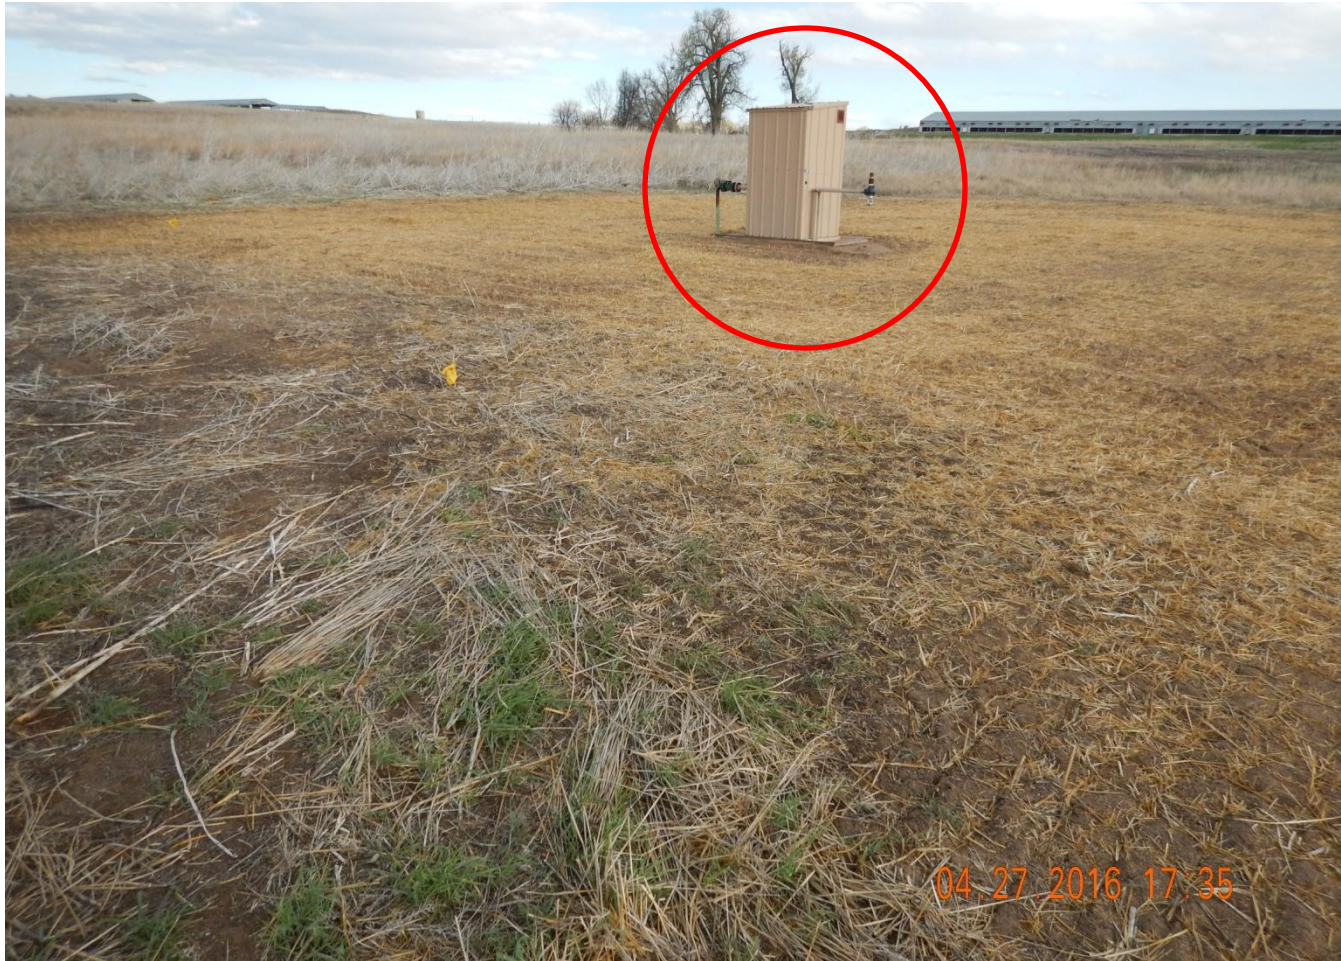
Photo 3. Photo taken from northern location, facing Southeast. Seeded and mulched location. DCP equipment left behind.
