Final Reclamation Inspection

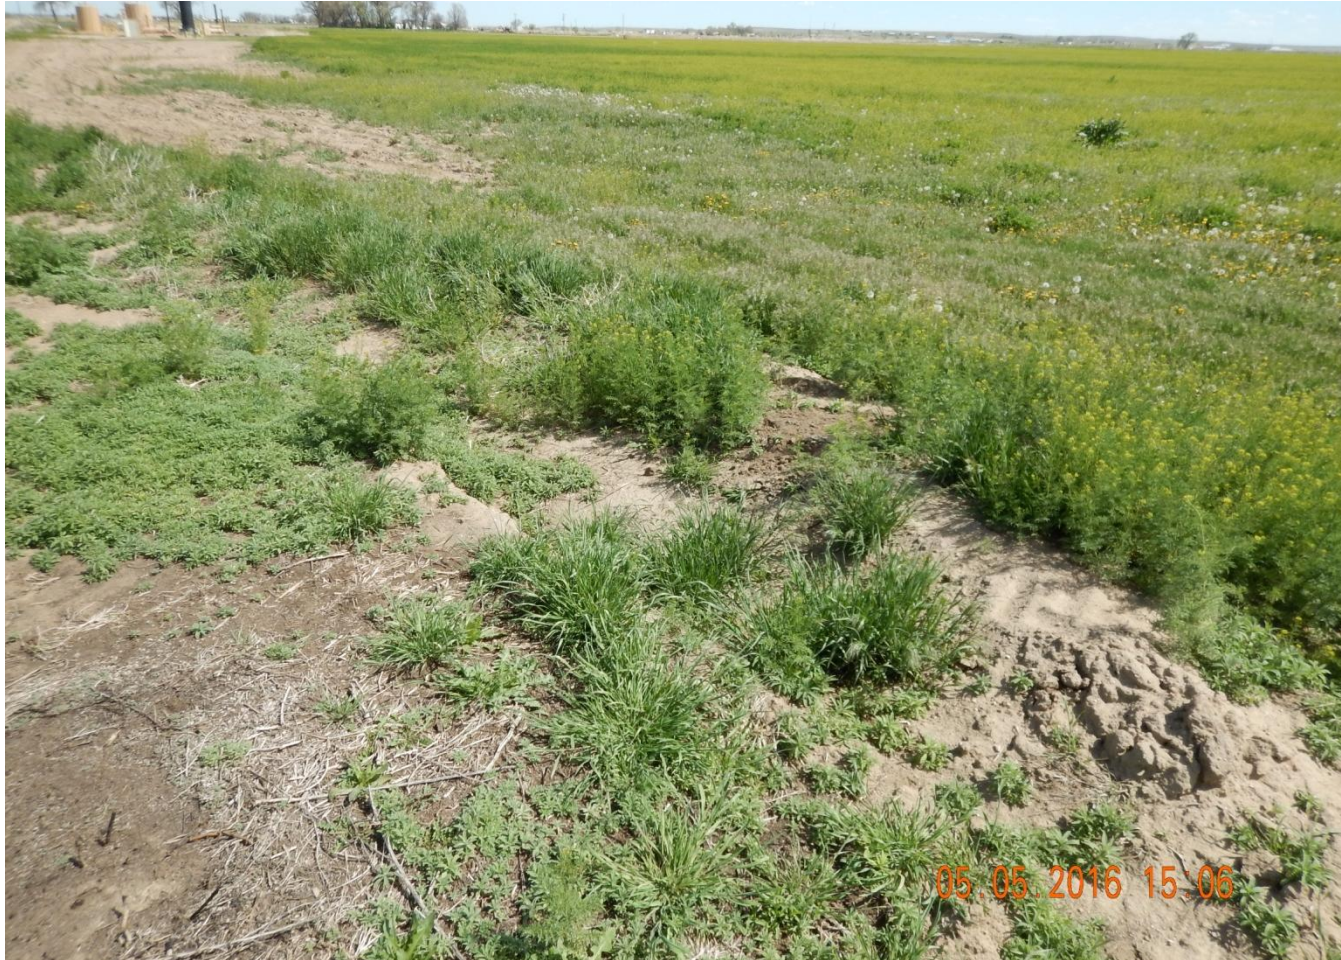
Photo 1. Photo taken from north of location, facing Southeast. It appears the location was never built.

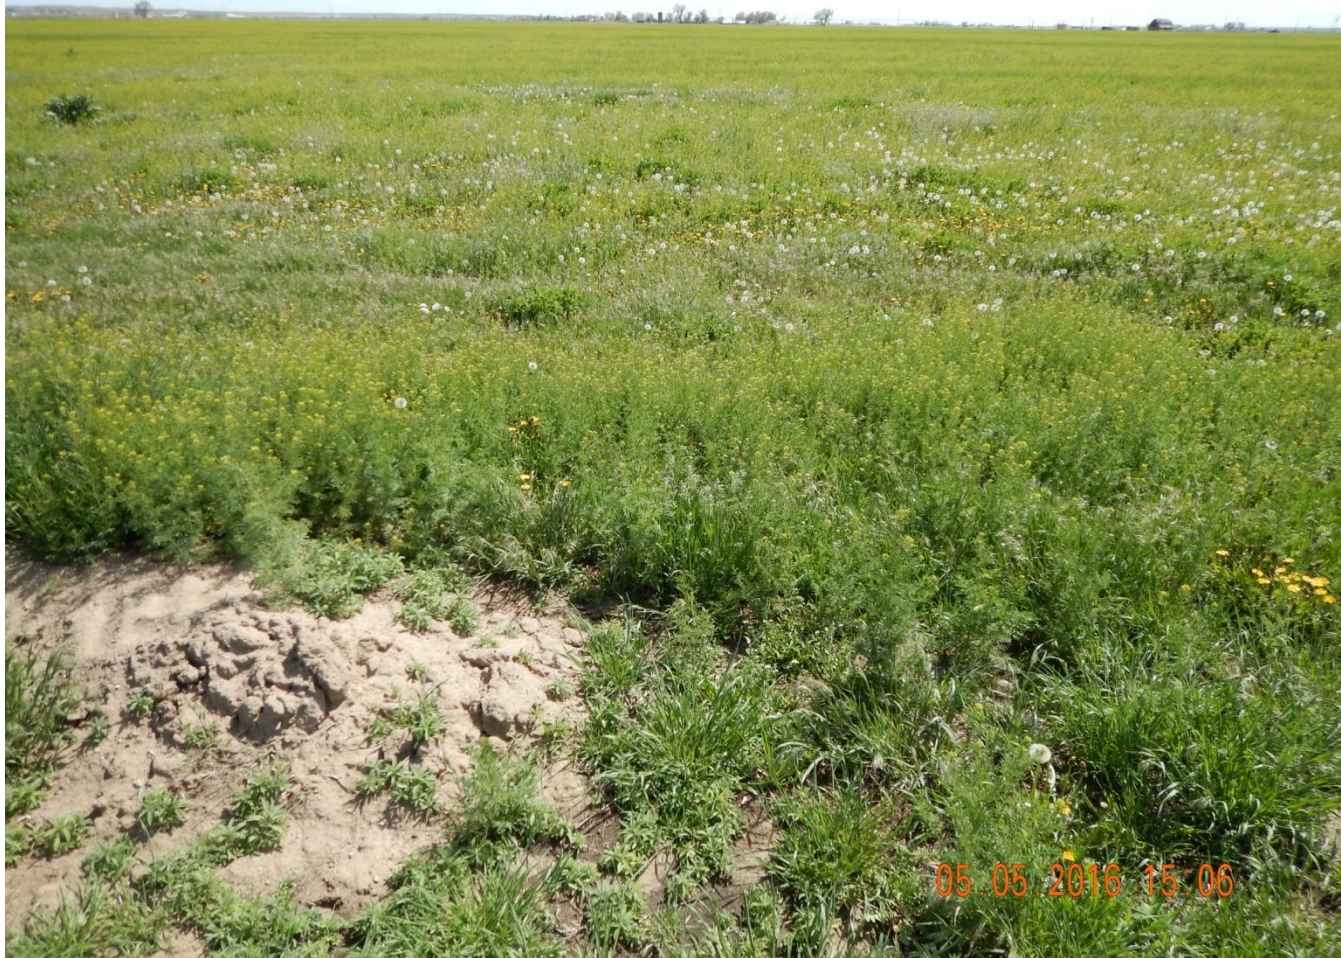
Photo 2. Photo taken from north of location, facing South. It appears the location was never built.

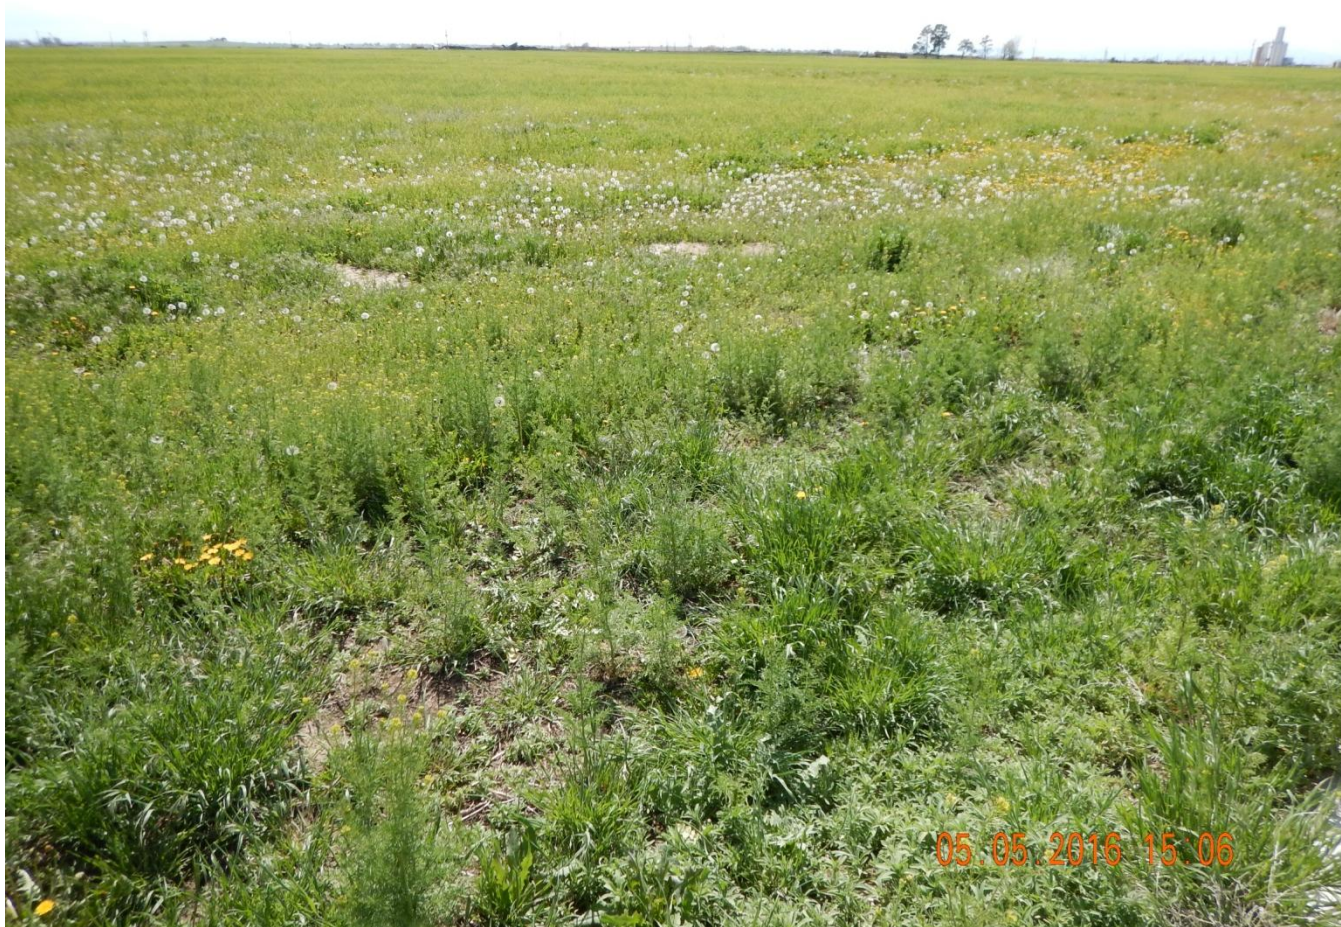
Photo 3. Photo taken from north of location, facing Southwest. It appears the location was never built.

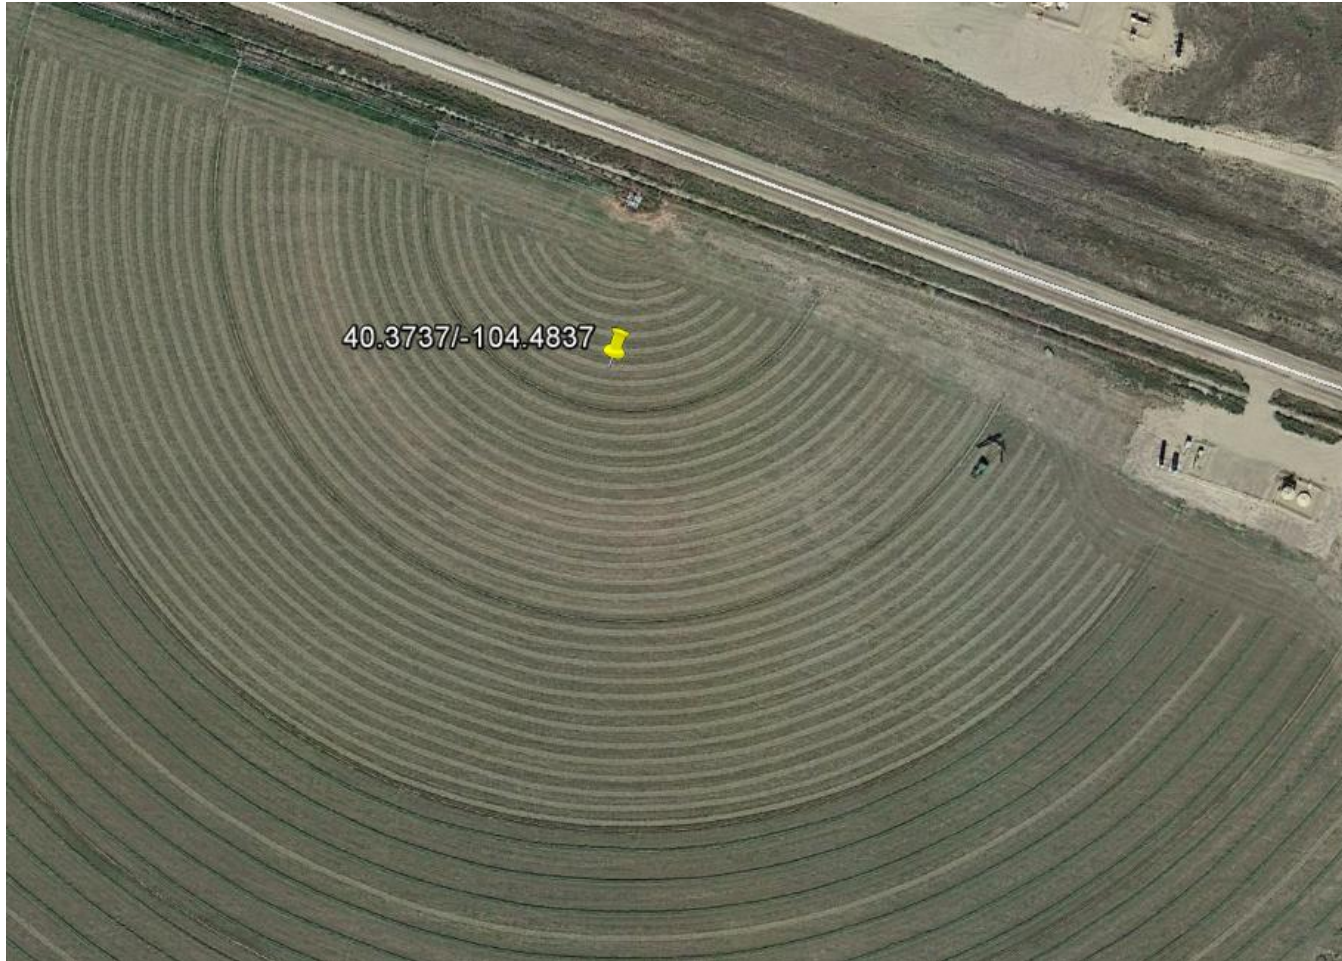
Photo 4. Google Earth aerial imagery taken 9/6/2013. It appears the location was never built based off aerial imagery and field observations.
