Construction Inspection

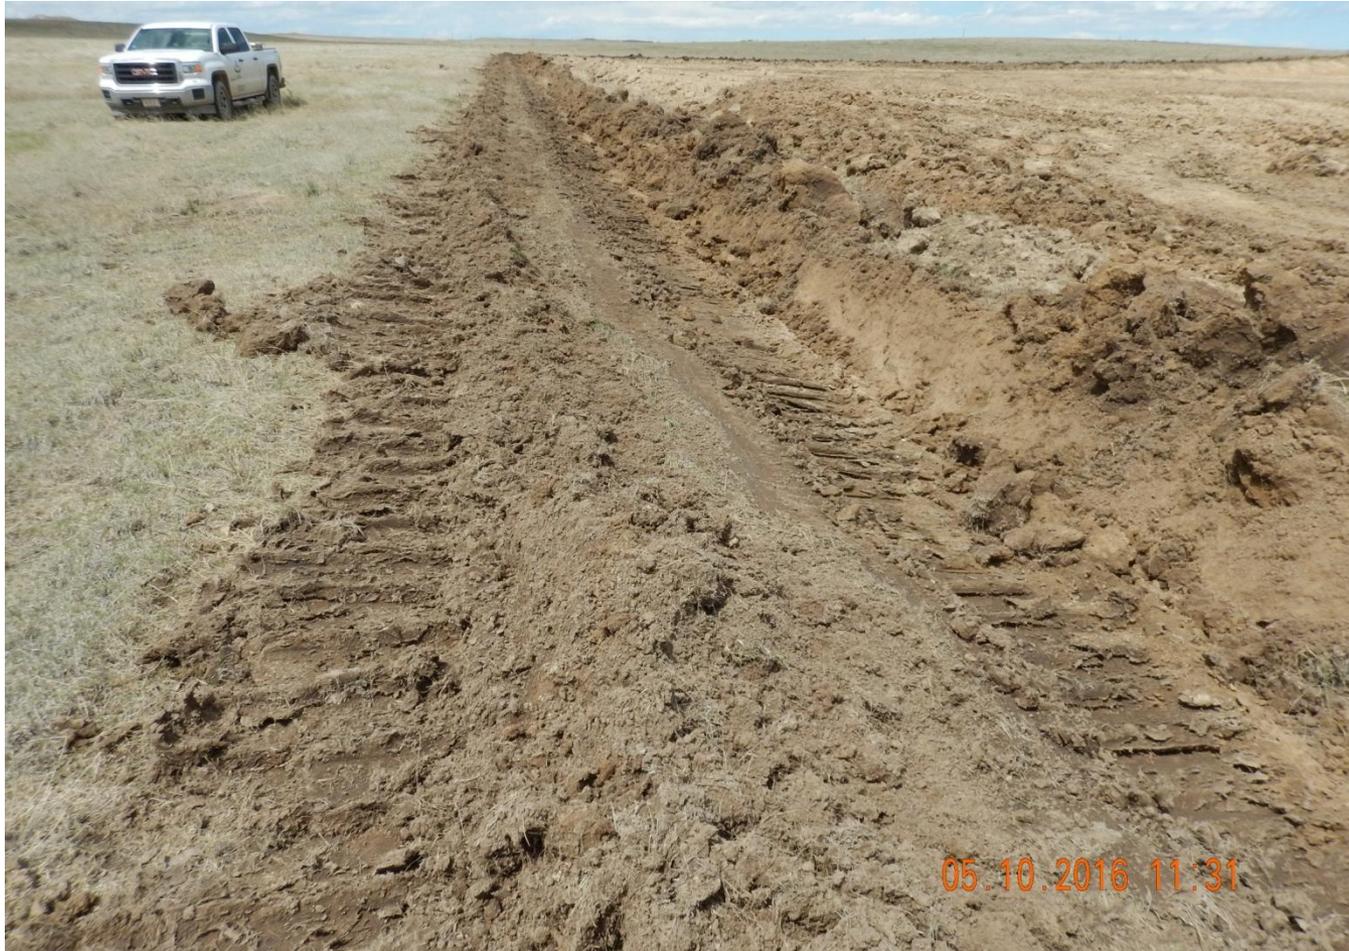
Photo 1. Photo taken from southeast location, facing West. Stormwater BMP installed in center of photo.

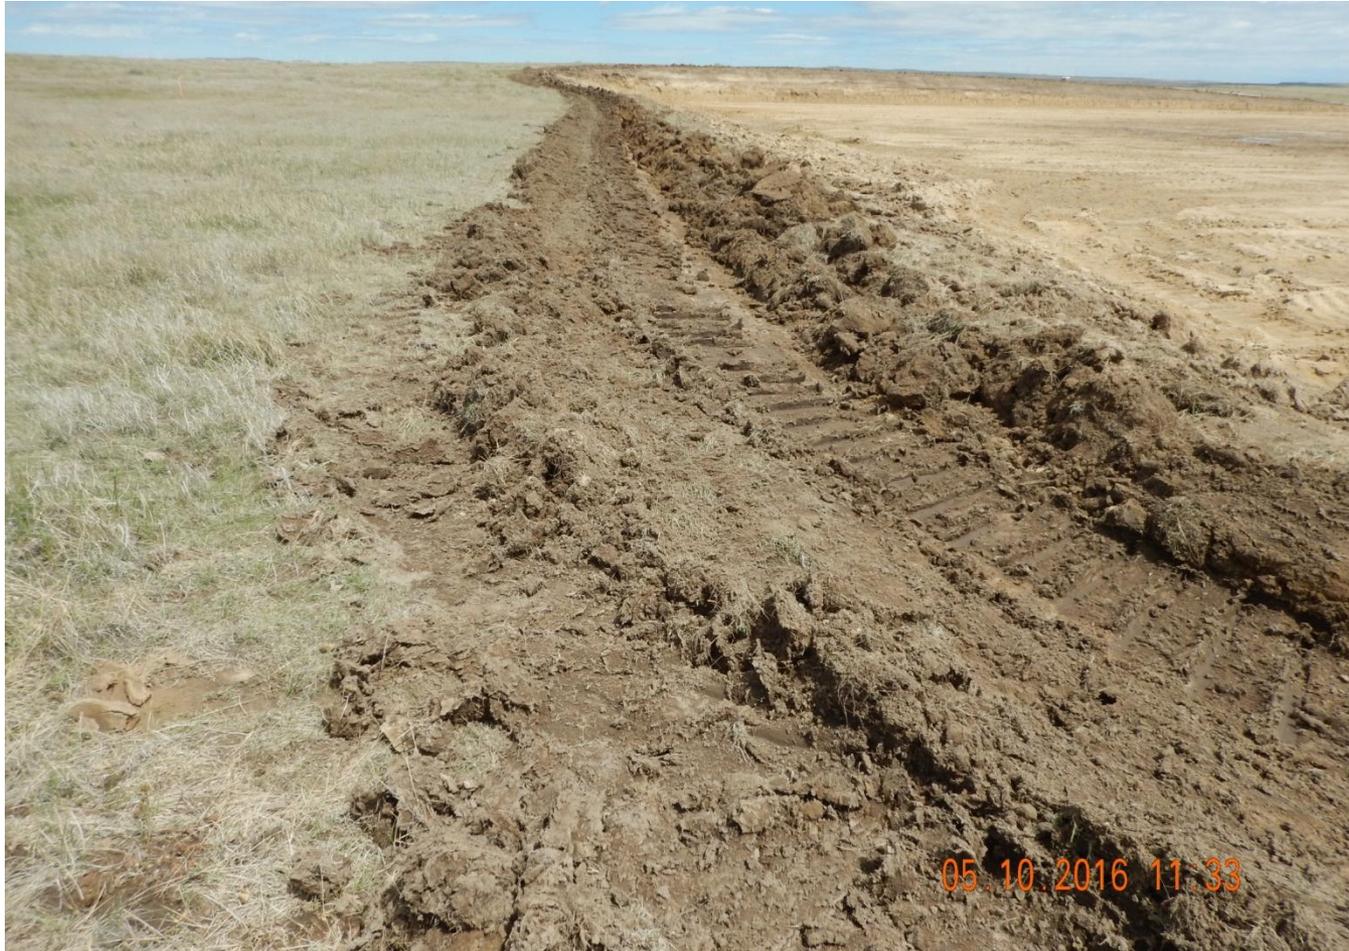
Photo 2. Photo taken from southeast location, facing North. Stormwater BMP installed in center of photo.

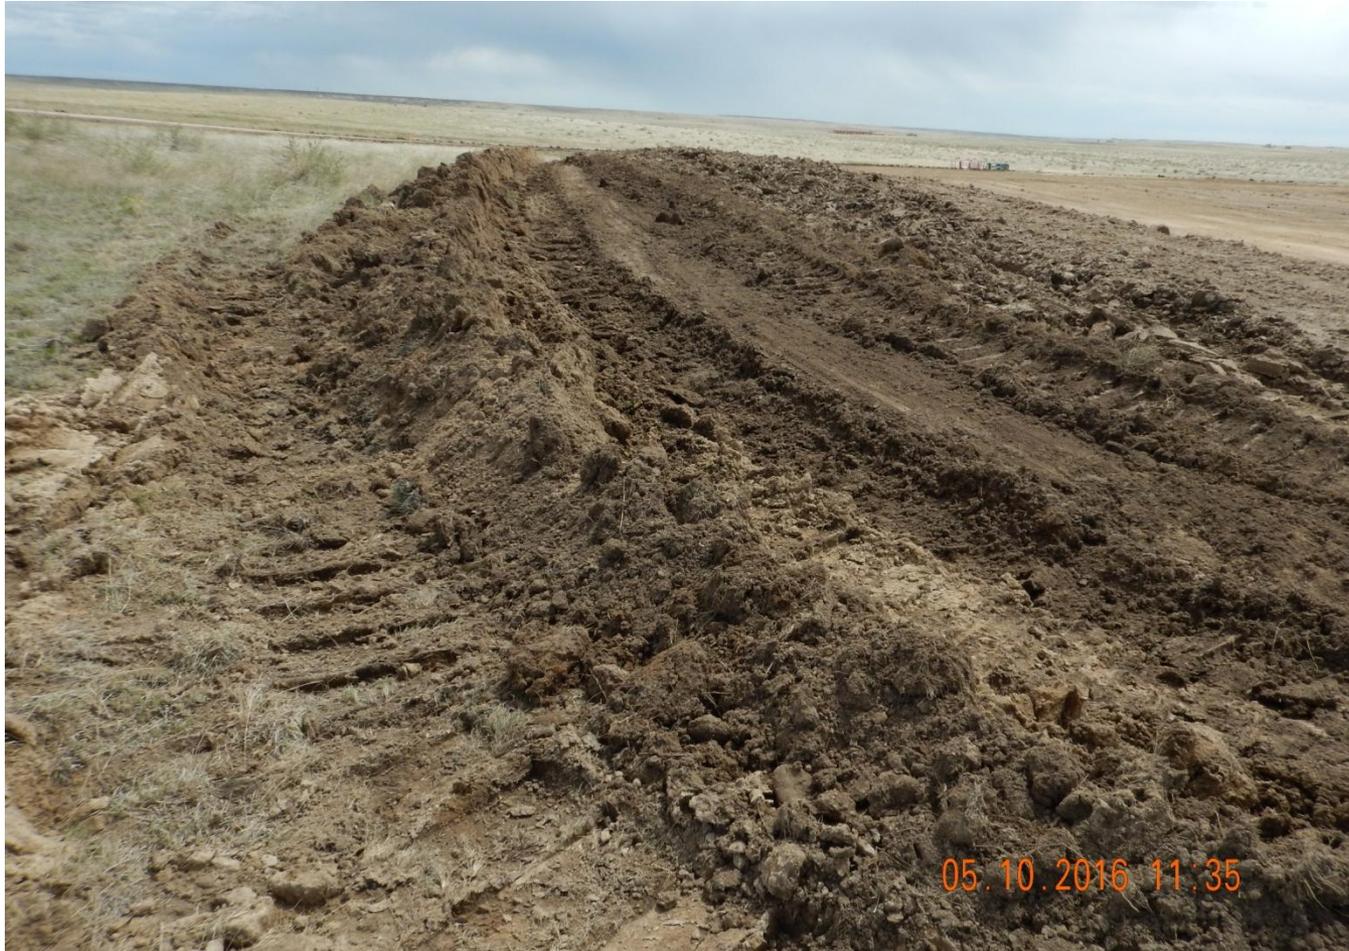
Photo 3. Photo taken from northwest location, facing East. Stormwater BMP installed in center of photo.

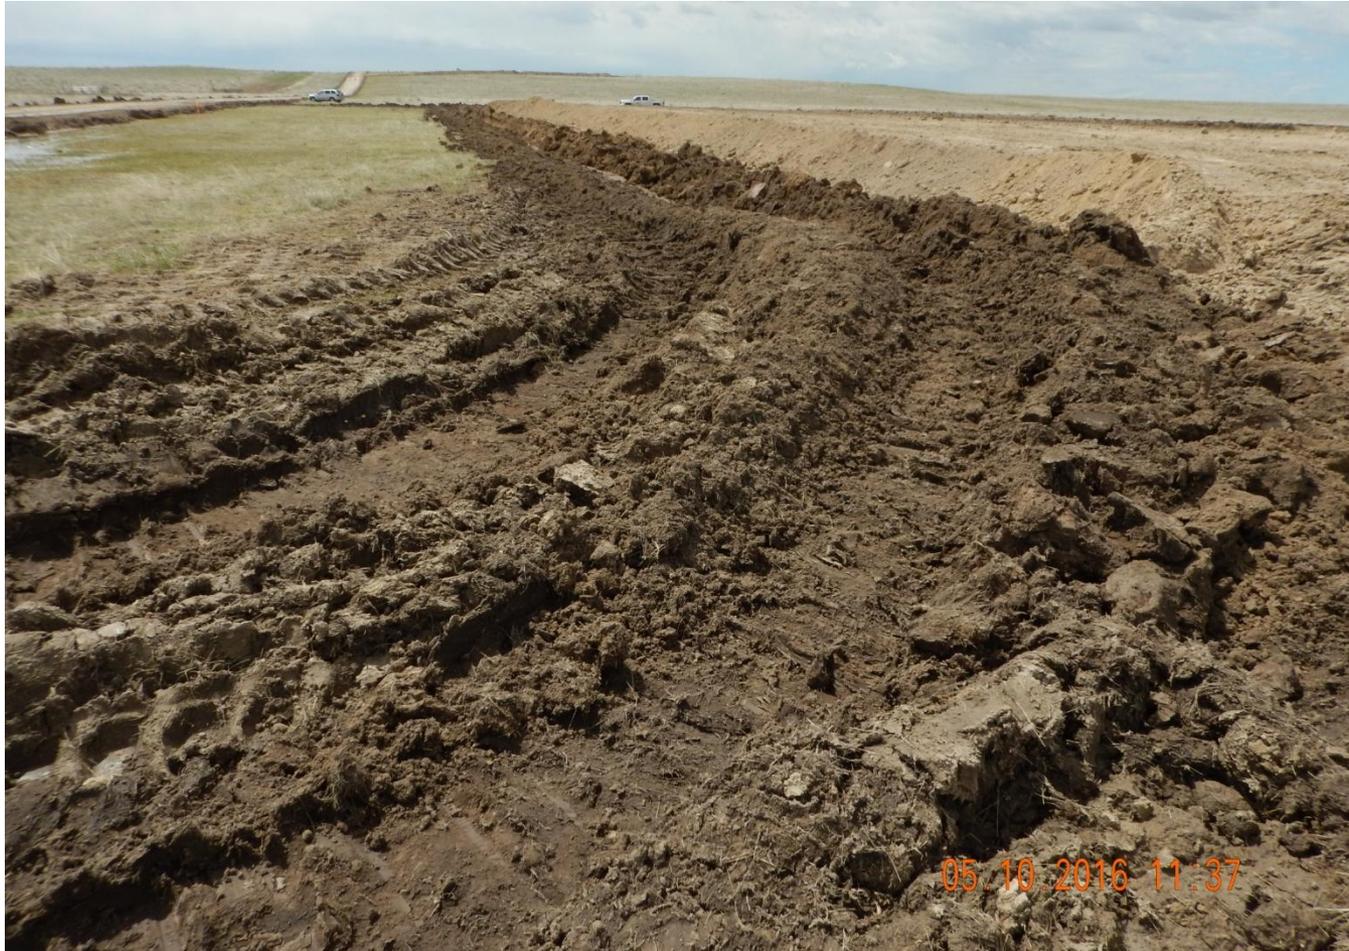
Photo 4. Photo taken from northeast location, facing South. Stormwater BMP installed in center of photo.

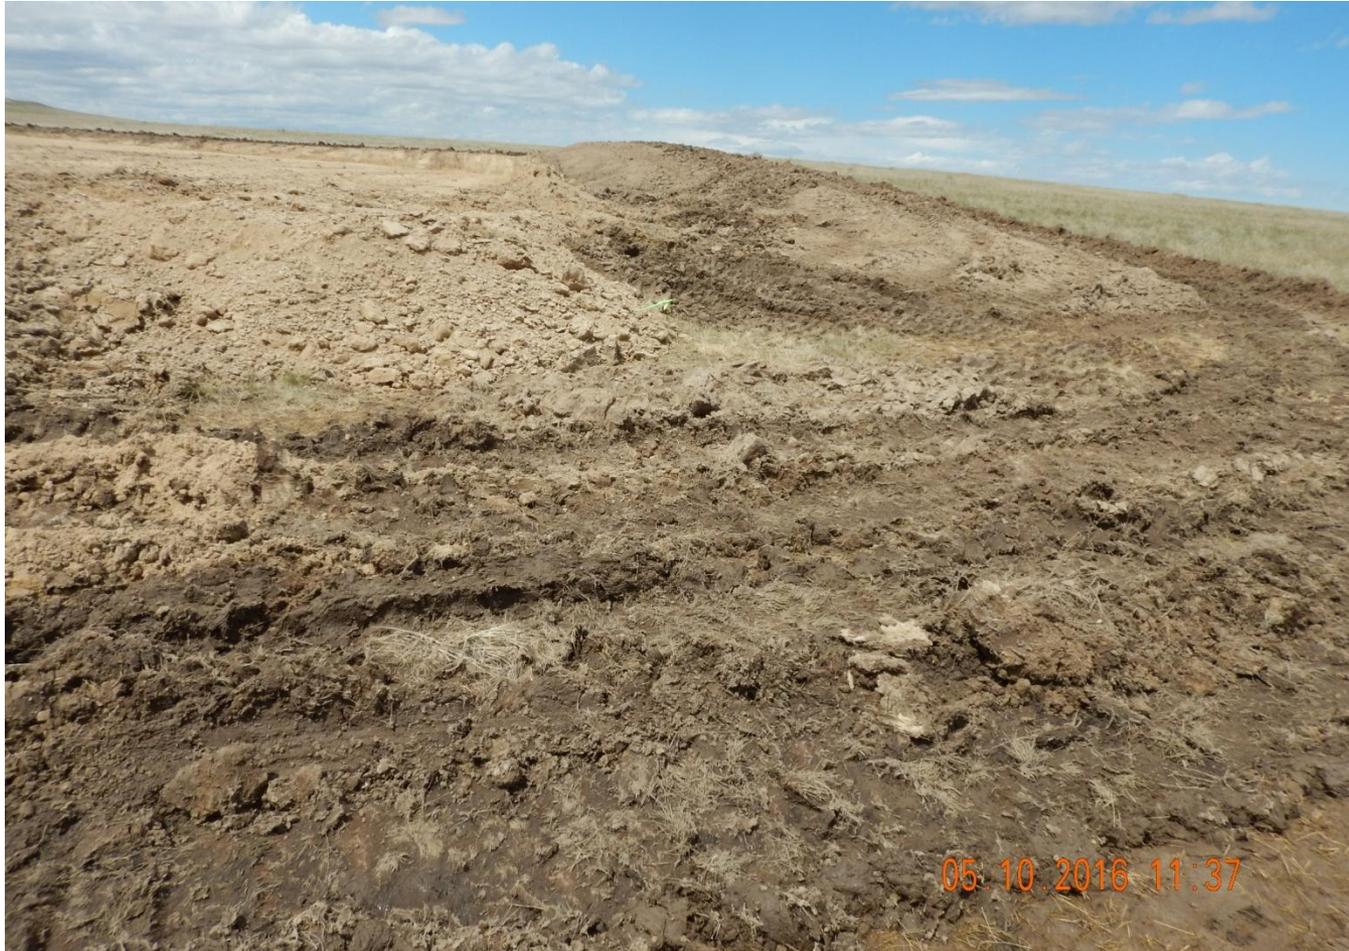
Photo 5. Photo taken from northeast location, facing West towards topsoil stockpile.
