Final Reclamation Inspection

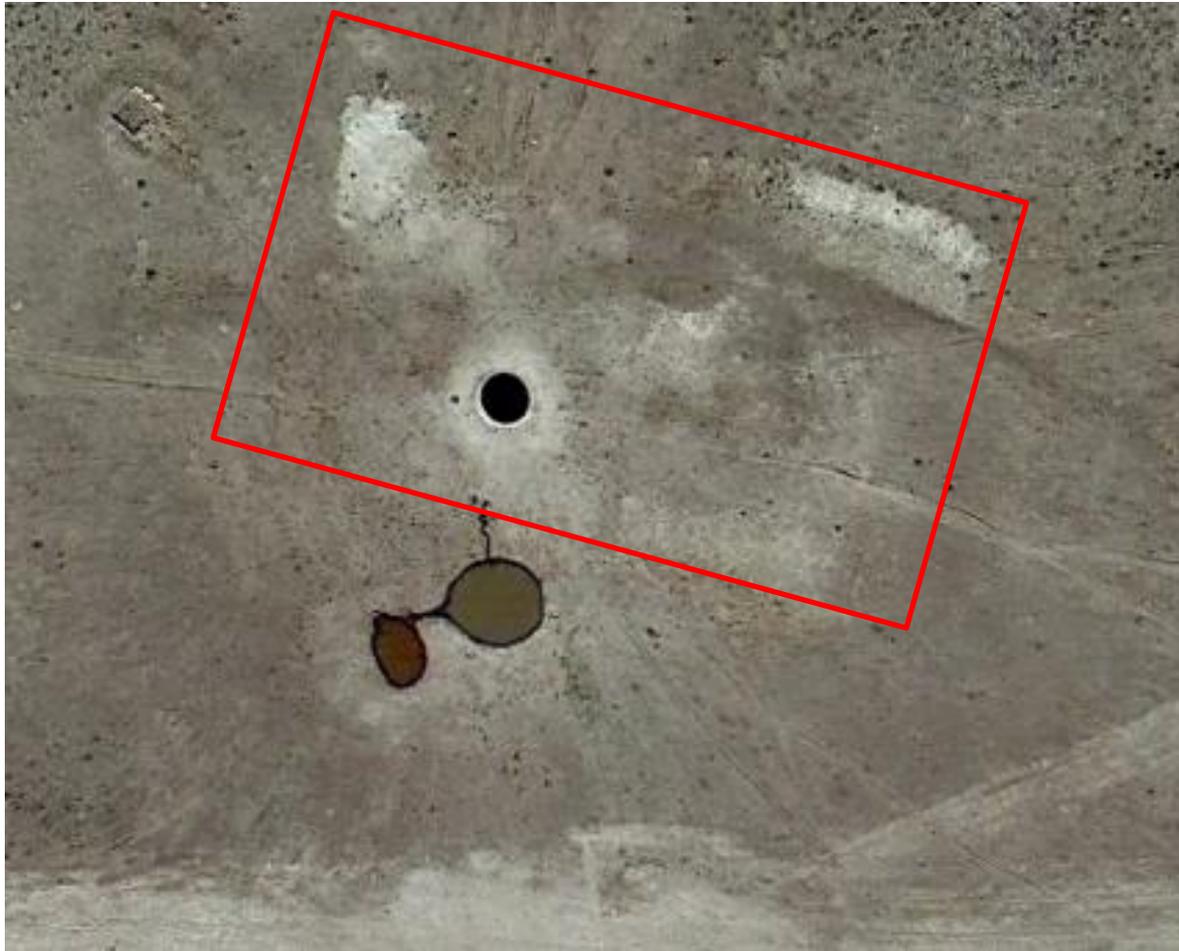
Photo 1. Google Earth aerial imagery taken 9/7/2013. Disturbance boundary highlighted in red is evident. Cut slopes still present and equipment left behind. See following photos.

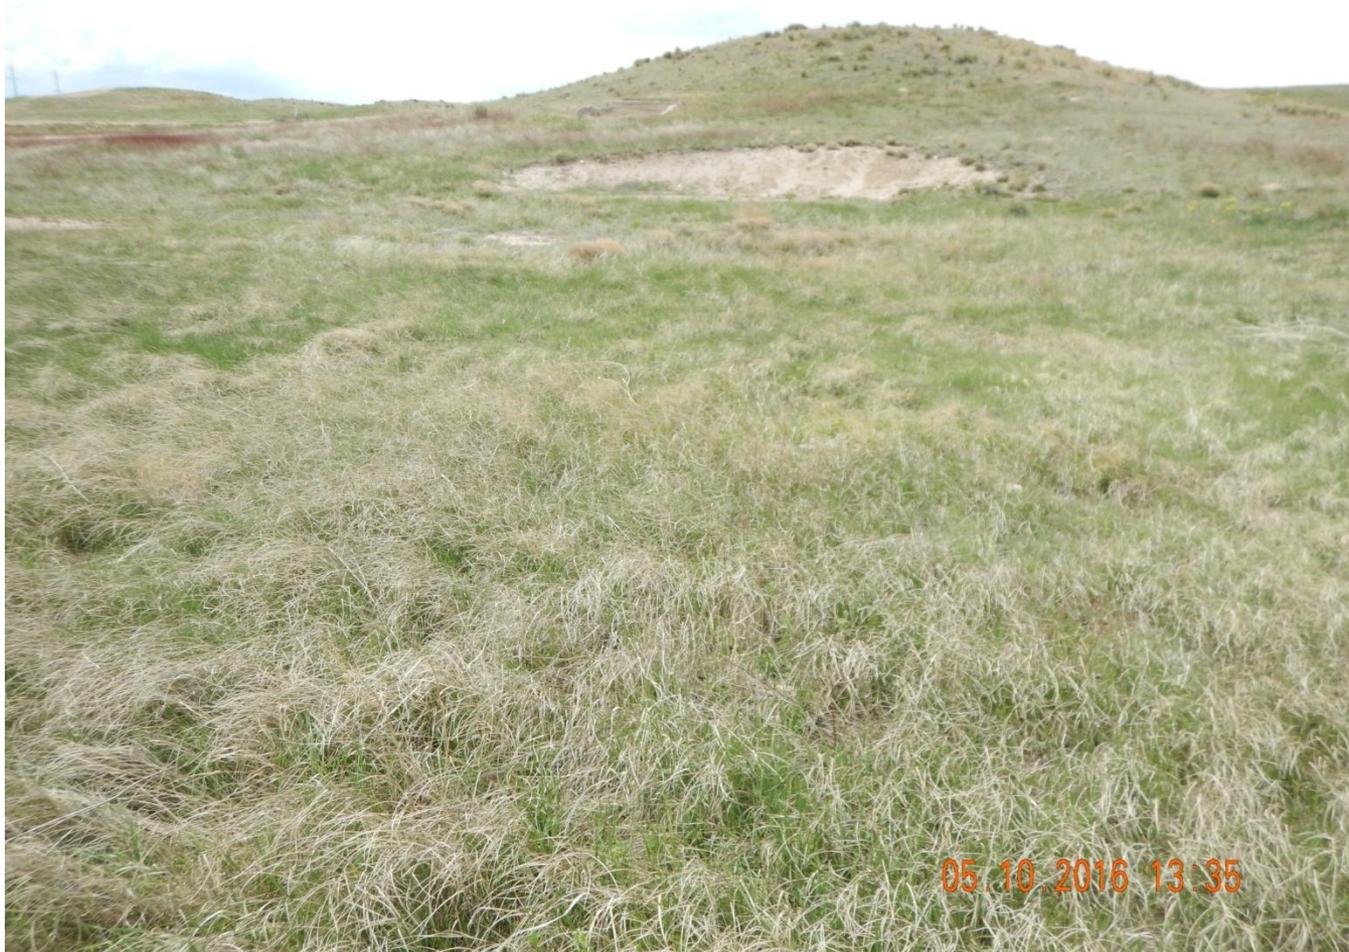
Photo 2. Photo taken from center of location, facing Northwest. Cut slope not stabilized with vegetation still in center of photo.

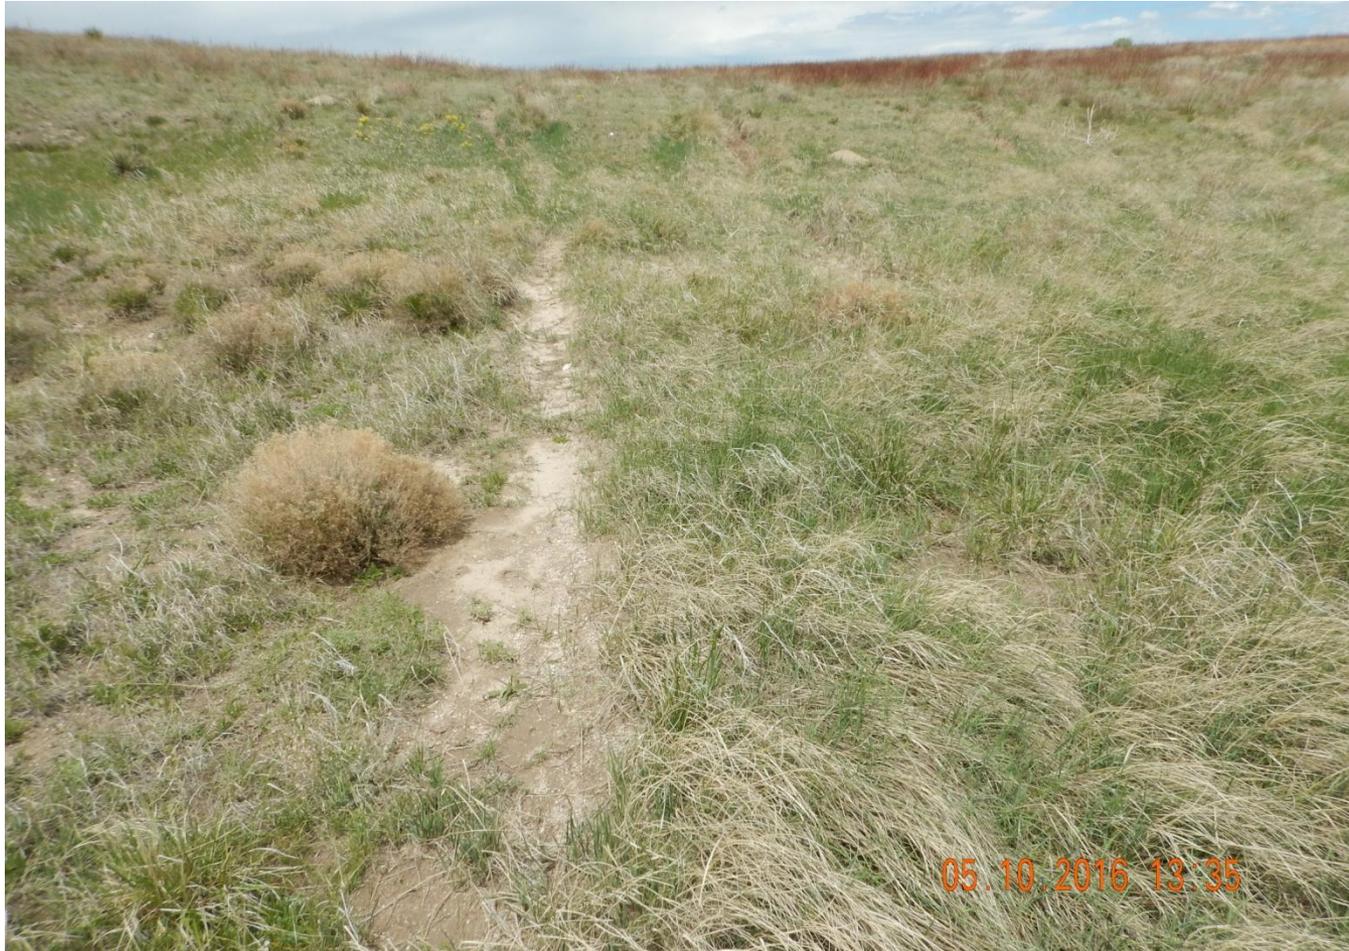
Photo 3. Photo taken from center of location, facing North. This portion of the location is good vegetation establishment. Cattle trails are present throughout the location from current land use.

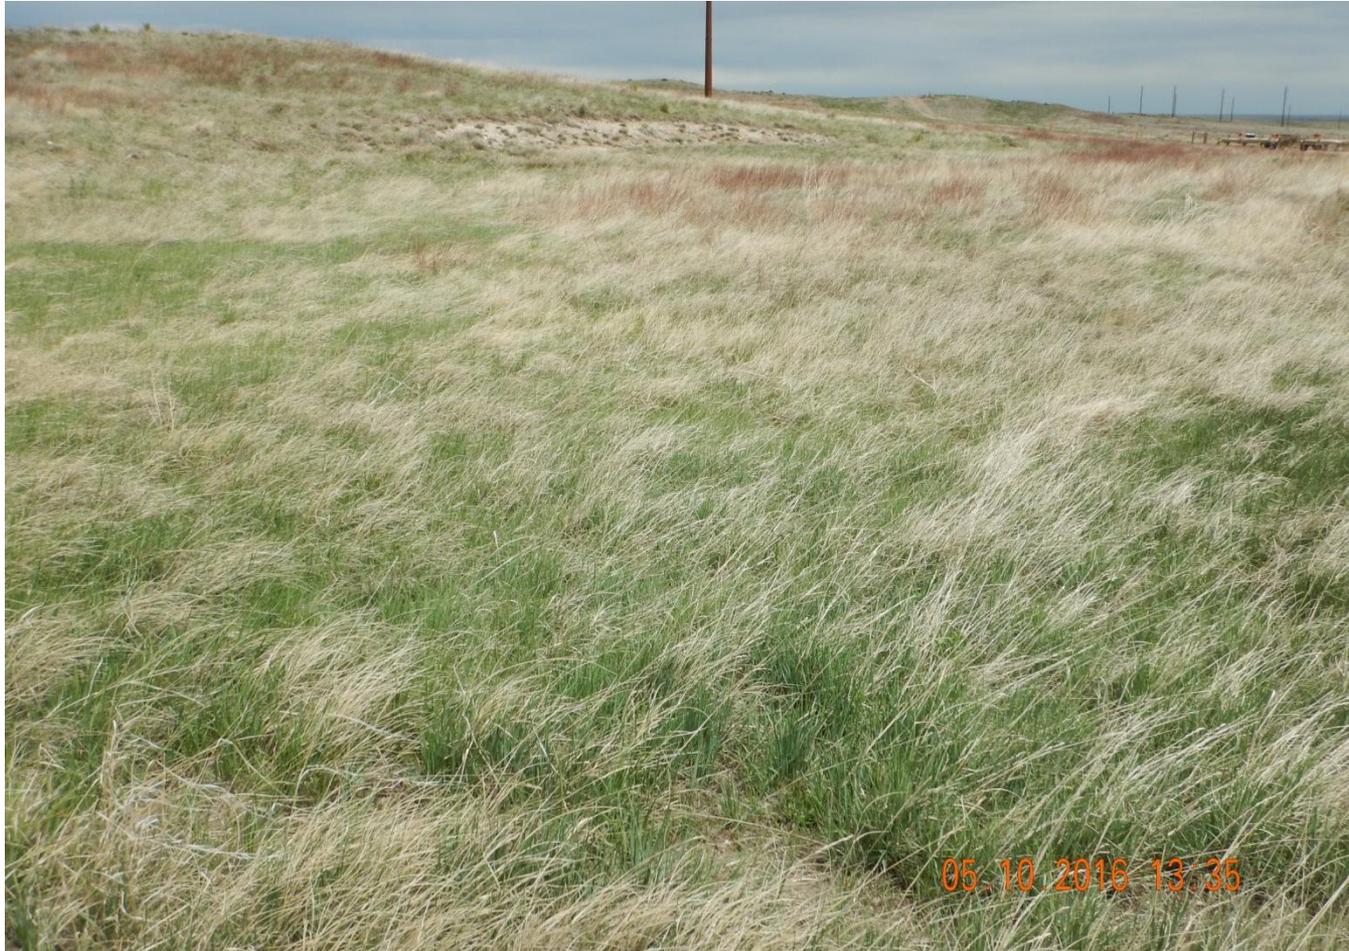
Photo 4. Photo taken from center of location, facing East. This portion of the location is good vegetation establishment but cut slope sparsely vegetated.

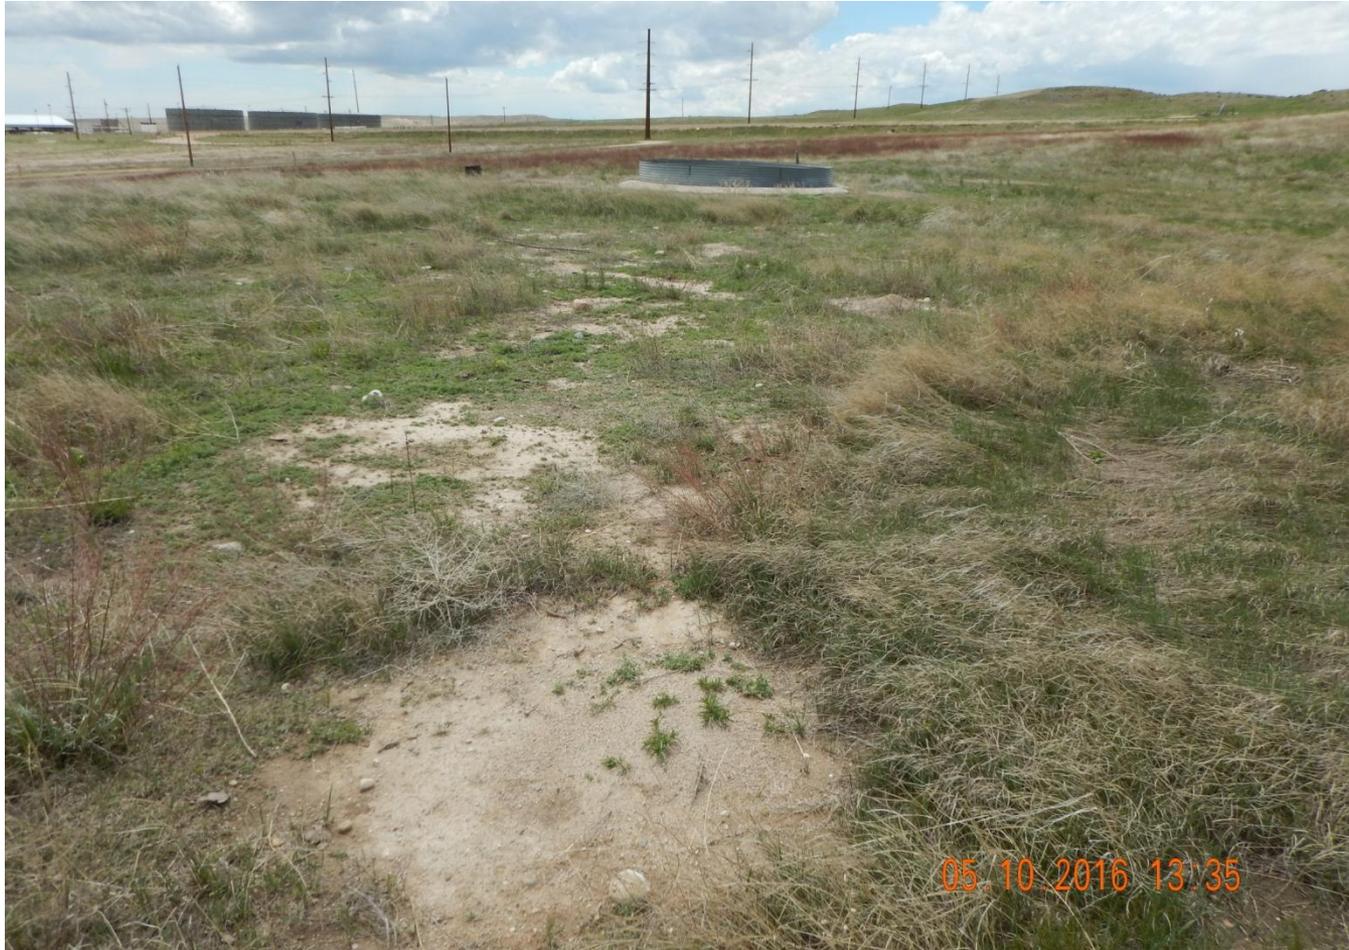
Photo 5. Photo taken from center of location, facing South. This portion of the location lacks uniform vegetative plant cover and is dominated by cheatgrass (*Bromus tectorum*).

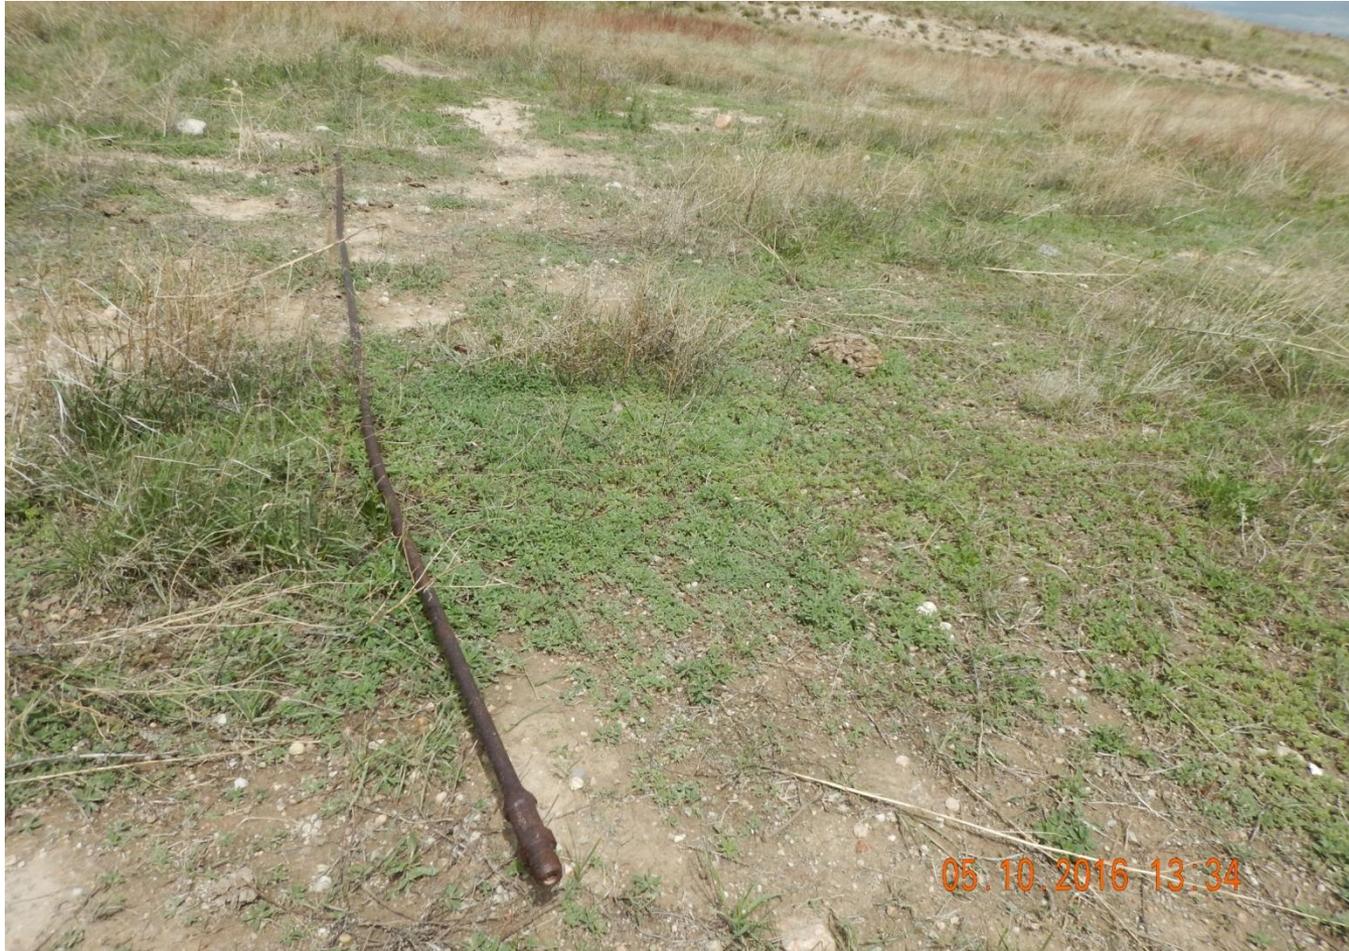
Photo 6. Photo taken from approximate location center. Equipment left behind.

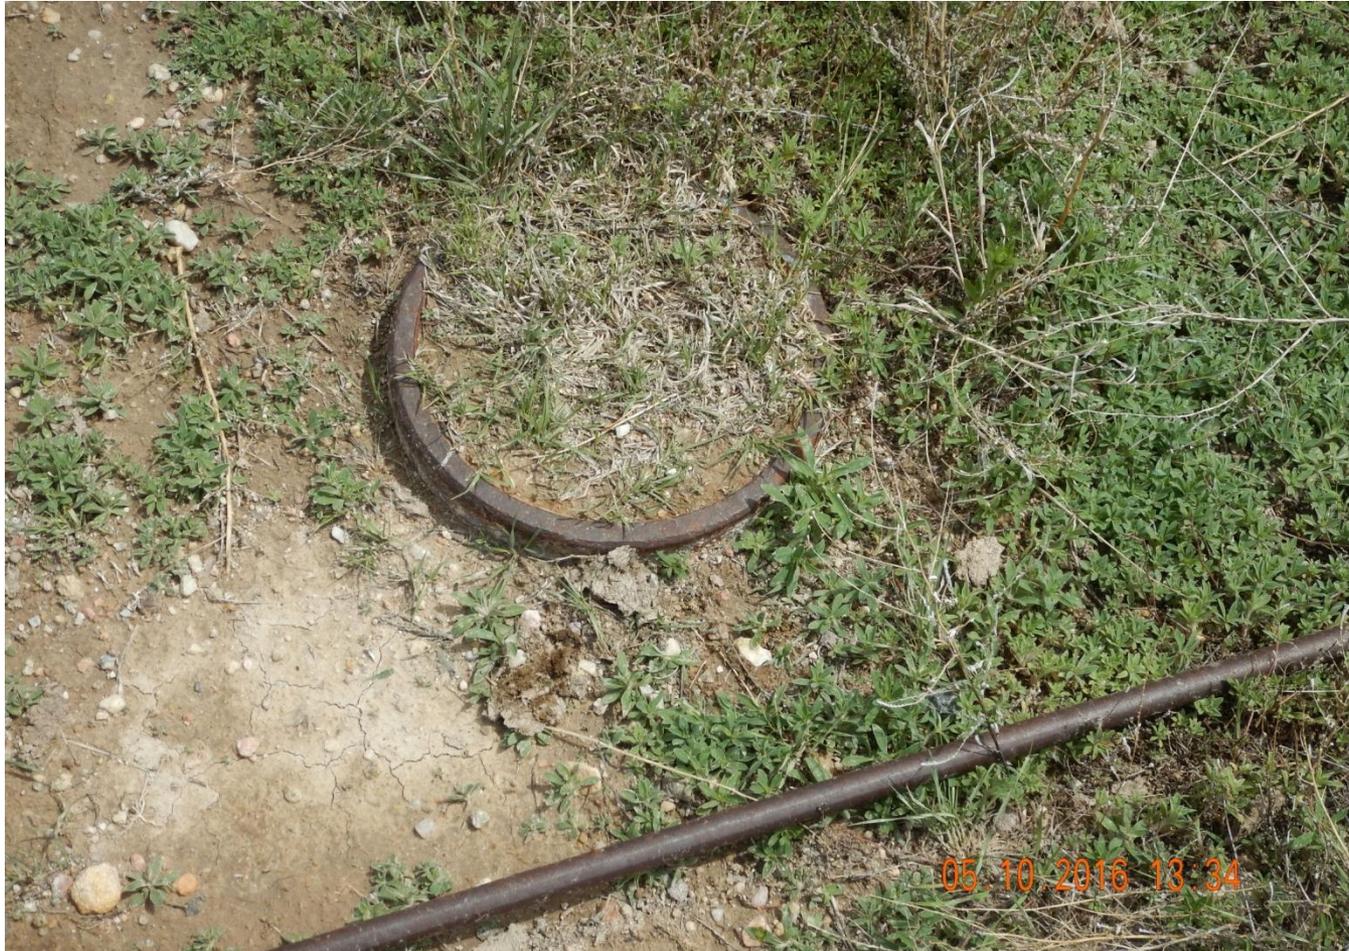
Photo 7. Photo taken from approximate location center. Equipment left behind.

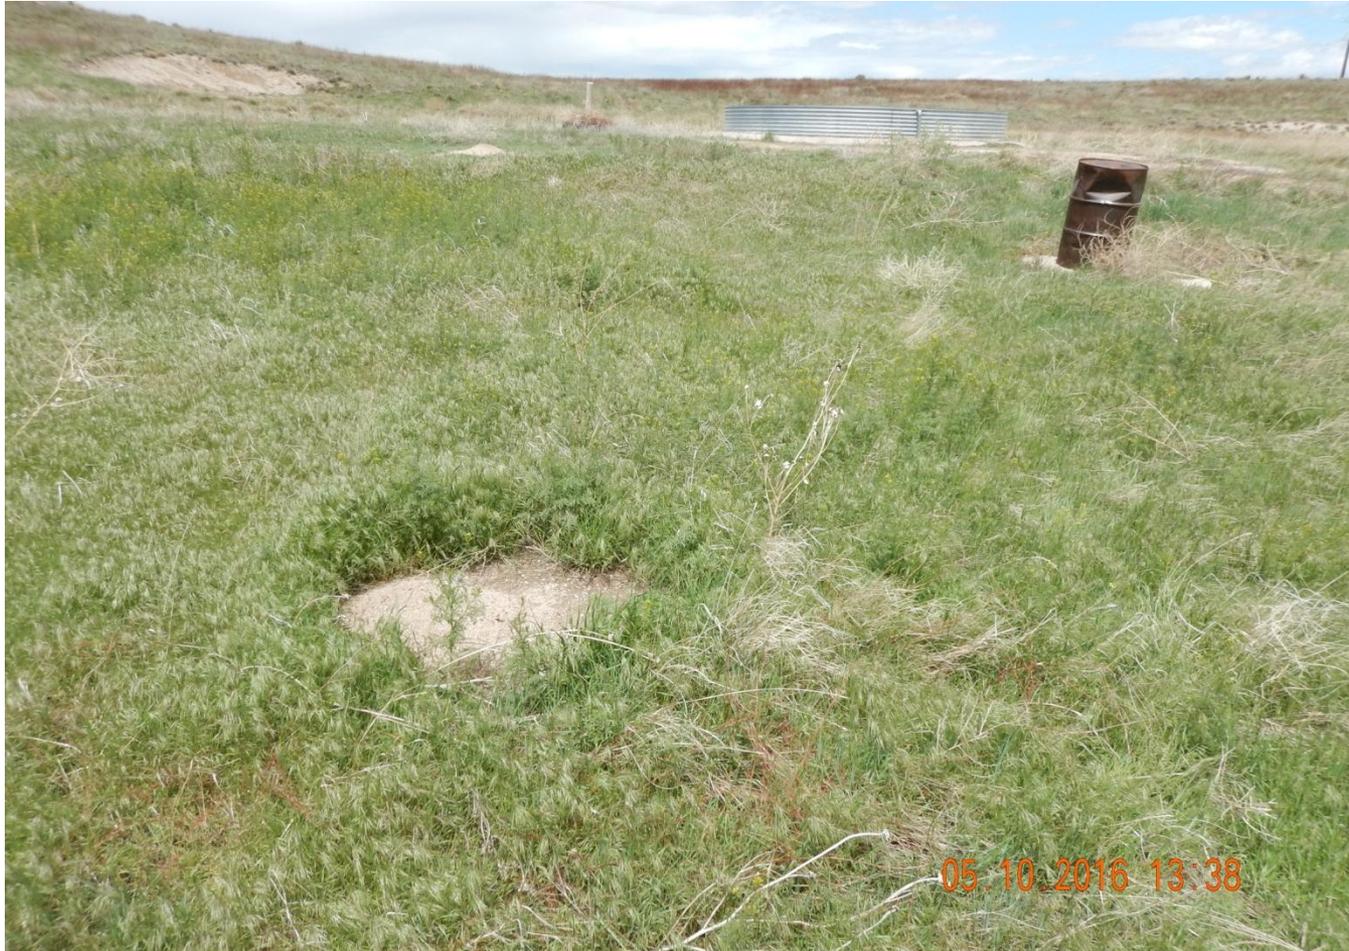
Photo 8. Photo taken from southern location, facing North. Cheatgrass throughout this portion of the location.
