Final Reclamation Inspection

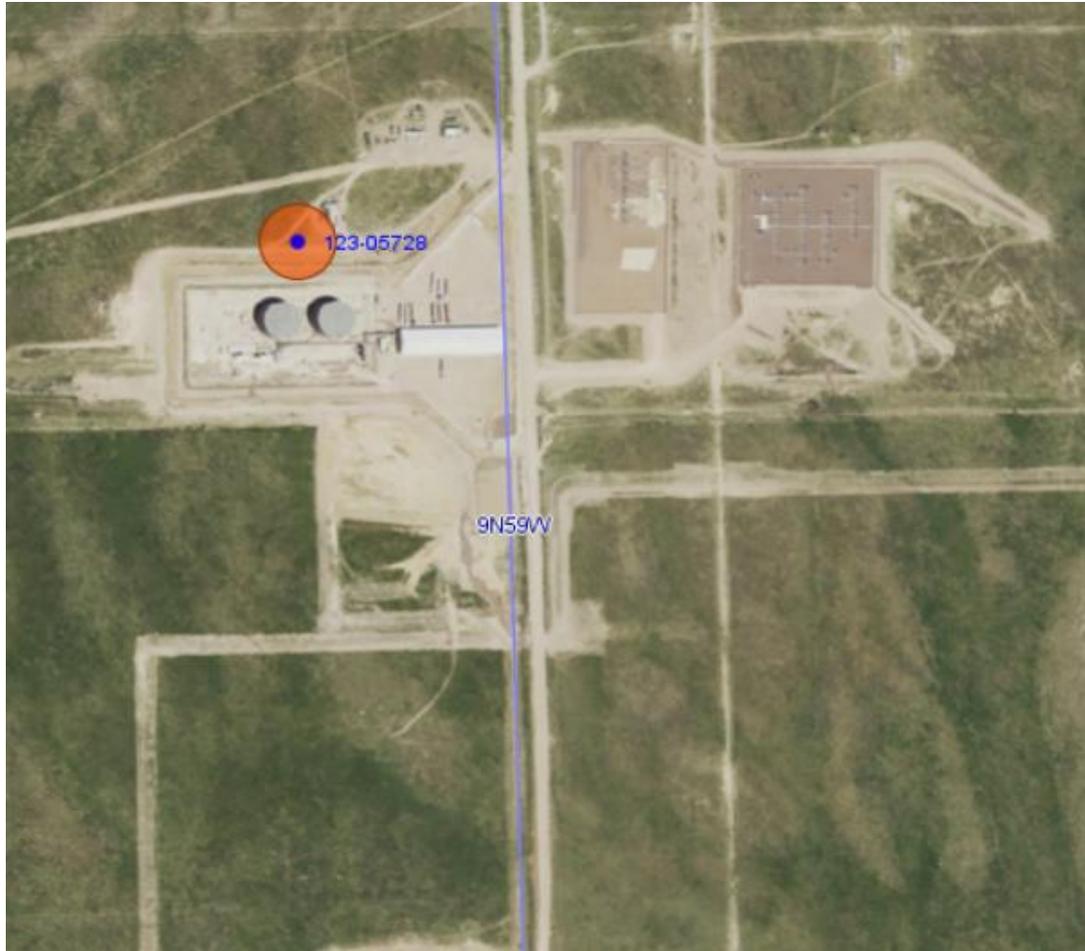
Photo 1. COGCC GISOnline aerial imagery taken 09/2015. Location has been recently developed into some type of industrial land use. Refer to following photos.

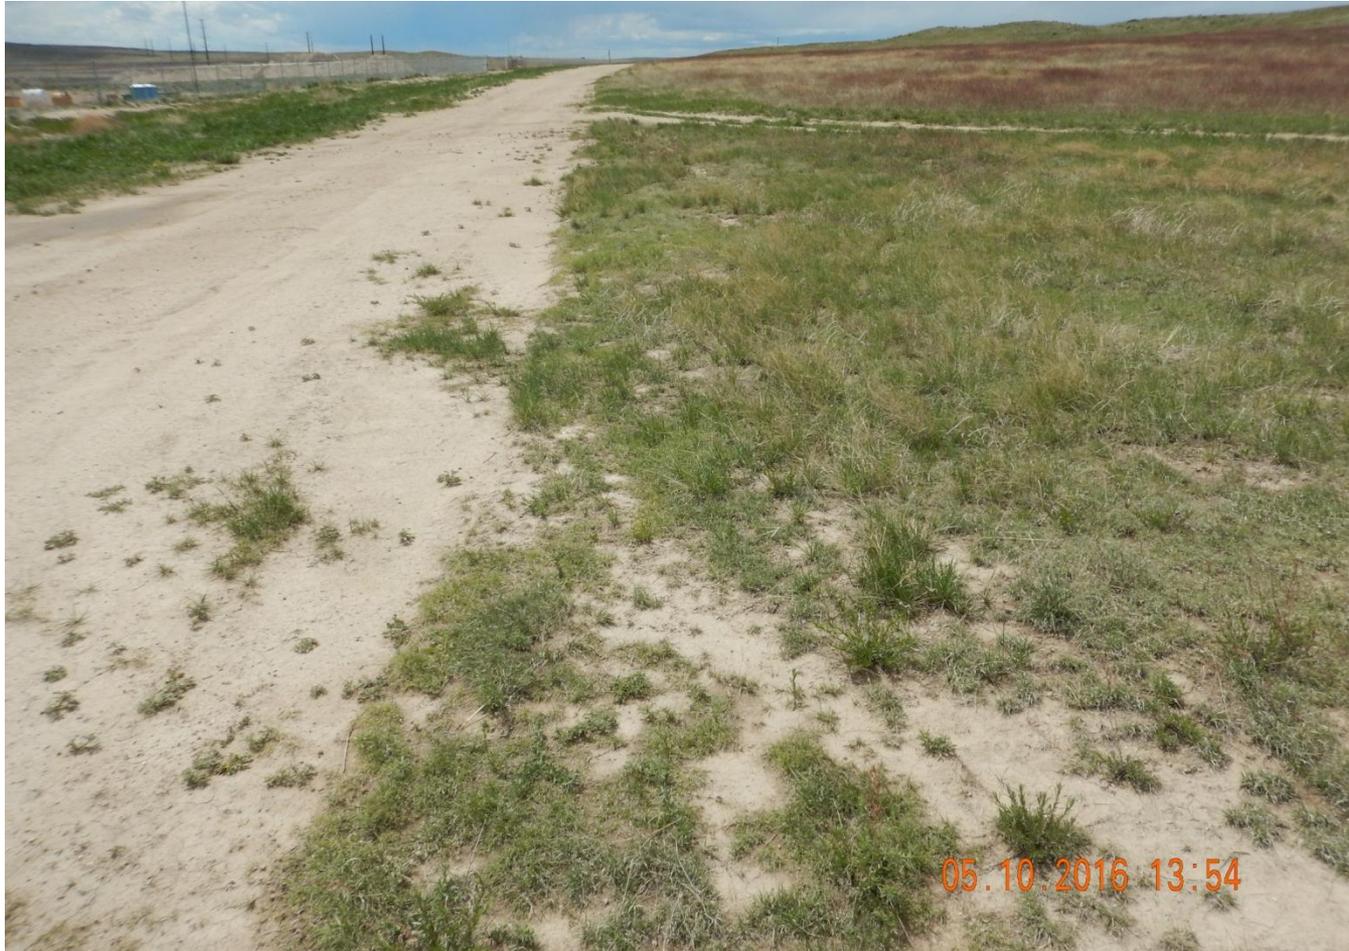
Photo 2. Photo taken from center of location, facing West. Location has been recently developed into some type of industrial land use.

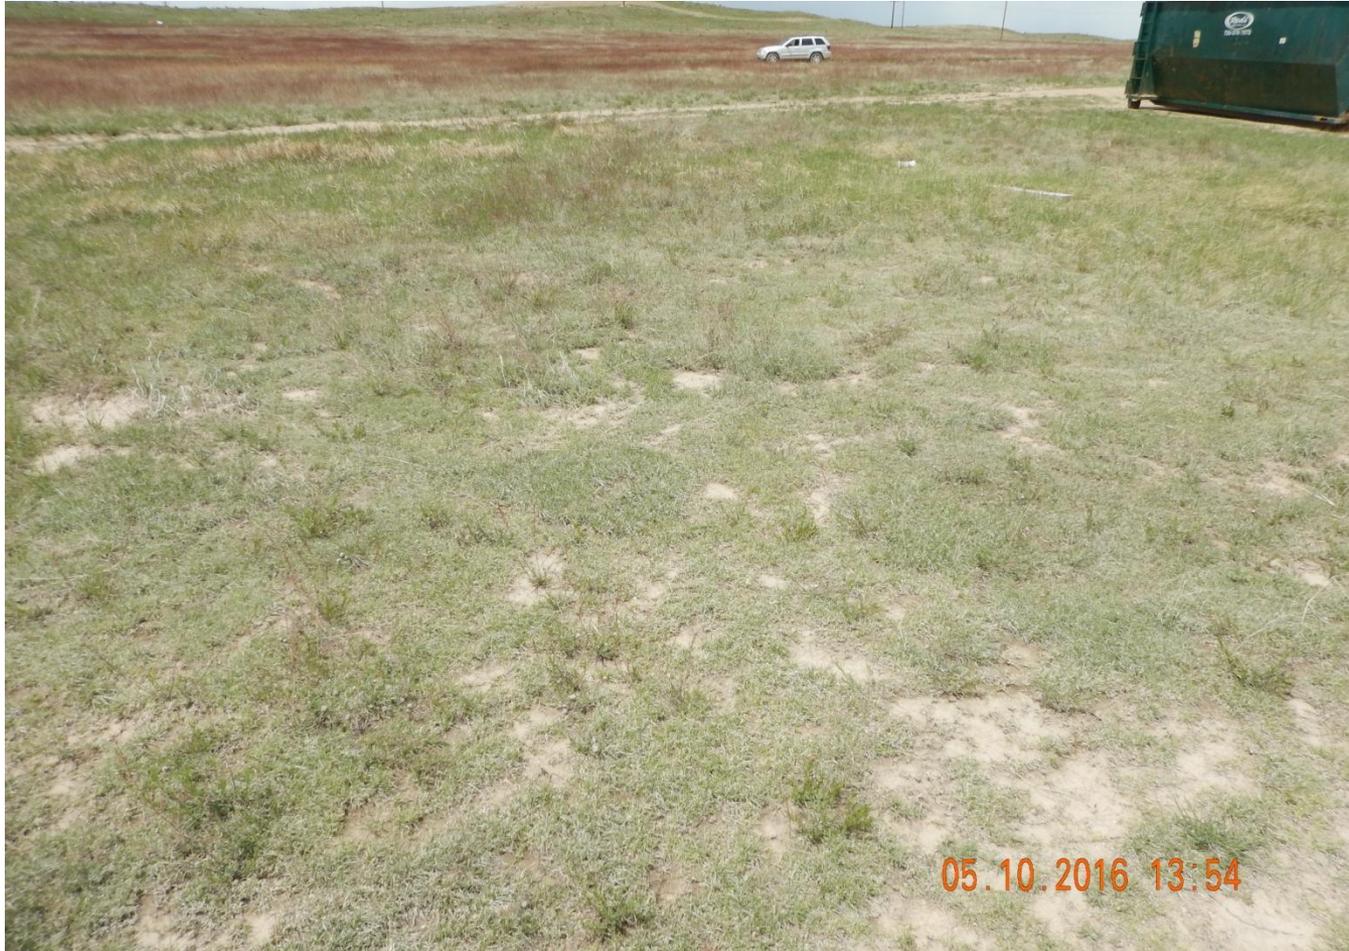
Photo 3. Photo taken from center of location, facing North. Location has been recently developed into some type of industrial land use.

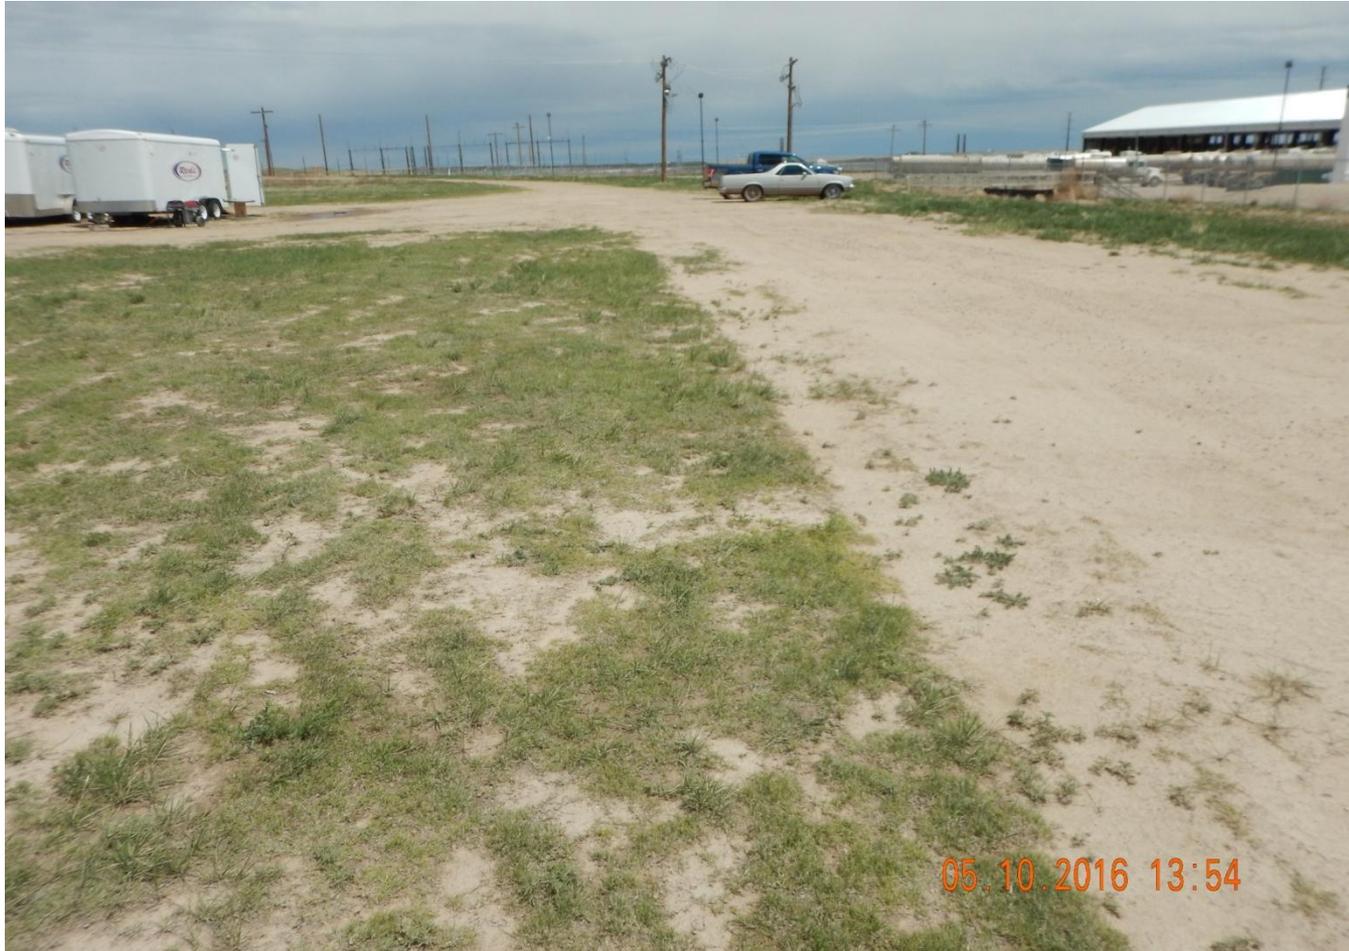
Photo 4. Photo taken from center of location, facing East. Location has been recently developed into some type of industrial land use.

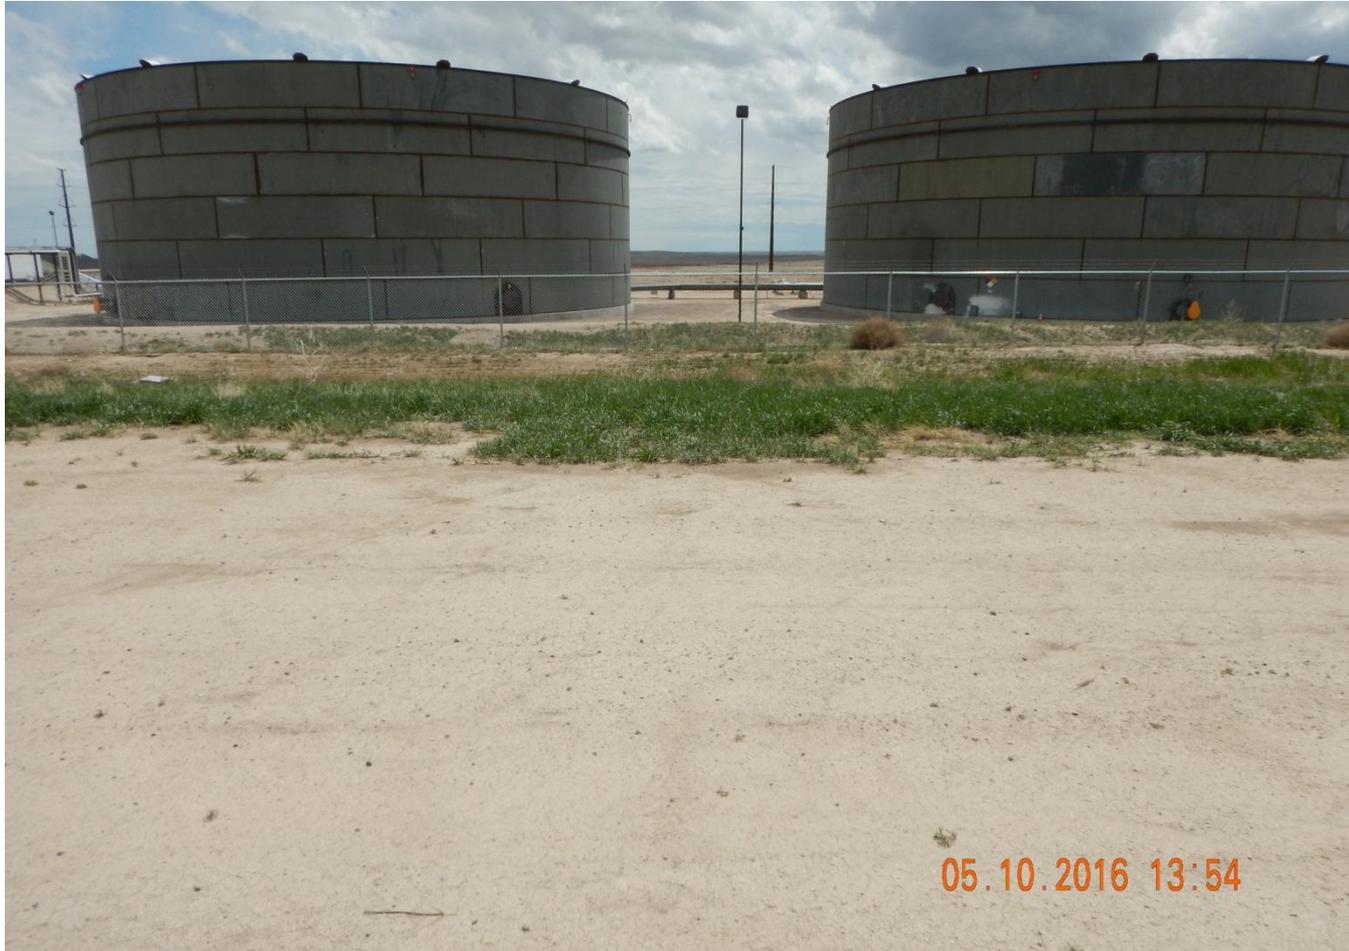
Photo 5. Photo taken from center of location, facing South. Location has been recently developed into some type of industrial land use.
