May 13, 2016

Inspection Photos: Silver Orphan API#081-06682

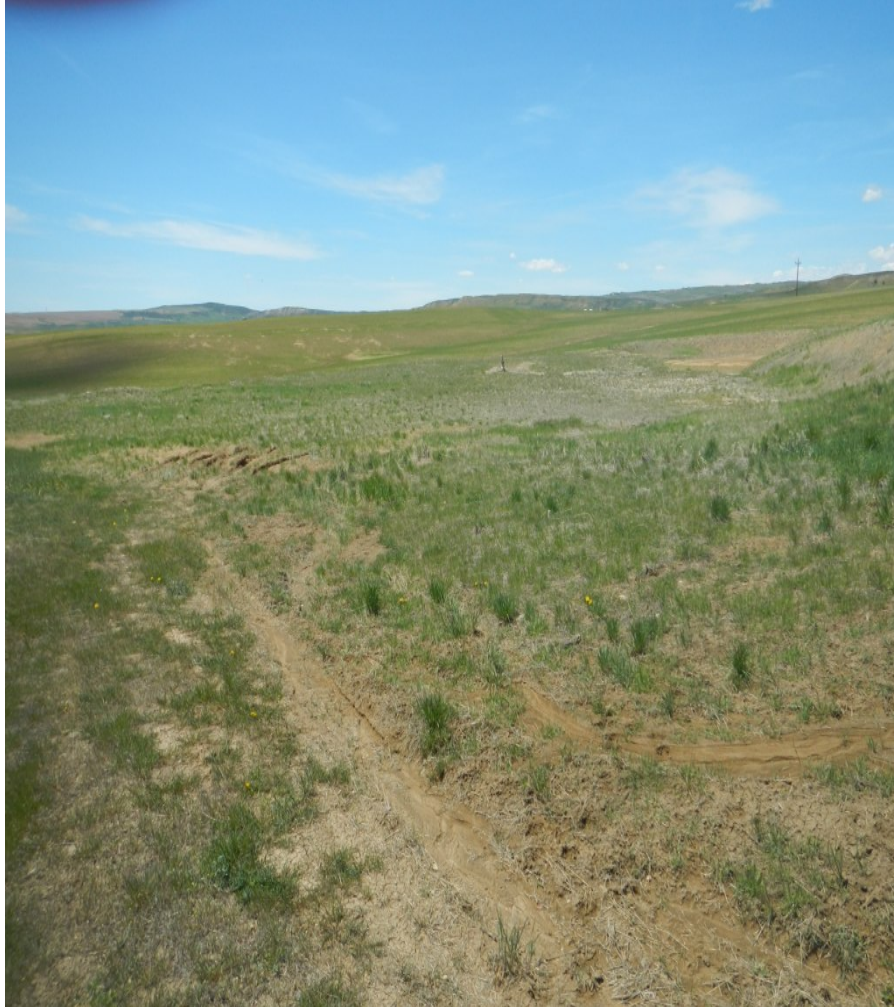
Photo#1:

View SE over Location.

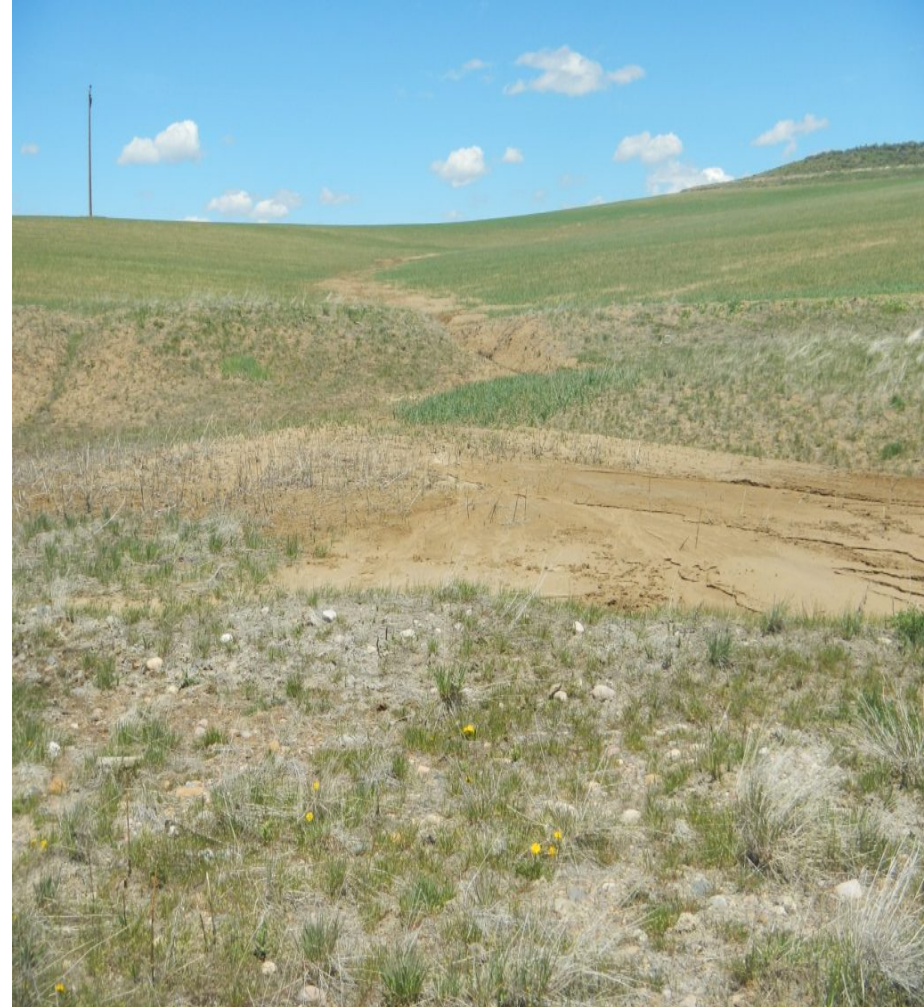
Photo#2:

Sediment Run-on from Crop Ground at NW Corner of Location..

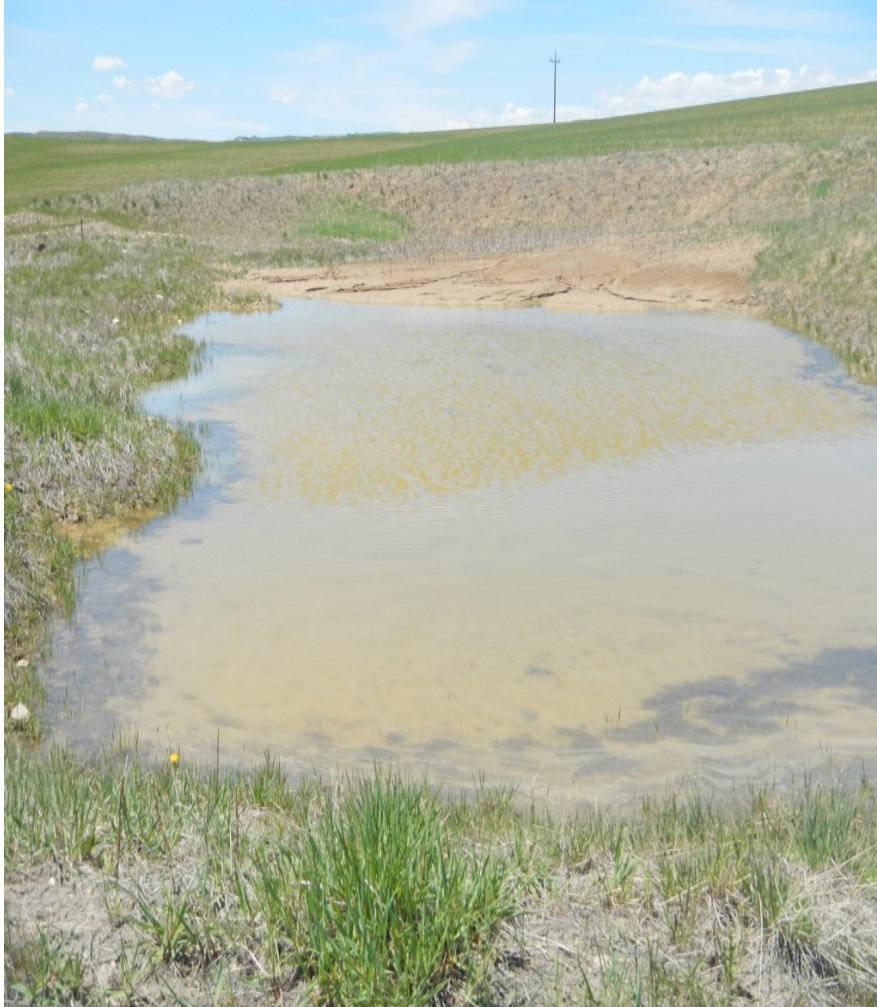
Photo#3:

Drainage Containment / Pit Area?

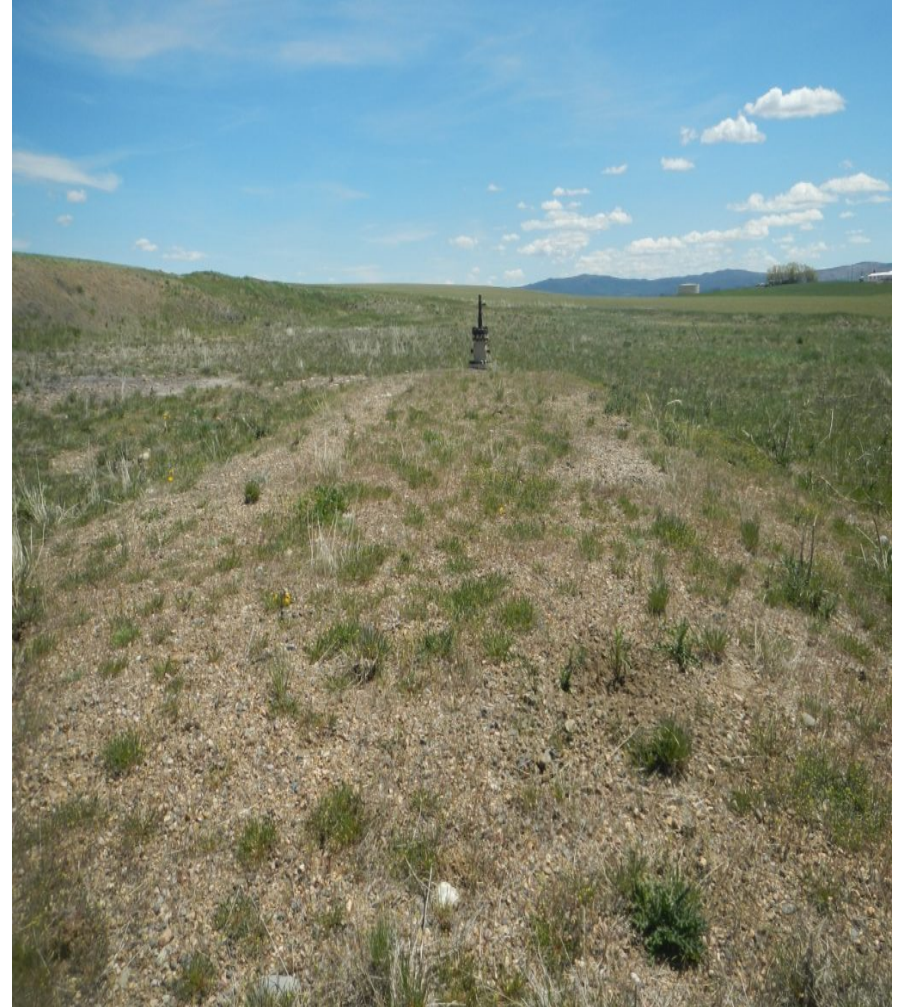
Photo#4:

Raised Well Head /Facility Area

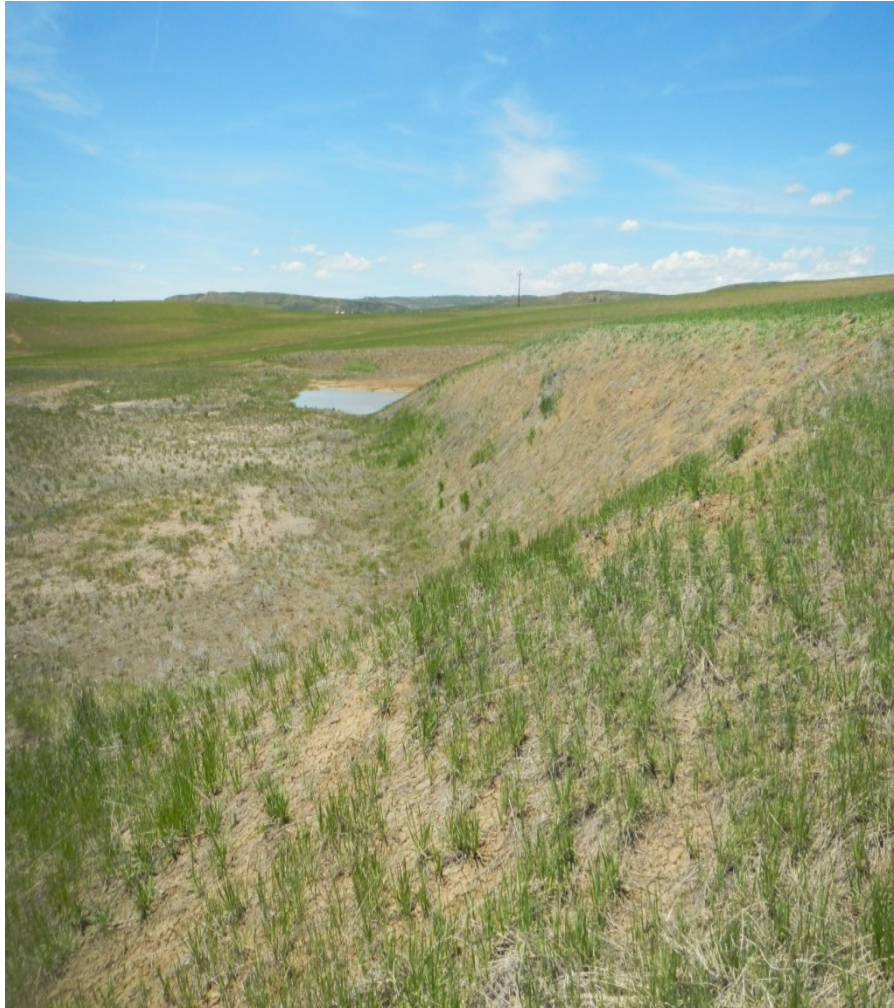
Photo#5:

View of Cut Slope from NE corner of Location.

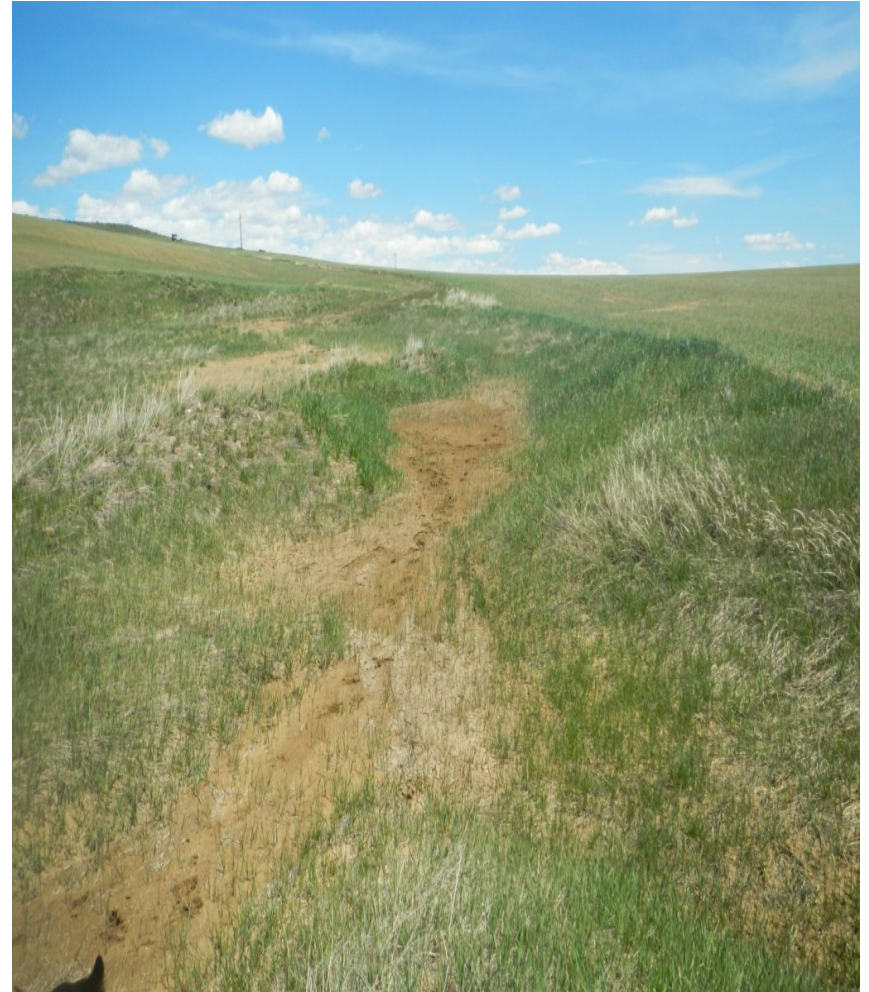
Photo#6:

Fill Slope containing Run-on from Crop ground.

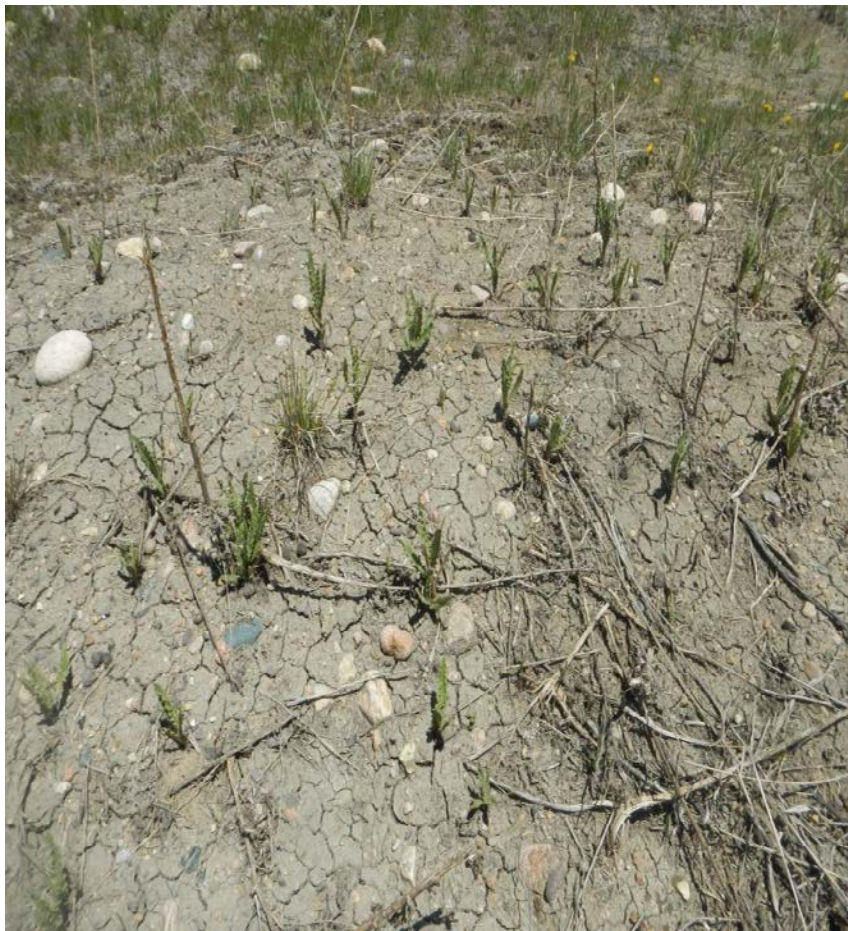
Photo#7:

Thistle Rosettes Emerging across Location

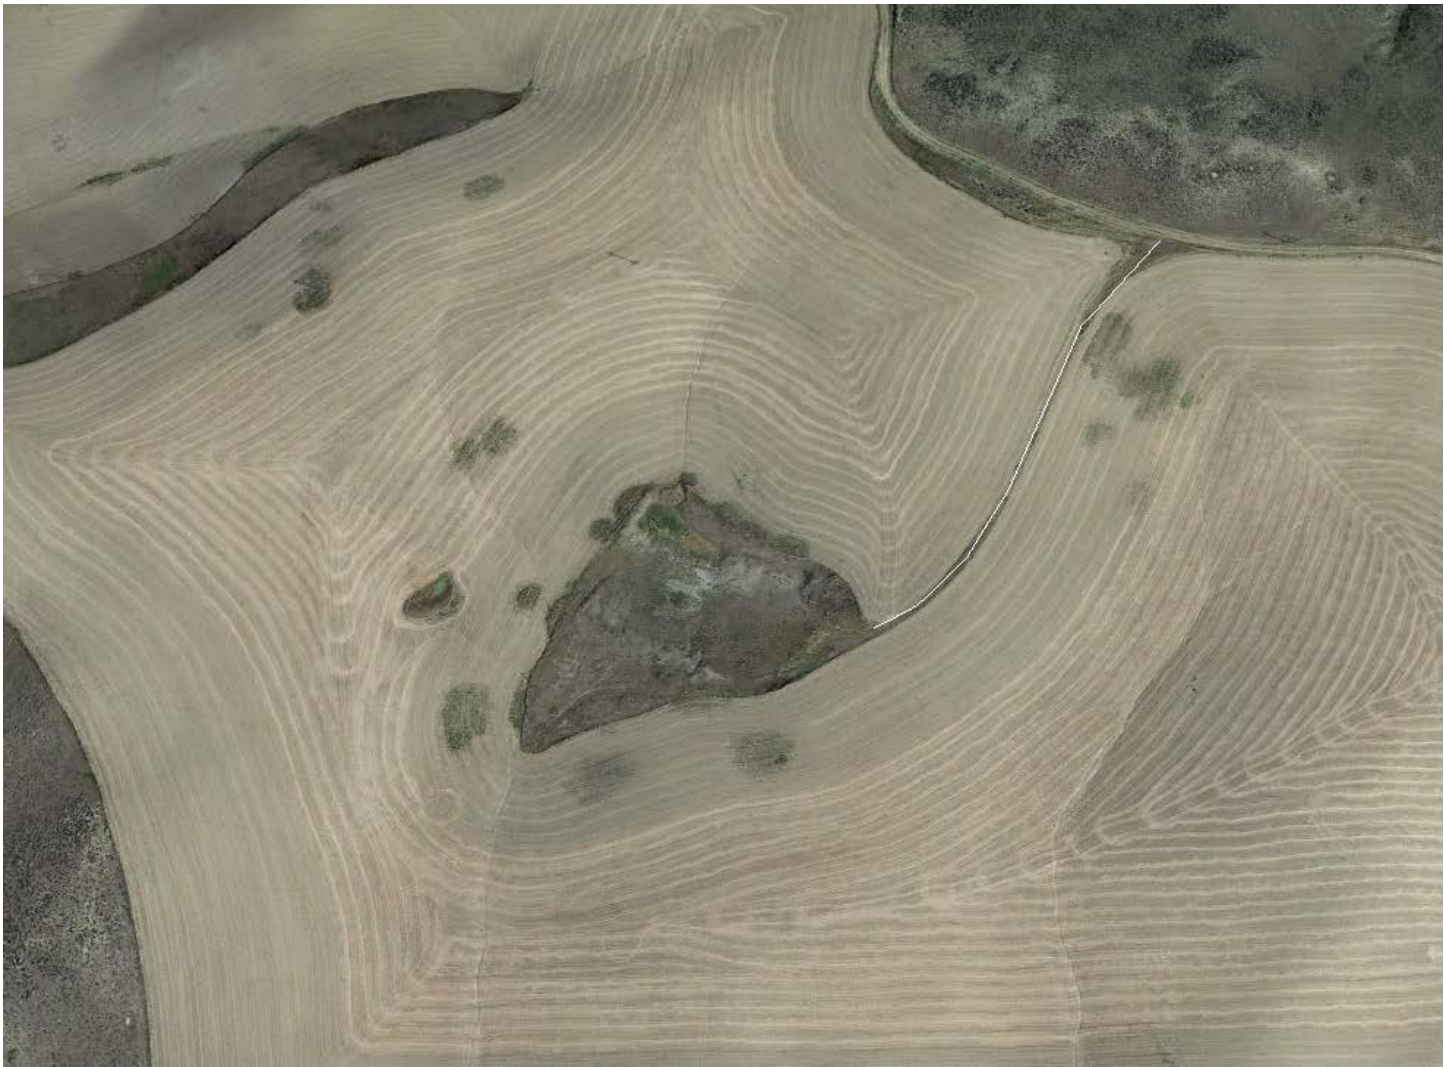
Silver Location surrounded by Crop Ground
